**NASA
Technical
Paper
2589**

September 1986

Impact Data From a Transport Aircraft During a Controlled Impact Demonstration

Edwin L. Fasanella,
Emilio Alfaro-Bou,
and Robert J. Hayduk

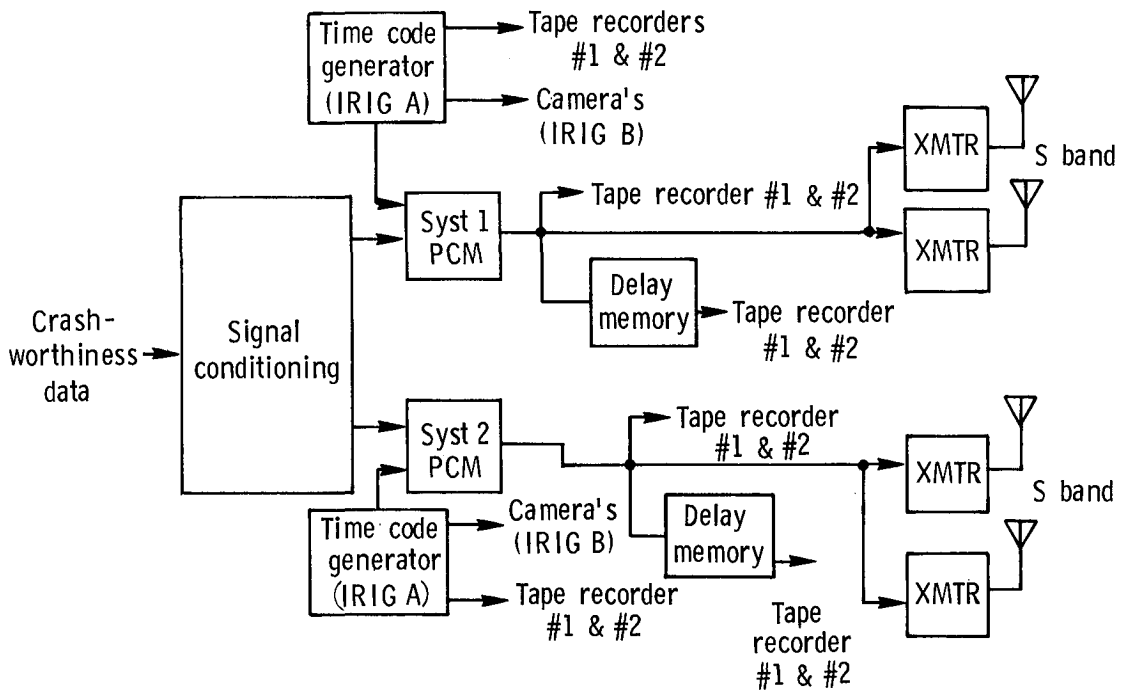
Figure 7. Block diagram of DAS.

Langley developed the complete instrumentation and data acquisition system (DAS) (fig. 7) for the CID. All accelerometers were piezoresistive and capable of measuring acceleration from 0 Hz to greater than 1000 Hz. The accelerometer maximum levels were set to approximately $\pm 150G$ for the normal (i.e., vertical) direction, $\pm 100G$ for the longitudinal direction, and $\pm 50G$ for the transverse direction.

The DAS, as designed, included two independent systems each capable of collecting and processing data from 180 sensors. The signal conditioning units (used in the DAS) had 30 channels per unit. There were six of these systems in each DAS for a total of 180 channels, of which 176 were used for data and the balance for system monitoring. The gain in the units ranged from 1 to 1000, with a full-scale output of 5 V into the pulse code modulation (PCM) system.

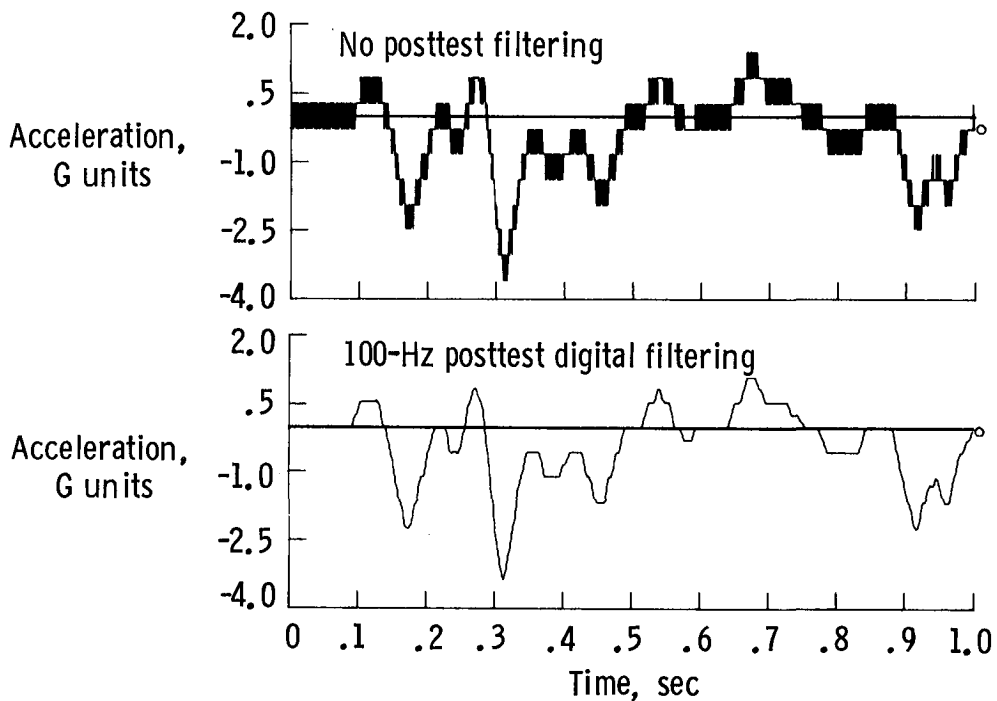
Figure 8. Data as recorded and digitally filtered.

Posttest low-pass digital filtering with a computer algorithm was performed on the data. In the frequency domain, a cosine function was arbitrarily used to represent the roll-off region (ref. 11). The digital filter was used to "smooth" the digital nature of the data and to remove unwanted high-frequency variations that were associated with the sample rate (fig. 8). All structural accelerations were digitally filtered with a low-pass 100-Hz digital filter, and the strain-gage instruments (restraint forces, bending bridges, and load links) were filtered with a low-pass 50-Hz digital filter.

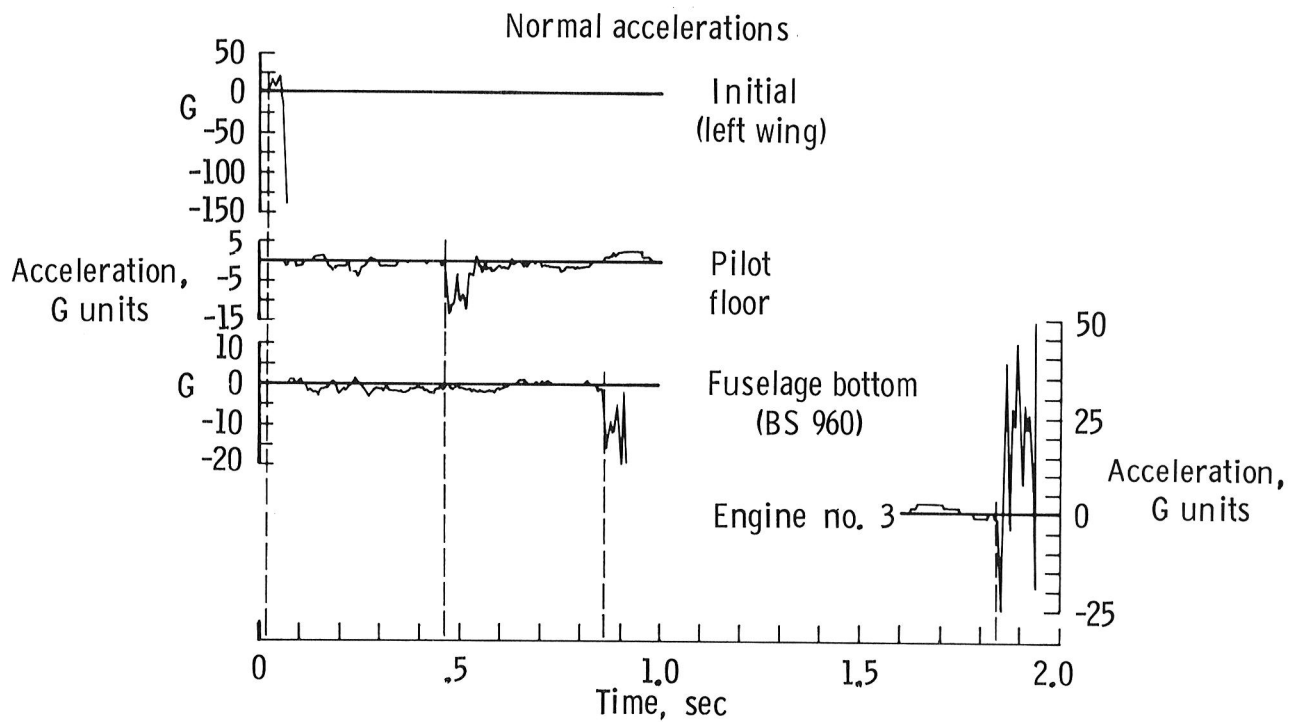
Figure 10. CID sequence of events.

The sequence of events during the first few seconds after impact is shown in figure 10 by a select set of vertical acceleration time histories. The time origin was chosen as 09:22:11 Pacific standard time (PST). The time from initial left-wing impact to the impact of the right-wing inboard engine with the wing opener was almost 2 sec. Since the fuselage impact was nose down, the nose-to-tail progression of structural response can be seen from the pilot-floor and BS 960 curves in figure 10.

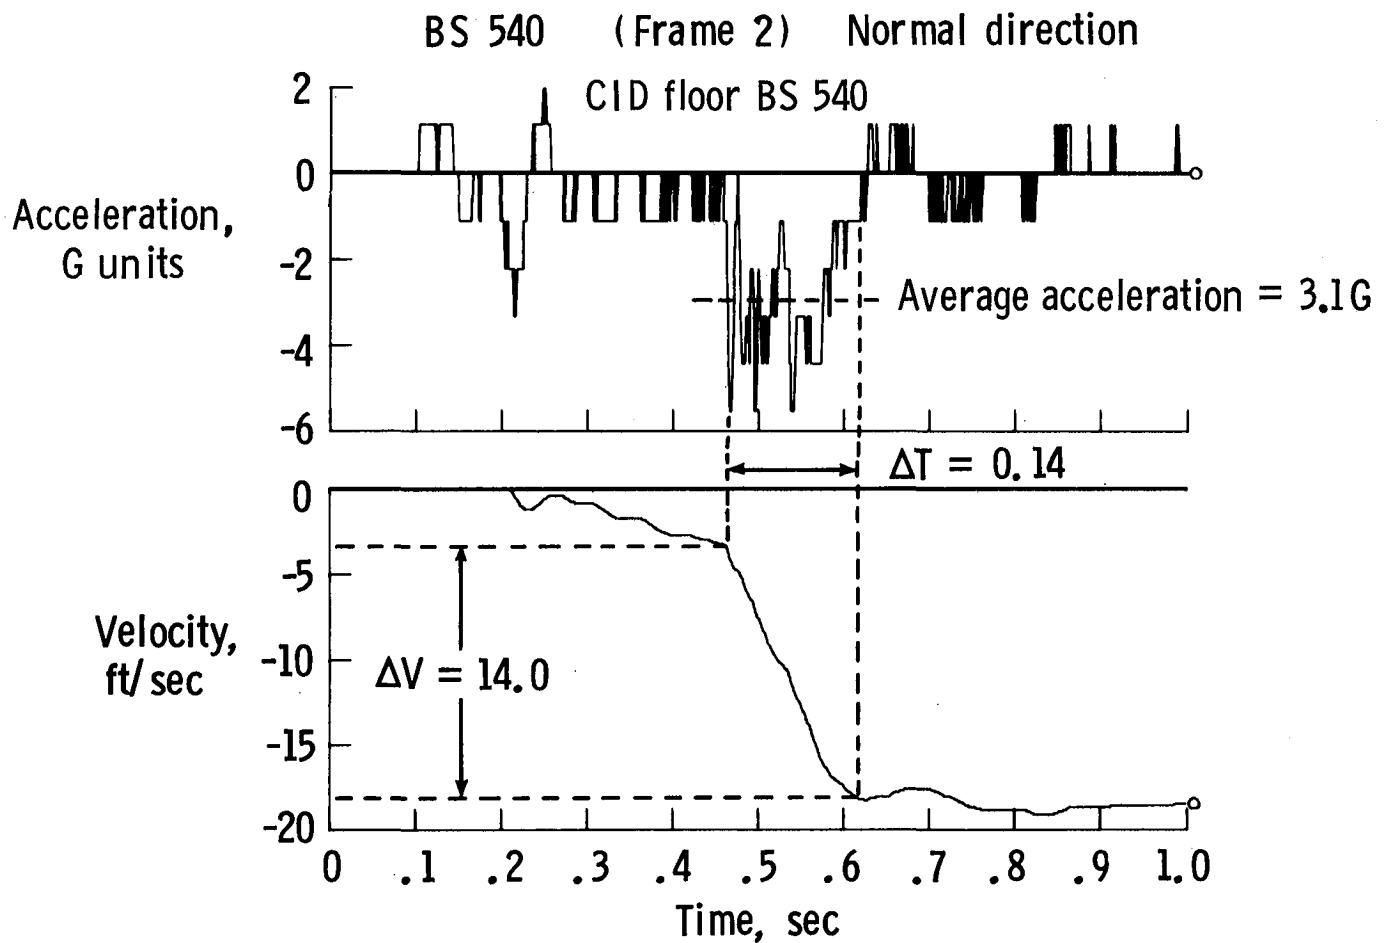
Figure 13. An example of acceleration, velocity change, and average acceleration for a typical data channel. The triangular equivalent pulse would have a peak acceleration of $6.2G$ (twice average).

The peak averaged acceleration data point corresponding to a particular time history is determined in this manner: The pulse duration corresponding to the primary impact is determined. Integration over this interval yields the change in velocity which, when divided by the duration, yields the average acceleration. Doubling the average acceleration to obtain the data points represented by pluses is effectively a triangularization of the actual acceleration pulse. (See fig. 13.)
