NASA Technical Memorandum 87719

# Technique for Measuring Side Forces on a Banked Aircraft With a Free-Swiveling Nose Gear

Sandy M. Stubbs and John A. Tanner

AUGUST 1986

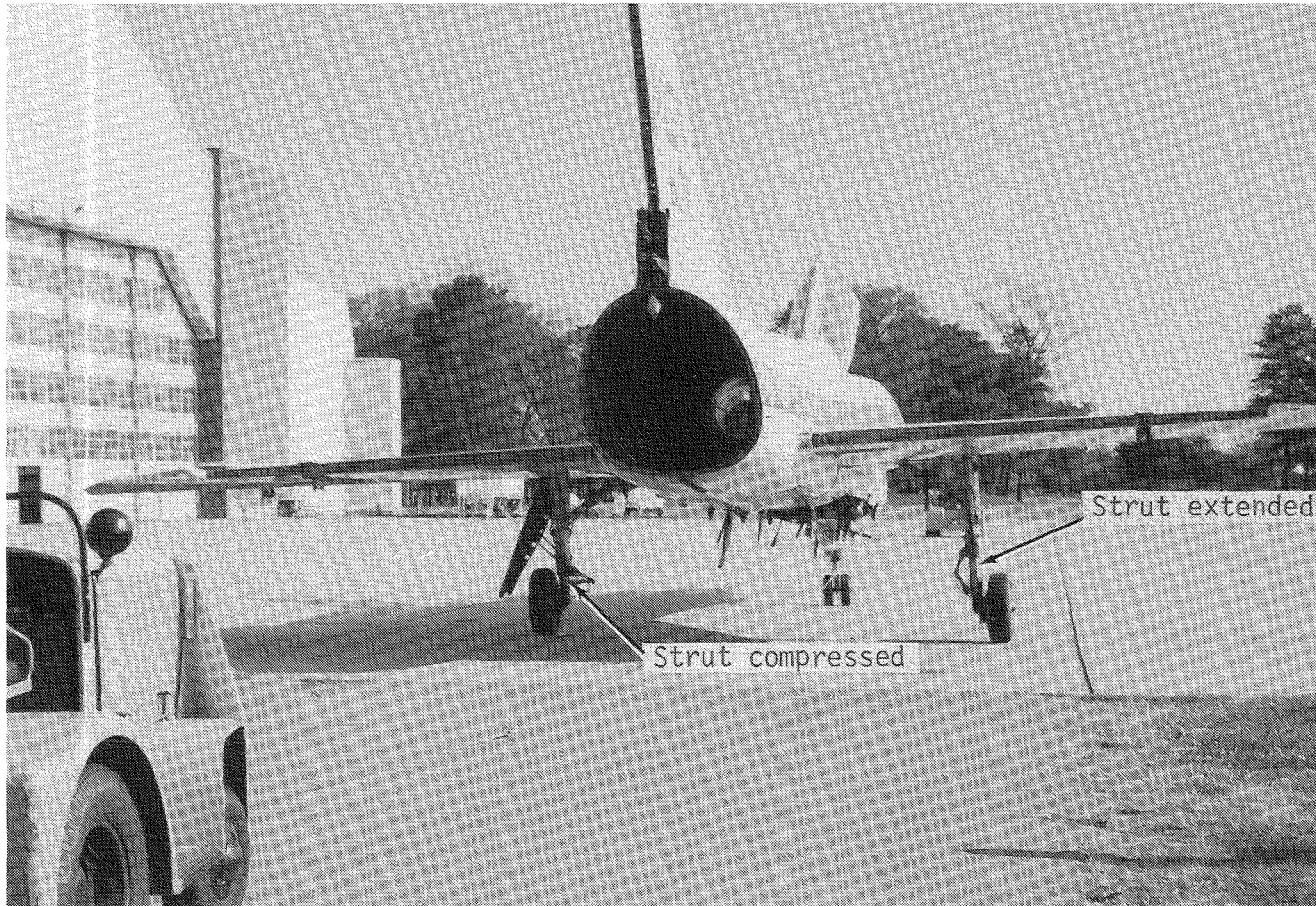
L-83-10,614

Figure 3. Differential strut strokes to produce bank angle of  $3^\circ$ .

Bank angle was obtained by reducing the strut charge pressure in the left main gear strut as shown in figure 3. The left main gear strut was stroked 9 in. more than the right main gear to give the vehicle a bank angle of  $3^\circ$ . No attempt was made to assure that the nose gear strut was vertical in the fore and aft plane.

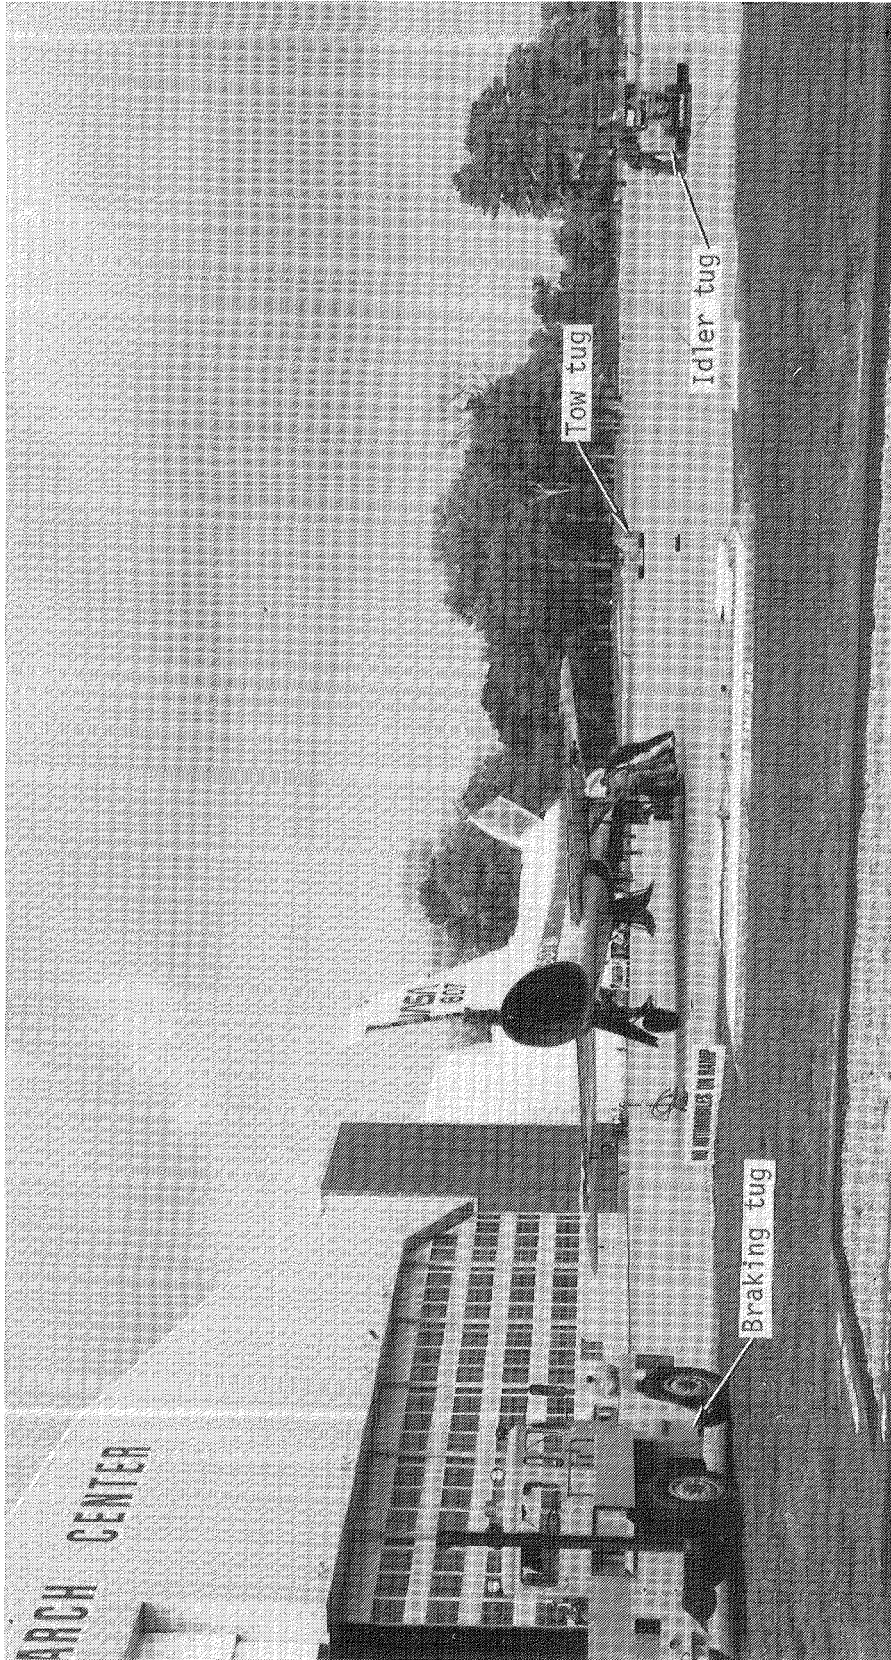
L-83-10,545

Figure 7. F-106 tow test setup.

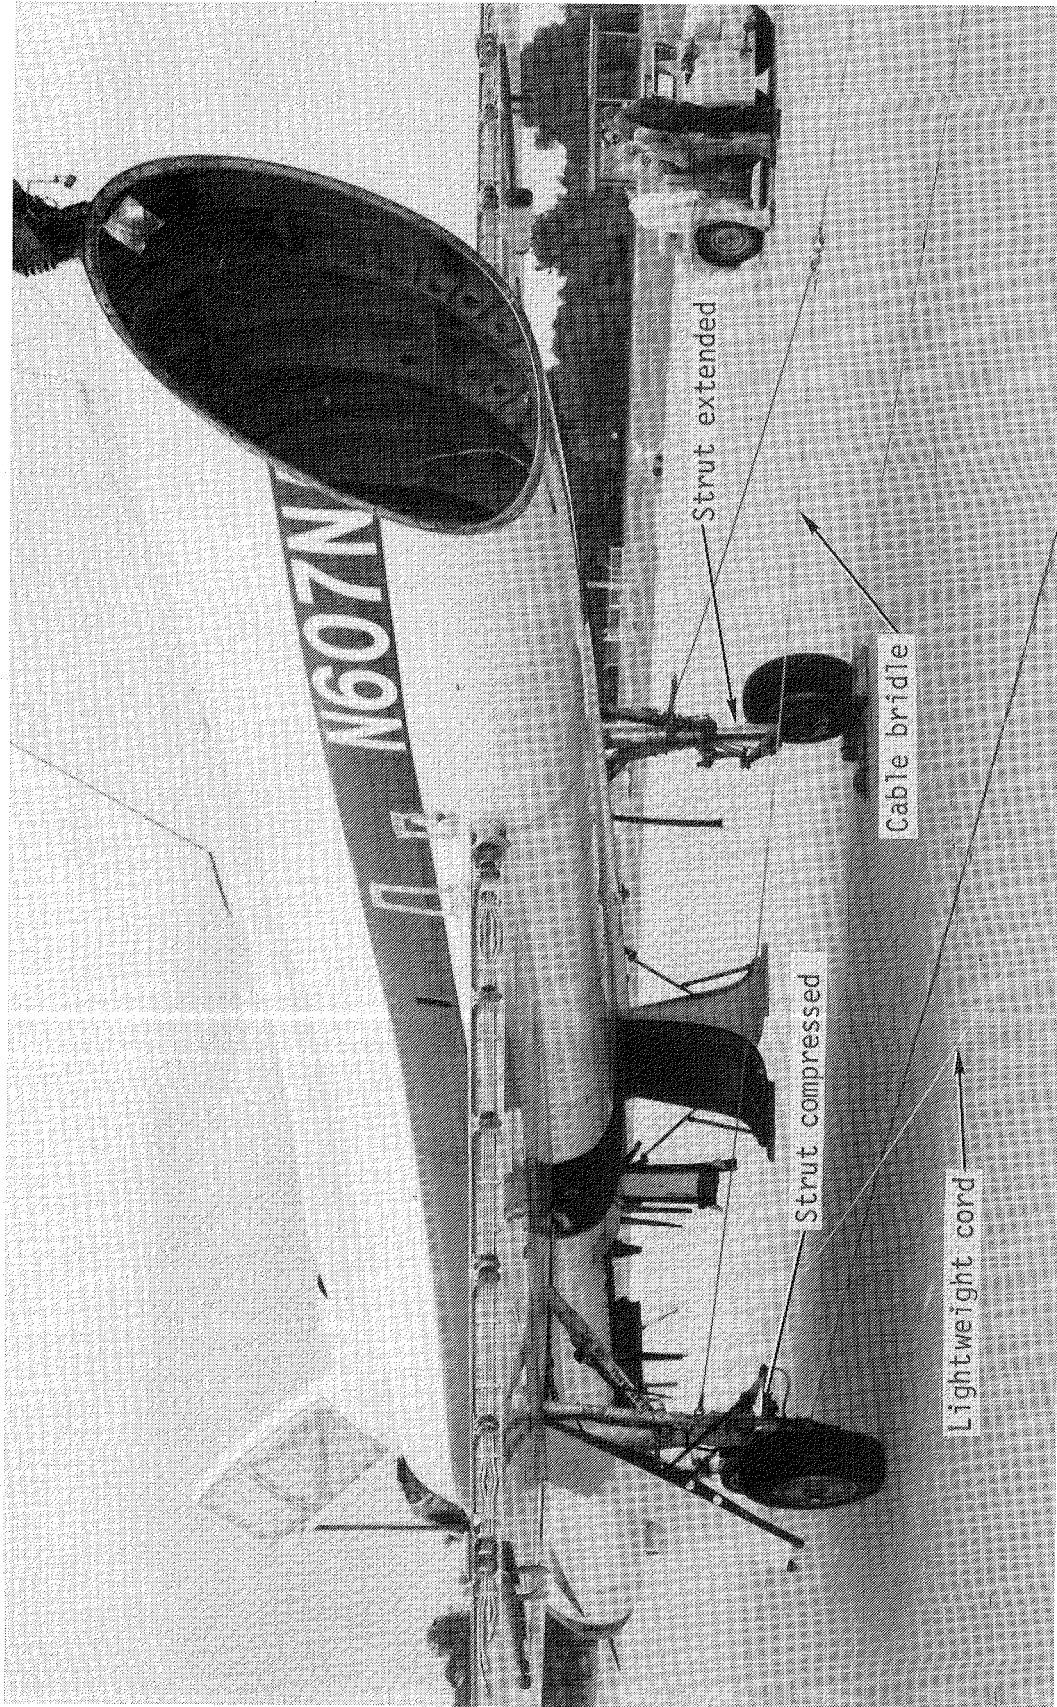
L-83-10,542

Figure 8. Cable bridle for braking tug.

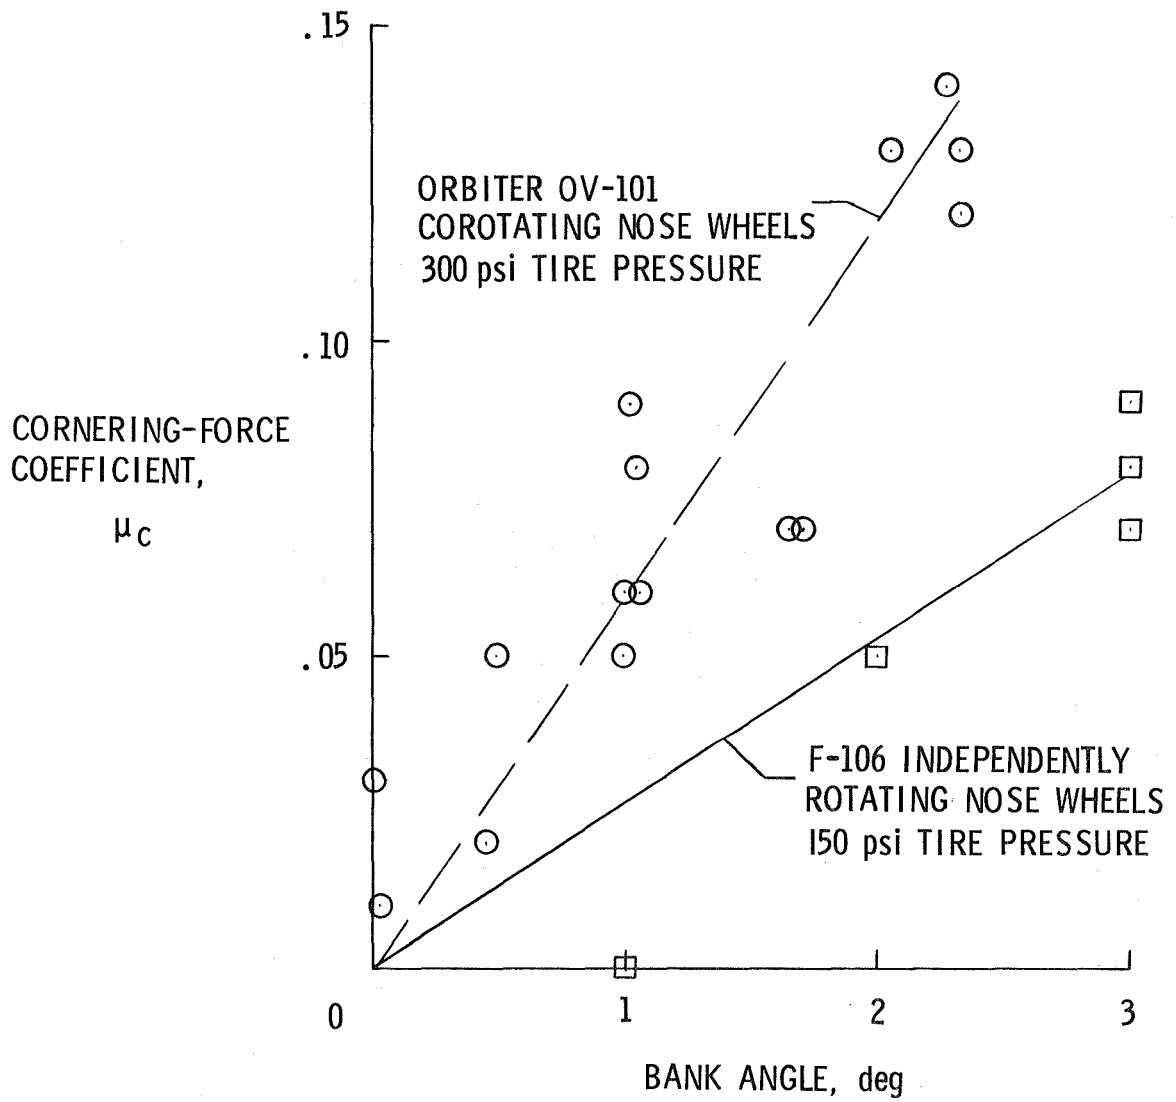
Figure 16. Cornering-force coefficients for both Shuttle orbiter OV-101 and F-106 for bank angles up to 3°.

For both the F-106 and the Shuttle orbiter, the side force divided by the normal force of the nose gears gives the cornering-force coefficient,  $\mu_c$ , listed in tables I and II and plotted in figure 16. Some of the scatter in the circular data points for the Shuttle orbiter may be caused by slight wind effects and small runway crown effects or a tow distance insufficient to

permit a good fairing of the side-force data. Winds were slight, and crown effects were small; therefore, no attempt was made to normalize these factors. The dashed line, which is a fairing of the circular data points, has a slope of  $0.06\mu_c$  per degree.

The square symbols in figure 16 are the cornering-force coefficients for the F-106 aircraft for bank angles up to  $3^\circ$ . The solid line is a fairing of the data forced through zero. The solid line fairing has a slope of  $0.026\mu_c$  per degree. The F-106 data presented are only for nose tire pressures of 150 psi.

The data for both aircraft are shown together in figure 16 for convenience only, since the tire pressures, normal loadings, geometric trails, and tire sizes were quite different. In spite of the fact that the aircraft are quite different, it was felt that the effect of corotation was the major cause for the different slopes of the two straight-line fairings. The F-106 had independently rotating nose wheels, and the orbiter had corotating nose wheels. Additional data from tests subsequent to those of this report were published in reference 2 and indicate that corotation of nose wheels causes much higher side forces than independently rotating nose wheels.
