NASA Technical Memorandum 87771

TENSION STRENGTH OF A THICK GRAPHITE/EPOXY
LAMINATE AFTER IMPACT BY A 1/2-IN.-RADIUS IMPACTOR

C. C. Poe, Jr., W. Illg, and D. P. Garber

JULY 1986

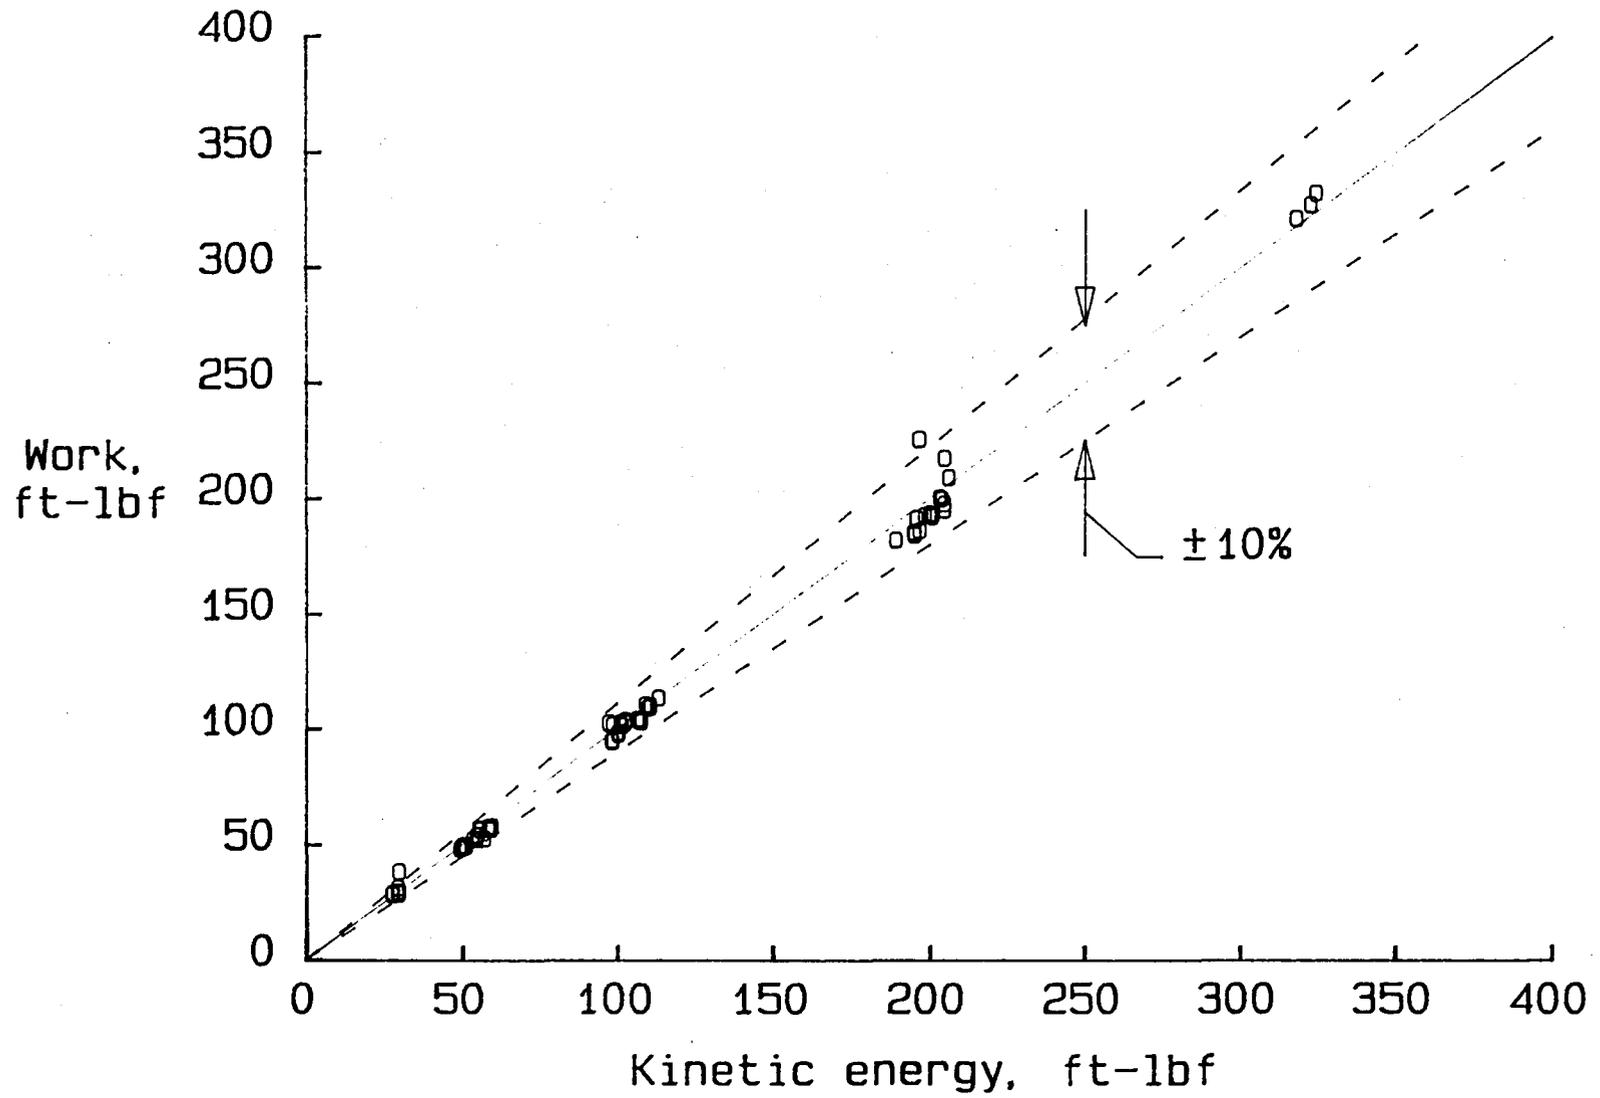
(a) Energy correlation

Figure 4.- Calibration check of impactor signals.

The accelerometer in the tup can measure accelerations from 0 to 20,000 g's in the range of 5 to 15,000 Hz and has a resonant frequency of 80 kHz. It was calibrated in a centrifugal acceleration device. The strain gages, which were connected in series, were statically calibrated in a testing machine by applying a load to the indenter and reacting it at the opposite end of the rod. The capability of the strain gages and accelerometer to make dynamic measurements was verified by checking energy and momentum balances. The kinetic energy is plotted against work in figure 4(a). Sometimes the signals were improperly recorded. Calculations for those tests are not plotted. However, the data that are plotted do represent all the impact conditions. Kinetic energy was calculated with $m_1 v_i^2 / 2$, where m_1 is the mass of the impactor and v_i is the initial impactor velocity from the velocimeter and work was calculated with $\int F(t) [\int a(t) dt] dt$, where $F(t)$ is the strain gage signal and $a(t)$ is the accelerometer signal. The impulse is plotted against the change in momentum in figure 4(b). Impulse was calculated with $\int F(t) dt$ and change in momentum was calculated with $m_1 (v_i - v_f)$, where m_1 , v_i , and $F(t)$ are the same as before and v_f is the final velocity after the last collision determined from $\int a(t) dt$. The solid lines in figures 4(a) and 4(b) represent perfect correlation and the dashed lines represent a plus and minus 10 percent deviation. Most of the calculations are well within the 10 percent lines. Thus, the energy and momentum balance quite well.

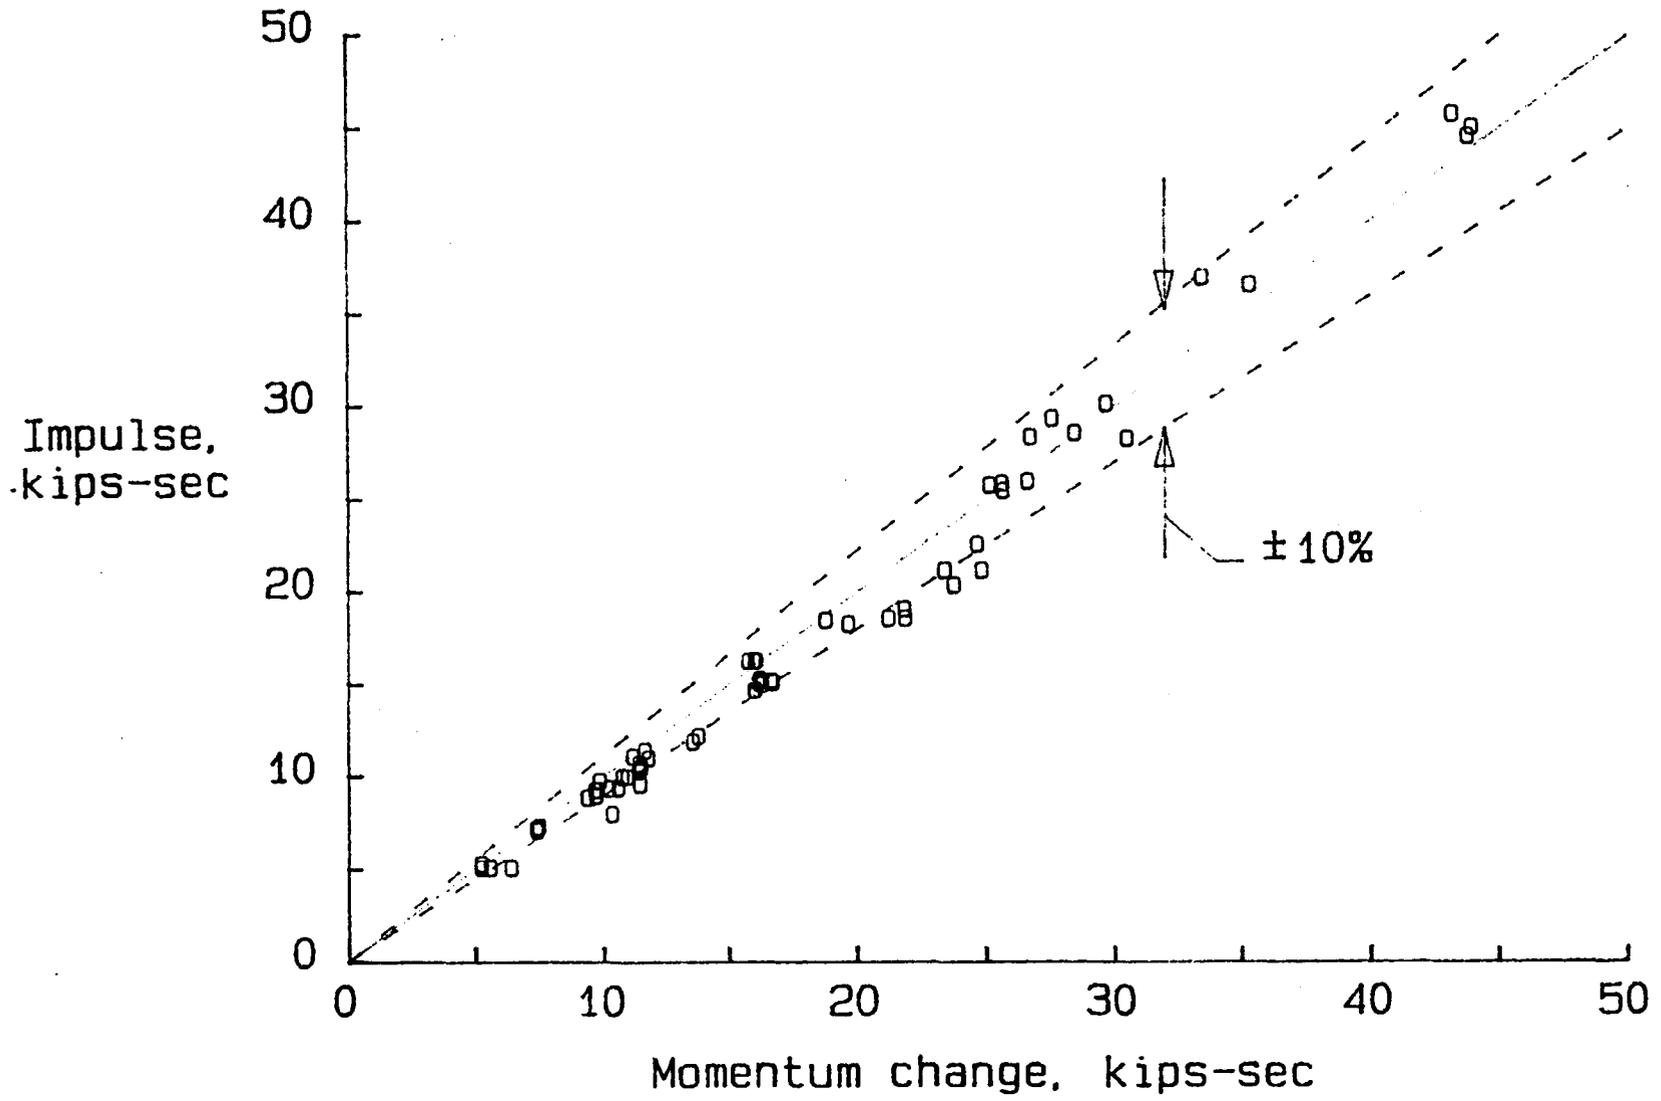
(b) Impulse correlation.

Figure 4.- Concluded.

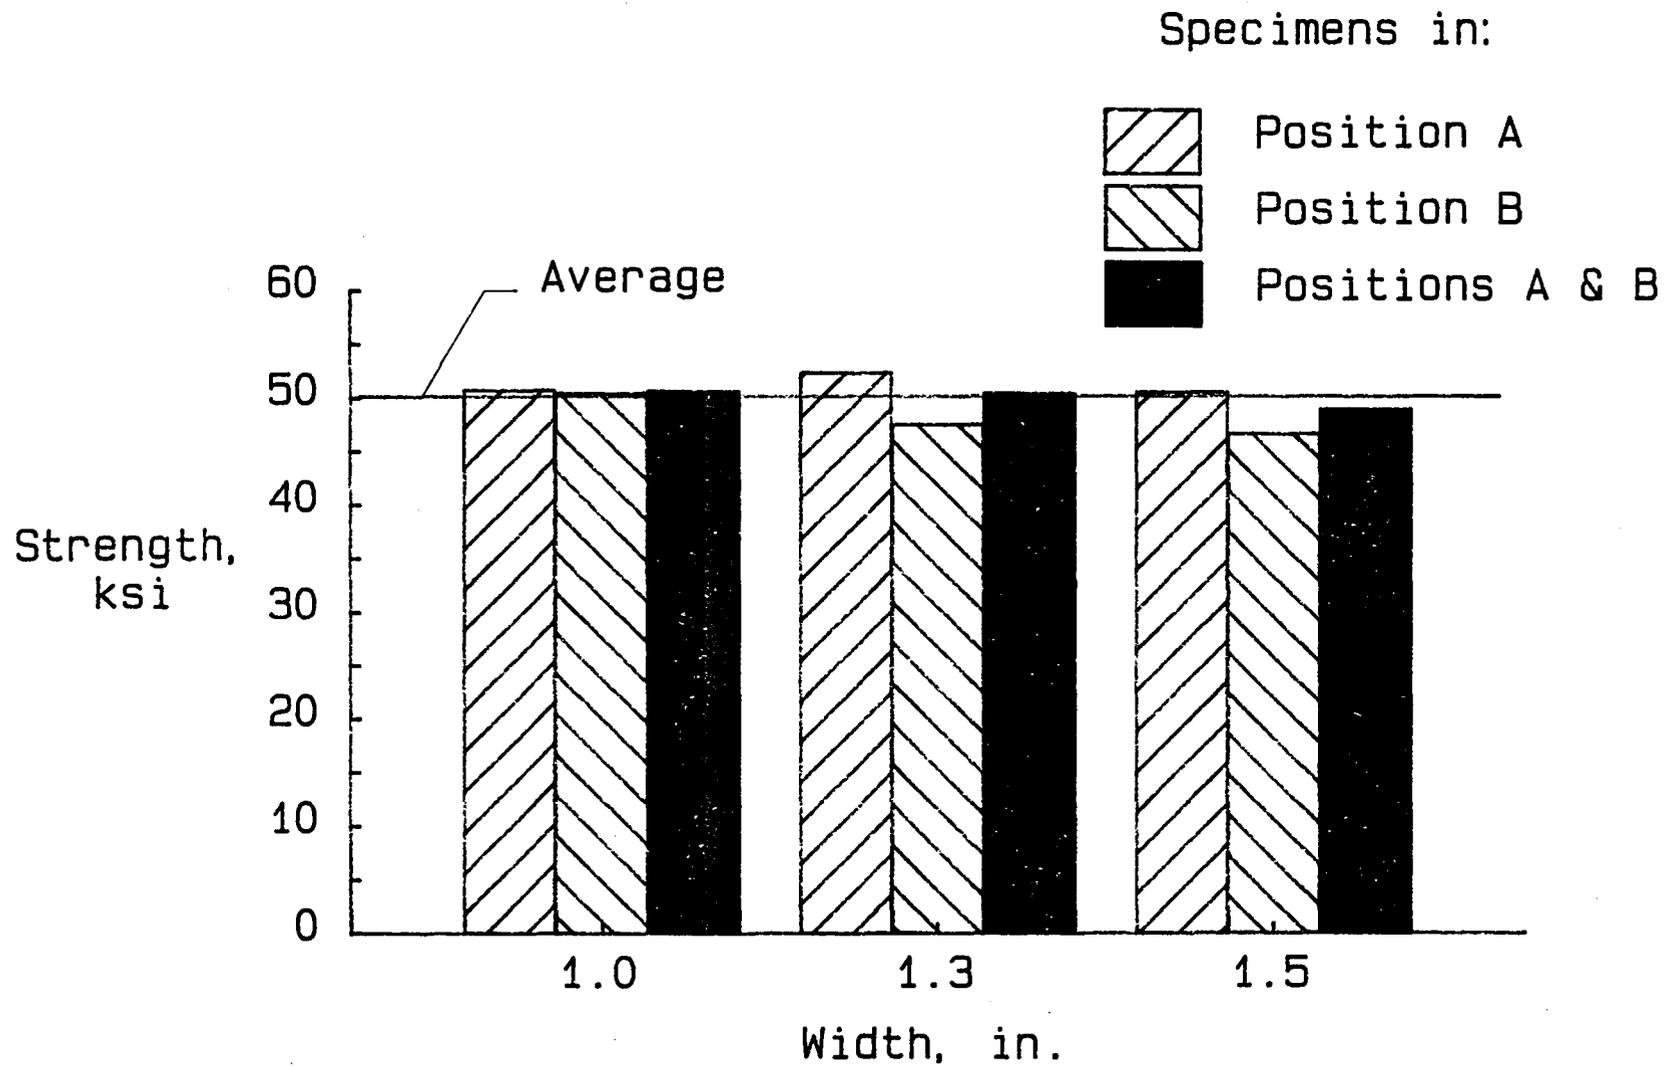
Figure 5.- Strengths of undamaged specimens.

The strengths of only three undamaged specimens were reported in reference 1. The width of the test sections in those three specimens was 1 inch. Since then, impacted specimens that were 1.3- and 1.5-inches wide have been tested. In order to increase the data base of undamaged strengths and to determine the effect of specimen width, sixteen undamaged specimens with 1.0, 1.3, and 1.5-inch-wide test sections were loaded to failure in tension using the same testing machine and procedure as that used for the impacted specimens. The failing stresses, which were calculated in the same manner as those of the impacted specimens, are given in table III.

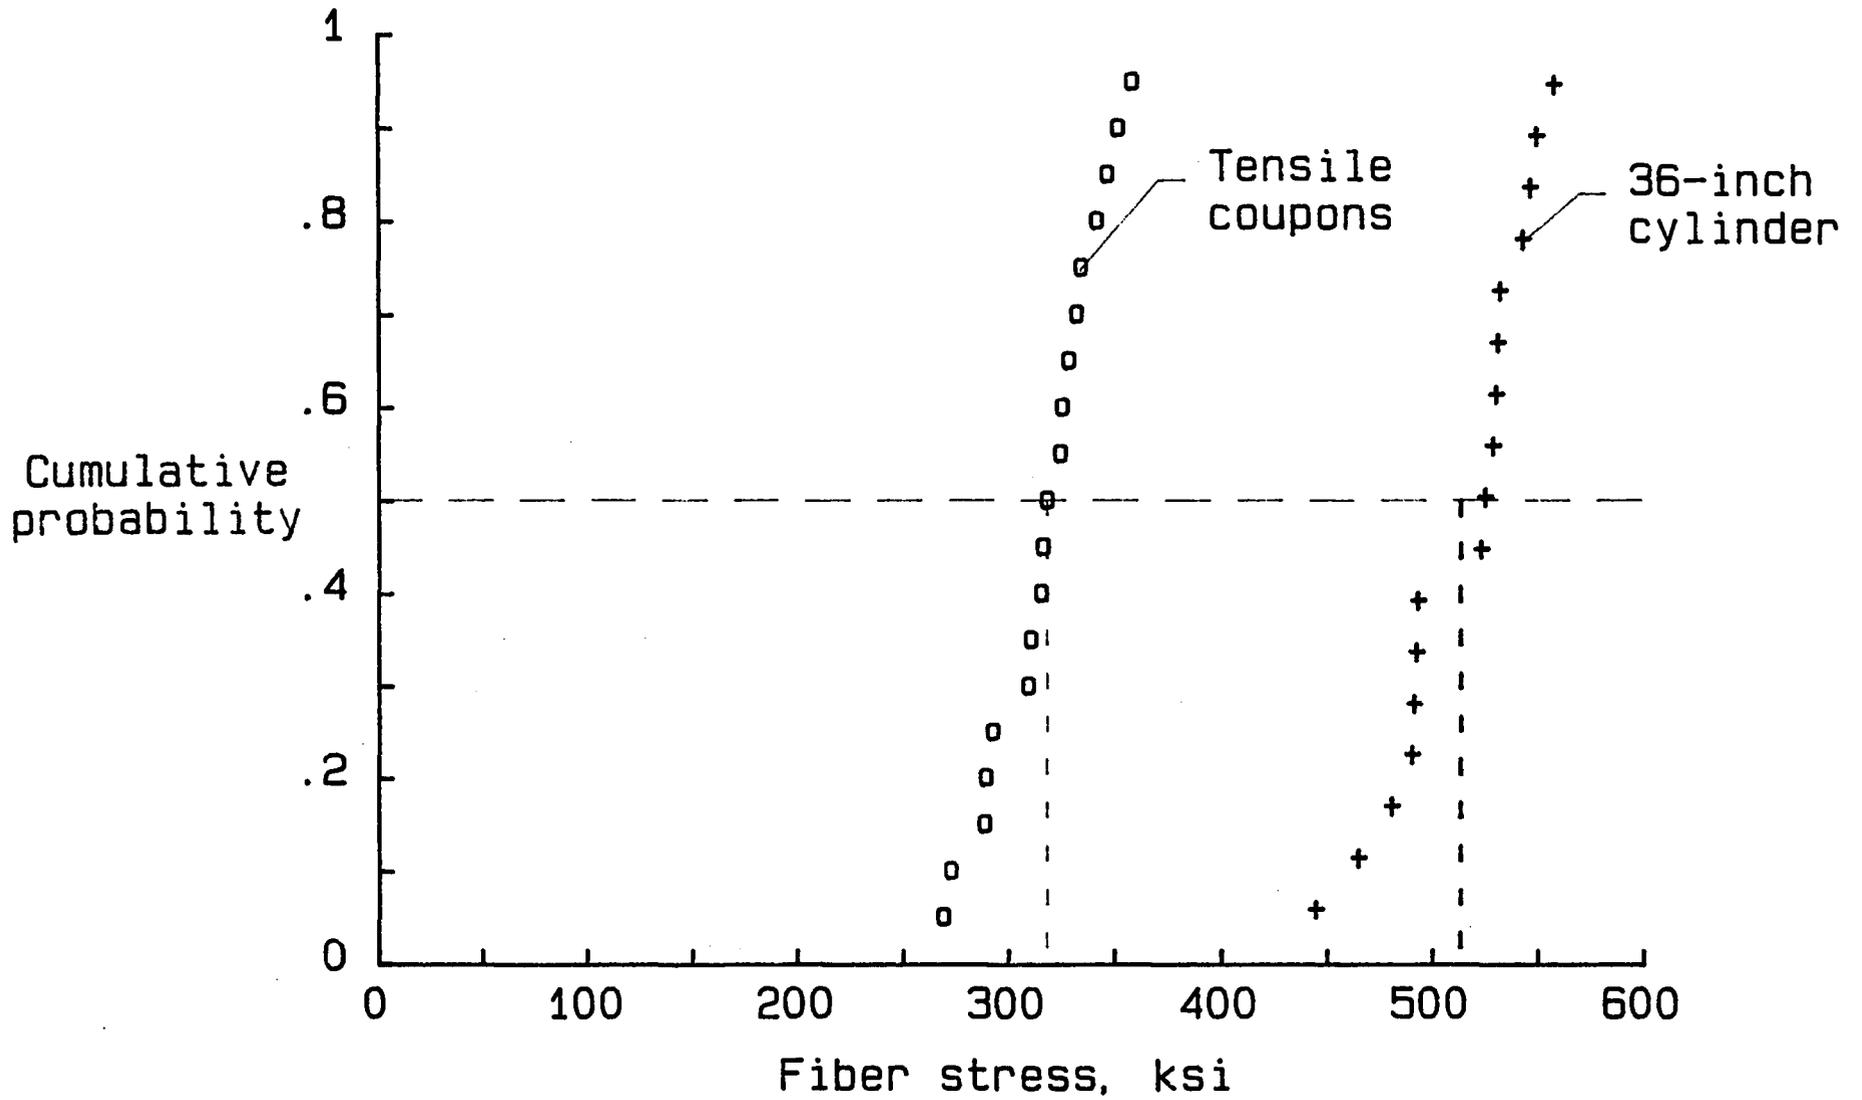
Figure 6.- Cumulative probability of strengths for undamaged specimens and 36-inch-diameter cylinders.

Hercules Inc. made and tested numerous 36-inch-diameter cylinders with a scaled-down thickness to determine design allowables for the FWC's. The cumulative probability of exceeding a given strength is plotted in figure 6. The strengths are given in terms of hoop fiber stress at failure. Using lamination theory, the hoop fiber stresses for the undamaged specimens in table

III were calculated and plotted in figure 6 for comparison. The mean value for the tensile specimens is 38 percent less than that for the cylinders, 317 ksi compared to 513 ksi. For the 36-inch-diameter cylinders, the mean fiber strength as determined from fiber-lot-acceptance tests was 590 ksi (ref. 1). The mean strength of the broadgoods fiber used in making the special 30-inch-diameter cylinder was 544 ksi. Thus, one would expect the stress in the hoop fibers of the tensile specimens at failure to be about 473 ksi ($513 \times 544 / 590$), not 317 ksi!

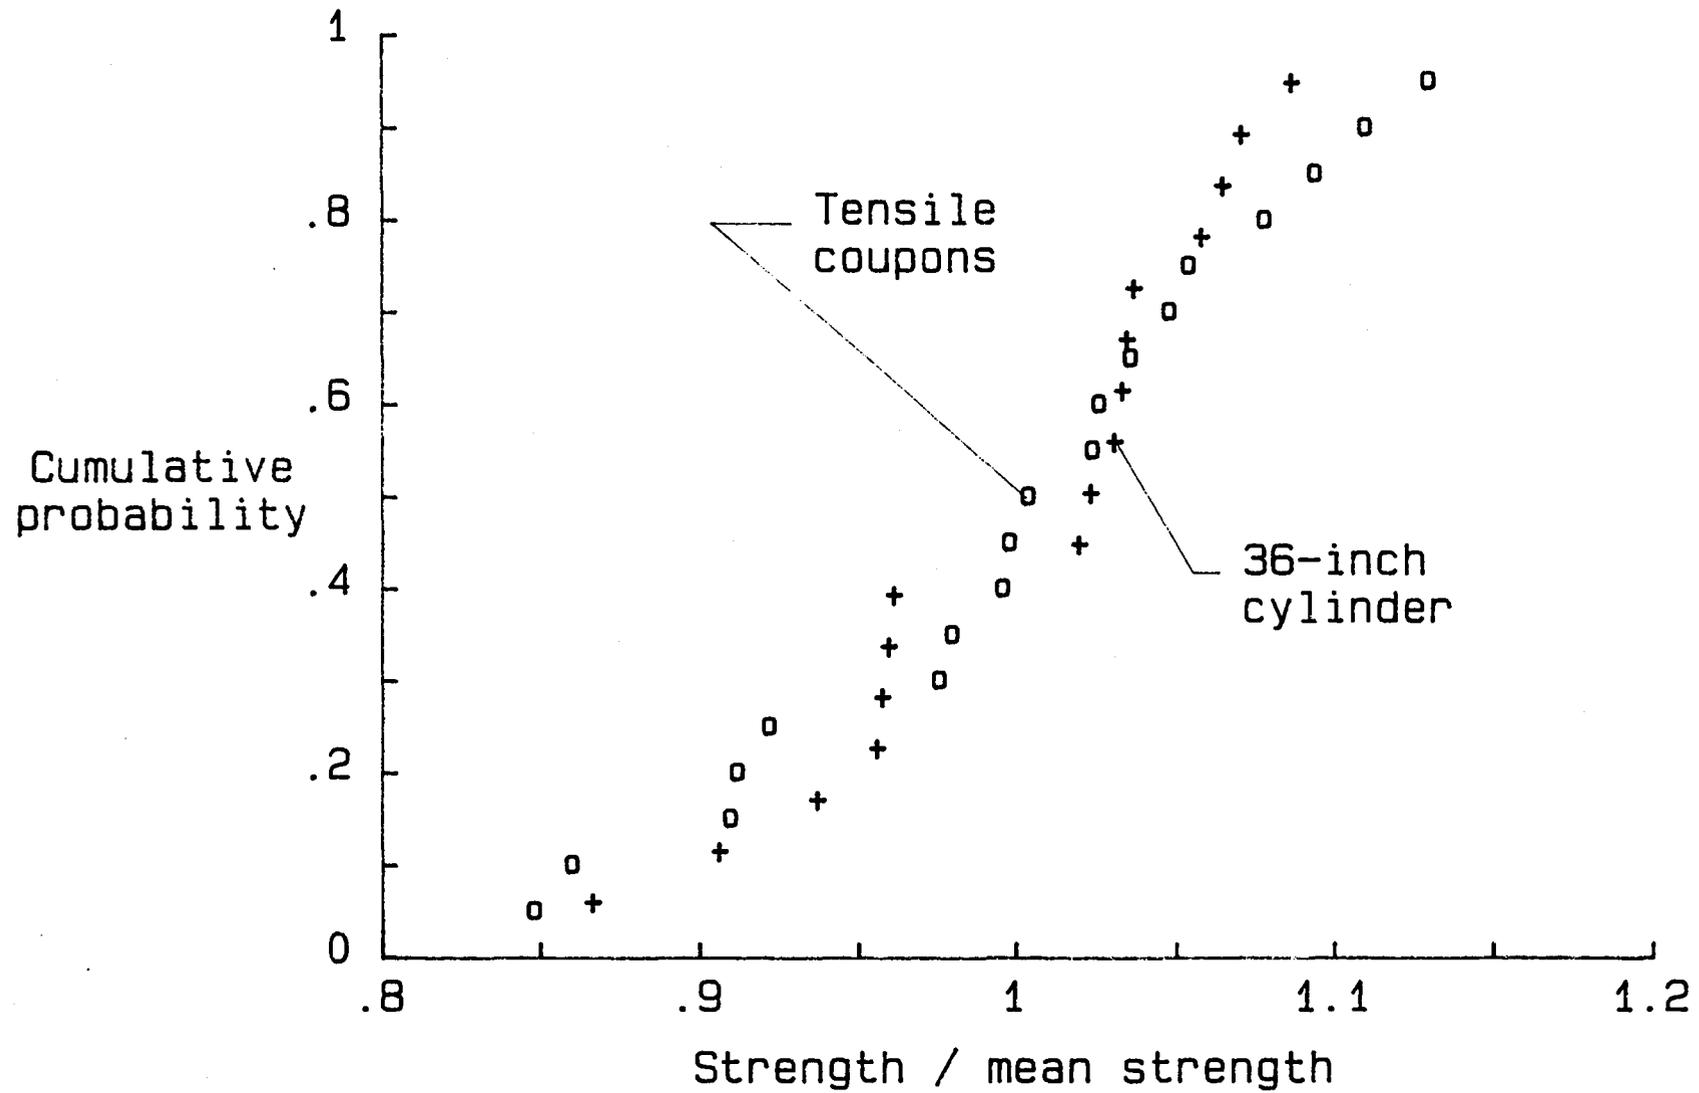
Figure 7.- Cumulative probability of normalized strengths for undamaged specimens and 36-inch-diameter cylinders.

The fiber stresses in figure 6 were normalized by their mean values and replotted in figure 7. The normalized fiber stresses for the tensile specimens and cylinders coincide, indicating that the variability in the two sets of data is about the same. Thus, the cause of the low strengths is probably the specimen configuration itself or some small-scale defect in the material that is uniformly distributed throughout the laminate.

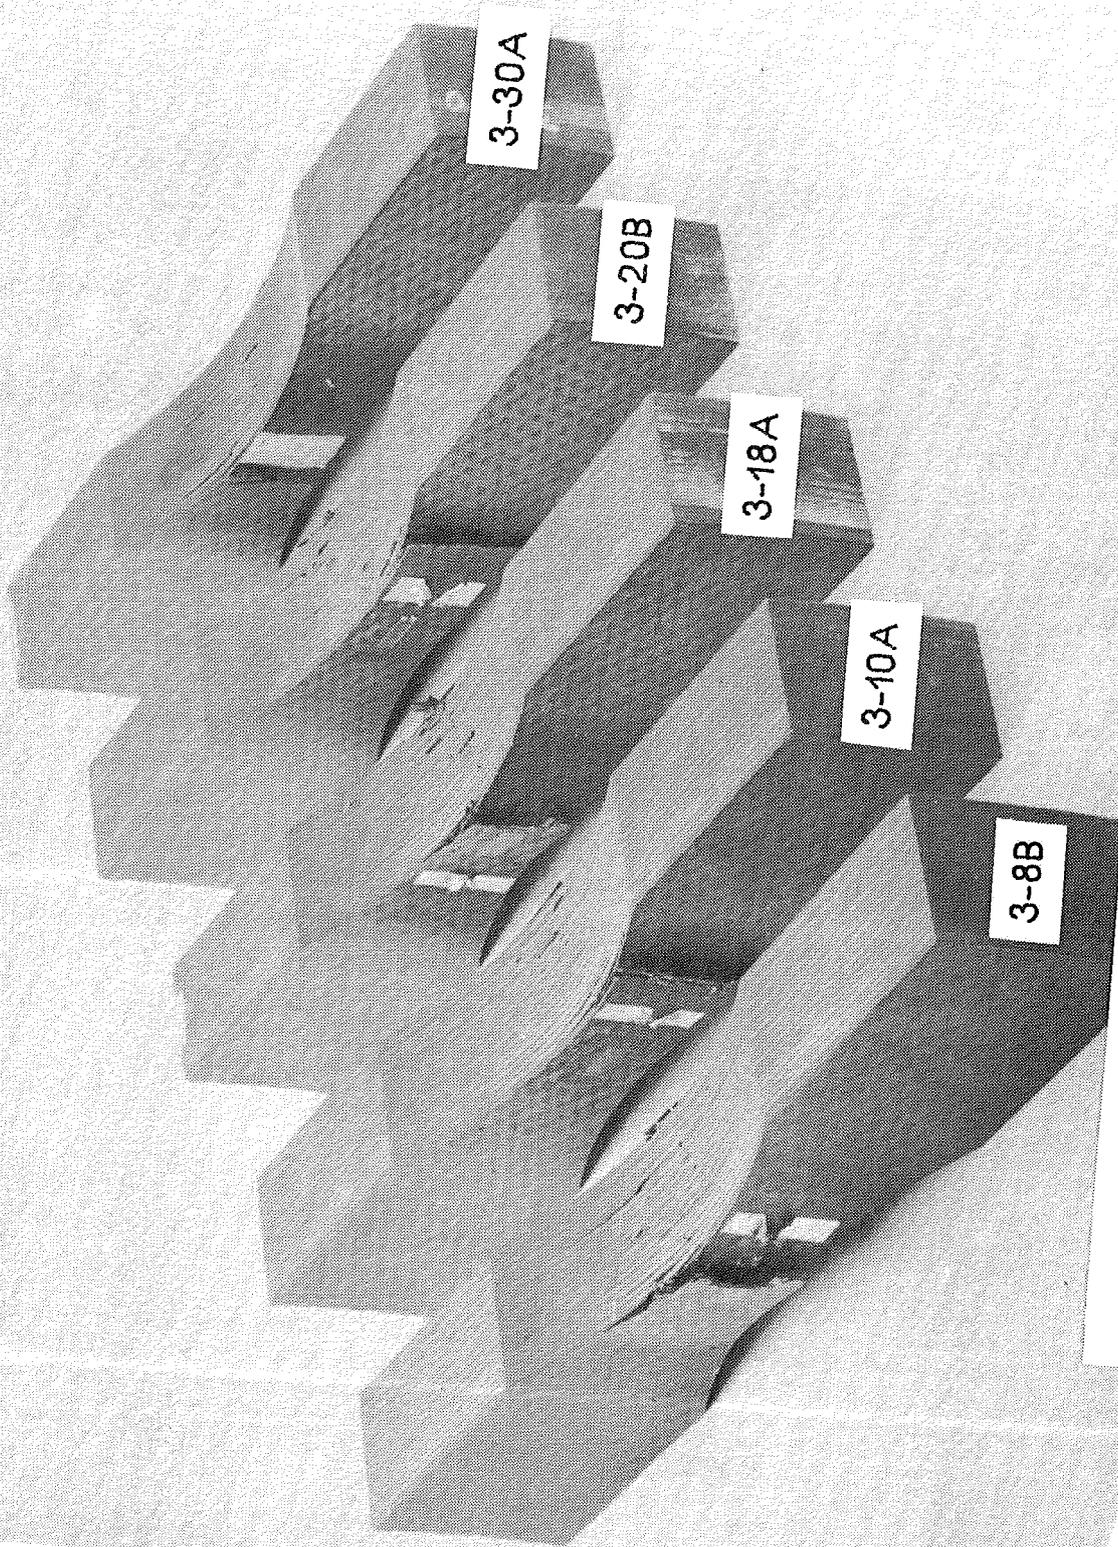
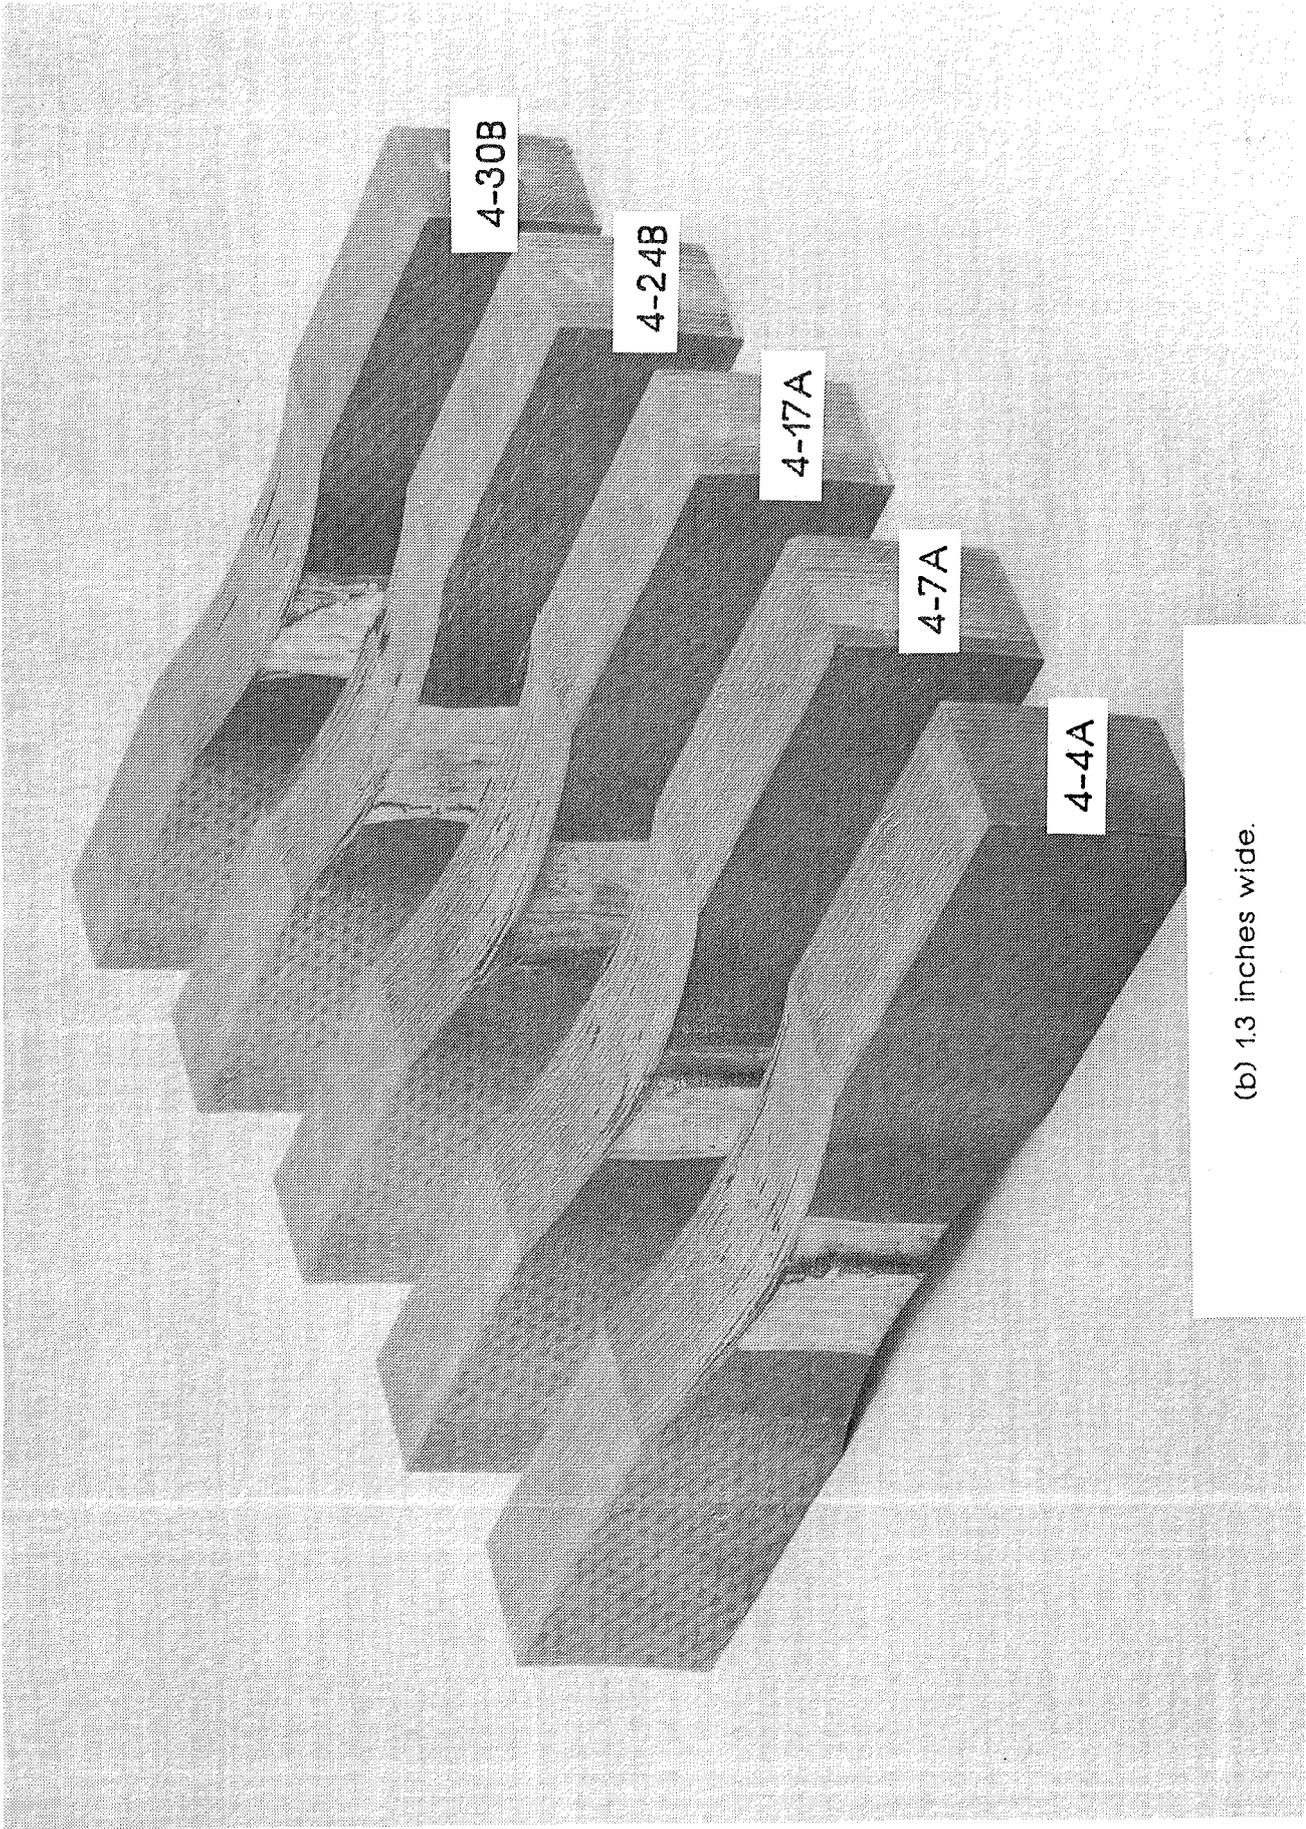
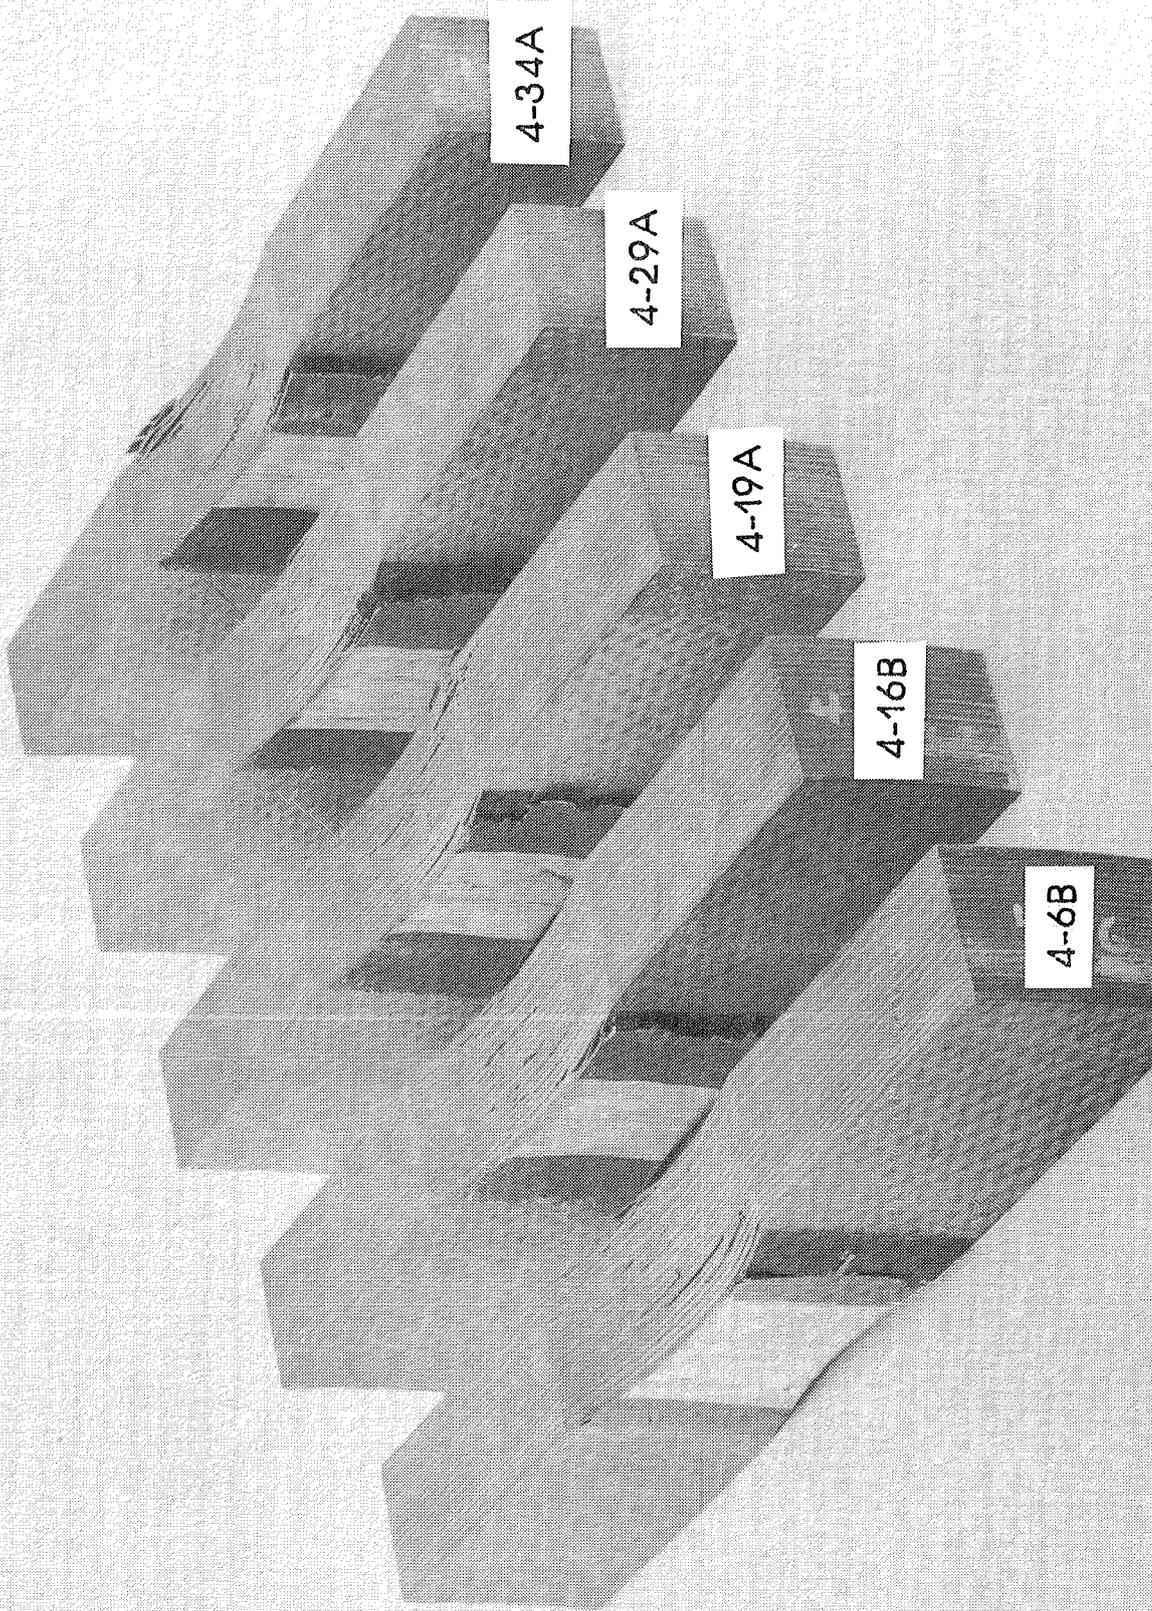
(a) 1.0 inches wide.

Figure 8.- Photographs of failed undamaged specimens.

(b) 1.3 inches wide.

(c) 1.5 inches wide.

Gripping failures.— Photographs of 15 of the 16 broken specimens are shown in figure 8. The inner surfaces of the laminate are toward the viewer. The light and dark bands are the hoop and helical layers, respectively. Specimen 3-28 was inadvertently left out of the photograph in figure 8(a). It looked much like 3-8, 3-18, and 3-30. One can see in figures 8(a) and 8(c) that the inner surface layers of two of the 1-inch-wide specimens (3-10 and 3-20) and all of the 1.5-inch-wide specimens broke just inside the test section at the edge of an aluminum shim and delaminated from the remainder of the laminate. Also, for two of the 1.5-inch-wide specimens (4-19 and 4-34), the outer surface layers also broke at the edge of a shim. On the other hand, the fracture paths in the 1.3-inch-wide specimens were well within the test section and away from the shims.

Large stresses at the leading edge of the shims caused the surface layers to break prematurely. The stresses were elevated by the large gripping pressure

The broken surface layers did not appear to include the stiff hoop layers. Therefore, they carry too little load to have caused the lower than expected strengths.

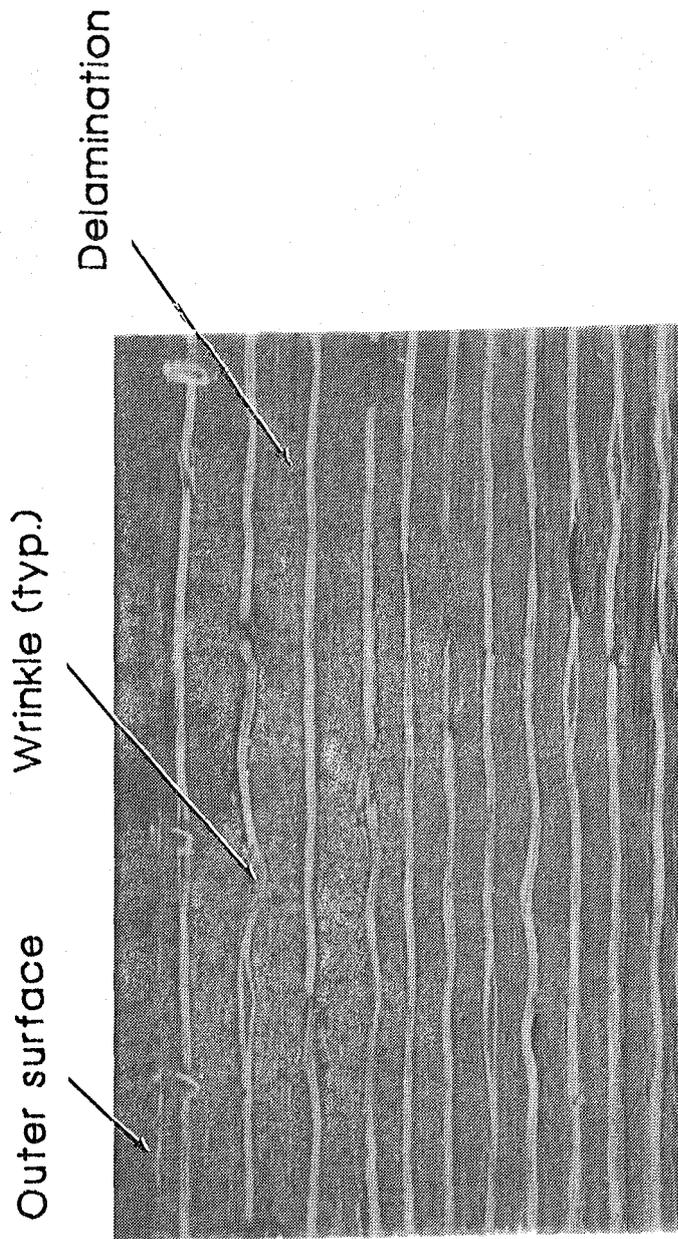
Figure 9.- Photograph of fracture detail in specimen 3-28.

Wrinkle-type defects.- A photograph revealing the details of the fracture near the outer surface of specimen 3-28 is shown in figure 9. The second hoop layer has several severe wrinkles near the center of the photograph. The fracture path from the broken surface layer passes through wrinkles.

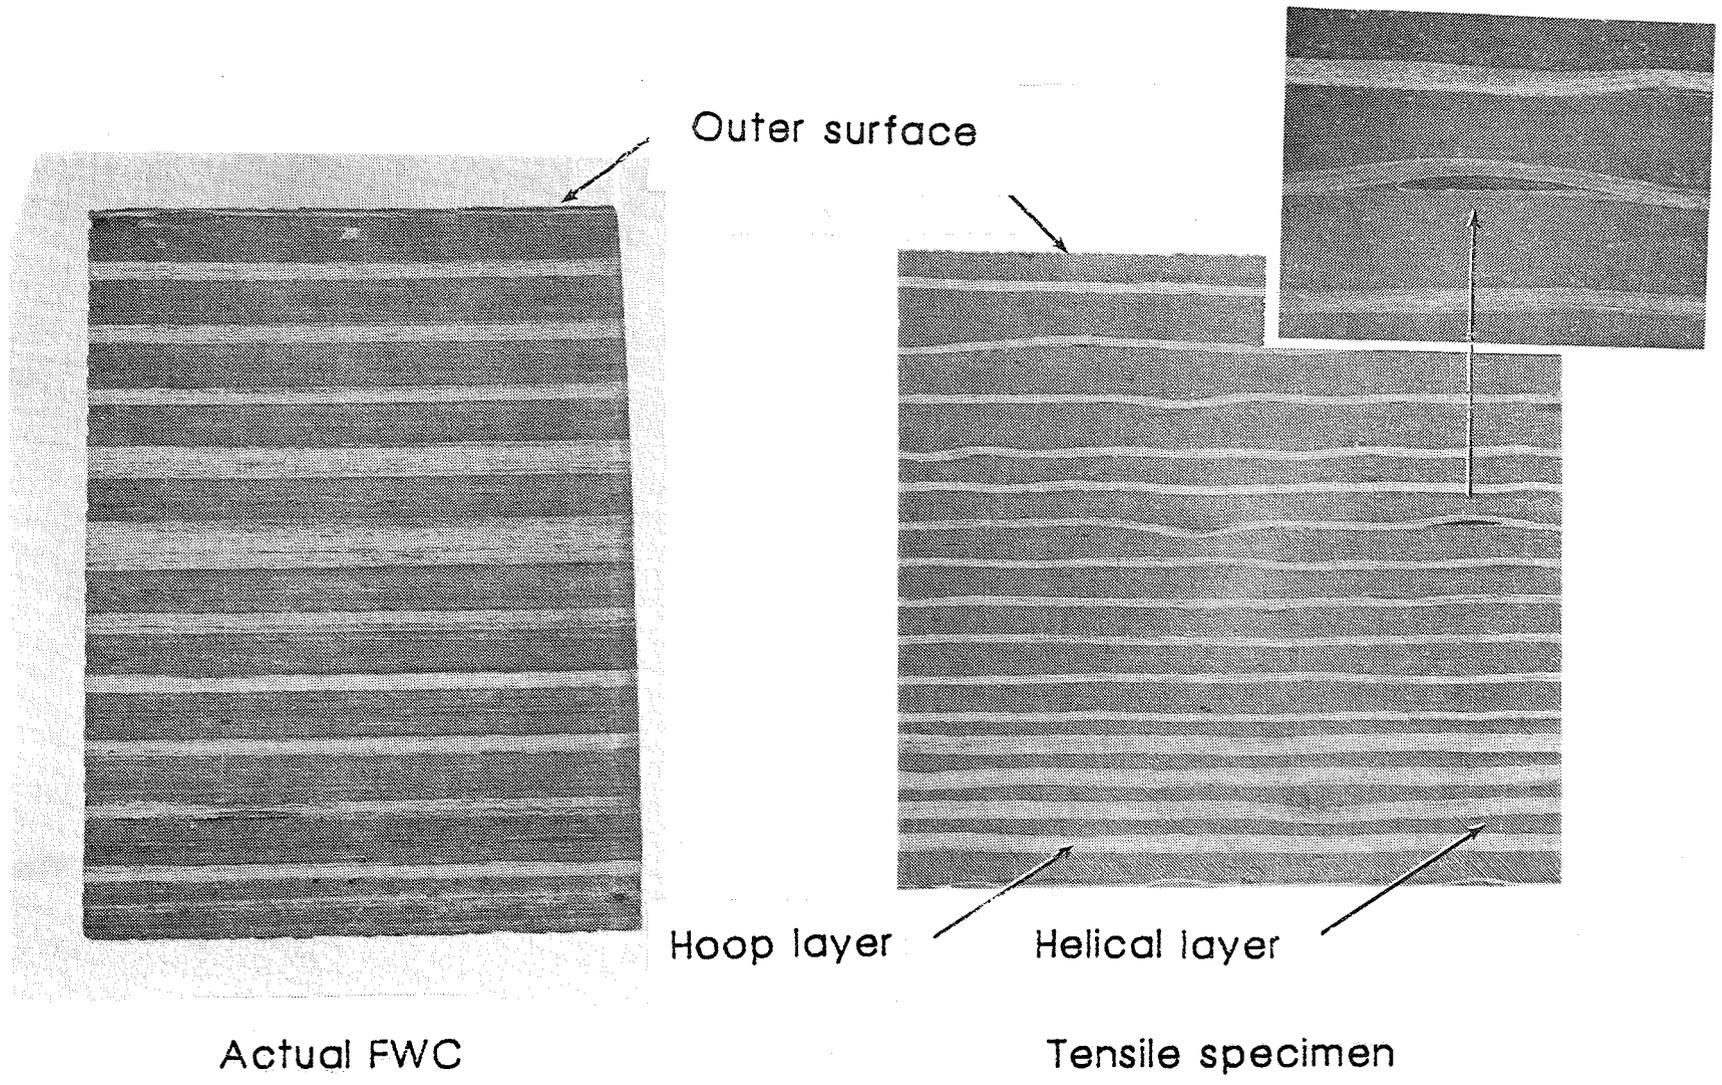
Figure 10.- Photographs of edges of a tensile specimen and a coupon from an actual FWC.

For comparison, photographs of an edge of a tensile coupon and a coupon cut from the tag end of an actual FWC case (excess material at end) are shown in figure 10. Although the layups are different, notice that the hoop layers (light bands) of the FWC case are straight, but those of the tensile specimen are wavy. The inset shows an enlargement of one wrinkle that is so high the epoxy did not fill in beneath it. These wrinkles are part of a pattern of waviness that occurs throughout all the specimens in varying degrees. It was probably caused when the helical layers were wound over the hand-layed hoop layers, which had no pre-tension.

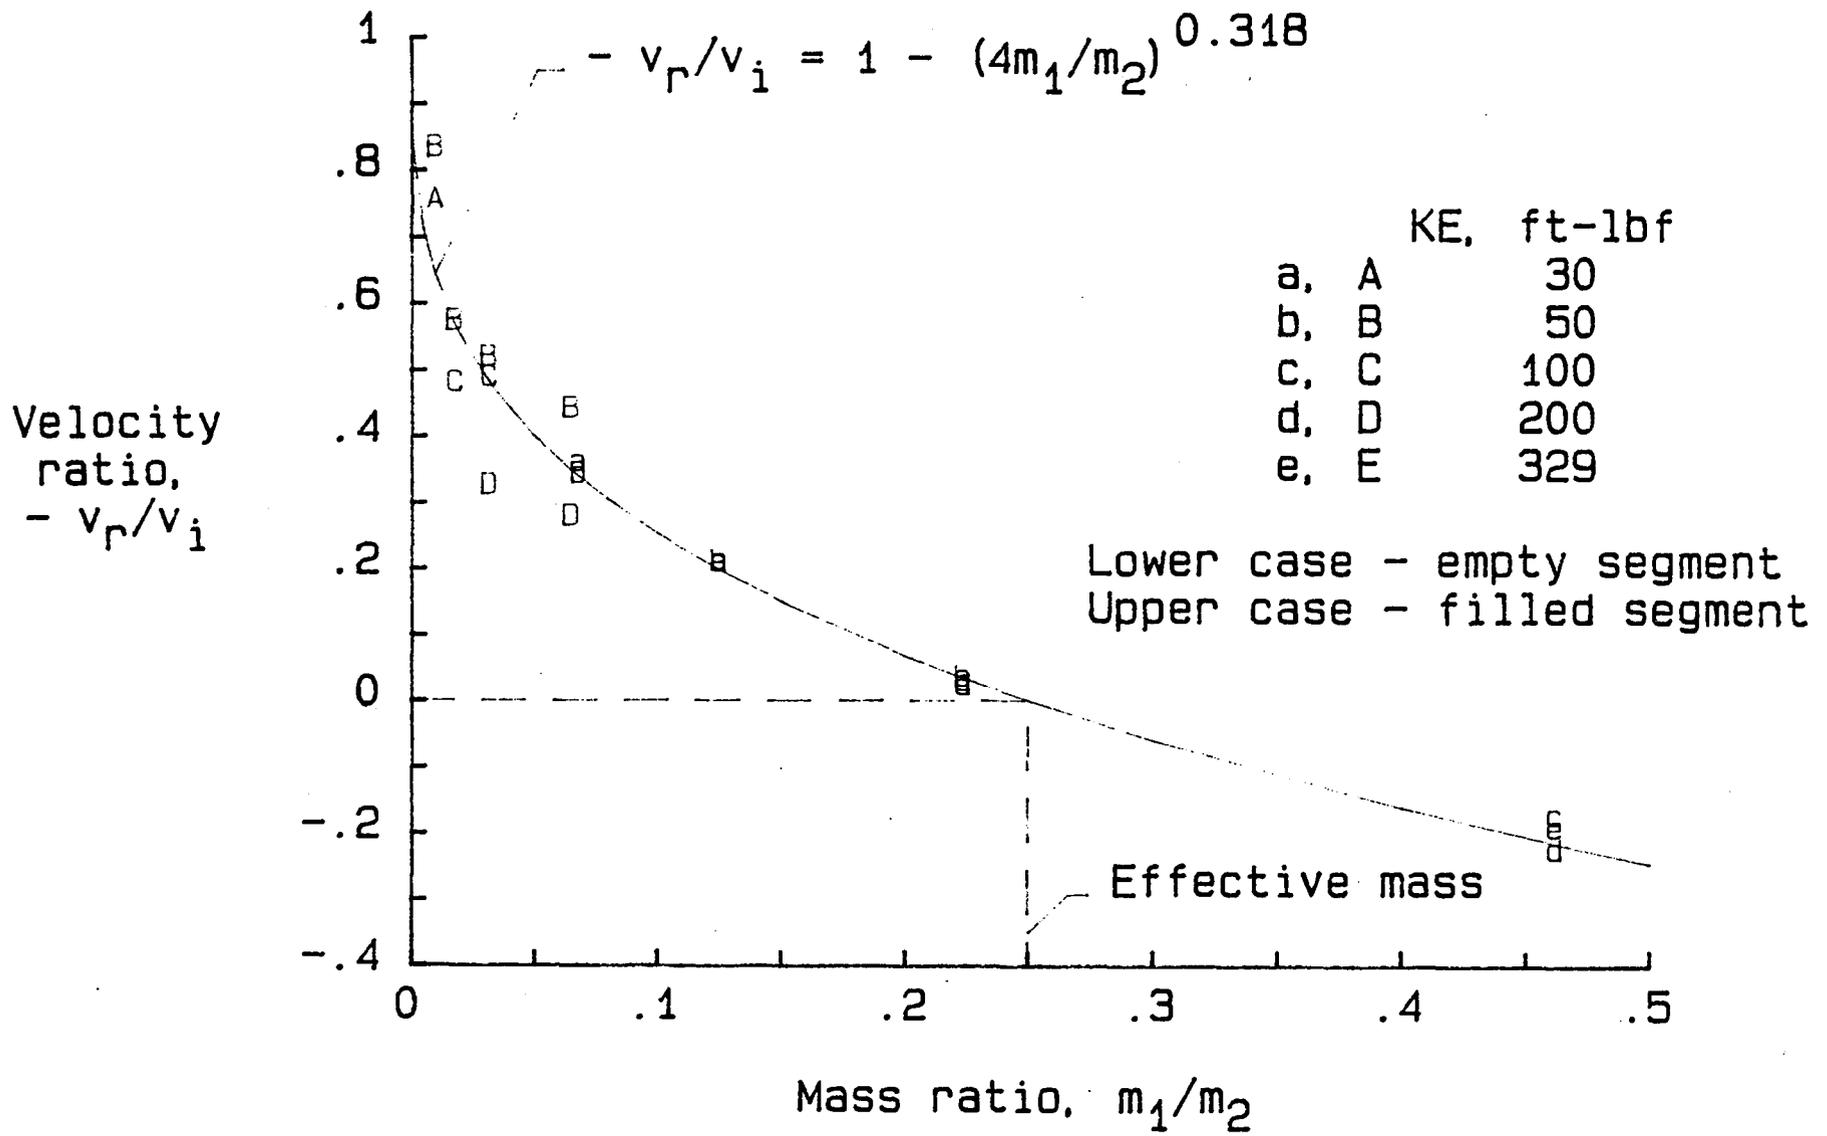
Figure 16.- Velocity ratio versus mass ratio.
