NASA Technical Memorandum 87771

TENSION STRENGTH OF A THICK GRAPHITE/EPOXY
LAMINATE AFTER IMPACT BY A 1/2-IN.-RADIUS IMPACTOR

C. C. Poe, Jr., W. Illg, and D. P. Garber

JULY 1986

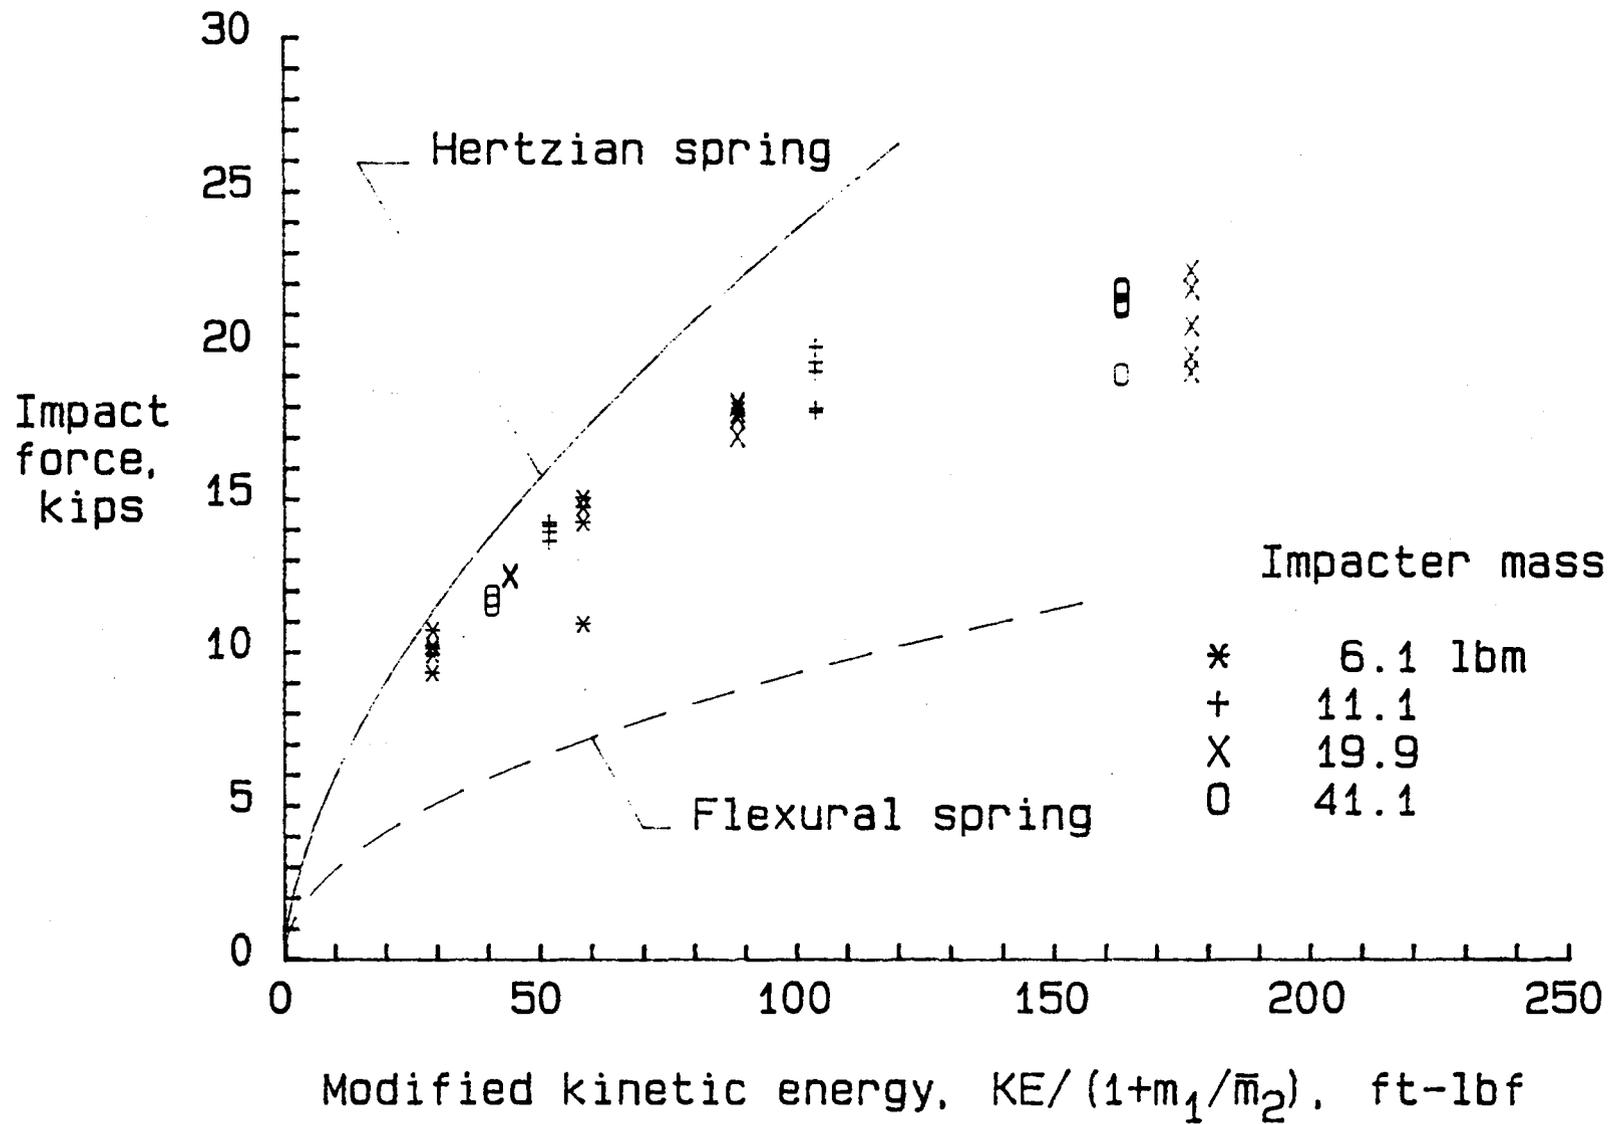
(a) Filled segment, $\bar{m}_2 = 159$ lbm.

Figure 17.- Impacter force versus impacter energy.

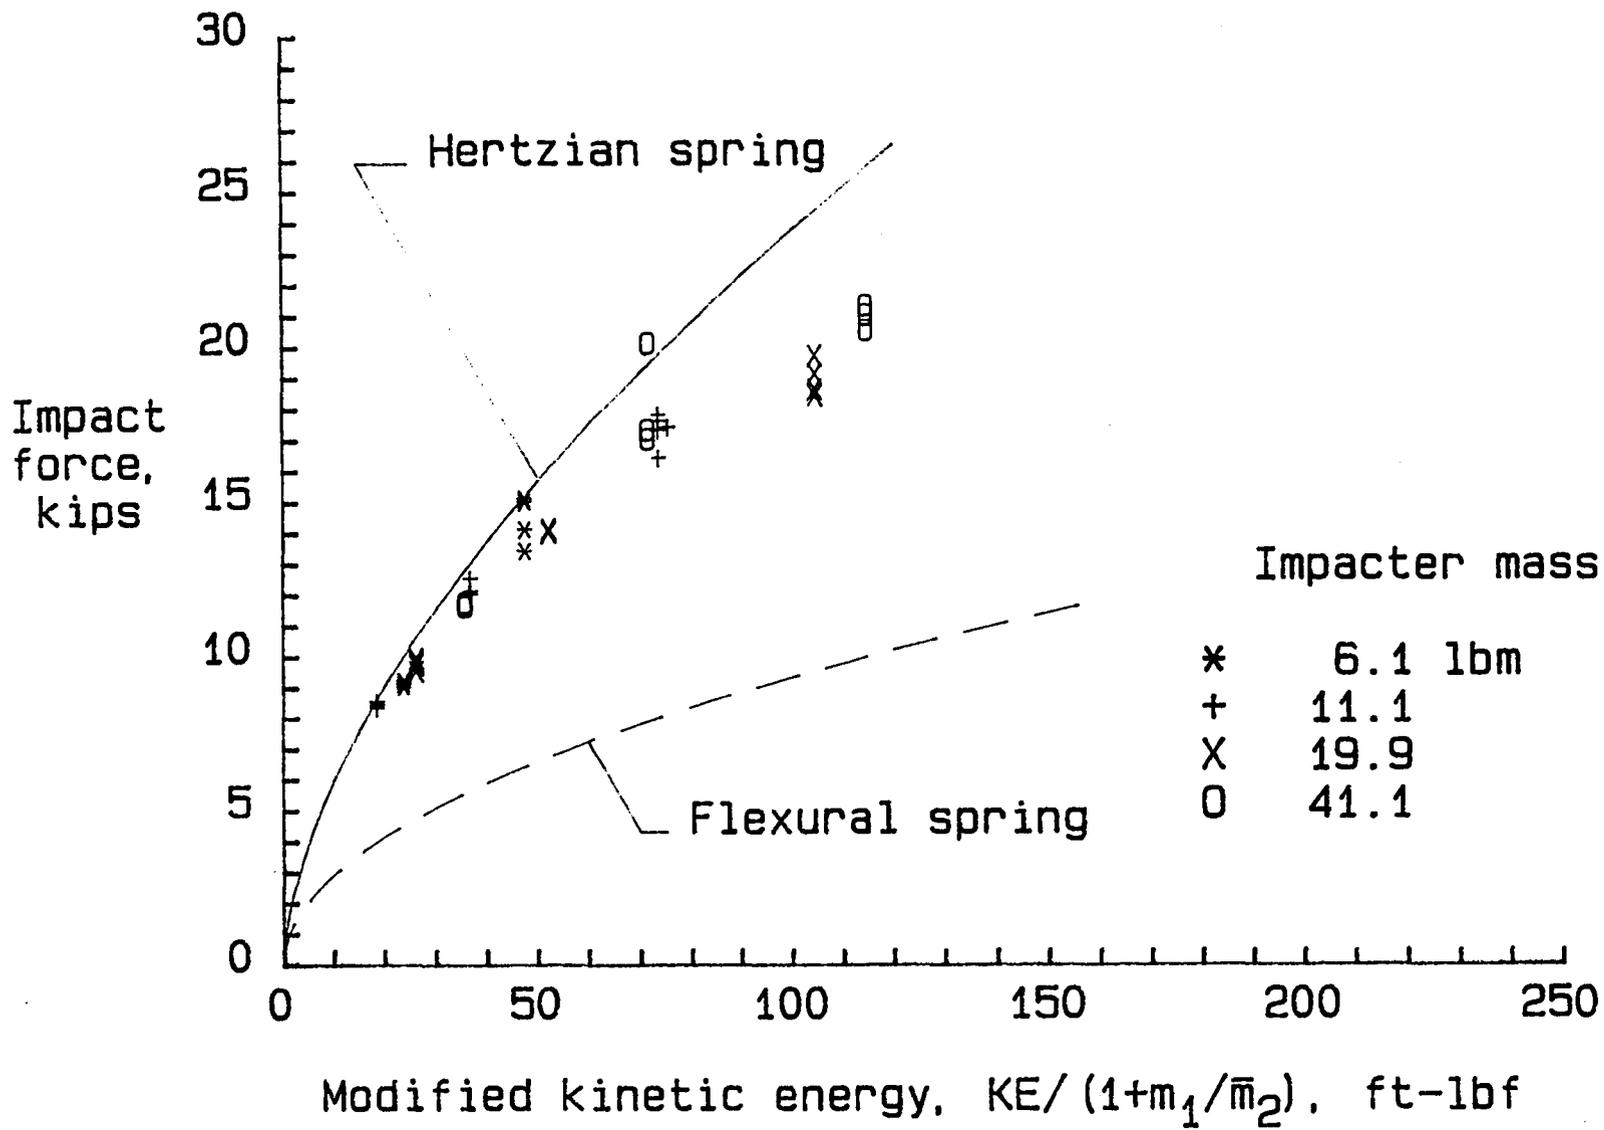
(b) Empty segment, $\bar{m}_2 = 22$ lbm.

Figure 17.- Concluded.

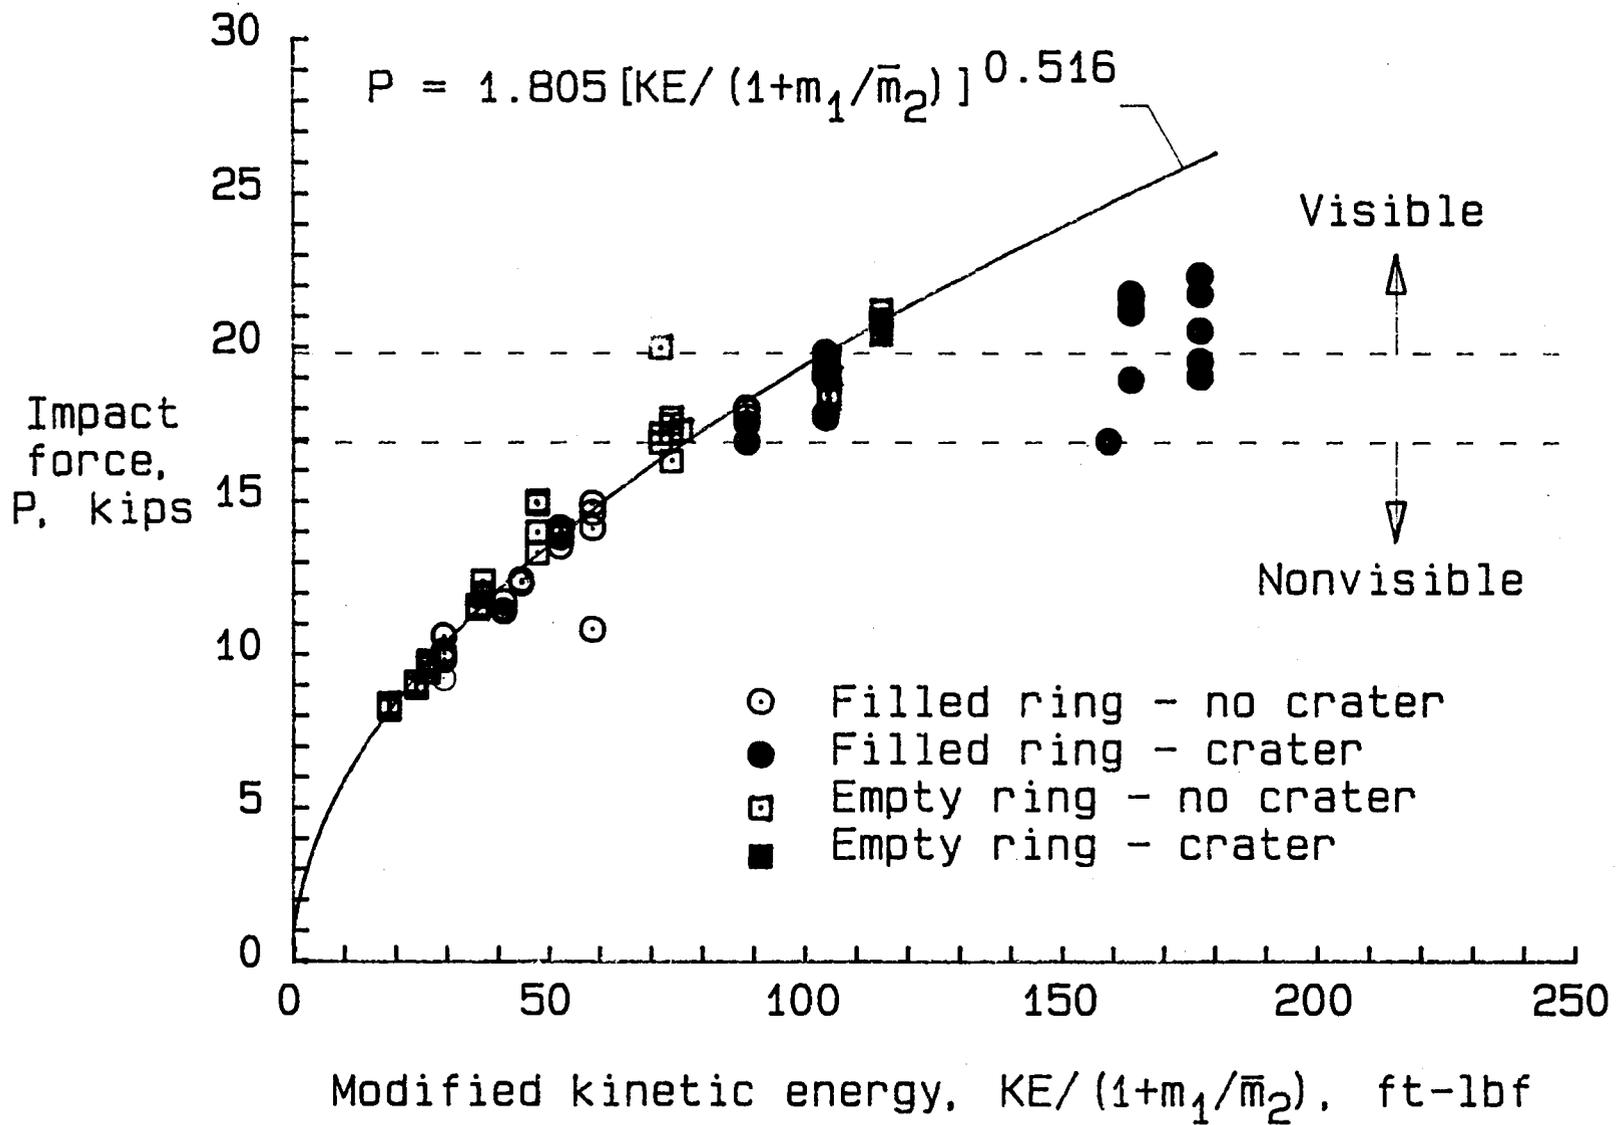
Figure 18.- Impacter force versus impacter energy for filled and empty rings.

which has the same form as equations (3) and (5) for the Hertz law and a linear spring, was also plotted in figure 18. A linear regression analysis, excluding the data with craters, was used to determine the constants 1,810 and 0.516. Equation (9) fits the data without craters quite well. When craters were made, the impact forces were smaller than predicted, indicating that the damage had a softening effect. The exponent 0.516 is between 3/5 and 1/2, the exponents in equations (3) and (5), respectively.

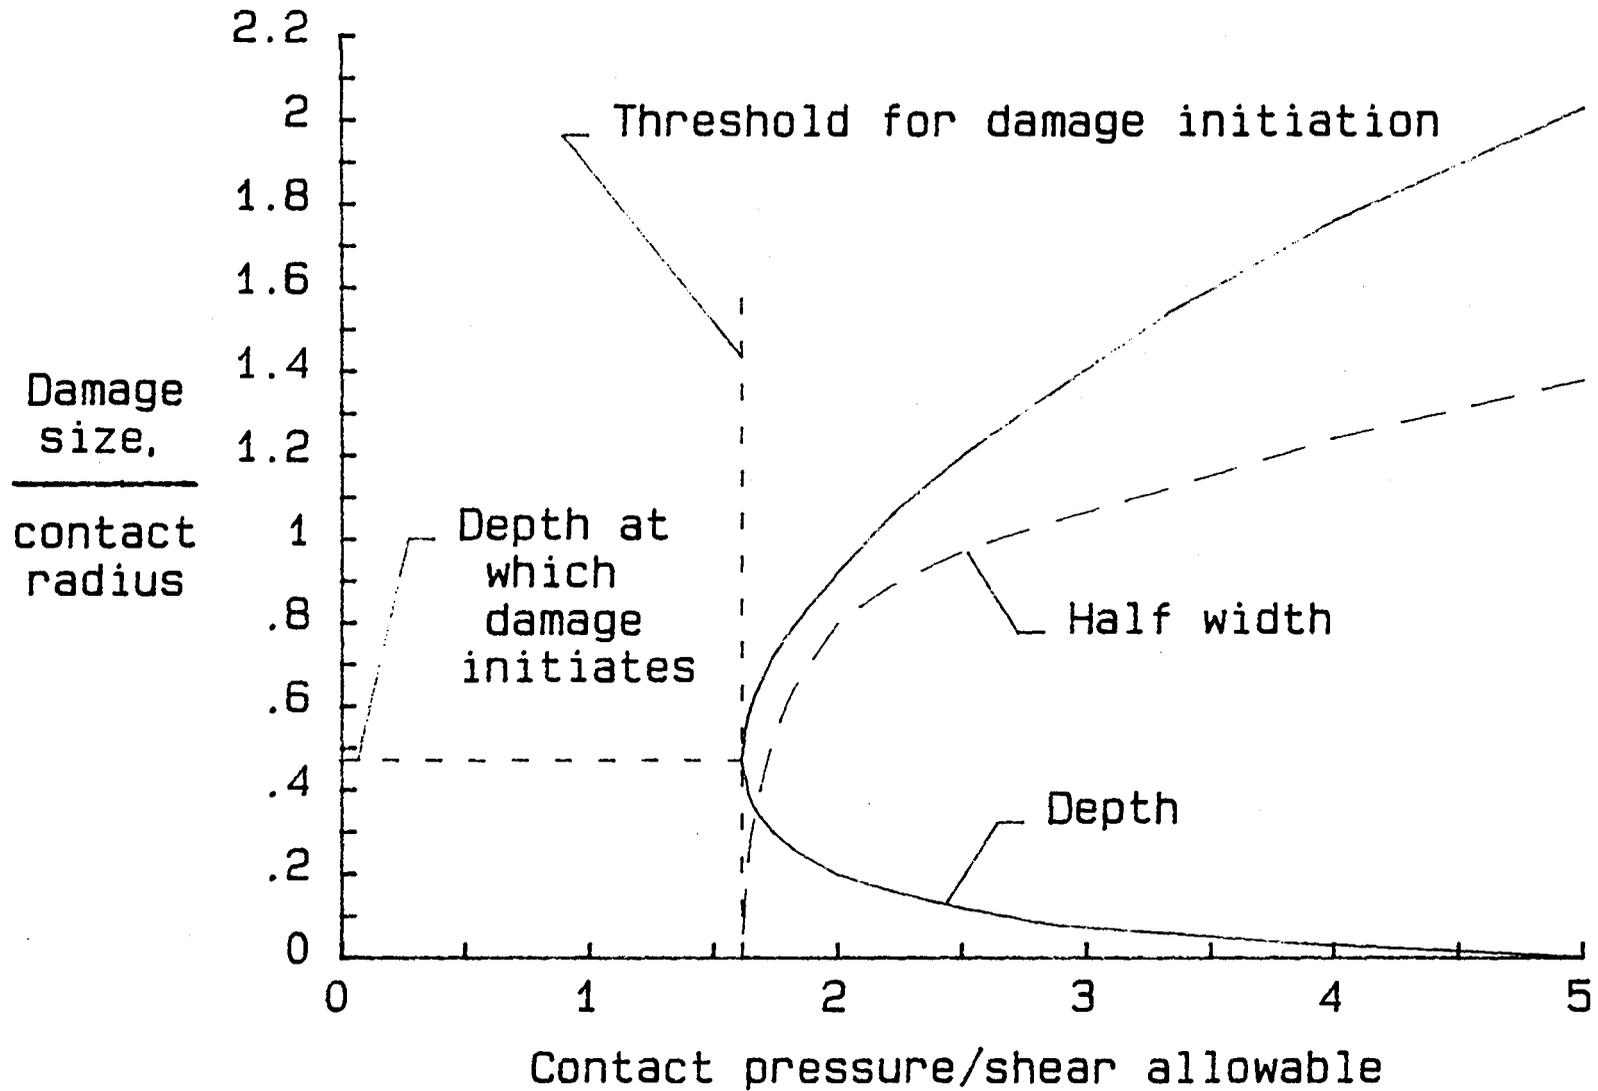
Figure 20.- Damage size versus contact pressure according to Love's solution and principal shear criterion for failure.

divided by the contact area or $p_c = P/(\pi D^2/4)$. The maximum value of the hemispherical pressure is 1.5 times the average value and occurs at $\rho = 0$. Assuming failure occurs at a critical value of principal shear stress, the contours of principal shear stress represent damage contours. The depth and width of the damage contours are plotted against the contact pressure in figure 20. Damage initiates below the surface at $\rho = 0$ and $2z/D = 0.47$ when the contact pressure is approximately 1.61 times the allowable shear stress. As the pressure increases, the damage spreads in all directions and reaches the surface at a pressure equal to approximately 5.0 times the allowable shear stress. After damage initiates, the width increases rapidly with pressure until it is about equal to the contact diameter. Then it increases with pressure very slowly. The depth of damage is always larger than the half-width of damage.

The curves in figure 20 can be used to predict the depth of impact damage if the allowable shear stress, the contact radius, and the contact pressure are known. For the Hertz law (ref. 4), the contact diameter is

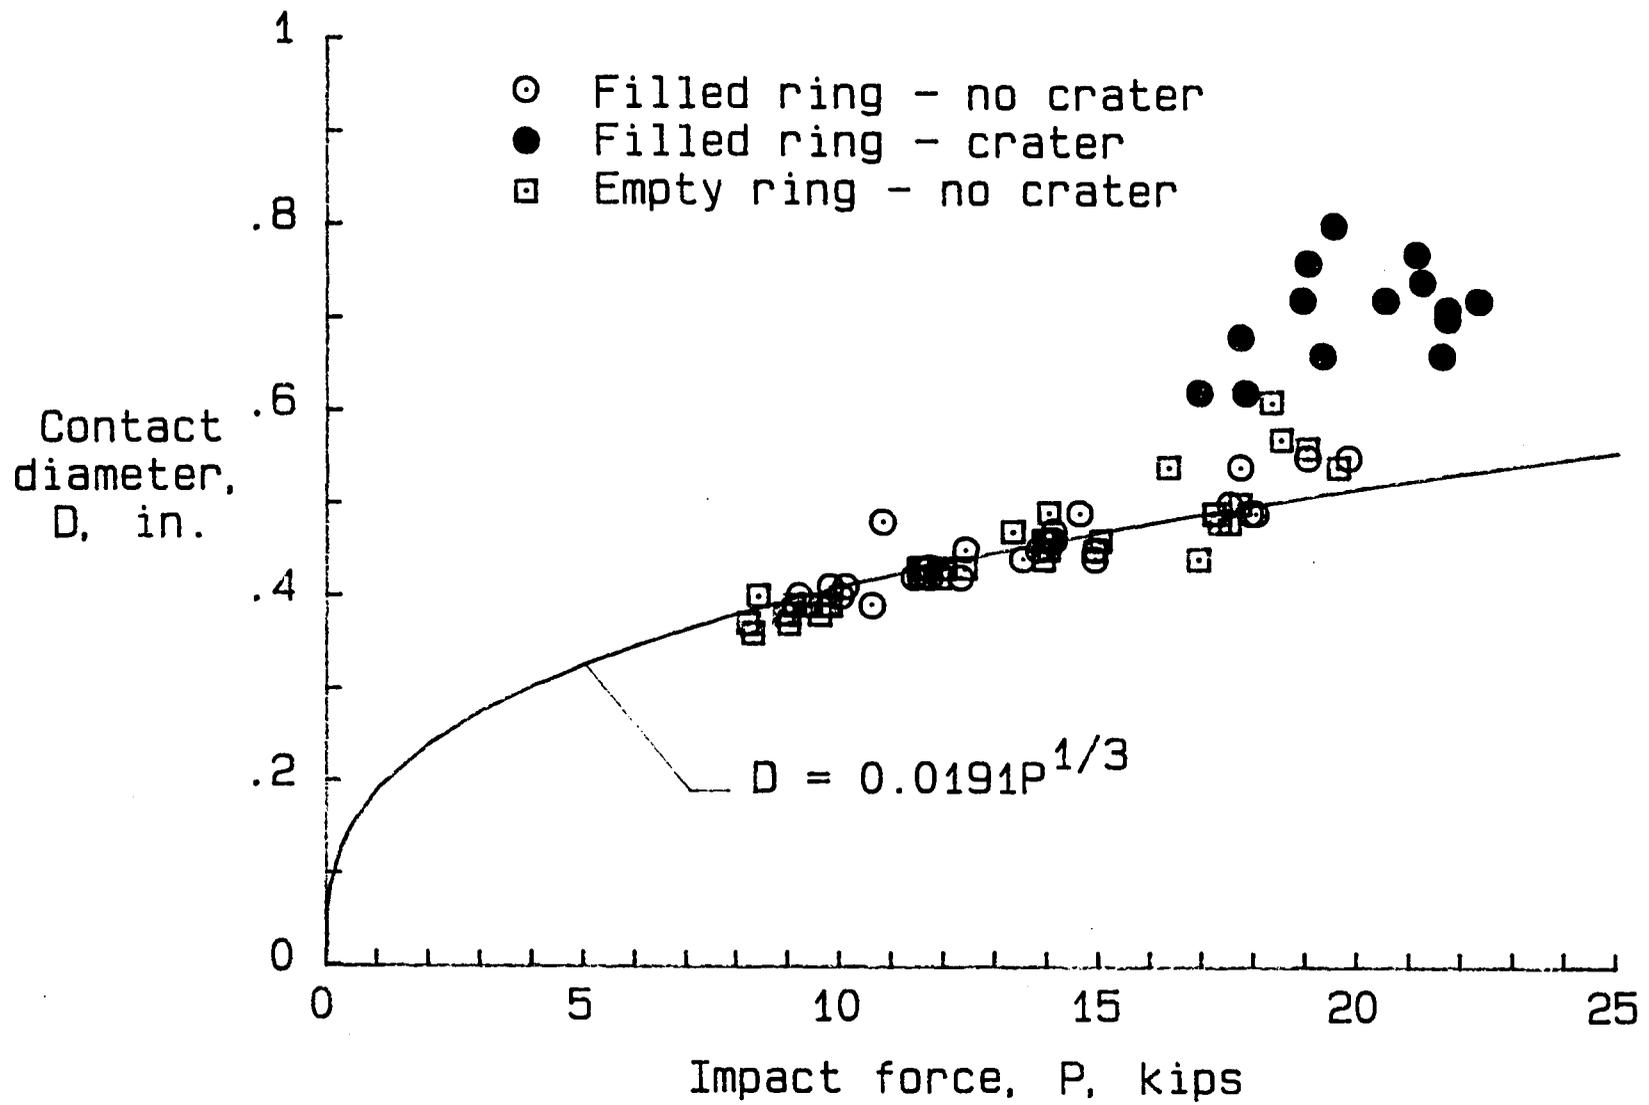
Figure 21.- Contact diameter versus impact force.

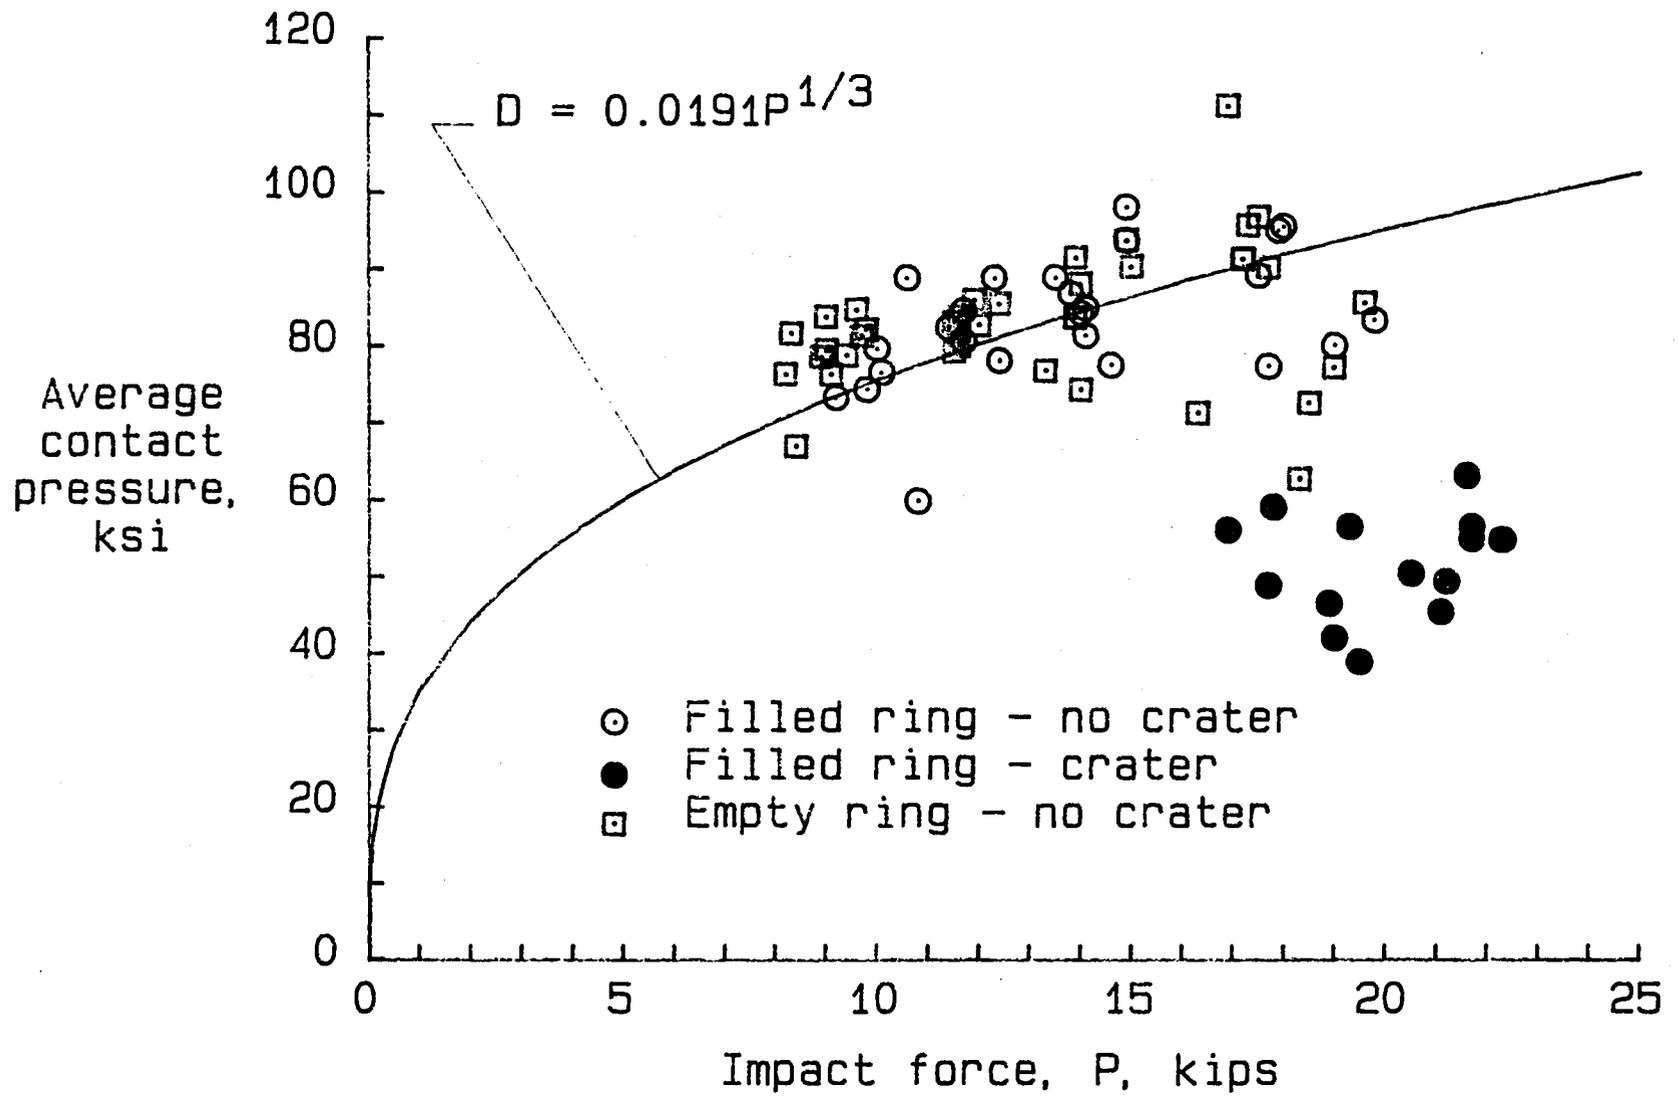
Figure 22.- Average contact pressure versus impact force.

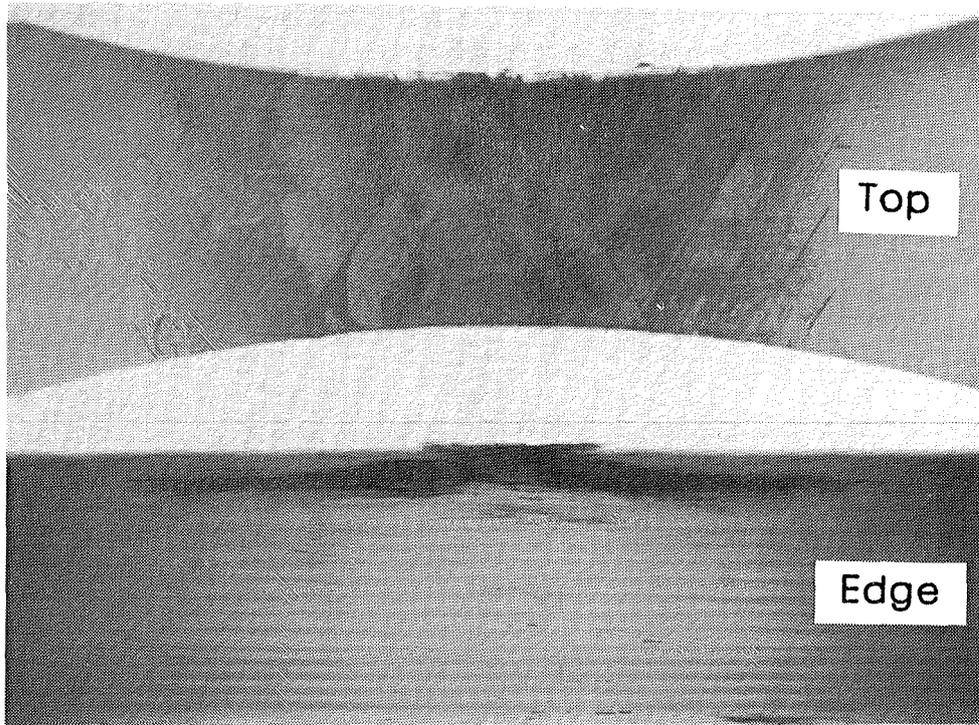
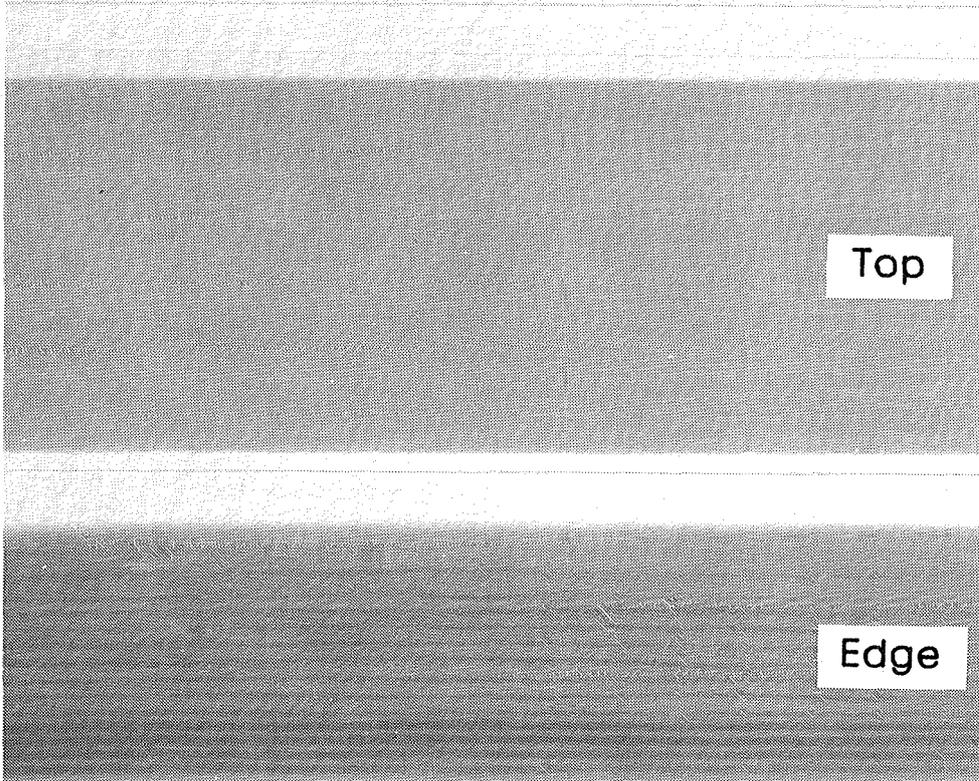
(a) Specimen 7-6 (P = 9.2 kips).

After
loading
to
1st-
ligament
failure

Before
loading

Figure 24.- Radiographs of first-ligament failure - filled ring.

For each combination of impactor mass and kinetic energy, one of the duplicate specimens was not loaded to complete failure. Instead, it was unloaded when the first ligament failed, removed from the testing machine, and x-rayed. Then, it was reinstalled in the testing machine and loaded to complete failure. Depths of the delaminations in the radiographs were measured. The delamination depths are also given in tables I and II.

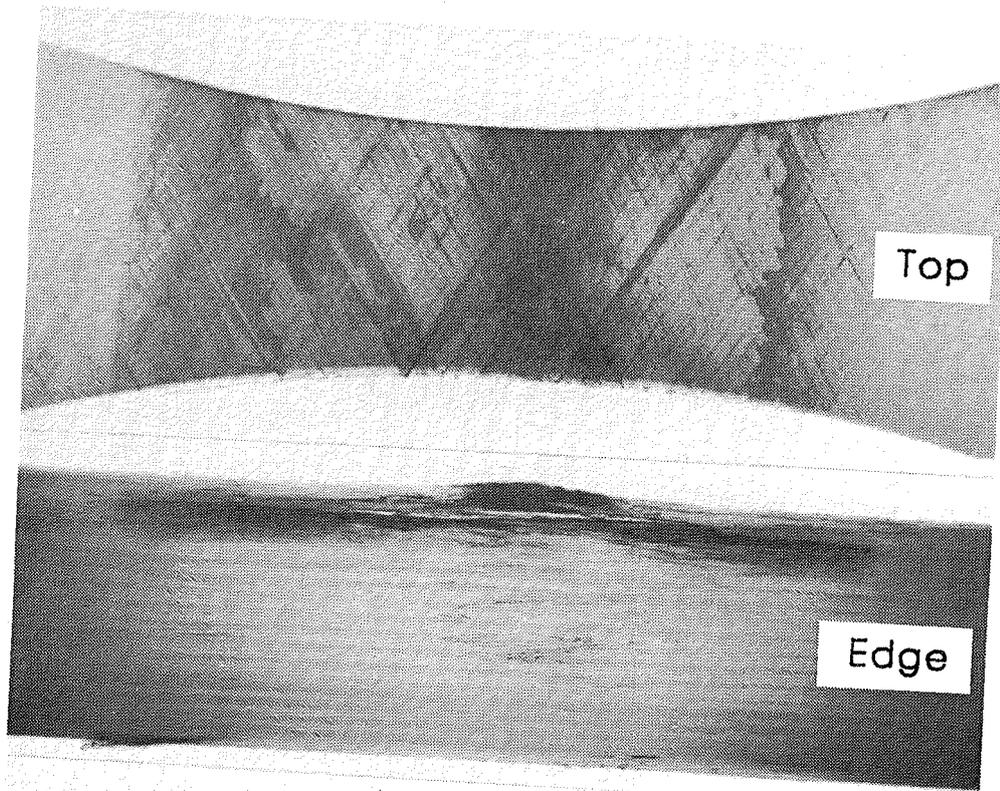
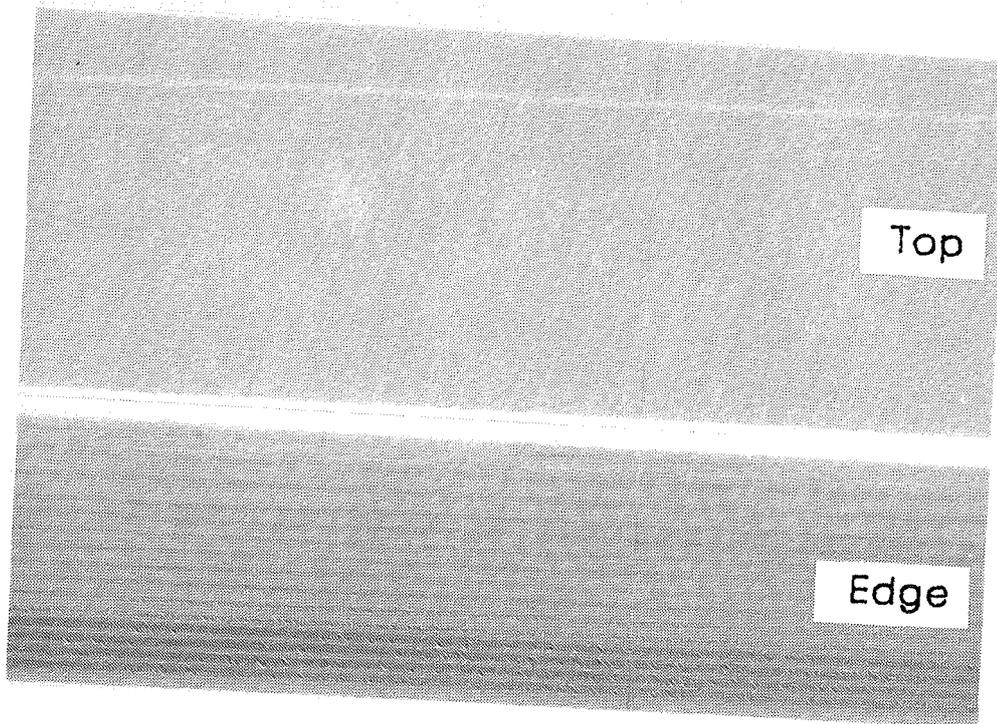
(a) Specimen 5-26 (P = 8.9 kips).

After
loading
to
1st-
ligament
failure

Before
loading

Figure 25.- Radiographs of first-ligament failure - empty ring.

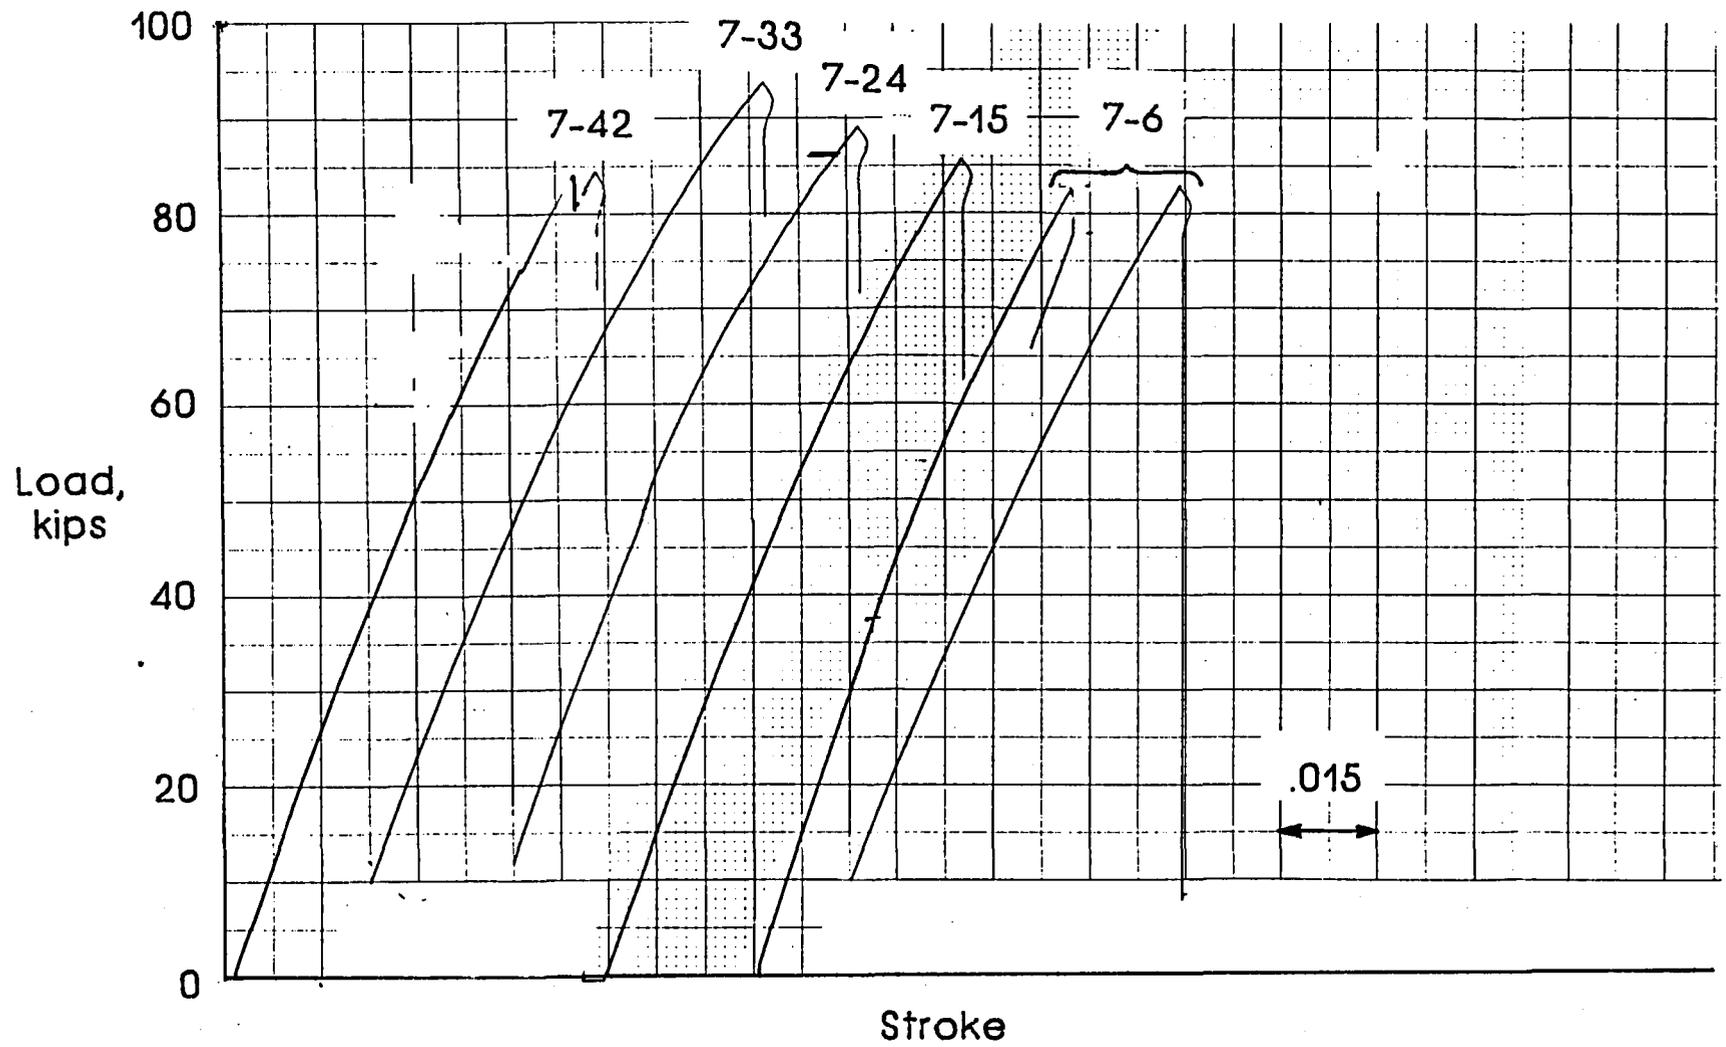
(a) $m_1 = 6.1 \text{ lbm}$ and $KE = 30.3 \text{ ft-lbf}$.

Figure 26.- Load-stroke records for impacted specimens from filled ring.

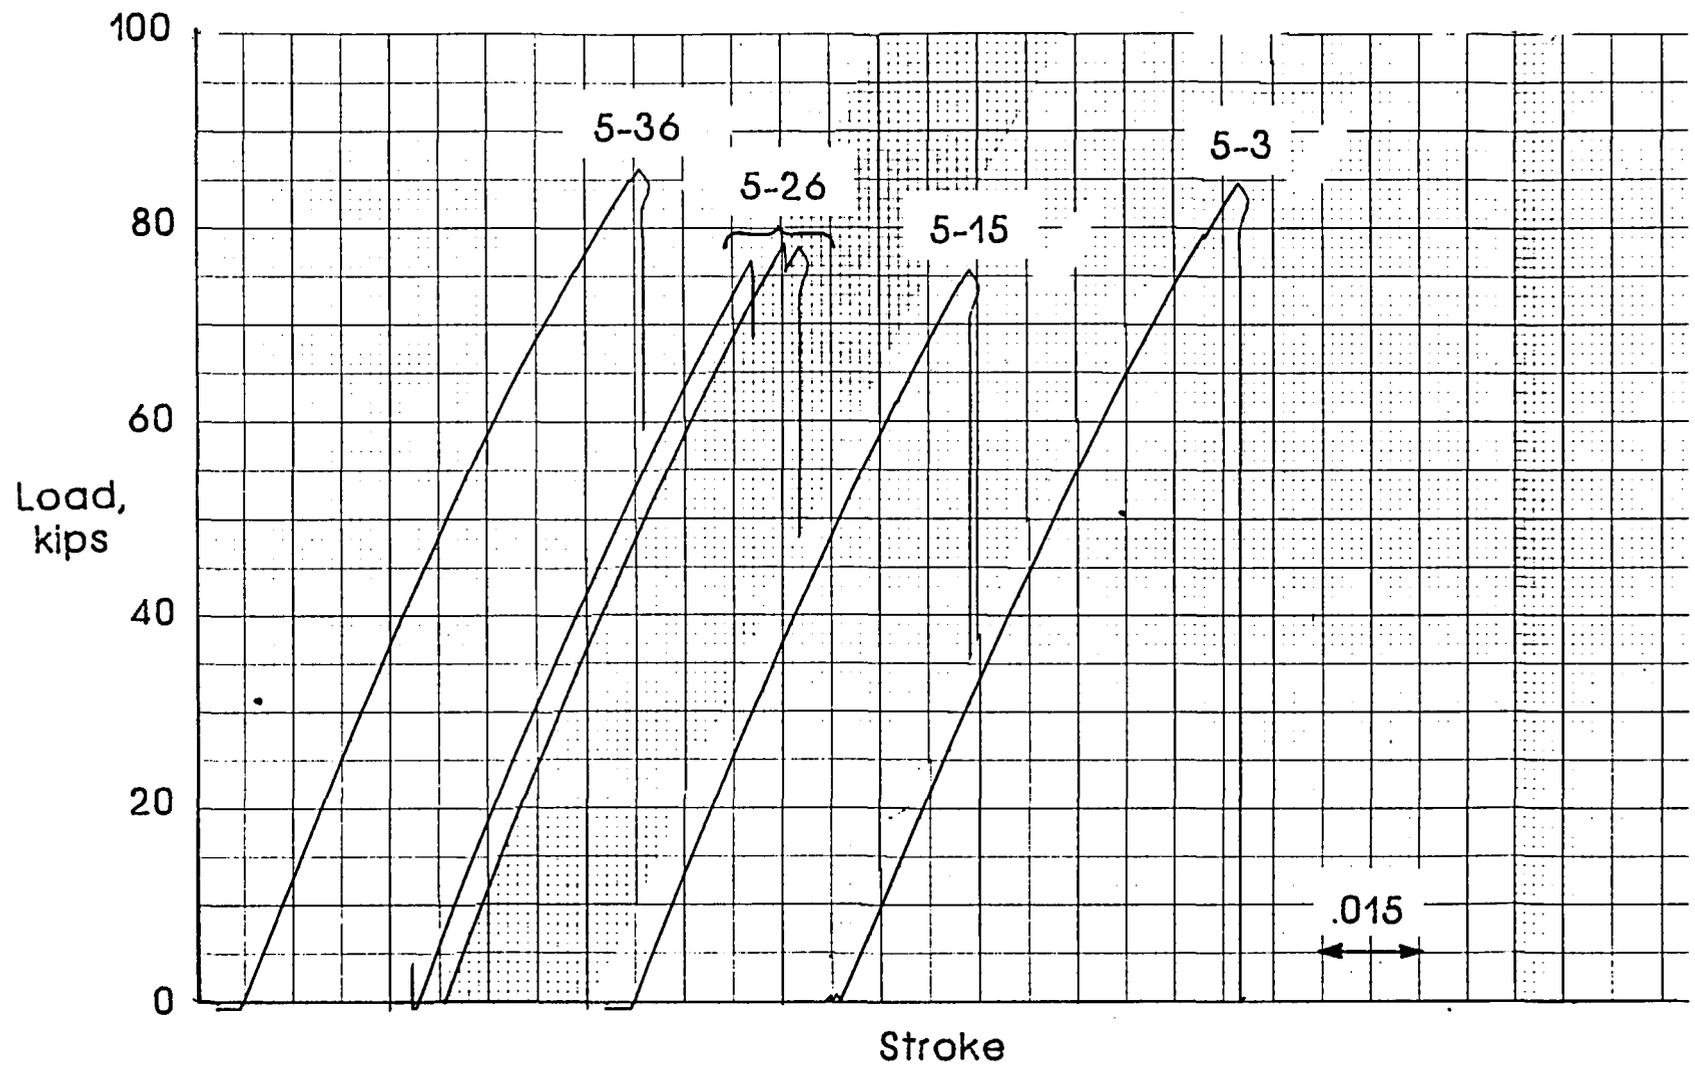
(a) $m_1 = 6.1 \text{ lbm}$ and $KE = 30.3 \text{ ft-lbf}$.

Figure 27.- Load-stroke records for impacted specimens from empty ring.

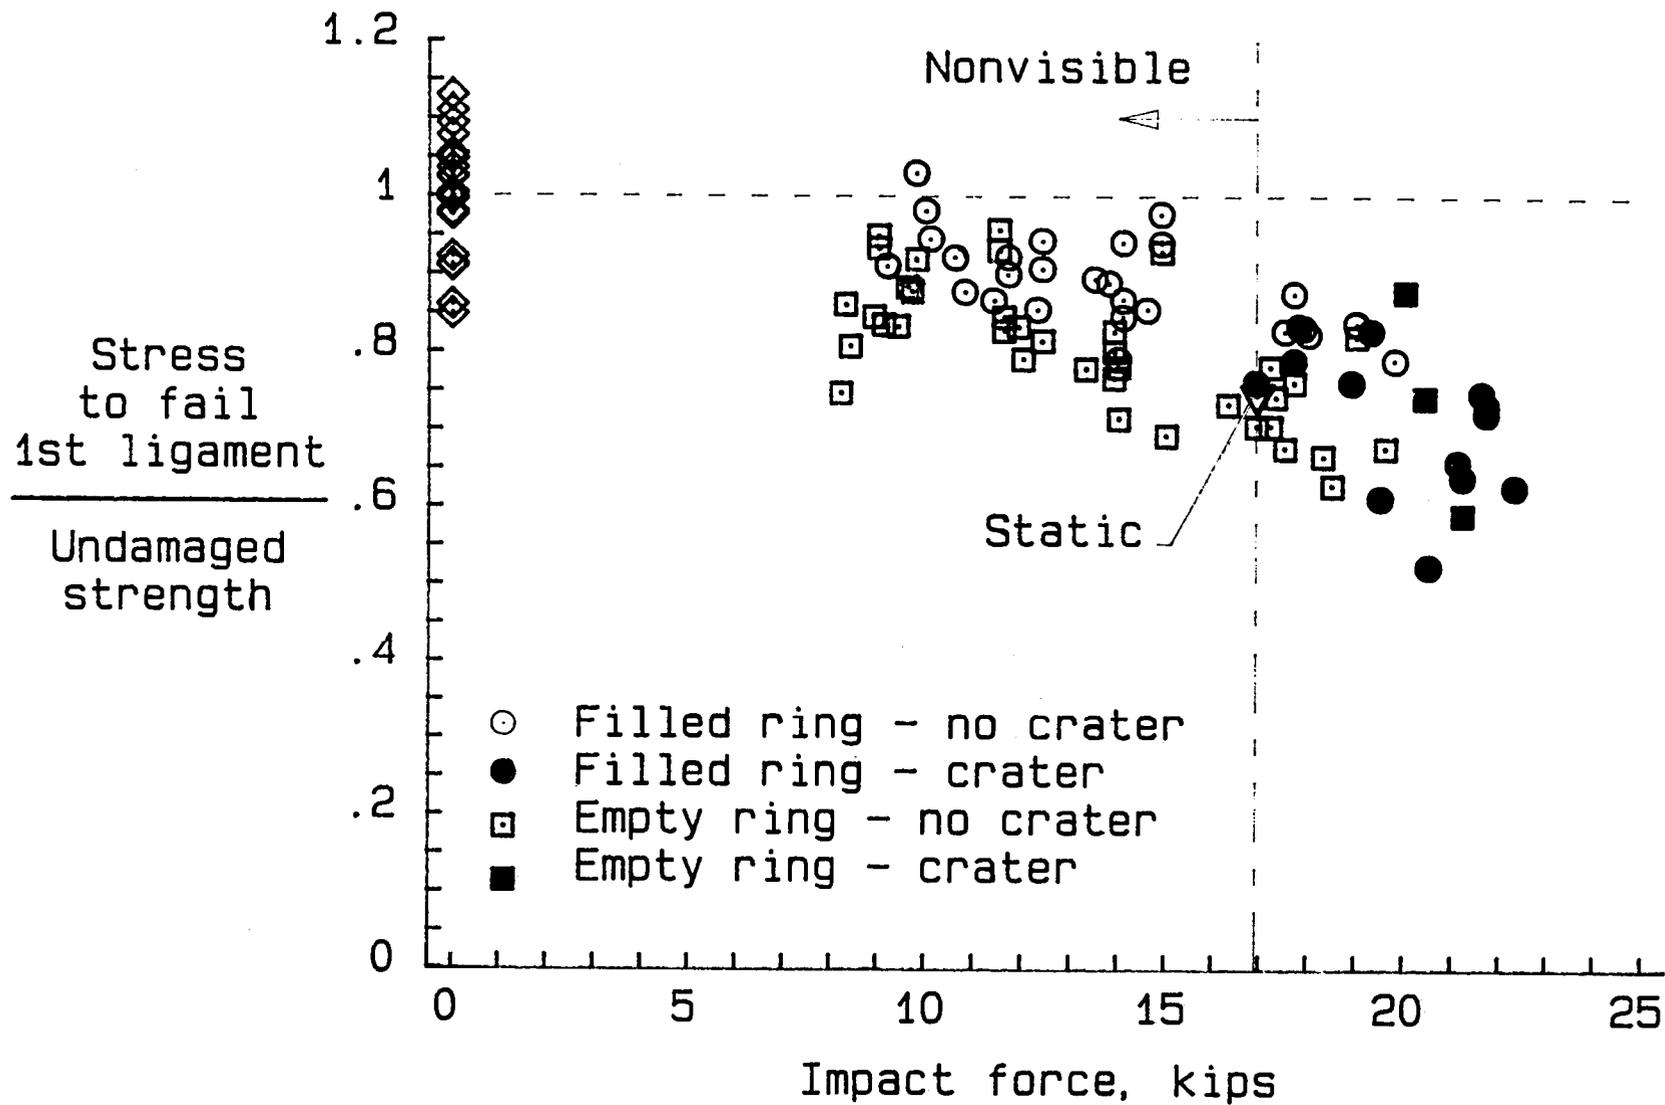
Figure 28.- Ratio of stress for first-ligament failure to undamaged strength versus impact force.

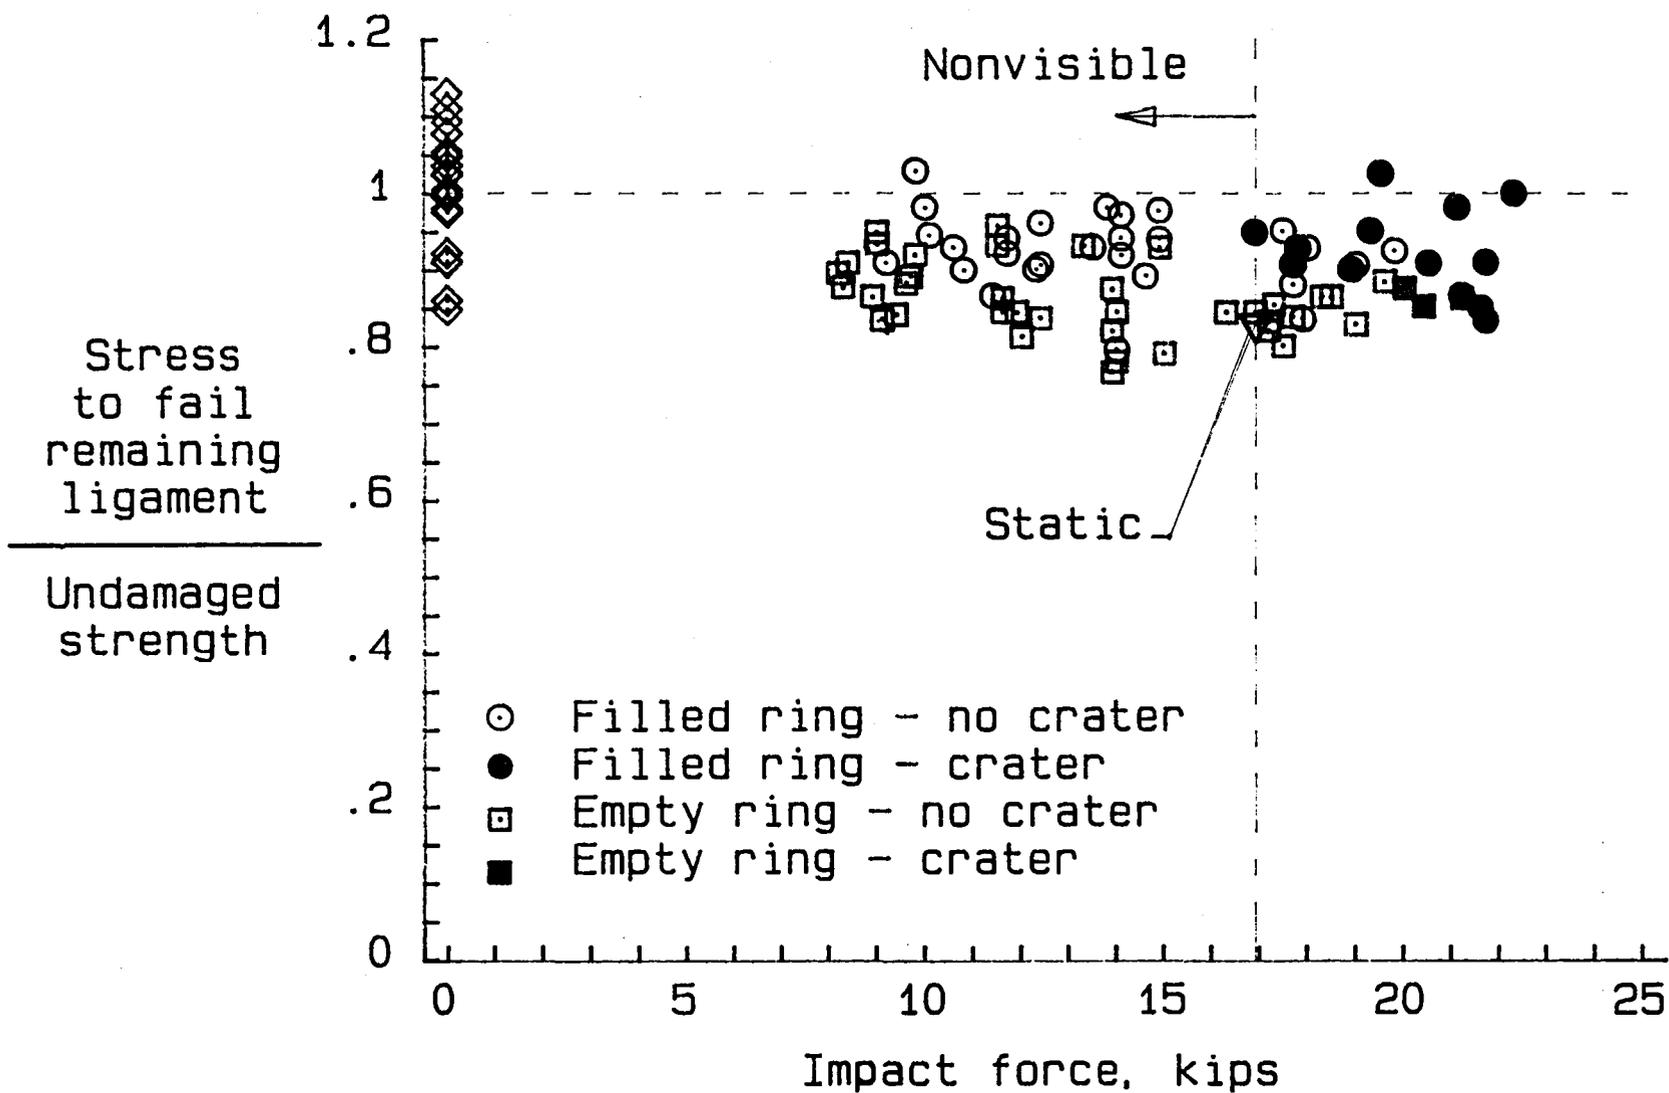
Figure 29.- Ratio of stress for remaining-ligament failure to undamaged strength versus impact force.
