NASA Technical Memorandum 87771

TENSION STRENGTH OF A THICK GRAPHITE/EPOXY
LAMINATE AFTER IMPACT BY A 1/2-IN.-RADIUS IMPACTOR

C. C. Poe, Jr., W. Illg, and D. P. Garber

JULY 1986

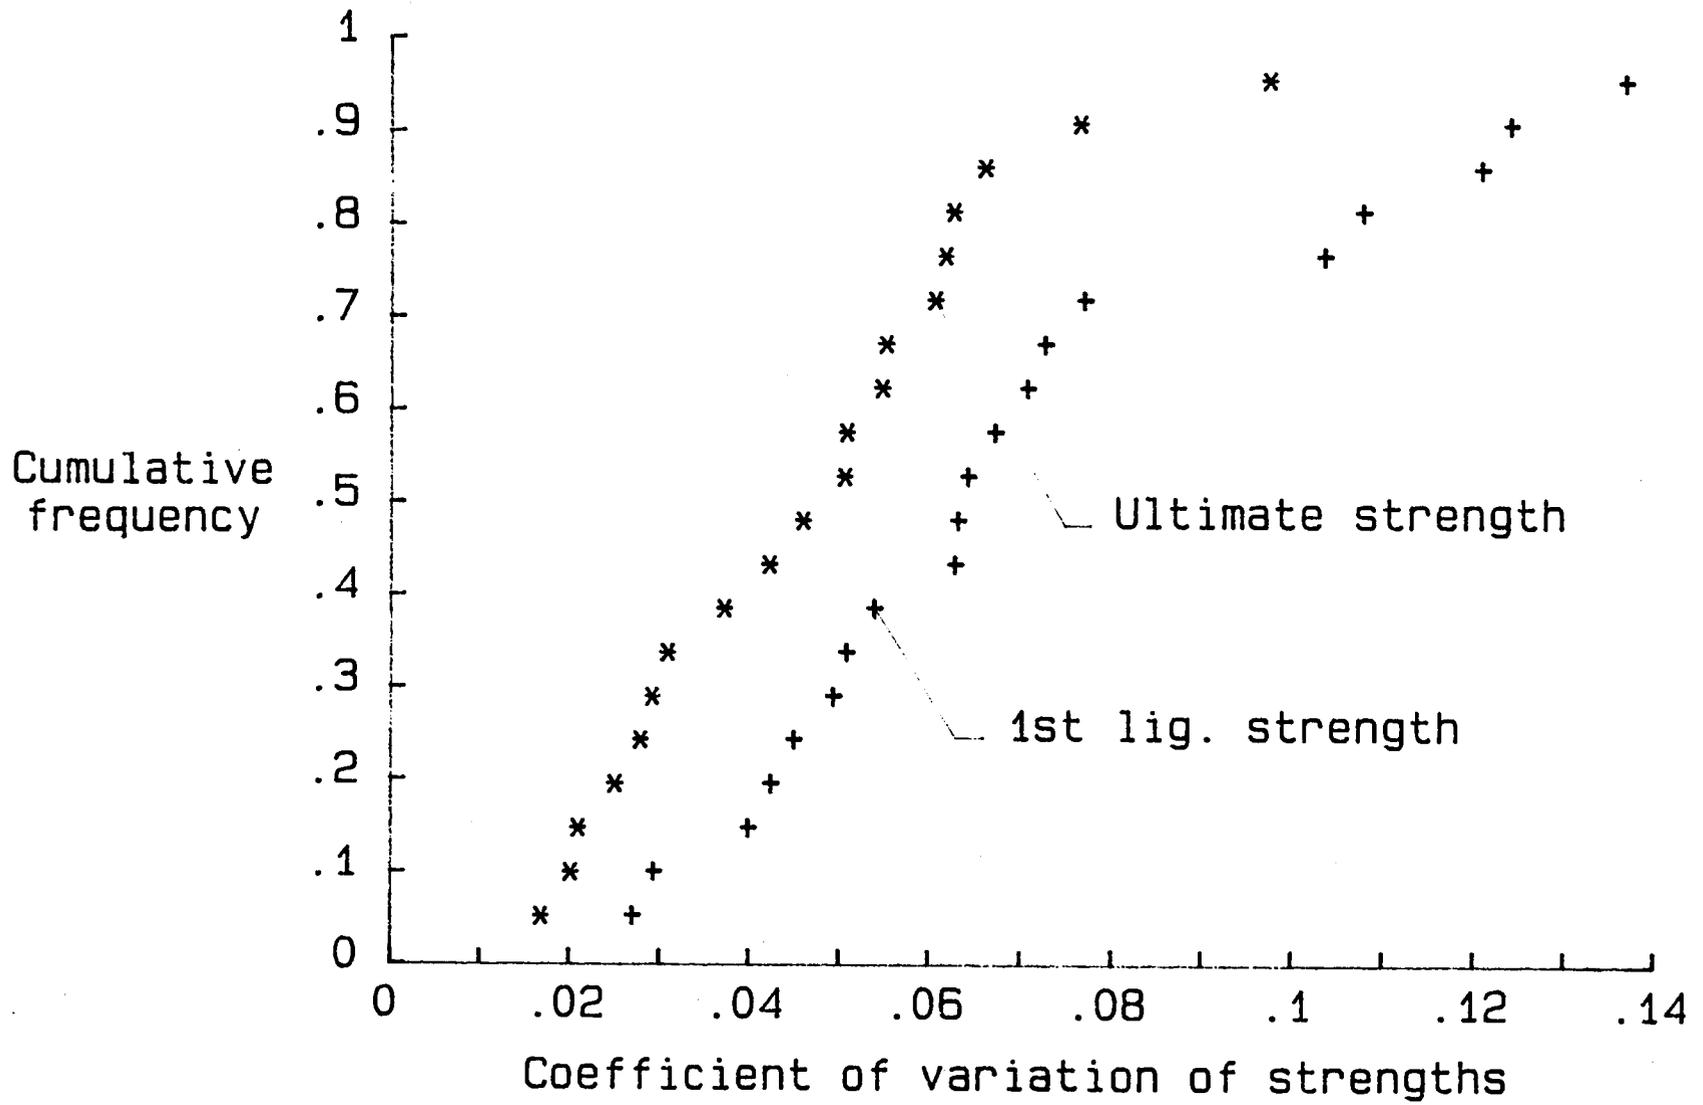
Figure 30.- Cumulative frequency versus coefficient of variation of strengths for groups of specimens with the same impactor mass and kinetic energy.

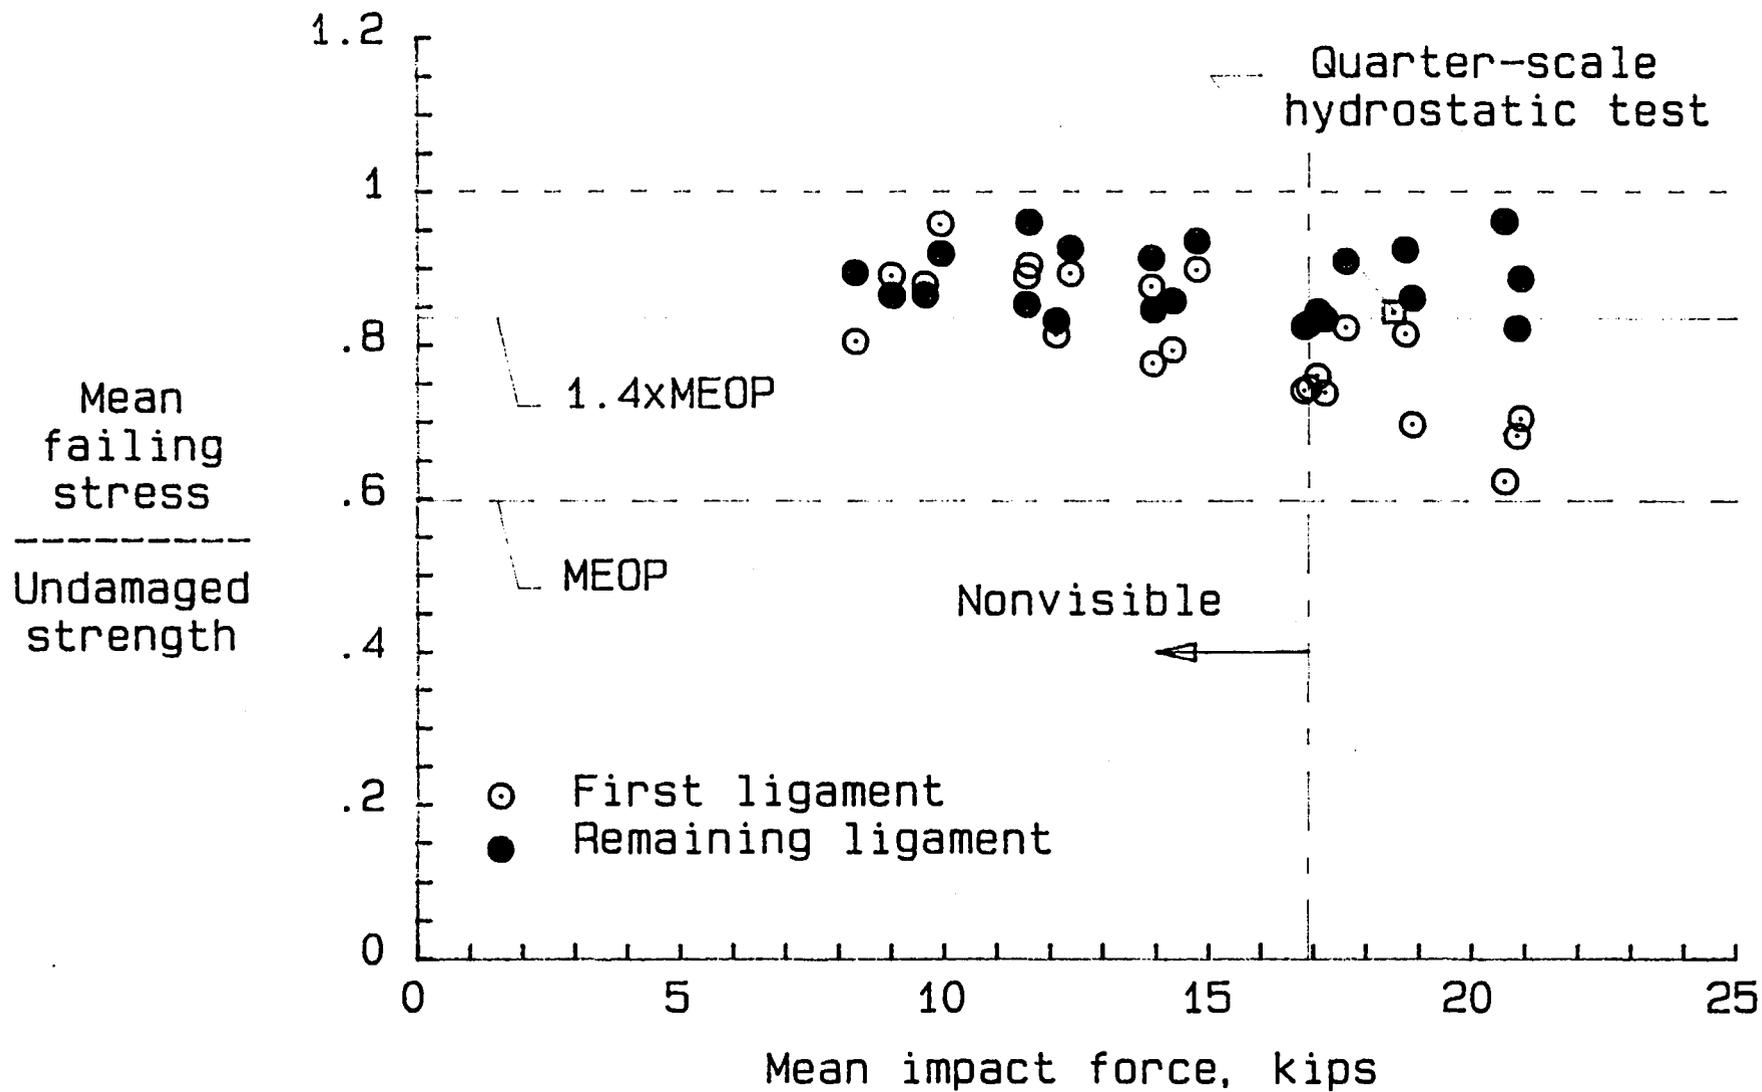
Figure 31.- Comparison of tensile tests and design conditions.

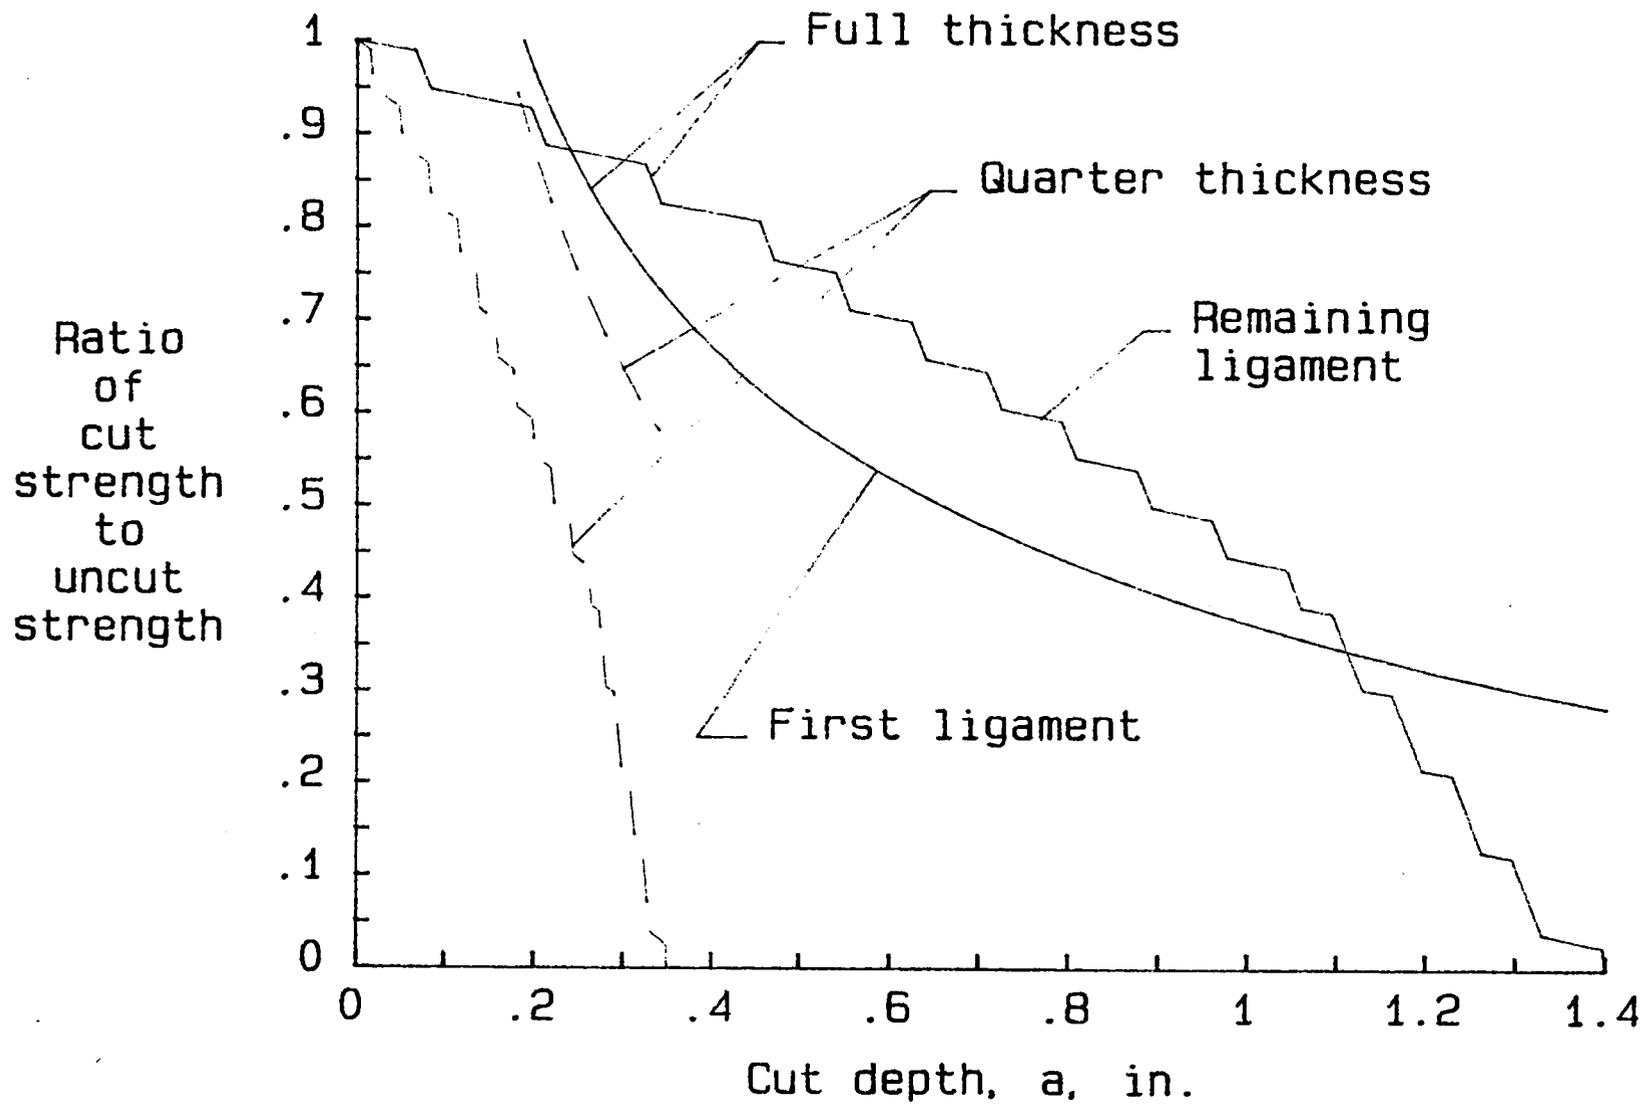
Figure 32.- Comparison of fracture behavior for full- and quarter-scale laminates. $c/a = 0.8$ and $K_Q = 27.3 \text{ ksi } \sqrt{\text{in.}}$

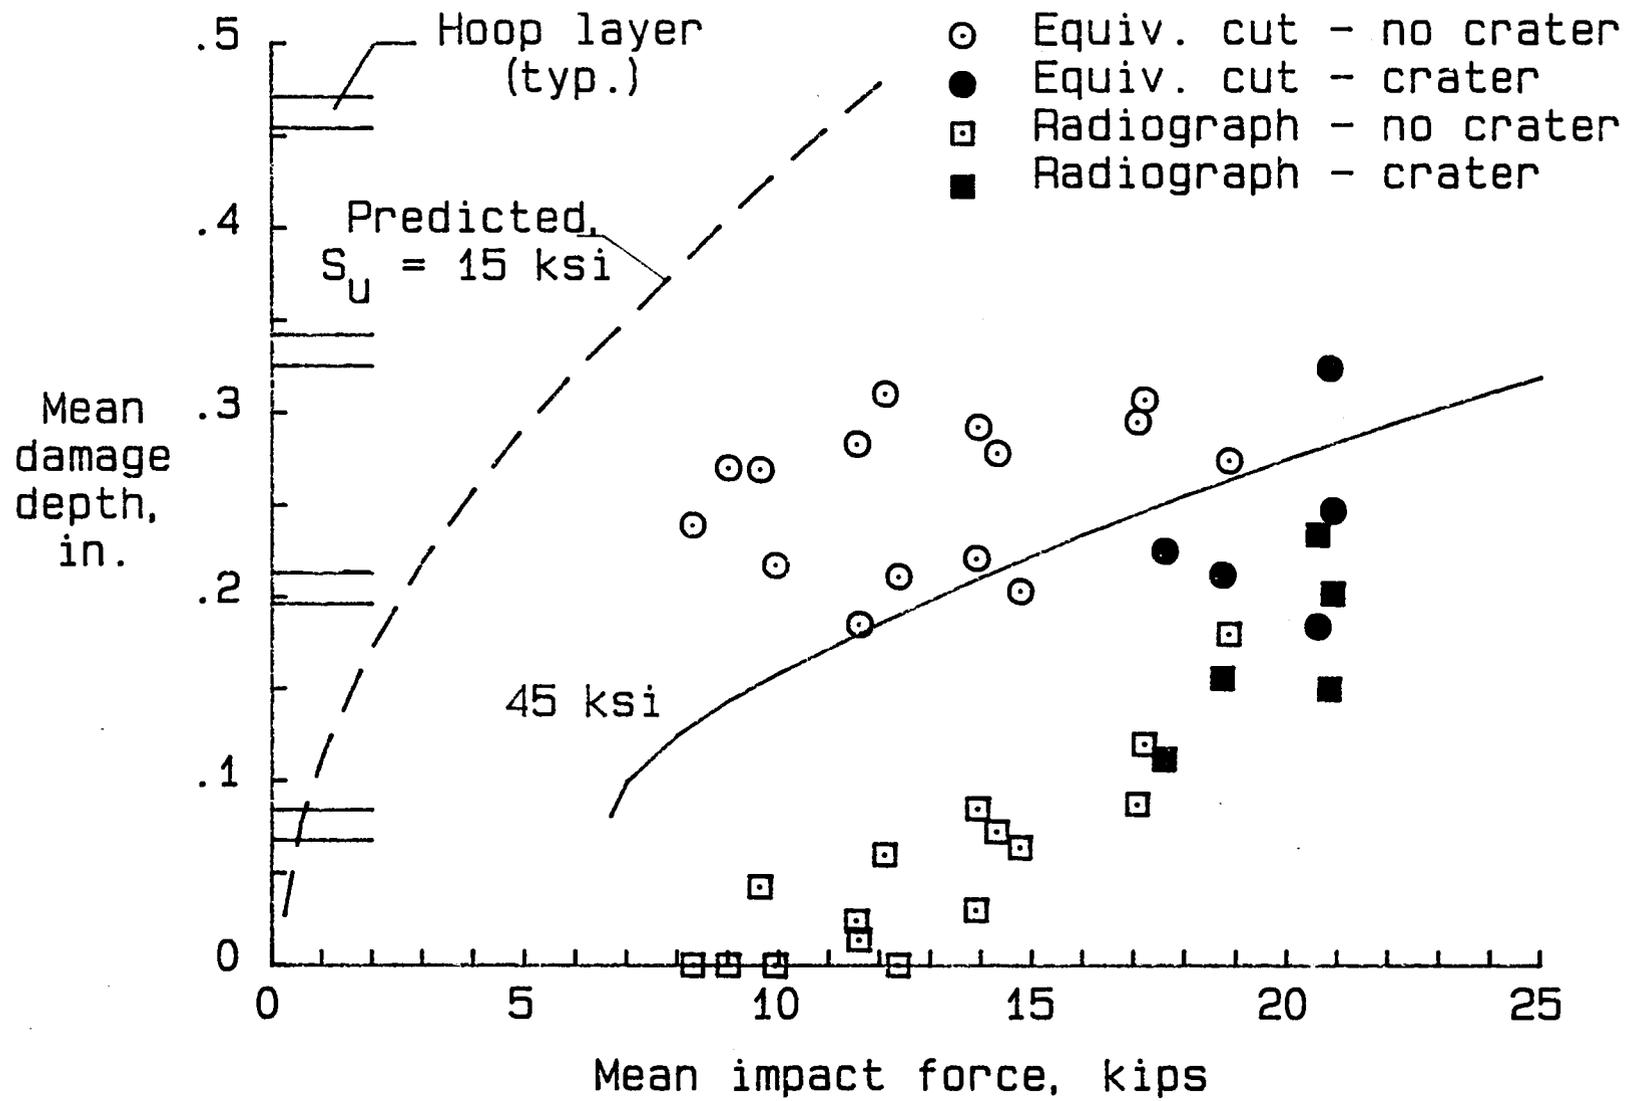
Figure 33.- Comparison of equivalent cut depth and measured and predicted damage depth.

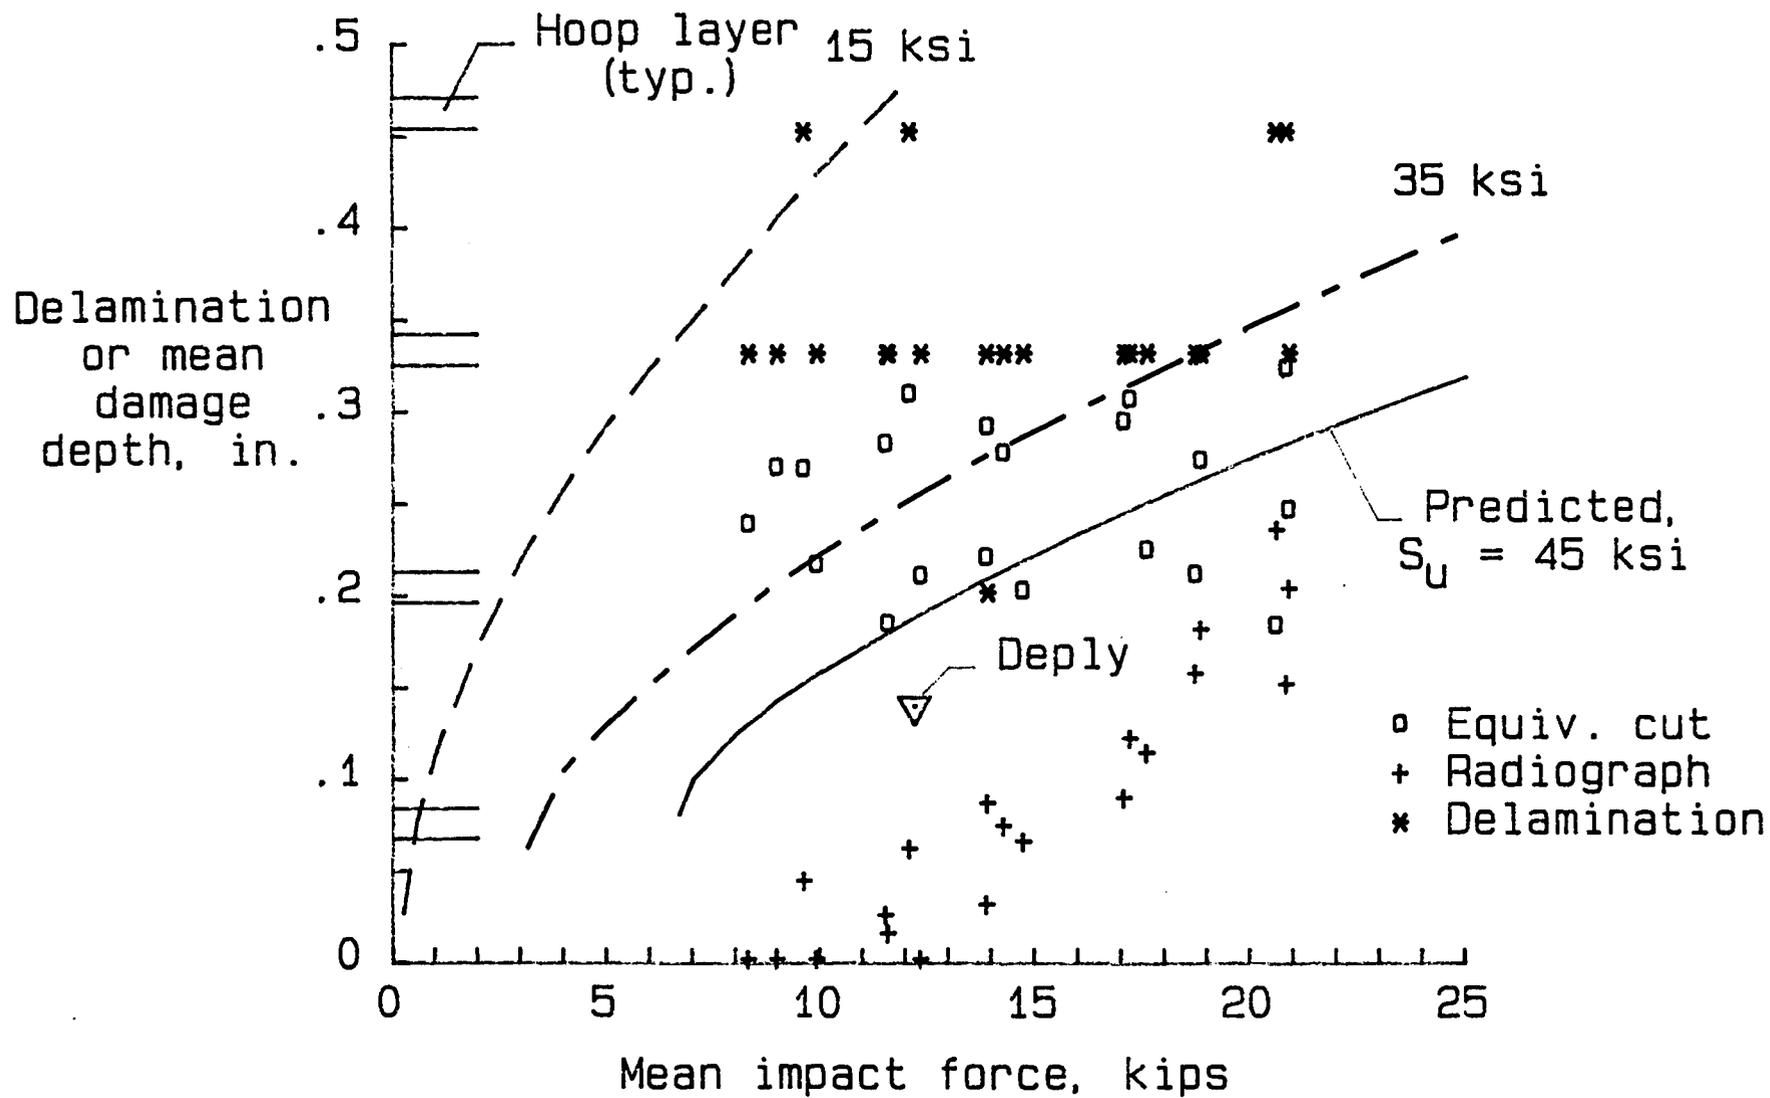
Figure 34.- Comparison of delamination and damage depth.

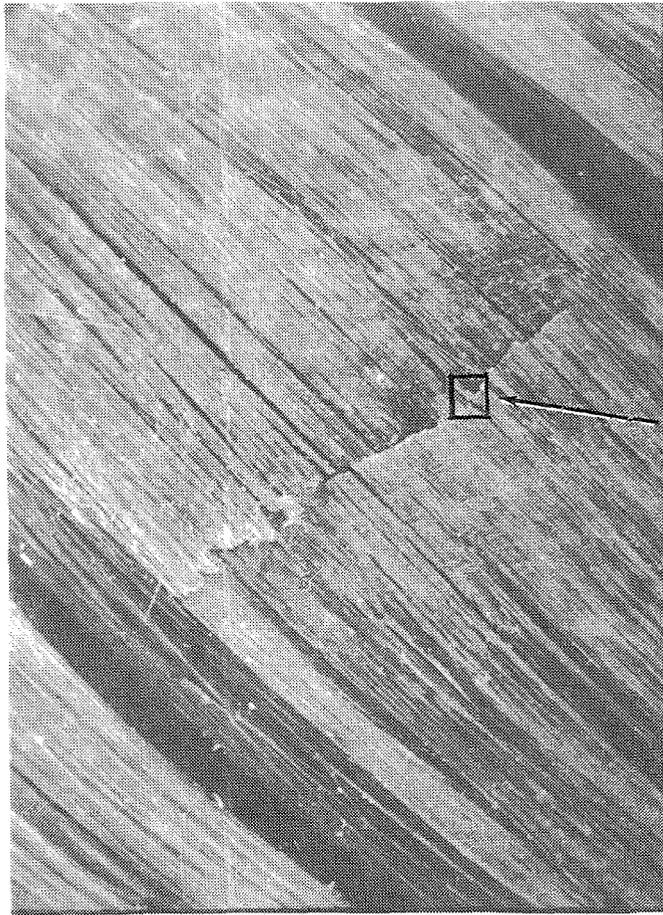
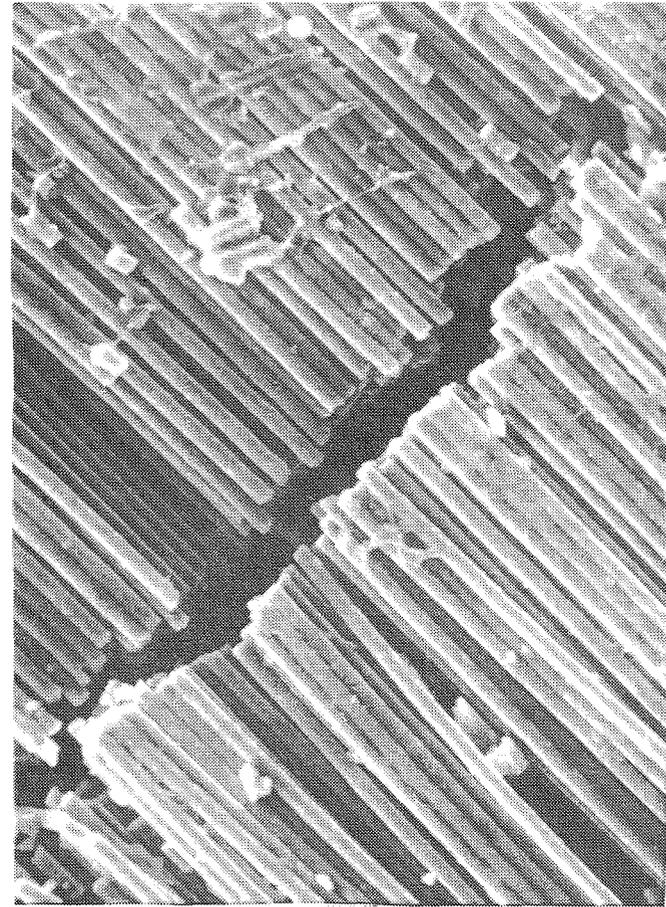
(a) 13X magnification.

(b) 280X magnification.

Figure 35.- Photographs of deepest layer with fibers broken by impact (second helical layer below the outermost hoop layer).

The local deformations, contact diameters, and contact pressures were predicted reasonably well with the Hertz law. Also, the effect on impact force of kinetic energy, impactor mass, and ring mass were predicted reasonably well with rigid body mechanics. However, the impact force predicted with rigid body mechanics using the static stiffness of the rings was much too small. Because the impact duration was only a few milliseconds, the rings were effectively smaller than their actual size and very stiff. The depth of broken fibers, which was determined by destructive examination, was predicted reasonably well using Love's solution for pressure applied on part of the boundary of a semi-infinite body and a principal shear stress criterion. However, the reduction in strengths corresponded to damage deeper than the depth of the broken fibers. Fibers below the broken fibers were apparently weakened by the impacts.
