**THE INFLUENCE OF DEFECTS ON THE
FATIGUE RESISTANCE OF BUTT AND
GIRTH WELDS IN A106B STEEL**

B. N. Leis, D. P. Goetz and P. M. Scott

**Contract NAS1-17404
JULY 1986**

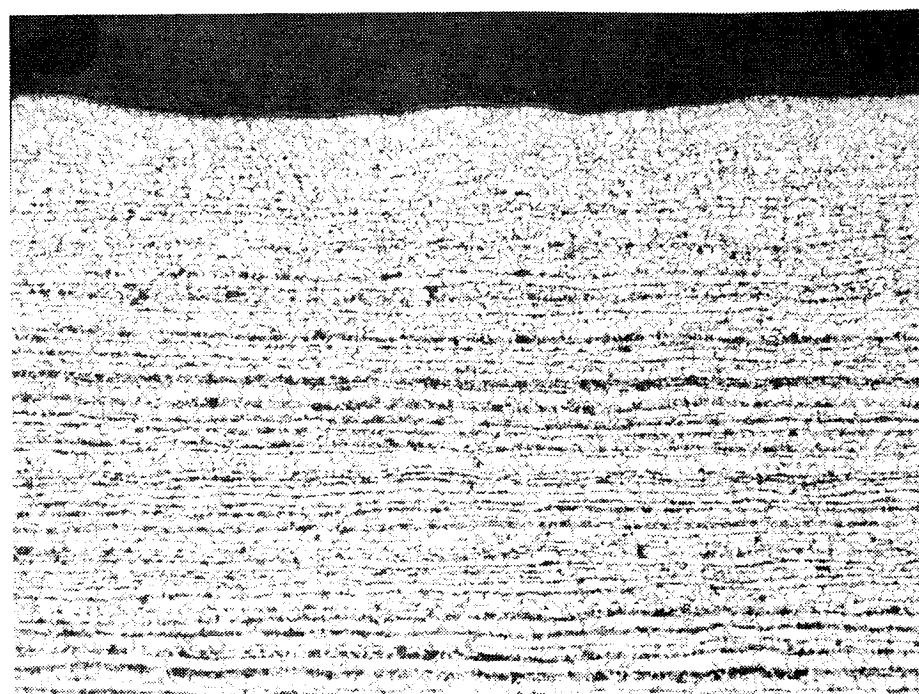
a. L-T direction at mid thickness

FIGURE 1. MICROSTRUCTURE OF THE BASE METAL IN THE
NORMALIZED CONDITION

Micrographs (100 x magnifications) were made to document the microstructure of the base metal in the normalized condition. Micrographs were taken at different locations in different orientations. Little difference in the microstructure was observed for the different orientations and locations. Figure 1 shows views of the typical microstructure taken in the L-T direction, at mid-thickness and at the surface. These views are typical of normalized steel showing a mix of ferrite and pearlite and evidence

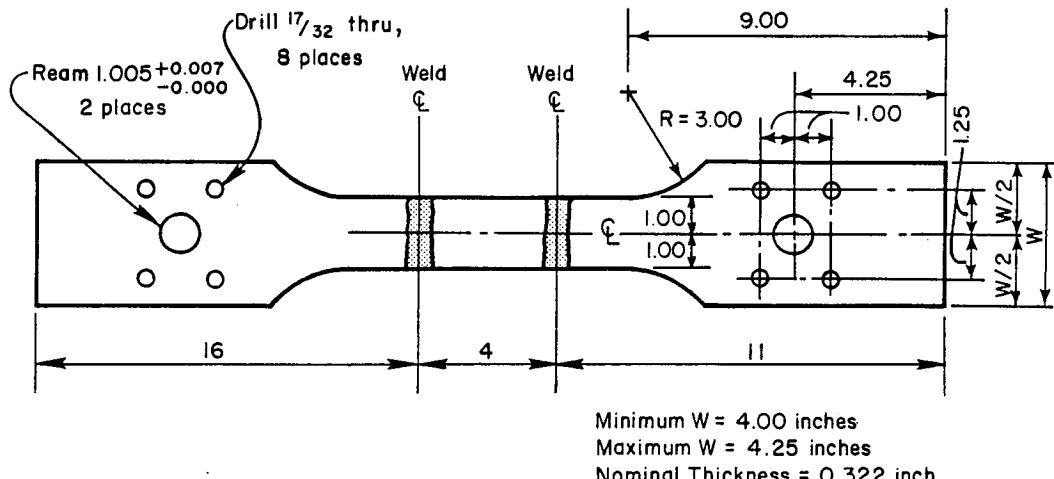
FIGURE 2. FLAT PLATE SPECIMEN DESIGN

Flat plate specimens. The specimen design used in the flat plate tests is shown in Figure 2. The material used was described above. The 203 mm (8-inch) pipe was cut to length, then cut lengthwise into two halves, flattened, and then normalized to relieve the flattening stresses. The flattened plates were saw cut at the locations for the welds, and the edges were beveled in preparation for welding. Flattened backup rings were used in making the welds. All of the welds were inspected and found to be code-acceptable welds. The specimens were then normalized again. During the normalization, the specimens were stacked in an oven with the ends unsupported. As a result, some of the ends drooped during heating. The specimens were then normalized again.

Reference tests. Crack growth data were developed using a flat plate specimen with quality welds (Figure 2). Unlike the specimens used for the comparative experiments, both sides of the specimen were ground flat. The backup ring and weld reinforcement were completely removed. An EDM flaw was cut completely through the thickness at the mid-width on both welds forming a center cracked panel. A Krak gage was mounted at each of the eight surface flaw tips. An automated data acquisition system was used to collect crack growth data during the test. The specimen was cycled in a load control mode

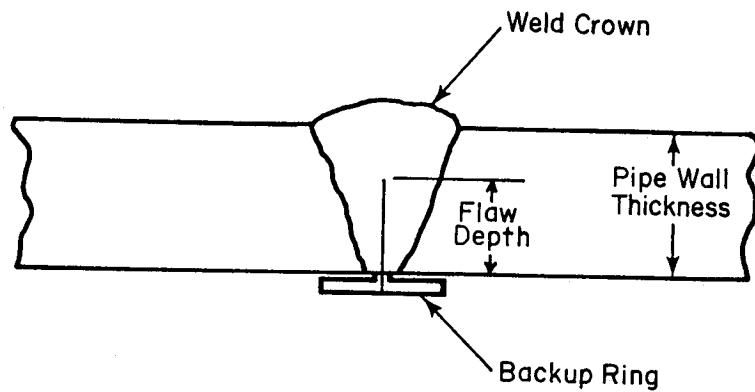
FIGURE 3. REFERENCE FOR MEASURABLE FLAW DEPTH FOR EDM FLAWS

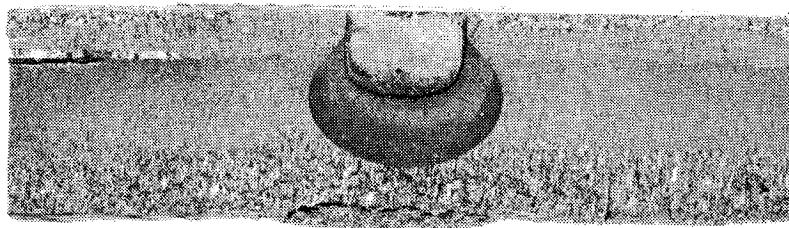
FIGURE 4. FRACTOGRAPH ILLUSTRATING CRACK PINNING BY THE BACKUP RING
(Note: EDM flaw is cut through ring with its position
referenced to the surface of the plate, as if the backup
ring did not exist.)

Early in the testing, it was discovered that the unstressed backup ring could "pin" the crack. This is illustrated by the fracture surface shown in Figure 4. Because this complex growth would confuse subsequent data interpretation, the backup rings on the remaining specimens were cut by EDM by using a flat electrode with a curved edge (a 76 mm (3-inch) radius). Figure 5 shows an example of the result as seen on a fracture surface. The backing ring was cut so as to "unpin" the defect by cutting to nearly intersect the defect at the surface of the specimen. Thus, care was taken to make the cut 0.127 - 0.254 mm (0.005-0.010 inch) shallower than the thickness of the backup ring to ensure that the weld metal was not cut.

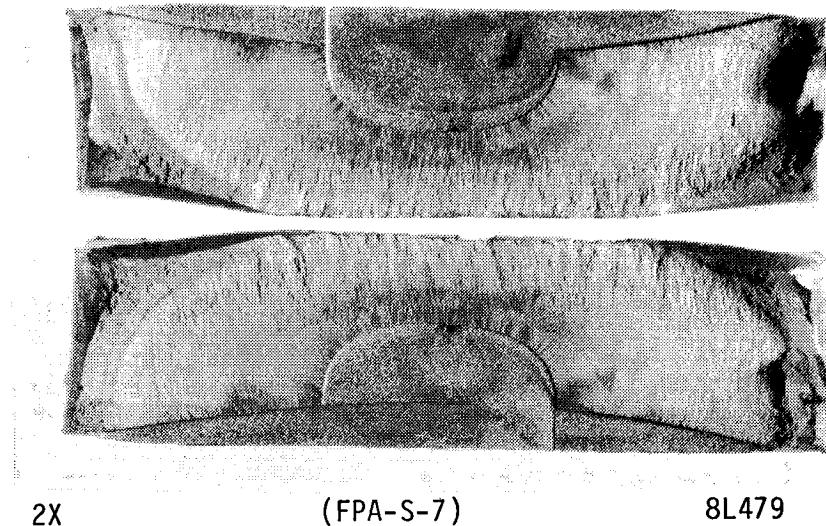
FIGURE 5. FRACTOGRAPH SHOWING EDM FLAWS AND BACKUP RING CUT BY EDM

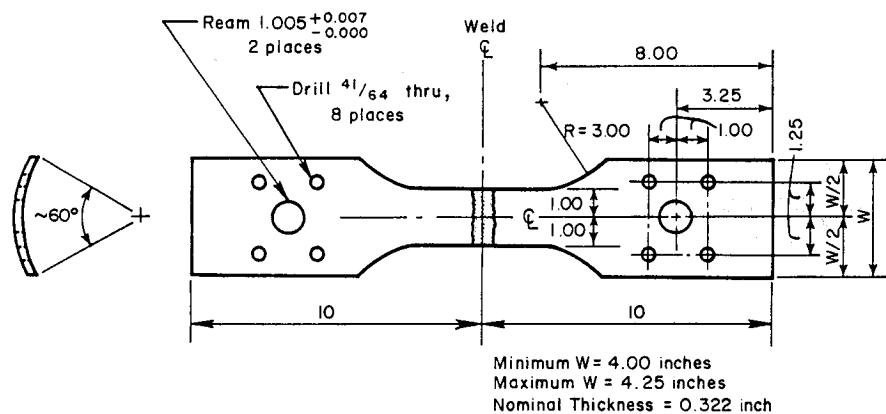
FIGURE 6. PIPE WALL SEGMENT SPECIMEN DESIGN

Pipe wall segment specimens. The specimen design used in the pipe wall segment tests is shown in Figure 6. Pieces of pipe were first cut to the proper length. They were then cut into two equal lengths. The edges of the

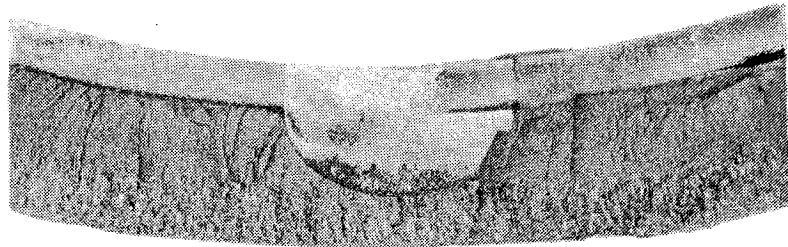
FIGURE 7. FRACTOGRAPH SHOWING EDM FLAWS AND BACKUP RING CUT BY EDM

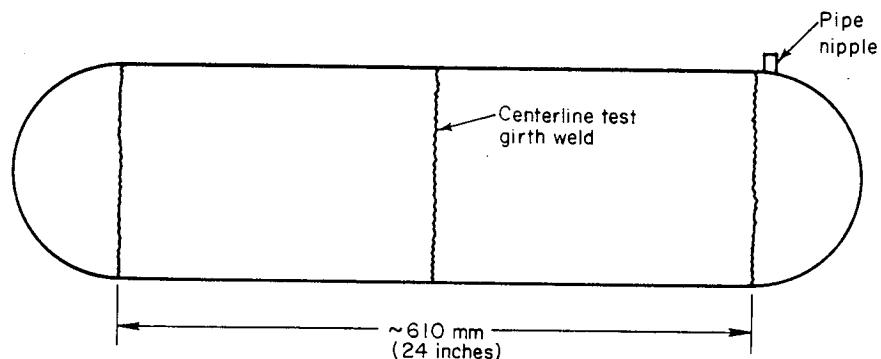
FIGURE 8. SCHEMATIC OF 203 MM (8-INCH) NOMINAL DIAMETER PIPE-SEGMENT TEST SPECIMEN

The 203 mm (8-inch) diameter specimens were fabricated as pressure vessels with end caps on each end and a centrally located girth weld as shown in Figure 8. One of the end caps was fitted with a nipple for a pressurization line. The length of the vessels from end cap weld to end cap weld was approximately 610 mm (24-inches). The center girth welds contained an internal surface defect, either an artificial defect in a code-acceptable weld or a natural defect introduced using one of the welding procedures discussed previously.

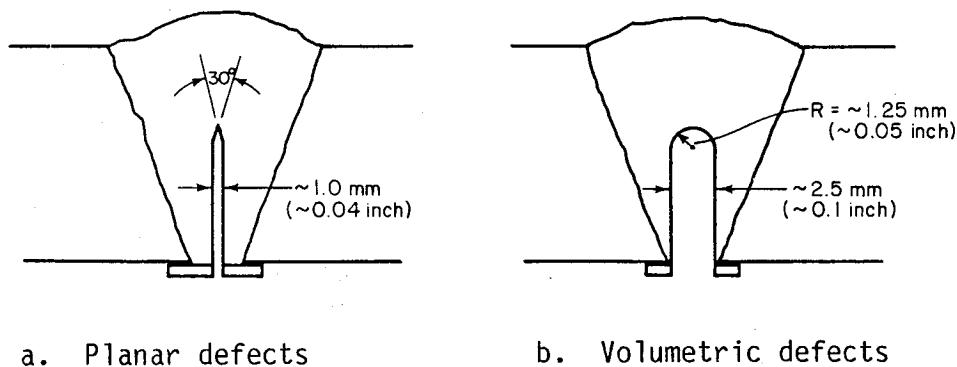
FIGURE 9. DETAILS OF ARTIFICIAL DEFECTS

The nominal defect size was the same for each of the 12 experiments. The defect extended 120-degrees around the pipe circumference. The depth was approximately 4.95 mm (0.195-inch). This depth was approximately 60 percent of the pipe wall thickness, with an area equal to about 20 percent of the cross section. The depth was referenced to the inside surface of the pipe and not the backing ring (see Figure 3). The size of these defects was chosen on the basis of LEFM estimates that indicated such flaws would grow through the wall thickness in reasonable lives (i.e., similar lives to those in the flat plate and wall segment tests) at code allowable stress levels. For safety considerations the length of the defect was selected so that the failure mode of the defect would be a leak and not a rupture based on a ligament instability analysis. Four of the twelve specimens had an artificial planar type of defect. The defect was introduced using electro-discharge-machine (EDM) techniques. The tip of the electrode was tapered in order to achieve a sharp notch tip as indicated in Figure 9a. Four of the twelve specimens had an artificial volumetric type of defect. This type of defect was introduced using EDM techniques except a wide electrode with a curved blunt tip illustrated in Figure 9b was used. The remaining four specimens had a natural planar defect introduced by the previously discussed methods. Because previous wall segment tests indicated that unrealistic defect sizes or stresses would be required to achieve fatigue lives of interest in this program, pipe-segment specimens with natural volumetric defects were not fabricated.

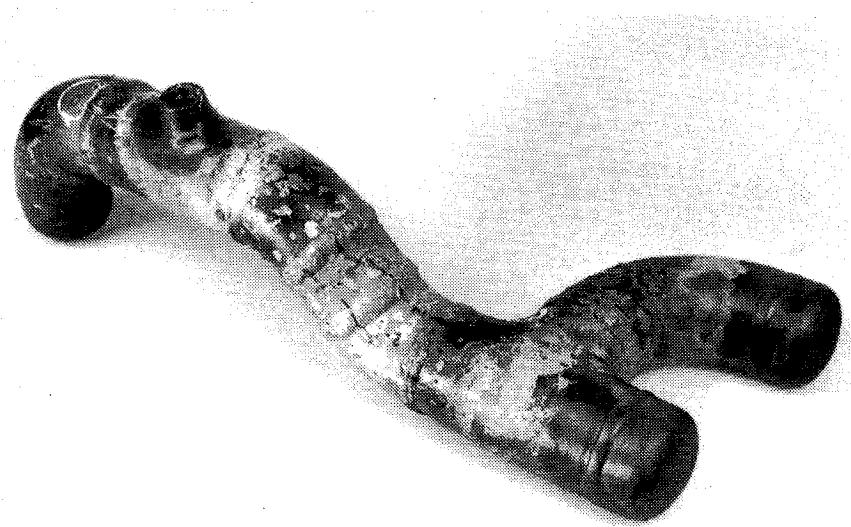
a. Specimen No. 1

Table 6 presents the results of the radiographic inspections for the welds in these two 76 mm (3-inch) diameter specimens. These results were supplied by the sponsor. Specimen 1, shown in Figure 10a, contained a pipe tee, a pipe elbow, two short lengths of straight pipe, three end caps, a pipe nipple, three quality end cap welds, and three defective girth welds. Specimen 2 contained a pipe tee, two elbows, two metric joints, two short straight sections of pipe, three end caps, a pipe nipple, three code-acceptable end cap welds, and six defective girth welds.

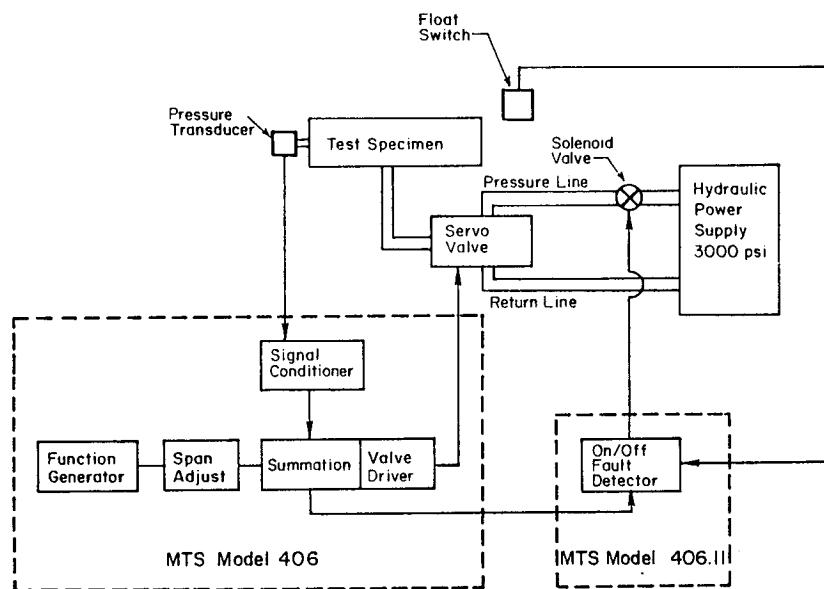
FIGURE 11. SCHEMATIC OF THE VESSEL AND PIPE TEST LOOP

Vessel and pipe tests. Testing was done in a containment vessel large enough to hold the test specimens. A schematic of the facility is shown in Figure 11. Tests were conducted in closed-loop pressure control to a sinusoidal waveform at a frequency of 1 Hz. Hydraulic oil was used as the pressurizing medium. The calibration of the pressure transducer was traceable to NBS. Two different systems were used to detect failure and shutdown the facility. A flapper-type switch was positioned directly over the centerline of the flaw such that if the flaw broke through the wall, and resulted in a pin-hole leak, the resulting jet of oil would contact the flapper, activate the switch, and shutdown the system. The second system was a float device such that when the oil in the vessel escaped through the resulting through-wall flaw, the oil level in the containment vessel rose, activating the float device, and shutting down the system.

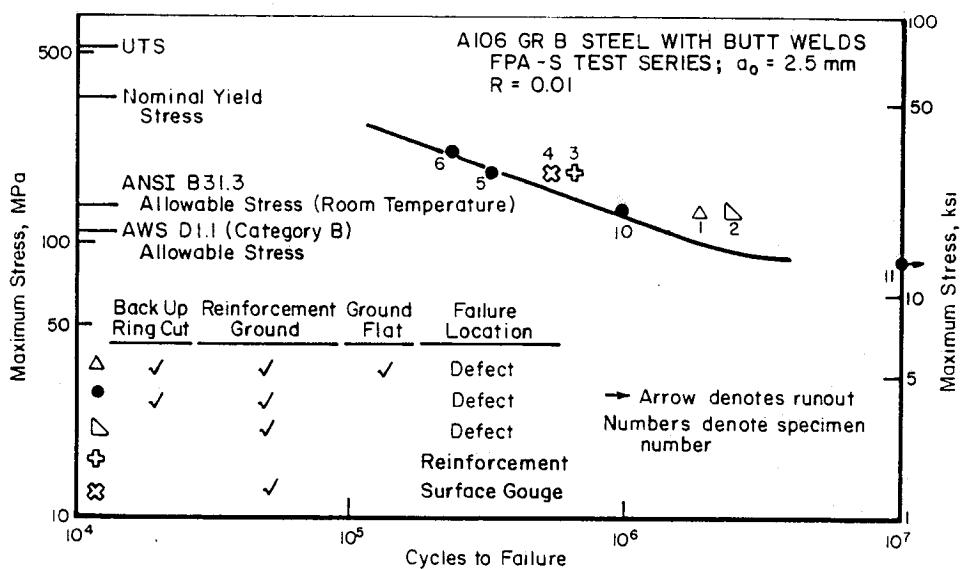
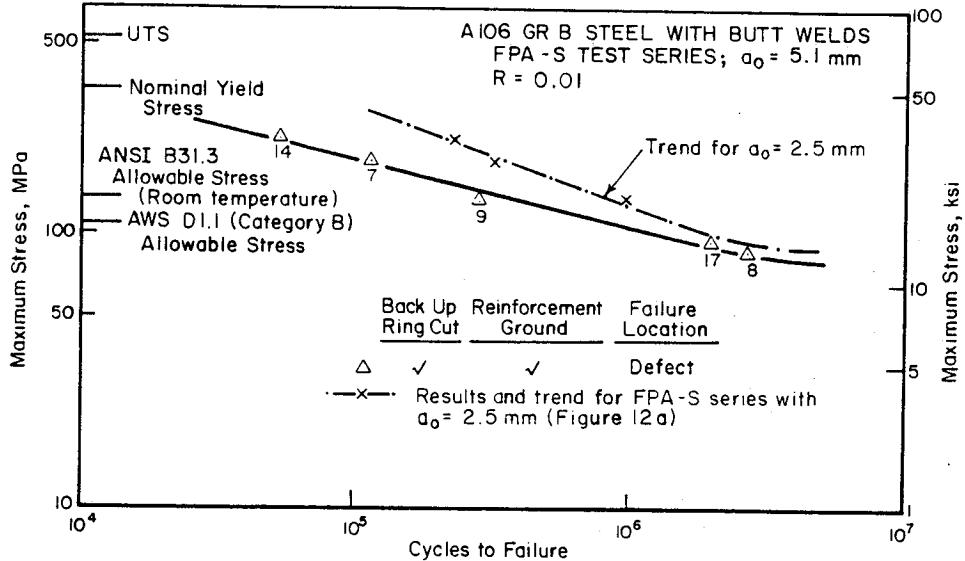
a. Initial flaw size of 2.5 mm (0.1 inch)

b. Initial flaw size of 5.1 mm (0.2 inch)

FIGURE 12. STRESS-LIFE BEHAVIOR OF FLAT PLATE BUTT WELD SPECIMENS WITH ARTIFICIAL PLANAR FLAWS (FPA-S)

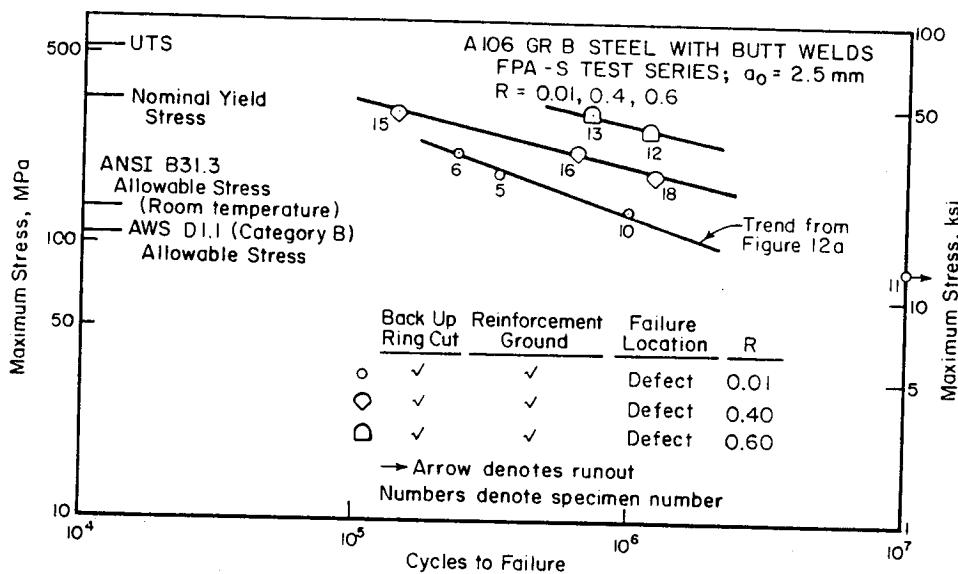
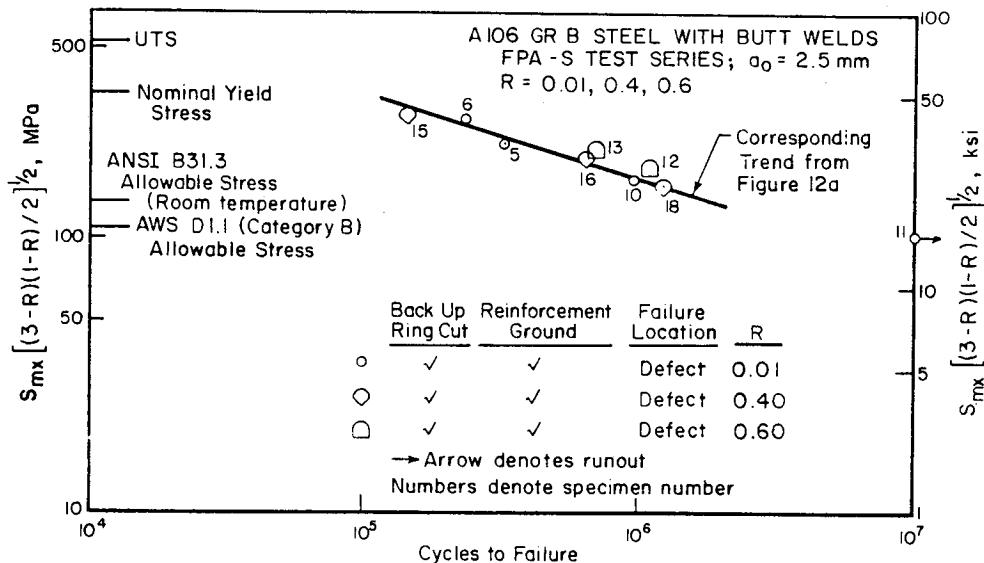
a. On maximum stress versus life coordinates

b. Consolidated data using $S_{mx} [(3-R)(R-1)/2]^{1/2}$ [1]

FIGURE 13. EFFECT OF MEAN STRESS LIFE BEHAVIOR OF FLAT PLATE BUTT WELD SPECIMENS WITH ARTIFICIAL PLANAR FLAWS (FPA-S)

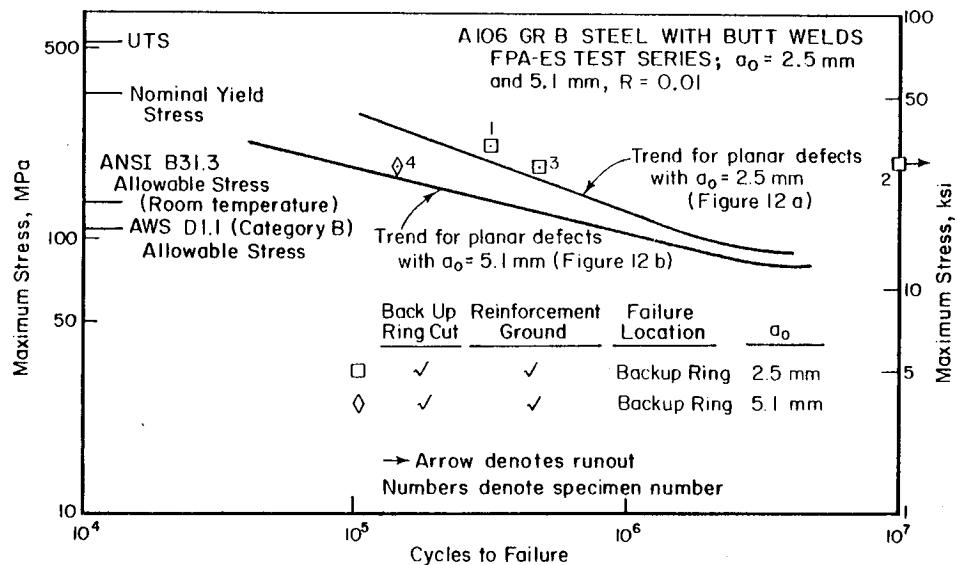
FIGURE 14. STRESS LIFE BEHAVIOR FOR FLAT PLATE BUTT WELD VOLUMETRIC DEFECT SPECIMENS (FPA-ES) IN COMPARISON TO PLANAR DEFECT SPECIMENS (FPA-S)

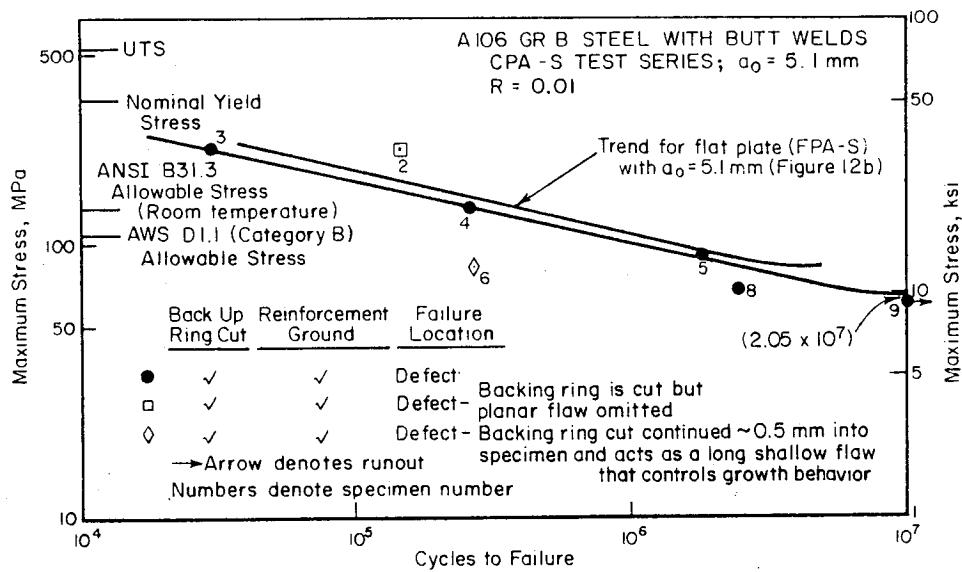
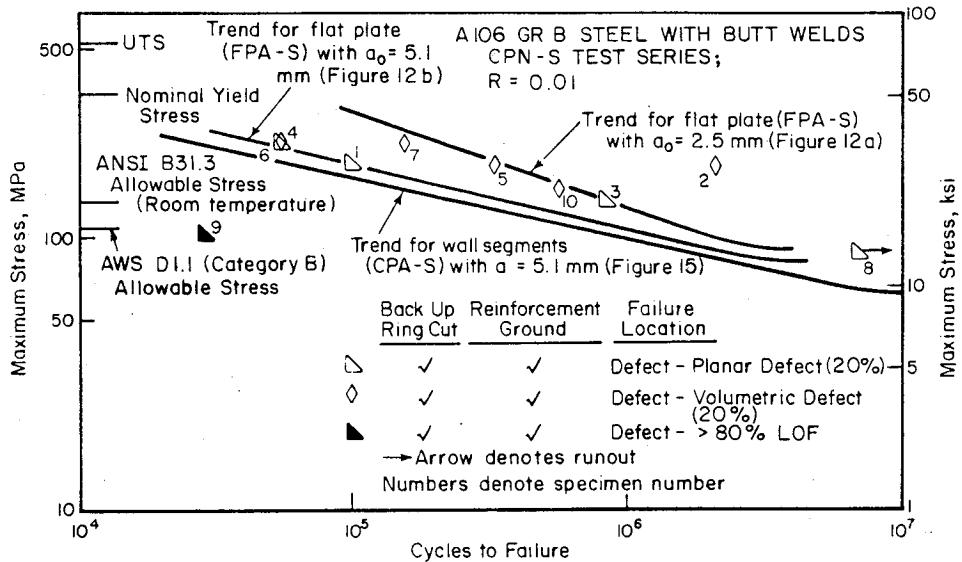
a. Results for artificial defects with $a_0 = 5.1 \text{ mm}$

b. Results for natural defects with $a_0 \sim 40$ percent by area

FIGURE 15. STRESS LIFE BEHAVIOR FOR BUTT WELDED WALL SEGMENT SPECIMENS (CPA-S)

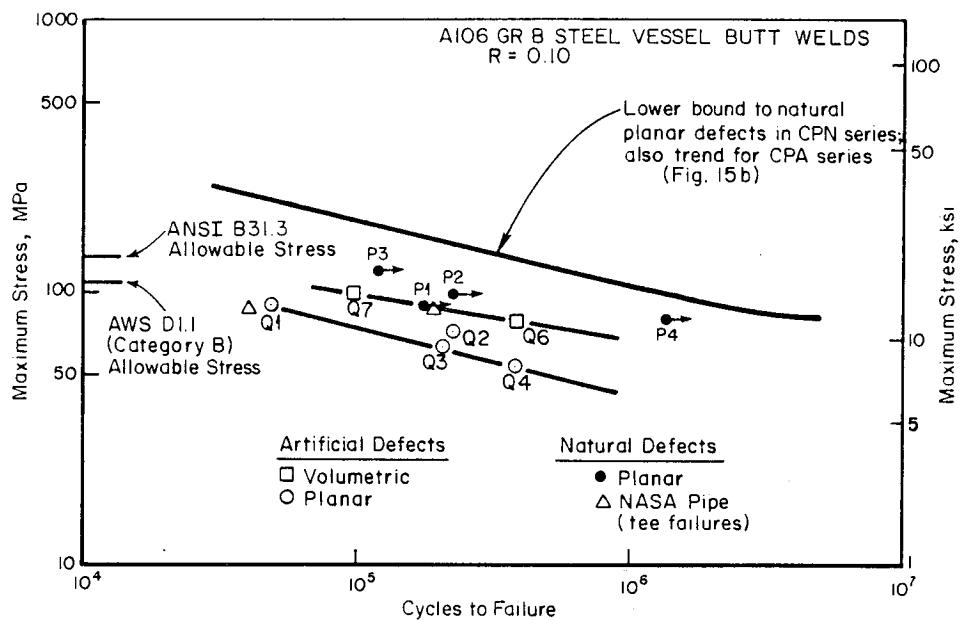
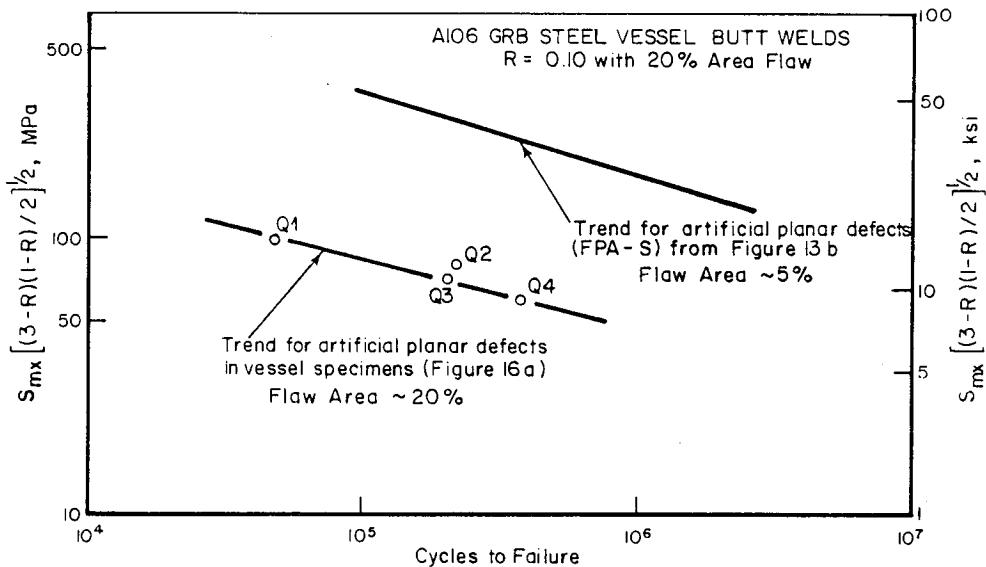
a. Stress-life behavior for planar and volumetric defects

b. Comparison of planar defects for vessel and flat plate specimens

FIGURE 16. STRESS-LIFE BEHAVIOR FOR BUTT WELDED VESSEL TESTS LEADING TO FAILURE AT THE DESIRED DEFECT

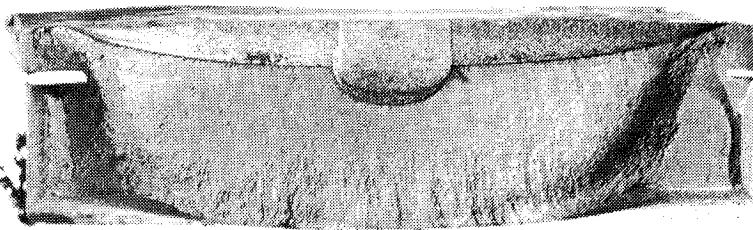
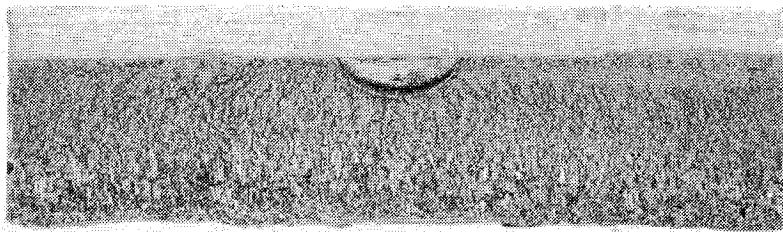
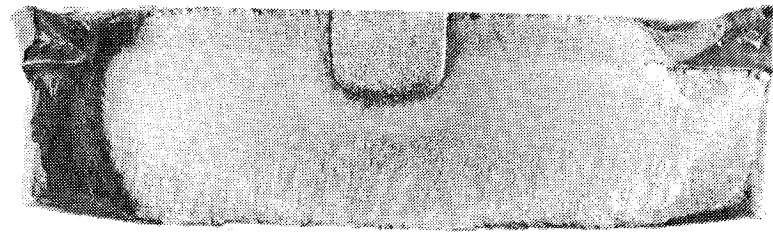
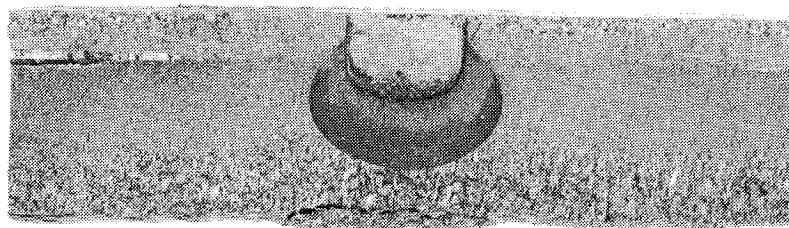
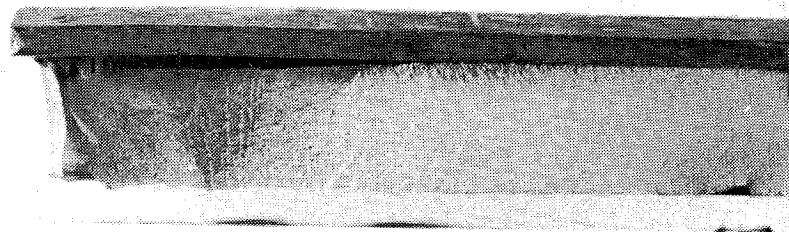
FIGURE 17. MACROGRAPHS OF FLAT PLATE SPECIMENS WITH
PLANAR FLAWS

Note: $a = 2.5 \text{ mm (0.1 inch)}$, $R = 0.01$
at 2X magnification

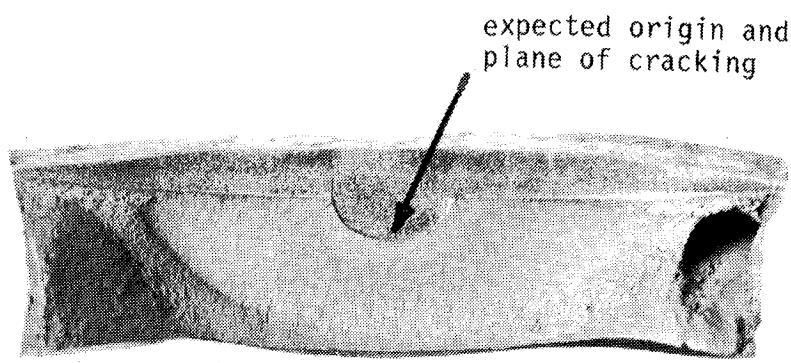
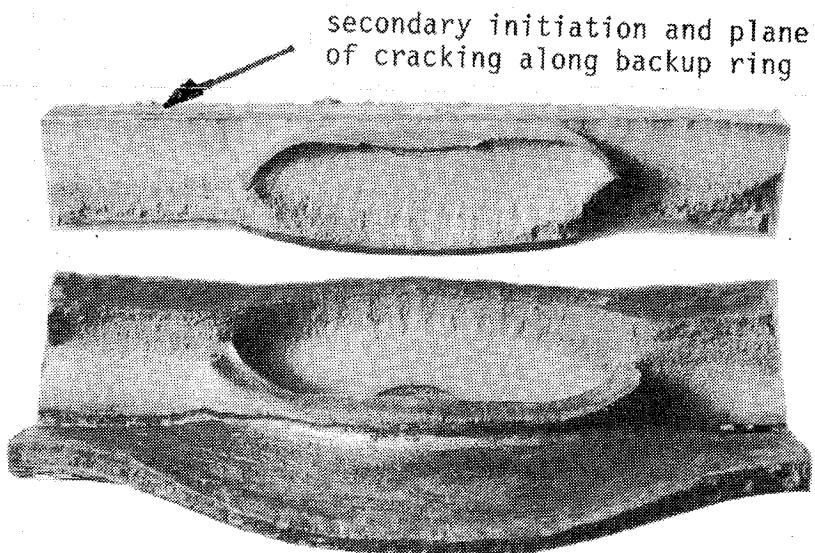
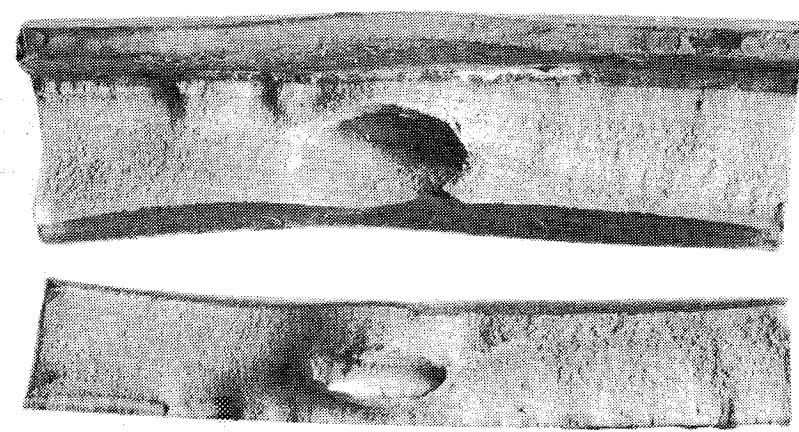
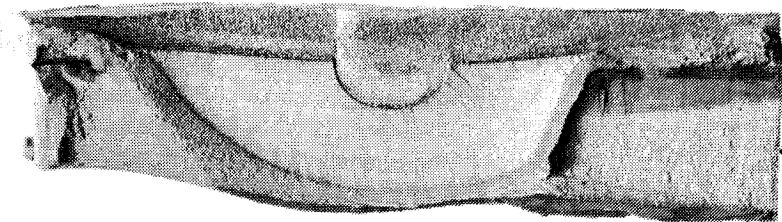
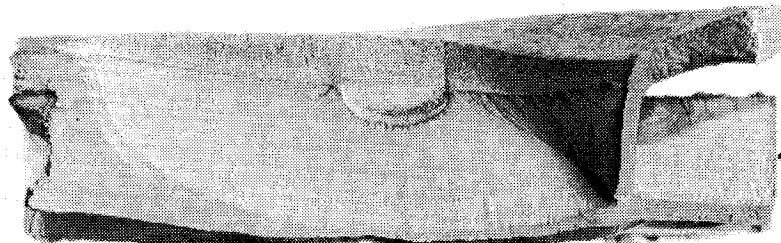
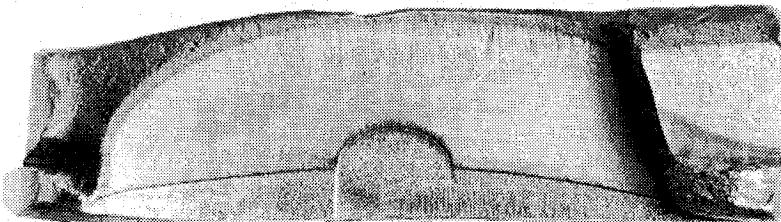
FIGURE 18. MACROGRAPHS OF FLAT PLATE SPECIMENS WITH PLANAR FLAWS
Note: $a = 2.5 \text{ mm}$ (0.1 inch), $R = 0.4, 0.6$

cracking from backup ring

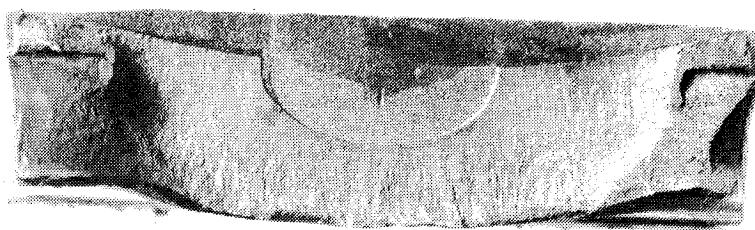
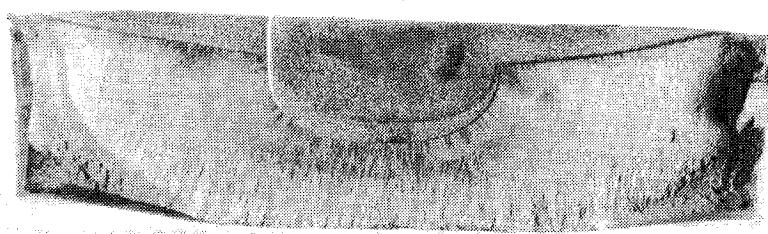
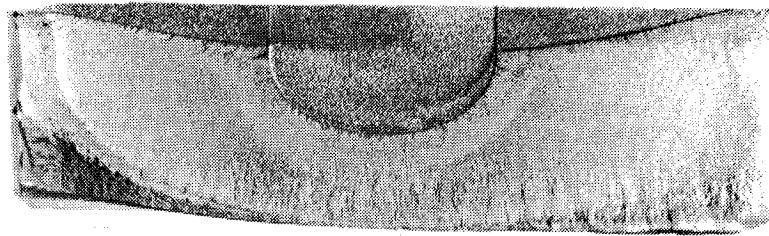
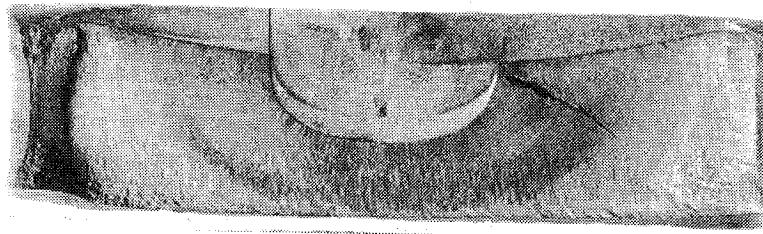
FIGURE 19. MACROGRAPHS OF FLAT PLATE SPECIMENS WITH PLANAR FLAWS

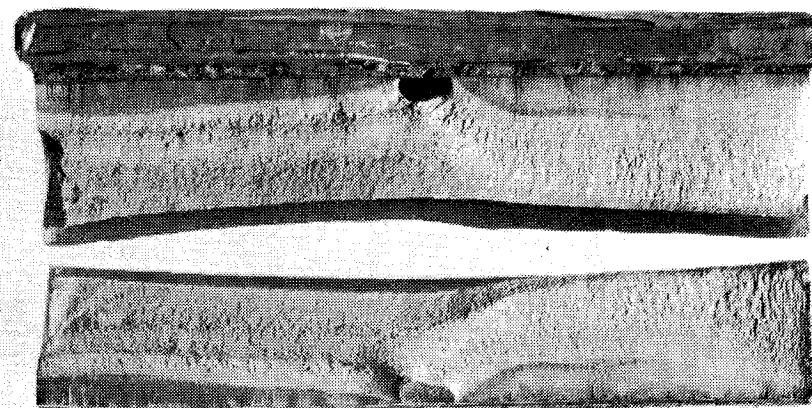
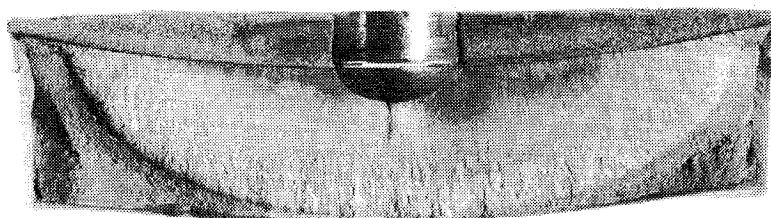
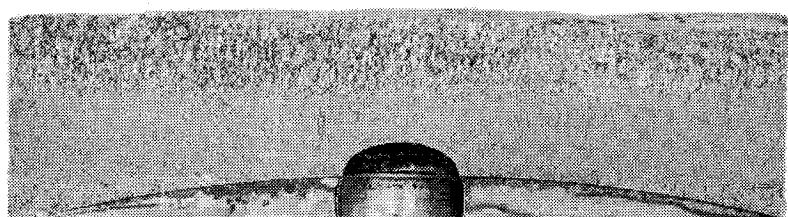
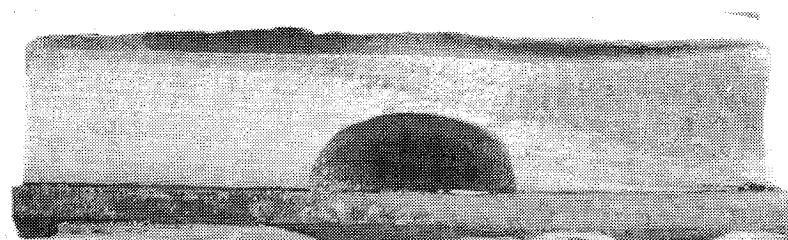
FIGURE 20. MACROGRAPHS OF FLAT PLATE SPECIMENS WITH VOLUMETRIC FLAWS

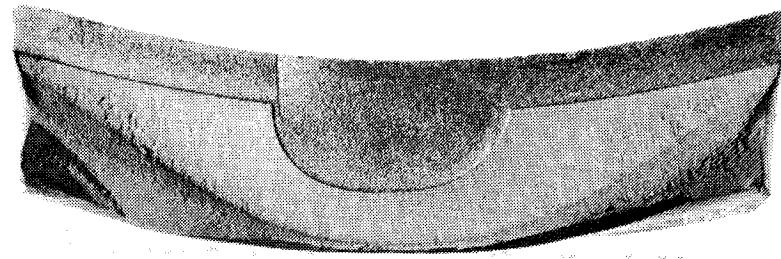
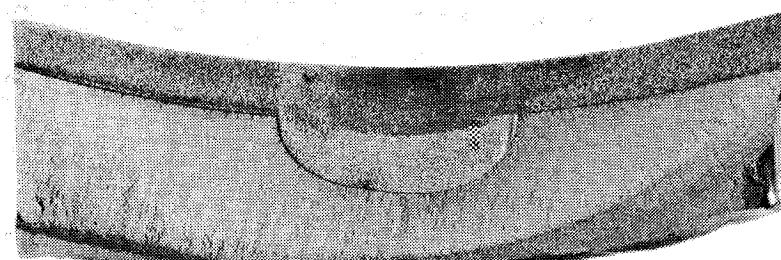
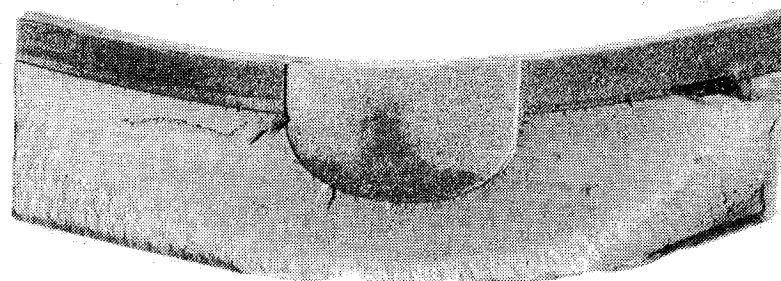
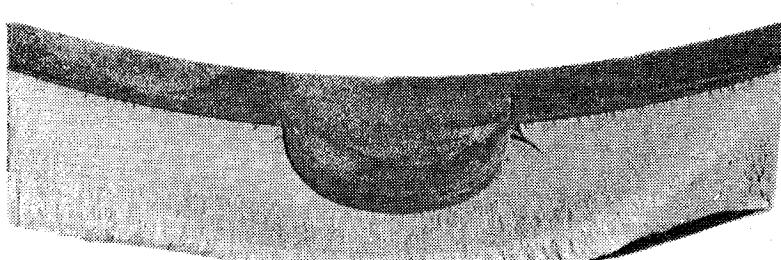
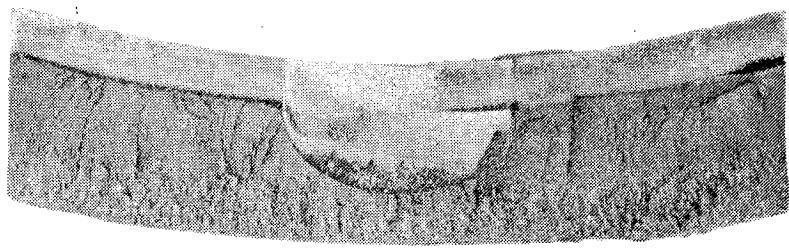
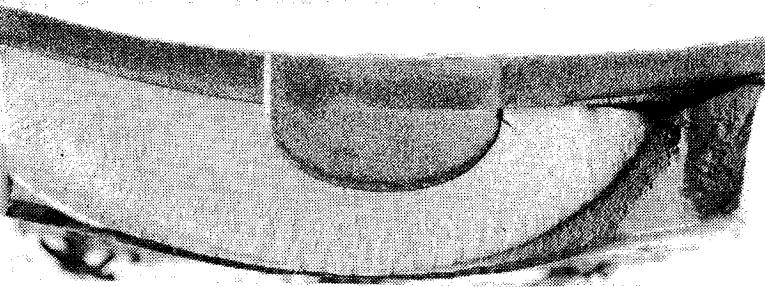
**FIGURE 21. MACROGRAPHS OF PIPE WALL SPECIMENS WITH
ARTIFICIAL FLAWS**

Pipe wall segment specimens. Figure 21 presents macrographs for pipe wall specimens with artificial flaws. The flaw of CPA-S-9 did not grow, as seen in Figure 21e. CPA-S-7 (Figure 21f) was marked by interspersing blocks of high and low amplitude loads. The marker bands cannot be seen at this magnification, nor could all of them be conclusively located at up to 2,500X magnification. Specimen CPA-S-2 is shown in Figure 21g. This specimen was inadvertently tested with no EDM flaw, but the backup ring was cut.

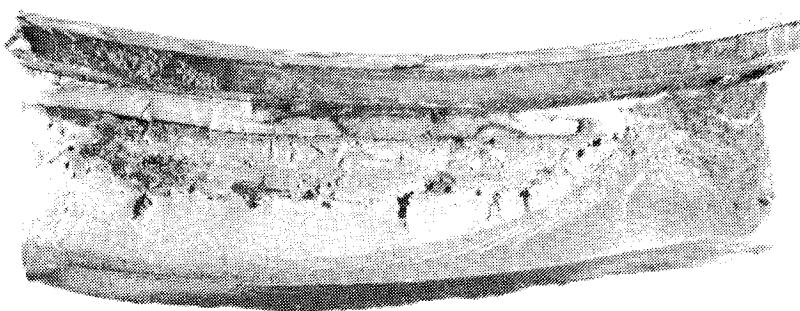
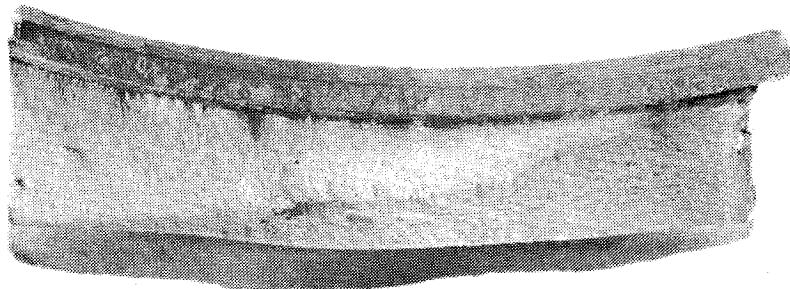
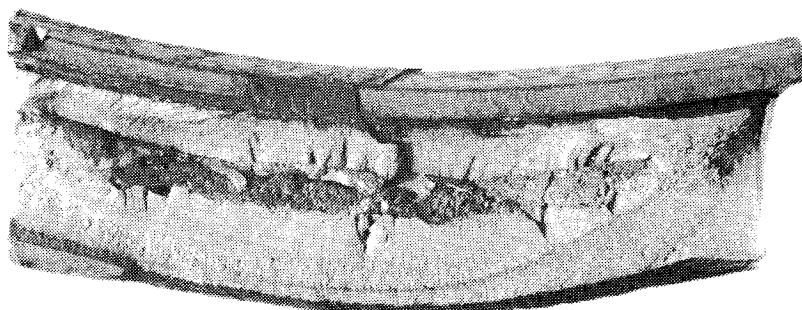
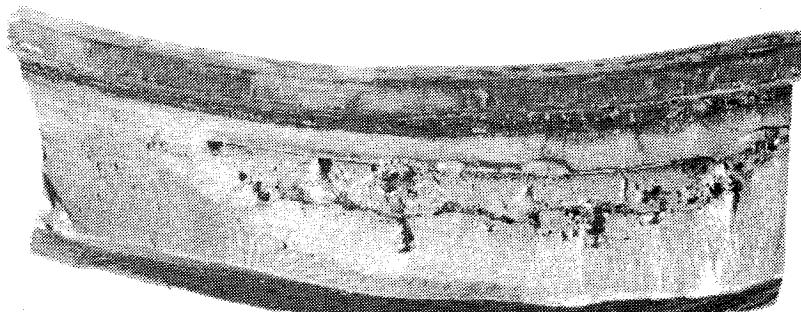
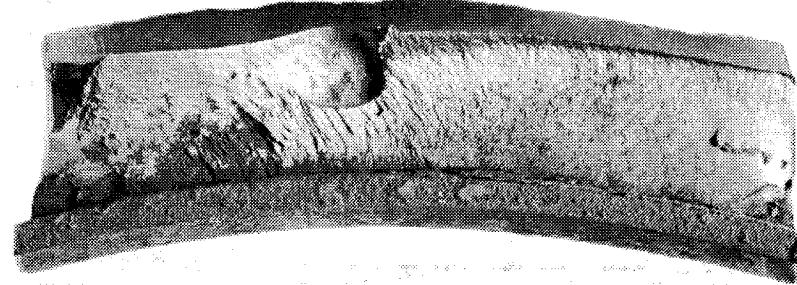
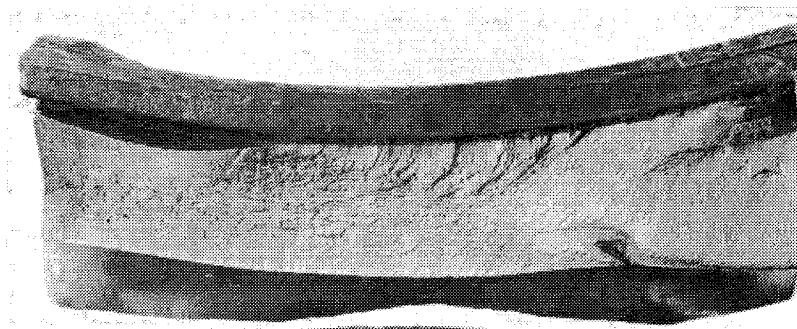
FIGURE 22. MACROGRAPHS OF PIPE WALL SPECIMENS WITH NATURAL VOLUMETRIC (V) AND PLANAR (P) FLAWS
