**THE INFLUENCE OF DEFECTS ON THE
FATIGUE RESISTANCE OF BUTT AND
GIRTH WELDS IN A106B STEEL**

B. N. Leis, D. P. Goetz and P. M. Scott

**Contract NAS1-17404
JULY 1986**

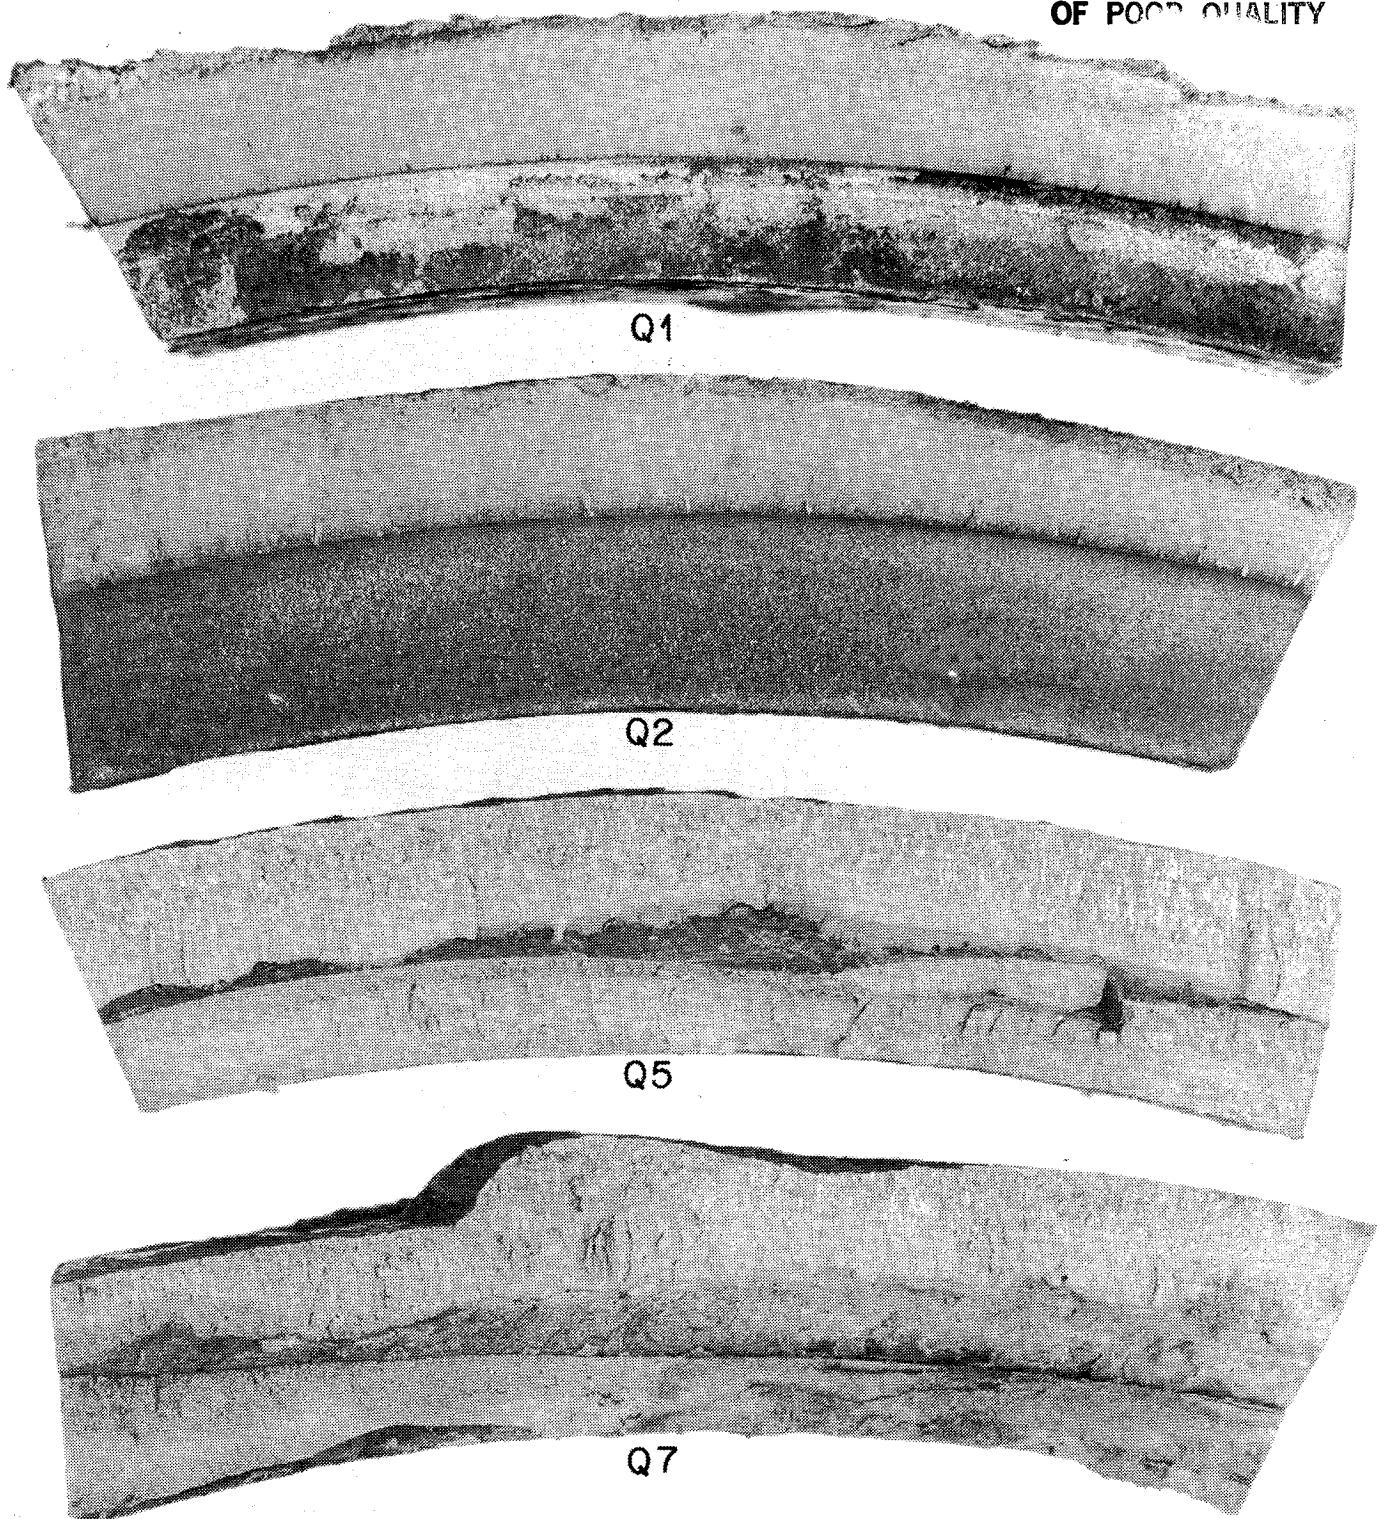
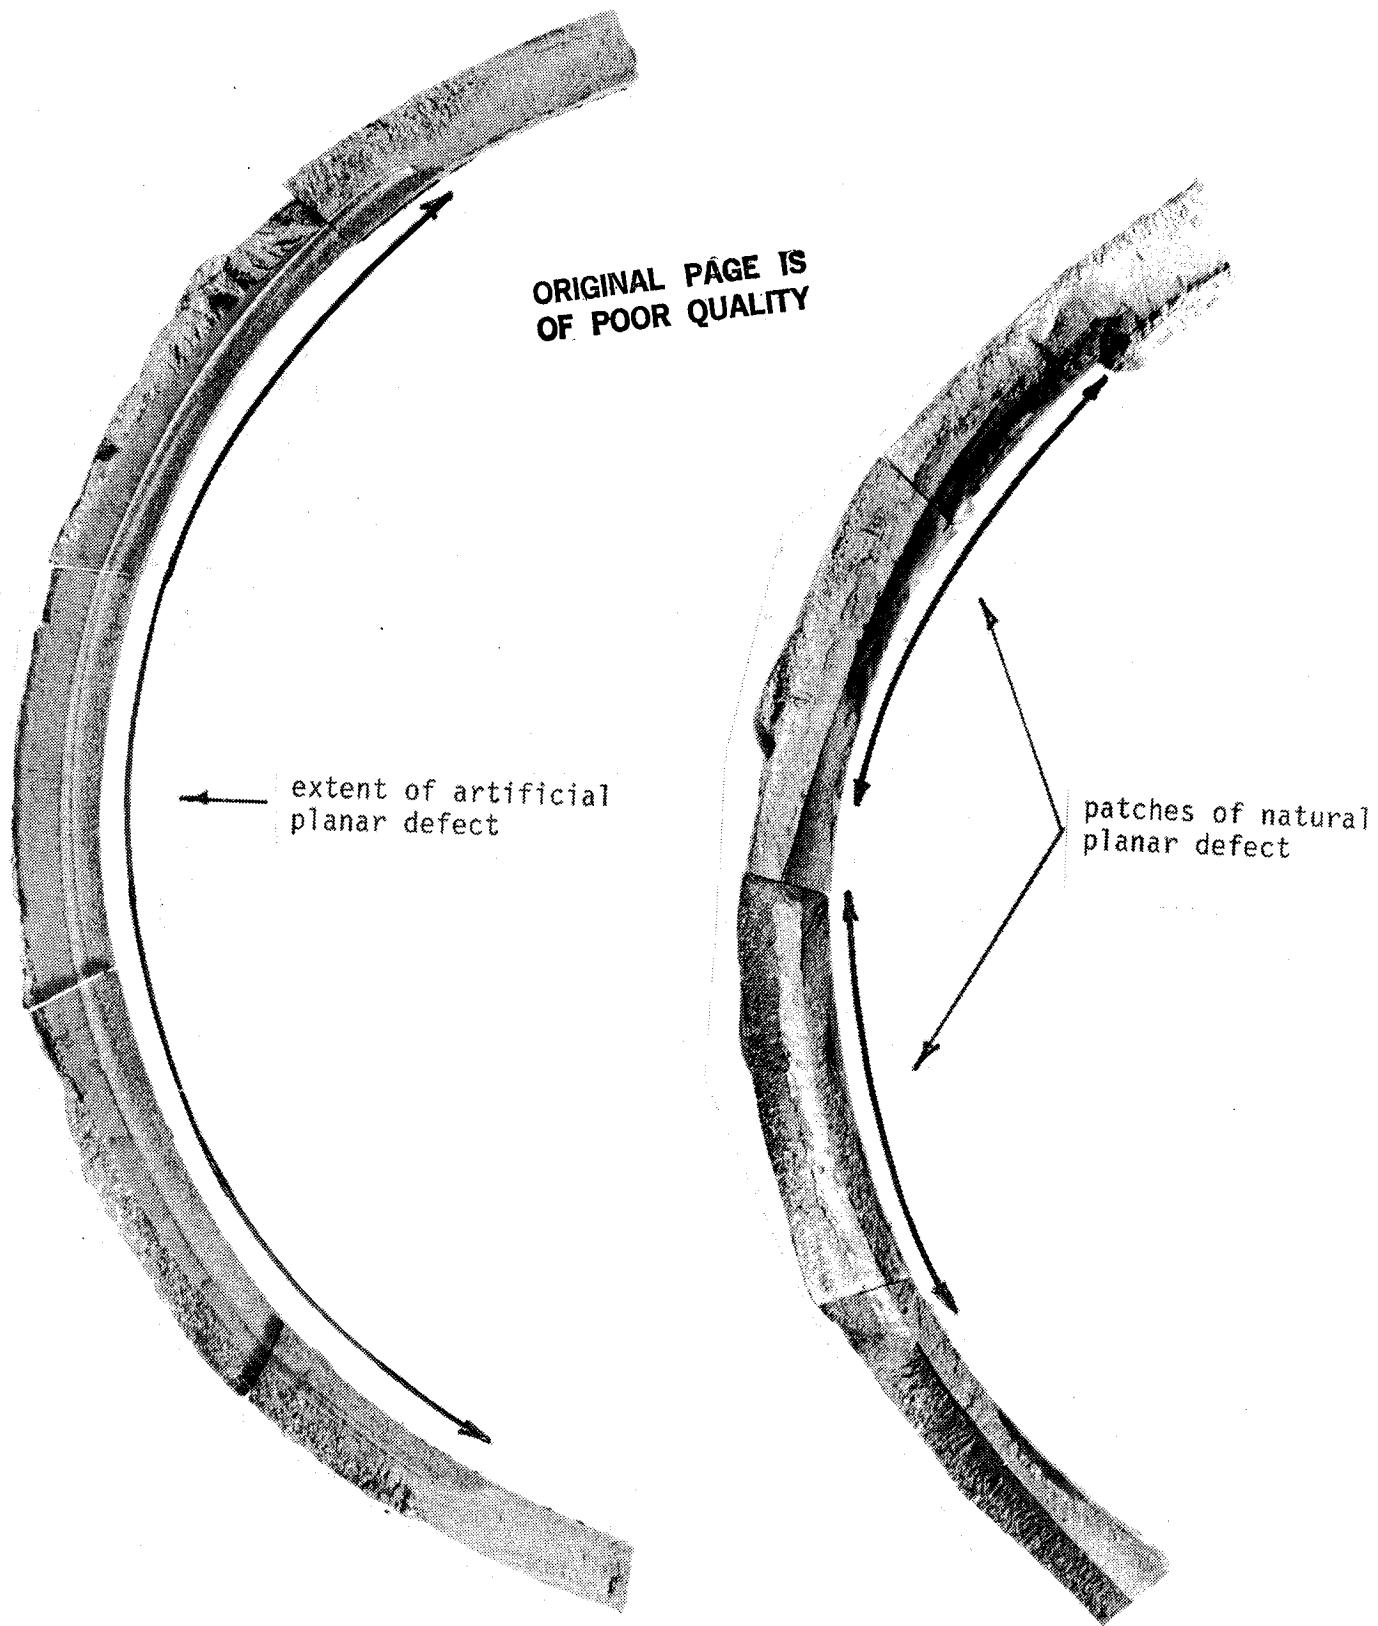
FIGURE 23. MACROGRAPHS OF VESSEL SPECIMEN FRACTURE SURFACES

b. Ring Segments depicting extent of propagation around the vessel

Vessel specimen. Figure 23a presents macrographs at the deepest penetration of the preflaw or in the region where the crack grew through the wall in Vessels 43Q1, 43Q2, 43Q5, and 43Q7. For Q1, Q2, and Q7, failure occurred by penetration of the crack in the area shown. However, for Q5 failure occurred at a "quality weld" at the end cap. Examination of the area at the root of the defect showed the crack had begun to grow at a number of sites along the root. Figure 23b presents ring sections of two vessels over which cracking occurred. Observed that for Specimen 43Q1 the defect extended into the wall primarily over its mid section, thereby decreasing the aspect ratio.

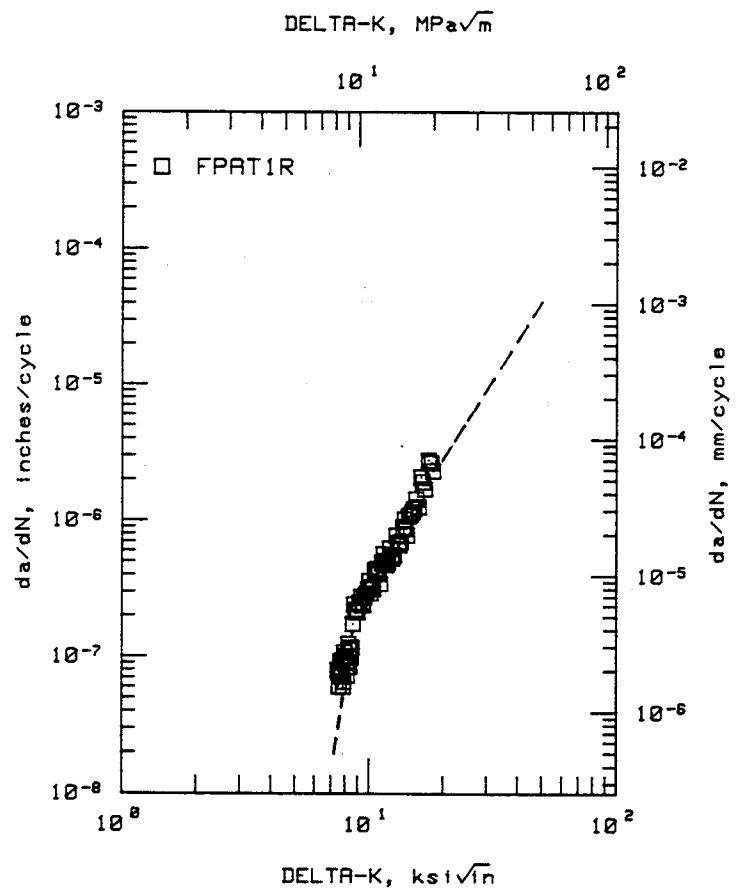
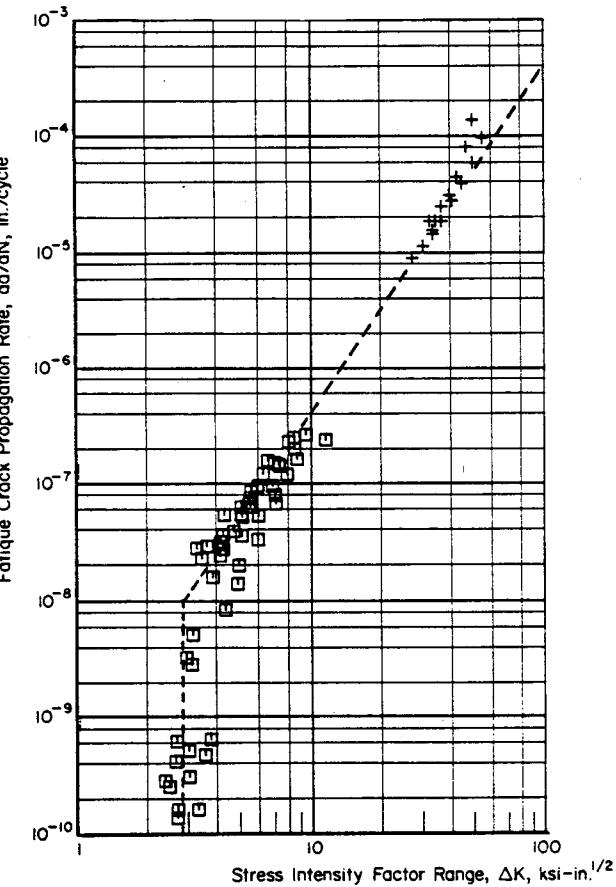
FIGURE 24. FATIGUE CRACK GROWTH RATE BEHAVIOR FOR A106-GRB

The linear fit with a threshold to match the data shown in Figure 24b is a better representation of steady state FCP behavior for the A106 GR B material. However, the bilinear equation better represents the growth process in the specimen since it accommodates the real startup transient. Differences between predictions made with a steady state trend for

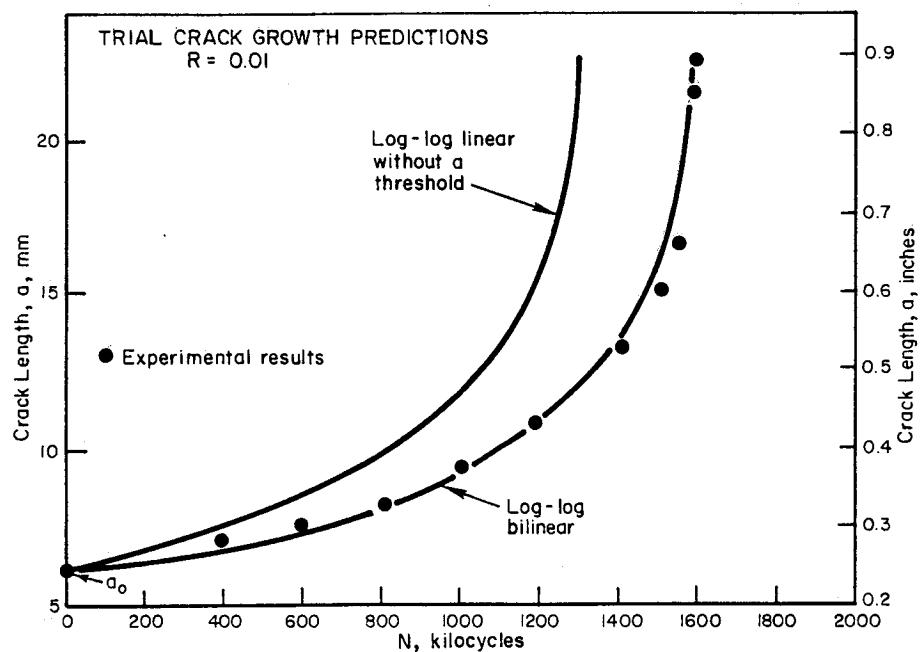
FIGURE 25. COMPARISON OF CRACK GROWTH RESULTS VS EXPERIMENT FOR TWO REPRESENTATIONS OF THE CRACK GROWTH CRACK RATE DATA

Observe in Figure 25 that excellent recreation of the a-N trend required the bilinear equation. This bilinear equation gave the correct a-N trend because it included the transient behavior that otherwise was ignored by the log-log linear fit.

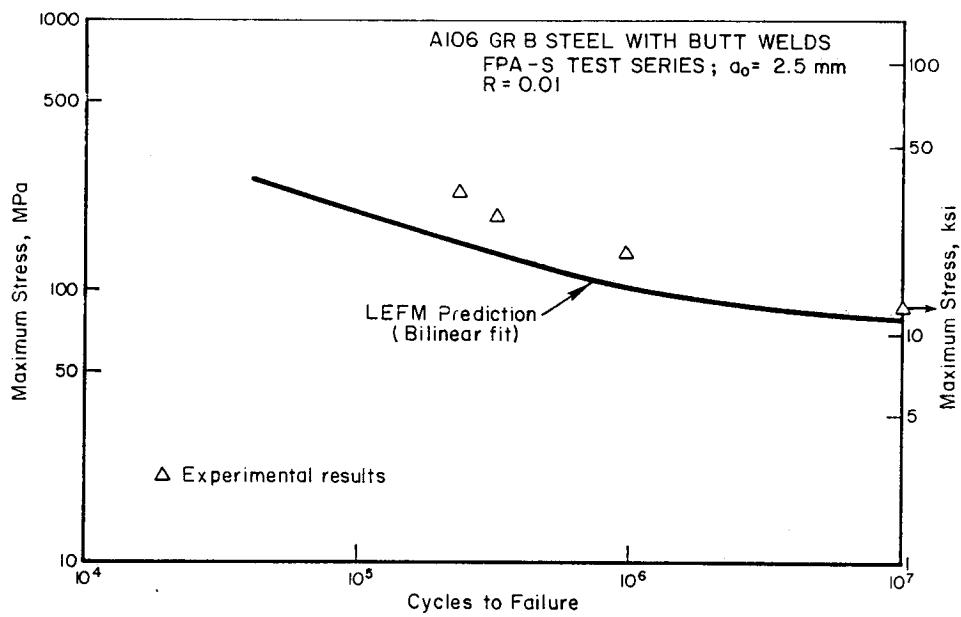
FIGURE 26. COMPARISON OF PREDICTED AND ACTUAL LIFE FOR FLAT PLATE SPECIMENS WITH $a_0 = 2.5$ MM

Selected predictions made using Figure 26b show similar results for the higher stresses for both initial flaw sizes. At the lower stresses, predictions made with the linear trend in Figure 24b, with or without a threshold, lead to comparable results since initial K levels are in excess of the threshold. For all cases with $a_0 = 5.1 \text{ mm}$, the difference between the predictions made using Figures 24a and 24b is less than +1 percent. The same is true at higher stresses for $a_0 = 2.5 \text{ mm}$. However, at lower stresses, life predictions begin the integration at ranges of stress intensity factor that fall at or below the so called threshold in Figure 24b or in the start-up

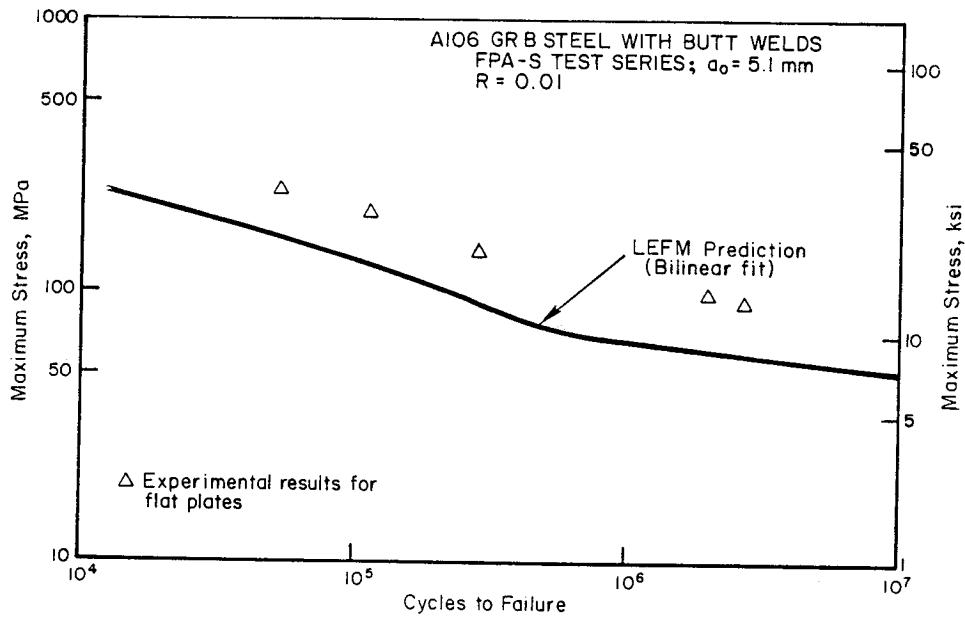
FIGURE 27. COMPARISON OF PREDICTED AND ACTUAL LIFE FOR FLAT PLATE SPECIMENS WITH $a_0 = 5.1$ MM

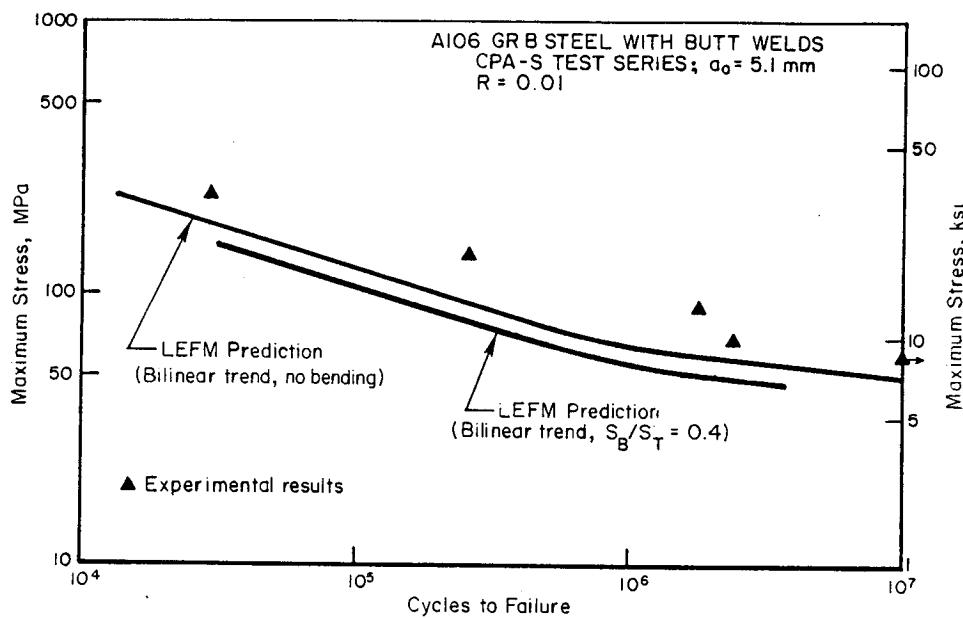
FIGURE 28. COMPARISON OF PREDICTED AND ACTUAL LIFE FOR WALL SEGMENT SPECIMENS WITH $a_0 = 5.1$ MM

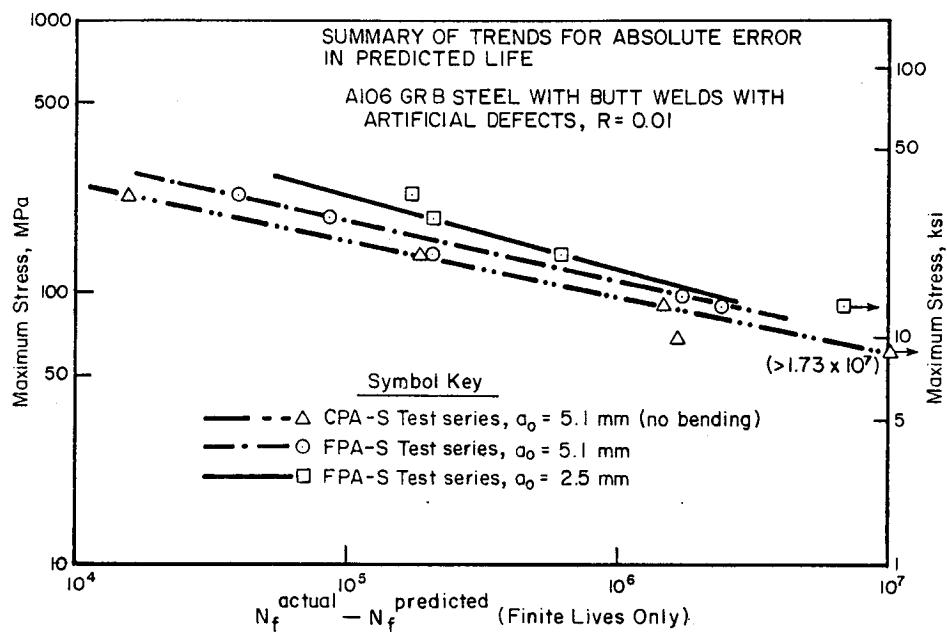
FIGURE 29. SUMMARY OF ABSOLUTE ERRORS IN PREDICTED AND ACTUAL LIFE FOR FLAT PLATE AND WALL SEGMENT SPECIMENS

Table 9 presents a tabular summary of the predictions. The absolute difference between the actual and predicted lives is plotted against maximum stress in Figure 29. The specimens with the smallest flaws give the largest errors as a function of stress. The pipe wall segment specimens and flat plate specimens with the same flaw size give similar errors at moderate stresses. Because of the LEFM model's apparent inability to predict fatigue life with reasonable accuracy, calculations for other flaw geometries would be suspect. Therefore, further predictions were not attempted. Because the error in predictions is a function of stress for a given initial flaw size and also depends on flaw size, the LEFM analysis would not directly correlate the results. LEFM could be forced to fit the data by the use of an empirical correction that depends on both flaw size and stress. But that correction works only for the material and geometry of the specimen and flaws examined. Because this correction lacks generality, it has not been developed. Moreover, because LEFM could not be used directly to consolidate the data, a

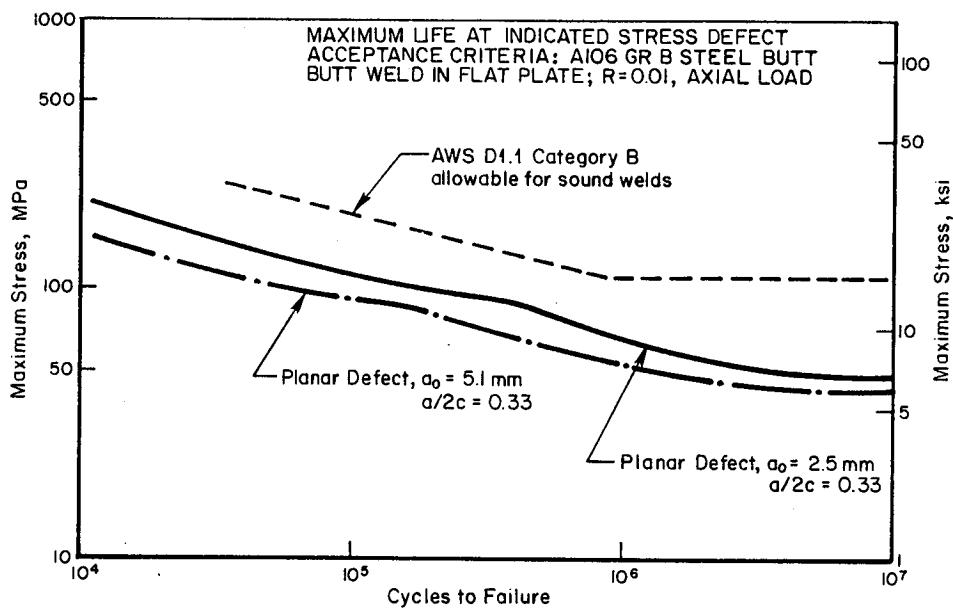
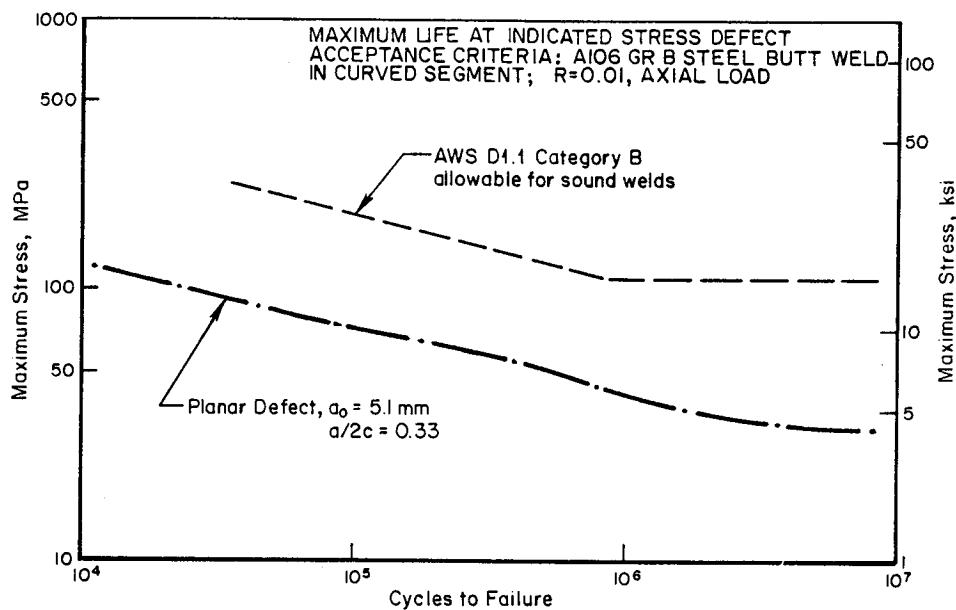
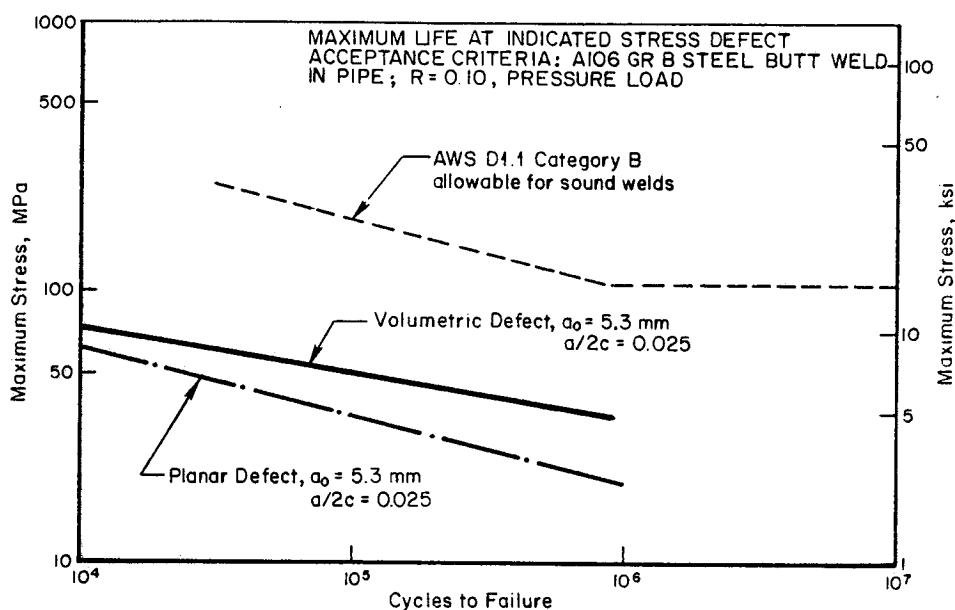
a. Axially loaded flat plates

b. Axially loaded curved segments

FIGURE 30. DEFECT ACCEPTANCE CRITERIA FOR BUTT WELDS
IN A106 GRB STEEL

c. Pressure loaded pipe

Figure 30 presents defect acceptance criteria including the 2 and 20 factor of safety. Part a of this figure represents axial loading of flat plate butt welds. Parts b and c represent butt welds under axial loading in curved segments and pressurized vessels (pipes), respectively. Note that the
