EFFECTS OF SURFACE CHEMISTRY ON HOT CORROSION LIFE

FINAL REPORT

**R.E. Fryxell
General Electric Company
Aircraft Engine Business Group
Cincinnati, Ohio 45215**

June 1986

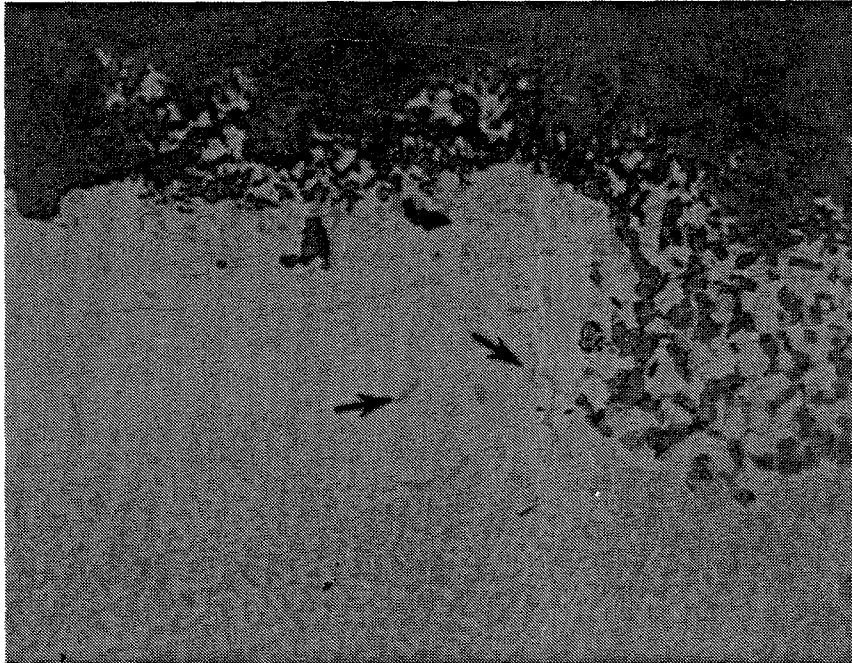
Figure 2. Southern Asia CF6-50 HPT Stage 1 Blade, Concave Side,
40%/80% Location, As Polished (1000×).

Arrows indicate presence
of Type 1 sulfides.

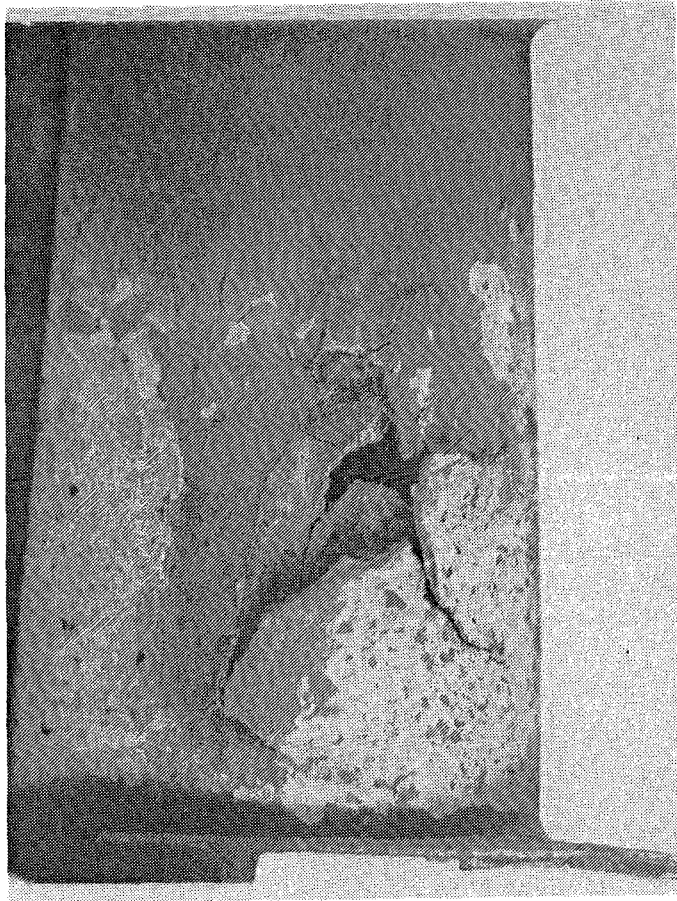
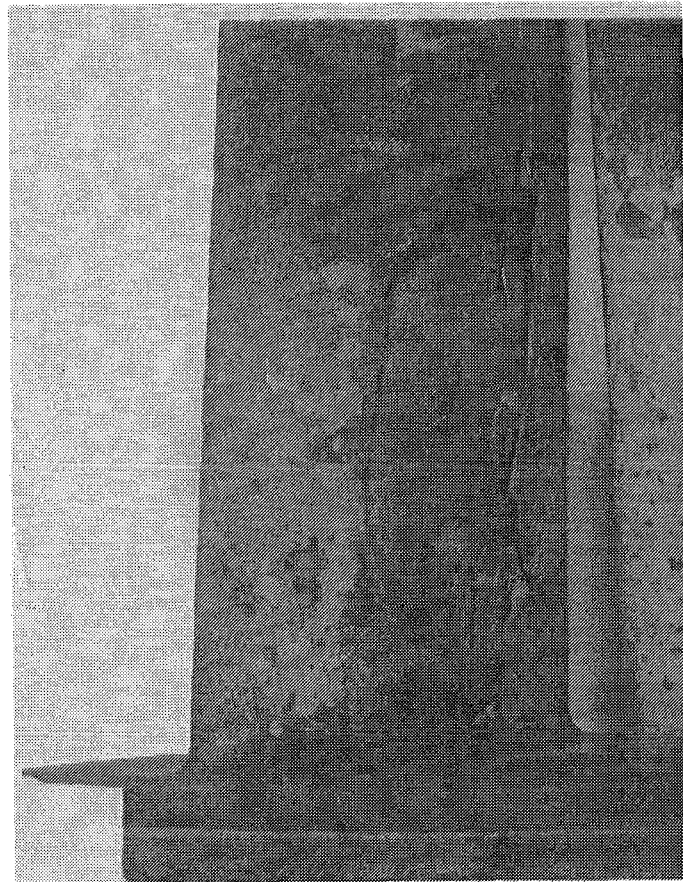
Inner
Band

Outer
Band

Figure 9. South American CF6-50 LPT Stage 1 Vanes After 15,155 Hours of Service.

This Stage 1 LPT vane was selected as an example of severe hot corrosion. LPT temperatures are considerably lower than in the HPT, and salt deposits are more likely to accumulate that may not evaporate during subsequent operation at high altitude. This is particularly true in relatively stagnant internal cavities. In the selected example, inside-out corrosion from such deposits was so severe it penetrated the airfoil in some locations. This evaluation, however, is confined to external surfaces that can be unambiguously related to operating parameters and to degradation of components elsewhere in the engine. Photographs of two adjacent vanes are shown in Figure 9.

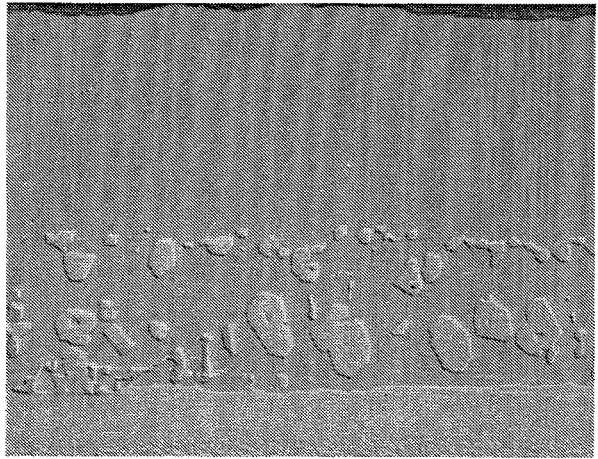
100 Hours

Figure 41. Codep Coated U700 after Isothermal Aging in Air at 1100° C (500×).

A similar conclusion appears unavoidable with respect to the other alloy elements in the systems, considered either singly or in combinations. Rather, attention is focused on precipitation phenomena in the diffusion zone. Note the microstructures in Figures 41 and 42. Visually, the diffusion zone in the as-fabricated condition is quite similar for the two systems: a close-spaced, needle-like phase in a β matrix, oriented normal to the surface. As aging at 1100° C progresses, this phase gradually disappears, and a blocky phase forms. The rate of this transformation is considerably faster for the U700 system and is nearly complete in 100 hours. In the René 80 system, a similar makeup of the diffusion zone is developed after 300 hours, but here there is the added complexity of the loss of much of the β structure caused by further loss of aluminum. As McCarron et al. have shown (Reference 7), γ' is considerably inferior to β in resistance to sulfidation.

- The notion of "tortuosity factor" may be invoked (References 9 and 10). That is, if aging significantly widens the spacing between impediment phases, diffusion processes (such as sulfidation) will proceed more rapidly. This is exemplified by the Codep/U700 specimen aged for 100 hours (Figure 41). On the other hand, note the analogous Codep/René 80 specimen in Figure 42. Although considerable blocky carbides have formed, there remains an "underbrush" of σ phases that continues to provide corrosion resistance.

- Figure 41: Coated U700 before and after 1100°C aging.
- Figure 42: Coated René 80 before and after 1100°C aging.
- Figure 54: Coated U700 after 1050°C aging.
- Figure 55: Coated René 80 after 1135°C aging.

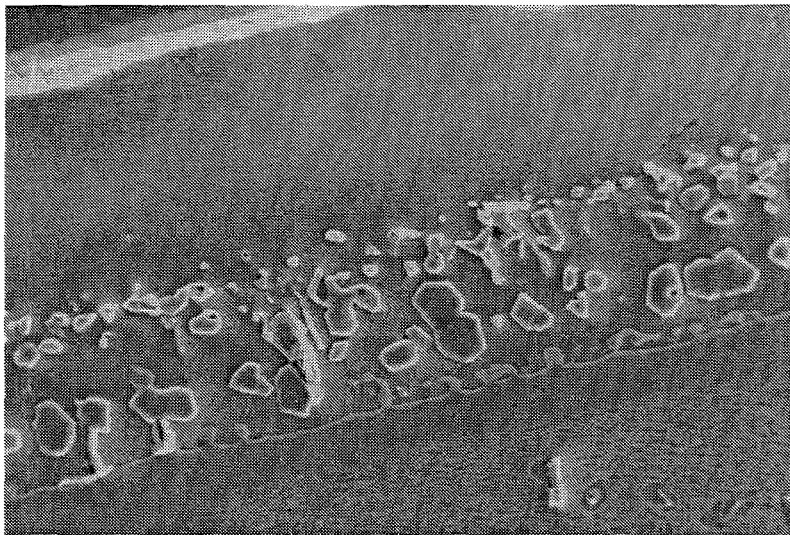
Cross-Sectional View (500×)

Figure 54. Codep Coated U700 (X102) after Isothermal Aging in Air at 1050° C for 10 Hours (500×).

Group 2 - Codep-coated U700 preaged at 1050° C: The intention was to preage at a lower temperature in order to cause only modest changes in the diffusion zone, anticipating little or no subsequent coating life degradation (nominal life about 500 hours with no preage). Figure 54 indicates that only minor changes occurred in the diffusion zone when compared to the as-coated

diffusion zone microstructure depicted in Figure 41. However, the average spacing of the acicular phases has widened appreciably and is not unlike that developed in 6 hours at 1100° C. This may be the reason the hot corrosion life of the coating after 1050° C aging was more severely degraded than expected, as shown in Figure 53, although somewhat less than was caused by preaging at 1100° C. The Al content in the additive layer of the coating was found to be about 25% in both the 10-hour and 20-hour specimens (Appendix). This is the same as previously reported for 15 hours at 1100° C.
