THERMAL BARRIER COATING LIFE PREDICTION MODEL DEVELOPMENT FIRST ANNUAL REPORT

By K.D. Sheffler and J.T. DeMasi

UNITED TECHNOLOGIES CORPORATION
Pratt & Whitney Group
Engineering Division

Prepared for
NATIONAL AERONAUTICS AND SPACE ADMINISTRATION

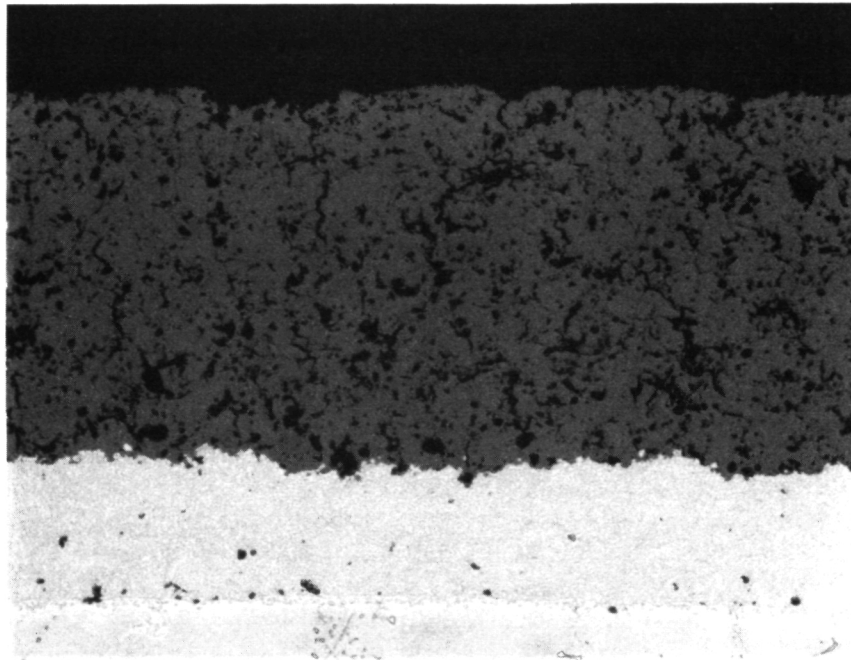
Figure 1 Thermal Barrier Coating System Microstructure

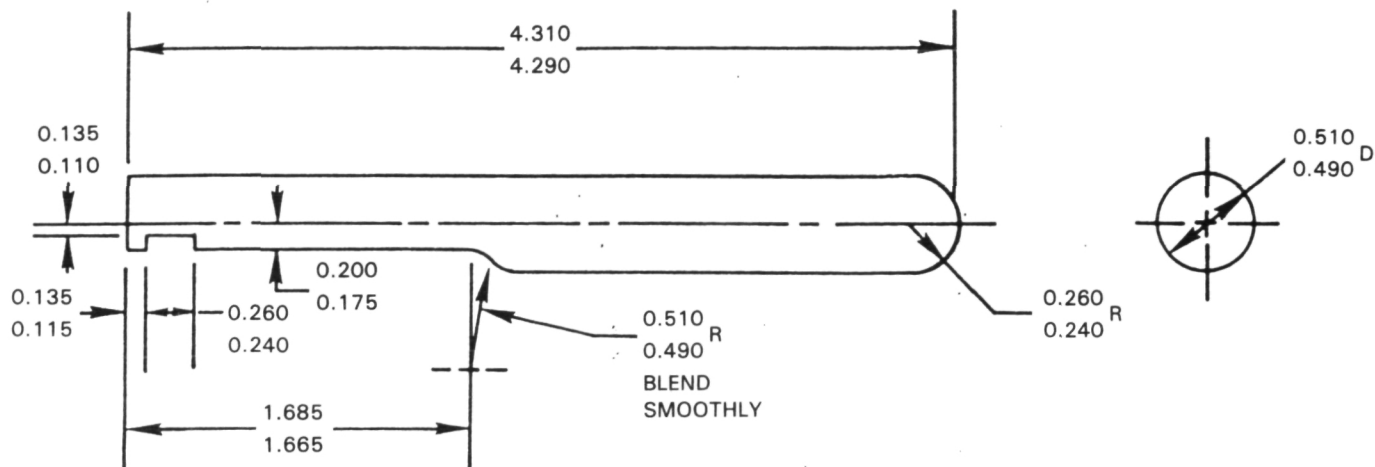
All Dimensions Shown In Inches

Figure 4 Burner Rig Coating Evaluation Specimen

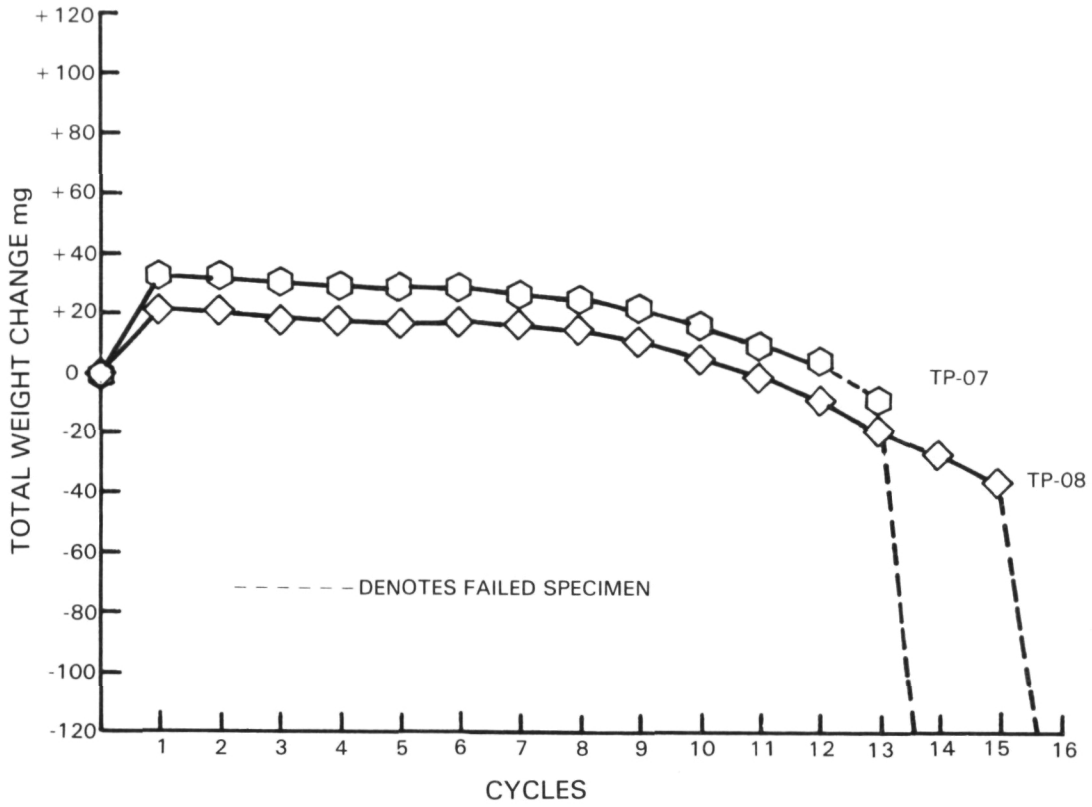
Figure 6 Task I Furnace Test Results; Weight Change Versus Cycles for 2100°F, Air, 10 Hour Cycle

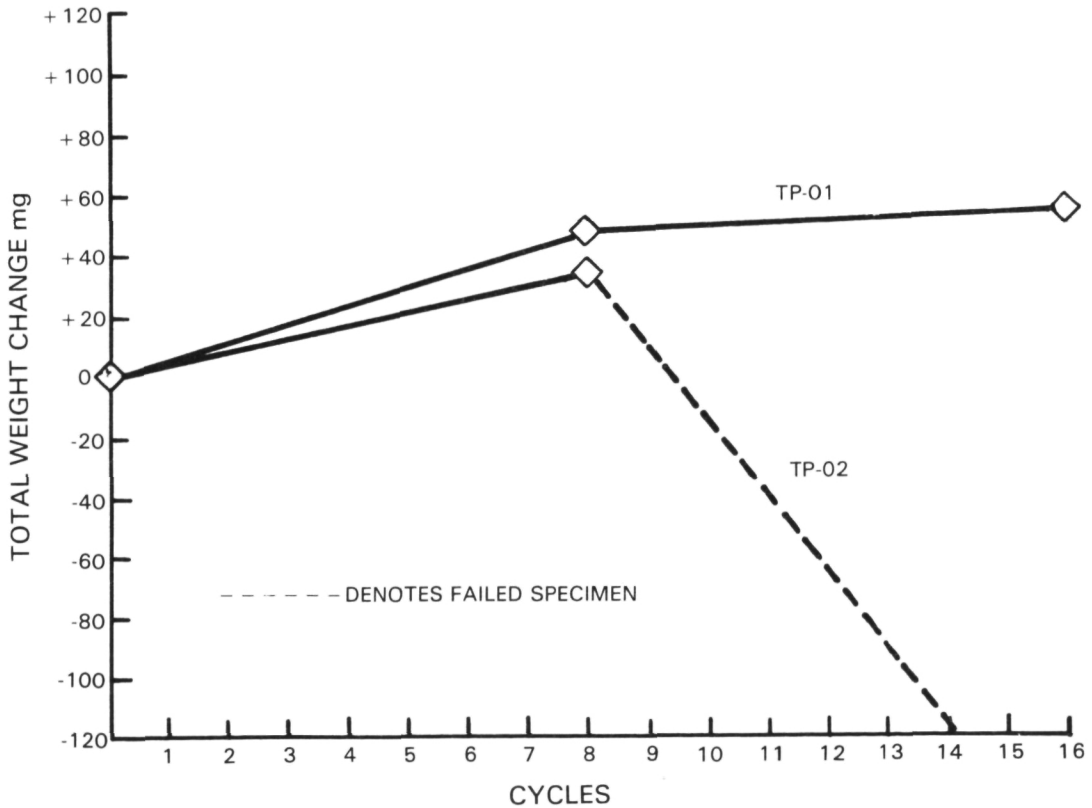
Figure 7 Task I Furnace Test Results; Weight Change Versus Cycles for 2100°F, Air, 80 Hour Cycle

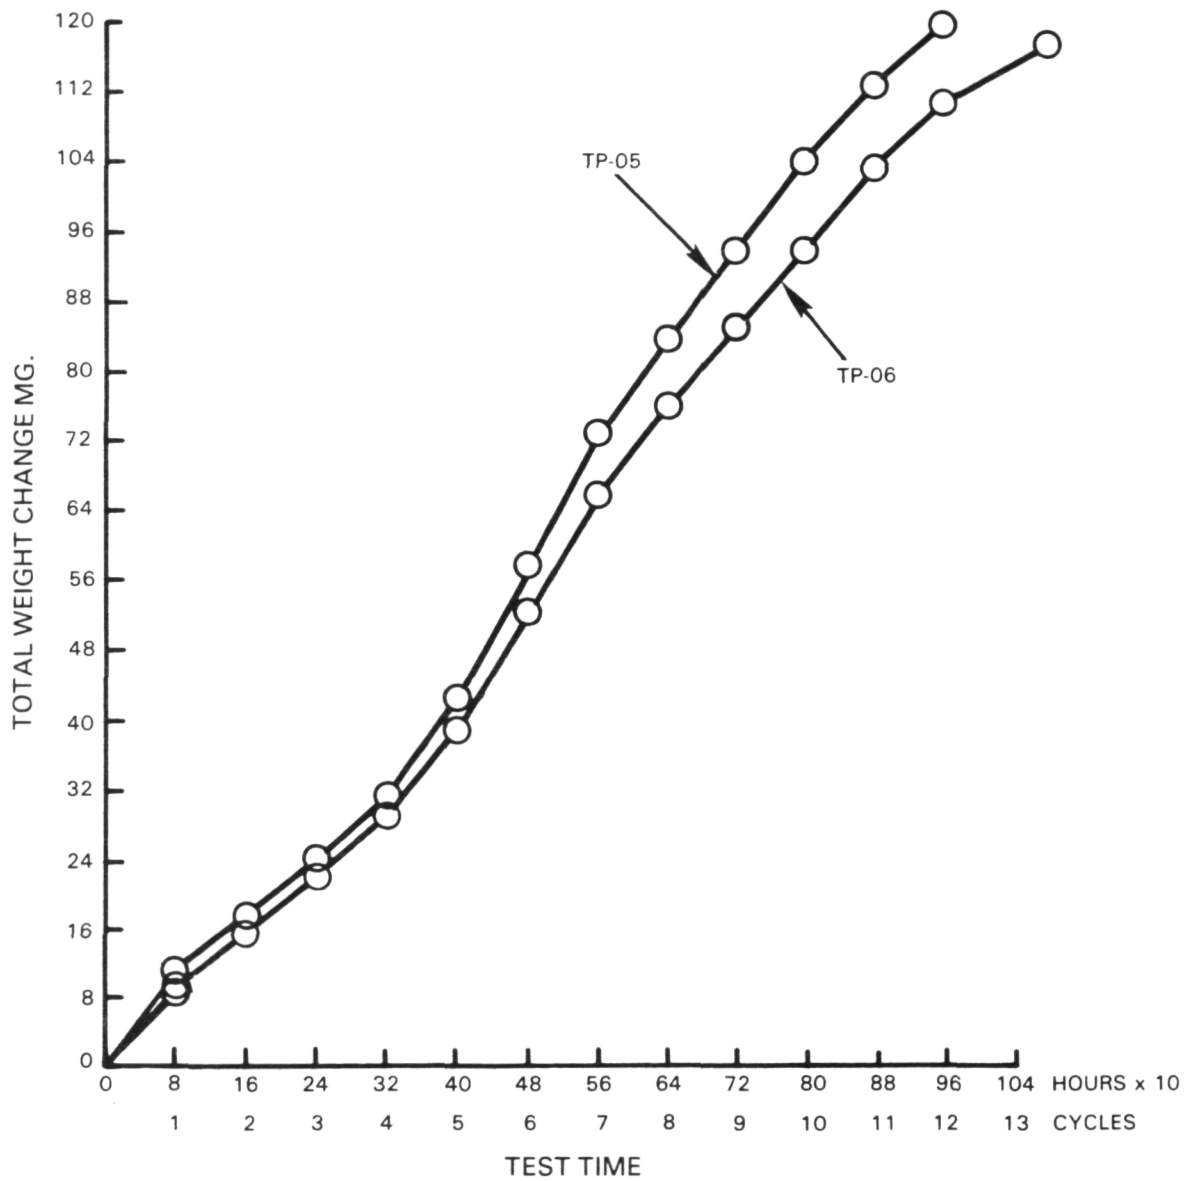
Figure 8 Task I Furnace Test Results; Weight Change Versus Cycles for 2100°F, Argon, 80 Hour Cycle

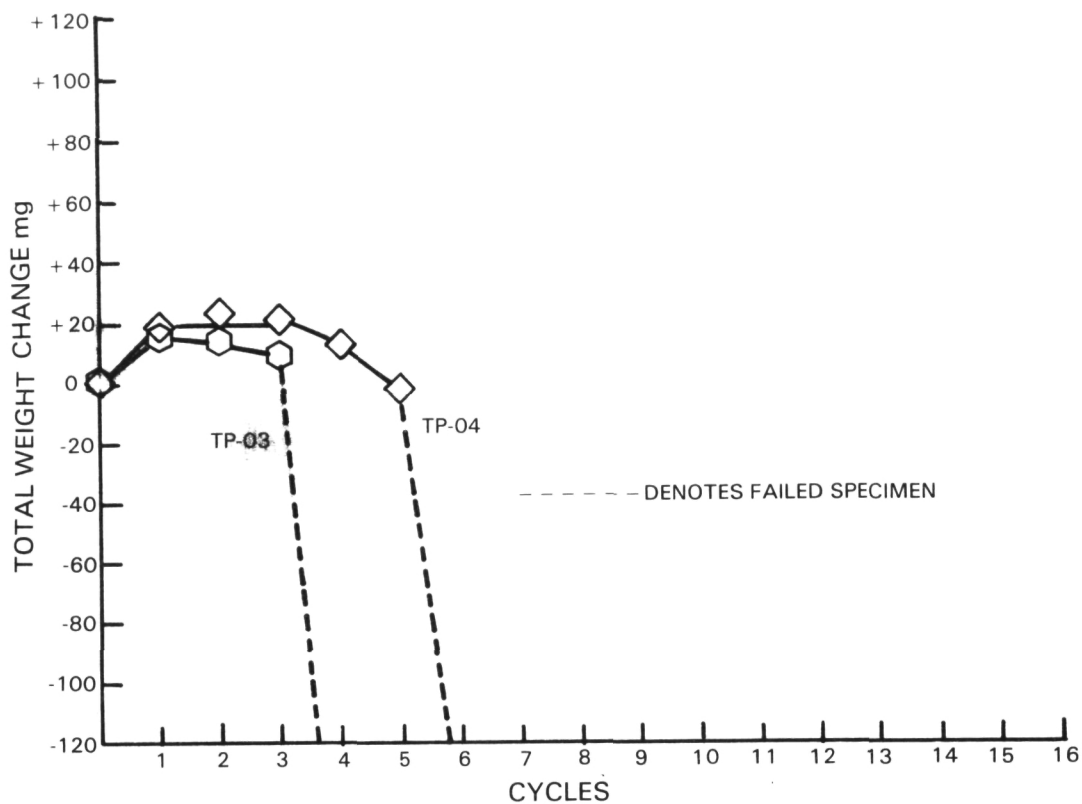
Figure 9 Task I Furnace Test Results; Weight Change Versus Cycles for 2200°F, Air, 10 Hour Cycle

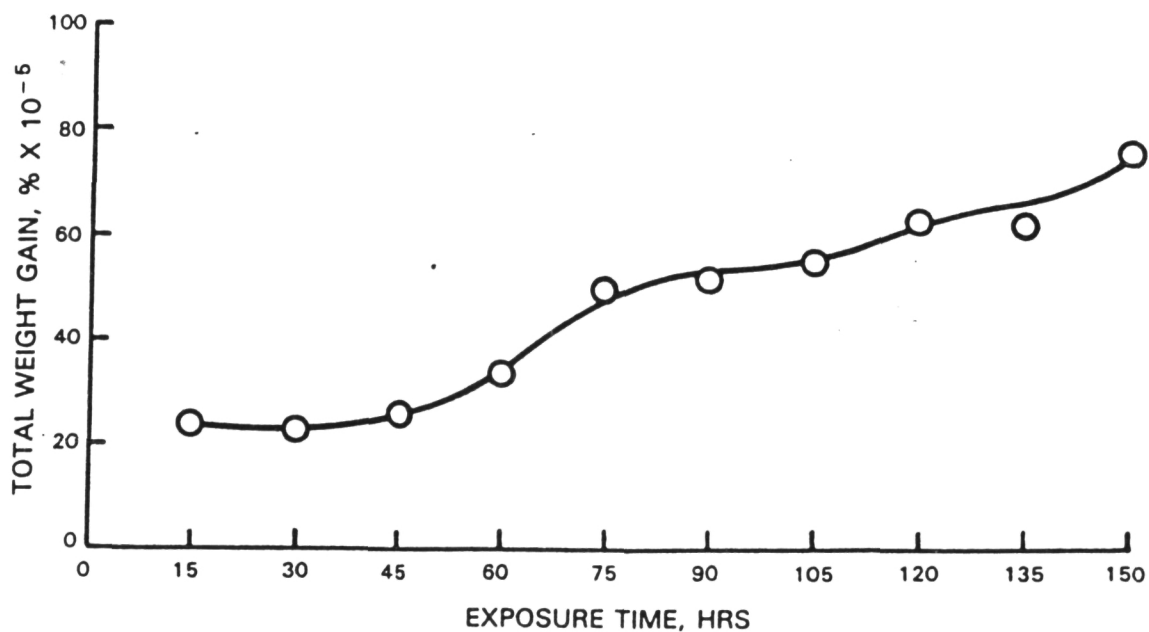
Figure 10 Task I Furnace Test Results; Weight Change Verses Exposure Time for Fractional Exposure Test, 2100°F, Air, 15 Hour Cycle

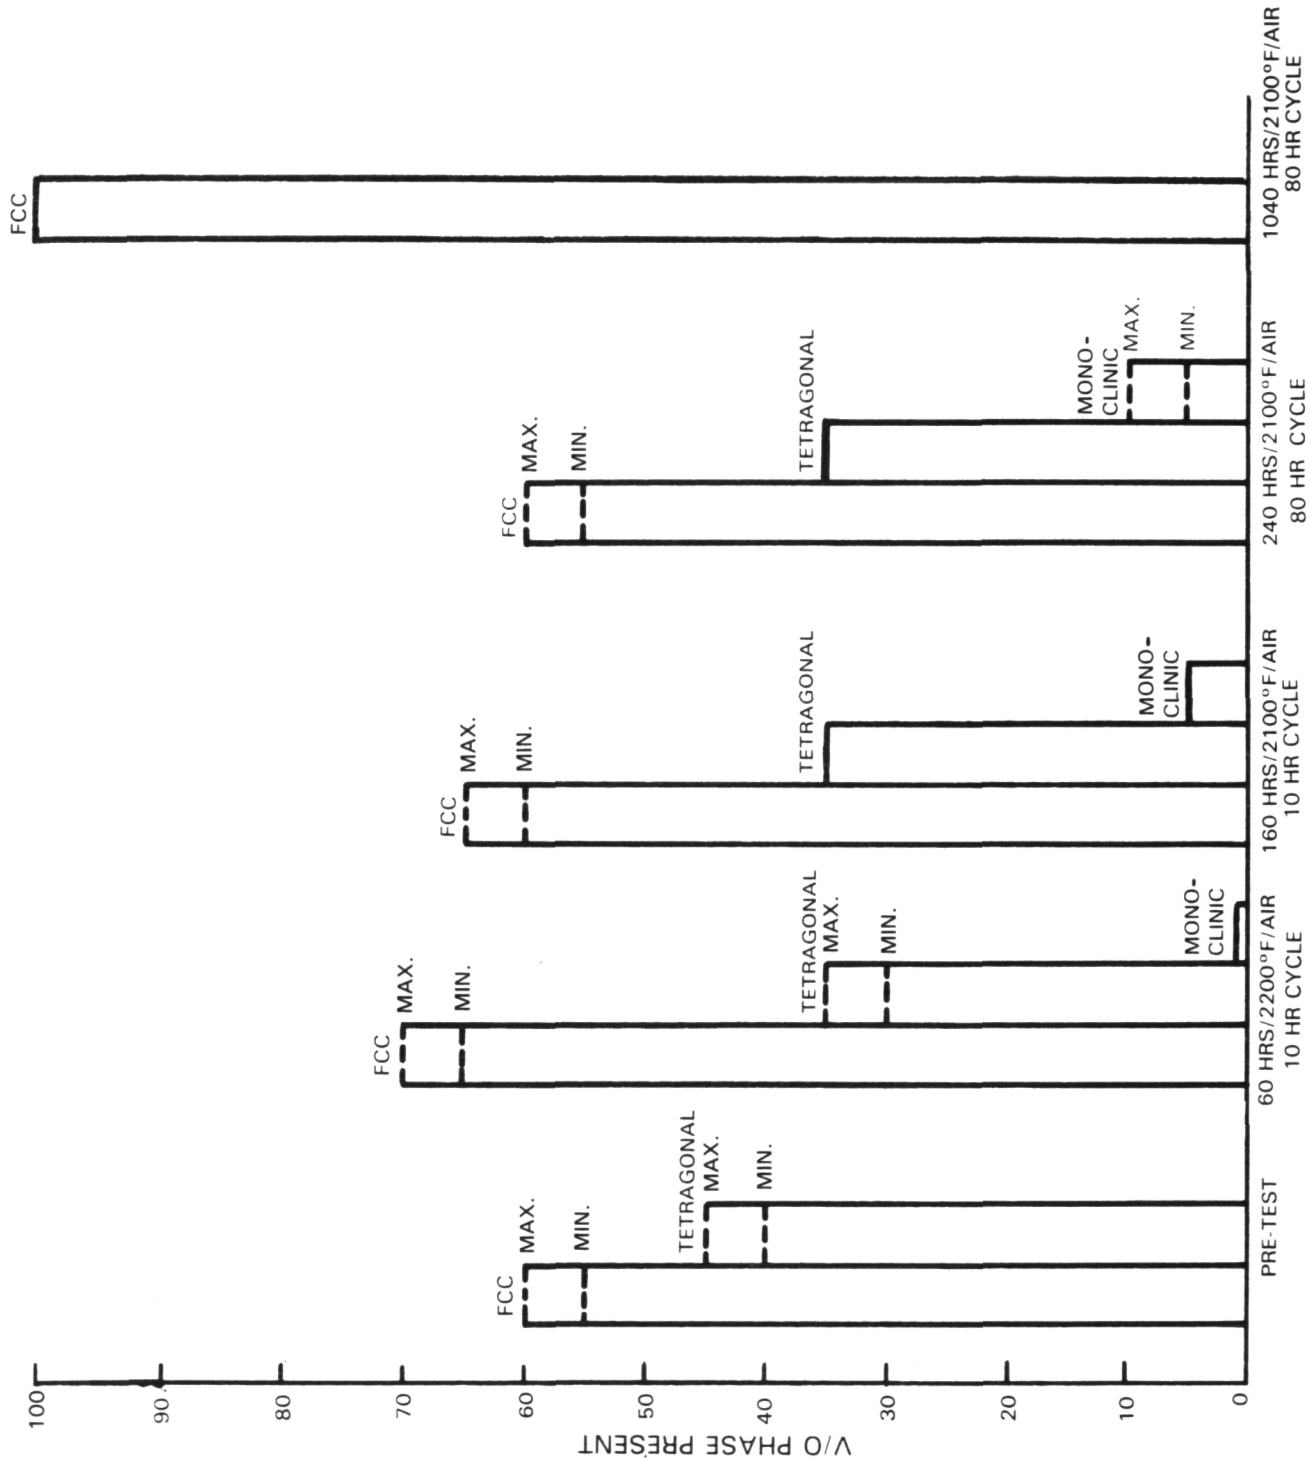
Figure 11 X-Ray Diffraction Results of Furnace Exposed Test Specimens

In the air exposed specimens, the v/o of monoclinic ZrO_2 increases with increasing exposure time. In individual comparisons between these tested specimens and the pre-test specimen, there is an apparent decrease in the tetragonal phase which accompanies the increase in the monoclinic phase and a slight increase in the FCC phase, suggesting that existing metastable tetragonal phase is undergoing transformation. In looking at the two specimens tested at 2100°F (different cycle lengths; 80 hrs. and 10 hrs.), one failing at 160 hours and the other at 240 hours, there appears to be not only an increase in the v/o monoclinic phase with time but an associated decrease in the v/o FCC phase and no change in the v/o tetragonal phase with increasing time.

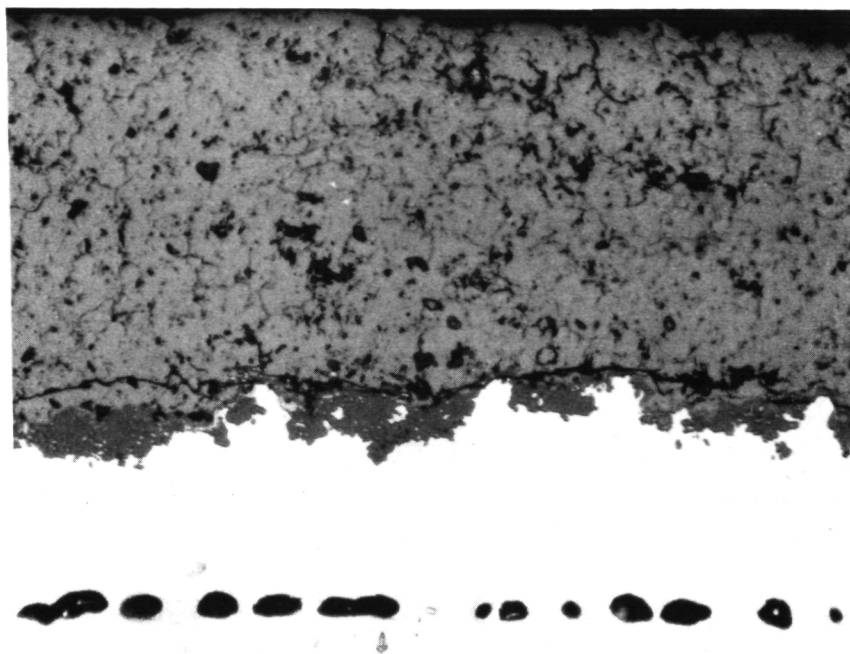
Figure 12 Light Photomicrograph of Post-Test Microstructure. Furnace Exposure in Argon of 2100°F with 80 Hours Inspection Intervals. (1040 hrs/13 Cycles)

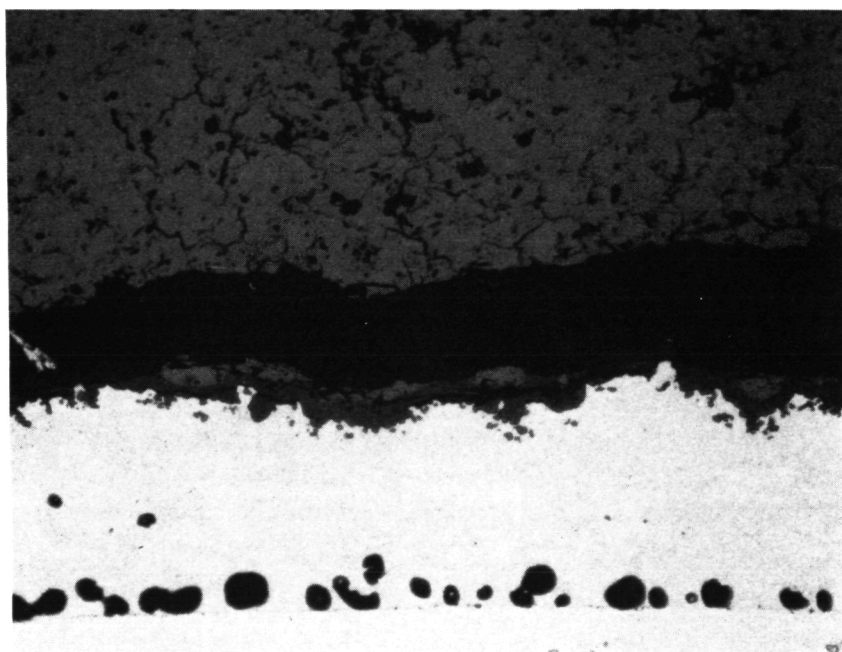
Figure 13 Light Photomicrograph of Post-Test Microstructure. Failed After Furnace Exposure in Air at 2100°F with 80 Hours Inspection Intervals. (240 hrs/3 cycles)

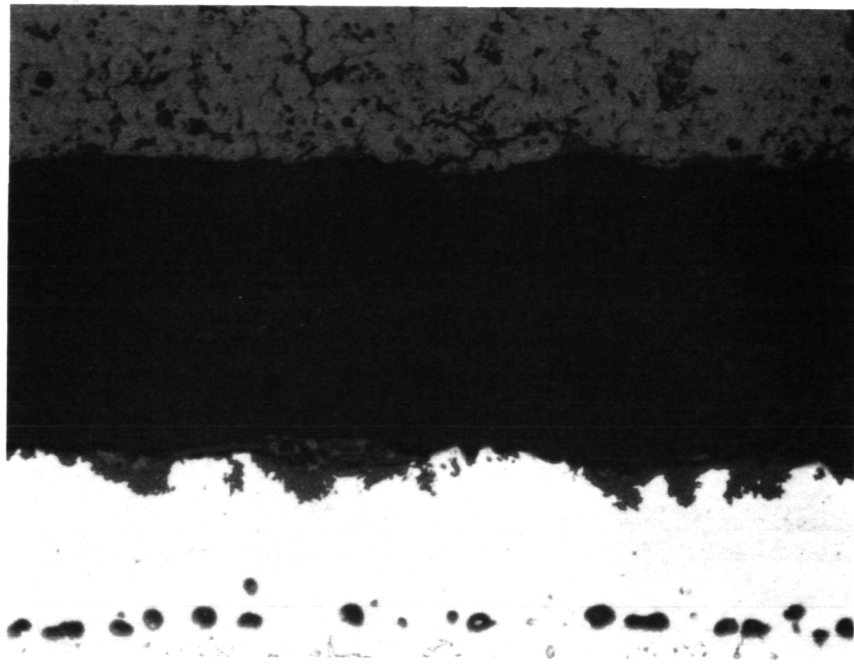
Figure 14 Light Photomicrograph of Post-Test Microstructure. Failed After Furnace Exposure in Air at 2100°F with 10 Hours Inspection Intervals. (160 hrs/16 cycles)

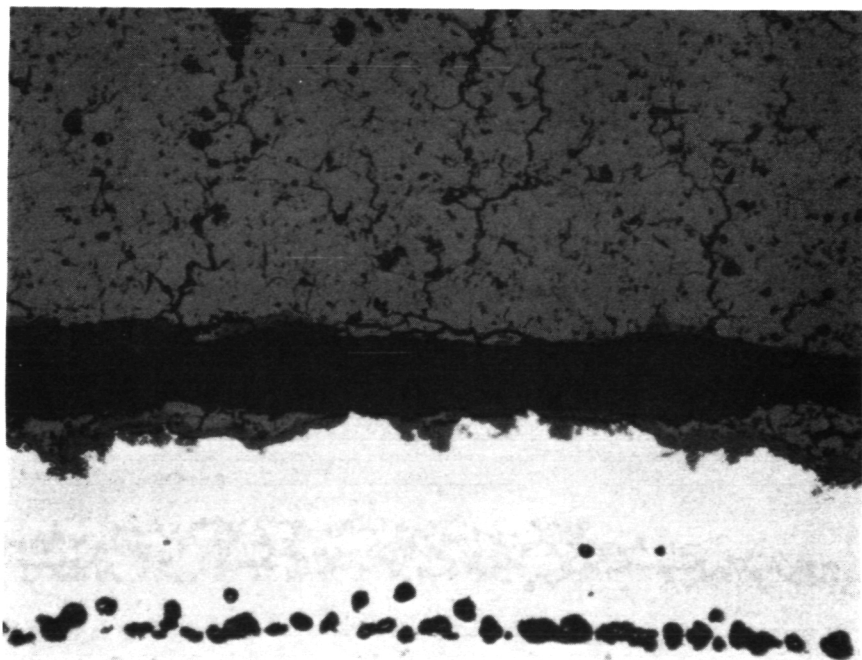
Figure 15 Light Photomicrograph of Post-Test Microstructure. Failed After Furnace Exposure in Air at 2200°F with 10 Hours Inspection Intervals. (60 hrs/6 cycles)

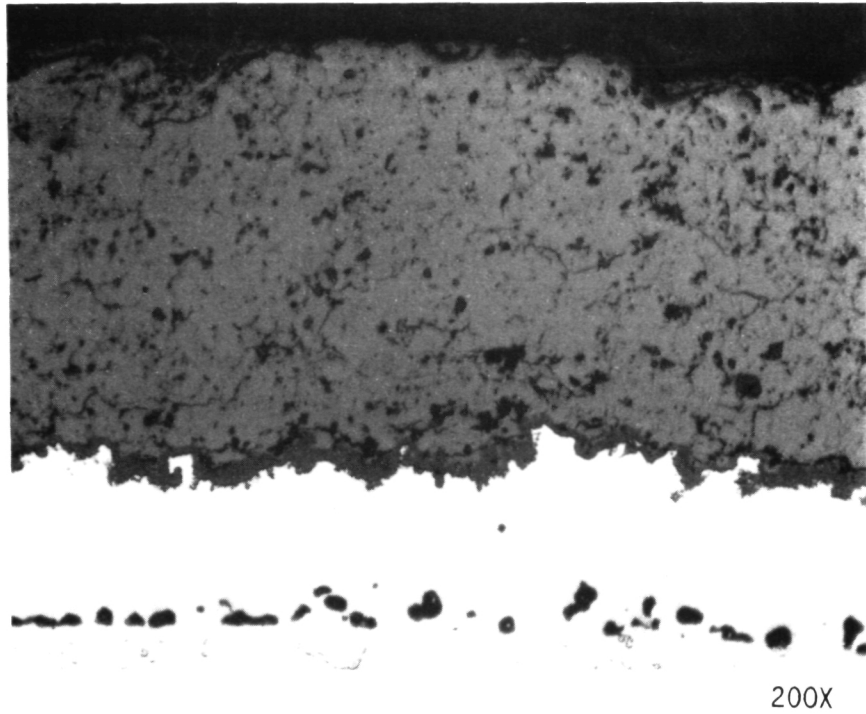
Figure 16 Light Photomicrograph of Post-Test Microstructure After Furnace Exposure in Air. (90 hrs/2100°F/1 cycle 60%)

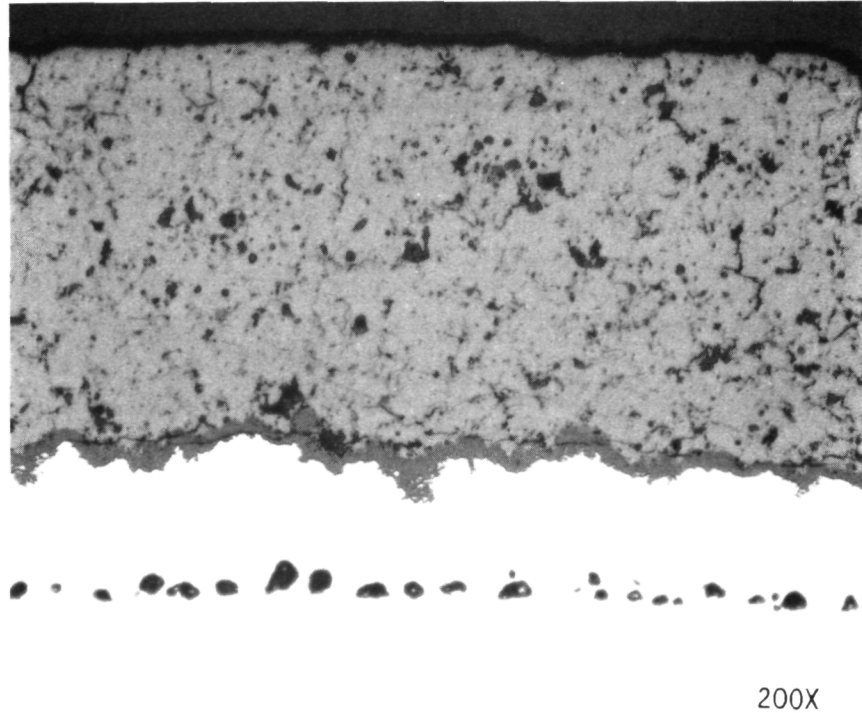
Figure 17 Light Photomicrograph of Post-Test Microstructure After Fractional Furnace Exposure in Air (135 hrs/2100°F/1 cycle 90%)

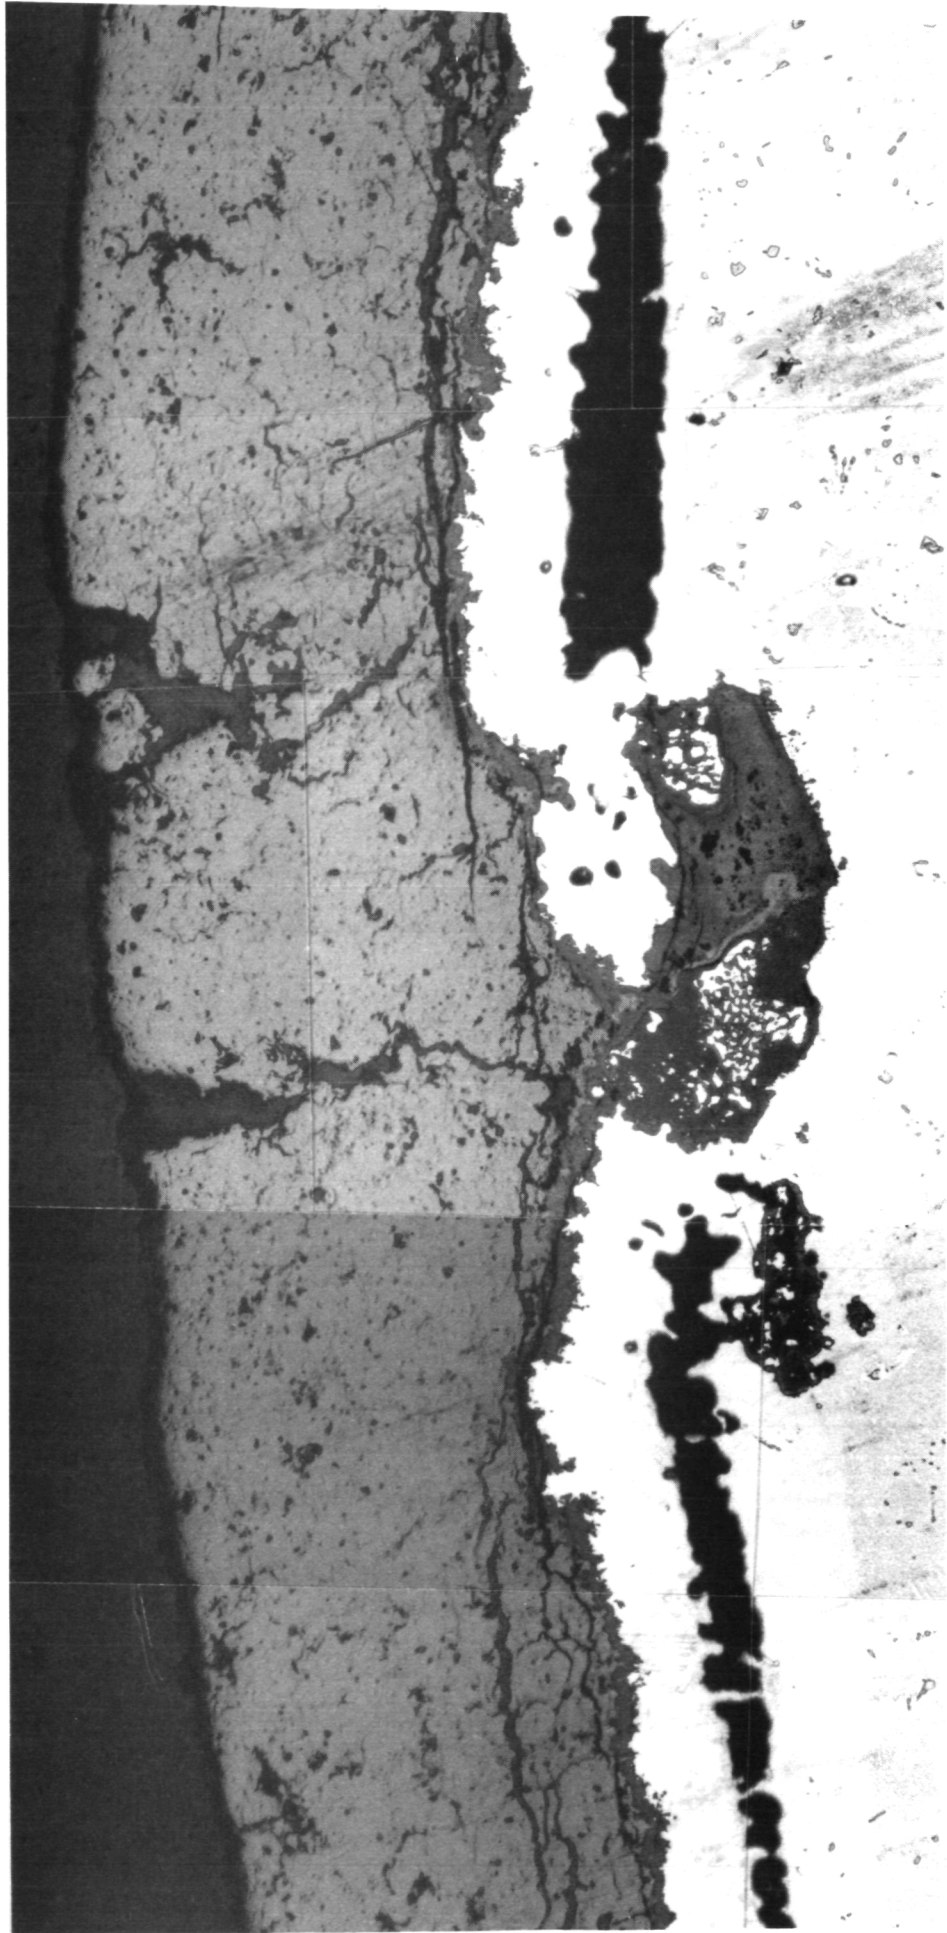
Figure 18 Light Photomicrograph of Post-Test Microstructure After 150 Hrs Fractional Exposure at 2100°F in Air

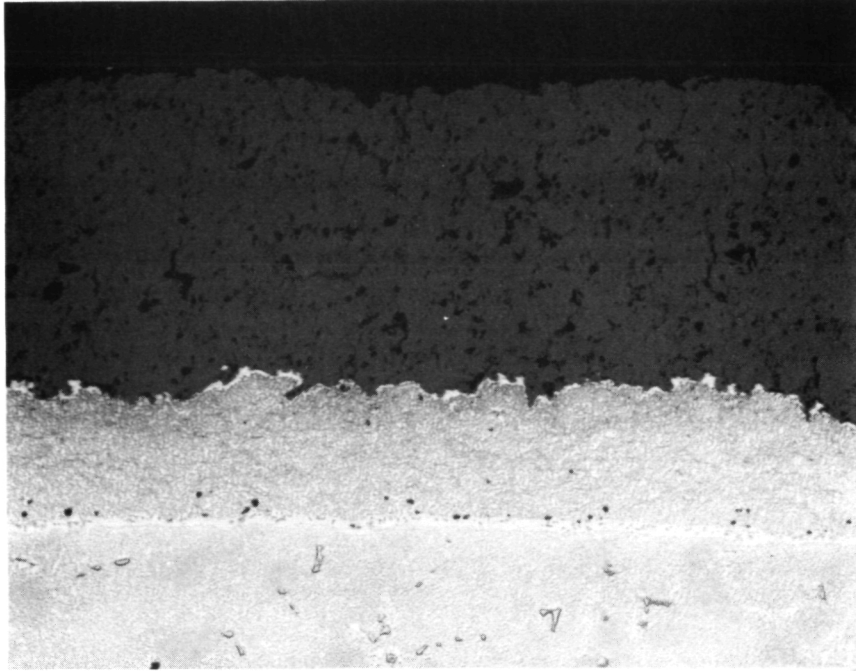
Figure 20a Light Photomicrograph of Pre-Test Microstructure (D2 Test)

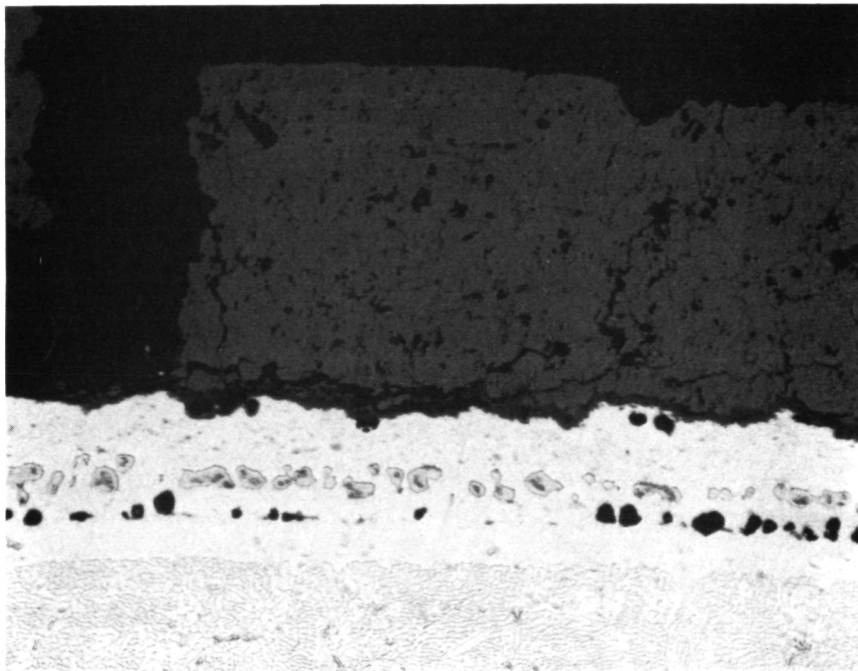
Figure 20b Light Photomicrograph of Baseline Post-Test Microstructure (D2 Test After 435 hrs at 2000°F/ Short Cycle/ Fast Heatup)

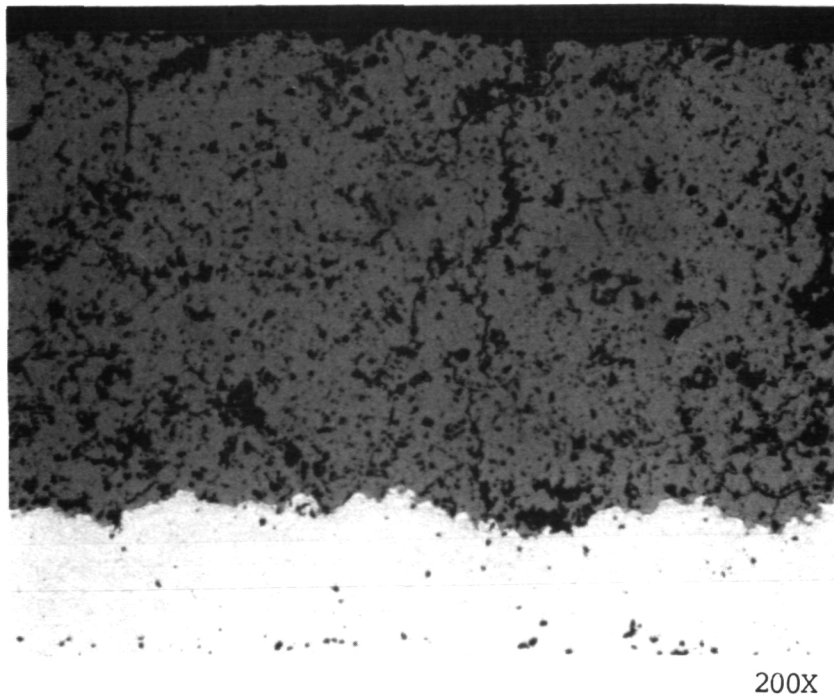
Figure 21a Light Photomicrograph of Baseline Pre-Test Microstructure (D1 Test)

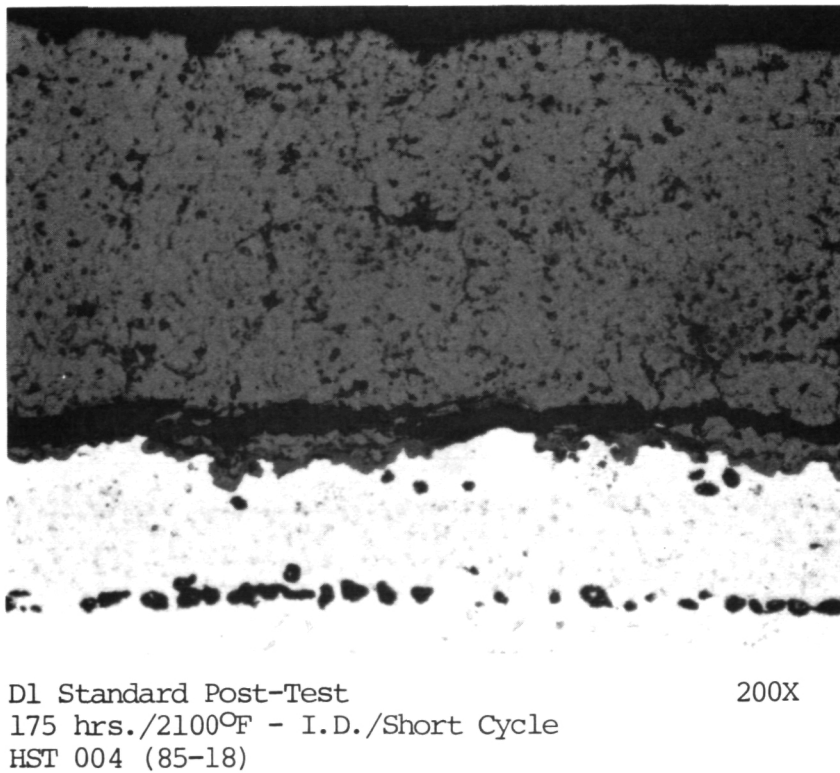
Figure 21b Light Photomicrograph of Baseline Microstructure After 175 hrs at 2100°F/Short Cycle/Fast Heatup

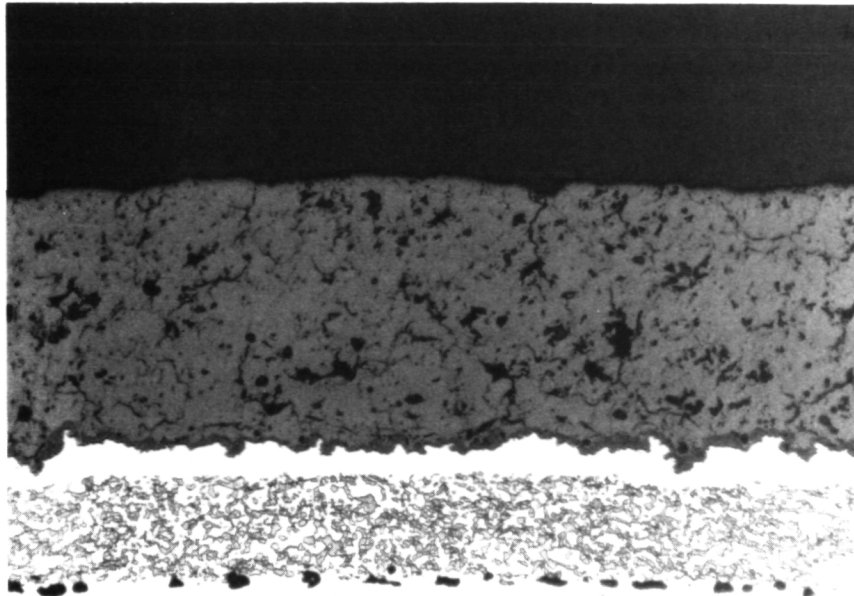
Figure 22a Light Photomicrograph of Pre-Burner Rig Test (D2) Microstructure for Pre-Exposed Specimen (Air/2000°F/100 hrs)

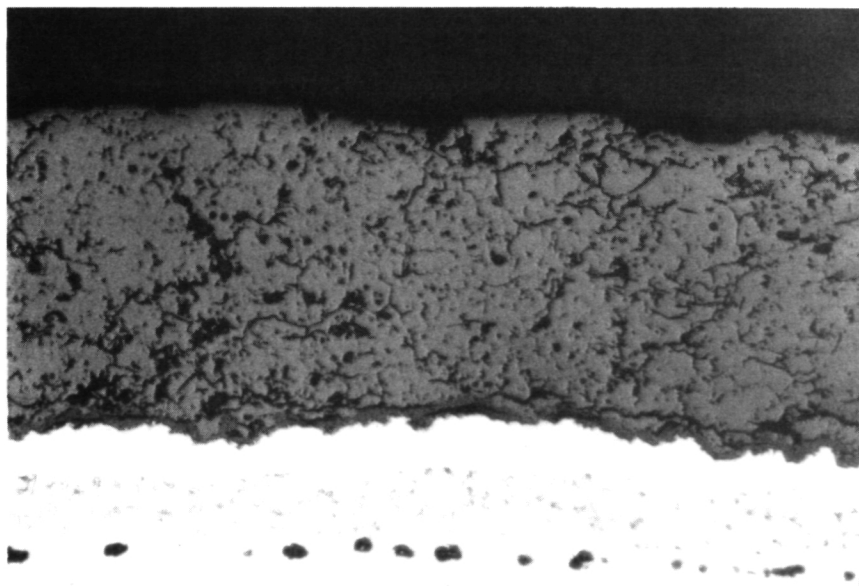
Figure 22b Light Photomicrograph of Post Burner Rig Test (D2) Microstructure for Pre-Exposed Specimen (Air/2000°F/100 hrs) After 215 hrs at 2000°F/Short Cycle/Fast Heatup

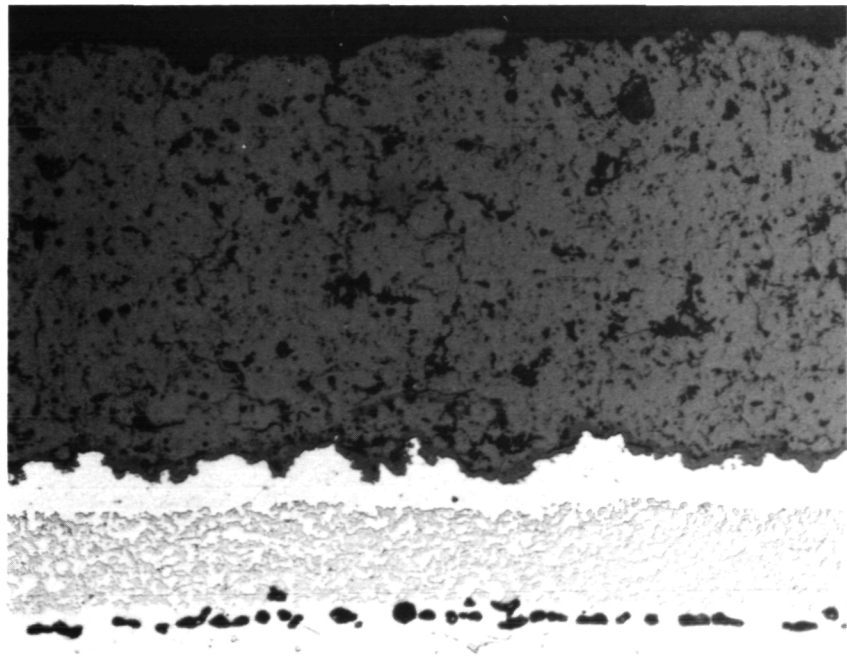
Figure 23a Light Photomicrograph of Pre-Burner Rig Test (D1) Microstructure for Pre-Exposed Specimen (Air/2100°F/40hrs)

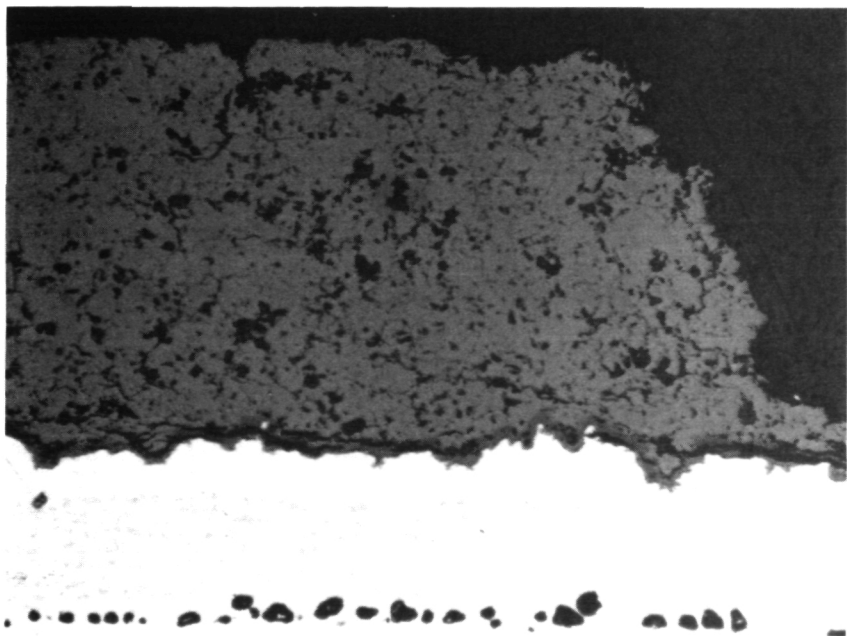
Figure 23b Light Photomicrograph of Post-Burner Rig Test (D1) Microstructure Pre-Exposed Specimen (Air/2100°F/40 hrs) After 50 hrs at 2100°F/Short Cycle/Fast Heatup

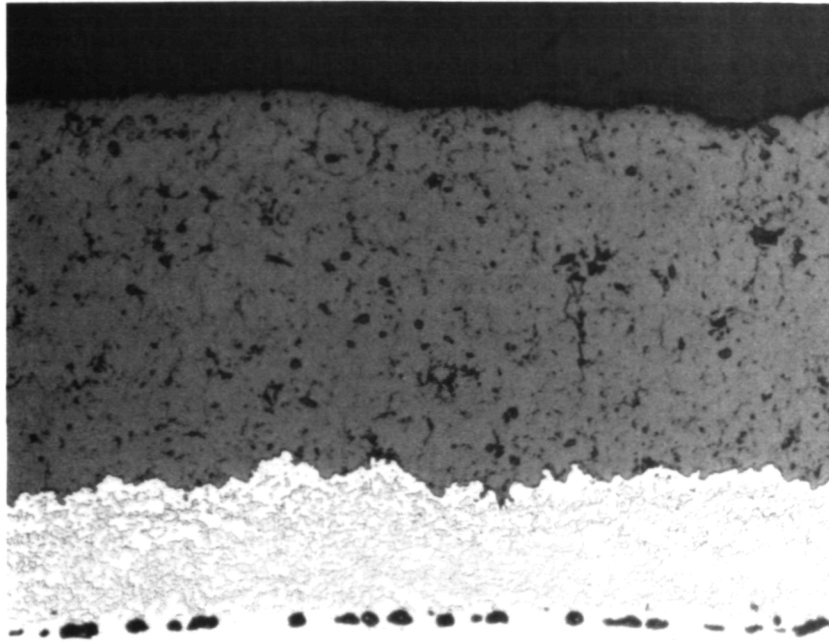
Figure 24a Light Photomicrograph of Pre-Burner Rig Test (D1) Microstructure for Pre-Exposed Specimen (Argon/2100°F/40 hrs)

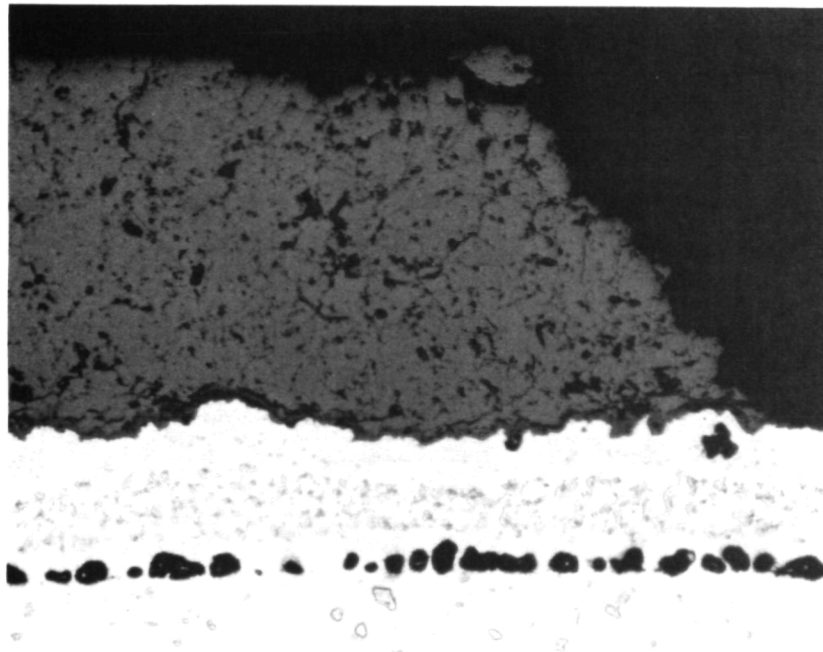
Figure 24b Light Photomicrograph of Post Burner Rig Test (D1) Microstructure for Pre-Exposed Specimens (Argon/2100°F/40hrs) After 67 hrs at 2100°F/Short Cycle/Fast Heatup

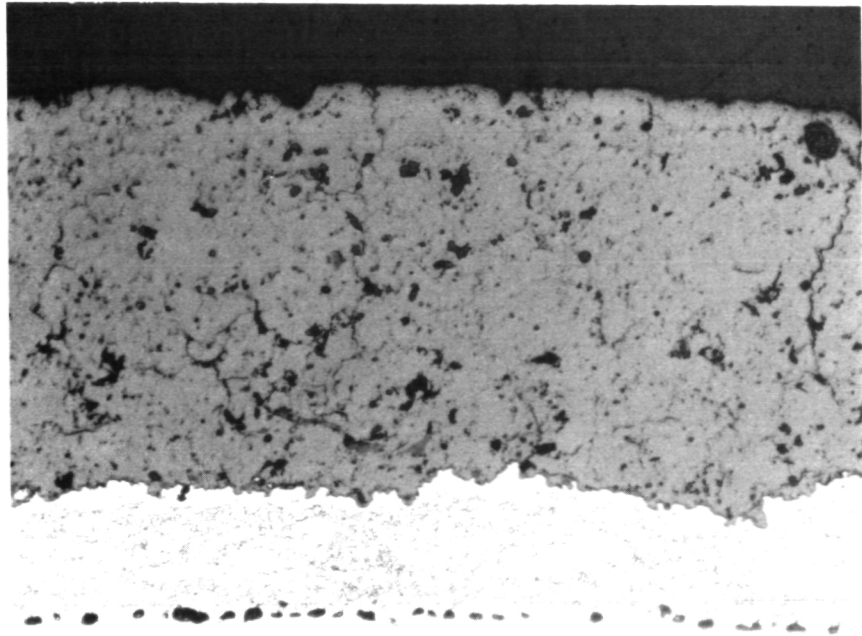
Figure 25a Light Photomicrograph for Pre Burner Rig Test (D2) Microstructure for Pre-Exposed Specimen (Ar/2000°F/100 hrs)

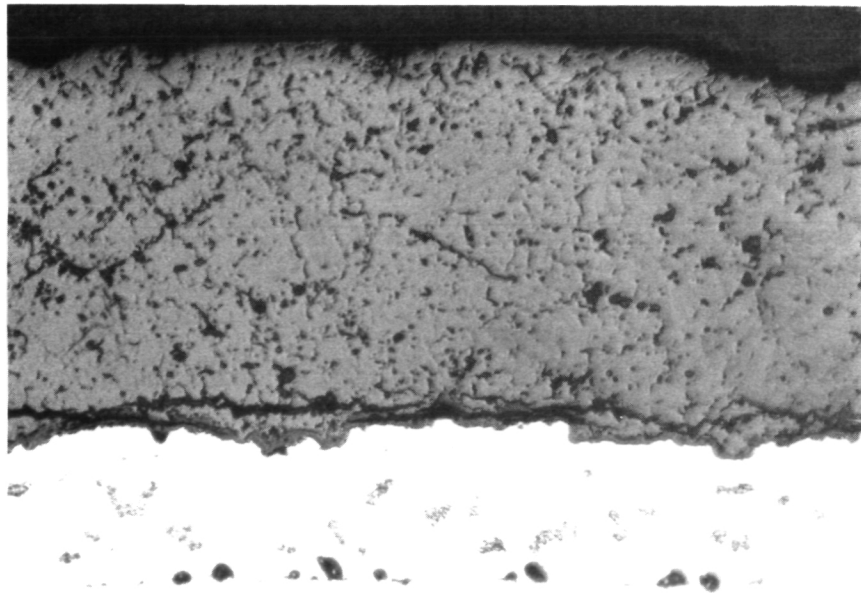
Figure 25b Light Photomicrograph of Post Burner Rig Test (D2) Microstructure for Pre-Exposed Specimen (Ar/2000°F/100 hrs) After 708 hrs at 2000°F/Short Cycle/Fast Heatup

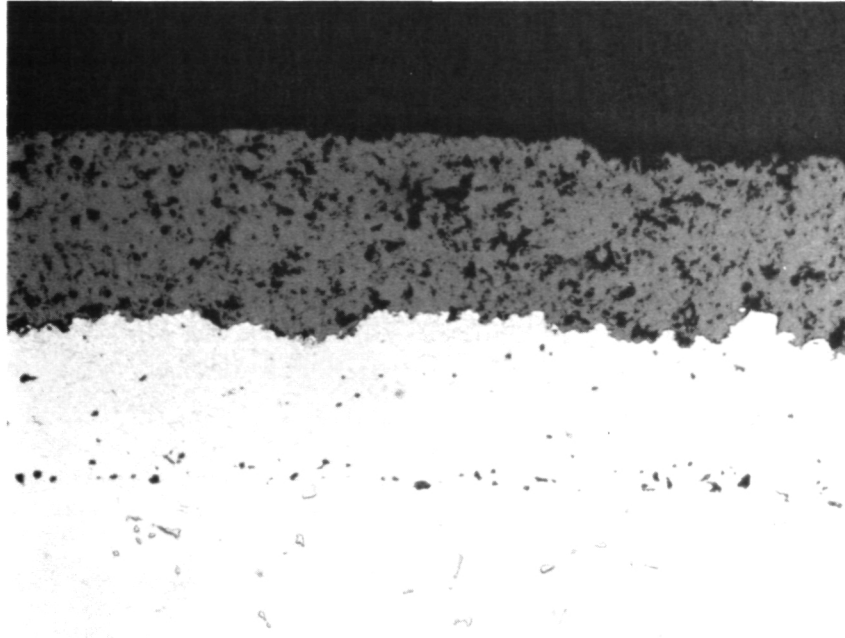
Figure 26a Light Photomicrograph of Pre-Test Microstructures for Thin Specimens, D1 Test 200X

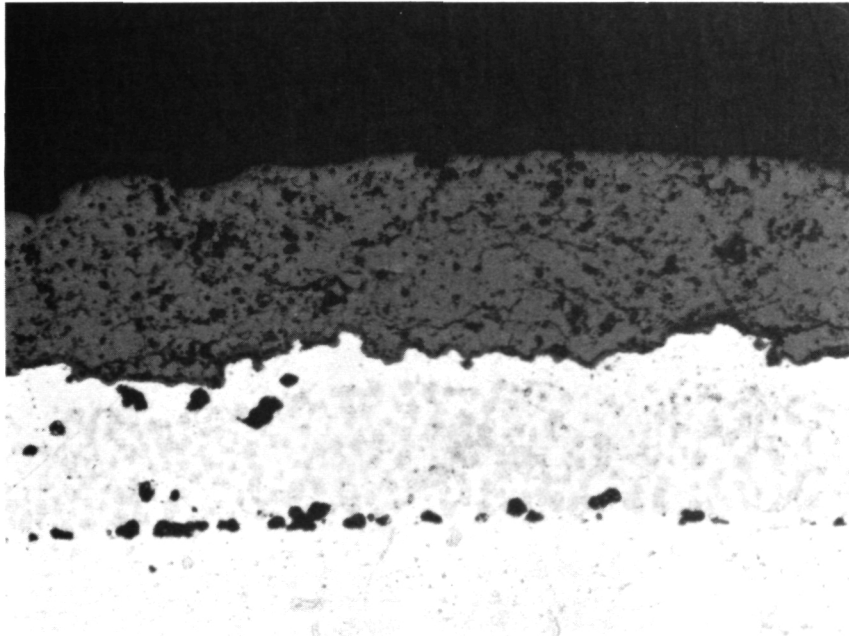
Figure 26b Light Photomicrograph of Post-Test Microstructures of Thin Specimens, D1 Test After 243 hrs at 2100°F/Short Cycle/Fast Heatup

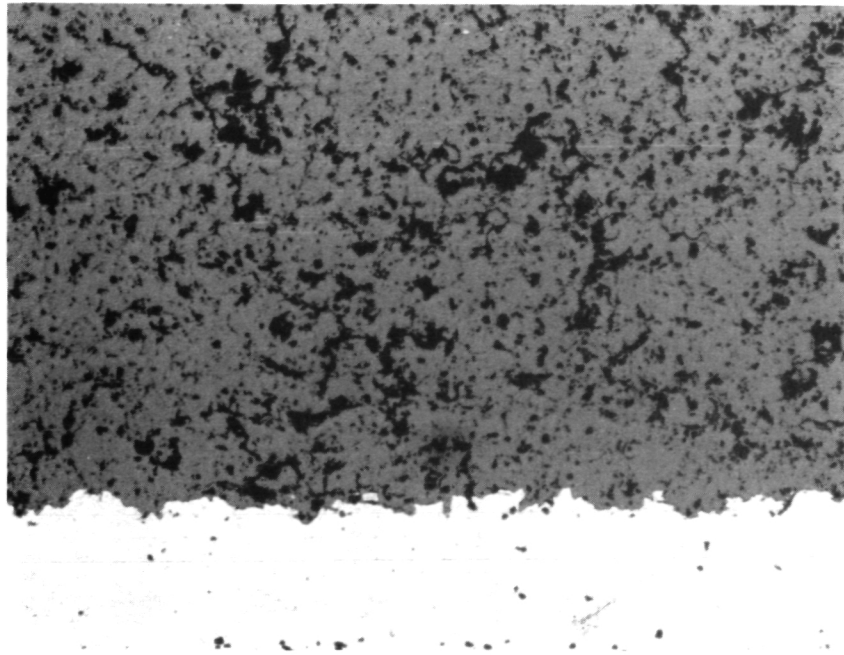
Figure 27a Light Photomicrograph of Pre-Test Microstructures for Thick Specimen, D1 Test

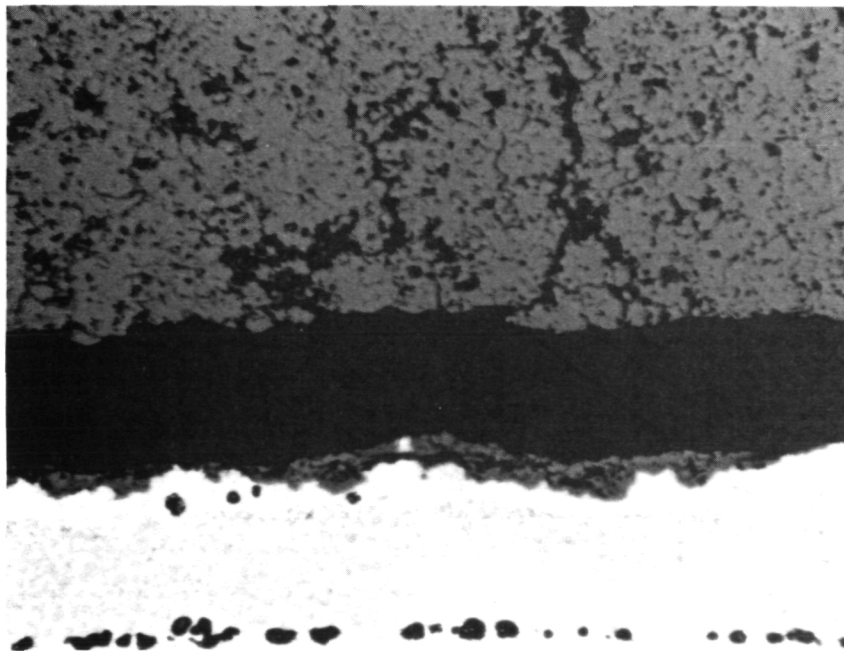
Figure 27b Light Photomicrograph of Post Test Microstructures for Thick Specimen, D1 Test, After 160 hrs at 2100°F/Short Cycle/ Fast Heatup
