THERMAL BARRIER COATING LIFE PREDICTION MODEL DEVELOPMENT FIRST ANNUAL REPORT

By K.D. Sheffler and J.T. DeMasi

UNITED TECHNOLOGIES CORPORATION
Pratt & Whitney Group
Engineering Division

Prepared for
NATIONAL AERONAUTICS AND SPACE ADMINISTRATION

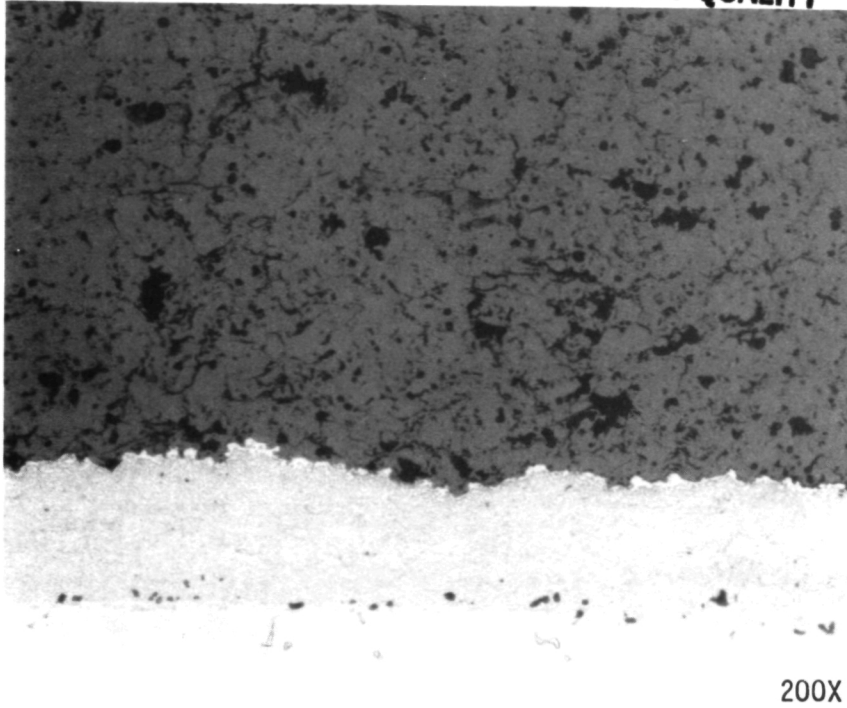
Figure 28a Light Photomicrograph of Pre-Test Microstructure for Thick Ceramic Specimen, D2 Test

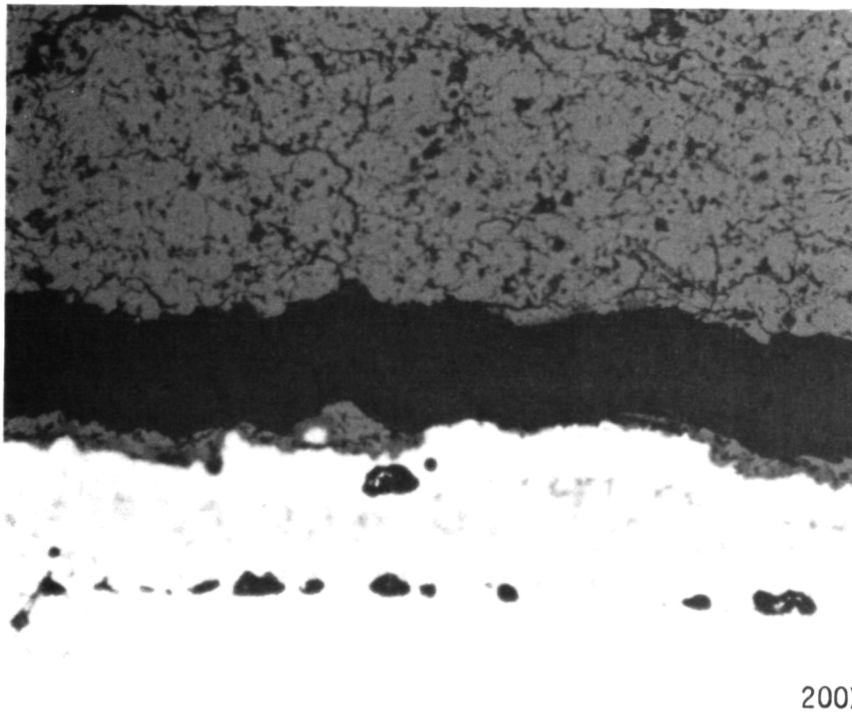
Figure 28b Light Photomicrograph of Post-Test Microstructure for Thick Ceramic Specimen, D2 Test After 454 hrs at 2000°F/Short Cycle/Fast Heatup

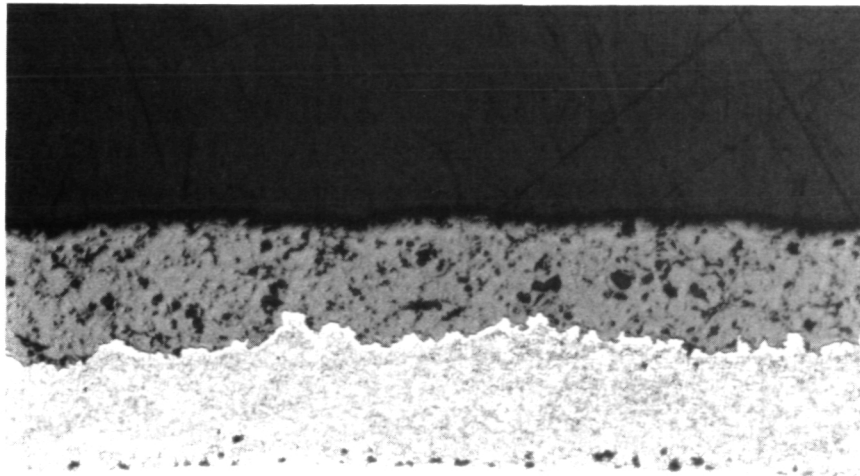
Figure 29a Light Photomicrograph of Pre-Test Microstructure for Thin Ceramic Specimen, D2 Test

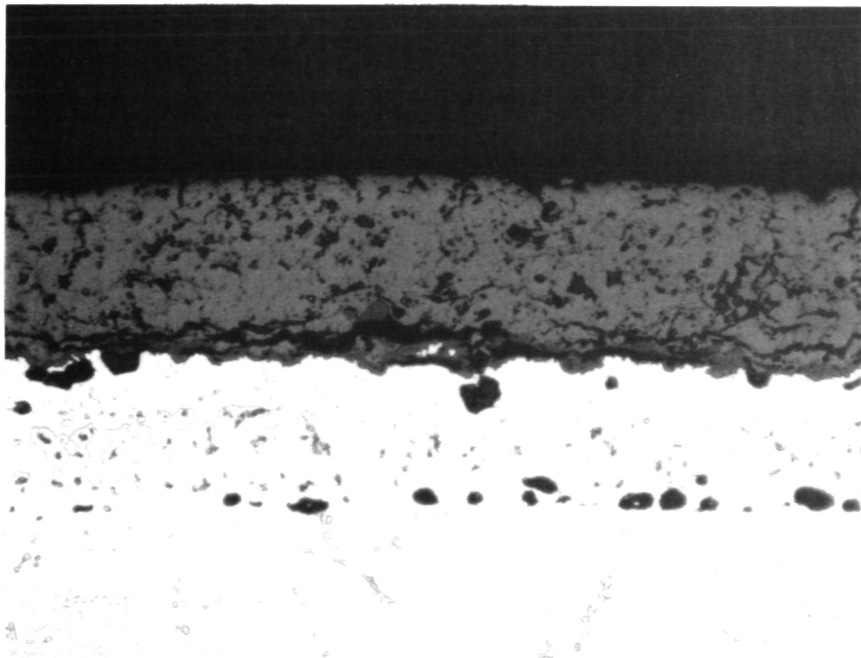
Figure 29b Light Photomicrograph of Post-Test Microstructure for Thin Ceramic Specimen, D2 Test After 492 hrs at 2000°F/Short Cycle/Fast Heatup

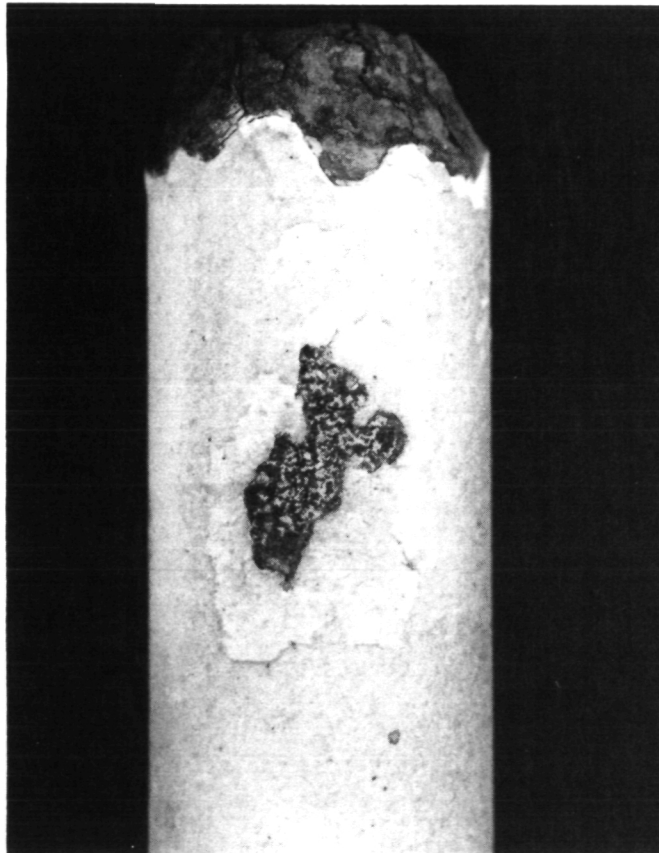
Figure 31 Cyclic Hot Corrosion Test Specimen Showing Multi-level Flaking of the Ceramic

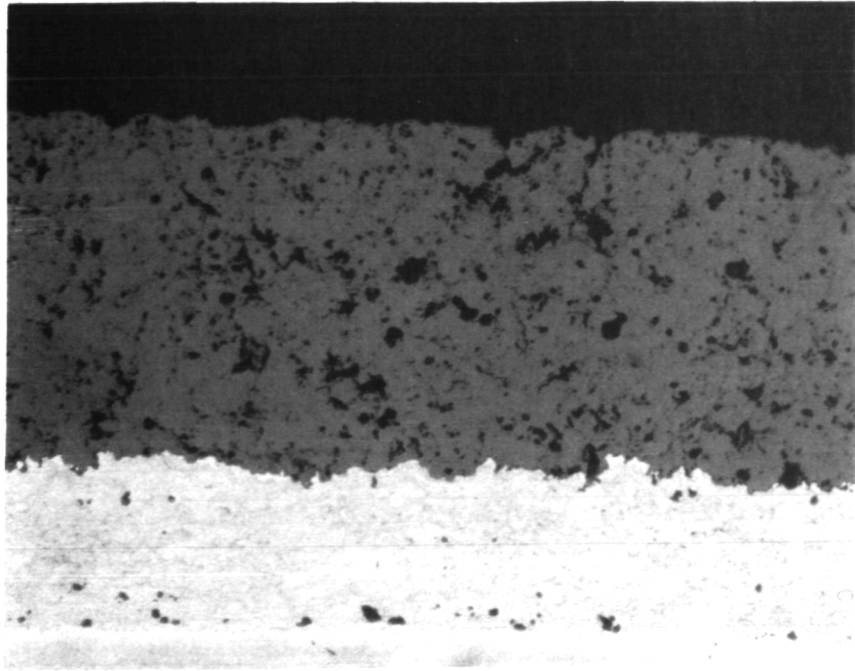
Figure 32a Pre-Test Hot Corrosion Test Specimen; 35 ppm Artificial Sea Salt/
1650°F/1 Hour Cycle

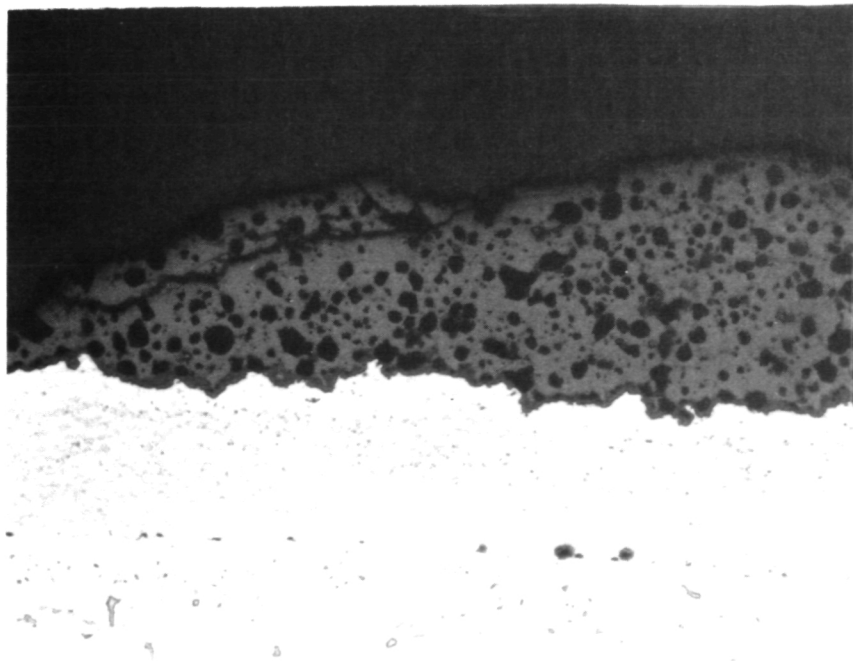
Figure 32b Post-Test Hot Corrosion Test Specimen Showing In-Plane Ceramic
Cracking in Central and Upper Portion of Ceramic Layer After 693
hrs at 35 ppm Artificial Sea Salt/1650°F/1 Hour Cycle

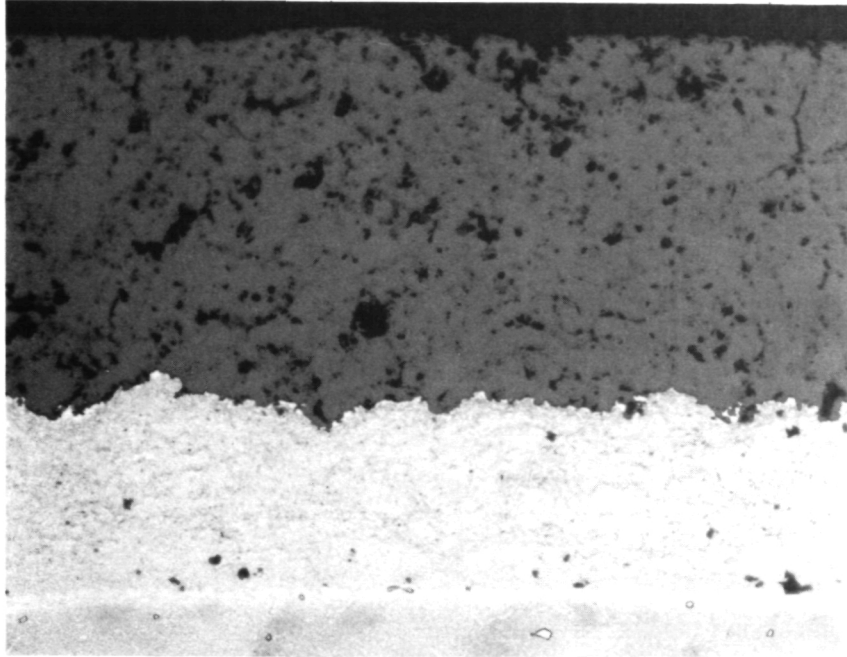
Figure 33a Pre-Test Hot Corrosion Test Specimen; 35 ppm Artificial Sea Salt/
1650°F/1 Hour Cycle

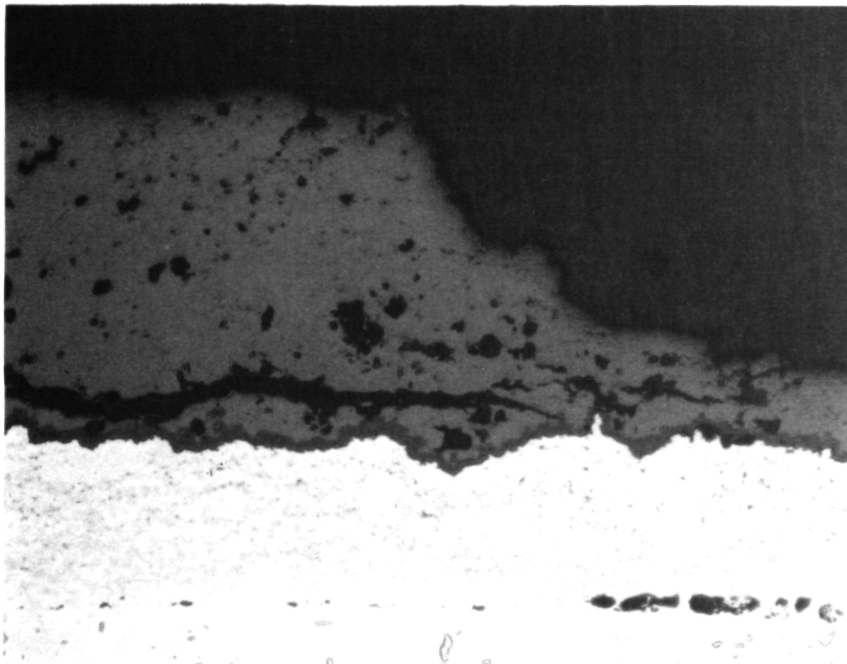
Figure 33b Post-Test Hot Corrosion Test Specimen After 1000 hrs at 35 ppm
Artificial Sea Salt/1650°F/1 Hour Cycle

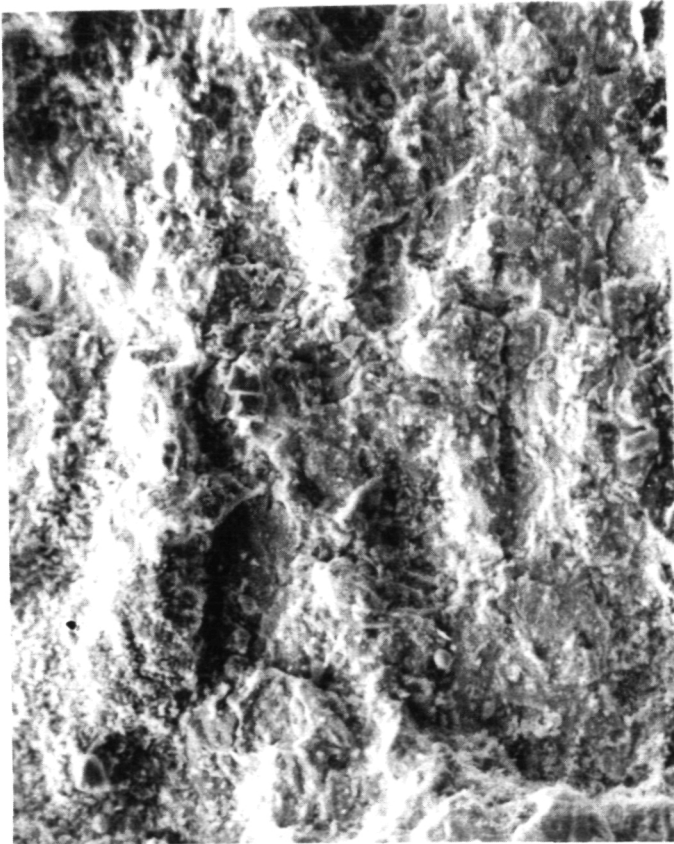
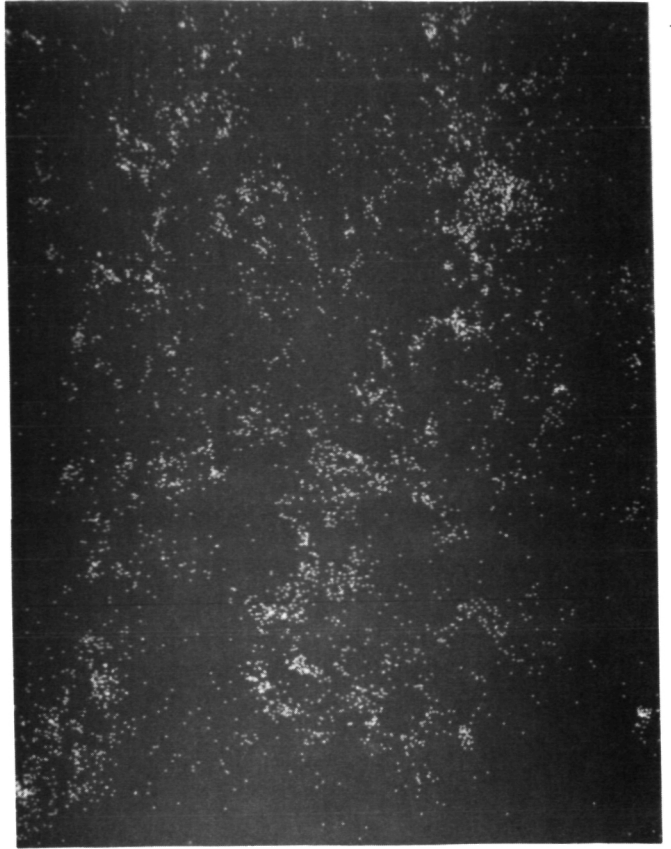
Figure 34 Cyclic Hot Corrosion Test
Specimen Surface (HST 086)
After 450 Hrs./1650°F - High
Corrodent Level Test

a) SEI Detailed Image Of Coating On Test
Bar Surface 800X

b) Sulfur X-Ray Map 800X

c) Sulfur X-Ray Map 800X

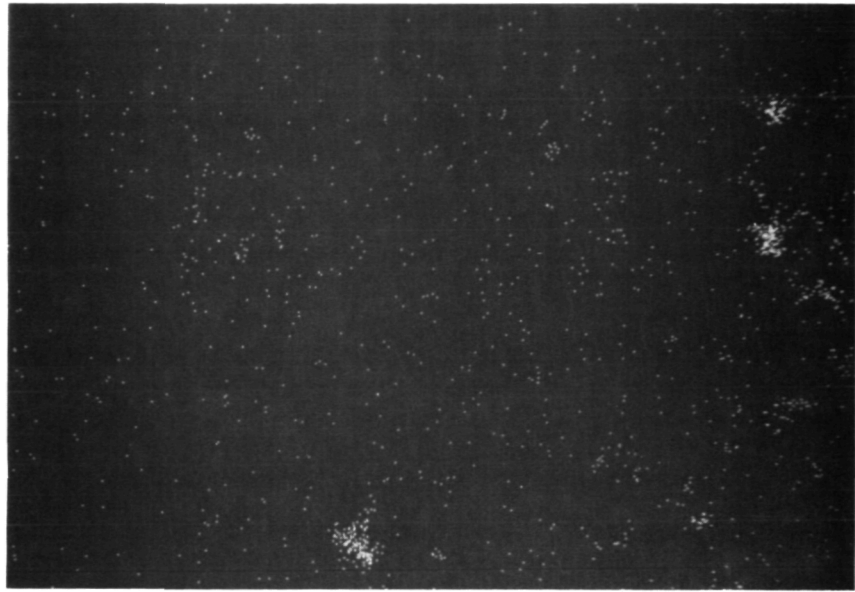
c) Na X-Ray Map

(continued)
Figure 35 Cyclic Hot Corrosion Test Specimen After 450 Hrs at 1650°F. High Corroderent Level in Area Near Failure.

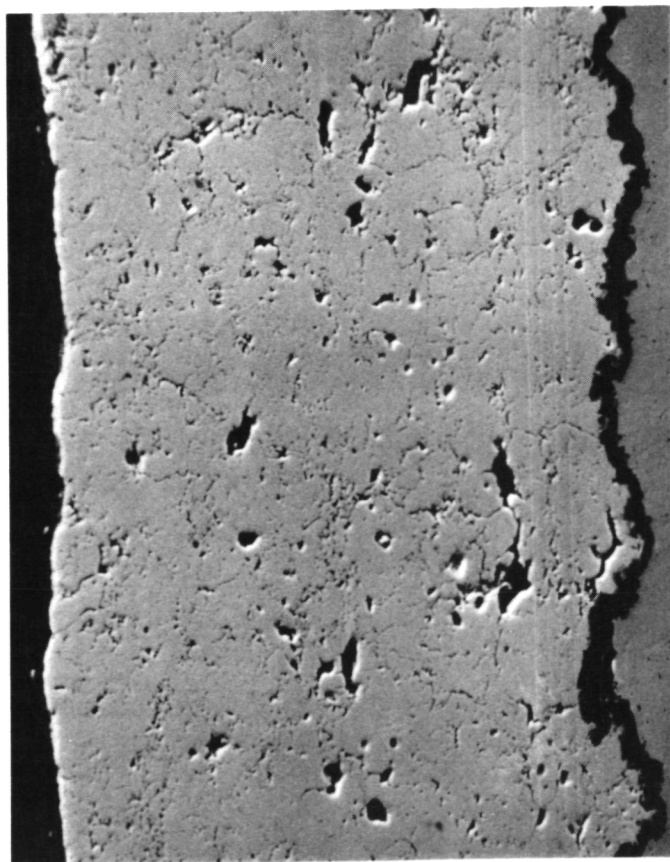
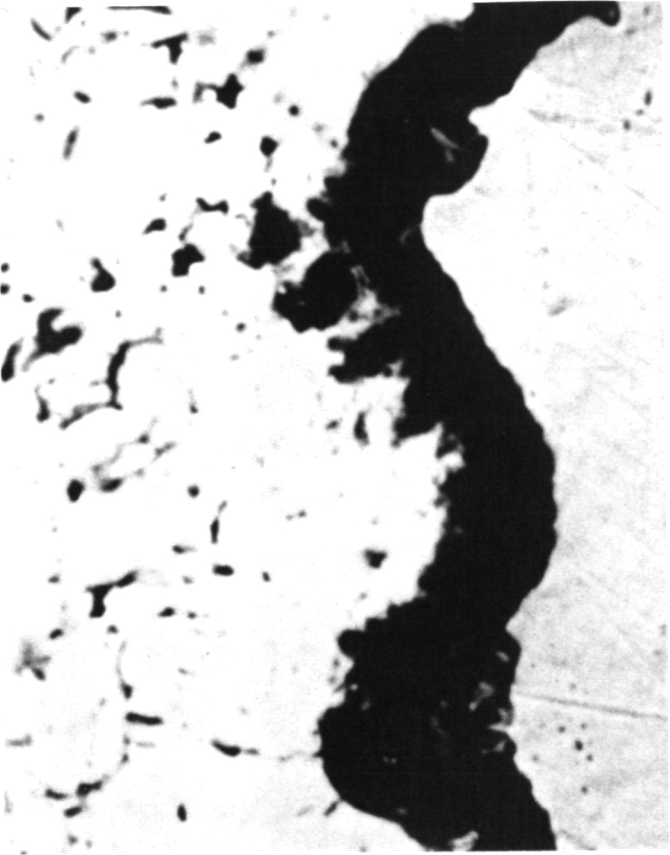
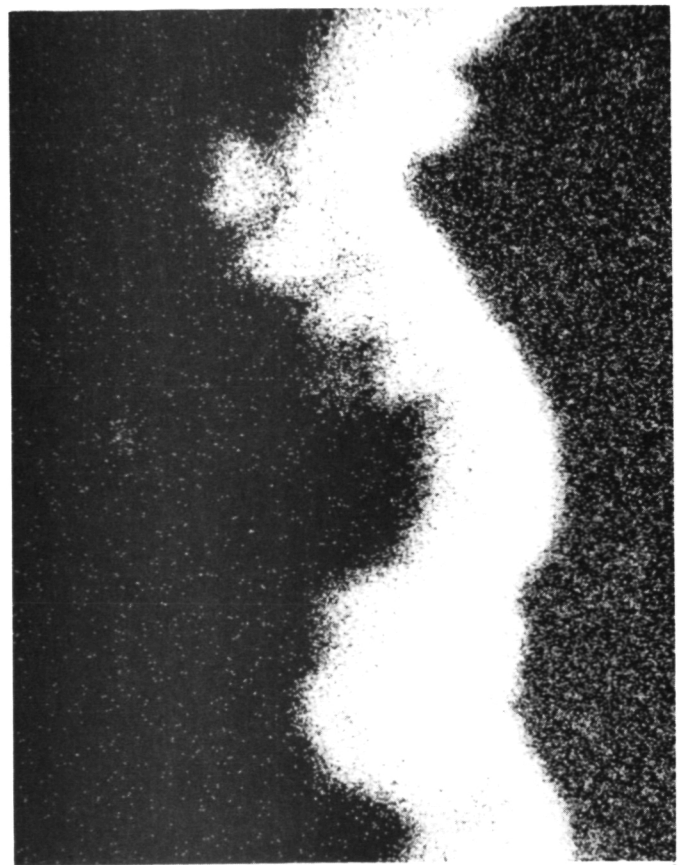
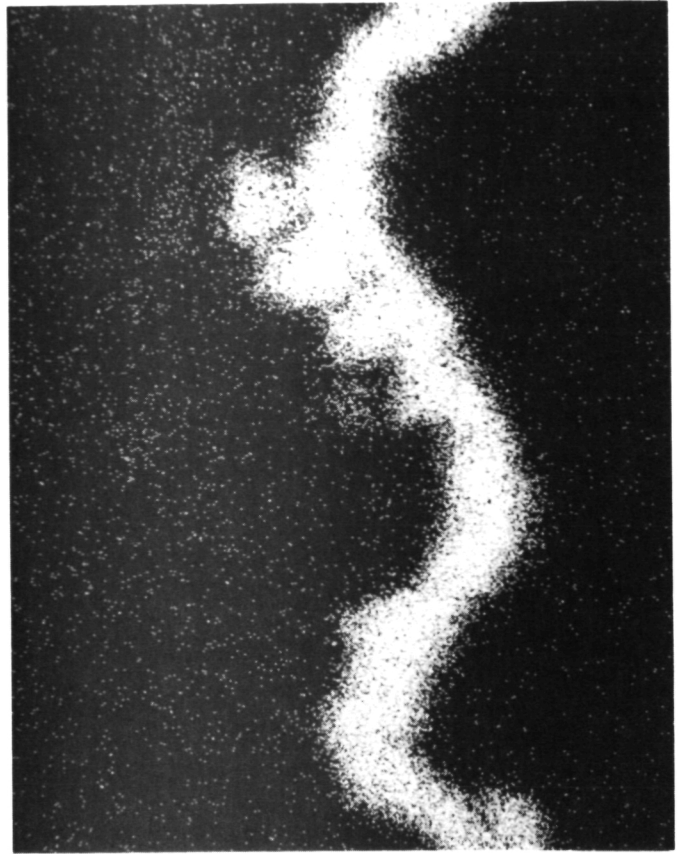
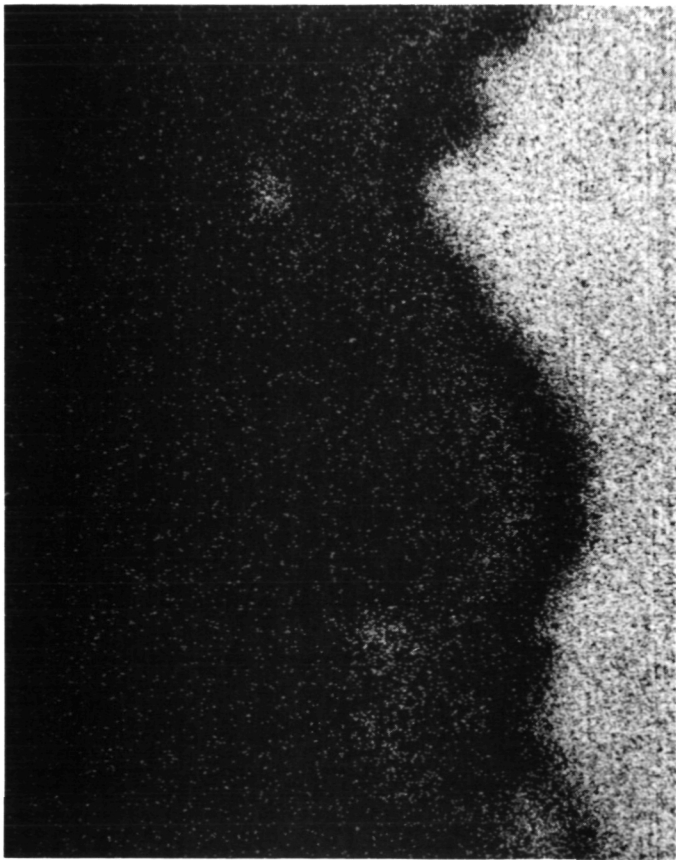
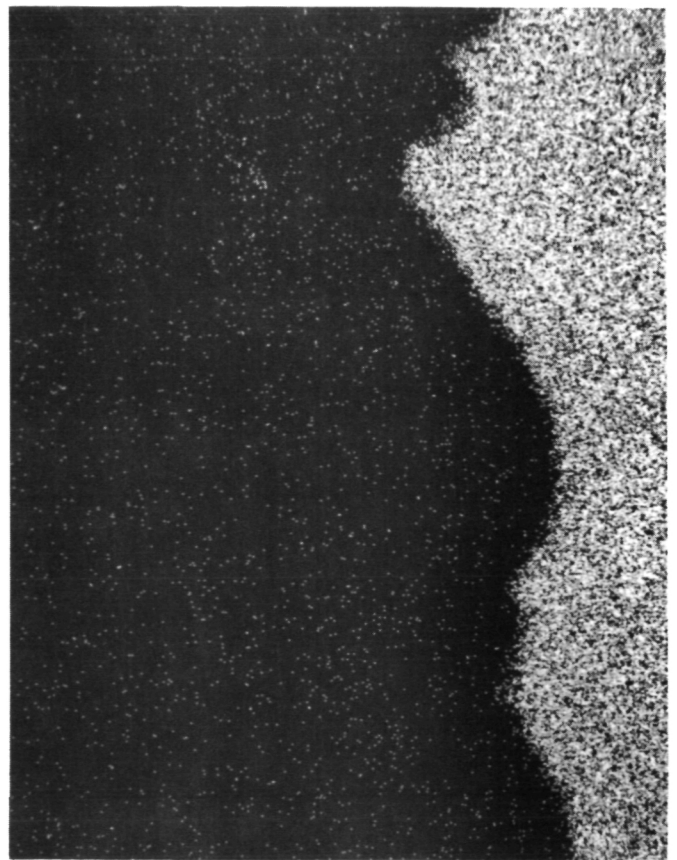
a) BEI

Detailed Image of Oxide Layer

Al X-Ray Map

Mg X-Ray Map

Figure 36 (Continued)
Cyclic Hot Corrosion Post-Test
Specimen After 1000 hrs at 1650°F/
Long Cycle/35 ppm Artificial Sea
Salt/1.3% SO₃

e) Cr X-Ray Map 2000X

f) Ni X-Ray Map 2000X

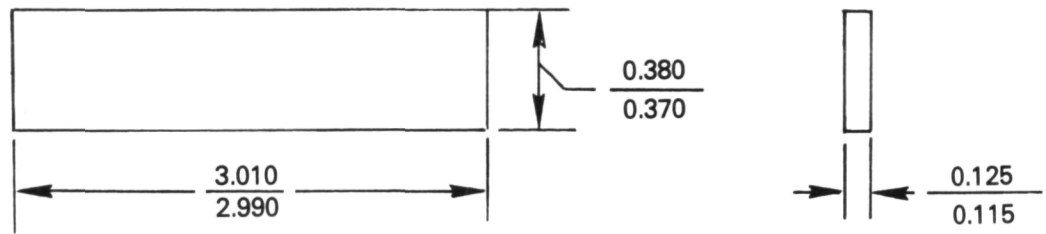
All Dimensions Shown In Inches

Figure 38 Bulk Four Point Bend Specimen Geometry Utilized for Determination of Elastic Constants, Stress Rupture, Creep, and Isothermal LCF Tests

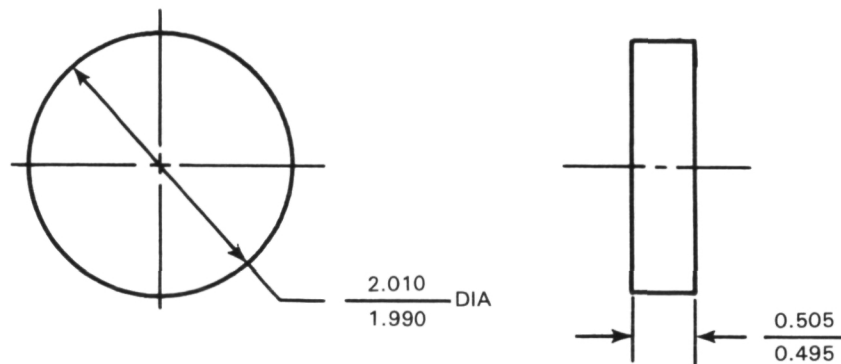
Figure 39 Thermal Conductivity Test Specimen

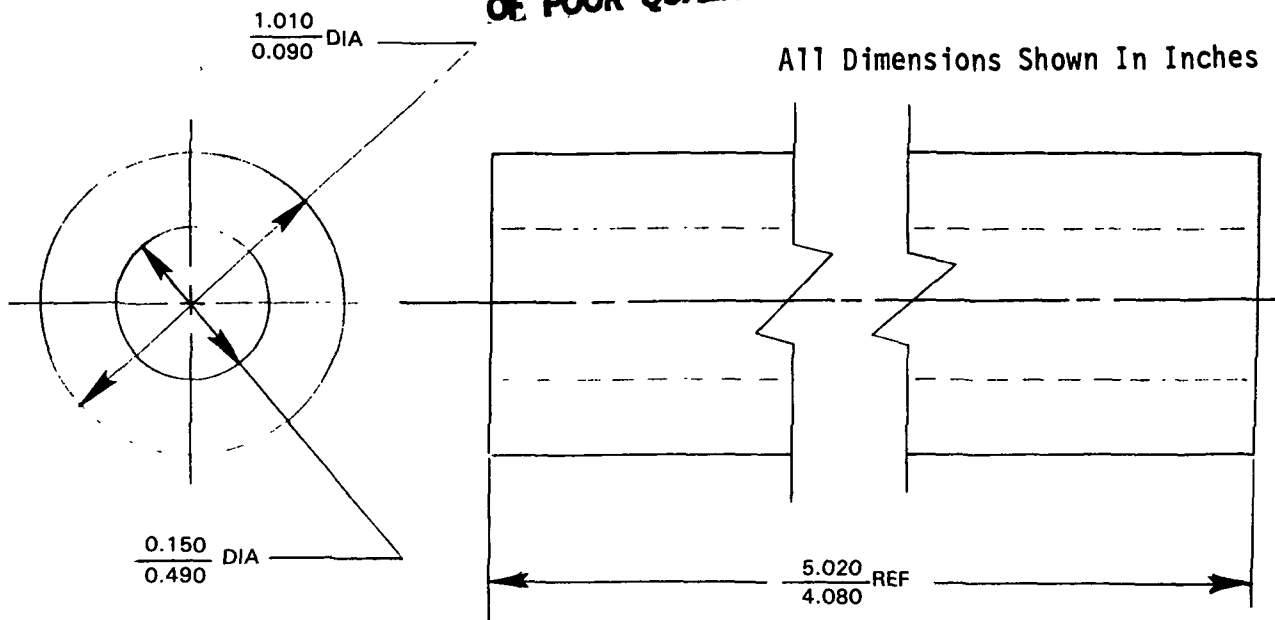
Figure 42 Single Rotating, Internally-Cooled Tube Tests Specimen Geometry

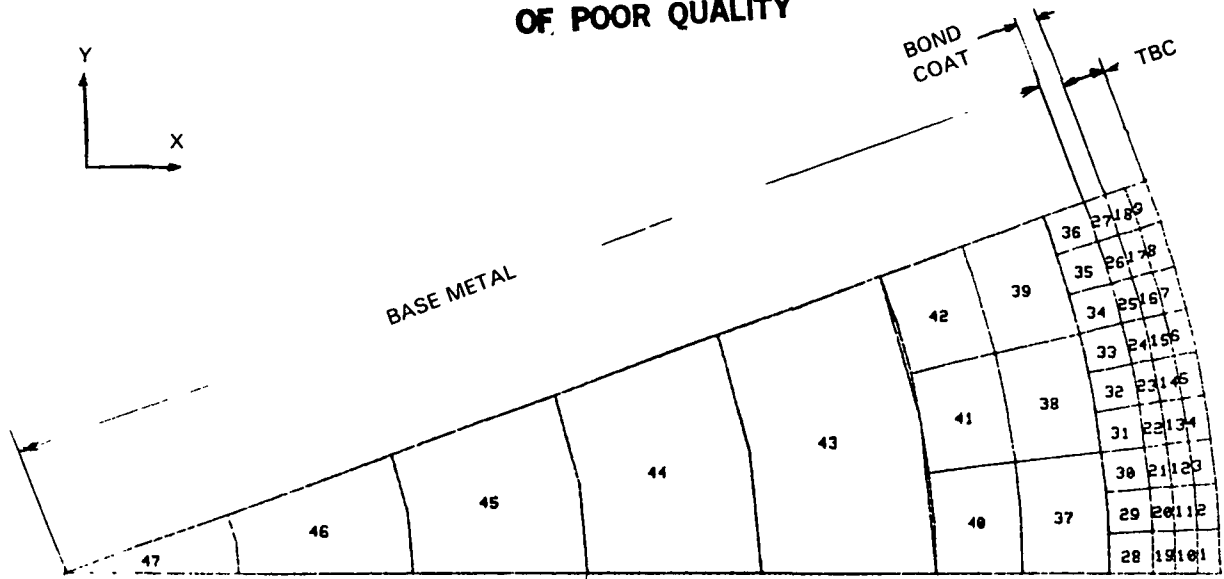
Figure 44 Modified Thermal Barrier Coating Life Model

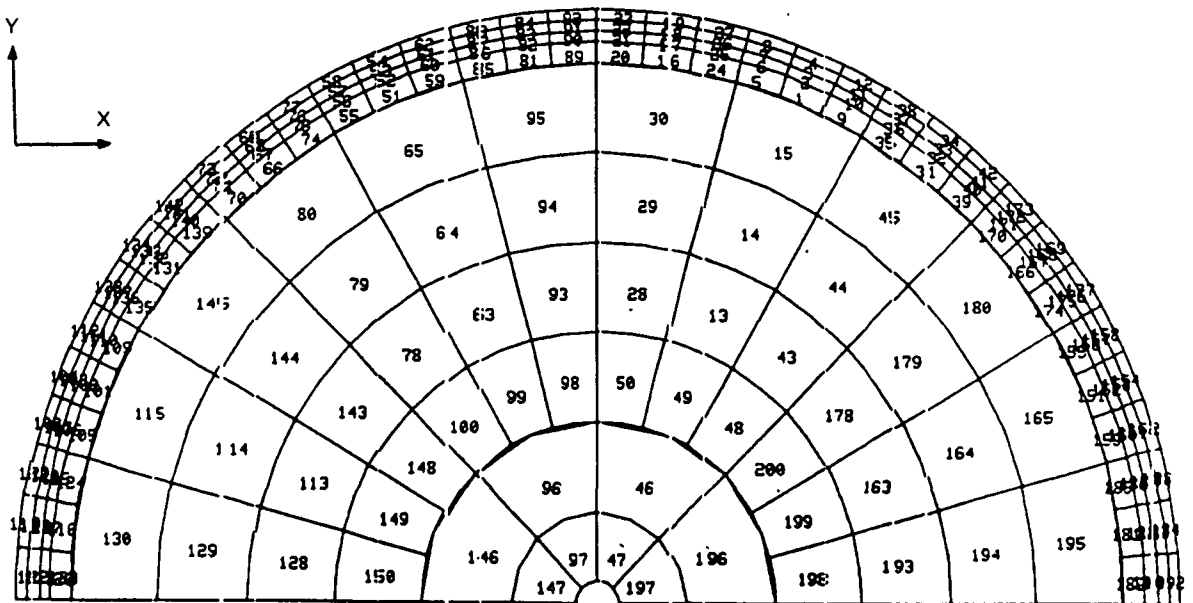
Figure 45 Finite Element Breakup

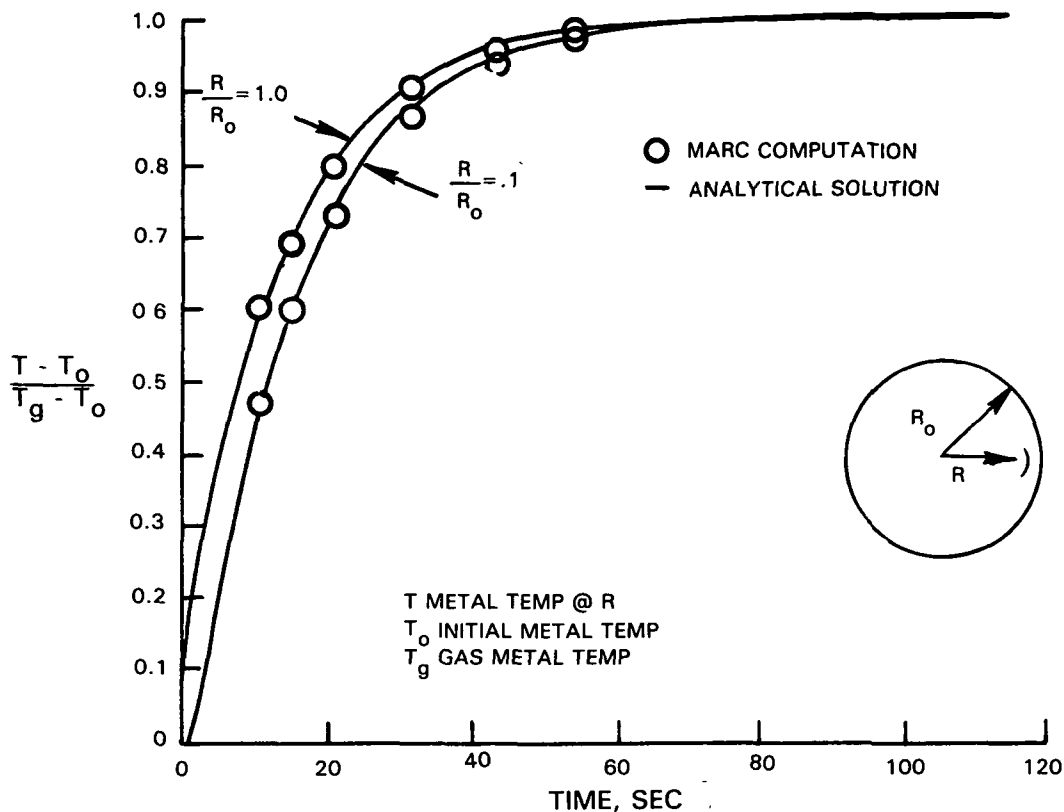
Figure 46 Results from Initial Marc Finite Element Heat Transfer Analysis Conducted on Test Specimen

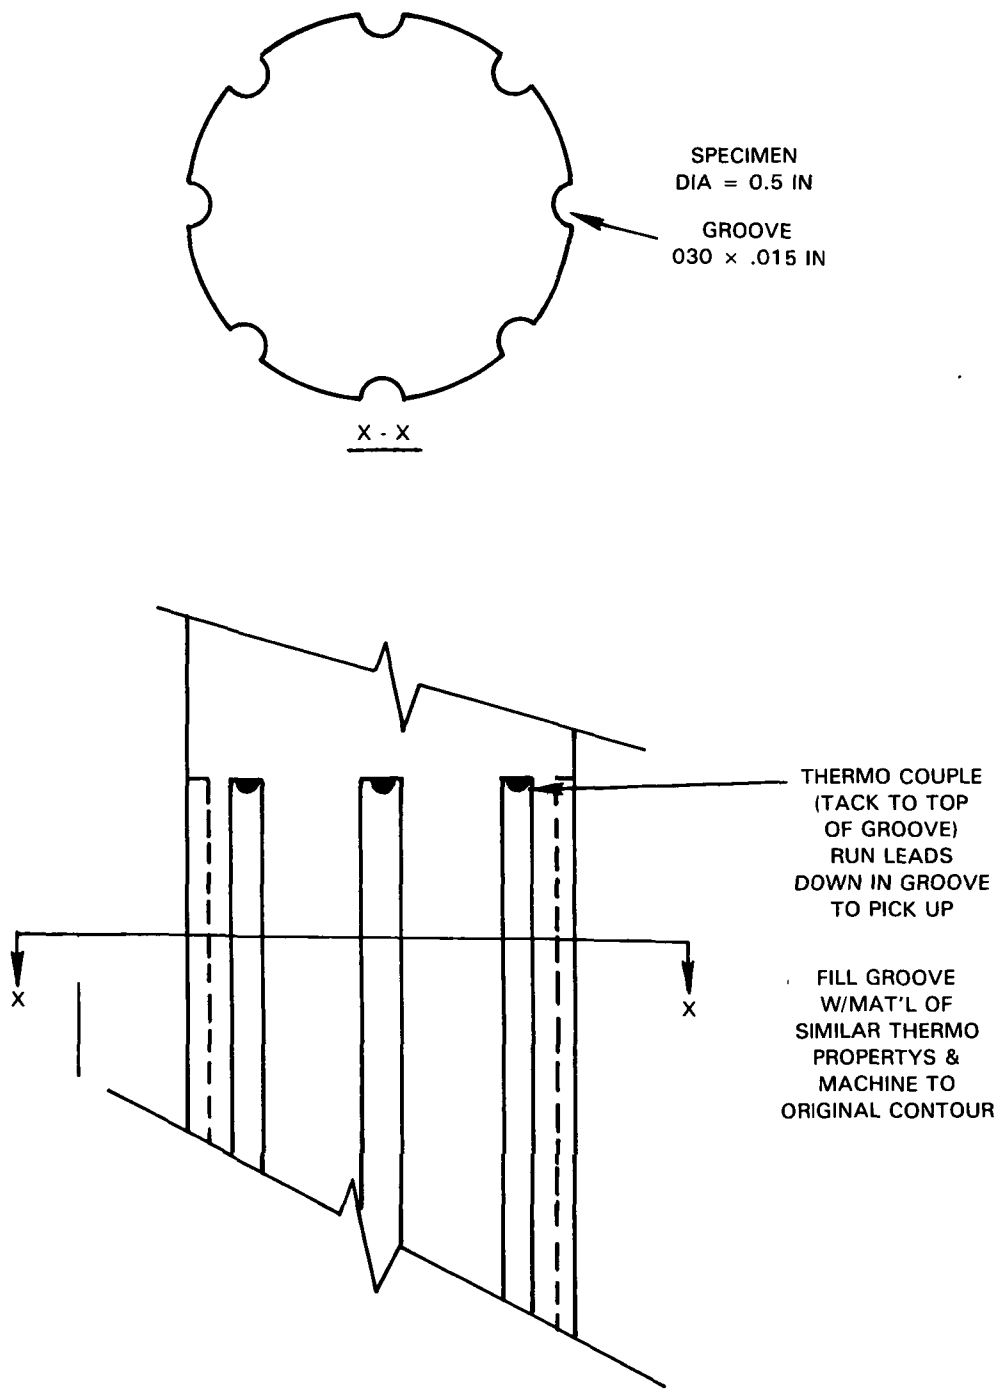
Two specimens were instrumented; one with and one without the ceramic coating layer. The uncoated specimen enabled determination of the surface convective boundary. The same derived convective boundary conditions will be imposed on the coated specimens. The difference in sensor readings will be due to the insulating effect of the ceramic coating. As time and temperature increase, radiation effects occur. This was monitored by having a band of material with known emissivity on the ceramic surface enabling temperatures to be read optically. Once the surface conditions were determined the entire temperature and corresponding thermal stress fields could be established.

Figure 47 Instrumented Test Specimen

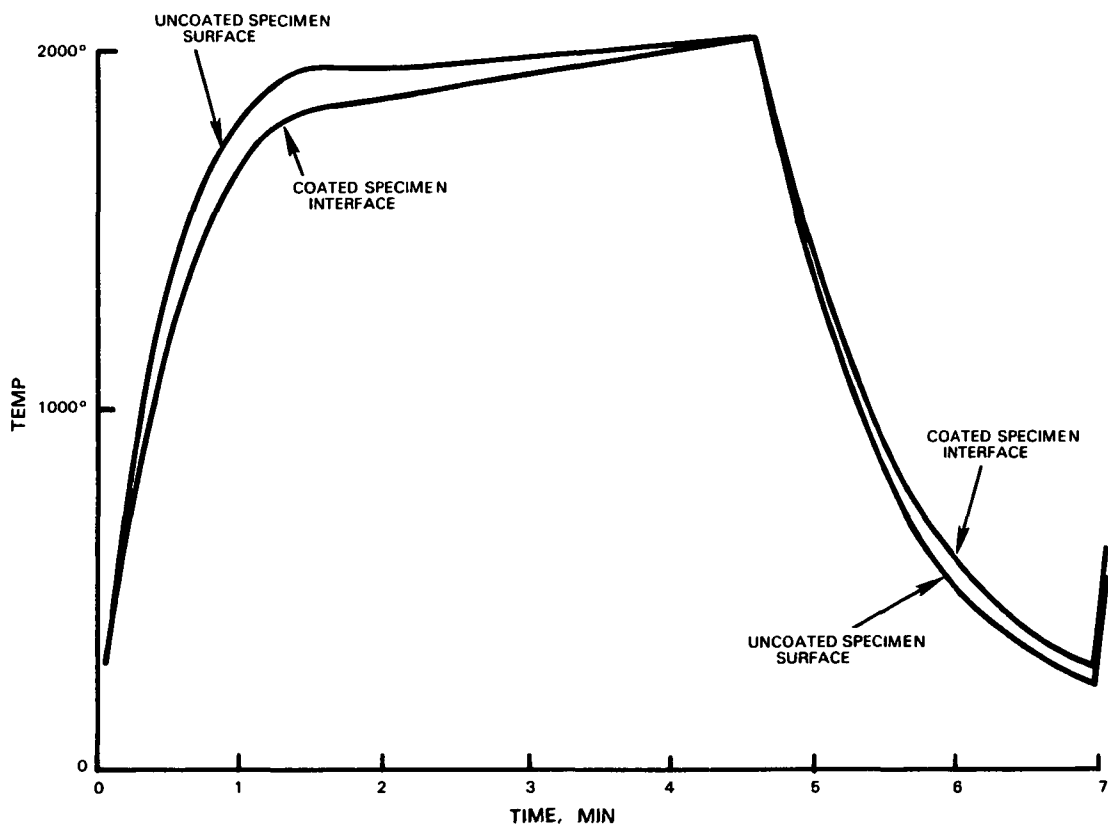
Figure 48 D1 Cycle Thermocouple Data

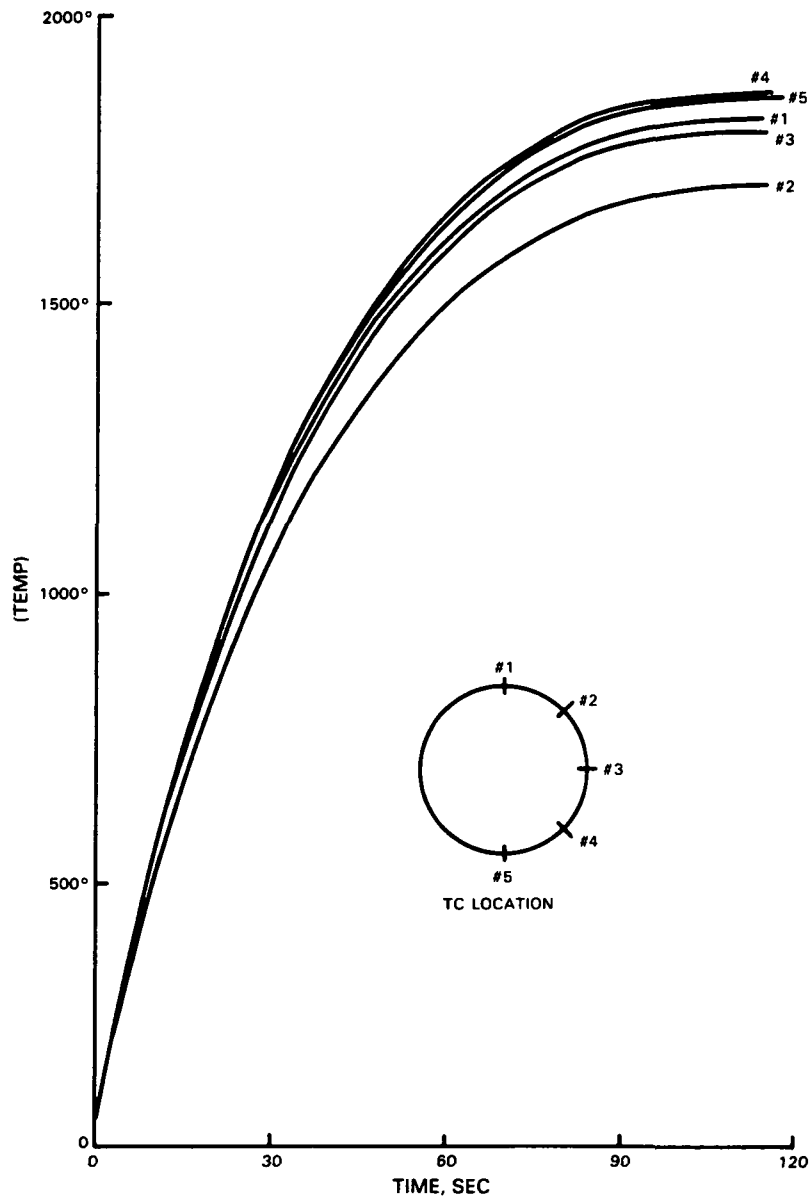
Figure 49 D1 Test, Coated Specimen Temperature at Interface

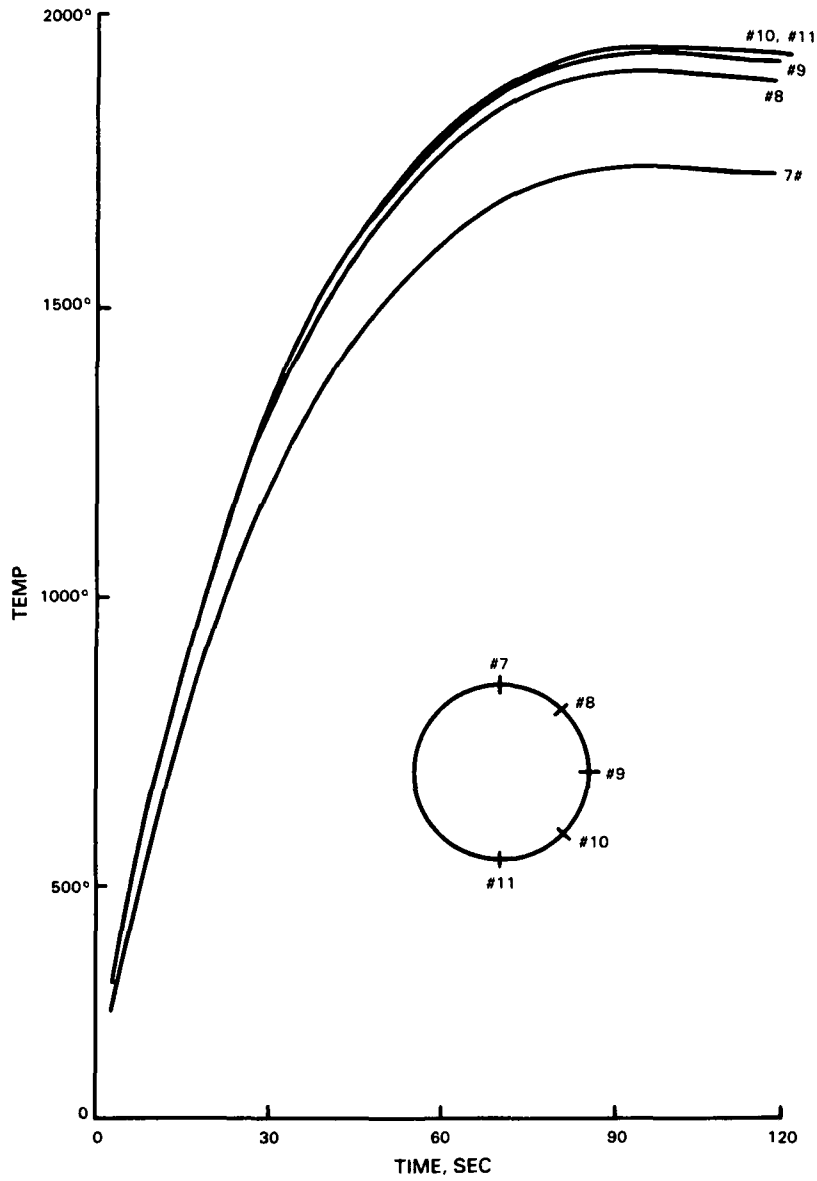
Figure 50 D1 Test, Specimen #2: Uncoated Specimen Surface Temperature

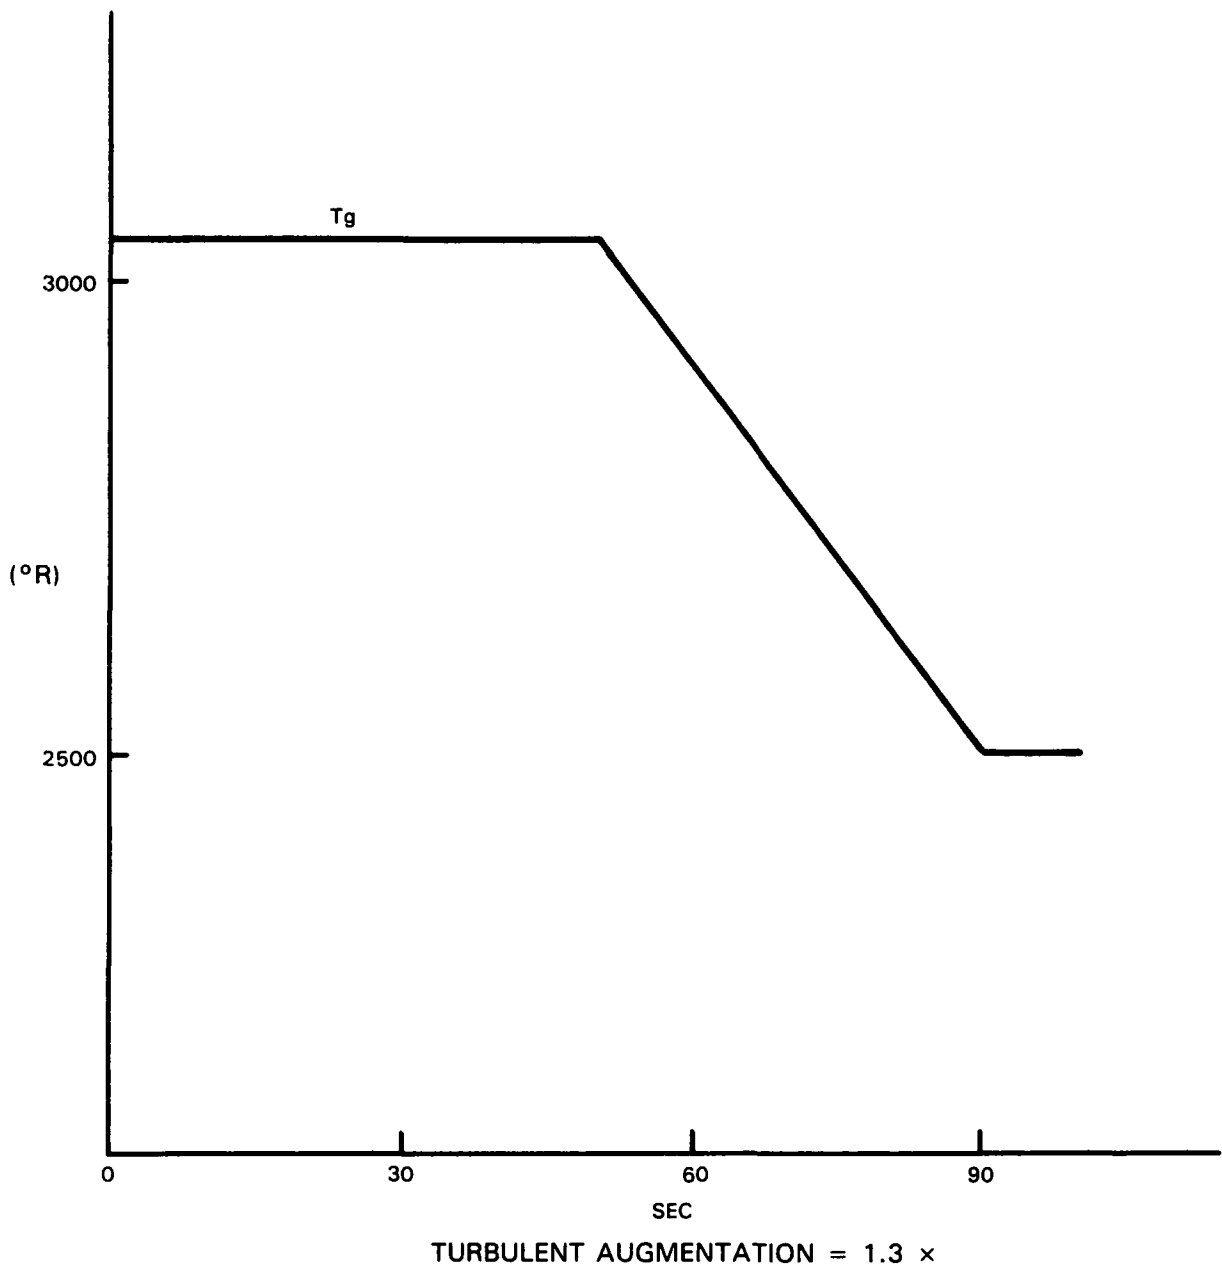
Figure 51 Cyclic Burner Rig Test at 2100°F, Short Cycle, Fast Heatup Rate (Condition D1) Data Match - Boundary Conditions in Marc Analysis

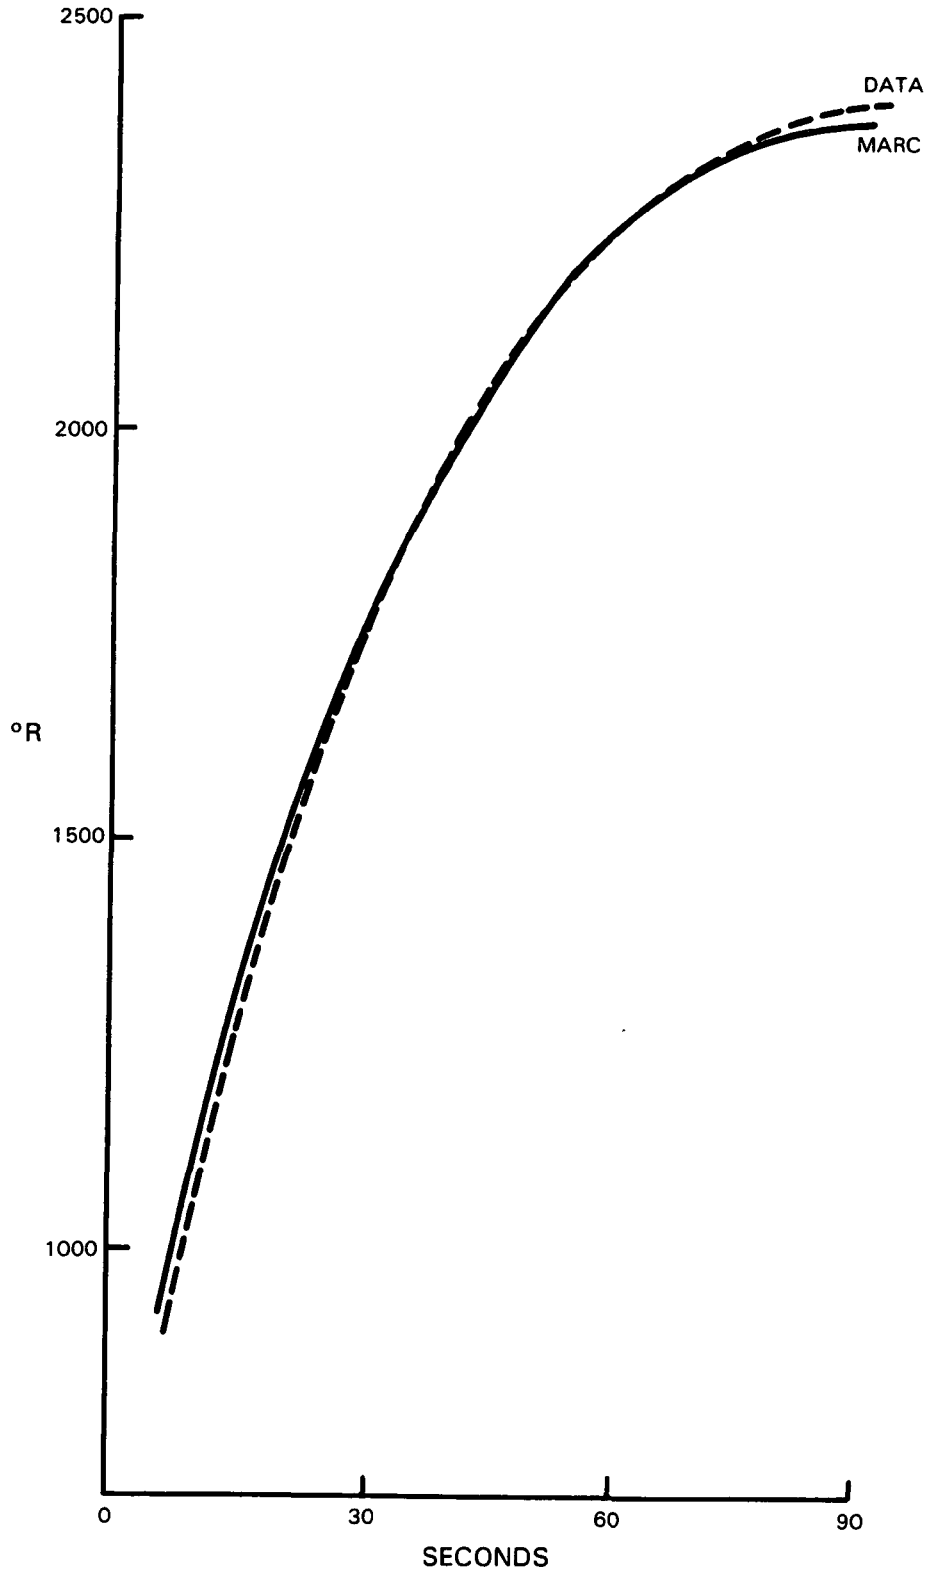
Figure 52 Cyclic Burner Rig Test at 2100°F, Short Cycle, Fast Heatup Rate (Condition D1) Data Match - Uncoated Specimen Surface
