THERMAL BARRIER COATING LIFE PREDICTION MODEL DEVELOPMENT FIRST ANNUAL REPORT

By K.D. Sheffler and J.T. DeMasi

UNITED TECHNOLOGIES CORPORATION
Pratt & Whitney Group
Engineering Division

Prepared for
NATIONAL AERONAUTICS AND SPACE ADMINISTRATION

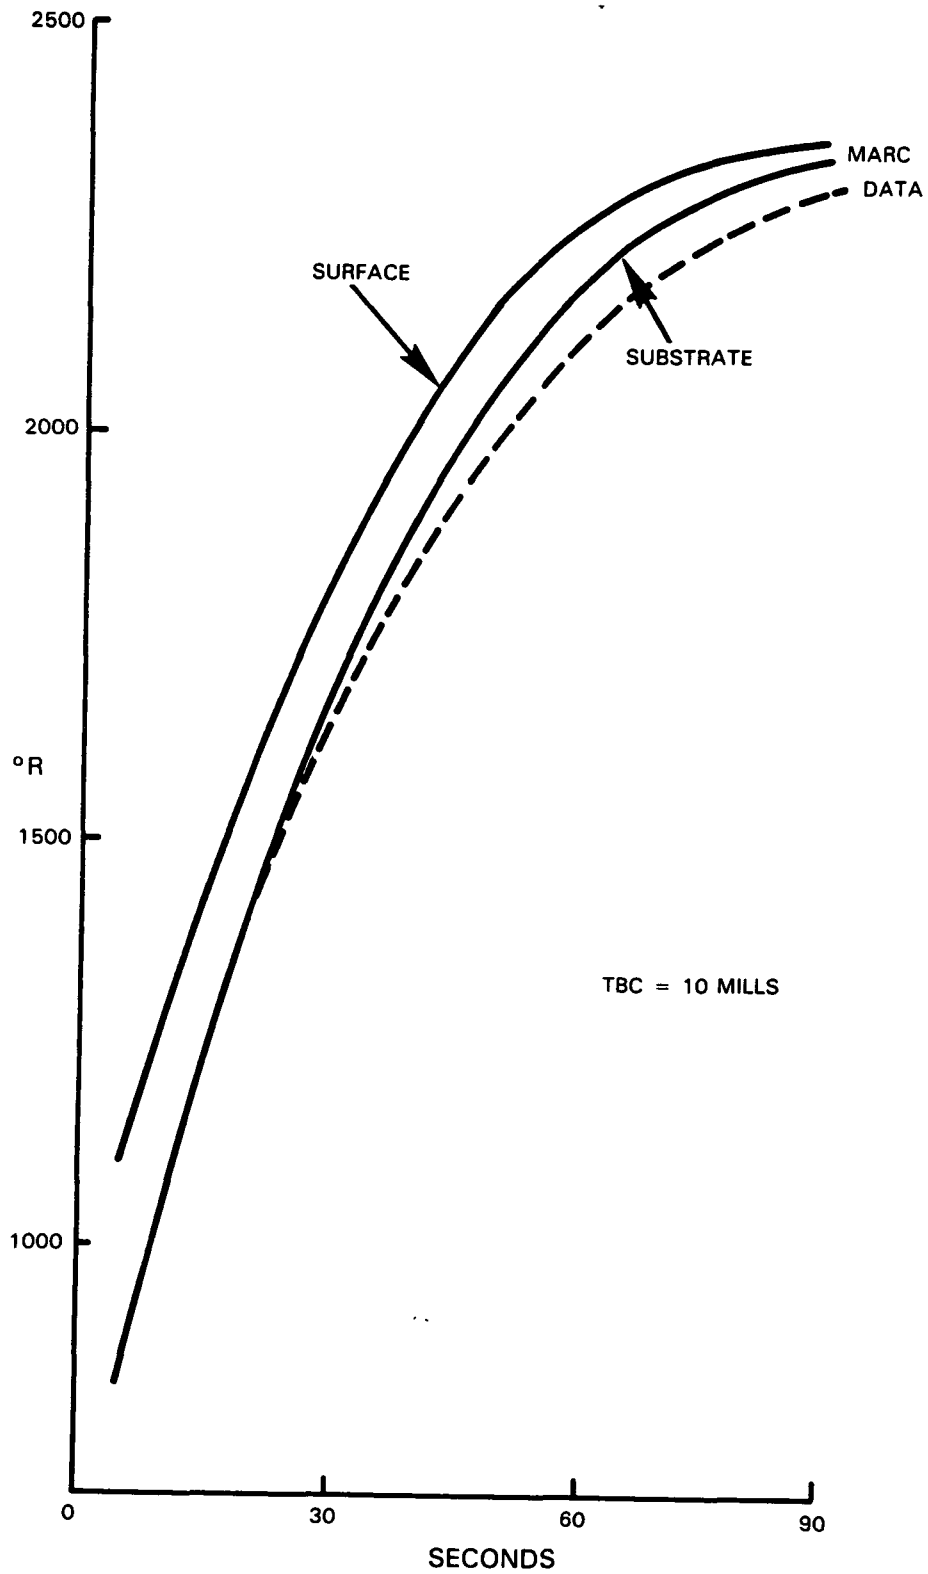
Figure 53 Cyclic Burner Rig Test at 2100°F, Short Cycle, Fast Heatup Rate (Condition D1) Data Match - Coated Specimen

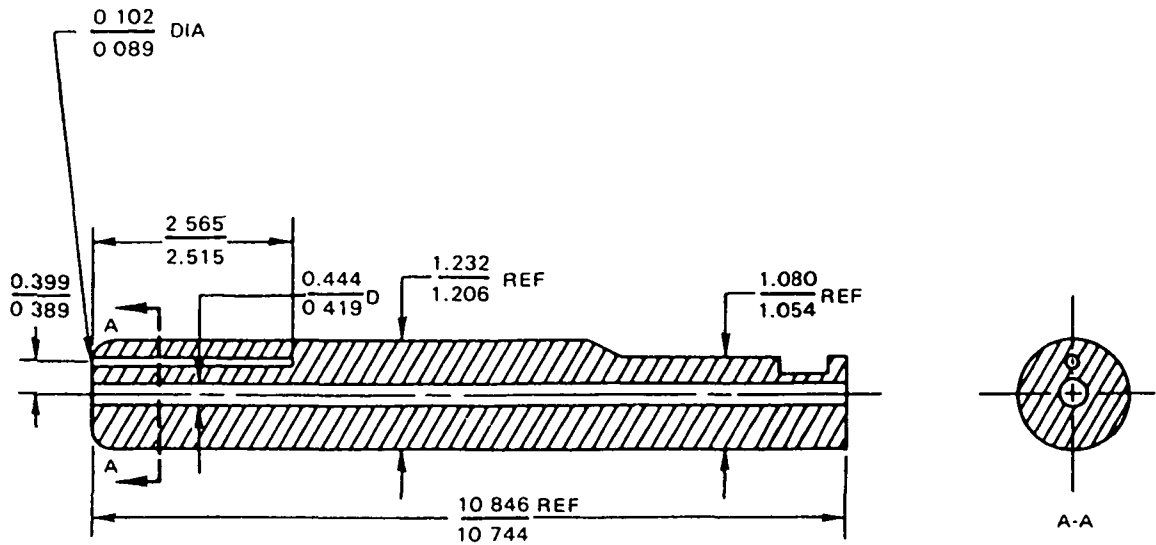
Figure A-1 Diagram of Thermocoupled Specimen Used for Burner Rig Testing. Dimensions are expressed in centimeters.

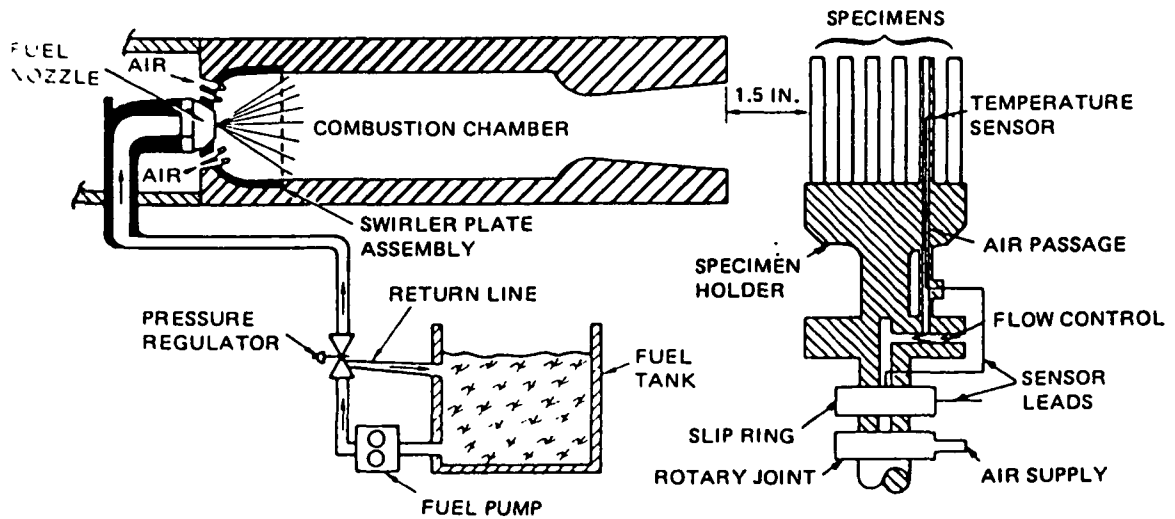
Figure A-2 Schematic Diagram of Cyclic Burner Rig Test Apparatus for Task I

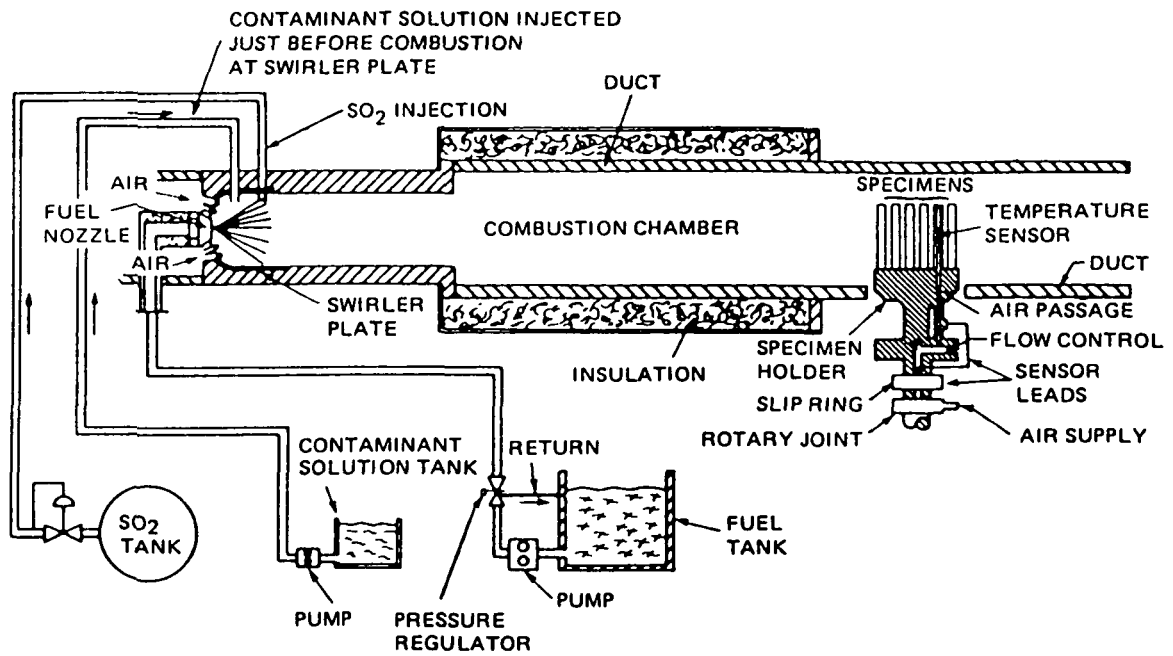
The hot corrosion test conditions used in Task I simulate typical hot corrosion conditions encountered in near ground aircraft engine operation. Selection of the 899°C (1650°F) ceramic surface temperature were based on conditions that exist where major salt loading from atmosphere contamination occurs. The test cycle was the same as that used for cyclic oxidation testing, i.e., 57 minutes in the flame and three minutes for air cooling.

Figure B-1 Schematic Diagram of Ducted Burner Rig Test Apparatus for Task I Hot Corrosion Exposure. Test specimens are enclosed to allow precise control of SO_3 and other contaminants.
