NASA Technical Memorandum 87604

THE EFFECT OF RESIN TOUGHNESS AND MODULUS ON COMPRESSIVE FAILURE MODES OF QUASI-ISOTROPIC GRAPHITE/EPOXY LAMINATES

MOHSEN M. SOHI, H. THOMAS HAHN, AND JERRY G. WILLIAMS

MARCH 1986

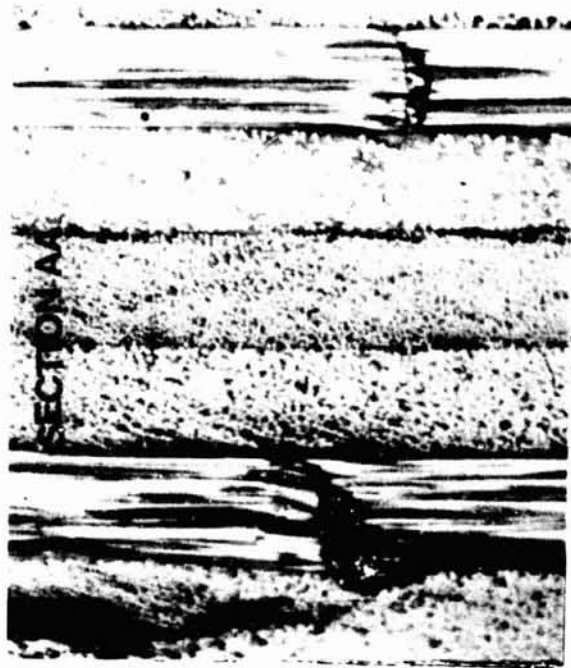
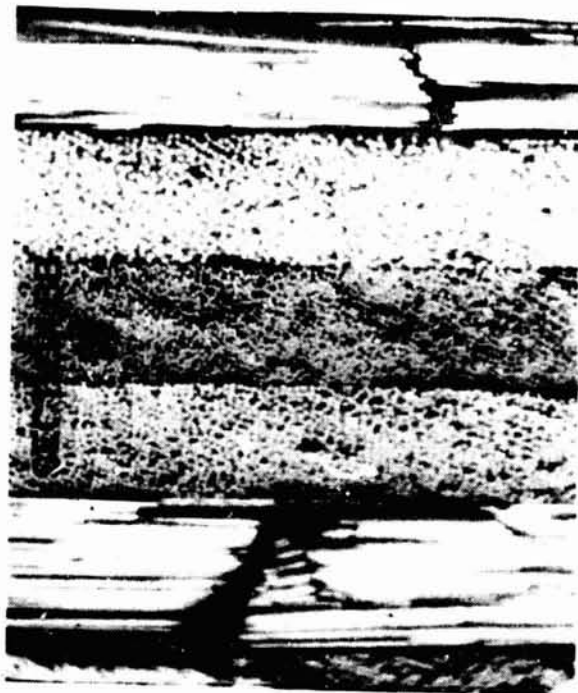
Figure 11. Partial failures in notched T300/4901/mpDA and T700/4901/MDA specimens;
 $d/w = 0.125$.

A combination of fiber kinking in 0-degree plies and delamination was also observed in laminates made with 4901/MDA and 4901/MPDA resins. Similar to the T300/5208 laminate, failure was initiated in the outer 0-degree plies, Figure 11. In these laminates, however, the kink band had propagated farther through the width of the ply when the test was stopped. It was therefore difficult to assess whether these laminates were any more tolerant of the initial damage than was the T300/5208 laminate.

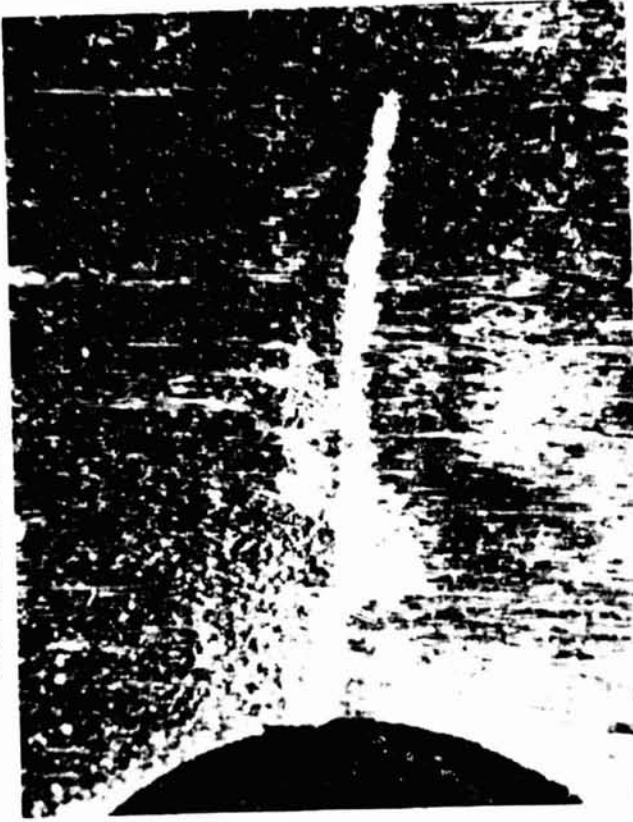
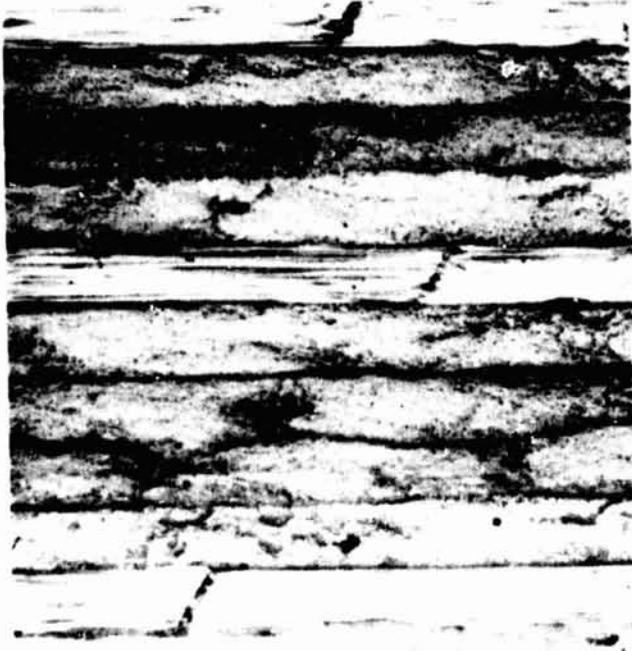
Figure 12. Partial failure in a notched T700/BP907 specimen; $d/w = 0.250$.

In laminates made with the BP907 resin, the kink band propagated some distance away from the hole before causing any delamination. Figure 12 shows partial damage in a T700/BP907 specimen. Although all the 0-degree

plies have failed, no delamination is present. Since the kink band shown in Figure 12 traveled more than one-fourth of the net specimen width on each side of the hole, it can be deduced that delamination was delayed up to an advanced stage of failure. Therefore, laminates made with the BP907 resin fail when most 0-degree plies fail completely accompanied by very little delamination.

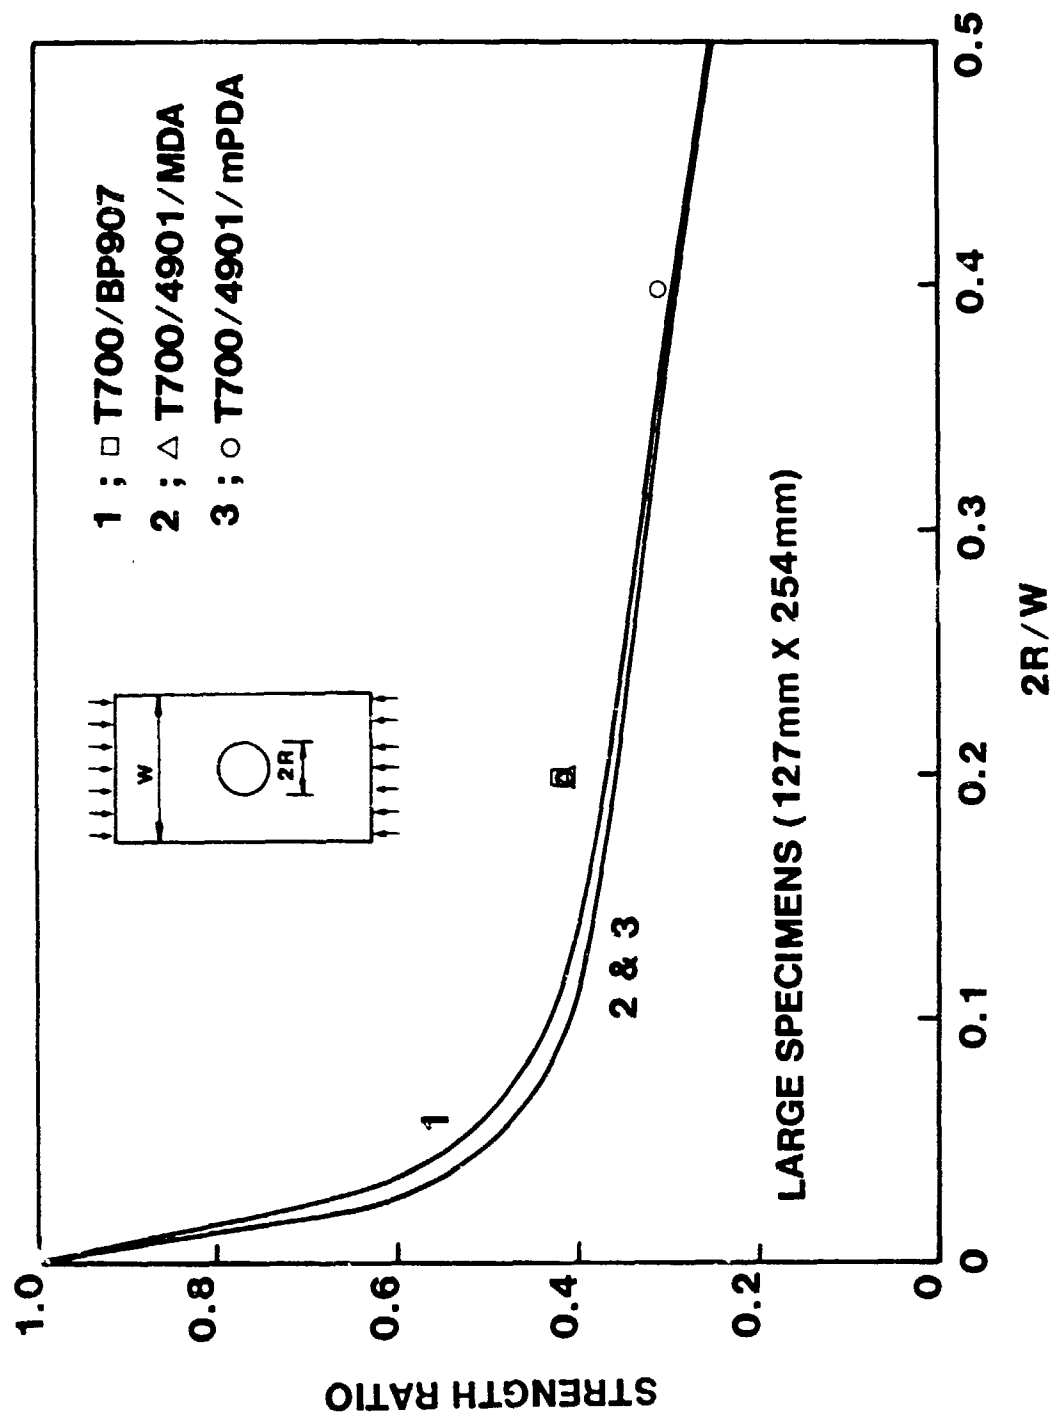
Figure 17. Change of unnotched-to-notched strength ratio with normalized hole diameter: T700 laminates 127 mm wide by 254 mm long.

With d_0 experimentally determined, the change of strength ratio σ_N/σ_0 with normalized hole diameter $2R/W$ as calculated by Equations 1 through 4 is shown together with the experimental data for each laminate in Figures 14 and 15. The experimental data for $[45/0/-45/90]_{6S}$ specimens 127 mm wide and 254 mm long are shown in Figures 16 and 17. Also shown in the latter figures are the predictions for the large specimens using the d_0 values obtained from the small specimens. The agreement between the experimental results and the predictions is quite reasonable.
