NASA Technical Memorandum 87133

The Mechanism of Erosion of Metallic Materials Under Cavitation Attack

Prepared for the
International Symposium on Cavitation
sponsored by JSME/ASME/IME(UK)/JSCE/IAHR
Sendai, Japan, April 16-19, 1986

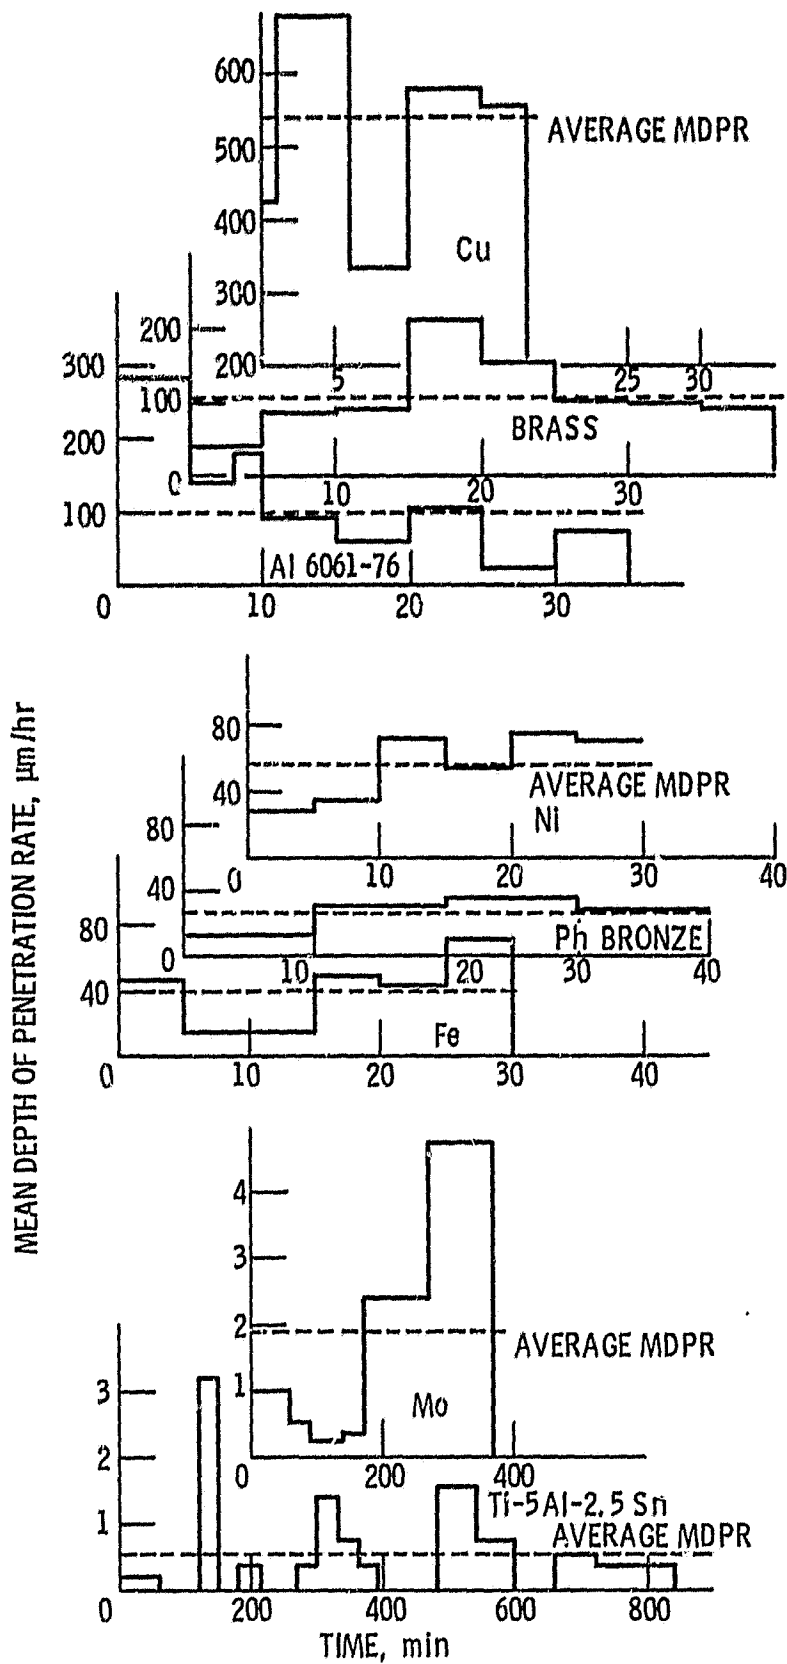
Figure 1. - Variations of MDPR with time.

The erosion of materials is expressed as the mean depth of penetration, MDP from the surface. The MDP is computed from the weight loss measurements, the surface area and density. The mean depth of penetration rate MDPR is the average rate of erosion during a given interval. The variations of MDPR of the different polycrystalline materials are shown in figure 1. The average MDPR of Al 6061-T6, brass and copper are 99.6, 107 and 542 $\mu\text{m/hr}$ respectively. The average MDPR of iron, bronze and nickel are 39.2, 26.4 and 56.1 $\mu\text{m/hr}$. Similarly, the average MDPR of titanium and molybdenum are 0.5 and 1.8 $\mu\text{m/hr}$. It may be seen that the average MDPR of the different materials varies over three orders of magnitude. The titanium alloy has the lowest average MDPR while copper has the highest. The MDP on titanium after 1800 min (30 hr) exposure to cavitation attack was only 15 μm while on copper it was 163 μm after an exposure of just 18 min.

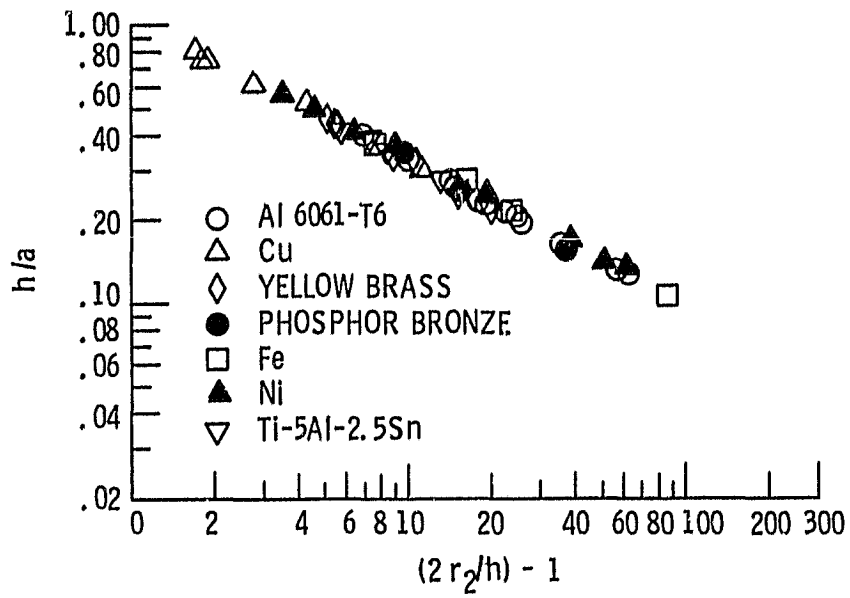
Figure 2. - Variation of the ratio h/a with $(2r_2/h) - 1$.

Figure 2 presents a plot of h/a against $(2r/h) - 1$ for the different materials. The values of h/a vary from 0.10 to 0.8 and in general increase with cavitation attack. It is not clear at this time whether the range of these values is controlled by parameters like grain size, strength properties, crystal structure, etc. Previous measurements of pit size for cavitation erosion in water by Robinson and Hammitt (ref. 26) indicated the ratio h/a to be 0.20. Stinebring et al. (ref. 27) determined the minimum and maximum values of h/a to be 0.068 and 0.332 respectively in their experiments in water.

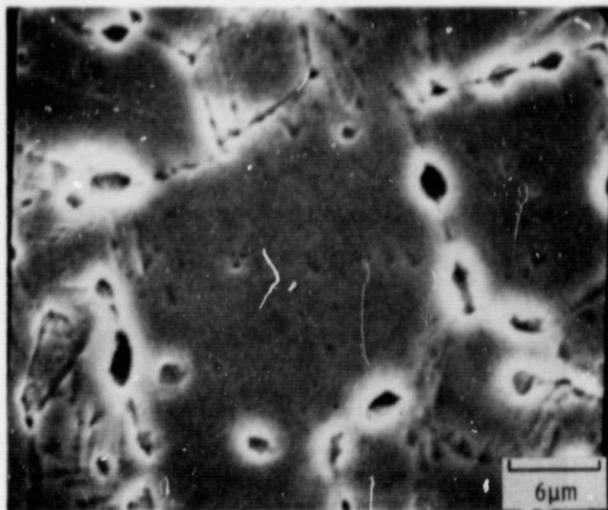
(a) $t = 10$ s, showing grain boundary attack.

Figure 3. - Scanning electron micrographs of cavitation attack on brass surface.

To understand the mechanism of deformation and formation of pits during cavitation attack, scanning electron microscopic observations are carried out at different intervals. Figures 3(a) to (c) present three typical micrographs of polycrystalline brass. After a cavitation attack for 10 s, figure 3(a) tiny pits are observed over grain boundaries. The grain boundary voids and softer lead precipitates appear to be favorable spots for early pit formation (ref. 20). With continued cavitation attack, the pits at the junction of three or more grain boundaries, figure 3(b) grow by erosion of the adjoining grains. During the early cavitation attack, considerable plastic deformation of grains through slip and twinning is noticed (ref. 20). Figure 3(c) shows a typical pit formation over a grain surface. The pits on grain surfaces appear to be dependent on the orientation of the individual grains. This aspect is clearly seen in the micrographs of pits on single crystals presented in the next paragraph.

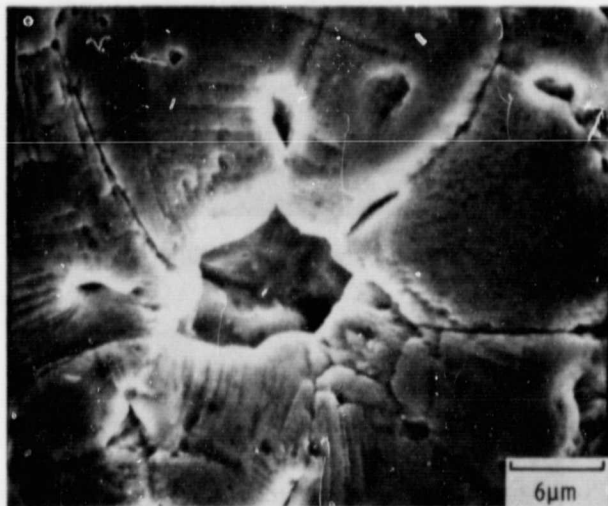
(b) $t = 50$ s, showing growth of pits at the junction of grain boundaries.

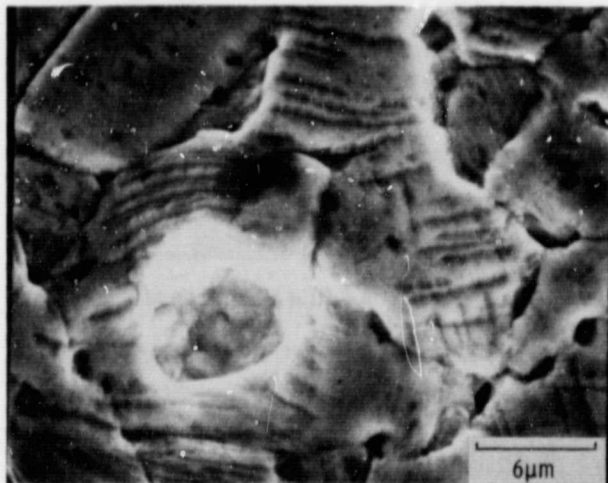
(c) $t = 50$ s, showing pit formation over a grain surface.

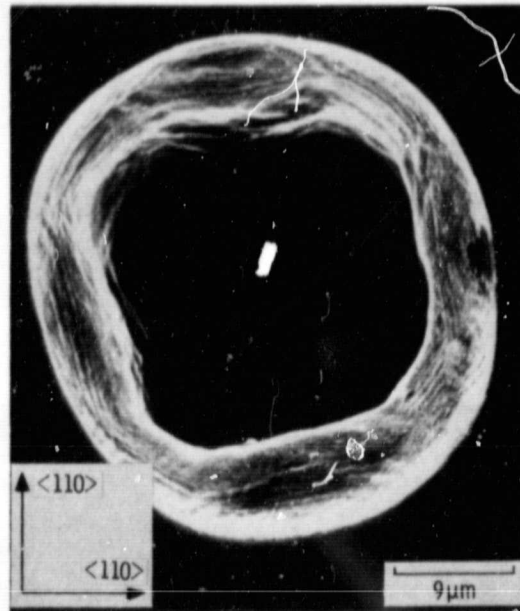
(a) $t=15$ min, A typical pit on (001) face.

Figure 4. - Scanning electron micrographs of
cavitation attack on α -brass single crystals.

Figures 4(a) and (b) present two micrographs of pits on α -brass single crystals of two orientations. The pits on crystal with (001) face exposed to cavitation are squares with rounded edges, figure 4(a) while the pits on crystal with (110) face exposed to cavitation are elongated in 110 direction, figure 4(b). Measurements of the variations of weight loss with test time of the two single crystals exposed to cavitation attack showed that crystal B with (110) face exposed to cavitation erodes faster than crystal A with (001) face exposed to cavitation. Measurements of surface roughness also showed that the pits in the case of crystal B are deeper and more closely spaced than those on crystal A.

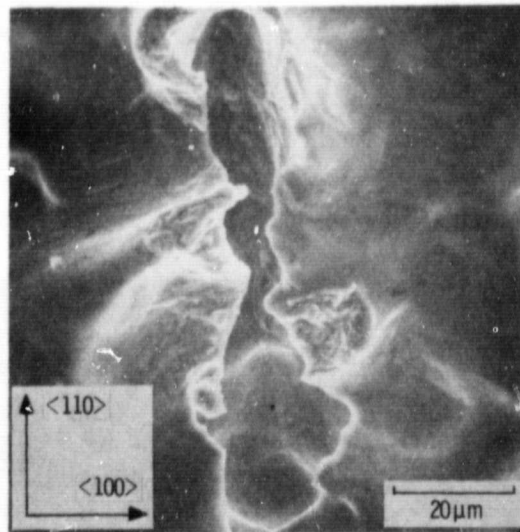
(b) $t=90$ min, A typical pit on (110) face.

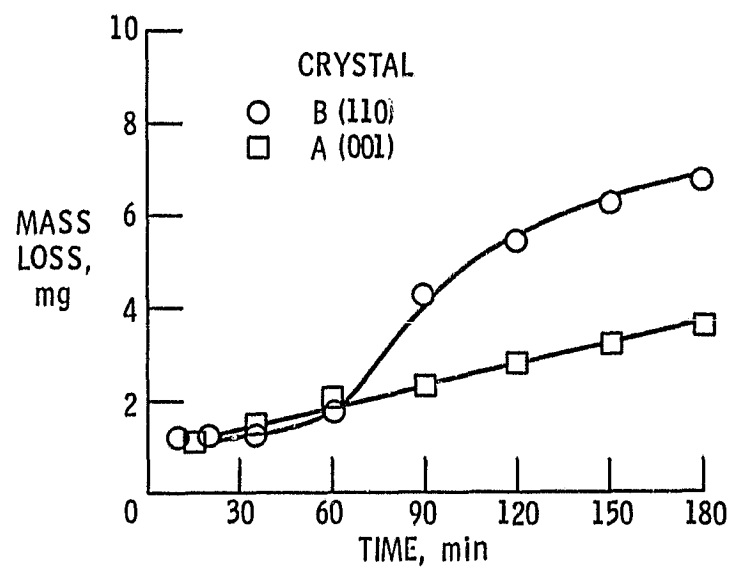
Figure 5. - Variation of weight loss with time-single crystals.
