WASHINGTON UNIVERSITY
DEPARTMENT OF PHYSICS
LABORATORY FOR ULTRASONICS
St. Louis, Missouri 63130

"Quantitative Non-Destructive Evaluation of Composite Materials Based on Ultrasonic Wave Propagation"

Semiannual Progress Report: March 15, 1985 - September 15, 1985

NASA Grant Number: NSG-1601

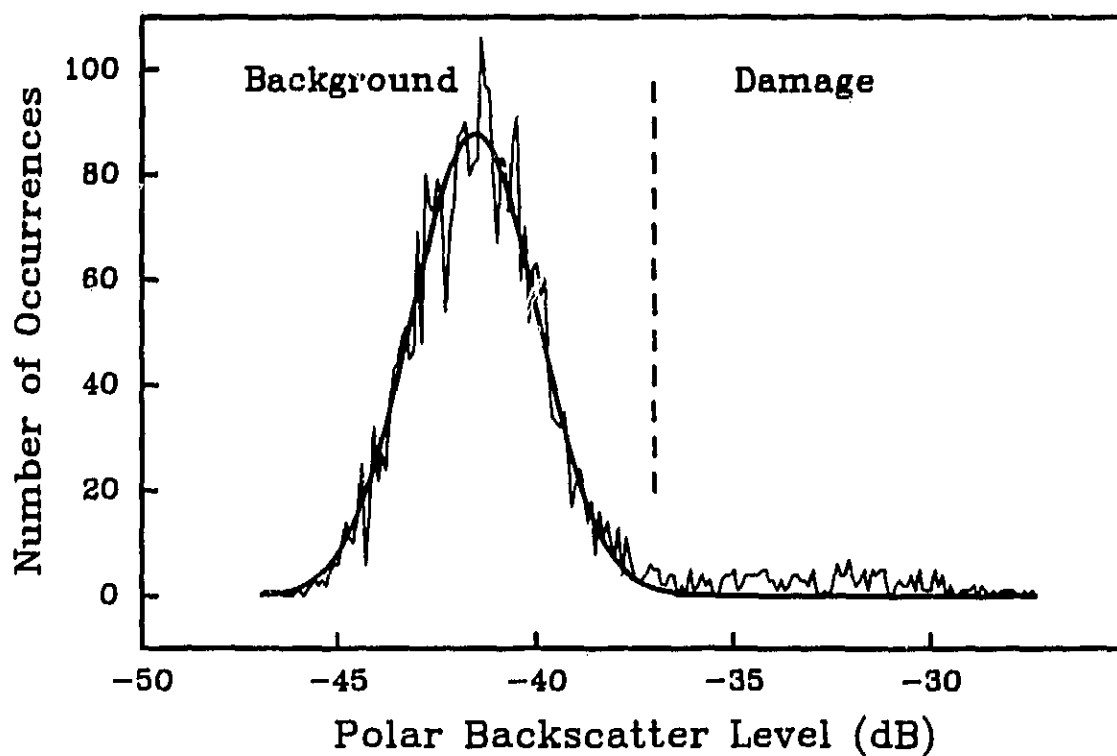
Figure 2 - Histogram of the quantitative backscatter values from the polar backscatter scan presented in Figure 1. The bin size was 0.1 dB. The heavy smooth line represents a normal distribution fit to the background.

regions. We chose to approximate this background by a normal distribution, which was determined by least-squares techniques. The smooth dark line in Figure 2 was generated from the least-squares parameters of the background distribution. An estimate of the area of damage was obtained by integrating the high scattering "tail" of the histogram and subtracting off the integral of the background distribution calculated over the same range of backscatter.
