TECHNICAL NOTE

Contract NAS8-32982 **Date** 11 October 1982 **Doc.** LMSC-HREC TN D867581

Title EVALUATION OF SRB PHENOLIC TPS MATERIAL MADE BY AN ALTERNATE VENDOR

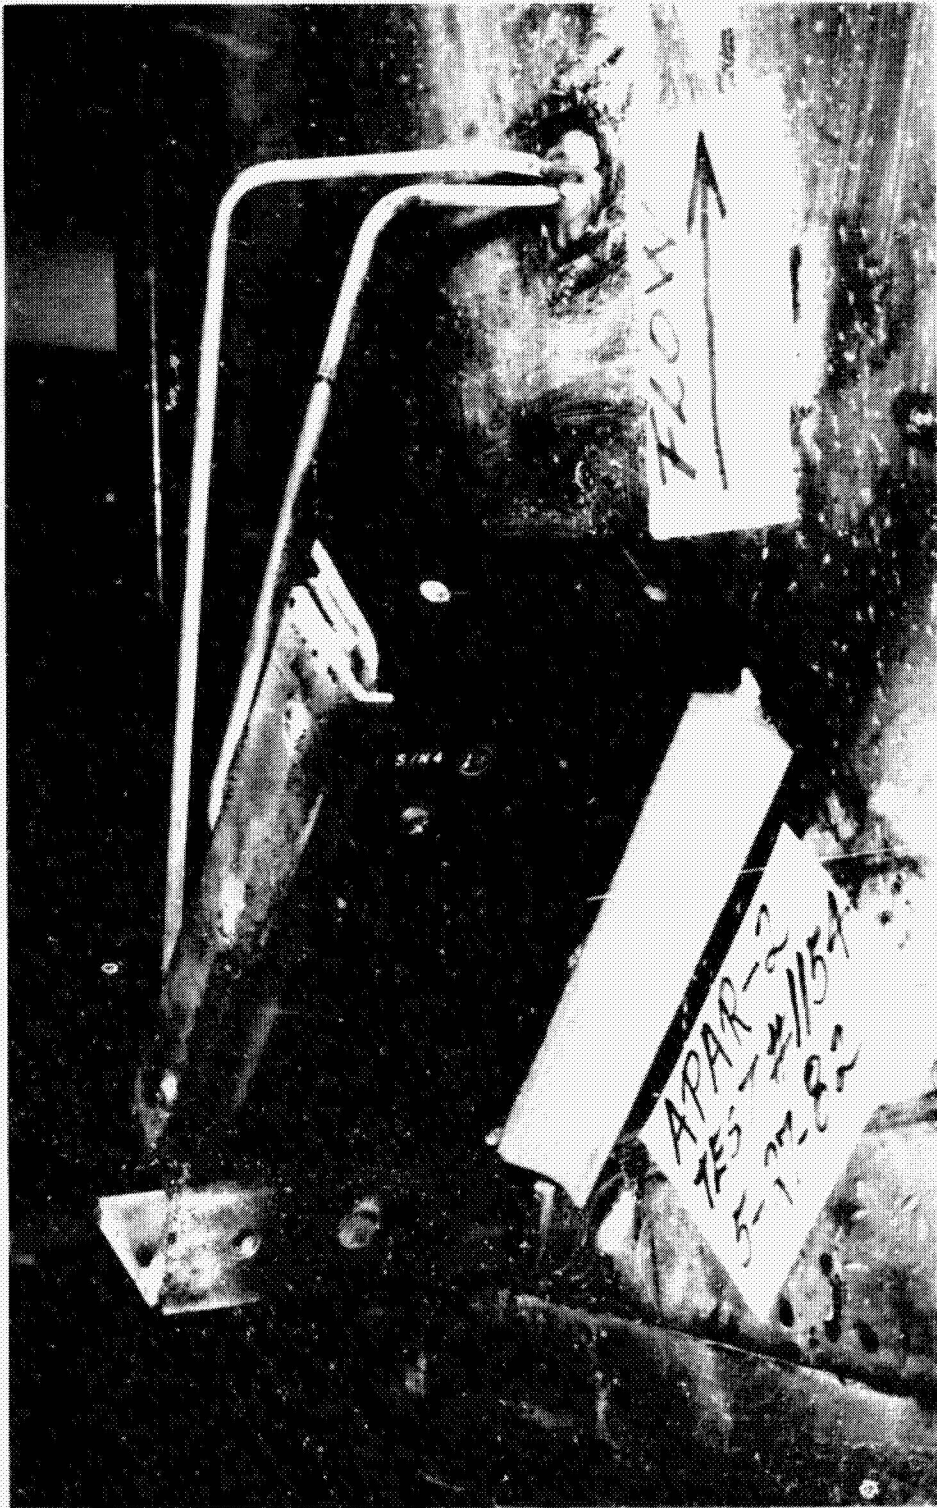
Fig. 10 - Model Setup for a Repeat Test of Attach Ring Shown in Fig. 6

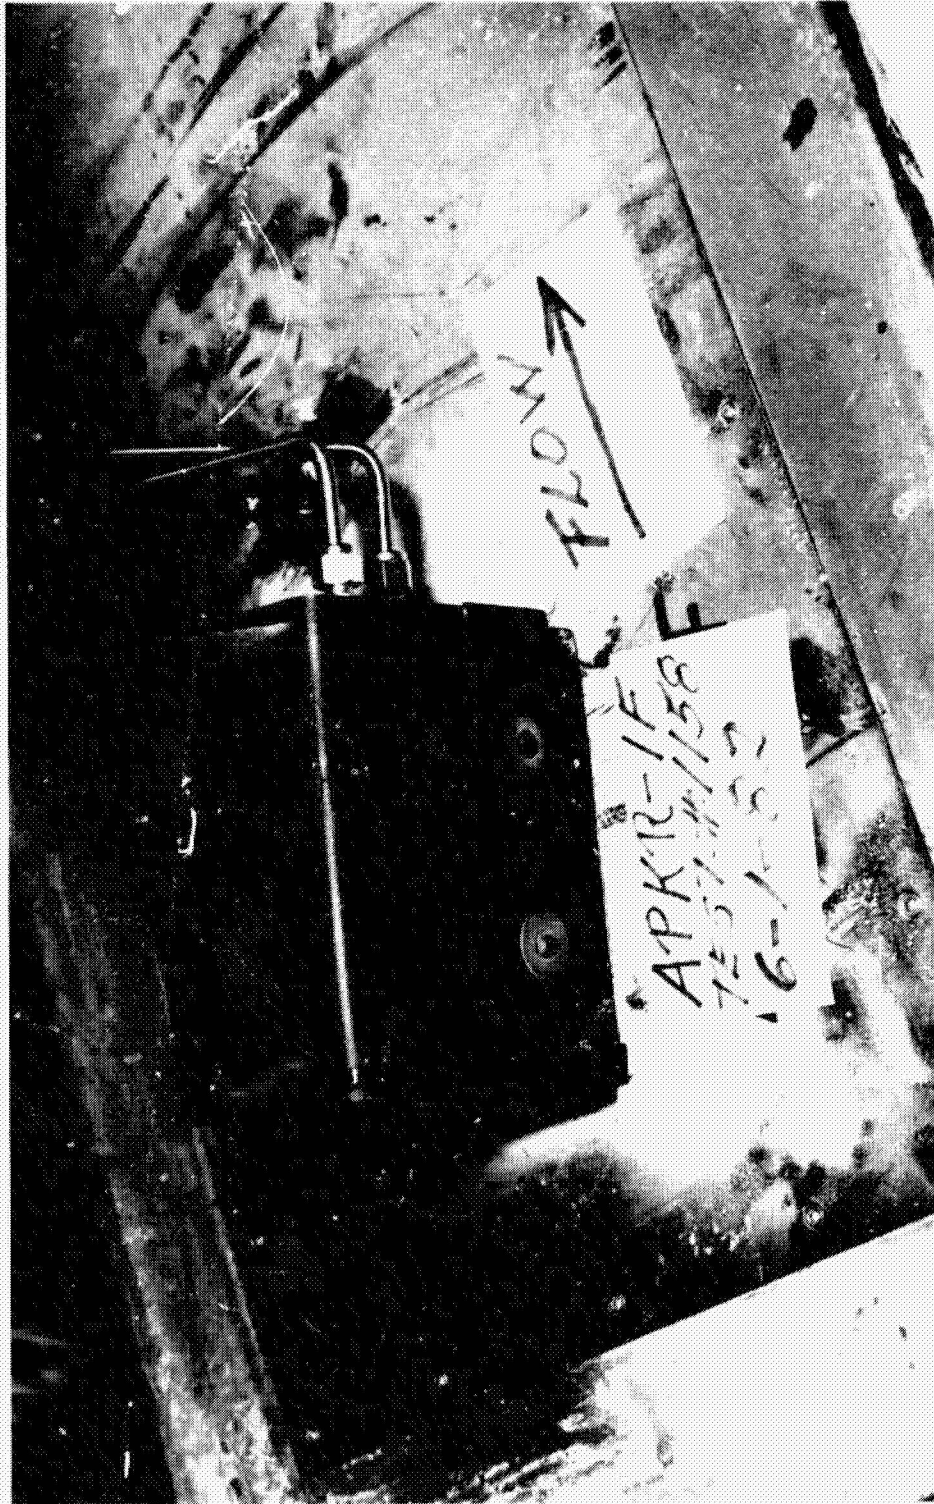
Fig. 14 - Pretest Photograph of Alternate Phenolic Fwd Face Model (The lower Z-section phenolic part made of old Edler material. The other face of this model was previously tested - see Fig. 8)

Figures 1 and 2 show the thin skin calibration models of the forward and aft face of the kick ring. A photograph of the attach ring calibration model is not available. Three 5-sec runs were made in the Hot Gas Facility for repeatability on each of the three models. The average cold-wall heating rates deduced from the temperature-time slopes of the responses measured by the thermocouples are shown in Figs. 3 through 5. The test samples were cut from a longer flight configuration section in case of the kick ring and from a channel shaped section of the alternate phenolic supplied by the new vendor. The models were completed using the old "Edler" small grey seal as seen in the pre- and post-test photographs of the test models in Figs. 6 through 17. The seal was lost in one attach ring test and eroded considerably in the other repeat test. However, the phenolic TPS performed excellent in all tests. In the case of the kick ring, the rear face was tested first and the same TPS was reconfigured for testing on the other face. When testing the forward face of the kick ring, the Z-section phenolic part used on the lower side of the face was from a previous, old "Edler" consignment of parts. It is seen to have lost layers in contrast to the new alternate phenolic TPS (see Figs. 14 through 17).
