# Flutter Clearance of the Schweizer 1-36 Deep-Stall Sailplane

Michael W. Kehoe and Joseph F. Ellison

(NASA-TM-85917) FLUTTER CLEARANCE OF THE  
SCHWEIZER 1-36 DEEP-STALL SAILPLANE (NASA)  
78 p HC A05/MF A01  
CSCL 01C

August 1985

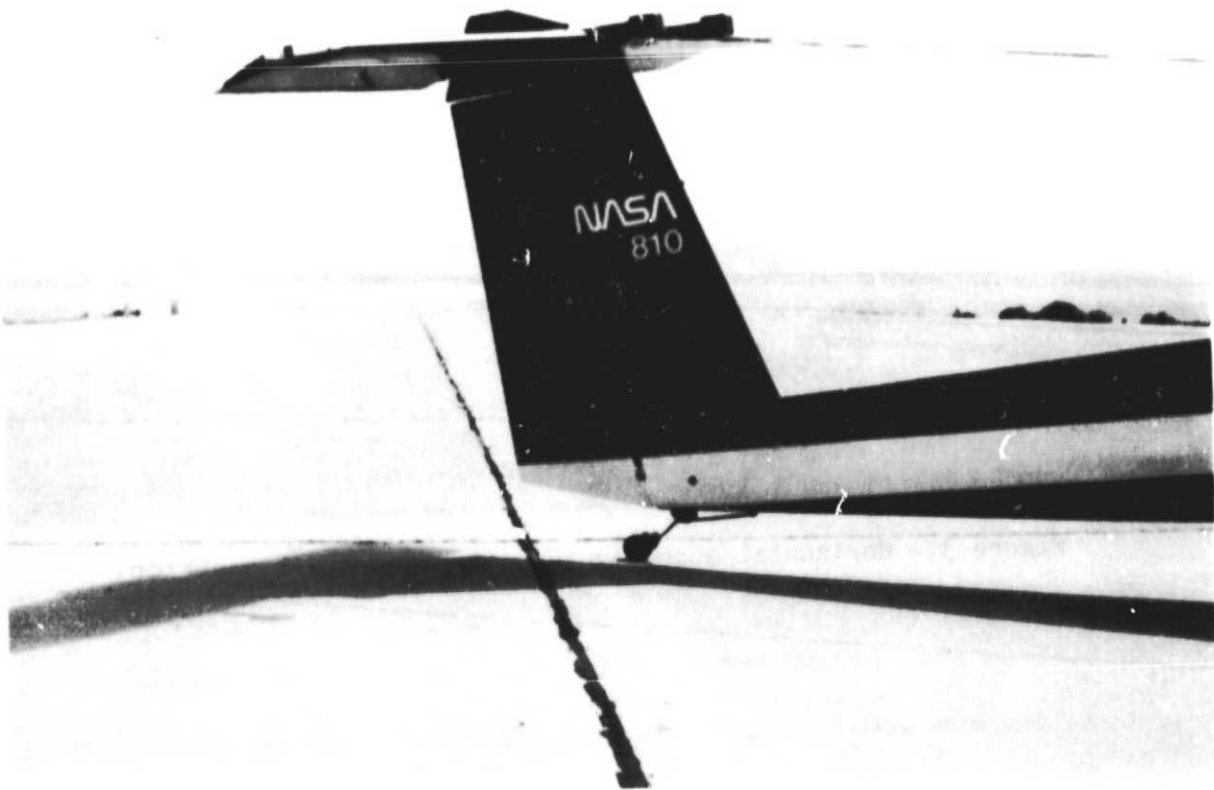
Figure 2.- Horizontal stabilizer in the normal flight position.

The Schweizer 1-36 sailplane (fig. 1) is a single-place, all-aluminum sailplane, except for the rudder, which is covered with fabric. The wing has a span of approximately 14 m (46 ft) and the fuselage length is approximately 6.4 m (21 ft). The horizontal stabilizer is a T-tail configuration with a span of 2.4 m (7.9 ft). The elevator is connected to the stick through a cable and pulley arrangement. The horizontal stabilizer in its normal flight position is shown in figure 2.

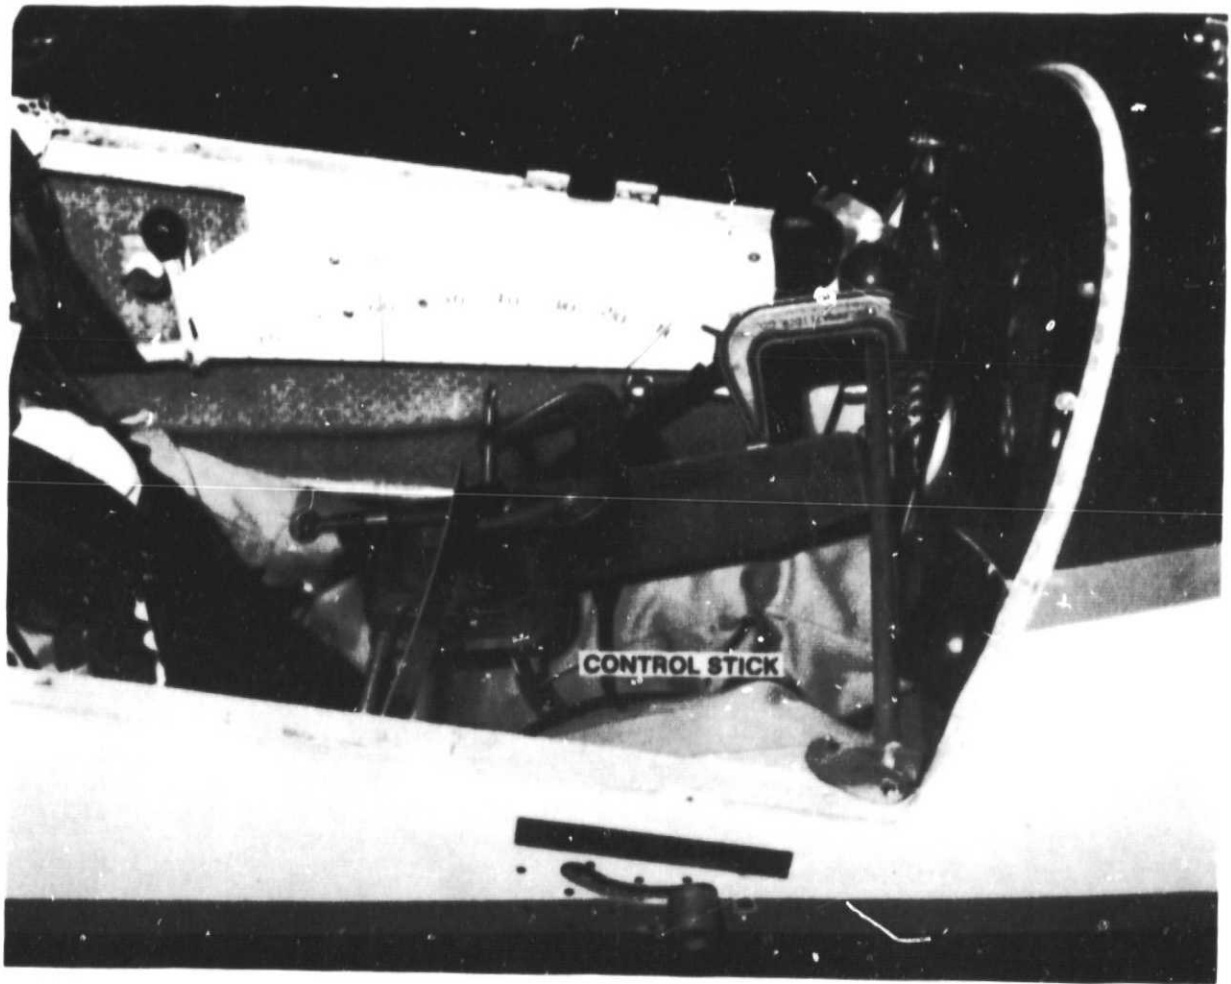
Figure 9.- Control stick locking mechanism.

The control stick was fixed in the cockpit by an arrangement of sheet metal and C-clamps as shown in figure 9. The rudder was fixed by clamping the rudder cables with C-clamps in the cockpit (fig. 10).

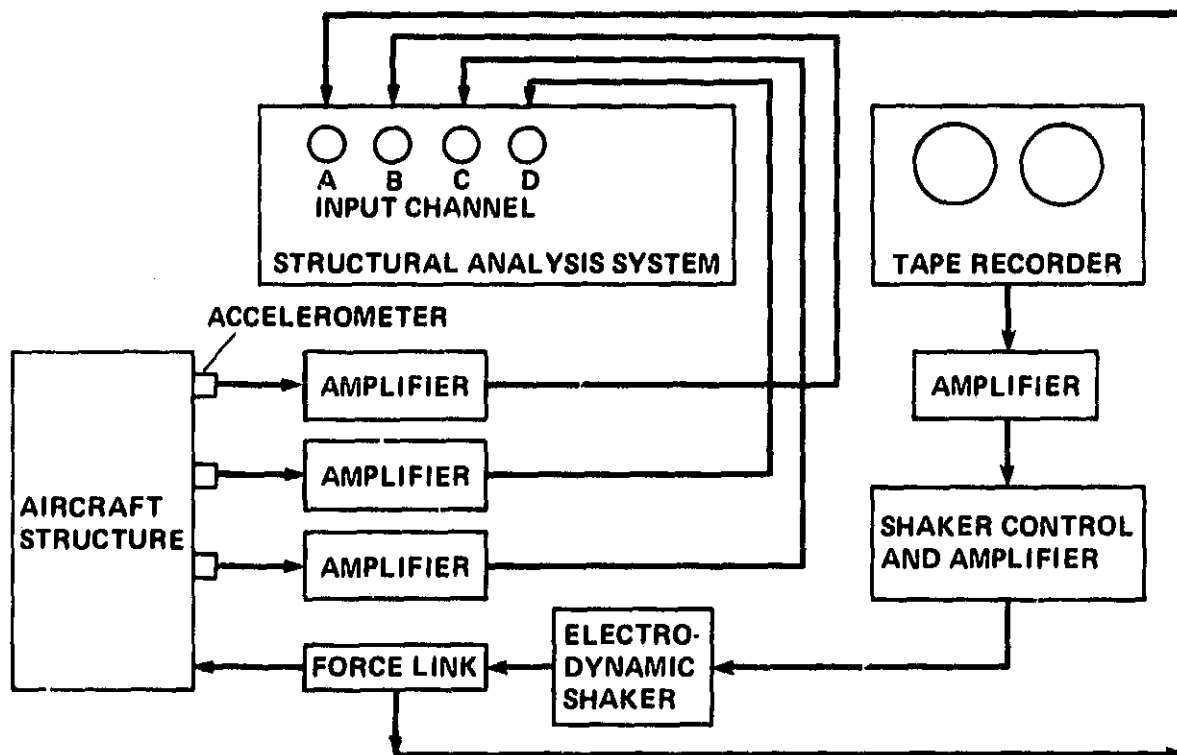
Figure 14.- Ground vibration test equipment diagram.

Excitation- The minicomputer system was capable of generating a sinusoidal or a random forcing function of a bandwidth and amplitude specified by the user. After computer generation of the random forcing spectrum, a tape recorder was used to record the input force time history. This signal was then played back through an electrodynamic shaker attached to the sailplane. A schematic of the setup is shown in figure 14.

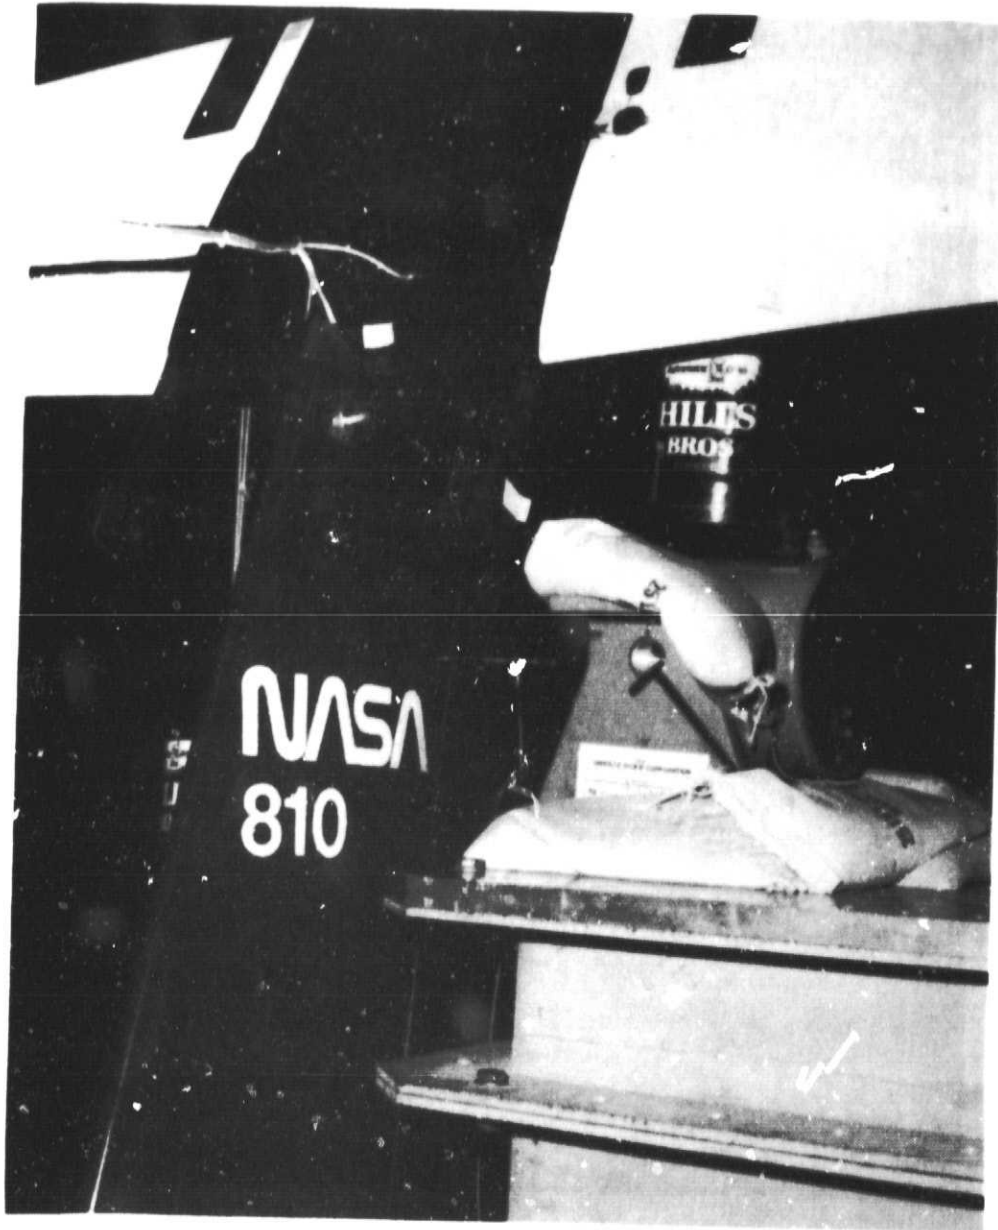
Figure 16.- Vertical fin shaker location.

A single shaker was placed at three different locations: vertically on the left aft wing tip (fig. 15), laterally on the vertical fin (fig. 16), and vertically on the aft fuselage (fig. 17). Each shaker was attached to the sailplane by means of a metal rod, a mechanical fuse, and a force link. The force link attached to a locking ball nut joint, which was mounted to the structure by a threaded stud. These components are shown in figure 15. The total weight of the shaker armature, attachment linkage, and force transducer was 0.4 kg (0.88-lb).

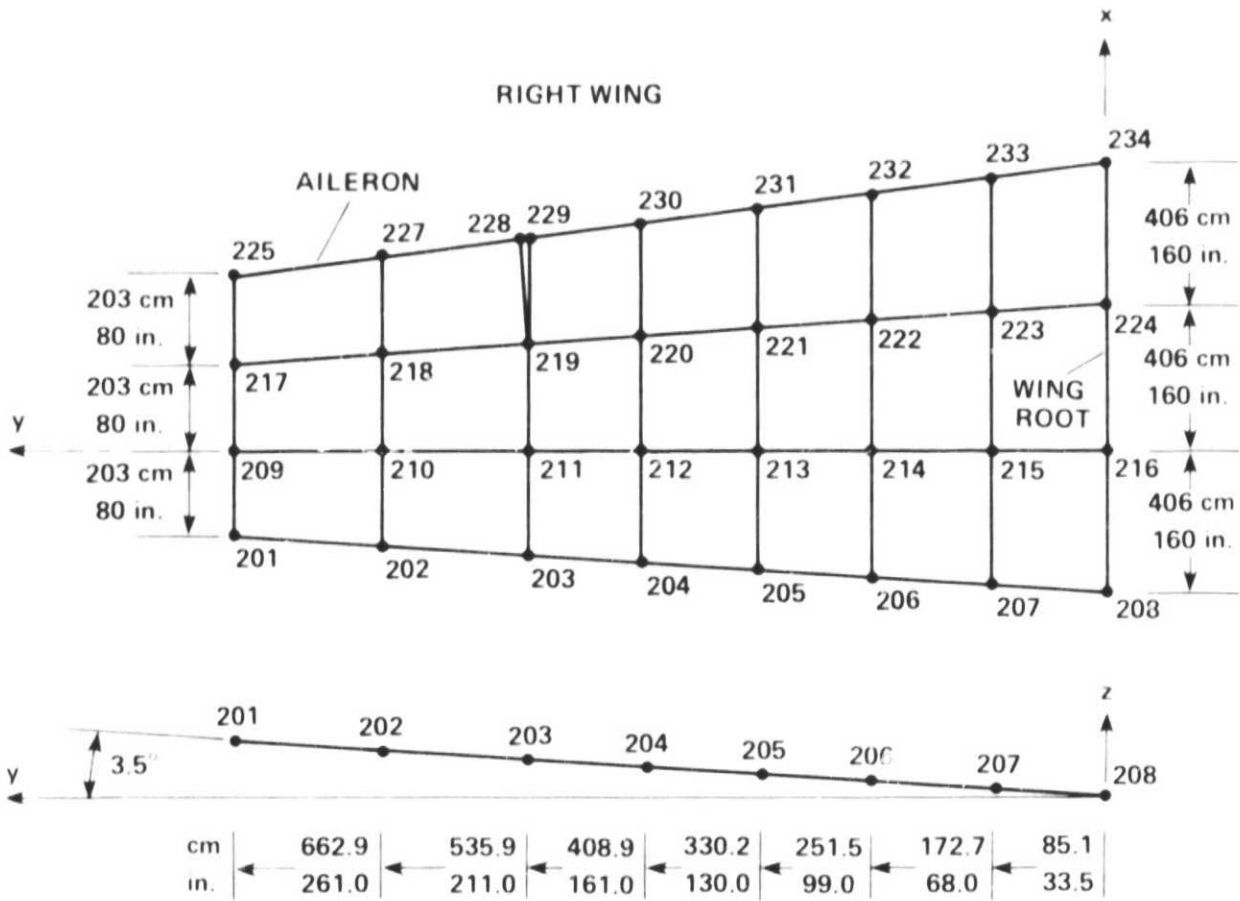
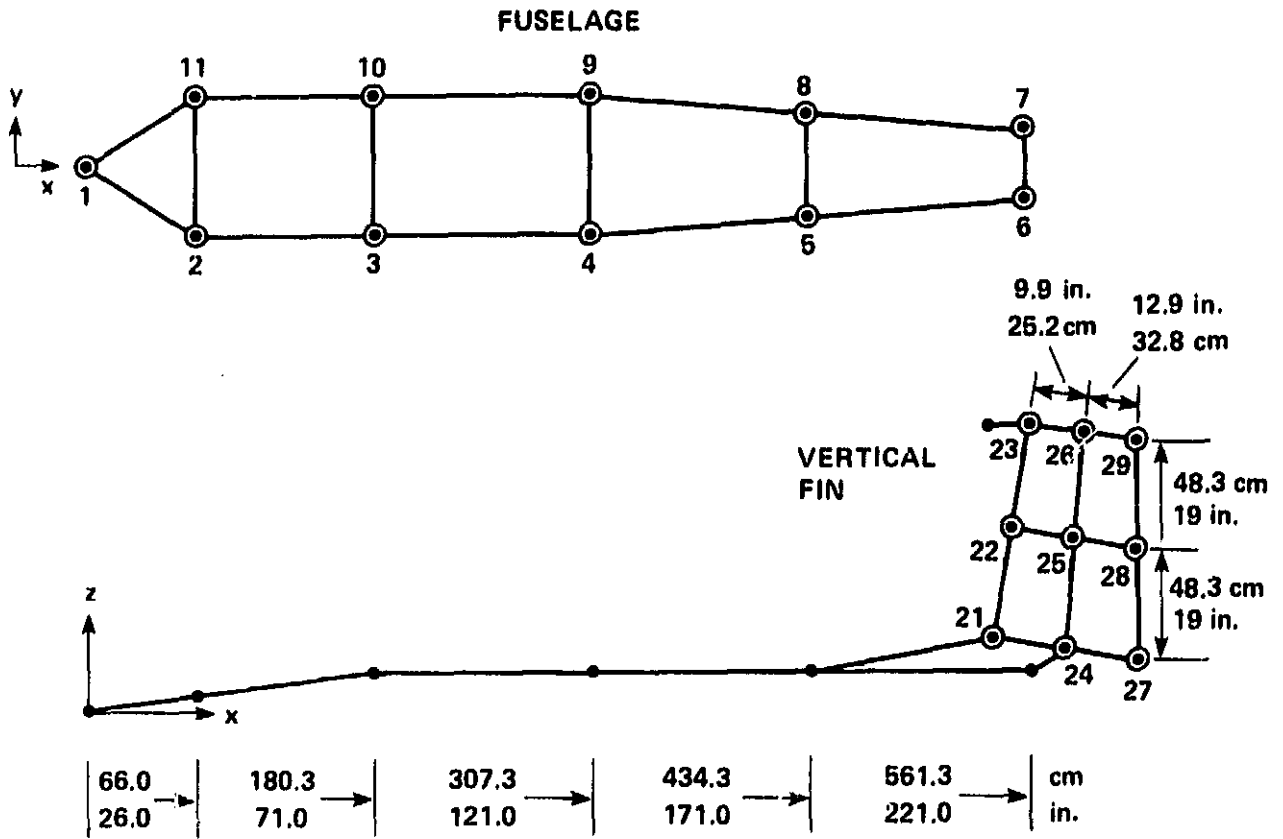
Figure 18.- Modal survey points.

(a) Left wing.

(b) Right wing.

(c) Fuselage and vertical fin.

(d) Horizontal stabilizer.

Data acquisition- Data were acquired with the structural analysis system for each location shown in figure 18. Transfer and coherence functions were then calculated. The coherence function was used as a measurement of the quality of the data before they were stored on the system disk. The base-band data were sampled at 128 samples/sec using a data block size of 1024 samples (8 sec required to fill the block). The anti-aliasing filters were set at 50 Hz. The total number of averages used to calculate each transfer function was 300. This total included an overlap factor of four. Overlap processing is a procedure by which a time history includes a certain amount of previously processed data and a certain amount of new data. This technique is useful when a Hanning window is used. A Hanning window was applied to the data to reduce leakage errors.

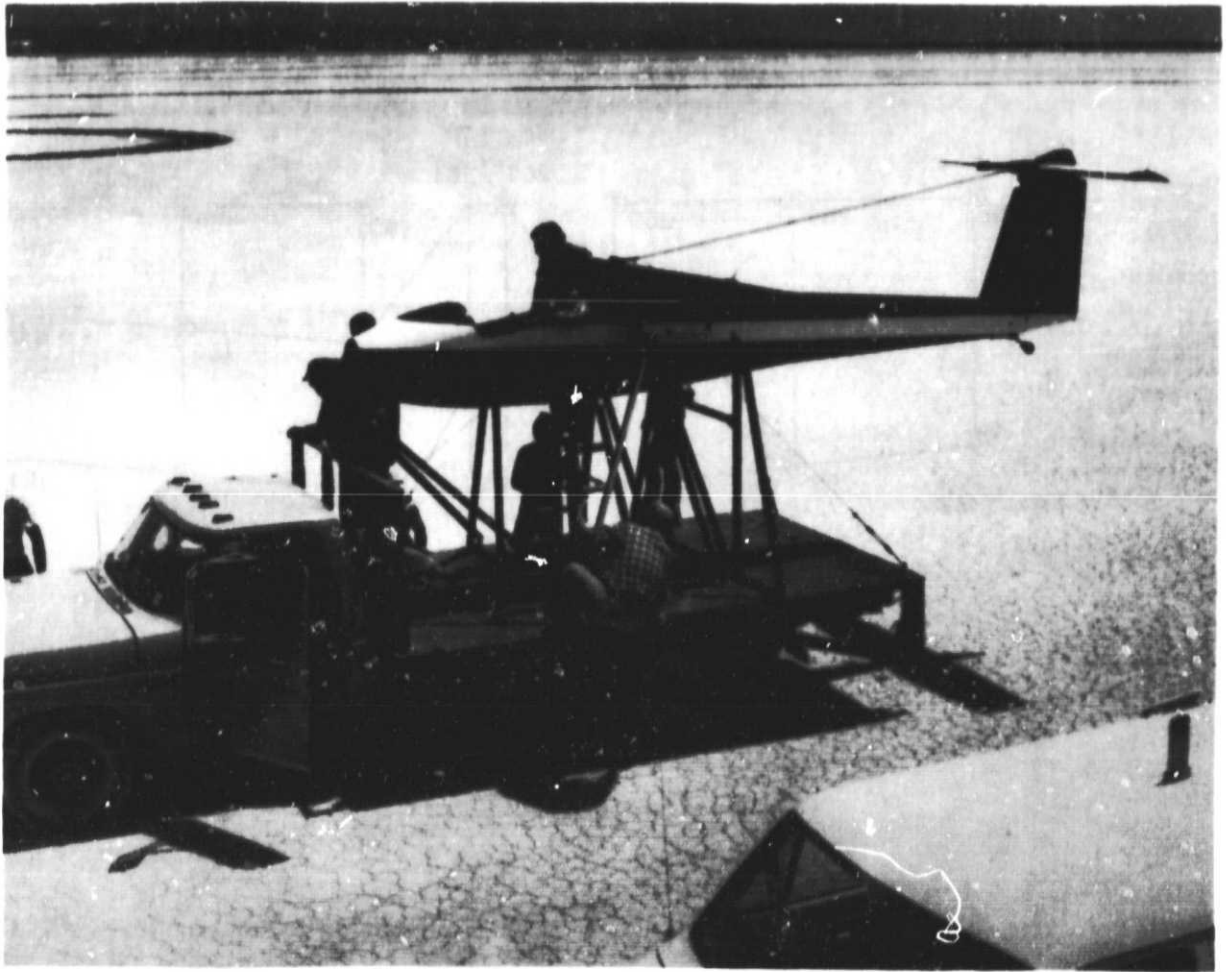
Figure 19.- Truck mounted sailplane with the horizontal stabilizer in the normal position.

The sailplane, without wings, was mounted high on a flatbed truck. The fuselage was mounted in two different positions. The first position was for flight with the horizontal stabilizer in its normal position (fig. 19) and the second position was with the horizontal stabilizer in the deep stall position (fig. 20).

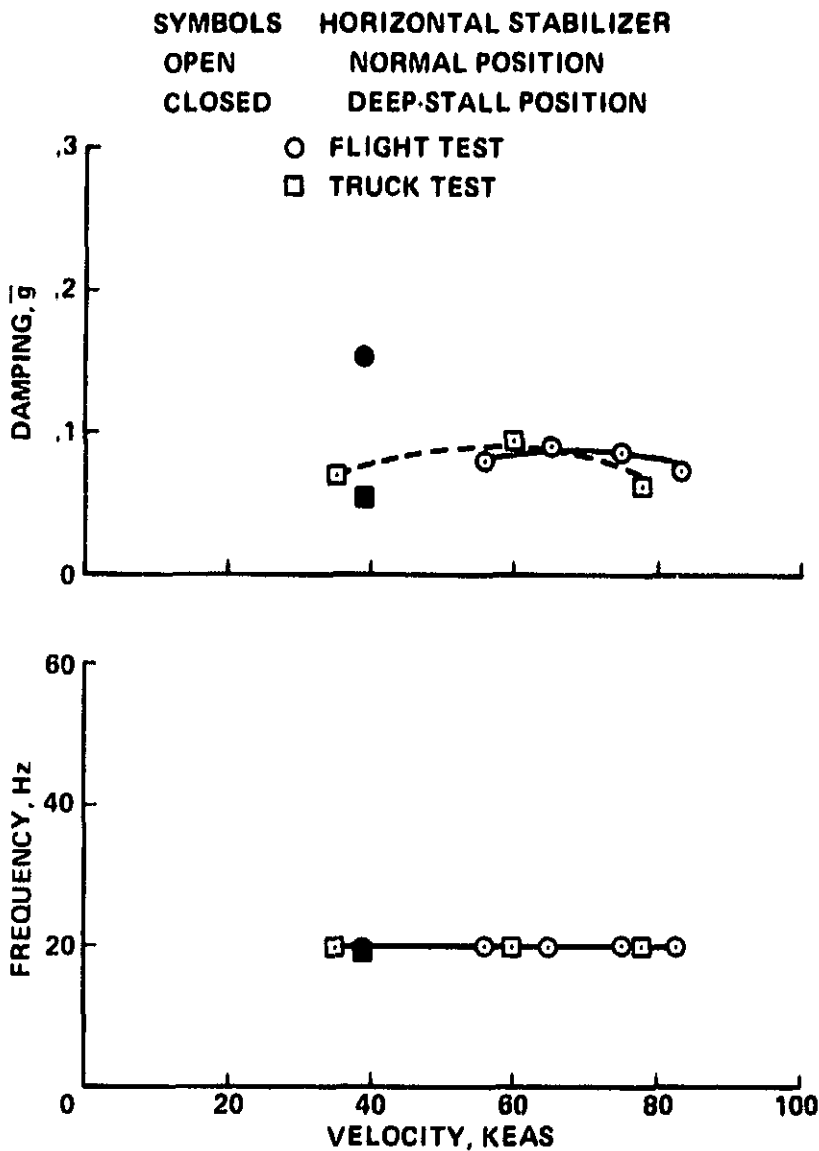
Figure 24.- Vertical fin bending modal data.

The results of the truck and flight tests are presented in figures 22-27. It was assumed that KEAS was equal to KCAS at these speeds and altitudes in figures 22-27. The modal data indicated good agreement between the two tests, although there are significant differences in the air densities tested. In general, the structure is heavily damped. The mode that exhibited the lightest damping was the elevator rotation mode (fig. 26).

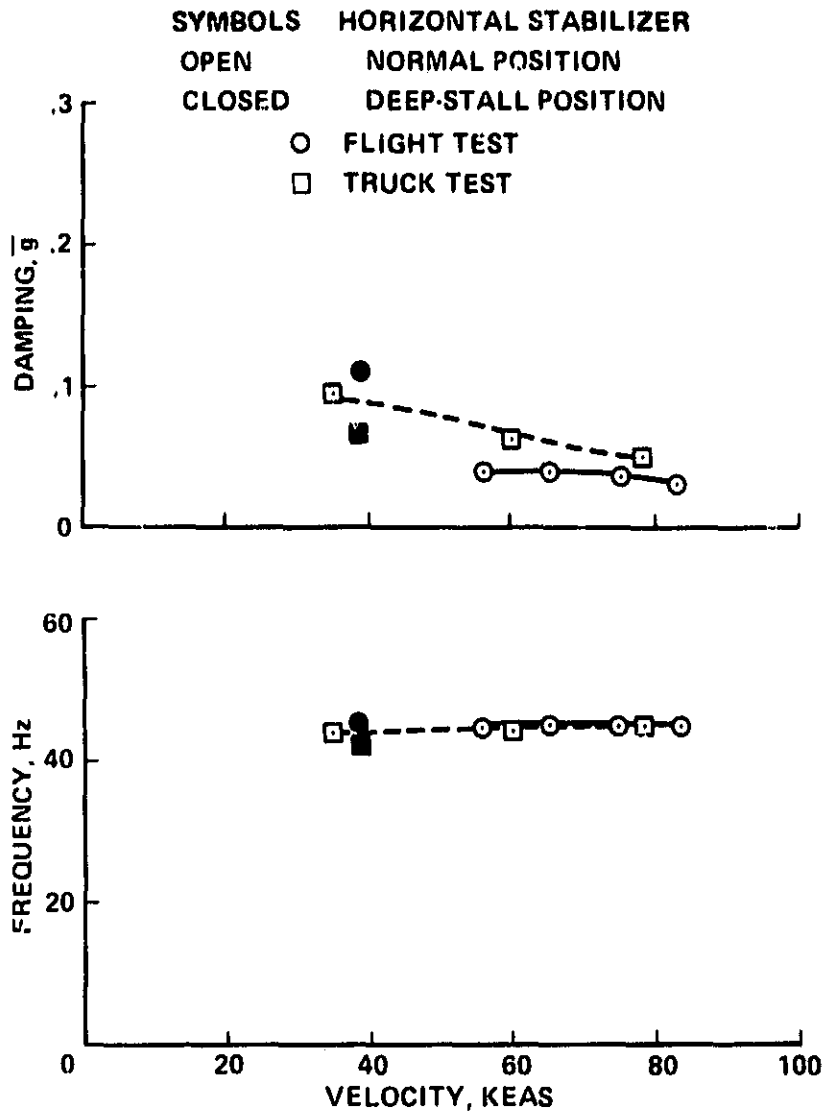
Figure 26.- Elevator rotation modal data.

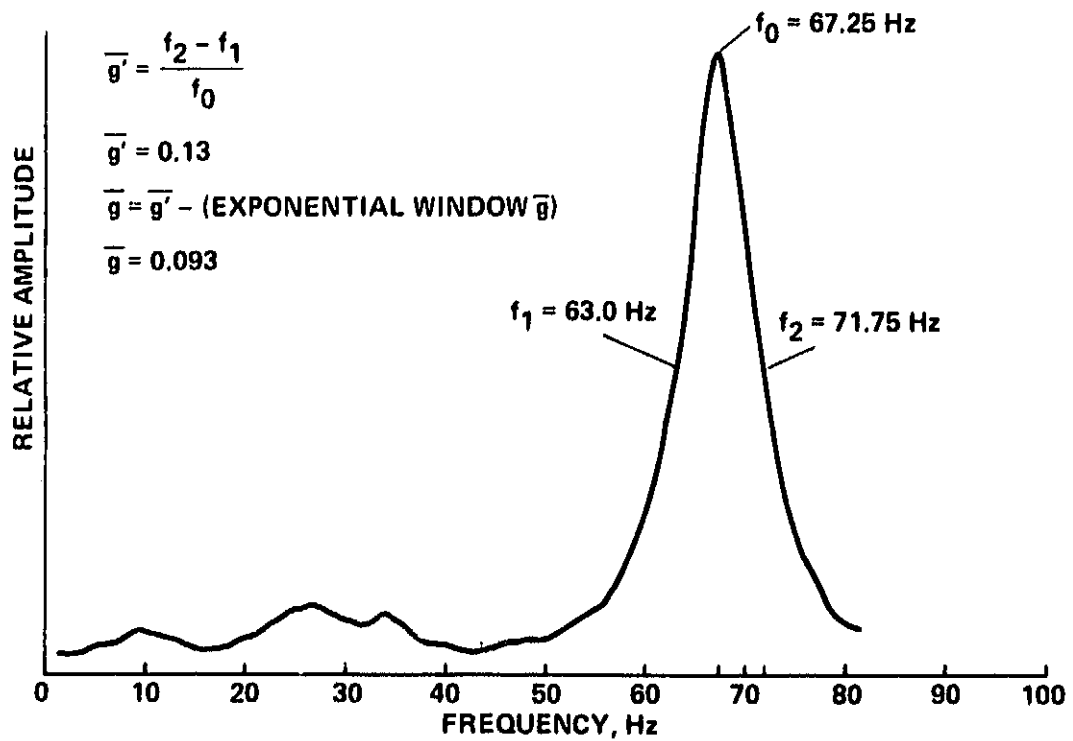
Figure A2.- Direct Fourier transform.
