DOE/NASA/0333-1  
NASA CR-174771

# Free-Piston Stirling Engine/ Linear Alternator 1000-Hour Endurance Test

Jeffrey Rauch and George Dochat  
Mechanical Technology Incorporated

Prepared for  
NATIONAL AERONAUTICS AND SPACE ADMINISTRATION  
Lewis Research Center  
Under Contract DEN 3-333

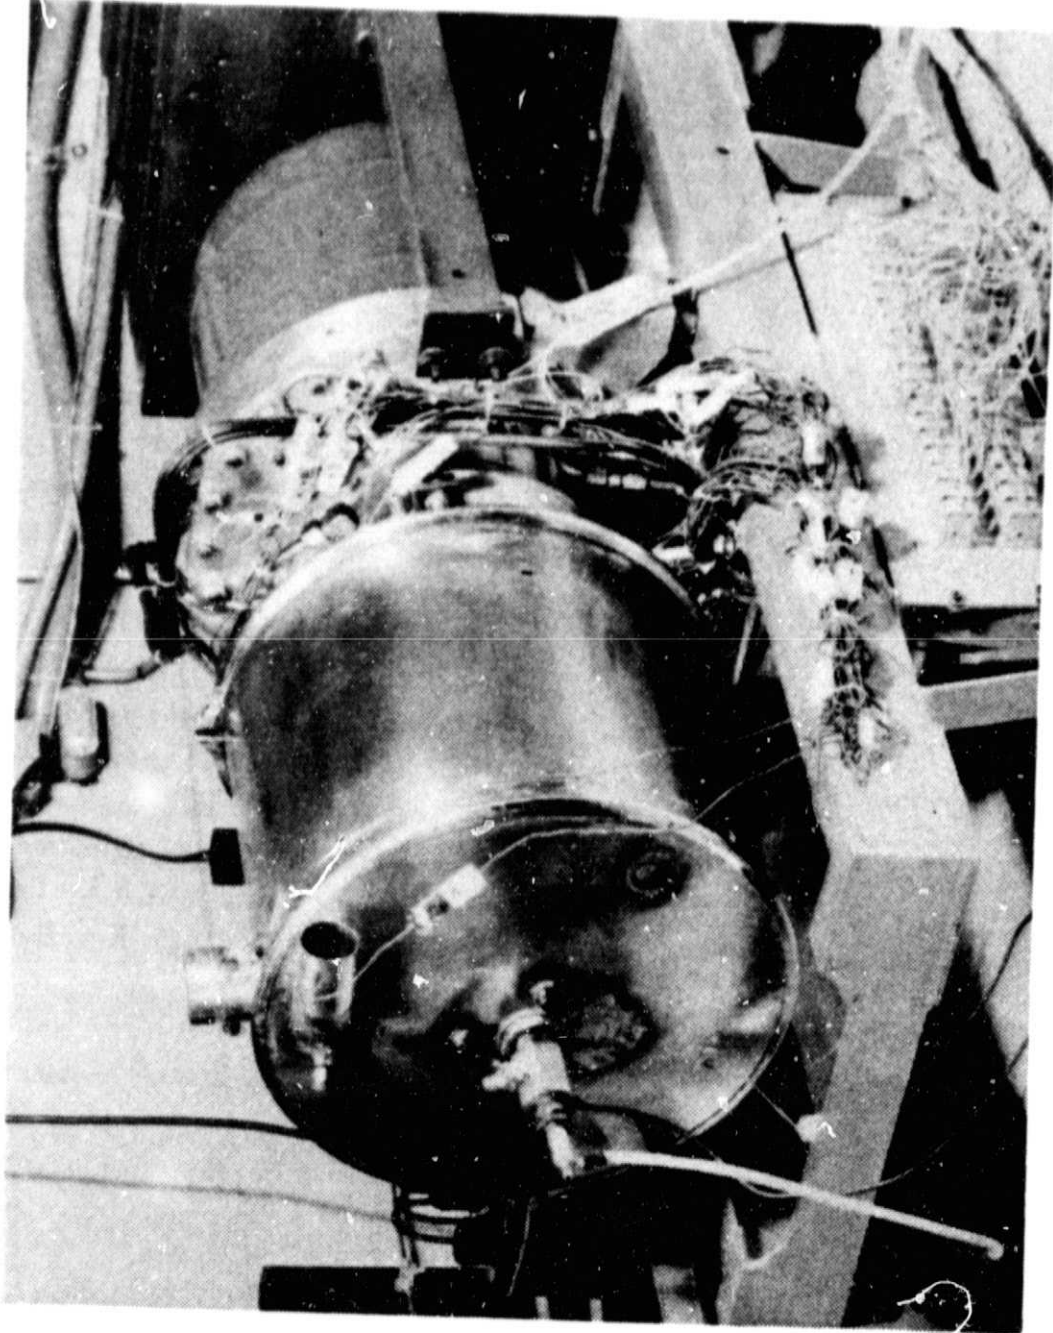
Figure 1-1 MTI FPSE EM #2 Installed for 1000-Hour Endurance Testing

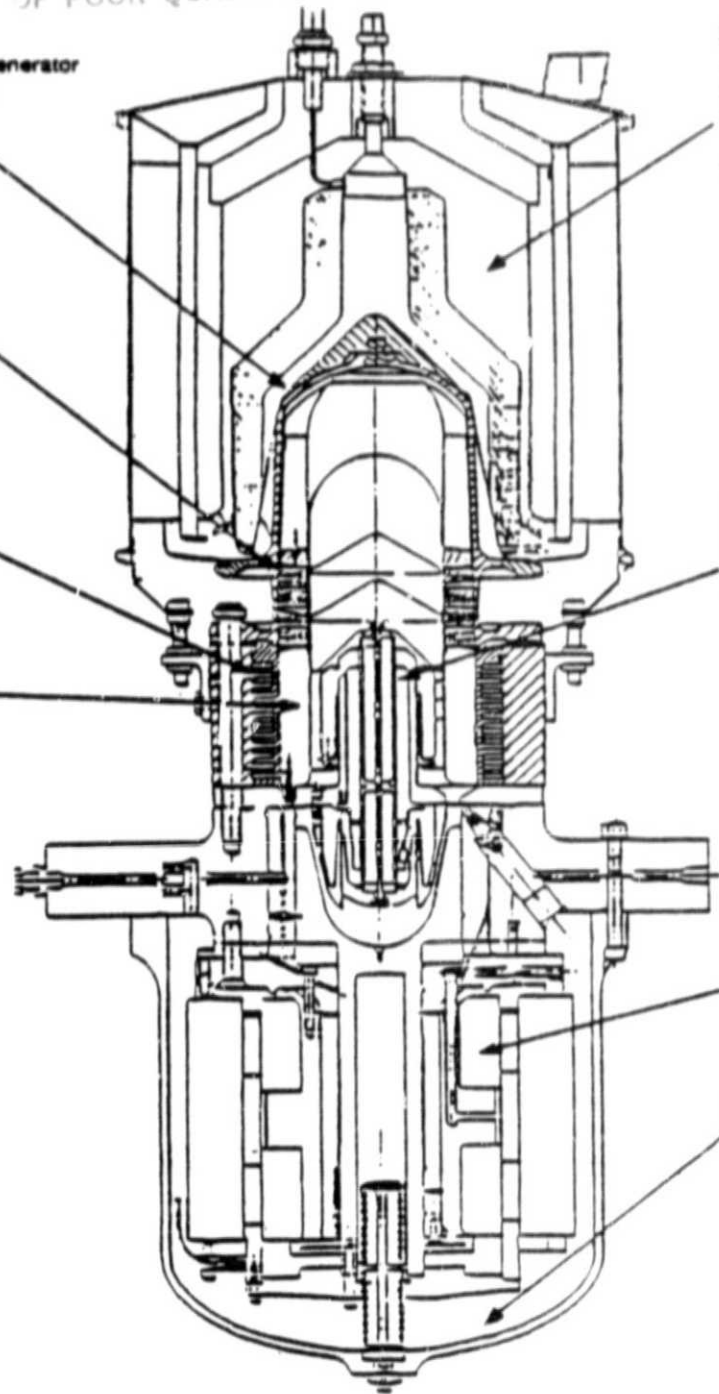
Figure 2-1 Engineering Model - Major Components

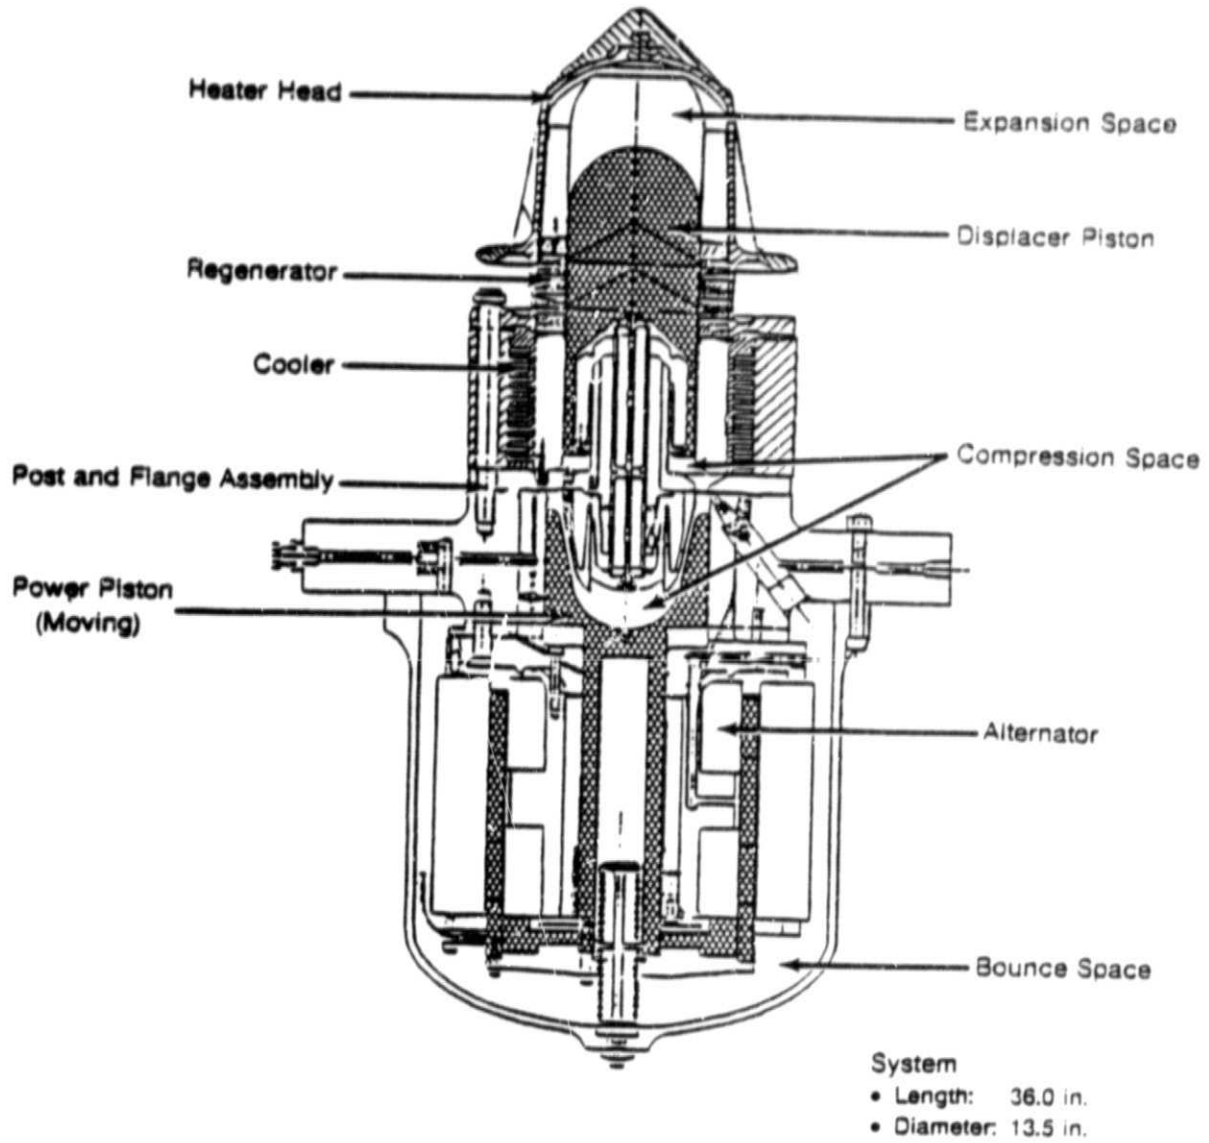
Figure 2-2 Schematic of Engine Components

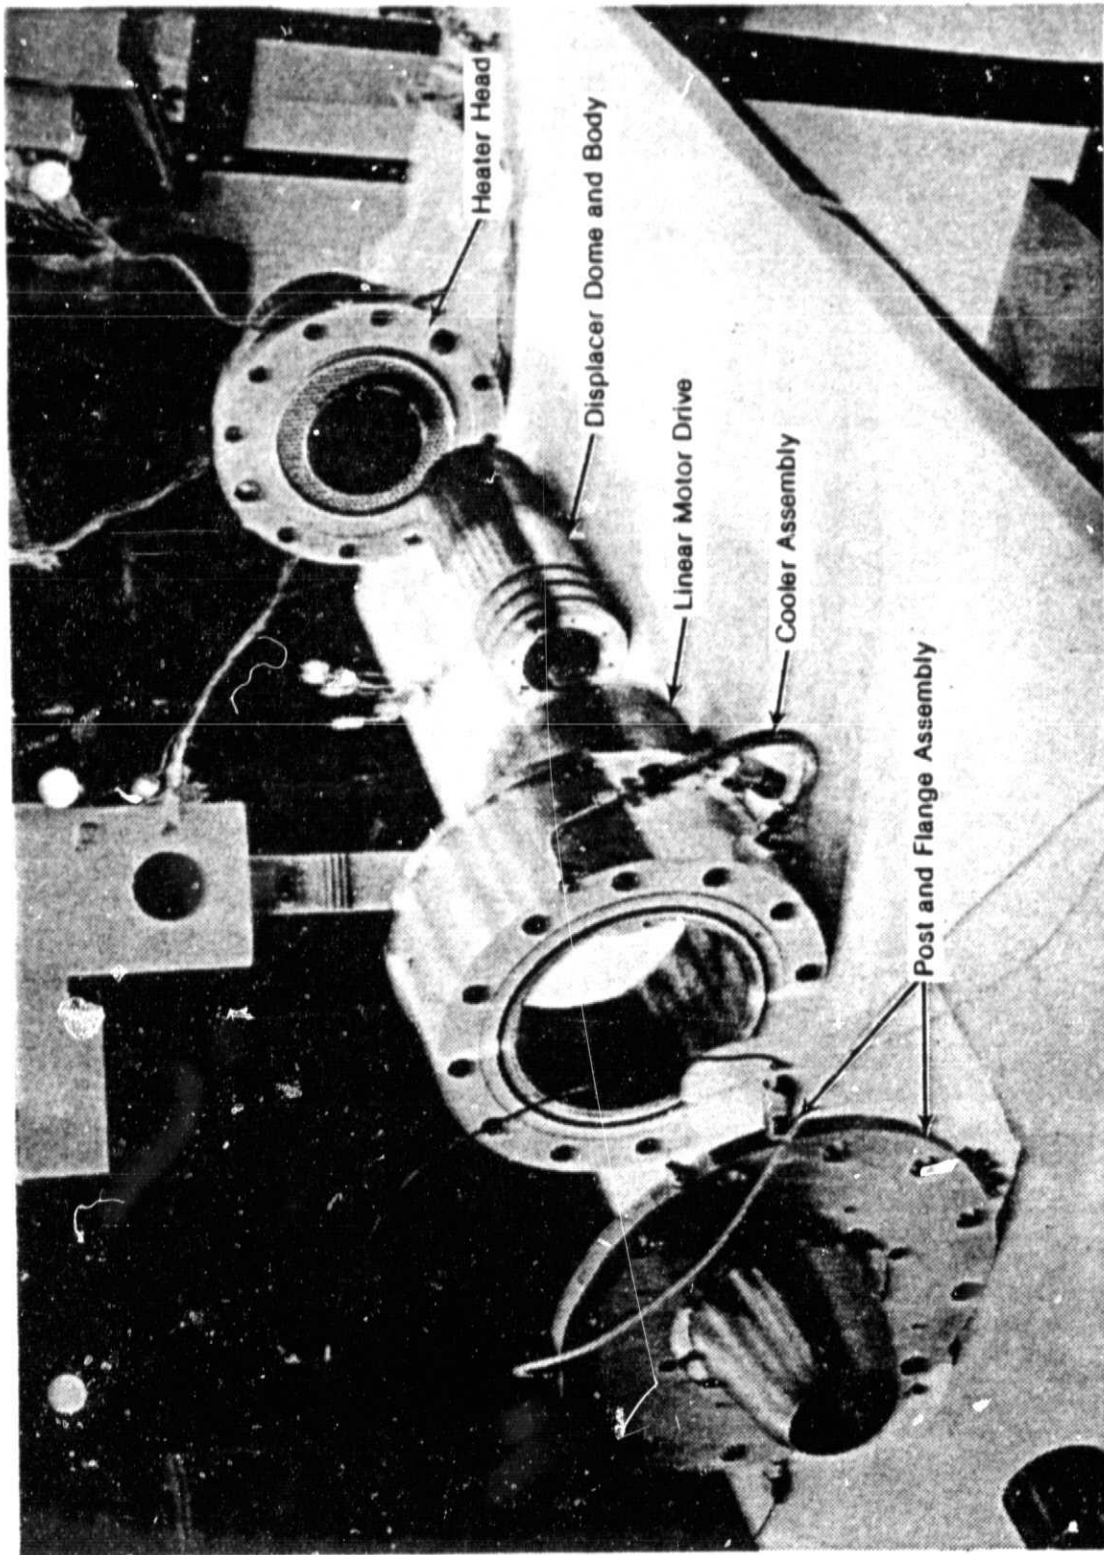
CT-82922A-19

Figure 2-3 MTI EM Linear Motor Driven Displacer Hardware

The combined EM posted displacer concept and linear motor drive consists of the displacer body and dome, hydrostatic gas bearing displacer rod, linear motor drive, and displacer gas springs. The displacer body contains the displacer cylinder clearance seal, and an integrally fabricated, linear electric motor armature, which is a basic part of the engine power-control system. The displacer rod and body are supported on gas bearings within the post and flange assembly (Figure 2-3). The rod area, which is the difference between the effective expansion-space face area of the displacer and the effective compression-space face area, determines the thermodynamic input power to the displacer.

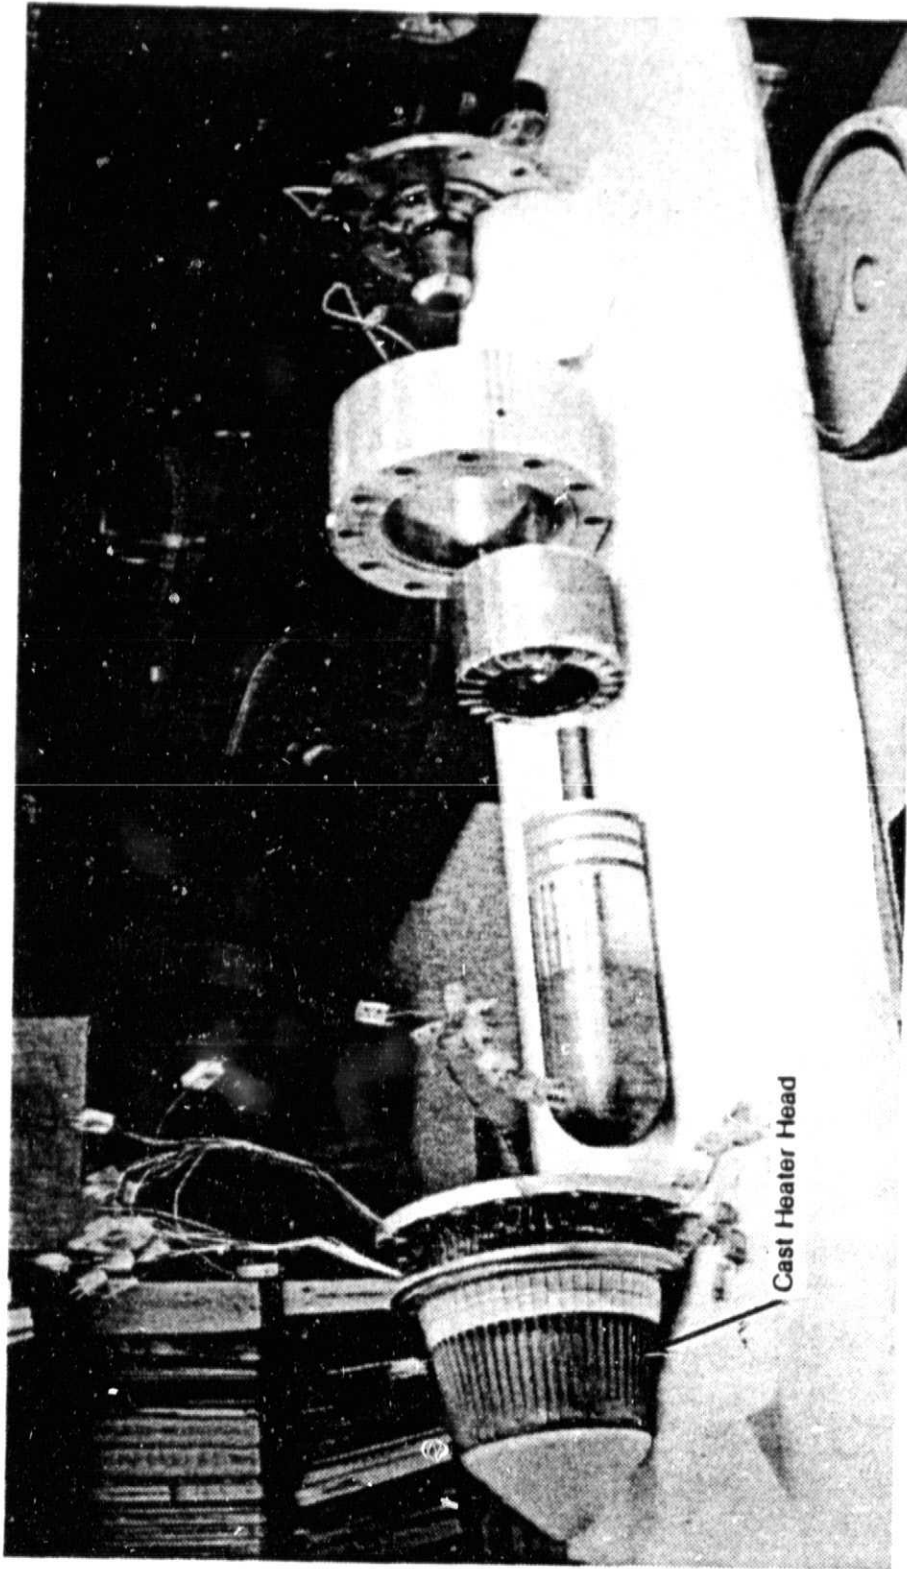
Figure 2-4 The EM Heater Head and Displacer Components

2.1.4.1 Heater Head. The EM heater head (Figure 2-4) was designed as a monolithic pressure vessel that is integral with the annular regenerator pressure wall (see Figure 2-5). This design, which requires no high-temperature structural weld or brazed joints, can be cast with integral internal and external fins.

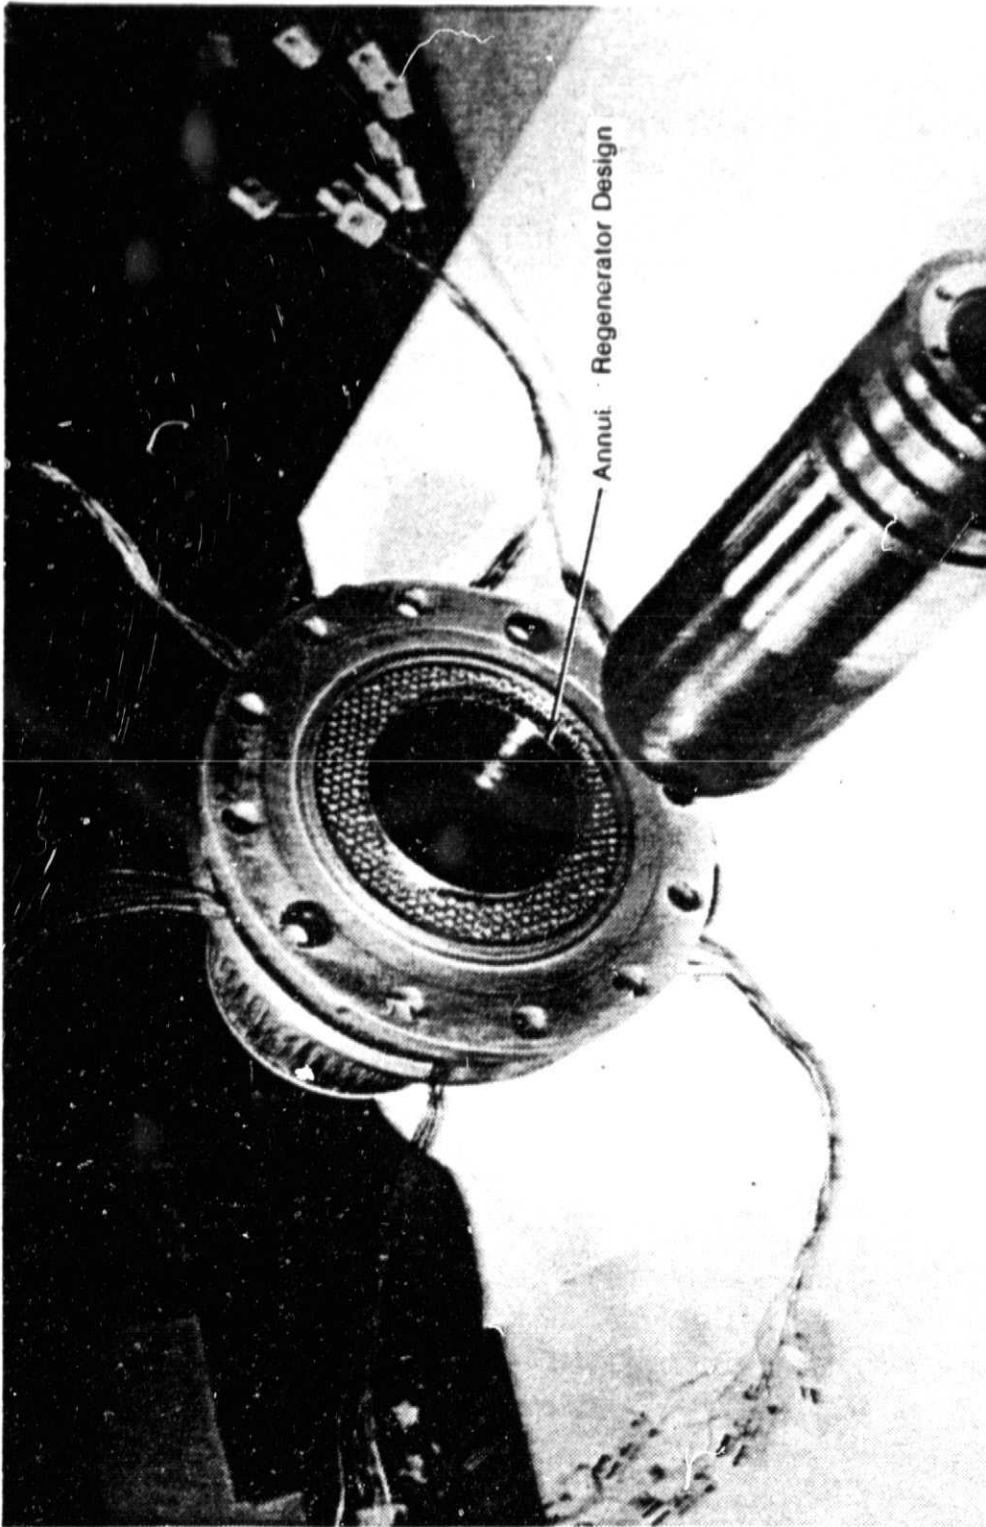
CT-82922A-22

Figure 2-5 Heater Head and Regenerator Housing

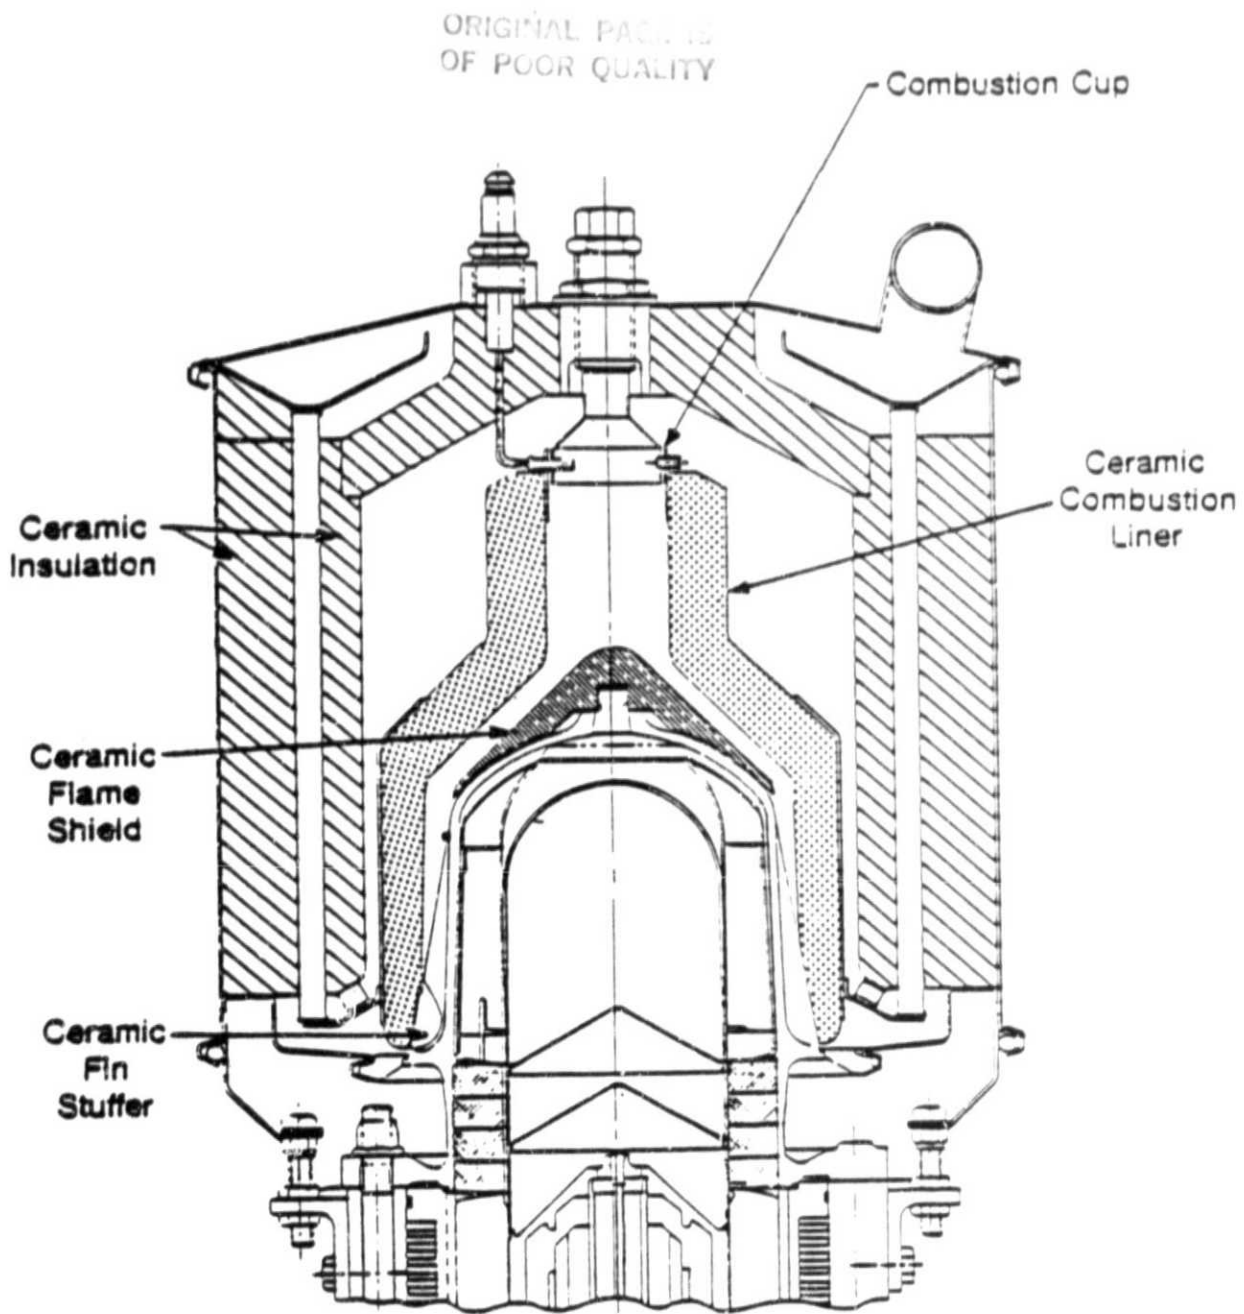
Figure 2-6 Engineering Model External Heat System

The EM combustor is a spin-off developed from the technology demonstrator engine (TDE) with major improvements in the preheater. Fuel and air are supplied to the combustor from an external air/fuel (A/F) control system. Inlet air is preheated by the combustion exhaust in a folded fin preheater. The preheater air enters the combustion chamber through a swirler cup to create a turbulent mixing zone, and fuel is injected through the center of the swirler cup into the combustion zone. The current combustor system (shown in Figure 2-6) is designed to burn natural gas at a peak firing rate of 16 kW. The combustor control senses heater head temperature and adjusts fuel and airflow to maintain the heater head temperature at the fixed operating temperature.

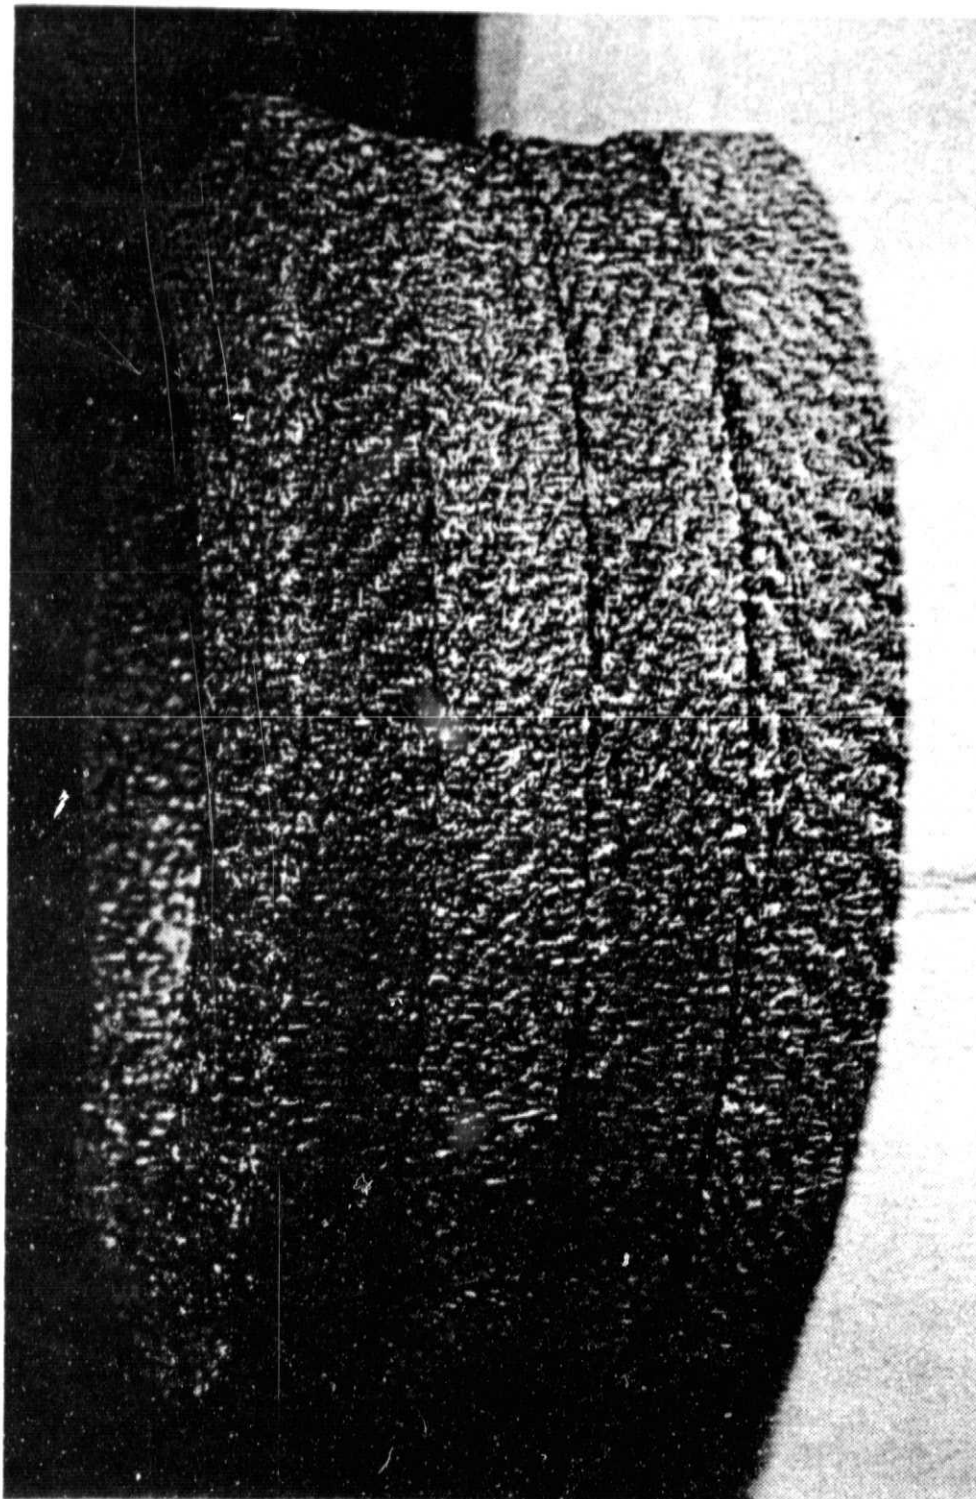
CT-82387E-2A

Figure 2-7 Metex Regenerator Stacks

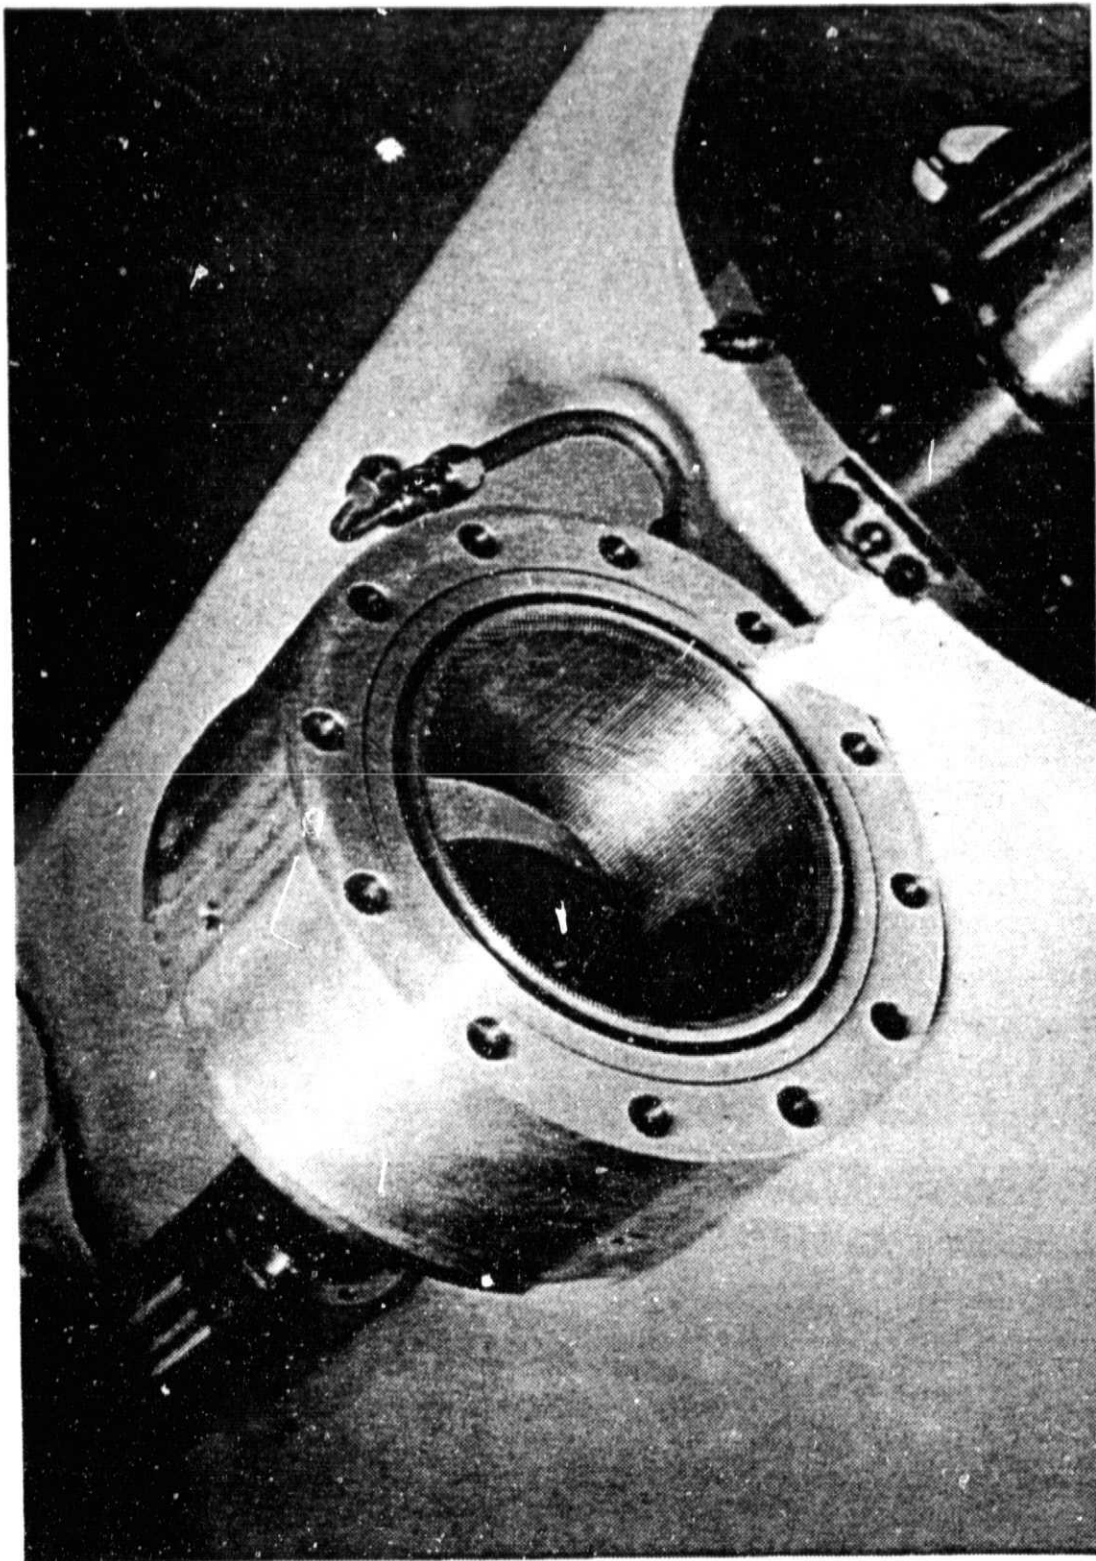
CT-82822A-23

Figure 2-8 Engine Cooler

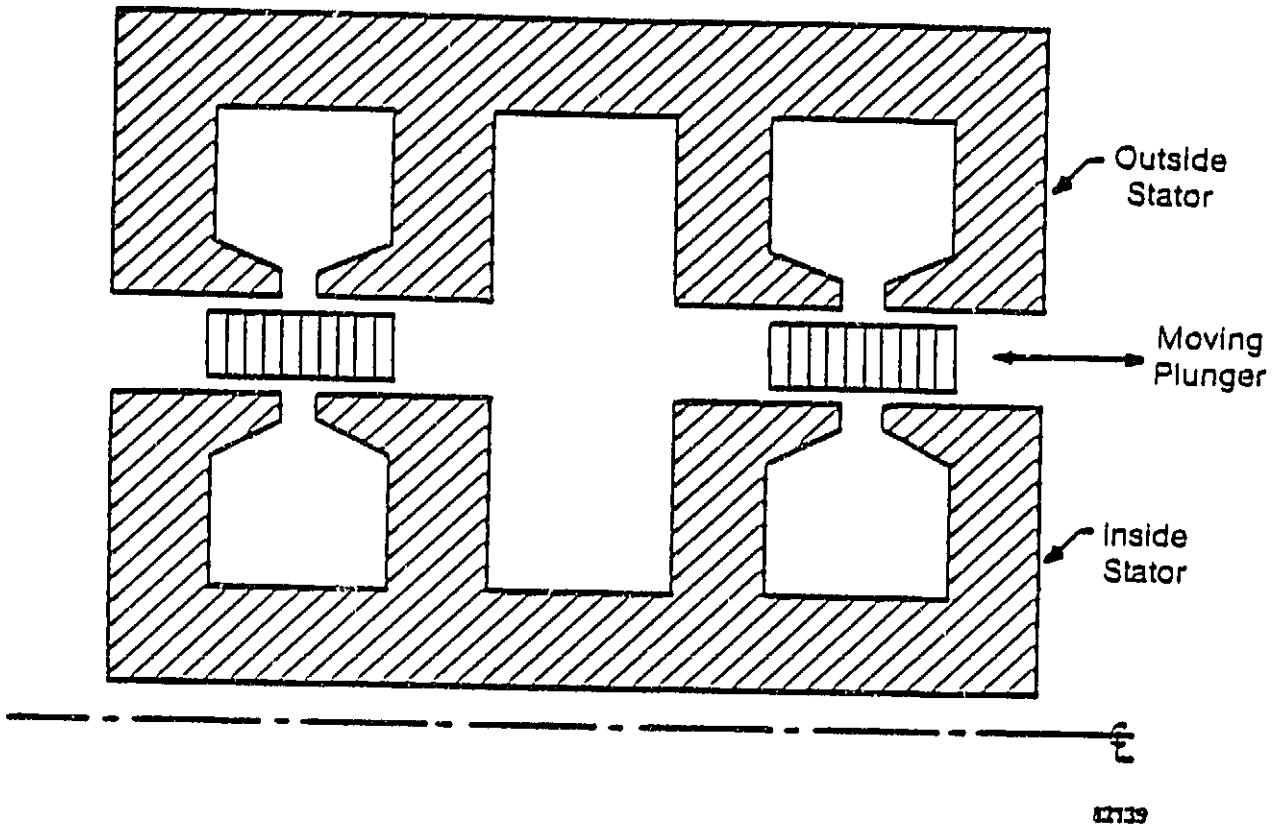
Figure 2-10 Partially Saturated Plunger with Inner and Outer Stator

The "partially-saturated plunger" alternator evolved from earlier flux-switching alternator configurations. This concept (shown in Figure 2-10) is based on the principle of minimizing the weight of the driven mass (plunger) at the sacrifice of the stationary mass (stator). The result is that only the pole pieces (required for "flux-switching") are needed to form the moving member. Furthermore, both inside and outside stator coils have been devised to optimize overall packageability and to enhance the alternator conversion efficiency. The latter can be achieved by virtue of the smaller mean diameter of the coil windings on the inner stator relative to the outer coils, thereby reducing the overall  $I^2R$  losses for the alternator system.

The linear alternator consists of a 0.5-in. thick cylindrical plunger that reciprocates between the inner and outer cylindrical stators. A DC field coil generates a toroidal flux path linking the inner and outer stators which passes through the two magnetically active rings on the plunger and passes in and out of the two

stators. Consequently, reciprocation of the plunger causes the flux toroid to move axially along the stator, sinusoidally linking and unlinking four physically separate AC output coils. These electrically connected coils act as a single output coil, providing alternating AC voltage and power.

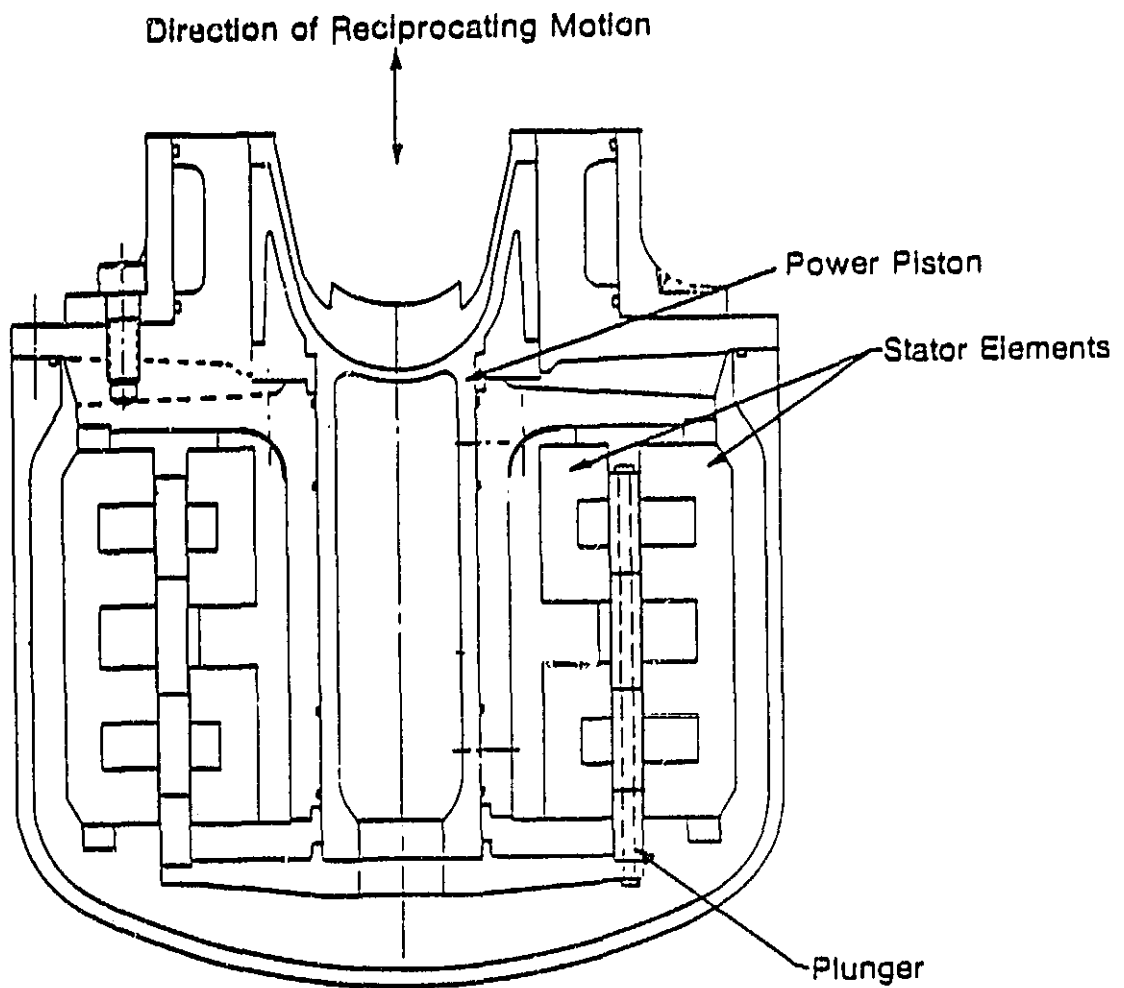
82056-1

Figure 2-11 Partially Saturated Plunger  
Alternator Subsystem

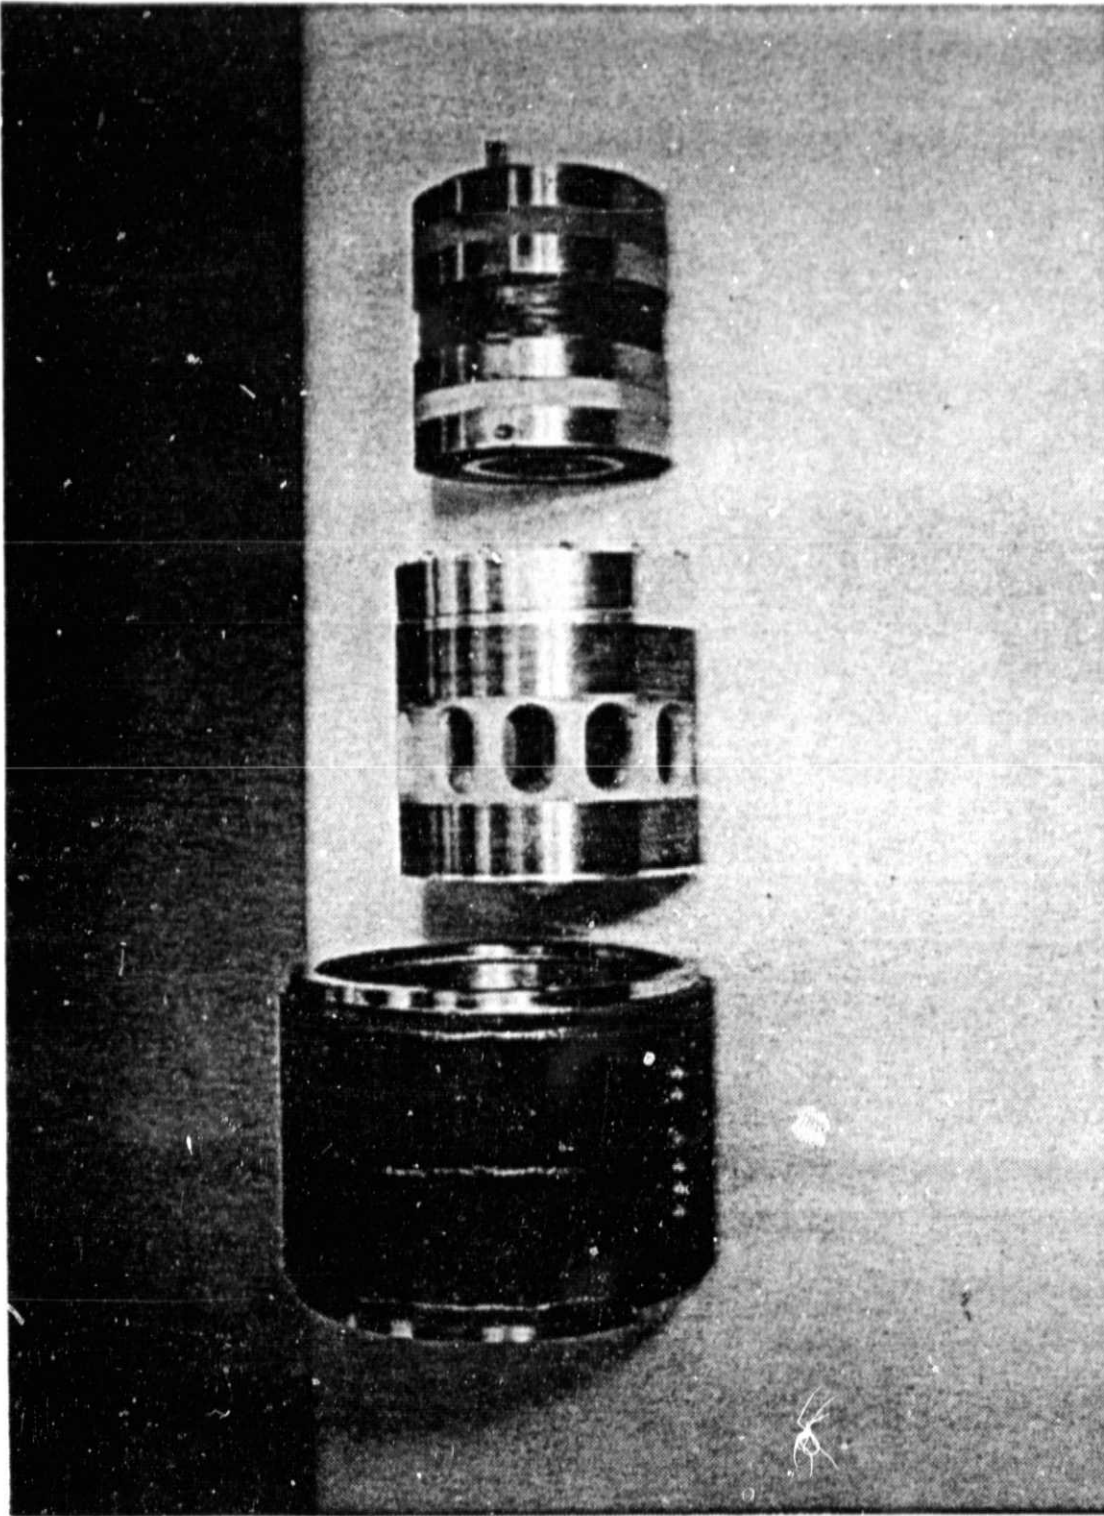
Figure 2-12 Partially Saturated Alternator Components

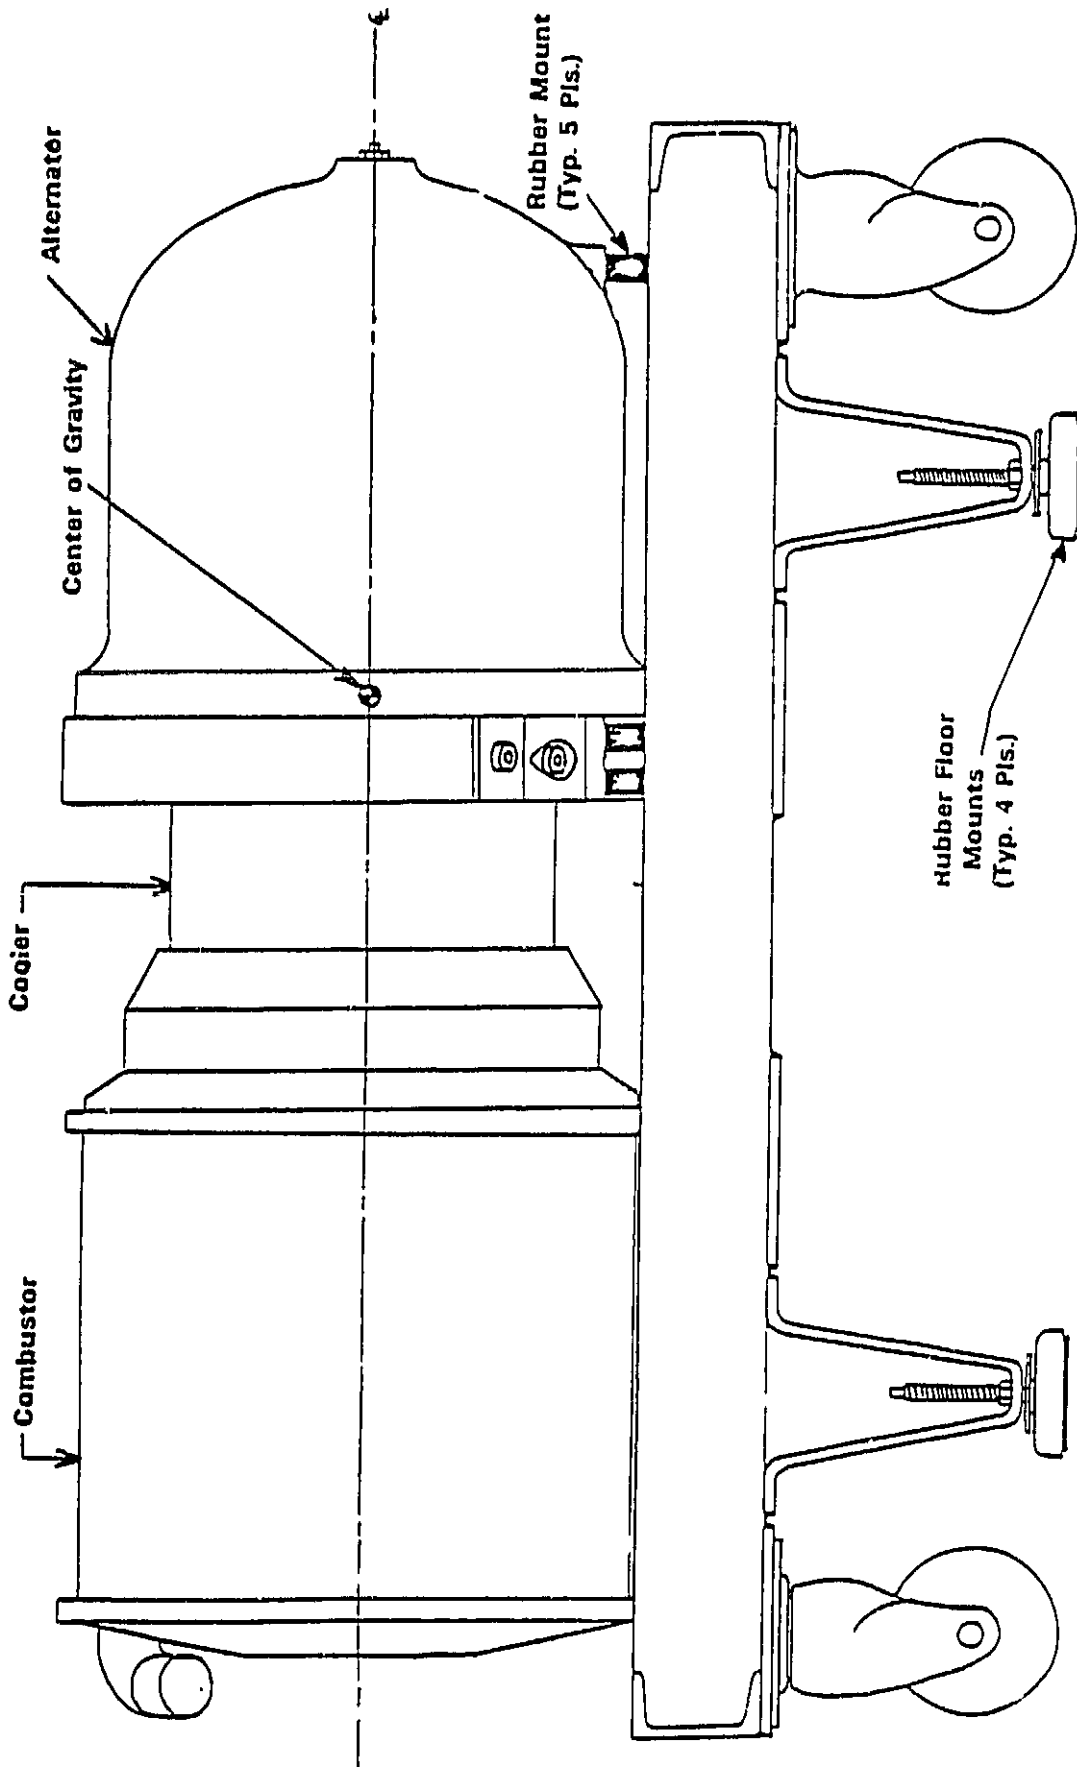
Figure 2-13 EM Skid Mounting Diagram

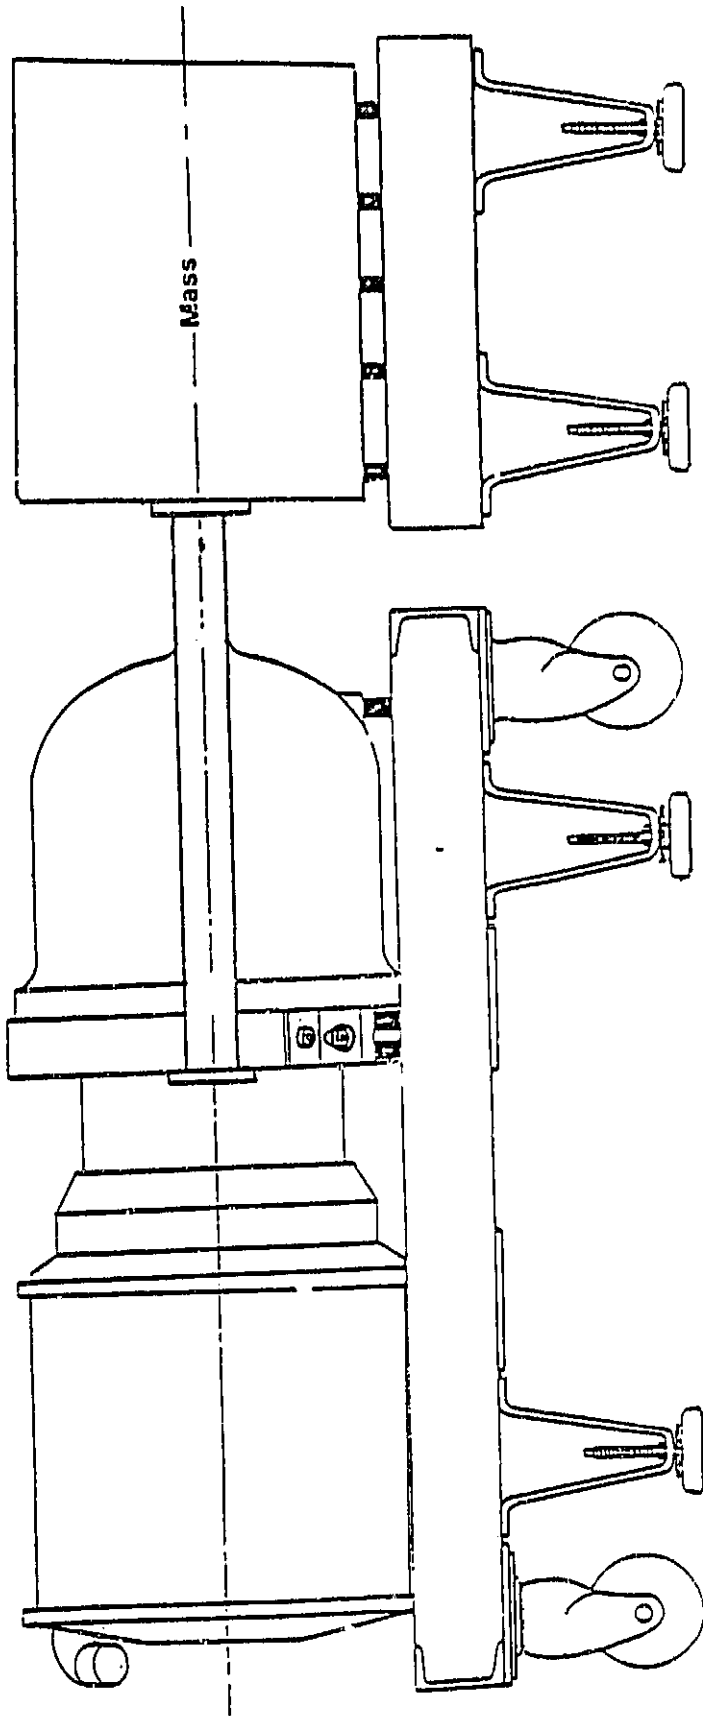
Figure 2-14 EM Skid Mount with Vibration Dampening Mass

There were several failures of the struts which connected the engine to the inertial mass. This had no effect on power module; however, if not caught quickly, operation after strut failure could cause rapid degradation of the combustor. The facility and interlock system designed to protect the engine from facility related failures caused numerous engine stoppages early in the test program. These problems were corrected and the test continued. By the duty-cycle test phase, the number of facility related stoppages were substantially reduced. The last 400 hours of duty-cycle testing were completed in 432 clock hours (18 days) or only 8% down time.

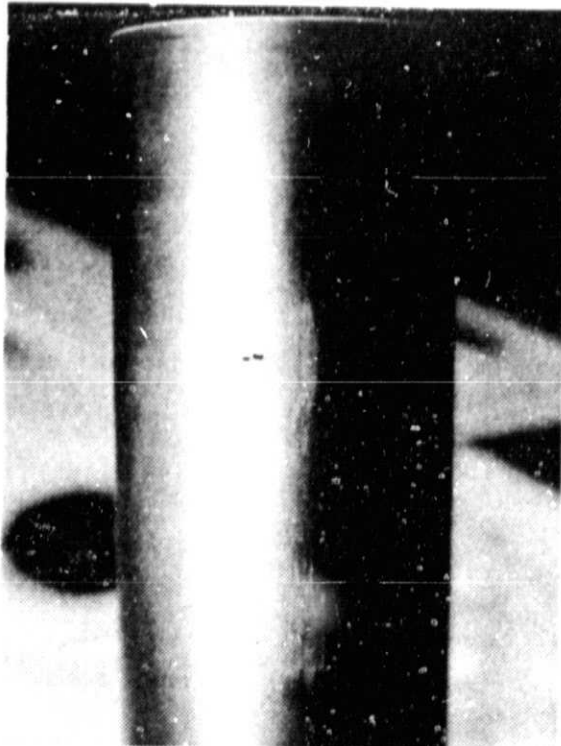
CT-831254B-6

Figure 3-2 Piston Rub Due to  
Dry Bearing Operation

2. After the completion of the full-stroke test, the engine was being run to repeat selected test point performance. Due to an operator error, the engine was run for approximately three minutes ( $\sim 10000$  cycles) without the hydrostatic gas bearings operating before the error was noticed and the engine shutdown. The subsequent inspection showed a number of local scratches, attributed to the dry-bearing operation, on the power piston (Figure 3-2) and mating bearing. The depth of the local scratches were not measurable by conventional instruments (micrometers); the surface profile (Figure 3-3) was measured in the areas shown in Figure 3-4 with a surface analyzer. Further, the bearing flow rate increased less than 10%
