DOE/NASA/0333-1  
NASA CR-174771

# Free-Piston Stirling Engine/ Linear Alternator 1000-Hour Endurance Test

Jeffrey Rauch and George Dochat  
Mechanical Technology Incorporated

Prepared for  
NATIONAL AERONAUTICS AND SPACE ADMINISTRATION  
Lewis Research Center  
Under Contract DEN 3-333

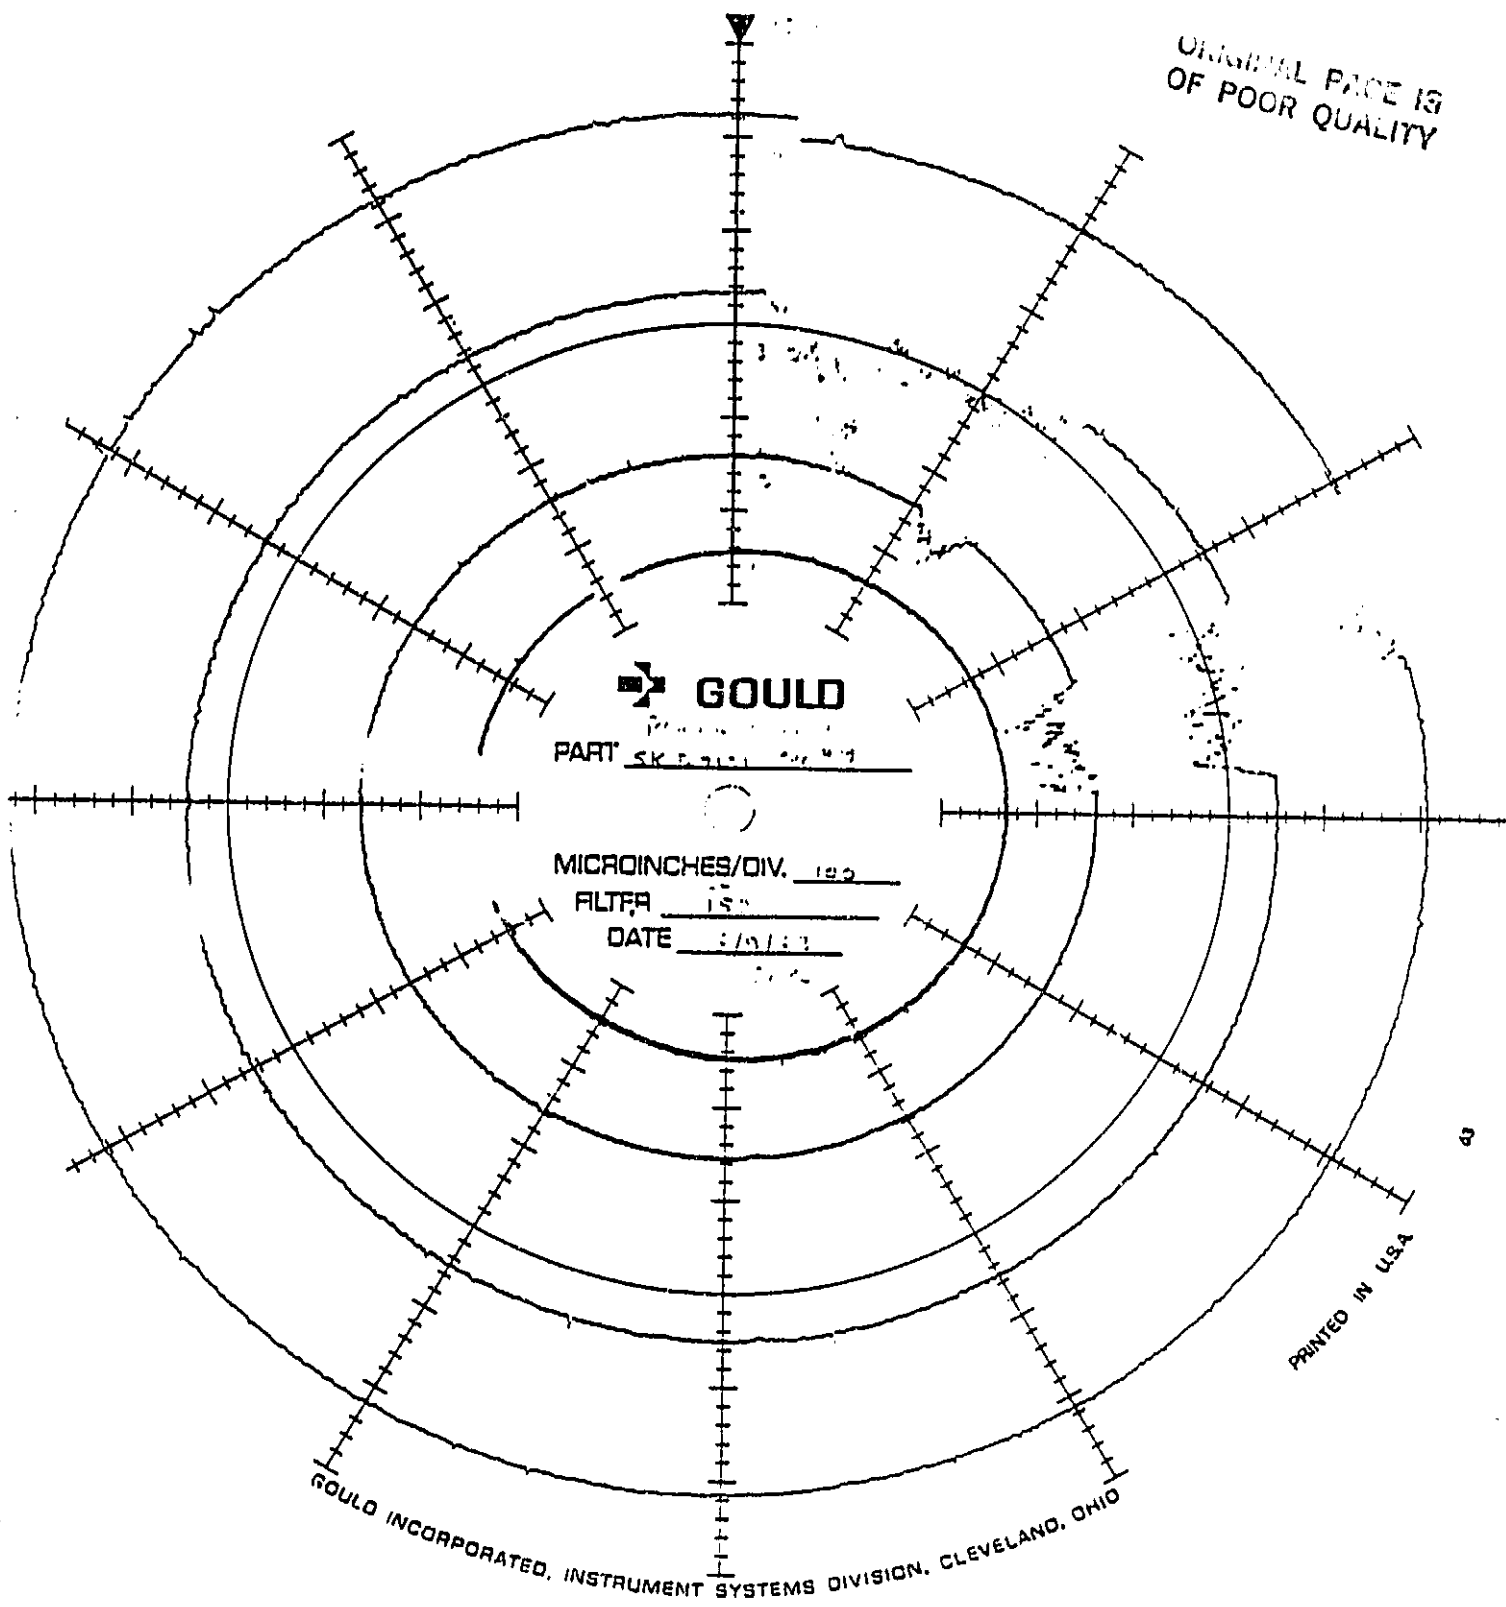
Figure 3-3 Surface Profile After Dry Bearing Operation

2. After the completion of the full-stroke test, the engine was being run to repeat selected test point performance. Due to an operator error, the engine was run for approximately three minutes ( $\sim 10000$  cycles) without the hydrostatic gas bearings operating before the error was noticed and the engine shutdown. The subsequent inspection showed a number of local scratches, attributed to the dry-bearing operation, on the power piston (Figure 3-2) and mating bearing. The depth of the local scratches were not measurable by conventional instruments (micrometers); the surface profile (Figure 3-3) was measured in the areas shown in Figure 3-4 with a surface analyzer. Further, the bearing flow rate increased less than 10%

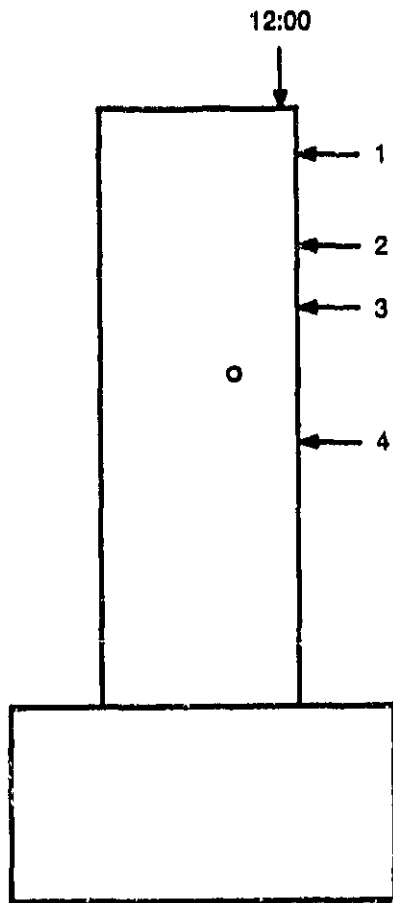
Figure 3-4 Location of Profile Measurement on Power Piston

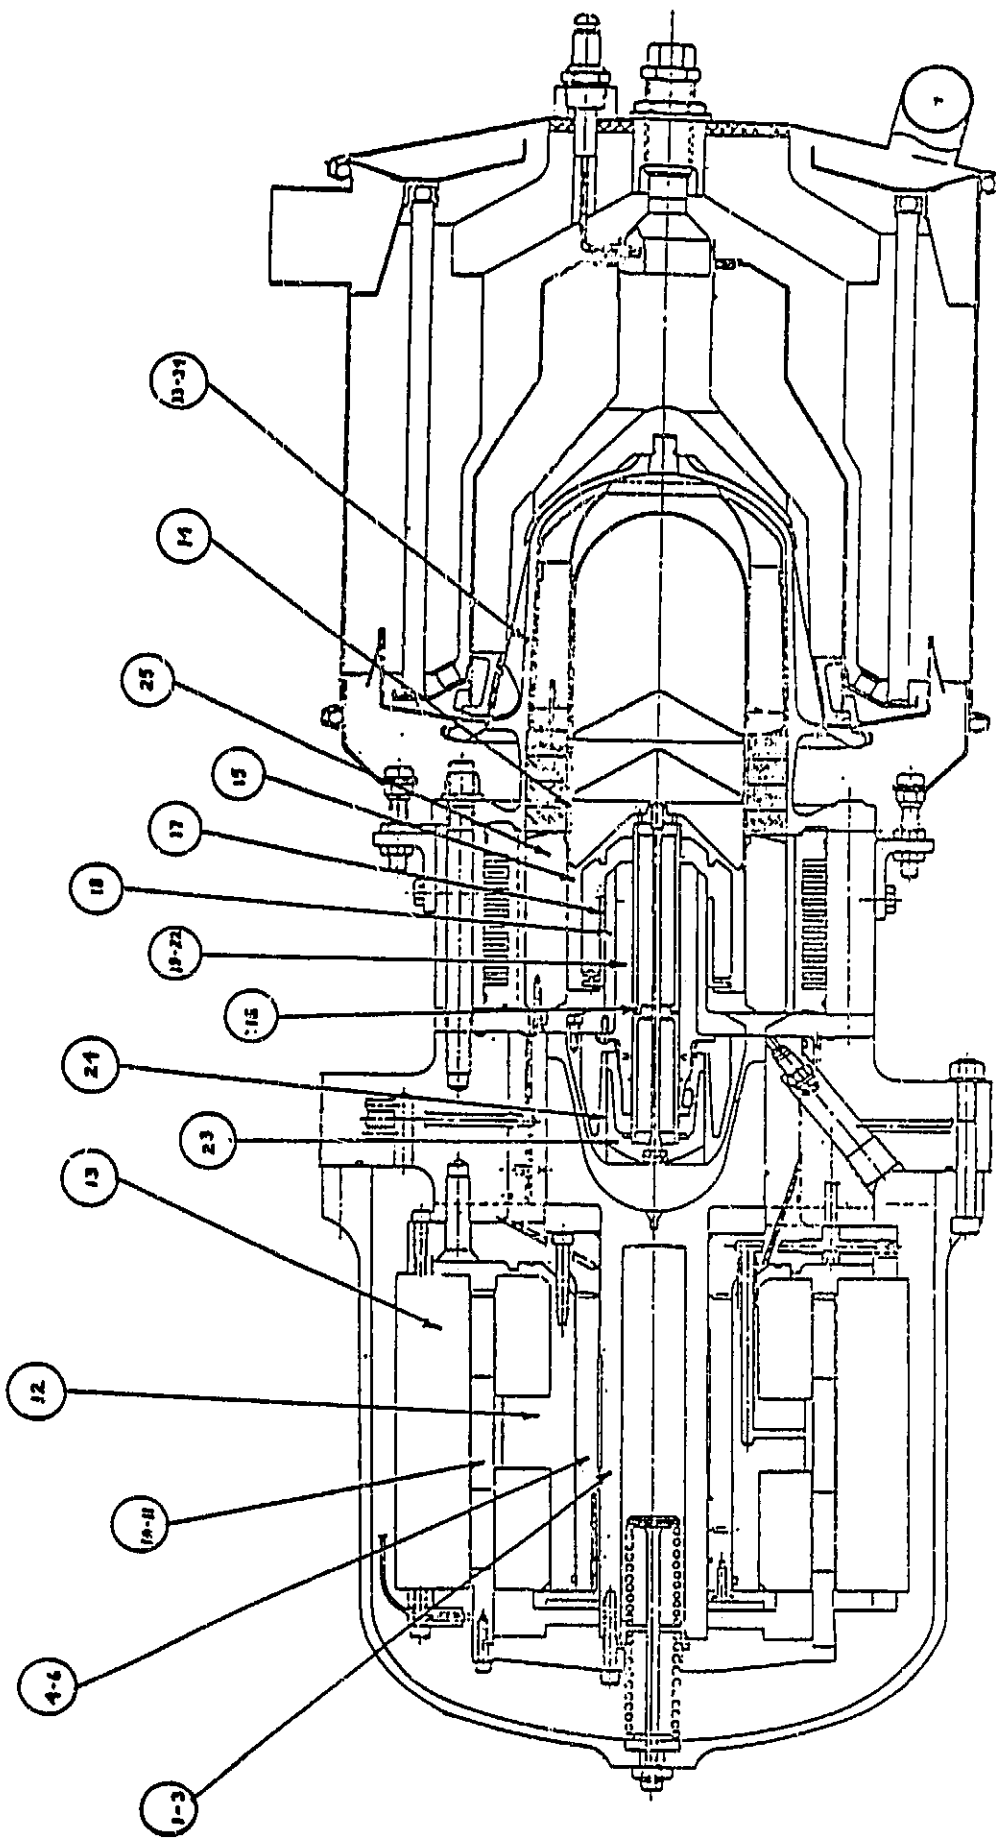
Figure 3-5 Critical Wear Surfaces Measured (numbers reference items on Inspection Summary Sheet, Table 3-2)

Prior to each test phase, the critical wear surfaces were thoroughly inspected and photographed. The engine was also inspected when a failure involving the power module occurred and following each test phase. Critical measurements and inspection locations are shown in Figure 3-5. These areas and the clearances are outlined as follows:

- Displacer Bearings/Seals - Clearance between displacer rod (rod that attaches to the displacer body) and post manifold. This clearance is important for proper operation of displacer gas bearings and to seal the forward and aft displacer gas springs from the bearing drains.
- Displacer Motor Seal - Clearance between outer diameter (O.D.) of the displacer body in the area of the permanent magnets and displacer motor liner which seals between the hot-expansion and cold-compression spaces.
- Displacer Gas Spring Seals - Clearance between the forward gas spring and outside diameter of the post, or between aft gas spring and gas

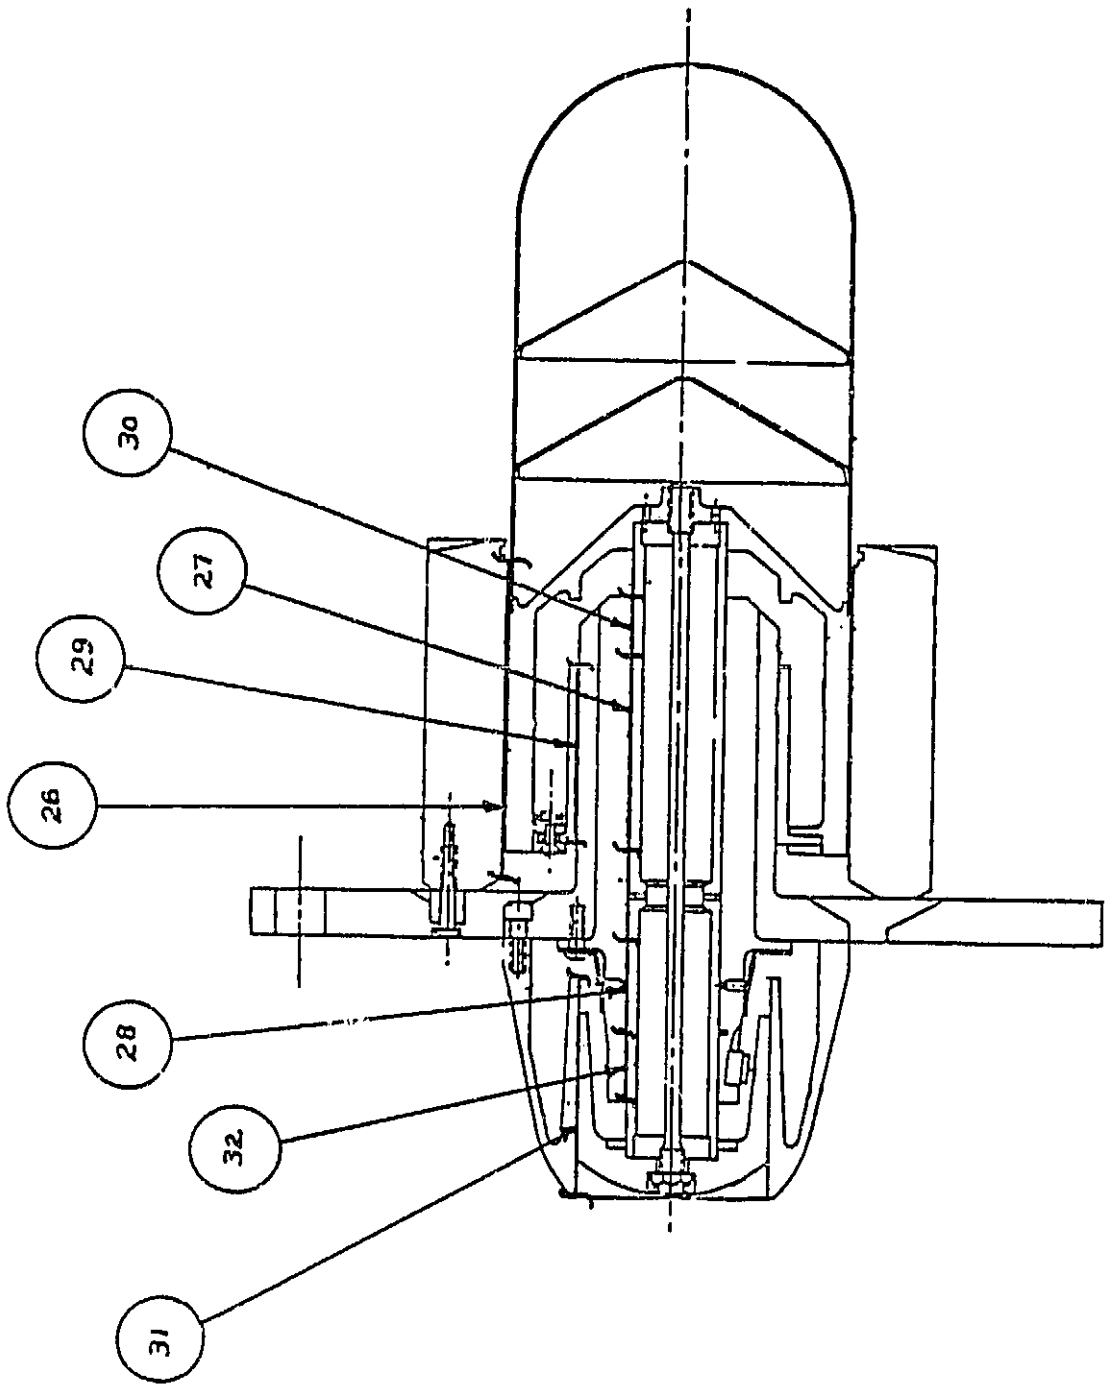
Figure 3-6 Critical Engine Clearances (numbers reference items on Inspection Summary Sheet, Table 3-2)

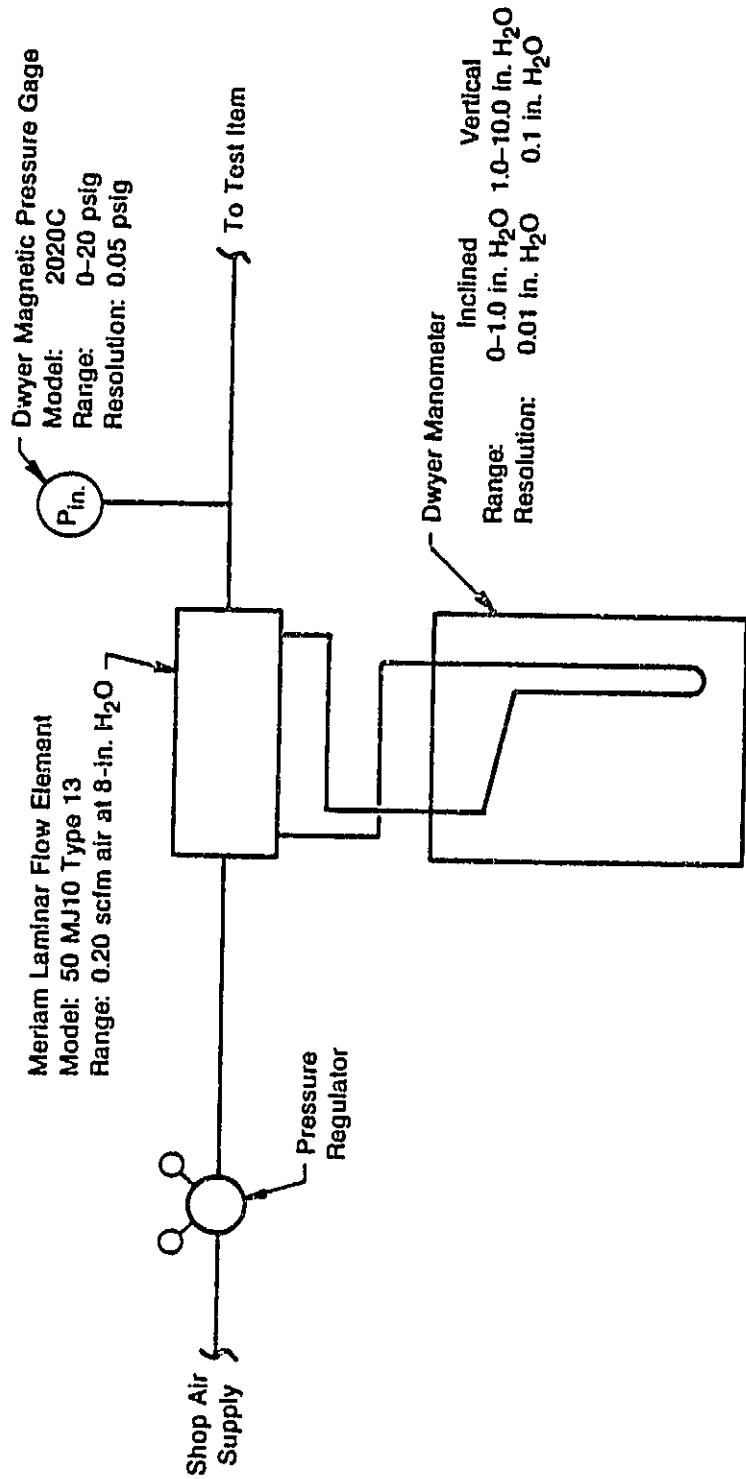
Figure 3-8 Bearing/Seal Flow Check Rig

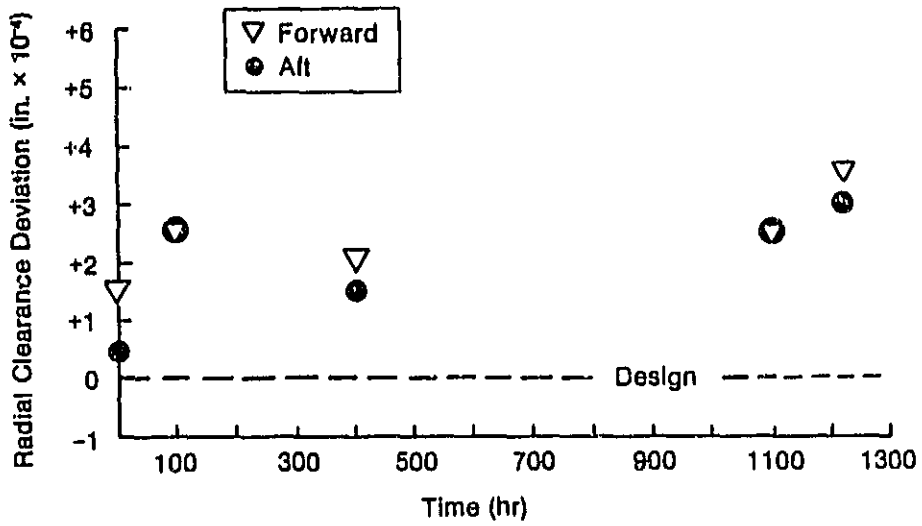
Figure 3-9 Measured Clearances - Displacer Bearings

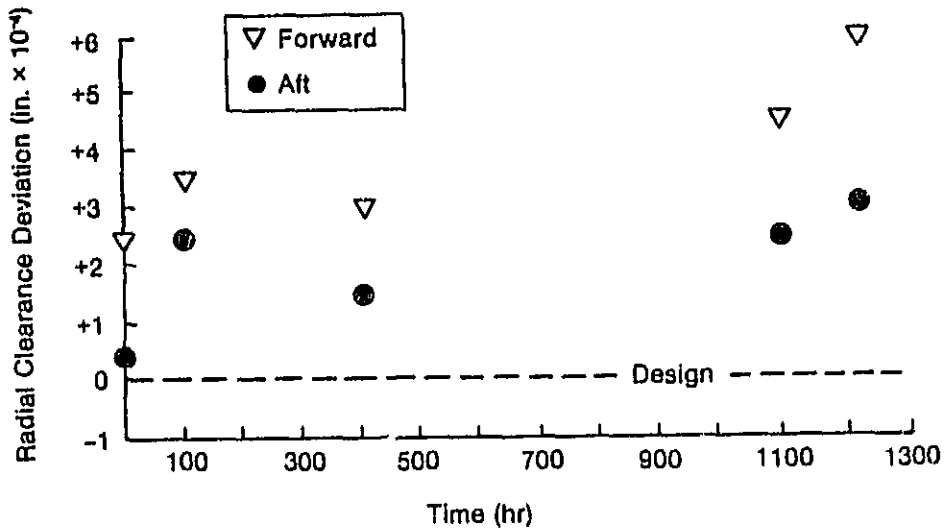
Figure 3-10 Measured Clearances - Displacer Rod Seals

The pre- and post-test inspections showed some clearance changes. Figures 3-10 through 3-15 indicate the clearance change between the initial inspection (No. 1) and the inspection at the end of 100 hours (No. 3). Table 4-2 summarizes these particular measurements. Most of the clearance changes were on the order of the measurement resolution. The displacer forward and aft bearing clearance, forward displacer gas spring clearance, and displacer bearing seal, however, appear to be significant. The motor clearance seal actually decreased during the test, which may be due to shrinkage of the phenolic liner. There was some heat discoloration of the liner. The increase in the displacer bearing clearance is not substantiated by the bearing flow check, which indicated a slight decrease in clearance. The other clearances, while significant, could not be checked against independent measurements. These would tend to increase the respective gas spring losses and, consequently, displacer motor power. However, displacer motor power and respective gas spring measured losses only increased slightly during the 100-hour test.

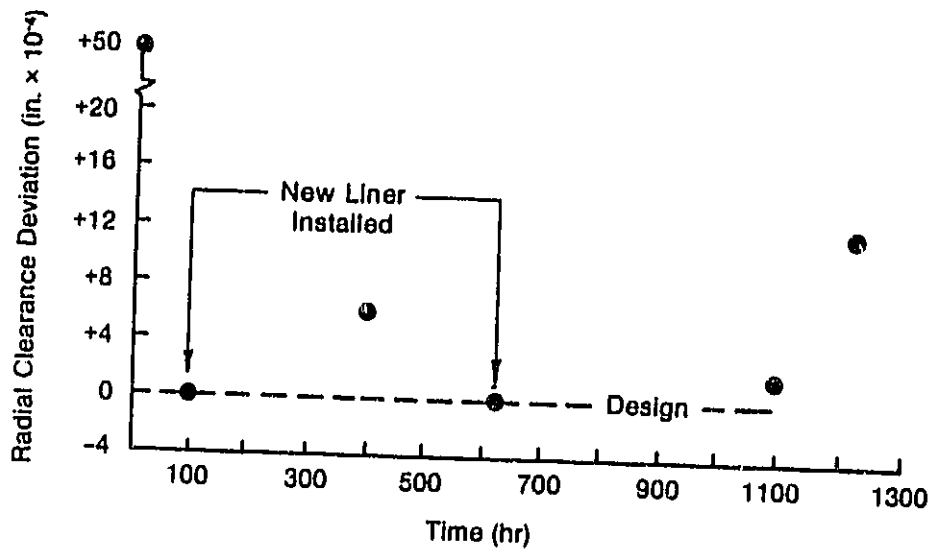
Figure 3-11 Measured Clearances - Displacer Motor Seal

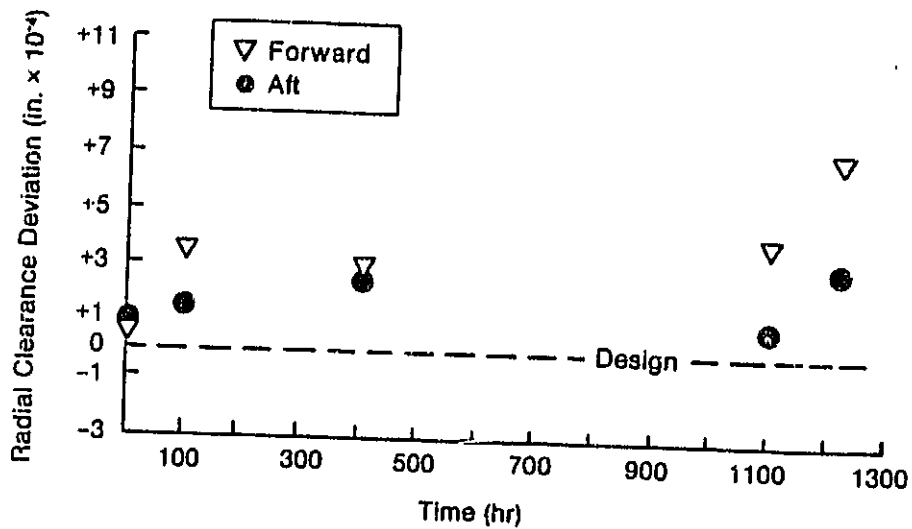
Figure 3-12 Measured Clearances - Gas Spring Seals

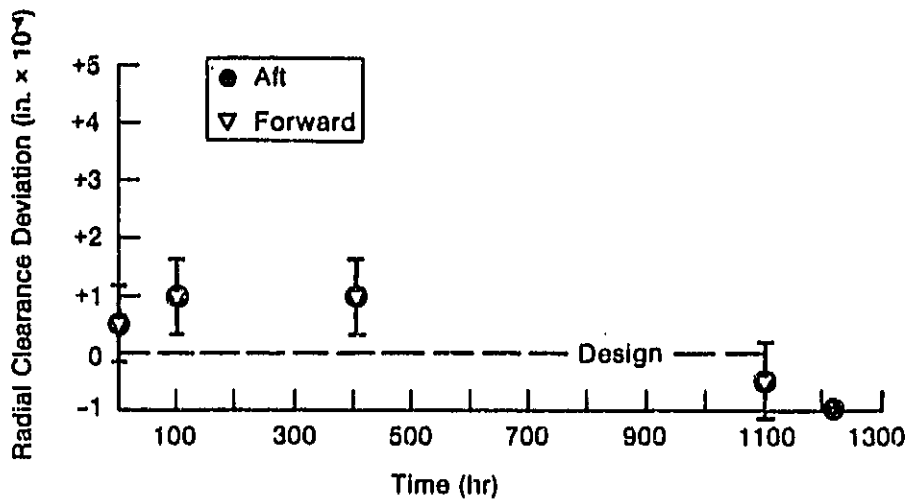
Figure 3-13 Measured Clearances - Power Piston Bearings

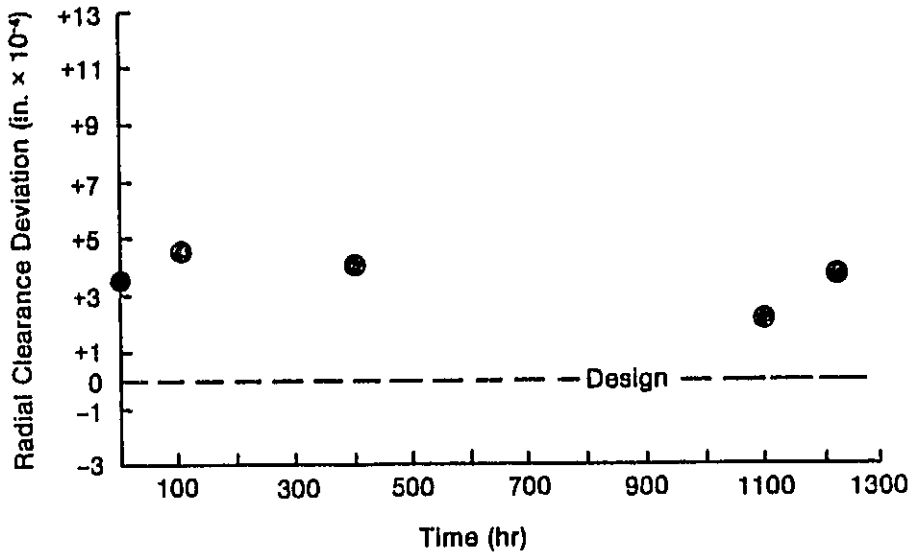
Figure 3-14 Measured Clearances - Power Piston Seal

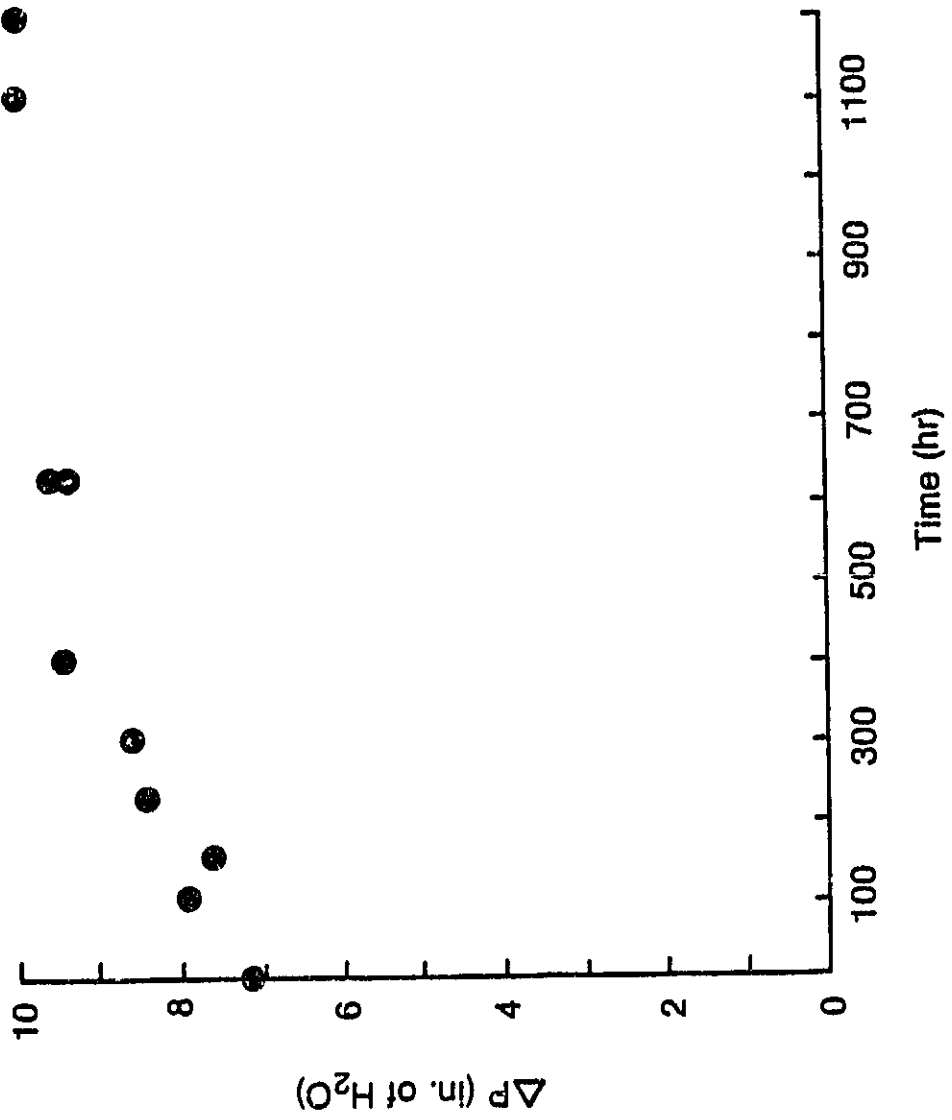
Figure 3-15 System Bearing Flow

The engine hardware was modified to add a check valve that would pump working fluid from the engine compression space to the bearing supply plenum. The check valves are based on a commercially available o-ring check valve in which an o-ring expands radially when the valve opens, then springs back into a groove to close. The power piston and cylinder were also modified to increase the mid-stroke port area and to enlarge the passages between the ports and bounce space. The initial

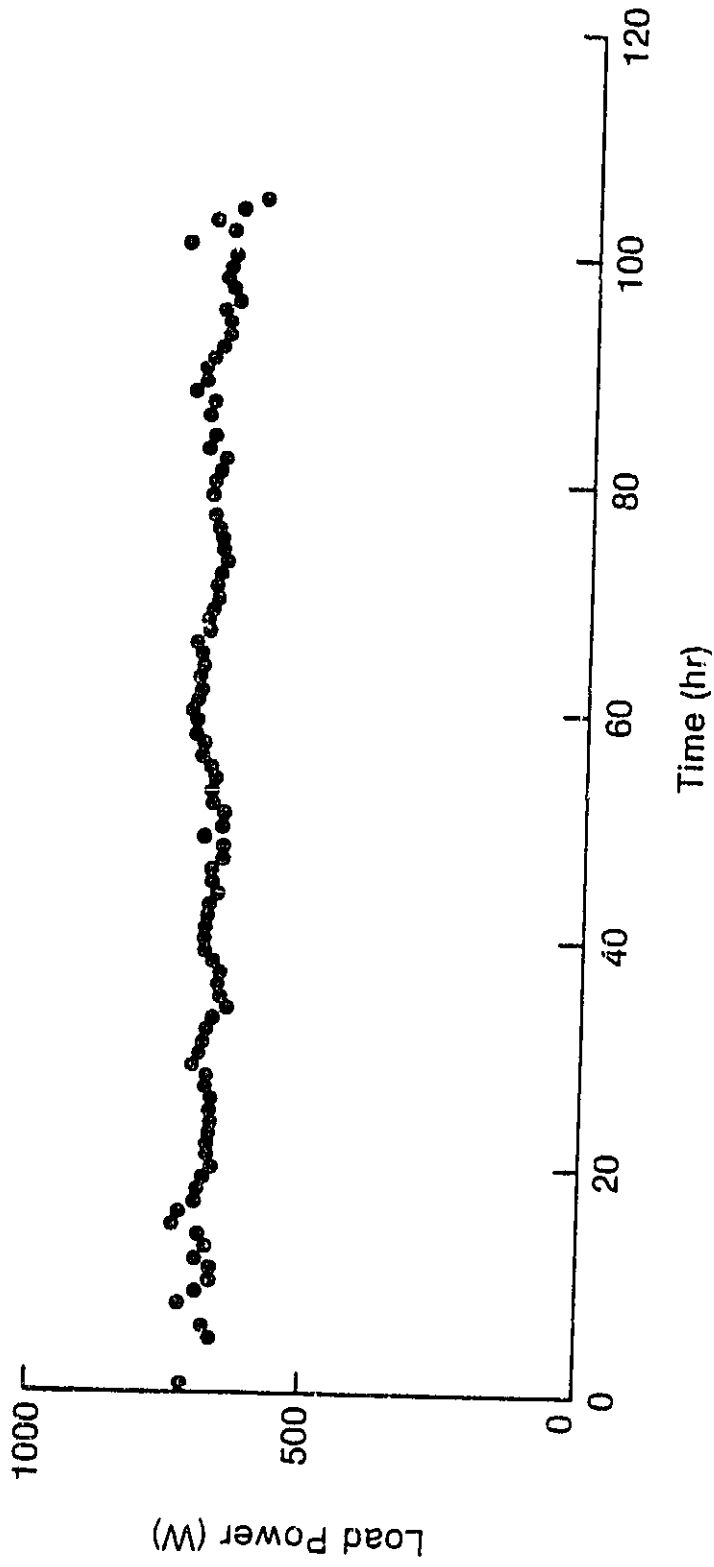
Figure 4-1 Power Output During Phase I (Low Power) Testing

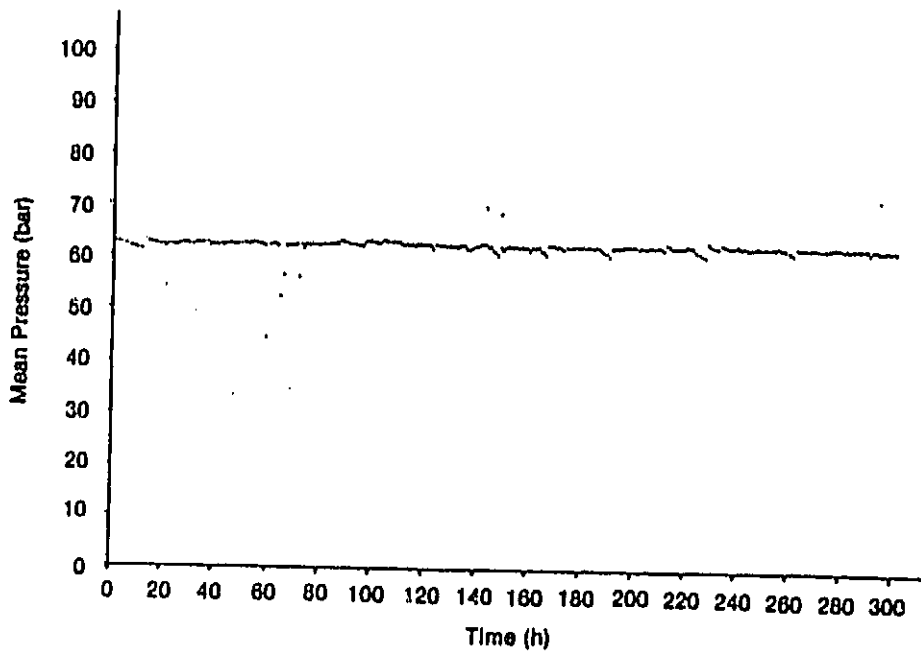
Figure 5-1 300-Hour Full-Stroke Test  
Mean Pressure versus Time

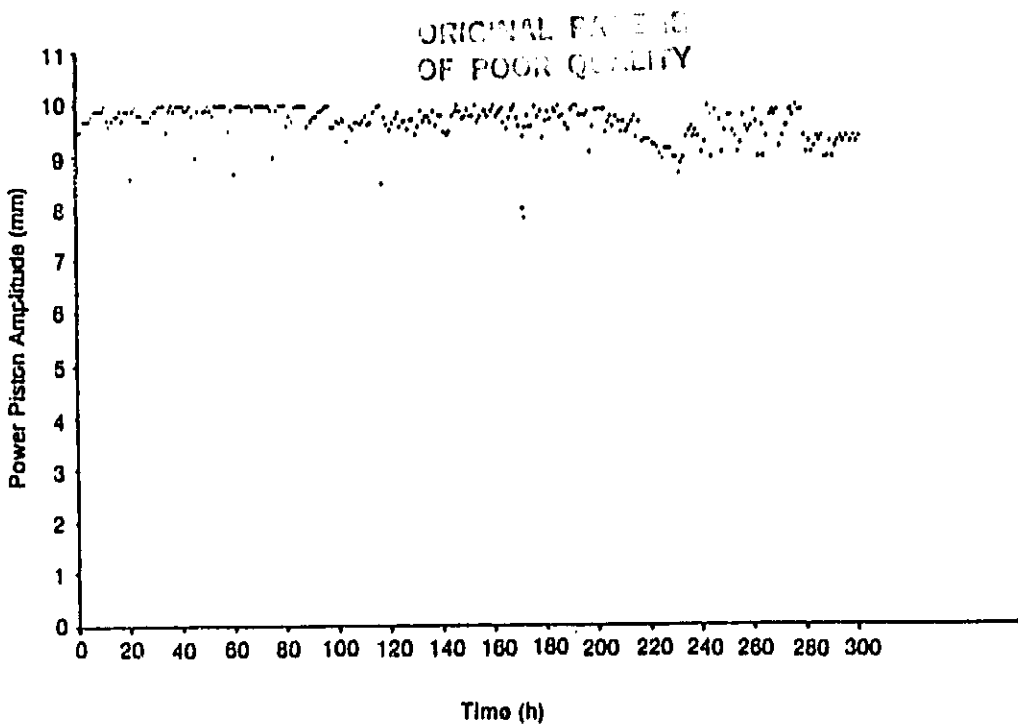
Figure 5-3 300-Hour Full-Stroke Test  
Power Piston Amplitude versus Time

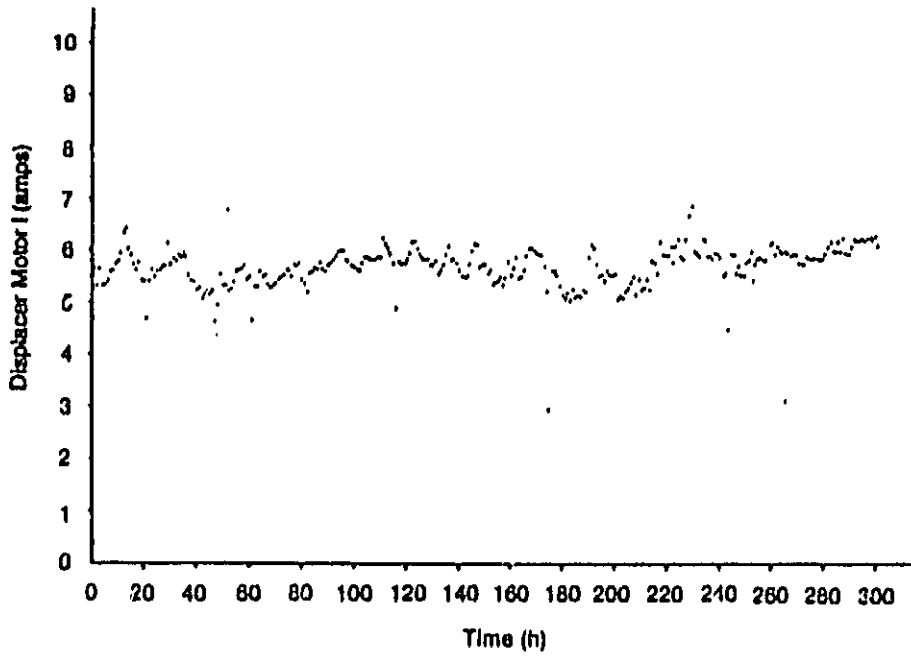
Figure 5-5 300-Hour Full-Stroke Test  
Displacer Motor Current versus Time

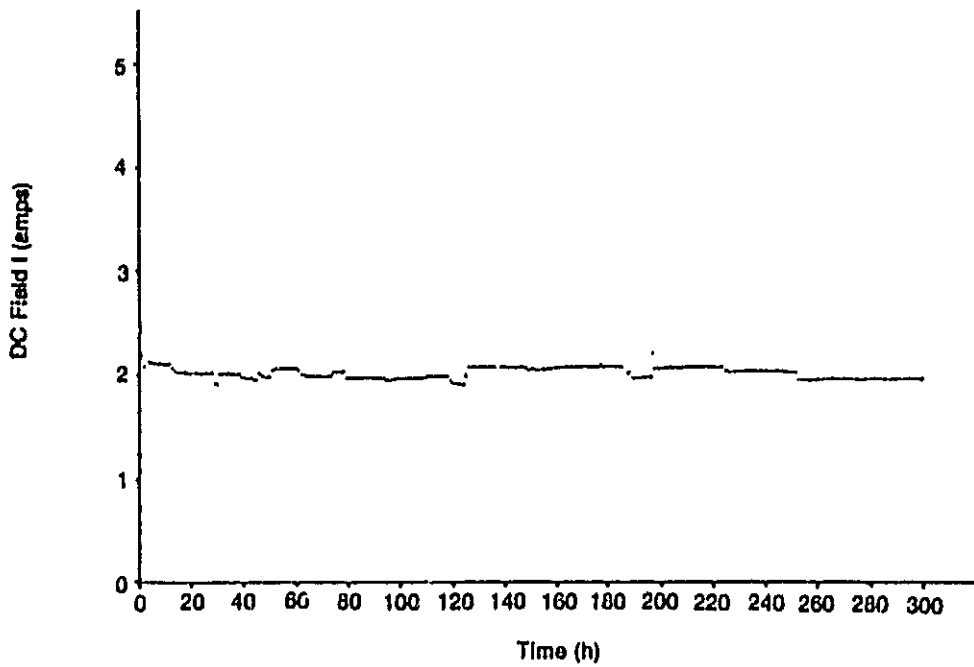
Figure 5-6 300-Hour Full Stroke Test  
DC Field Current versus Time

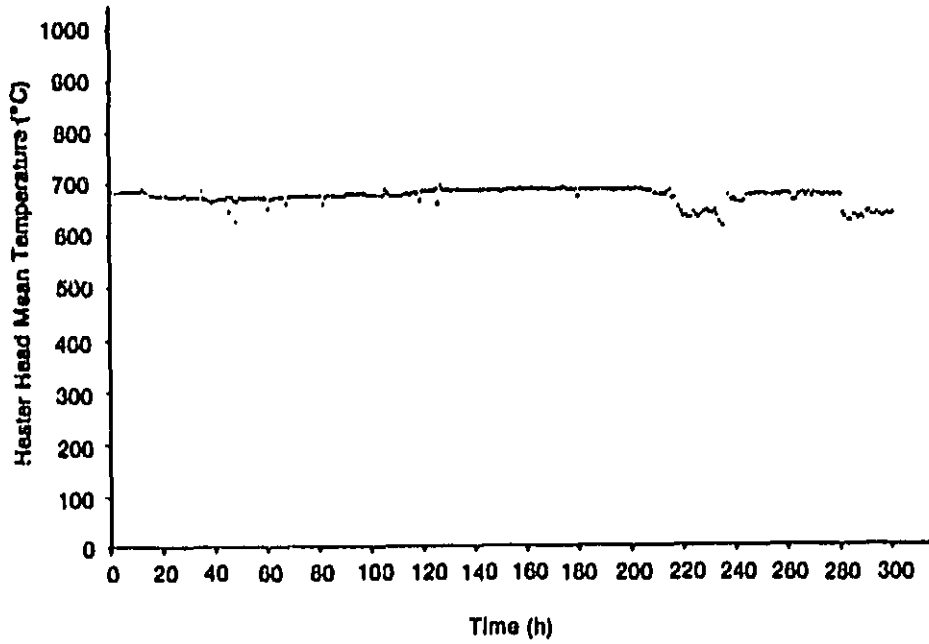
Figure 5-7 300-Hour Full-Stroke Test  
Heater Head Mean Temperature versus Time

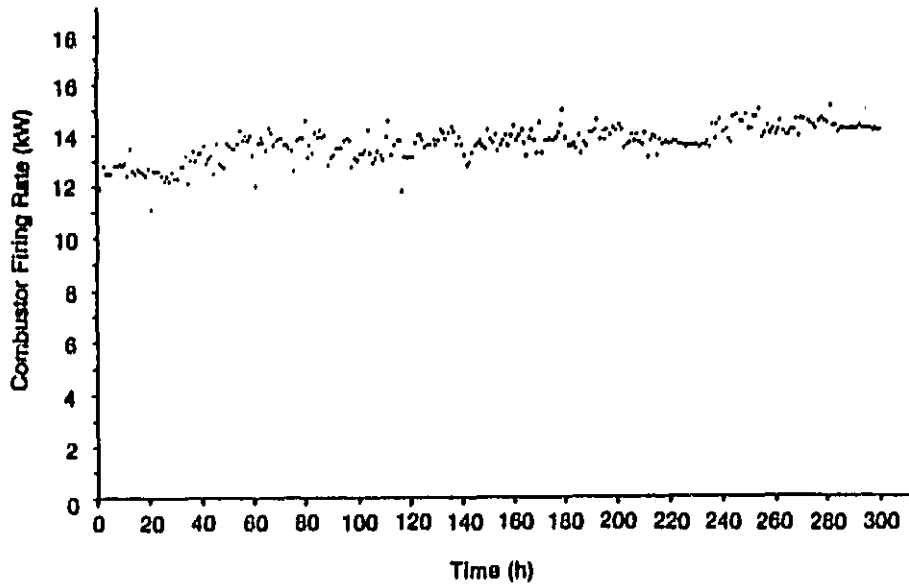
Figure 5-8 300-Hour Full Stroke Test  
Combustor Firing Rate versus Time

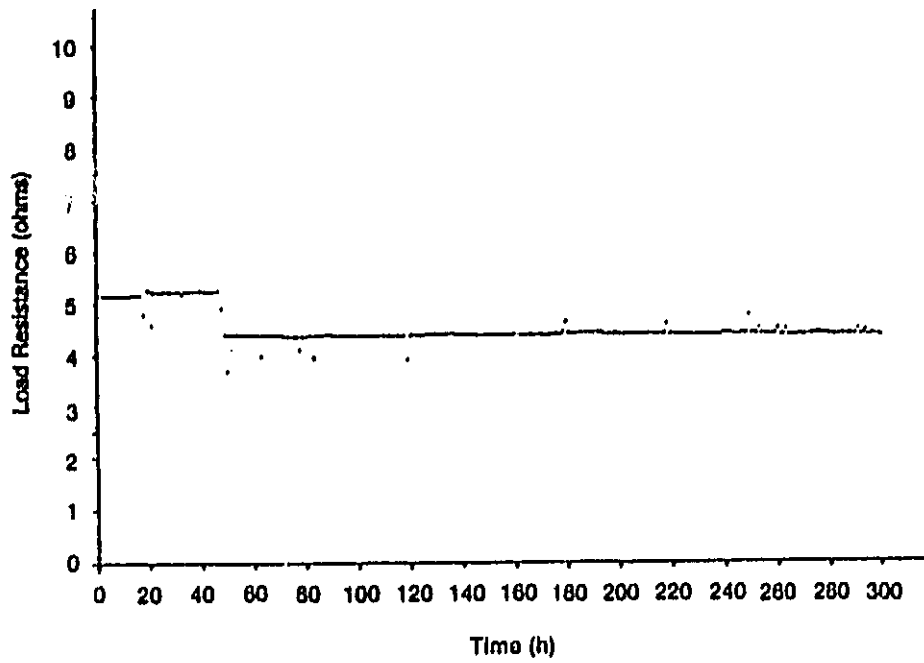
Figure 5-9 300-Hour Full-Stroke Test  
Load Resistance versus Time

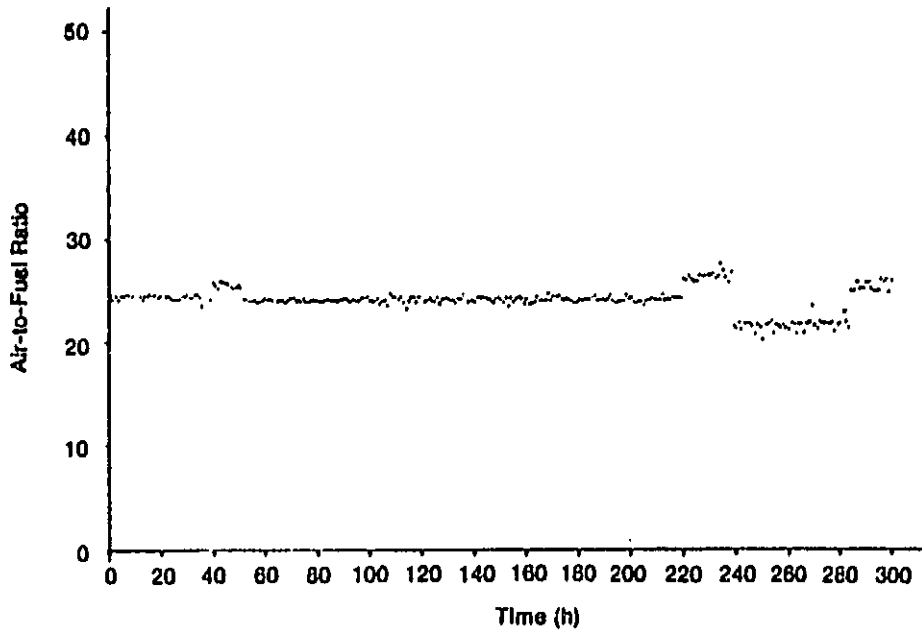
Figure 5-10 300-Hour Full-Stroke Test  
Combustor Air to Fuel Ratio versus Time

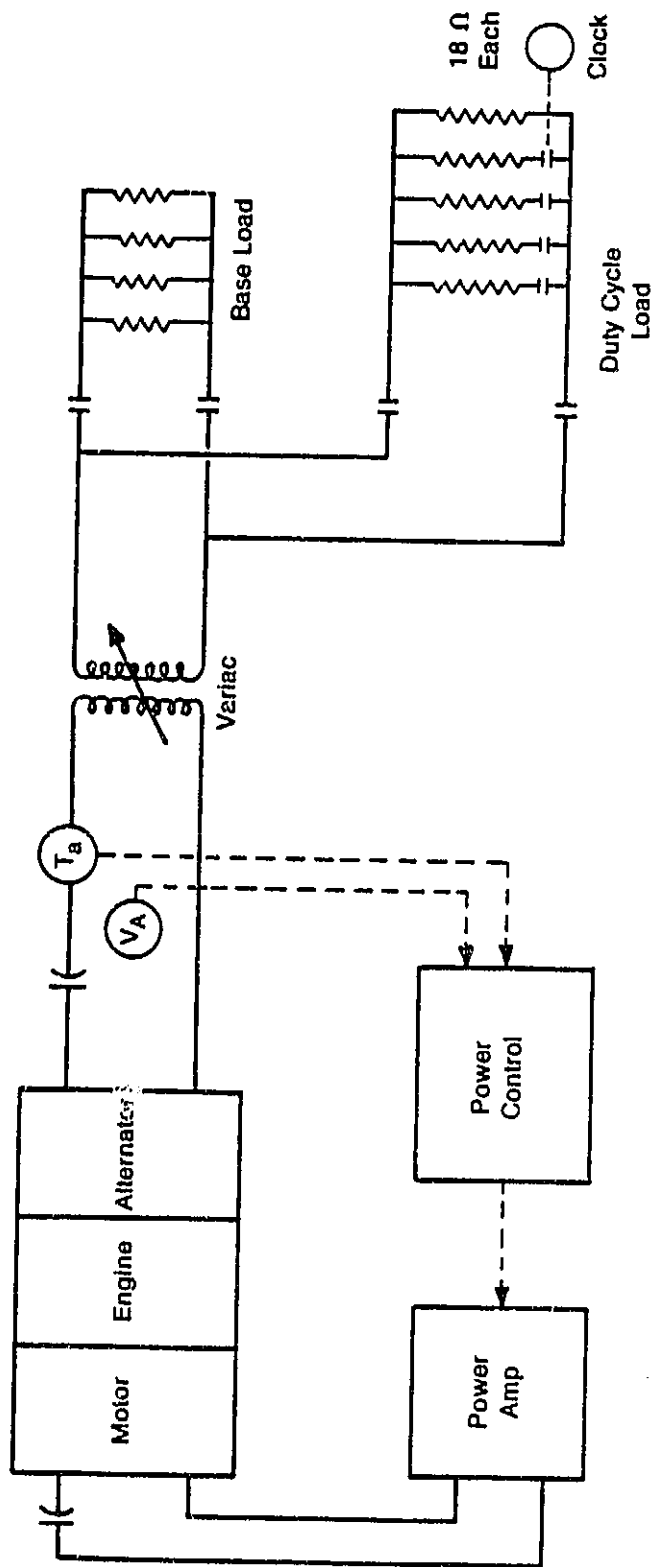
Figure 6-1 Duty Cycle Load Schematic

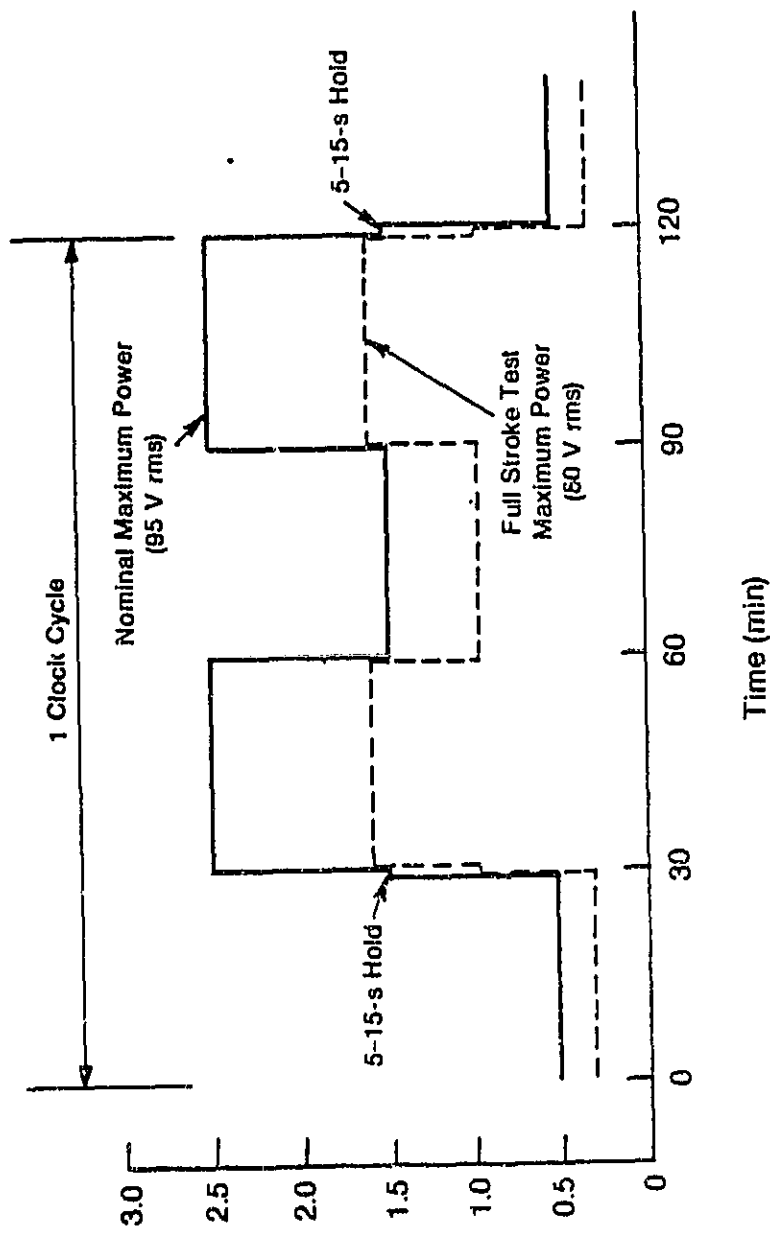
Figure 6-2 Duty Cycle Test Cycle

The large load changes (20 to 100% and 100 to 20% steps) are provided with a 5-15 second delay at the 60% load level. This reduced the impact of these large load changes. The engine and control responded very well to the duty-cycle load changes. The output voltage was maintained very consistently, with little or no overshoot during load change .

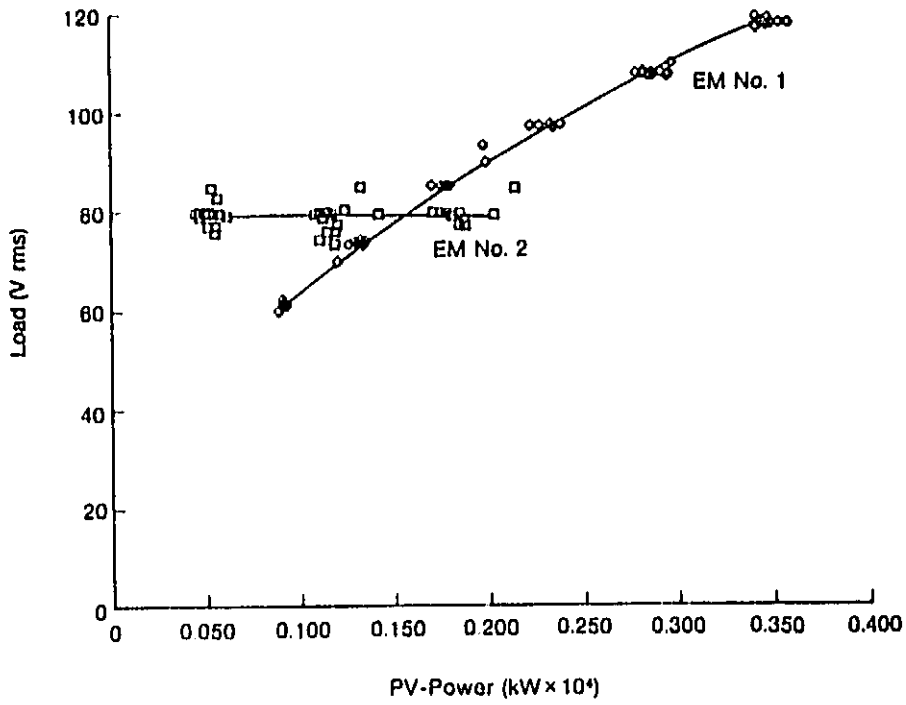
Figure 6-3 EM #2 Operation -  $V_{Load}$  versus PV Power

Performance of the two EM engines is compared in Figures 6-3 through 6-17 at various power levels. EM No. 2 was operated at constant load voltage and various load impedances (Figure 6-3), while EM No. 1 was operated at a constant load impedance and various voltage levels. The power piston amplitudes necessary to produce the desired output voltages (Figure 6-4) indicate a reasonable agreement between the physical hardware and the model. The piston stroke versus power curves are different for two reasons: 1) different loading conditions; and, 2) the hardware differences in the two alternators (i.e., EM No. 2 has fewer AC turns than EM No. 1).

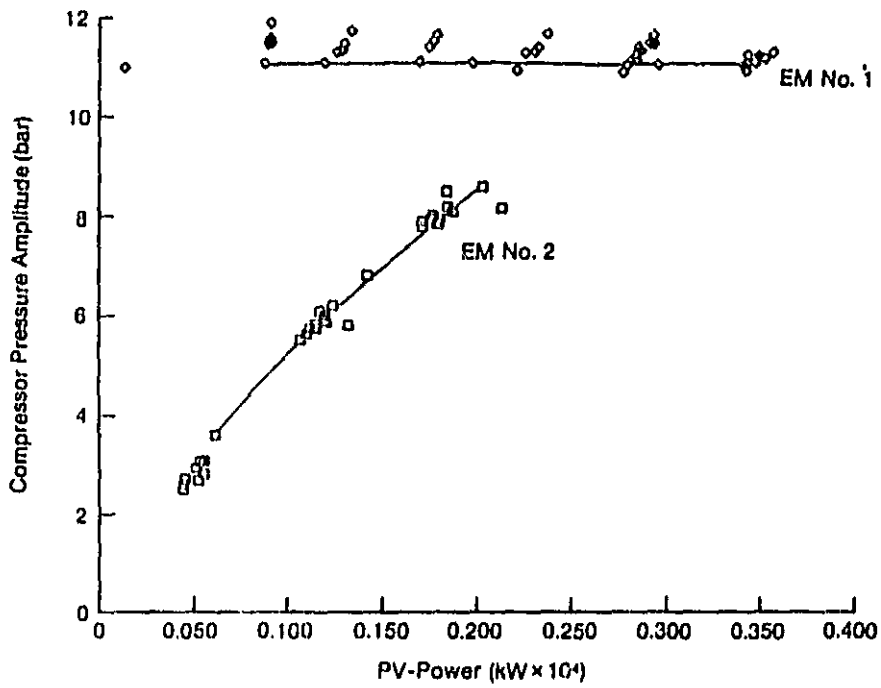
Figure 6-5 EM #2 Operation - Pressure Amplitude versus PV Power

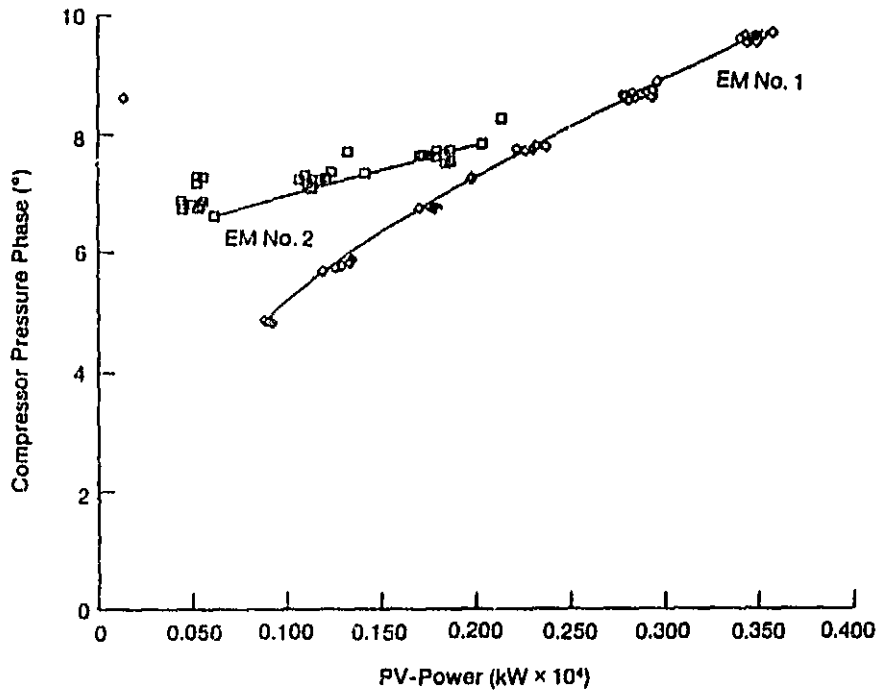
Figure 6-6 EM #2 Operation - Pressure Phase Angle versus PV Power
