DOE/NASA/0333-1  
NASA CR-174771

# Free-Piston Stirling Engine/ Linear Alternator 1000-Hour Endurance Test

Jeffrey Rauch and George Dochat  
Mechanical Technology Incorporated

Prepared for  
NATIONAL AERONAUTICS AND SPACE ADMINISTRATION  
Lewis Research Center  
Under Contract DEN 3-333

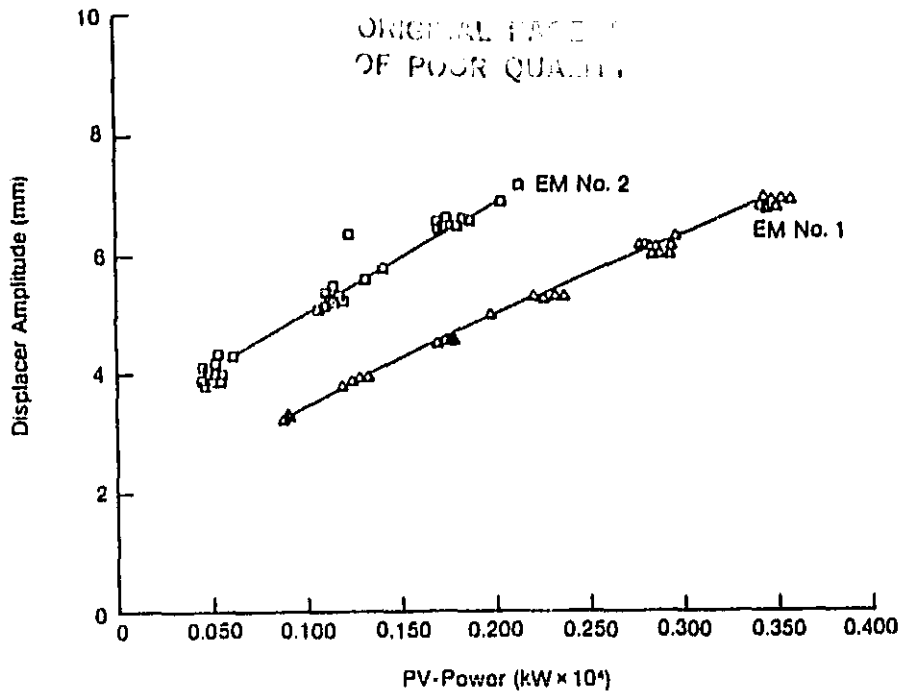
Figure 6-7 EM #2 Operation - Displacer Amplitude versus PV Power

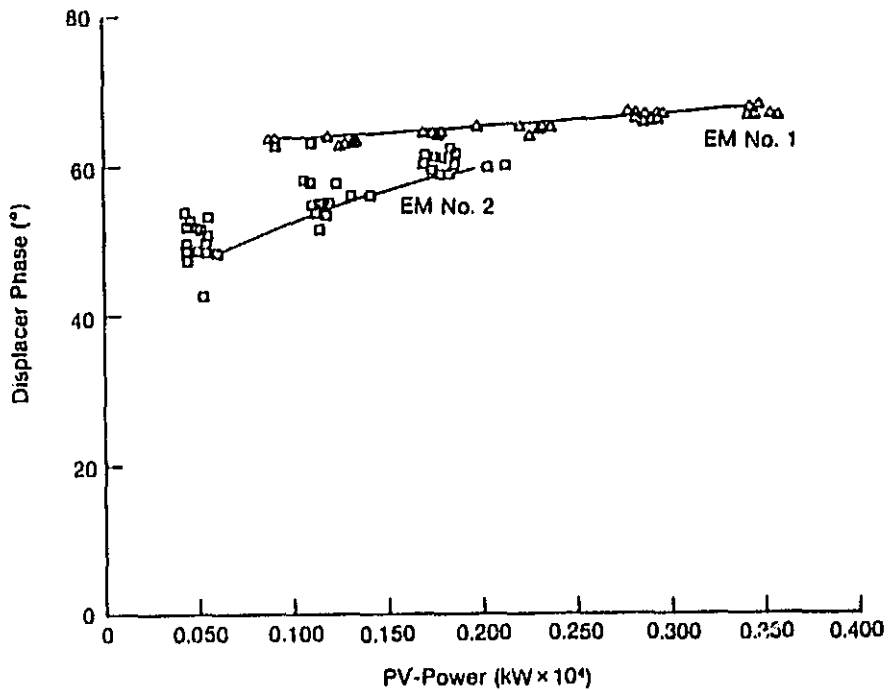
Figure 6-8 EM #2 Operation - Displacer Phase K versus PV Power

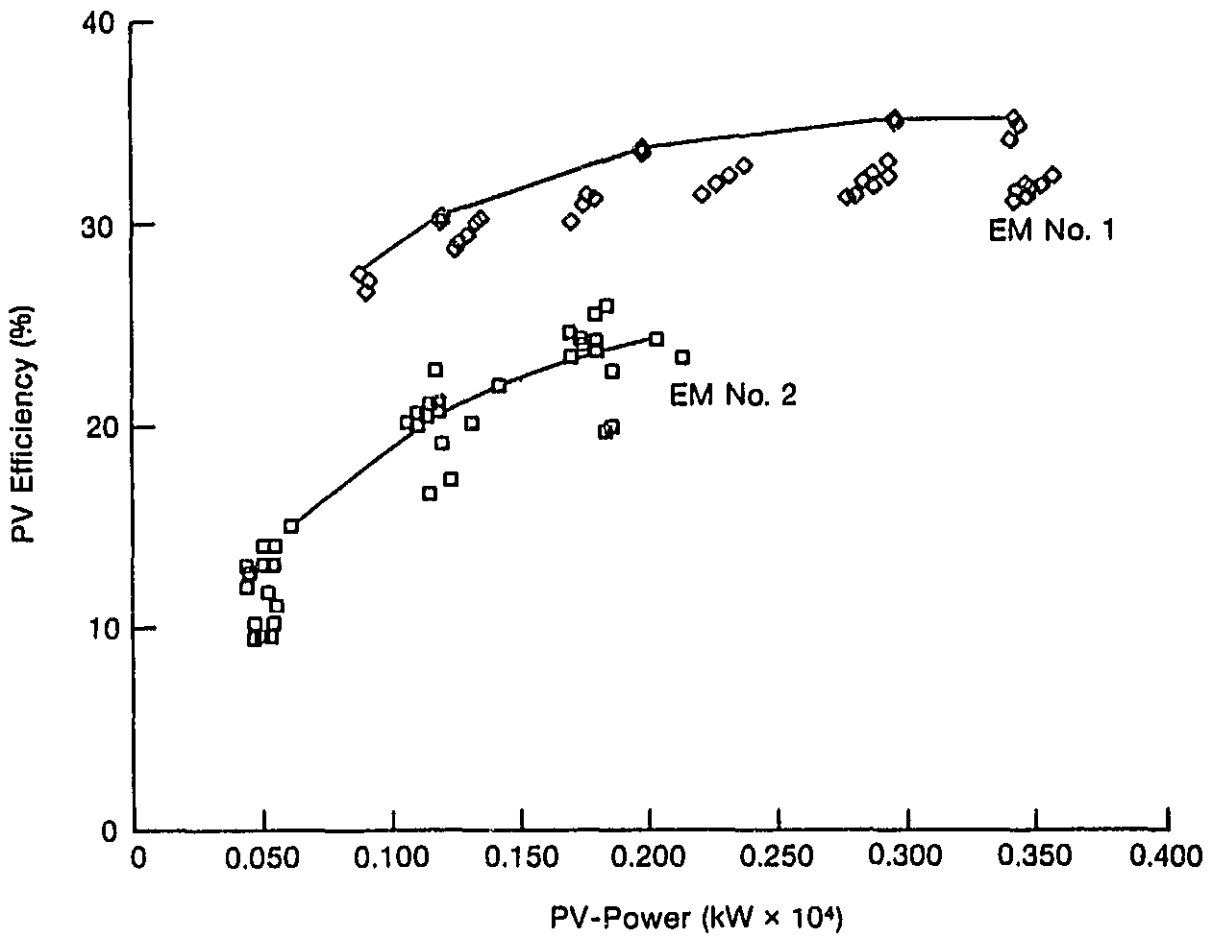
Figure 6-9 EM #2 Operation - PV Efficiency versus PV Power

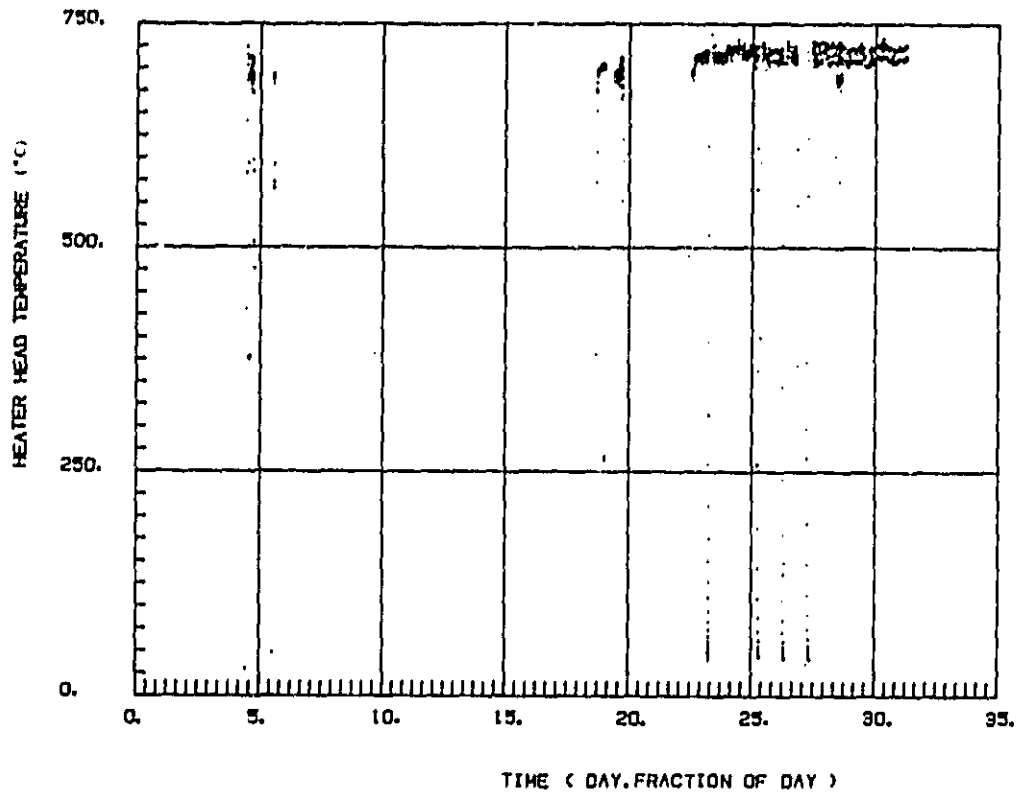
Figure 6-10 Heater Head Temperature versus Time

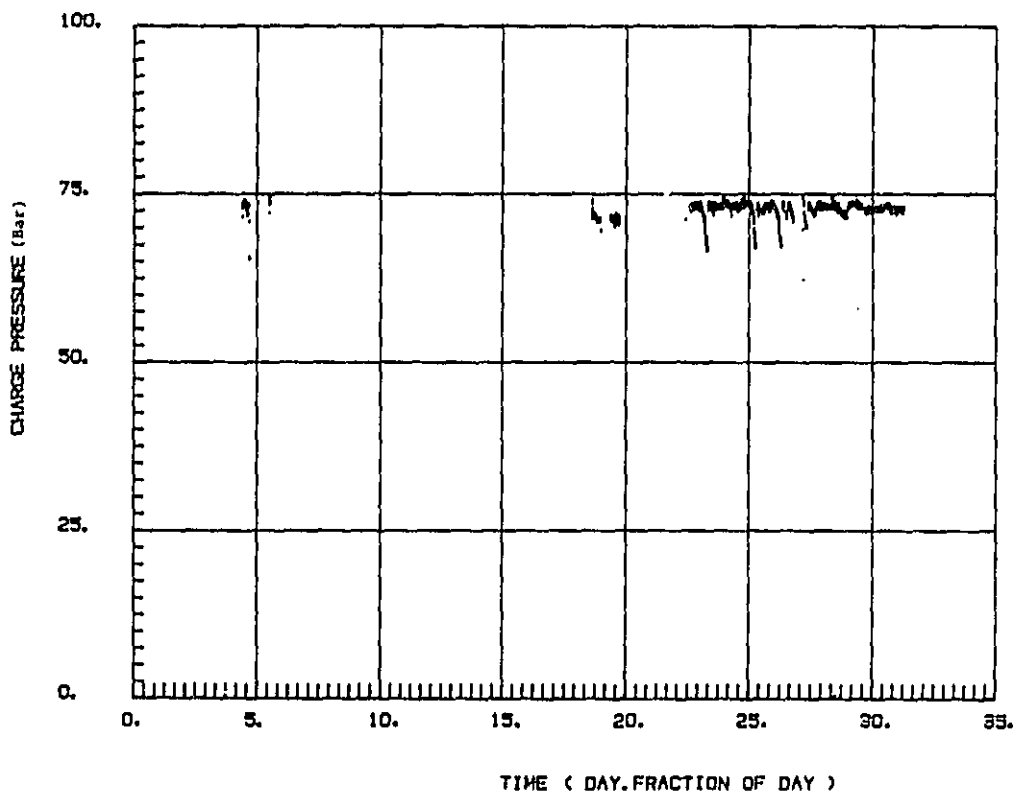
Figure 6-11 Charge Pressure versus Time

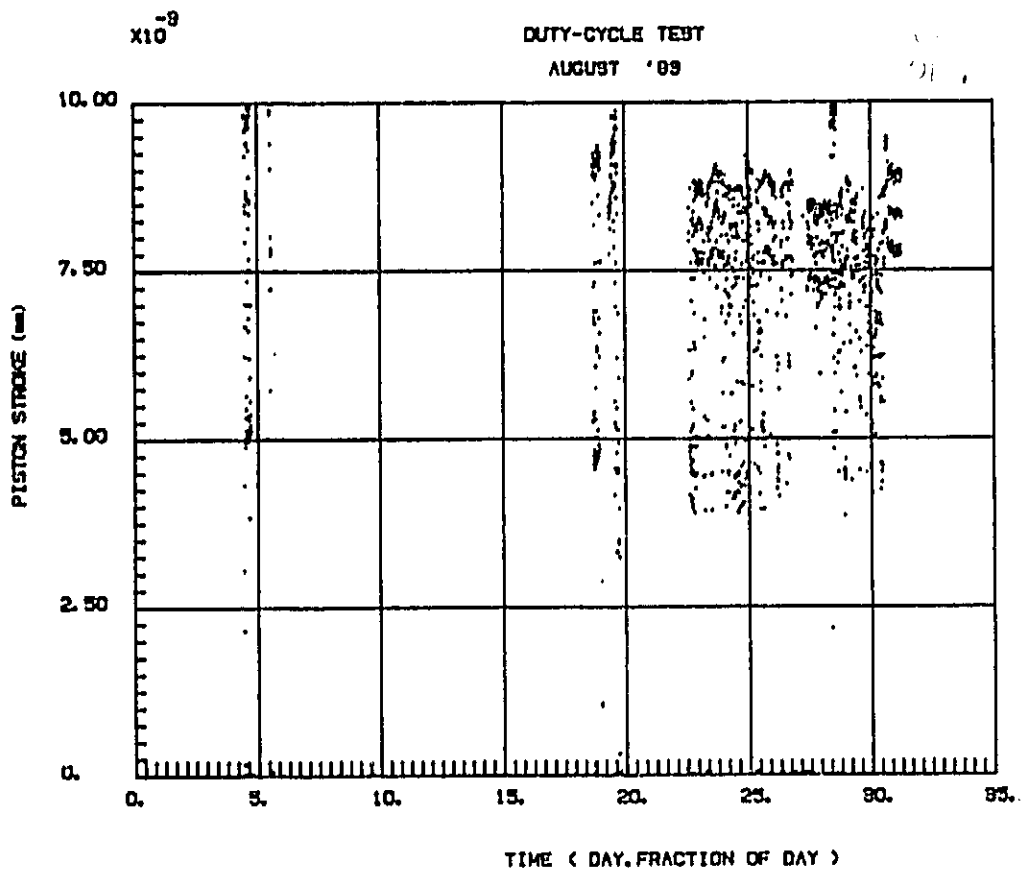
Figure 6-12 Piston and Displacer Stroke versus Time

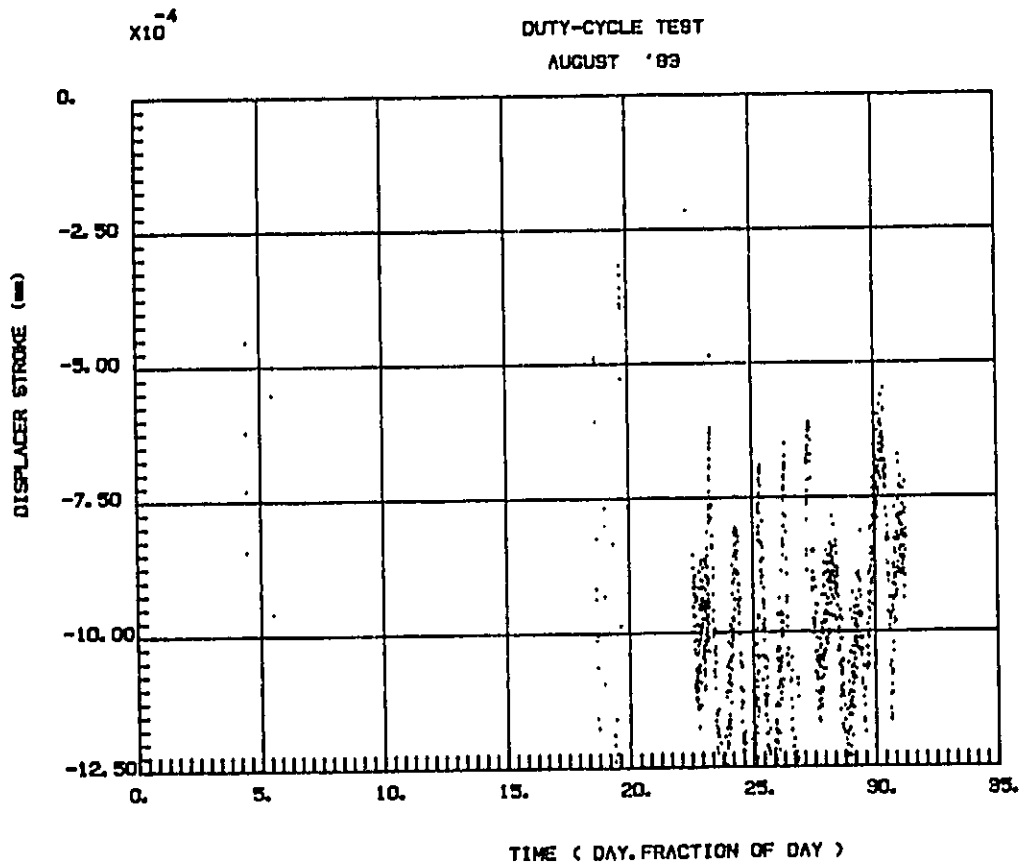
Figure 6-13 Piston and Displacer Stroke versus Time

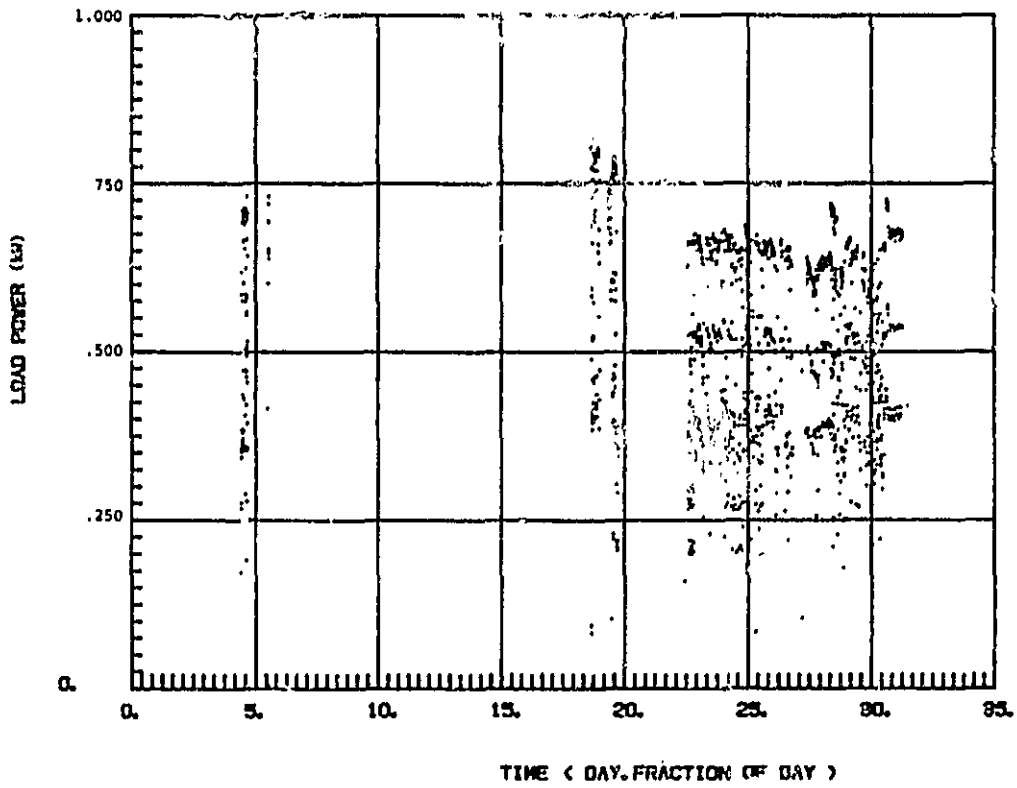
Figure 6-14 Load Power versus Time

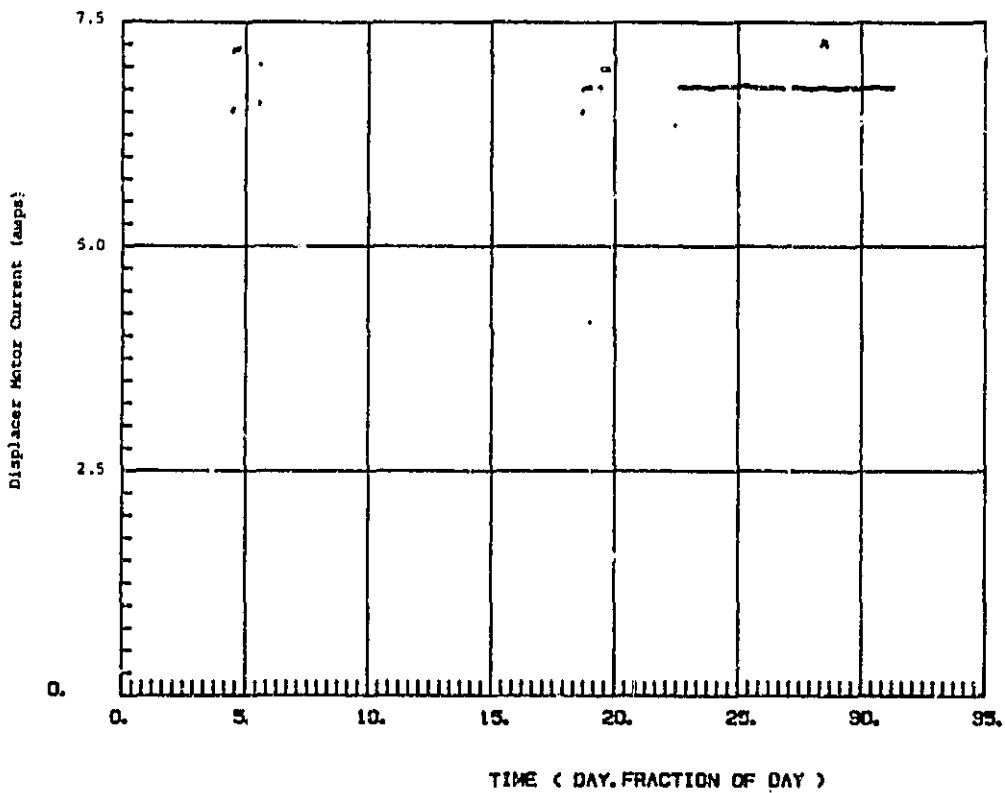
Figure 6-15 Motor Current versus Time

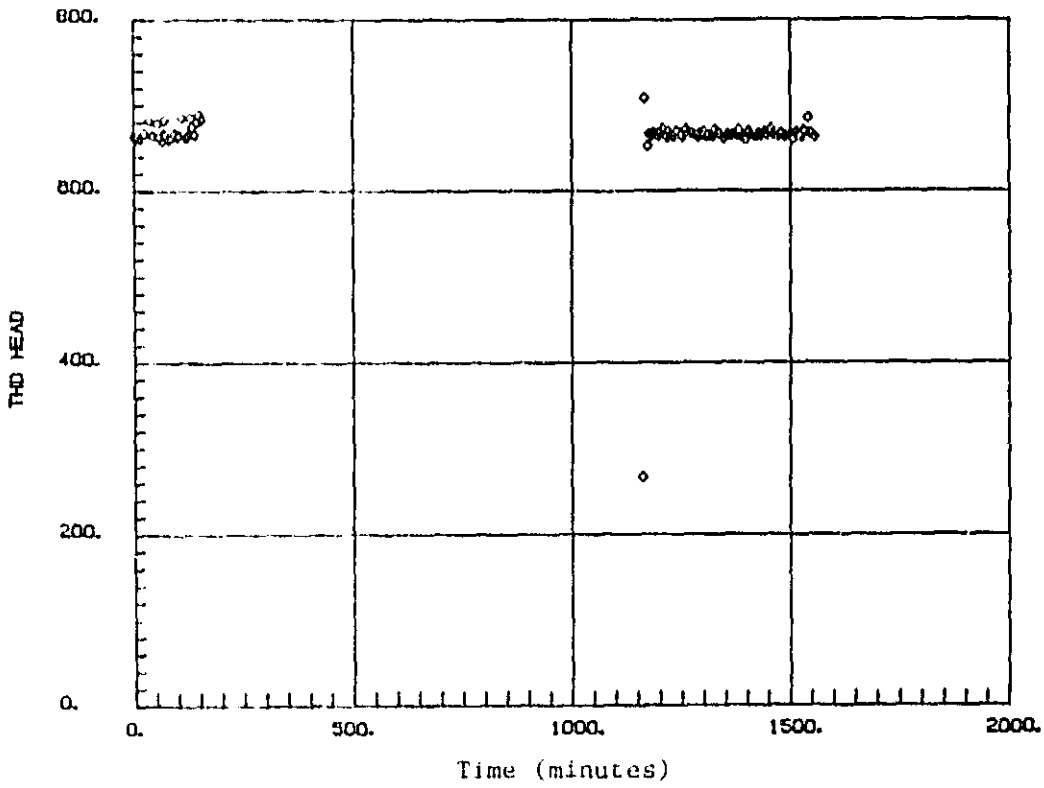
Figure 7-1 Tread Operating Range

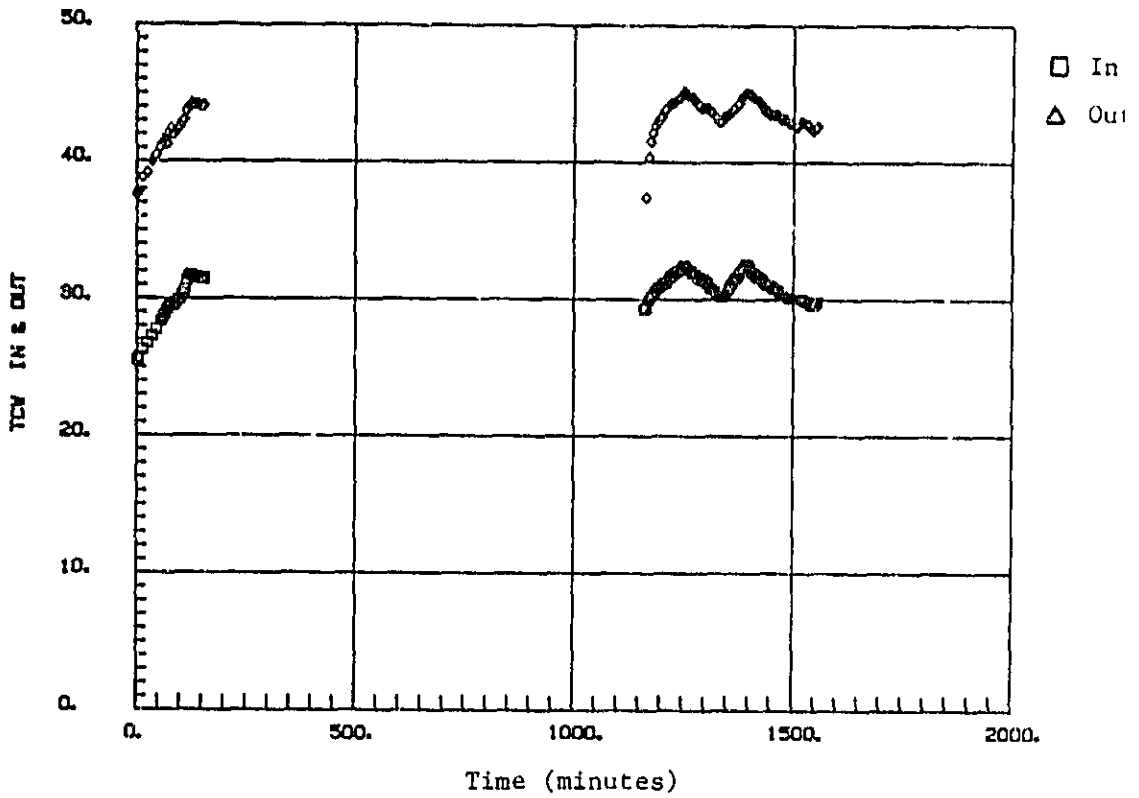
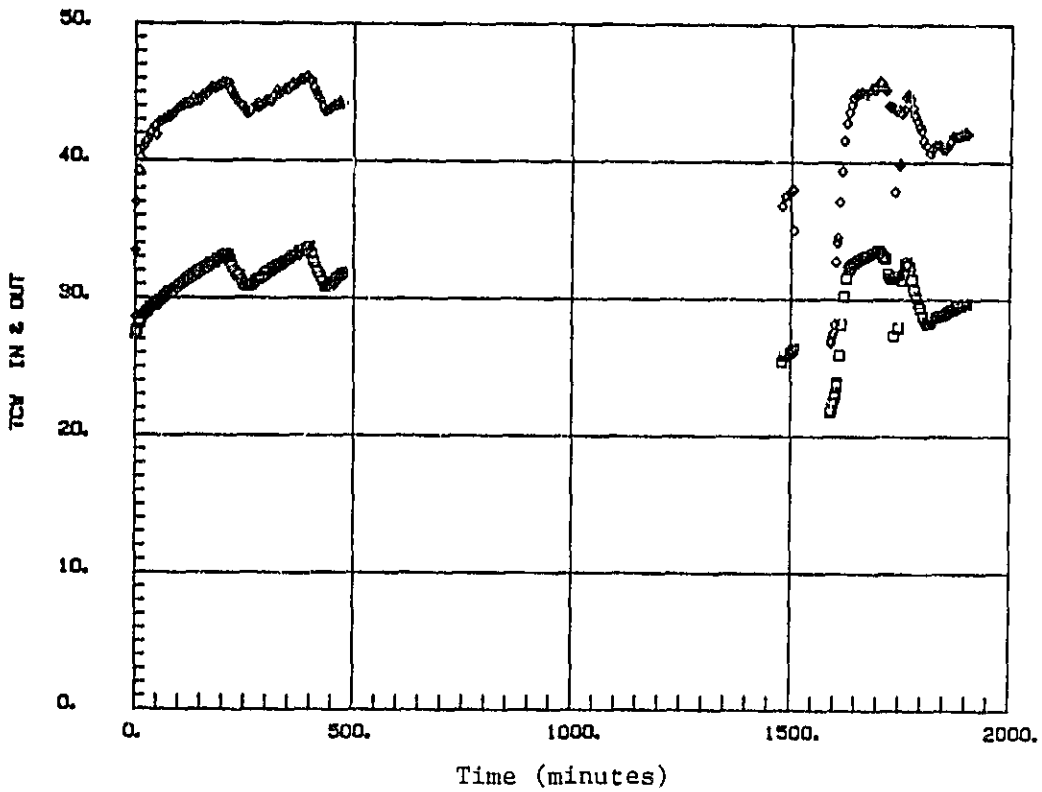
Figure 7-2 Cooling Water Temperature and Difference Operating Range

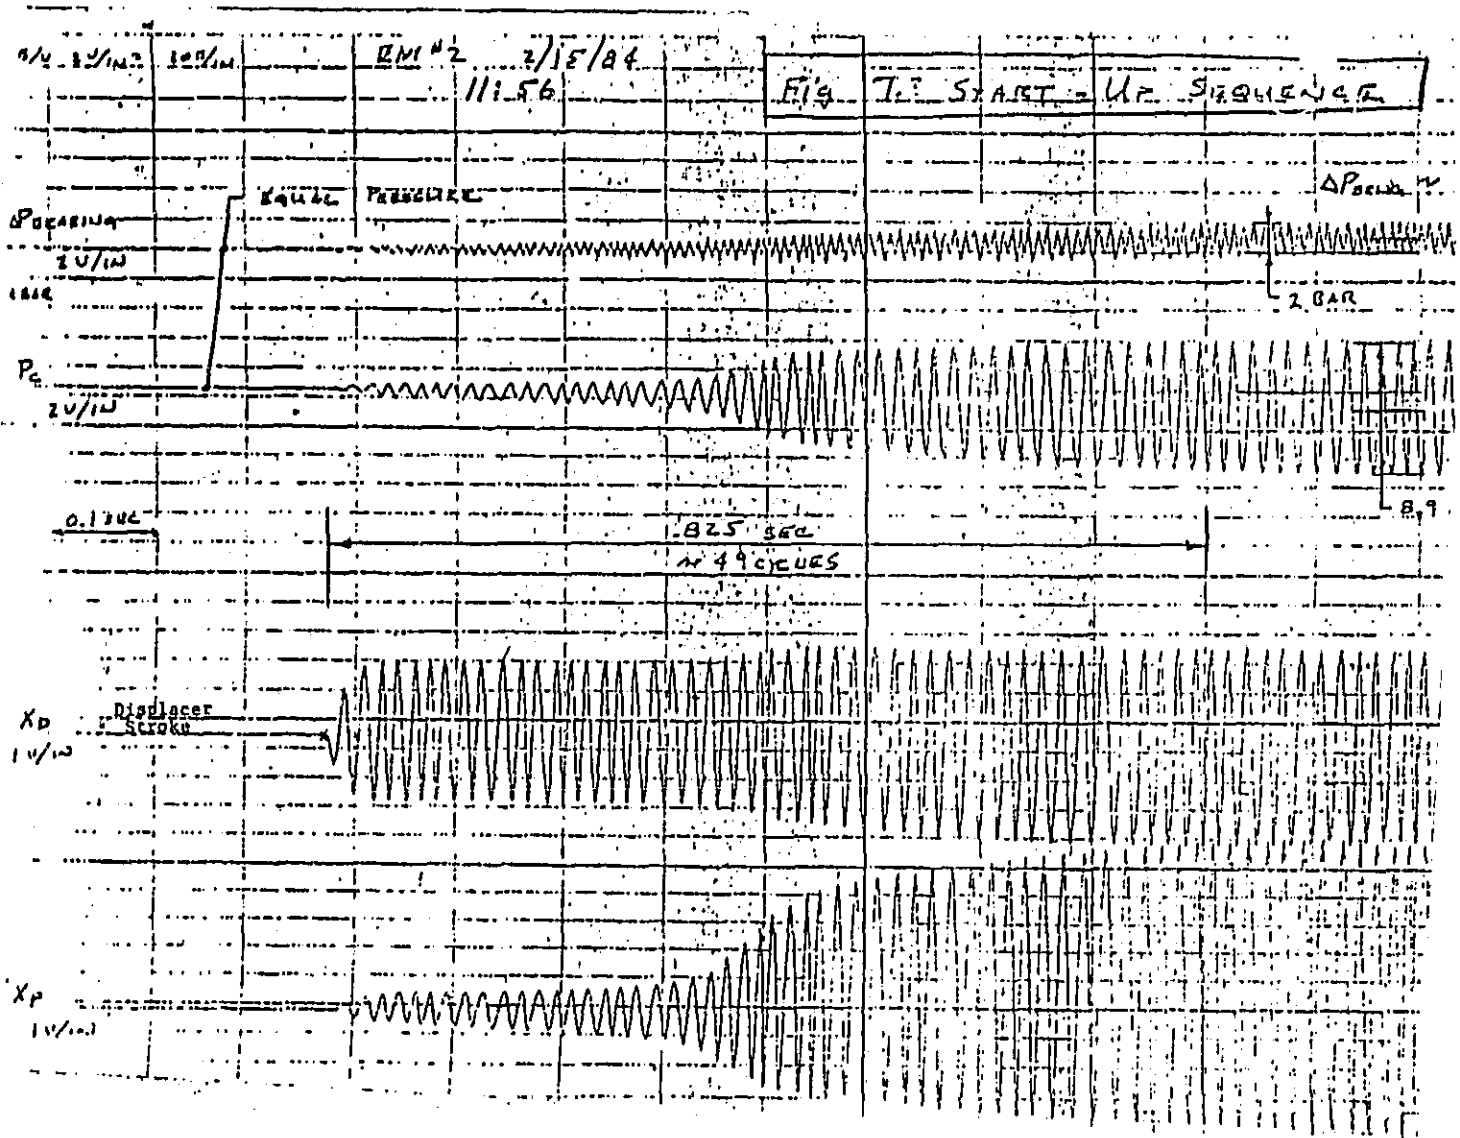
Figure 7-3 Start-Up Sequence

The delay in the piston stroke, and thus pressure amplitude, in coming up to stroke is due to the additional leakage loss of the mid-stroke ports. When the stroke increases to the point where the ports begin to close, the leakage loss drops relative to the stroke and reduces the load on the thermodynamic cycle, thus making more energy available for driving the power piston.

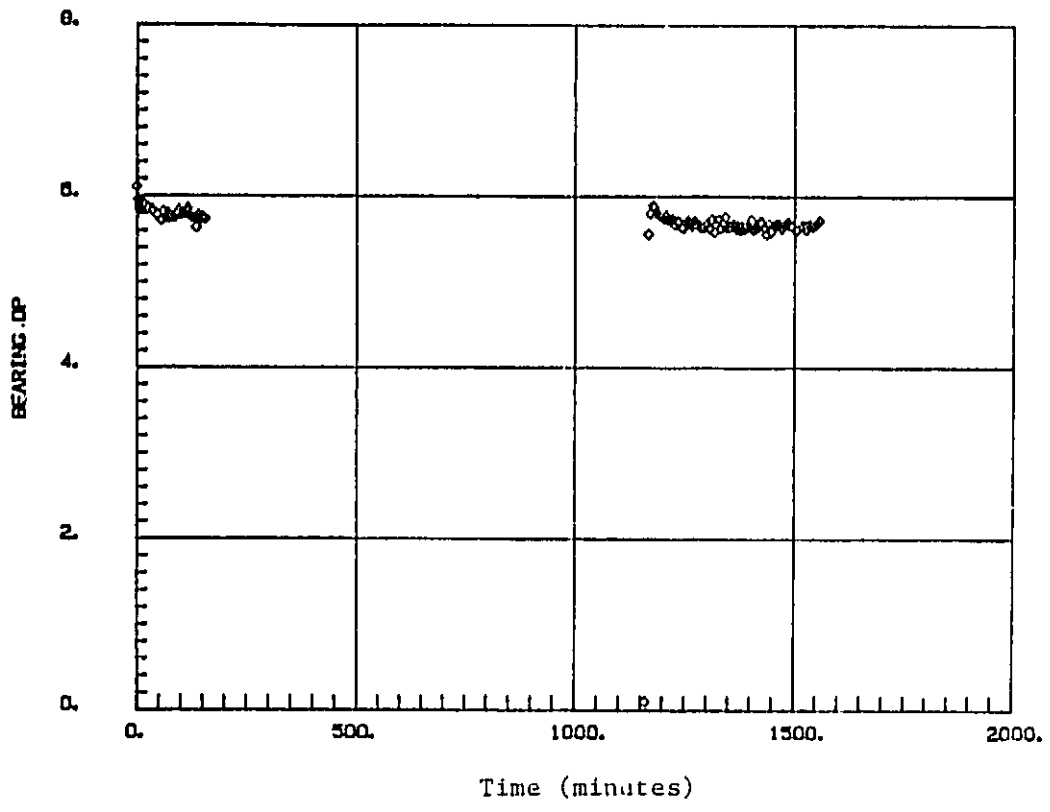
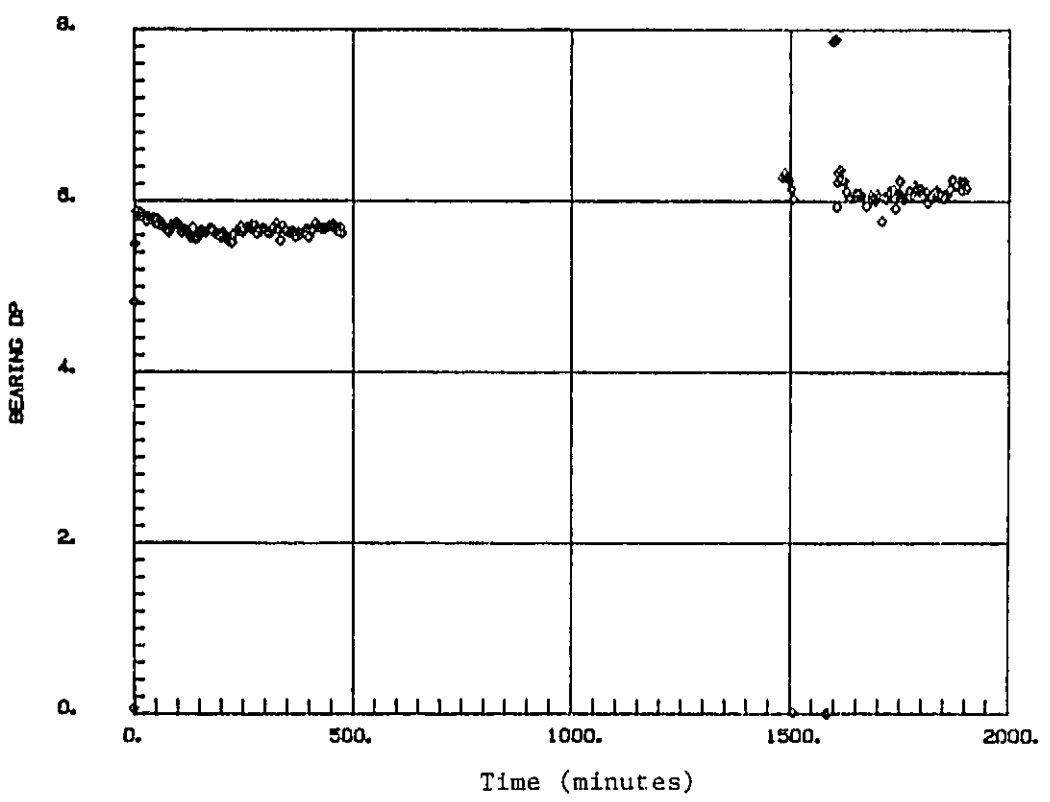
Figure 7-4  $\Delta P_{\text{bearing}}$  Operating Range

The steady state bearing  $\Delta P$  (Figure 7-4) was relatively constant during the first three days. On 21 February 1984, the bearing check valve system was modified to improve the tuning, and thus the bearing supply pressure. The bearing pressure was increased from 5.7 to 6.1 Bar.

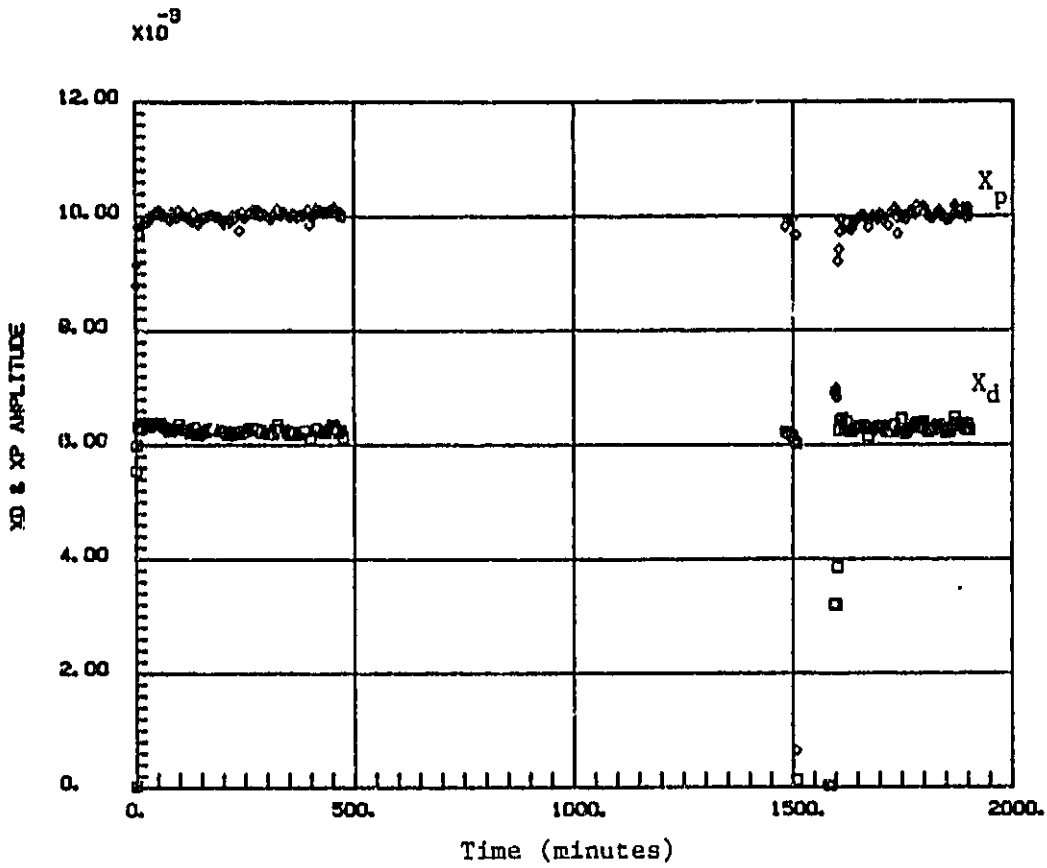
Figure 7-5 Displacer ( $X_d$ ) and Power Piston ( $X_p$ ) Amplitude Operating Range

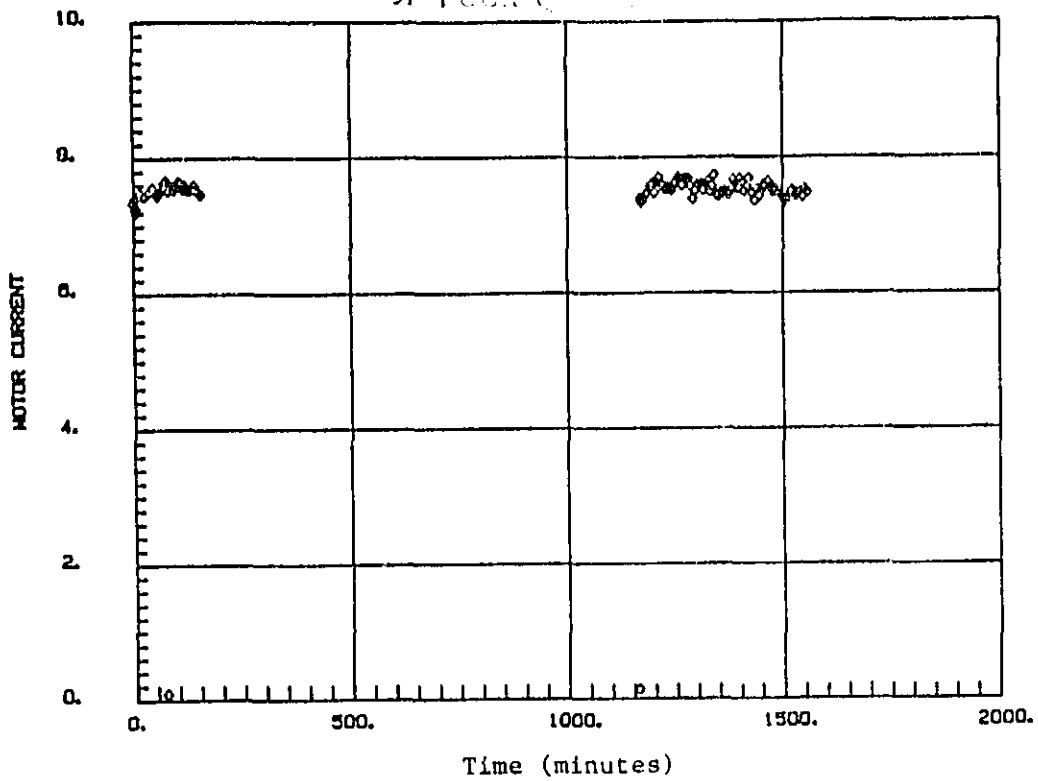
Figure 7-6 Displacer Motor Current Operating Range

The motor current (Figure 7-6) is proportional to the force that the motor imposes on the displacer and is the most sensitive to changes in dynamic or thermodynamic losses. This is evident by the scatter in the current during the first three days of testing compared to other parameters, such as piston and displacer amplitude. The data from 15 February 1984 indicates a potential increase in losses during the first hour of operation, after which the current dropped to the same as the previous two days of testing. The data from 21 February 1984 exhibits more scatter than was observed on 13-15 February 1984. This may be an indication of intermittent increases in losses which may be an early indication of engine degradation. Subsequent engine inspection indicated rubbing between the displacer rod and the bearing it runs in, and could explain the intermittent high current observed in the test data.
