(NASA-TM-87007) EFFECTS OF WEAR ON  
STRUCTURE-SENSITIVE MAGNETIC PROPERTIES OF  
CERAMIC FERRITE IN CONTACT WITH MAGNETIC  
TAPE (NASA) 26 p HC A03/MF A01 CSCL 11G

# Effects of Wear on Structure-Sensitive Magnetic Properties of Ceramic Ferrite in Contact with Magnetic Tape

Kazuhisa Miyoshi and Donald H. Buckley  
*Lewis Research Center  
Cleveland, Ohio*

Prepared for the  
Tribology Conference  
cosponsored by the American Society of Lubrication Engineers  
and the American Society of Mechanical Engineers  
Atlanta, Georgia, October 8-10, 1985

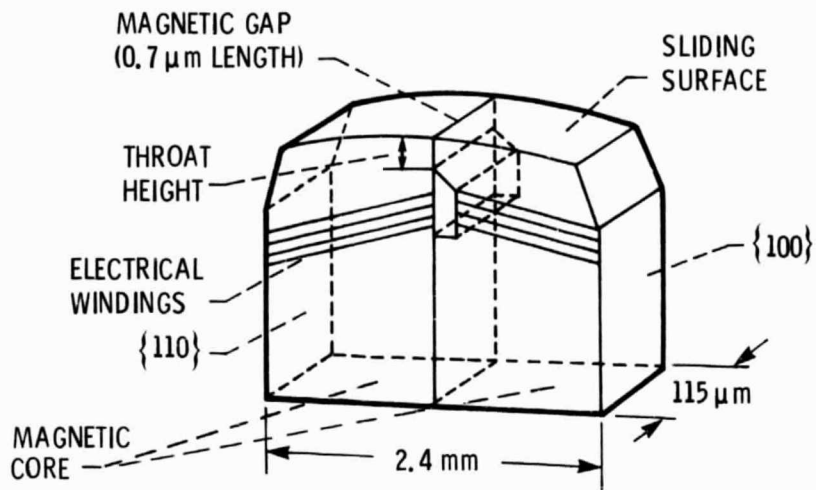
(a) Magnetic recording head (single-crystal Mn-Zn ferrite).

Figure 1. - Schematics of magnetic head and tape.

hardness (Ref. 4). Therefore the magnetic head was oriented with its Mn-Zn ferrite {110} surface nearly parallel to the sliding interface and its {100} surface perpendicular to the sliding direction (Fig. 1(a)). The orientation was determined with the back-reflection Laue method. The {100} and {110} surfaces were oriented to an accuracy of  $\pm 1^\circ$ . The magnetic gap was 115  $\mu\text{m}$  wide, the width of the recorded track, and 0.7  $\mu\text{m}$  long.

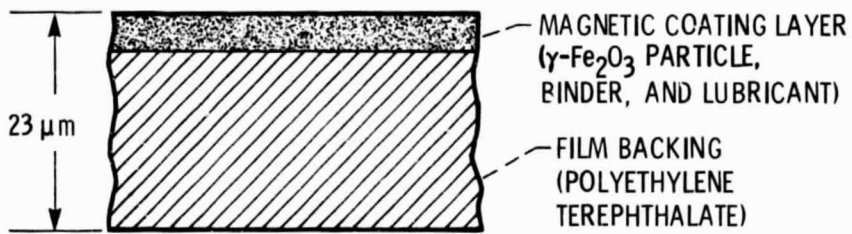
(b) Magnetic tape.

The magnetic tape used in this investigation had a layered structure (Fig. 1(b)): a magnetic layer of  $\gamma\text{-Fe}_2\text{O}_3$  powder, binder, and lubricant; and a polymer-base film (polyethylene terephthalate) backing. It was 23  $\mu\text{m}$  thick and 12.7 mm wide. The two tapes used in this investigation differed in the binder and lubricant material.

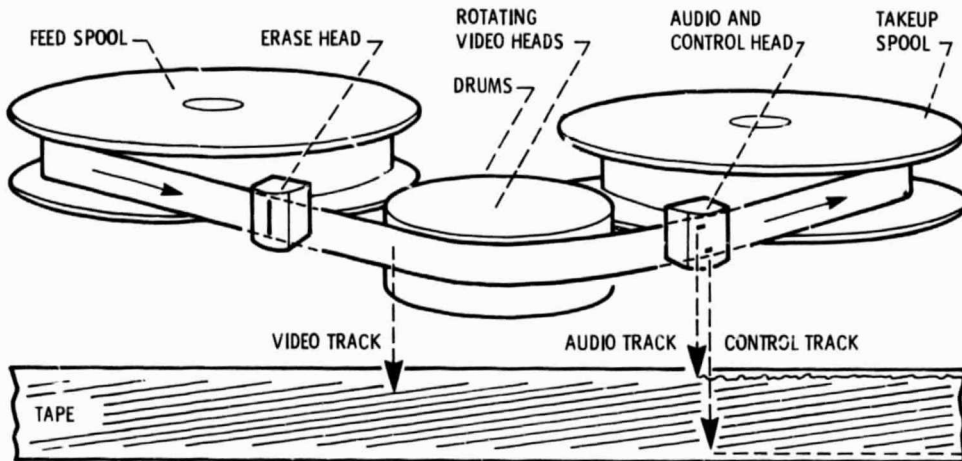
(a) Helical scan recorder.

Figure 2. - Friction and wear apparatus.

The apparatus used in this investigation was a modified commercial two-head, helical-scan video tape recording system (Fig. 2 (Ref. 15)). The two video heads were exactly opposite each other on the drum. A measurement microscope and a tape-tension-measuring device were mounted in the system. The measurement microscope measured the head displacement from the drum surface and the head wear and provided a surface profile of the head.

The 12.7-mm-wide magnetic tape was wound around the drum at a  $190^\circ$  wrap angle and traveled helically at 0.19 m/s at an angle of  $2^\circ 50'$  on the drum surface. The tape tension was controlled by a tension arm. The final tape tension was three times greater than the initial tape tension. The tape tension was used to vary the normal load applied to the head-tape contact.

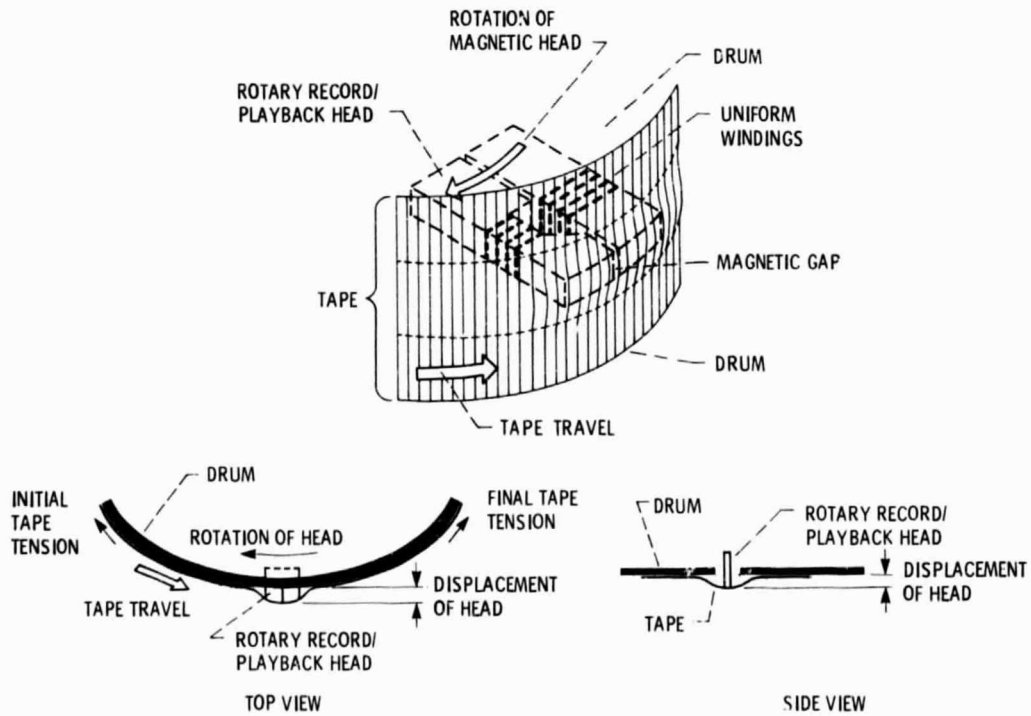
(b) Configuration of head-to-tape contact.

The normal load could also be controlled by displacing the head radially from the drum surface (Fig. 2(b)). The applied load and friction force were proportional to the tape tension and the amount of head displacement to displacements of 150  $\mu\text{m}$ . At displacements above 150  $\mu\text{m}$  the tension increased at a slightly higher rate with further increases in head displacement.

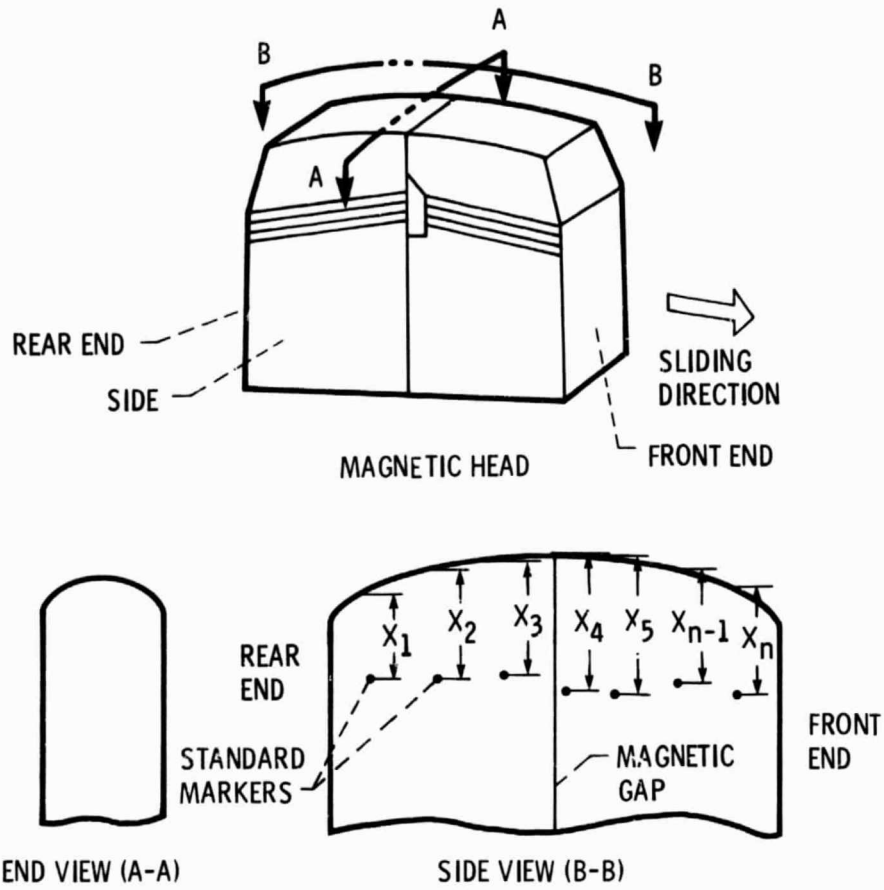
Figure 3. - Schematics of end and side views of magnetic head.

An optical interference microscope was used to examine the end-view contour (A-A) of the sliding surface of the magnetic head (Fig. 3). The side-view contour (B-B) and wear measurement of the magnetic head were determined as follows (Fig. 3): An optical microscope was used to examine the side of the magnetic head and to photograph it at a magnification of 600 before and after the sliding friction experiments. Small scratches or dents on the side of the magnetic head were used as standard markers. Lines parallel to the front end, the rear end, or the magnetic gap of the head and extending through the standard markers were drawn on the photomicrographs. The distances between the standard markers and the sliding surface of the magnetic head ( $X_1, X_2, X_3, \dots, X_{n-1}, X_n$ ) were then measured. The amount of wear reported herein was obtained by averaging the distance  $X_1$  to  $X_n$  from seven or eight measurements.

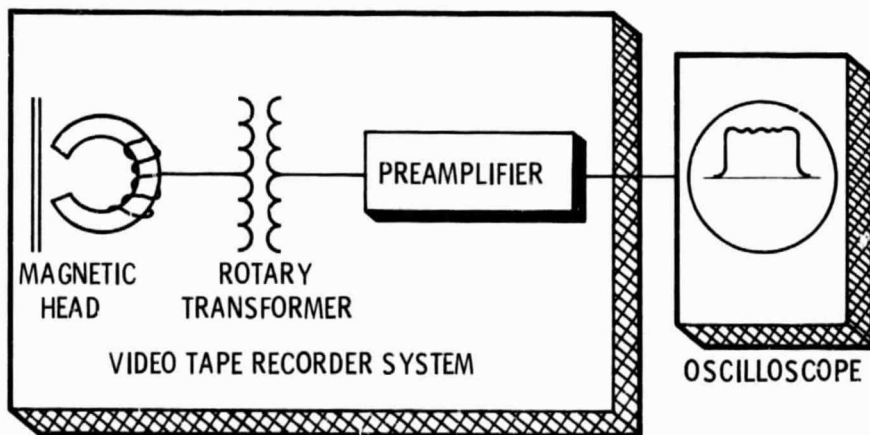
Figure 4. - Experimental setup of video tape recorder system.

The effect of wear on the electrical characteristics of magnetic head-tape contacts in the recording system was examined by using the experimental setup illustrated in Fig. 4. First, a string of alternating sine waves with a

nonfrequency-modulated 3-MHz signal at a recording current of 60 mA was supplied and recorded on the magnetic tape via the magnetic head. The signal was then read back via the magnetic head. The readback signal was amplified 8 and 500 times through a built-in rotary transformer and preamplifier, respectively. The readback signals were monitored by an oscilloscope at a sweep speed of 2 ms/cm and at a sensitivity of 0.02 V/cm during the sliding friction experiments. Readback signal levels (in decibels) during sliding were defined by  $D = 20 \log (G_n/G_1)$ , where  $G_1$  is the standard readback signal (in volts) and  $G_n$  is an arbitrary readback signal (in volts).

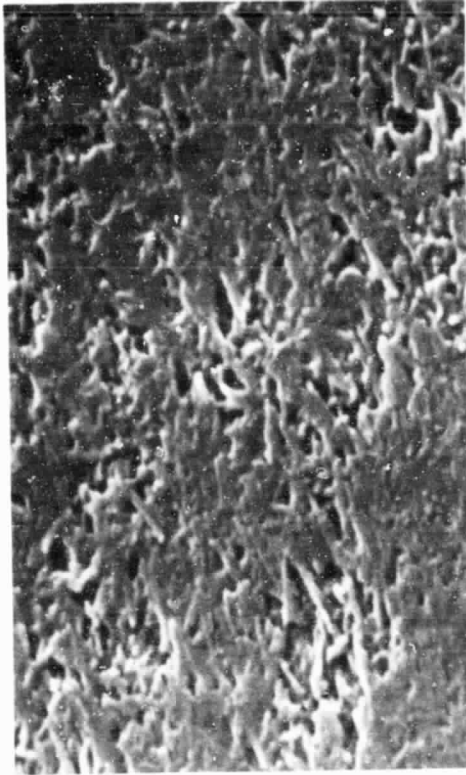
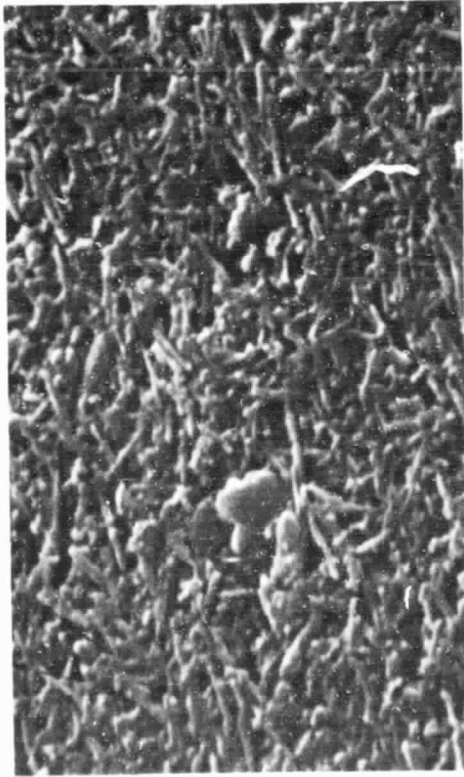
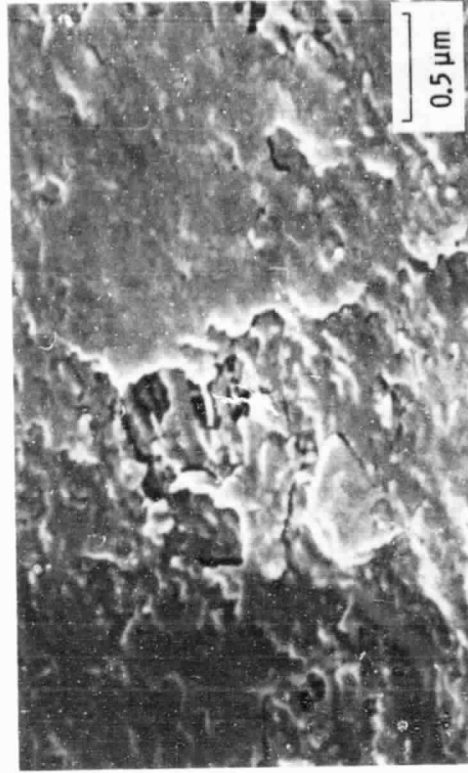
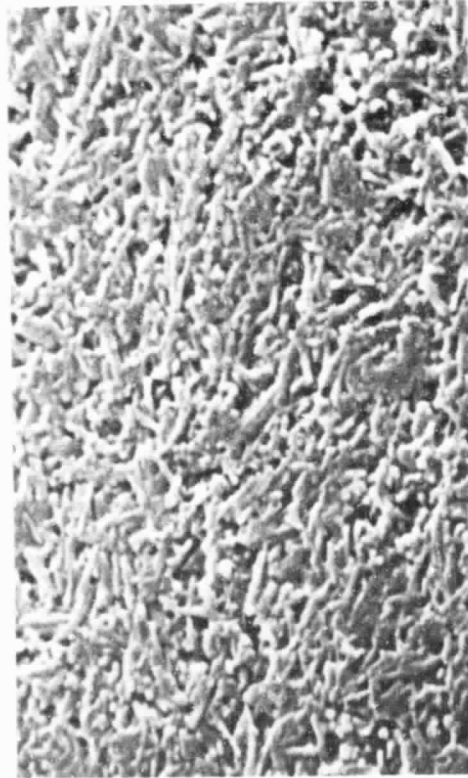
WEAR TRACK

AS-RECEIVED SURFACE

(a) Tape 1.

(b) Tape 2.

Figure 5. - Scanning electron photomicrographs of as-received surface and wear track on stationary magnetic tapes after 18 000 passes of a Mn-Zn ferrite head in sliding contact.

Sliding friction experiments were conducted to examine the tape wear behavior with a magnetic head at an initial tape tension of 0.49 N and a head displacement of 168  $\mu\text{m}$  in laboratory air. Sliding action produced visible wear tracks on the magnetic tapes. Scanning electron photomicrographs were taken of the as-received surfaces of the tapes (tapes 1 and 2) and of the wear tracks on the tapes (Fig. 5). The head passed the same track on each tape 18 000 times; the tapes were stationary.

The as-received surfaces of tapes 1 and 2 were similar, but their wear tracks were quite different. The scanning electron photomicrographs clearly

reveal some plastic flow of binder on tape 1 but considerable flow on tape 2. The wear track of tape 2 consisted primarily of the binder, which flowed over the magnetic particles. The nature of the binder and the lubricant obviously control the plastic flow behavior of the magnetic tape (Ref. 10). Plastic flow of the binder and lubricant can affect wear and cause a signal loss in the recording/playback process. These subjects are discussed later.

Composed largely of oxide particles, the magnetic coating layer of magnetic tape bears a certain resemblance to emery, a familiar abrasive (Fig. 5). Therefore the sliding of a magnetic tape on a ferrite head abrades the ferrite (Ref. 4).

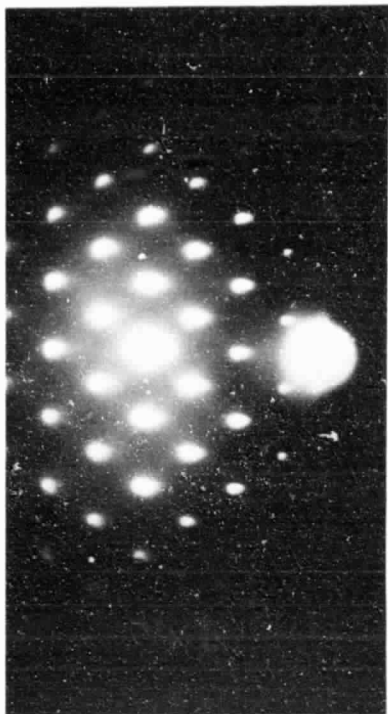
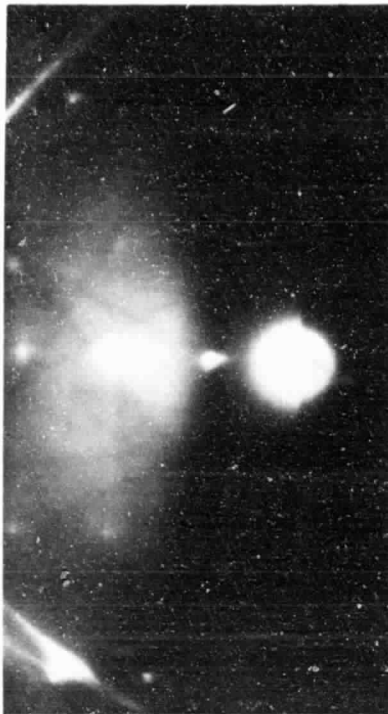
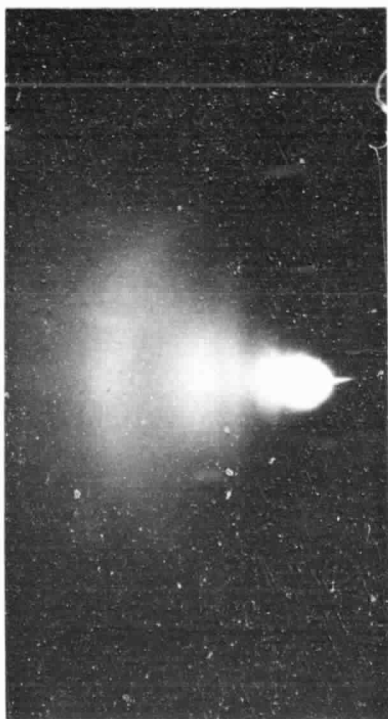
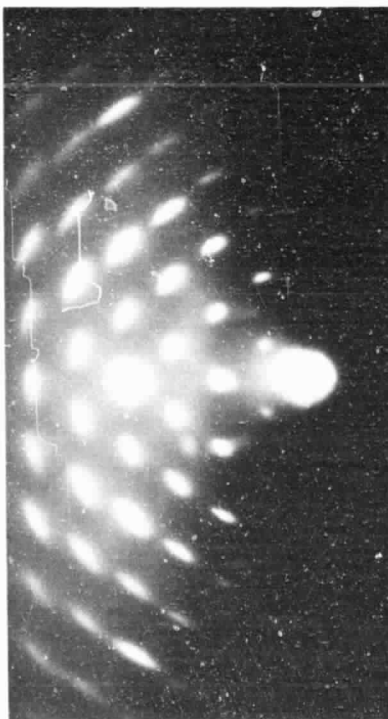
(c) Etched surface (etching depth, 0.3  $\mu\text{m}$ ).

(d) Etched surface (etching depth, 0.6  $\mu\text{m}$ ).

(a) Wear surface.

(b) Etched surface (etching depth, 0.1  $\mu\text{m}$ ).

Figure 6. - Wear surface of magnetic head in sliding contact with magnetic tape.

To investigate the crystalline state of the wear surface of the magnetic head, reflection electron diffraction patterns (Fig. 6) were obtained from the wear surface and the etched surfaces. The etching was done with hydrochloric

acid at  $50 \pm 1$  °C. The initial tape tension was 0.2 N, and the sliding distance was 60 km. The broad arc in electron diffraction pattern of the wear surface indicated formation of a nearly amorphous surface during sliding. The surface etched to depth of 0.1  $\mu\text{m}$  from the wear surface had an enlarged streak spot pattern. The streaking indicated a large amount of plastic deformation. Line defects can cause streaking in diffraction patterns. The surface etched to a depth of 0.3  $\mu\text{m}$  had a relatively sharp spot pattern without streaking. Furthermore the surface etched to a depth of 0.6  $\mu\text{m}$  had Kikuchi lines, consisting of pairs of black and white parallel lines, which are an indication of the bulk crystalline structure of the ferrite head.

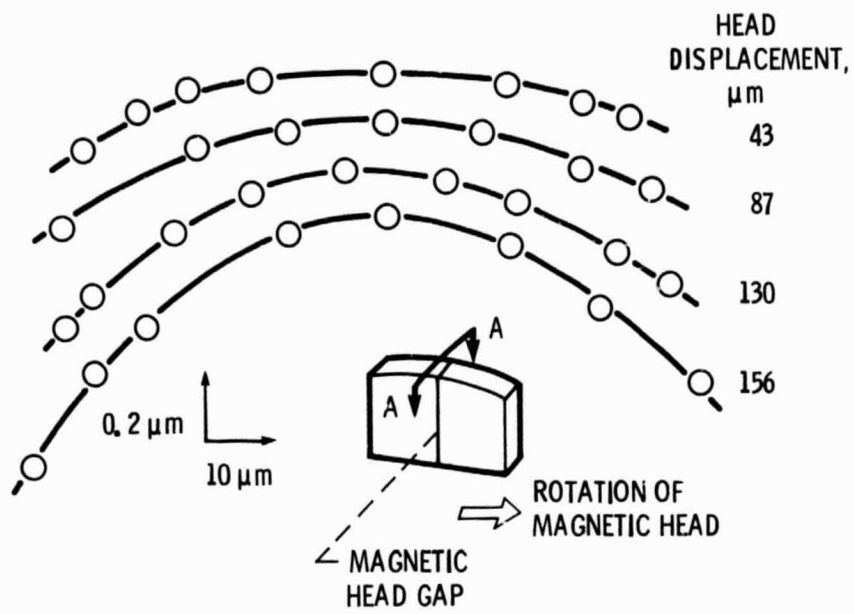
Figure 7. - End-view contours (lateral cross section A-A of wear surface of magnetic head at magnetic gap).

Since the magnetic tape was thin and flexible, the contour of the wear surface of the magnetic head was affected by tape tension and head displacement. End-view contours of the wear surfaces of magnetic heads at the magnetic gap (Fig. 7) were determined with an optical interference microscope. The contours were measured from interference fringes on the photomicrographs at a magnification of 600. The as-polished magnetic head with a lapping tape ( $\text{Al}_2\text{O}_3$ , number 2000) contacted magnetic tape 1 at an initial tape tension of 0.64 N for a total sliding distance of 550 km. Both the magnetic head and the magnetic tape were in motion. Figure 7 clearly reveals that the radius of curvature of the wear surface decreased with increasing head displacement.

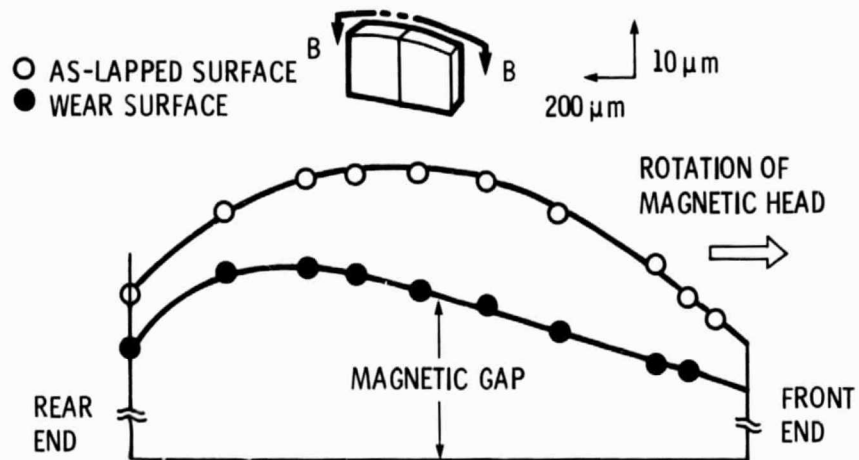
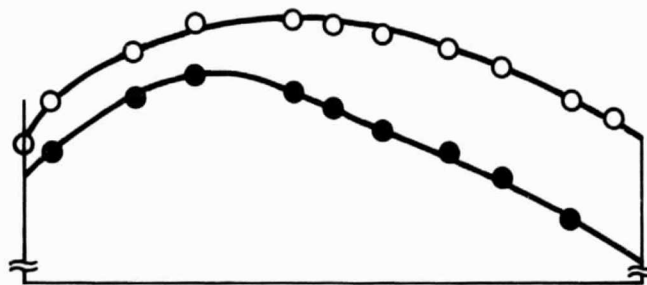
(a) Head displacement, 51  $\mu\text{m}$ .

(b) Head displacement, 152  $\mu\text{m}$ .

Figure 8. - Side view contours (longitudinal section B-B) of sliding surface of magnetic head.

In wear experiments to determine the side-view contours, the as-polished magnetic head with a lapping tape ( $\text{Al}_2\text{O}_3$ , number 2000) contacted magnetic tape 1 at a tape tension of 0.64 N for a total sliding distance of 970 km. Both the magnetic head and the magnetic tape were in motion. Figure 8 clearly indicates that much more ferrite was removed from the front sliding surface area of the head than from the rear. Higher contact pressure was applied to

the front than to the rear. Therefore the contour of the wear surface reflects the pressure distribution on the sliding surface.

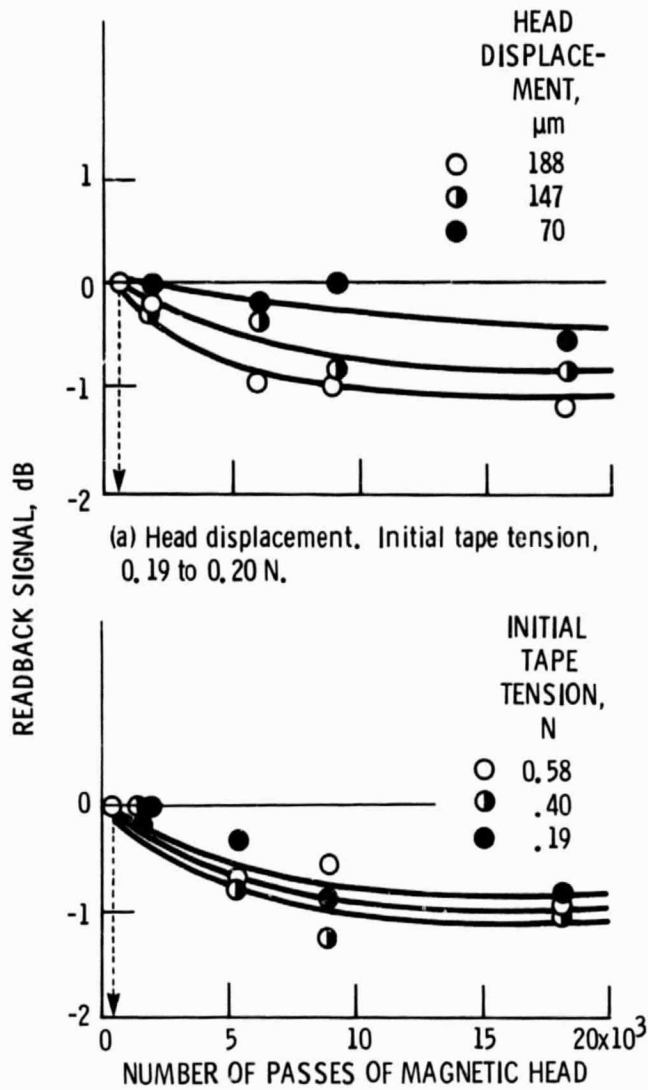
(a) Head displacement. Initial tape tension, 0.19 to 0.20 N.

(b) Tape tension. Head displacement, 147 μm.

Figure 9. - Signal output level as function of number of passes of magnetic head sliding against track on stationary magnetic tape.

The standard readback signal  $G_1$  was taken at the first 500 sliding passes of the head over the recorded track of the new tape. Signals were also read back continuously during multipass sliding of the head over the same track on the tape. The tape was stationary. The signal amplitude decreased with repeated passes of the head over the same track (Fig. 9). The signal loss increased with increasing head displacement (Fig. 9(a)). Tape tension, however, had almost no effect on signal loss (Fig. 9(b)). The reduction of signal output level was due to the tape wear discussed earlier. The deformed layer and the contours of the magnetic head did not vary markedly during multipass sliding on the recorded tape.

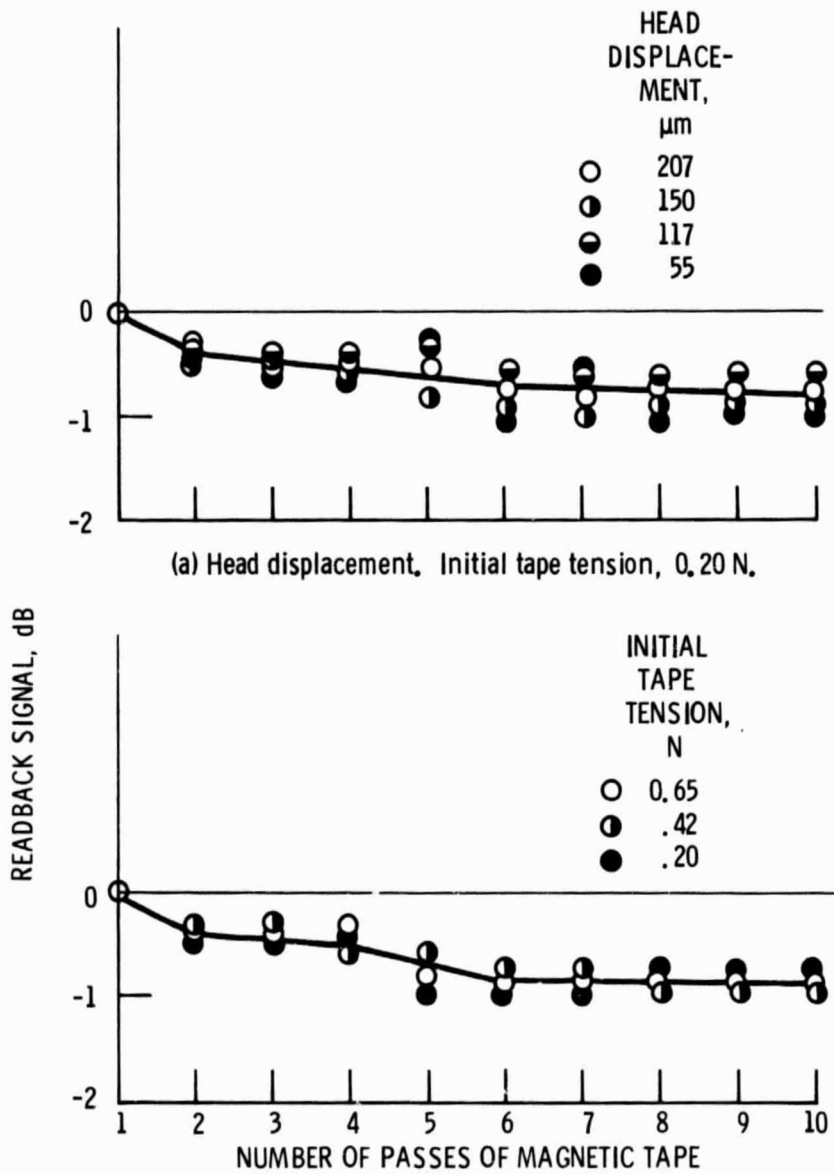
Figure 10. - Signal output level as function of number of passes of magnetic tape sliding against magnetic head.

Experiments were then conducted to determine readback signals as a function of the number of repeated passes of the recording tape. Both the recording tape and the magnetic head were in motion. The signal losses increased with the first few passes but became constant after five passes (Fig. 10). Tape tension and head displacement had almost no effect on signal loss. Again the signal losses were primarily due to medium wear.

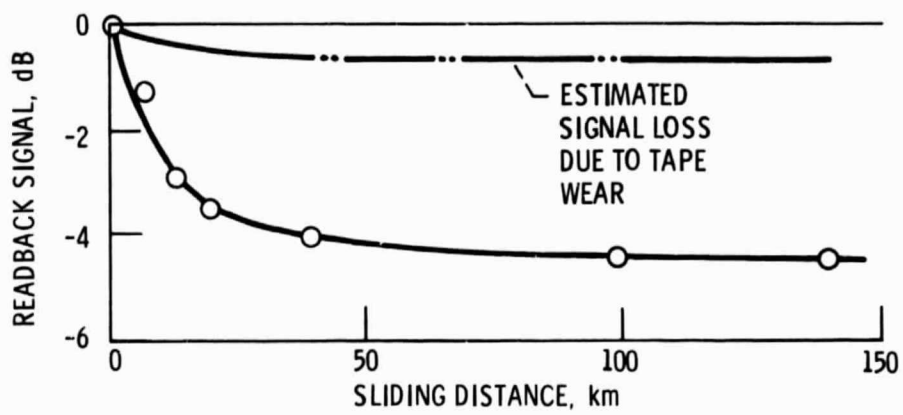
Figure 11. - Signal output level as function of sliding distance.

Head wear - To determine the effect of head wear on signal losses, the magnetic head was run against magnetic tape 1 with a desired tape tension and head displacement for a sliding distance of 60 km. The sliding surface of the magnetic head conformed to the magnetic tape, but the head had a deformed layer, as mentioned earlier. The sliding surface of the magnetic head was therefore etched to a depth of approximately  $0.1 \mu\text{m}$  in order to remove the residual deformed surficial layer from the wear surface. A new recorded tape (11 m long) was then run and the standard signal  $G_1$  was read back. The nonrecorded tape (230 m long) was repeatedly traveling, approximately 20 times its length, for a total sliding distance of 140 km. The head displacement was  $198 \mu\text{m}$  and the initial tape tension was 0.20 N. During the sliding experiment the 11-m-long recorded tape was replaced several times. It was played back and forth in order to read back signals  $G_n$  at various stages of the experiment. The results are presented in Fig. 11.

The readback signal amplitude decreased rapidly as the sliding distance increased to approximately 40 km (Fig. 11). It remained low and constant after 40 km. The development of a deformed layer and tape wear were the primary factors controlling signal loss. The signal losses due to the tape wear estimated from Fig. 10 were 1 dB or less, as indicated in Fig. 11. On the other hand, the signal losses due to deformation in the surficial layer of the magnetic head were approximately 3 dB (Fig. 11).

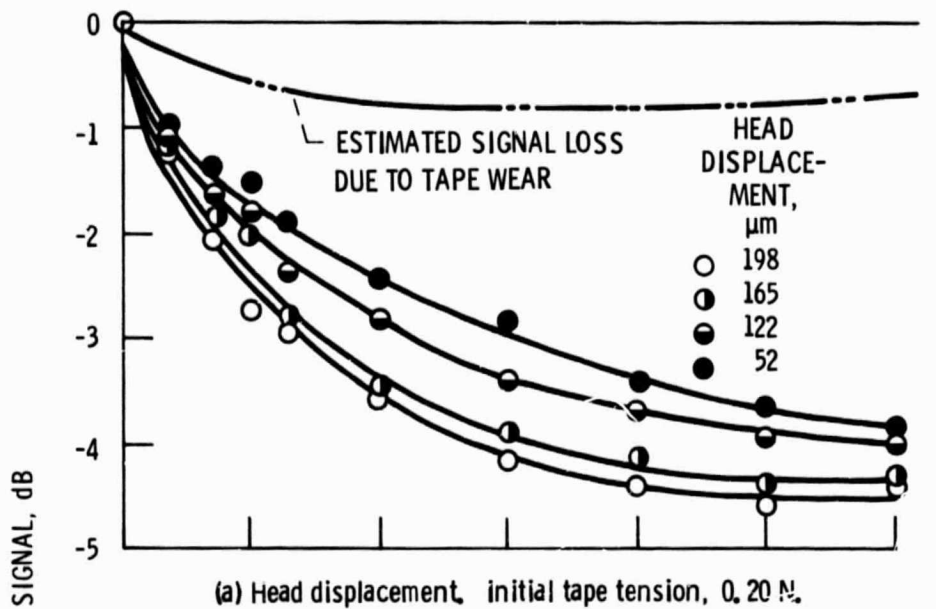
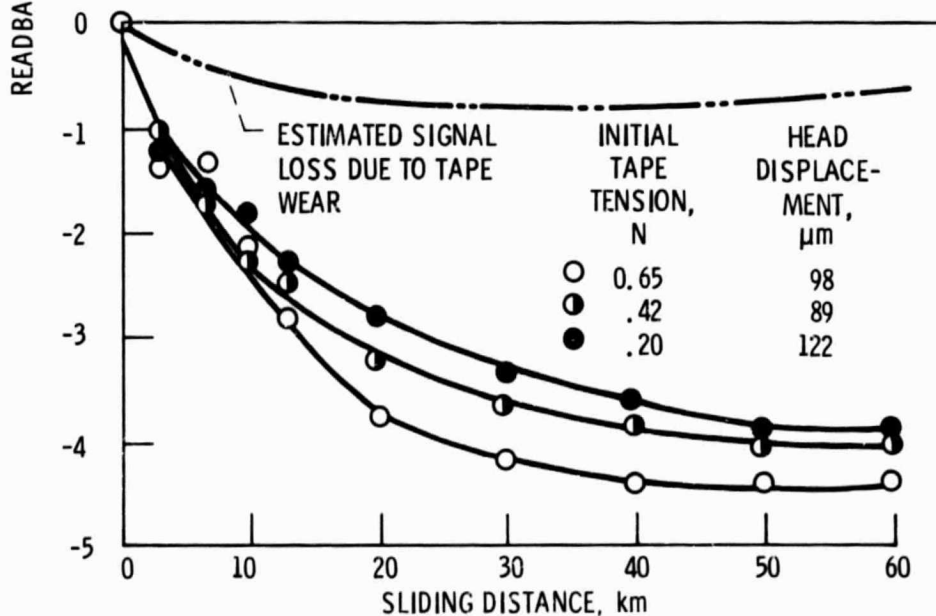
Figure 12. - Effect of applied normal load on signal output level.

The signal amplitude decreased rapidly with increasing sliding distance to 60 km (Fig. 12). The signal output loss increased with increasing tape tension and head displacement, that is, with increasing the applied normal load to the head. Typical examples of electron diffraction patterns were taken of the etched surface of the magnetic head before each sliding experiment and of the wear surface of the magnetic head after 60 km of sliding at a head displacement of  $198 \mu\text{m}$  and an initial tape tension of 0.20 N. The electron

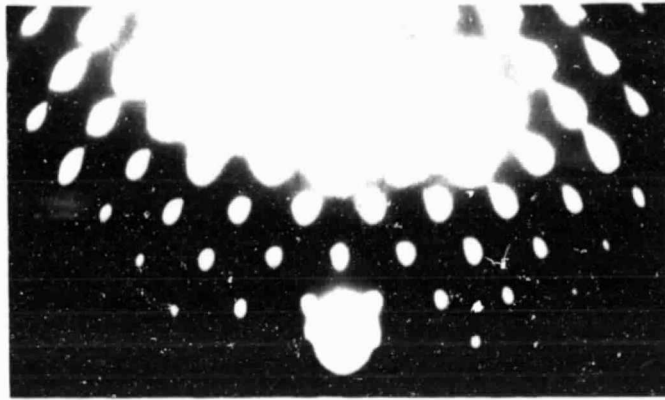
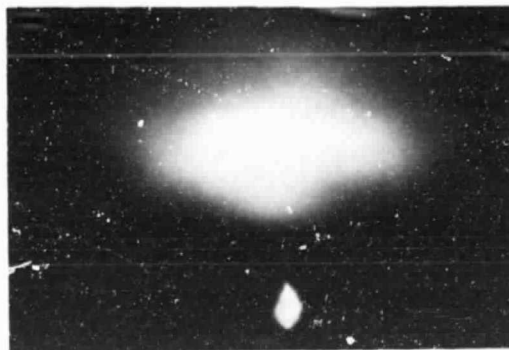
(a) As-etched surface before run.

(b) Wear surface after 60-km run.

Figure 13. - As-etched surface and wear surface of magnetic head in sliding contact with magnetic tape.

diffraction patterns (Fig. 13) clearly indicate that the crystalline state of the magnetic head changed drastically during the sliding process. Sliding action developed a nearly amorphous structure in the surficial layer of the single-crystal Mn-Zn ferrite head. Thus deformation in the surficial layer of the magnetic head is a critical factor in readback signal loss above 2.5 dB.
