**NASA CR-174915**  
**R85AEB307**

# **EFFECTS OF SURFACE CHEMISTRY ON HOT CORROSION LIFE**

## **SECOND ANNUAL REPORT**

**General Electric Company  
Aircraft Engine Business Group  
Cincinnati, Ohio 45215**

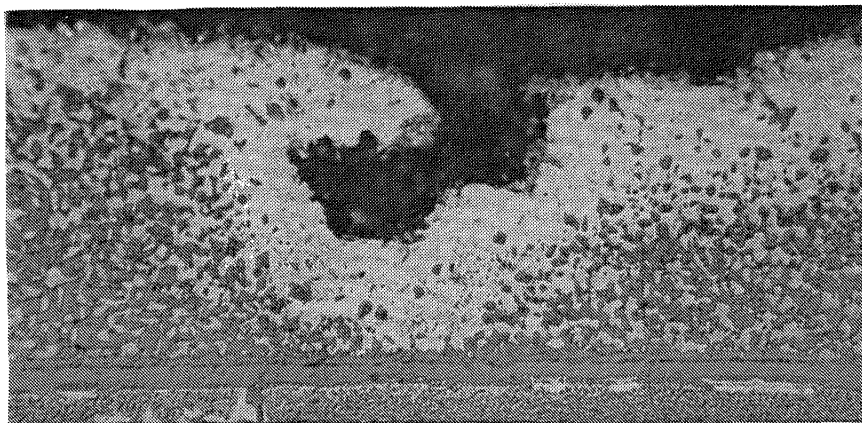
298.9 hr  
(U700)

528.1 hr  
(René 80)

997.1 hr  
(U700)

Figure 3. Photomicrographs of NiCoCrAlY coated specimens from hot corrosion burner rig test at 900° C showing progressive degradation with time.

The NiCoCrAlY coating is considerably more resistant to hot corrosion. Complete penetration was noted in only one of the four full term 1000 hour specimens. A series of three typical microstructures depicting the progress of hot corrosion with time is shown in Figure 3. The development of a substantial depleted layer at full term is shown, determined by EMP analysis to be primarily a loss of Cr, down to about half of the nominal 18%. There was a corresponding increase in Ni, but only a small decrease in Al. Type 1 sulfides could not be visually identified in the depletion zone as might have been expected, and this was confirmed with X-ray oscillographs. However, sulfur was found in local regions of scale deep within pits, primarily associated with Cr. Most of the scale was Al and Ti rich, and devoid of sulfur.

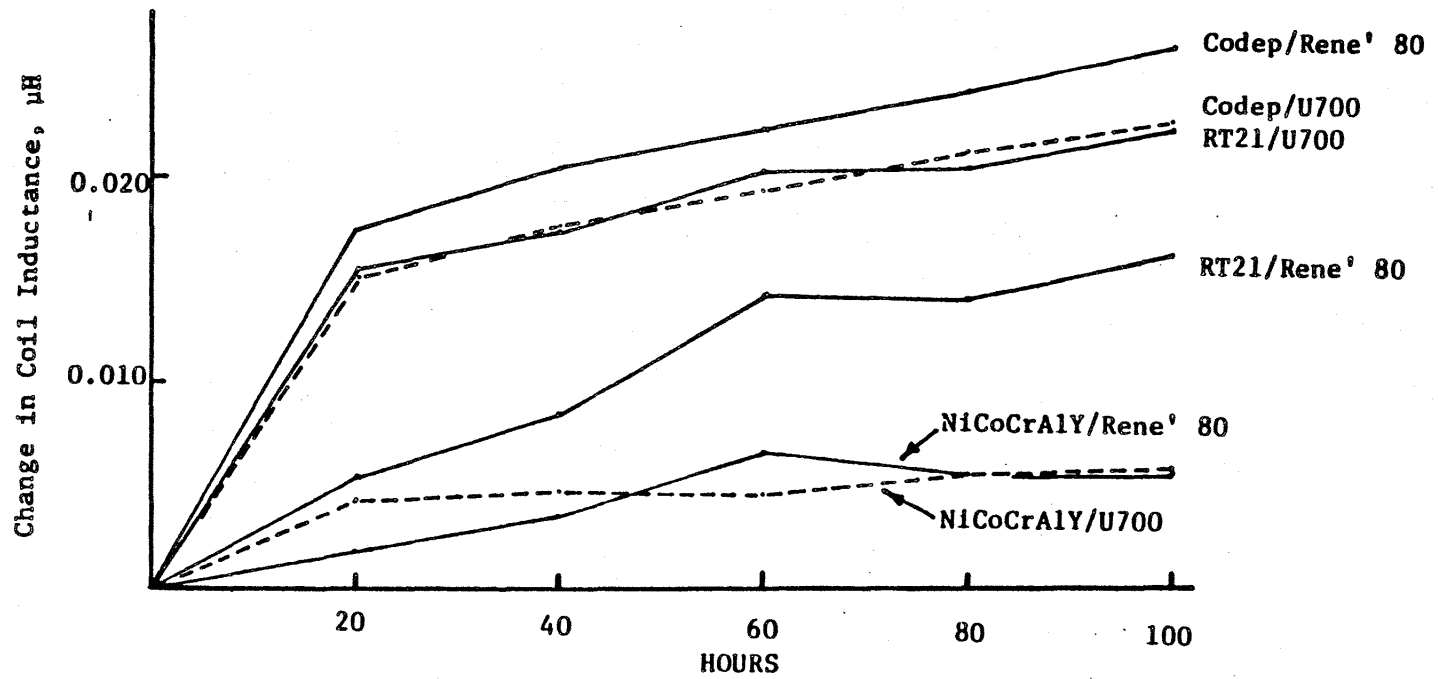
Figure 9. Changes in Coil Inductance in Static Oxidation at 1100° C, Cyclic Exposure.

In addition to the above metallographic and EMP observations, weight changes and coil inductance changes were recorded. These are summarized in Table V. The latter for cyclic exposures both in the burner rig and under static conditions are shown in Figures 8 and 9. There were no negative changes at the first inspection as previously noted for coated specimens in the Task II hot corrosion test at 900° C (Figure 1).

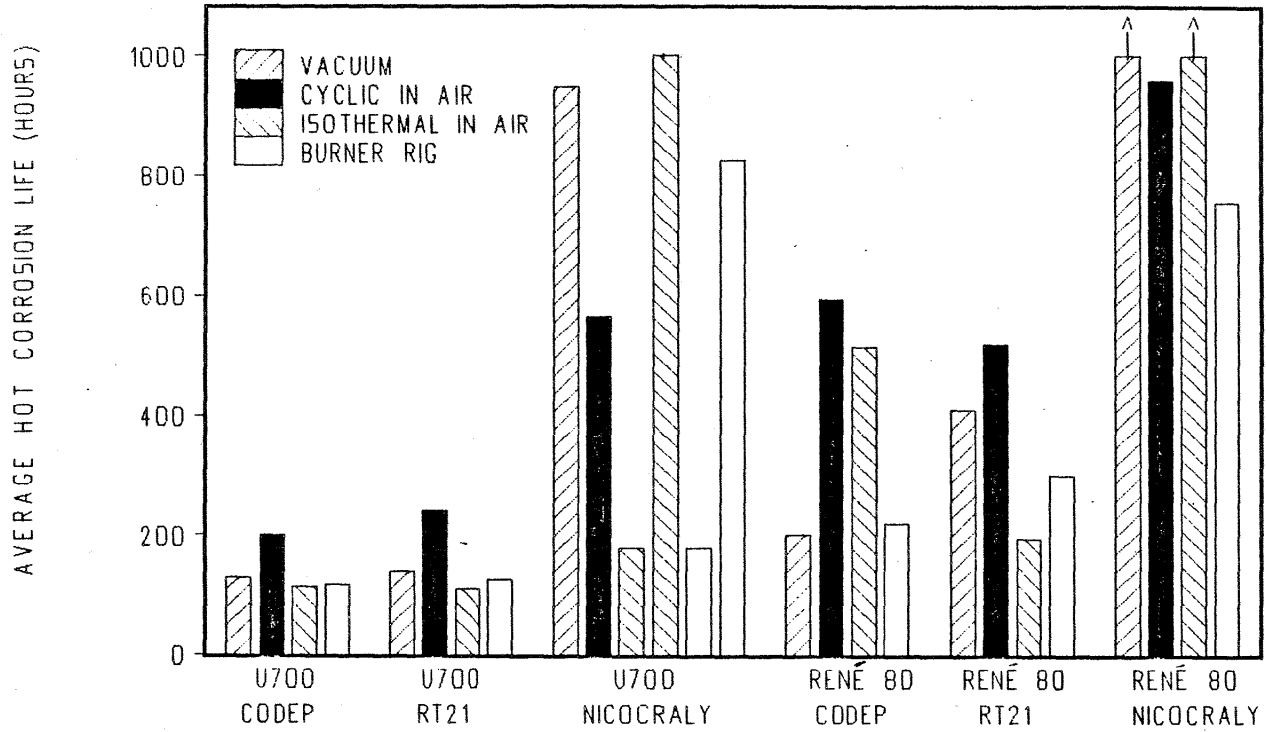
Figure 11. Task IV Results, 100 Hours of Preaging.

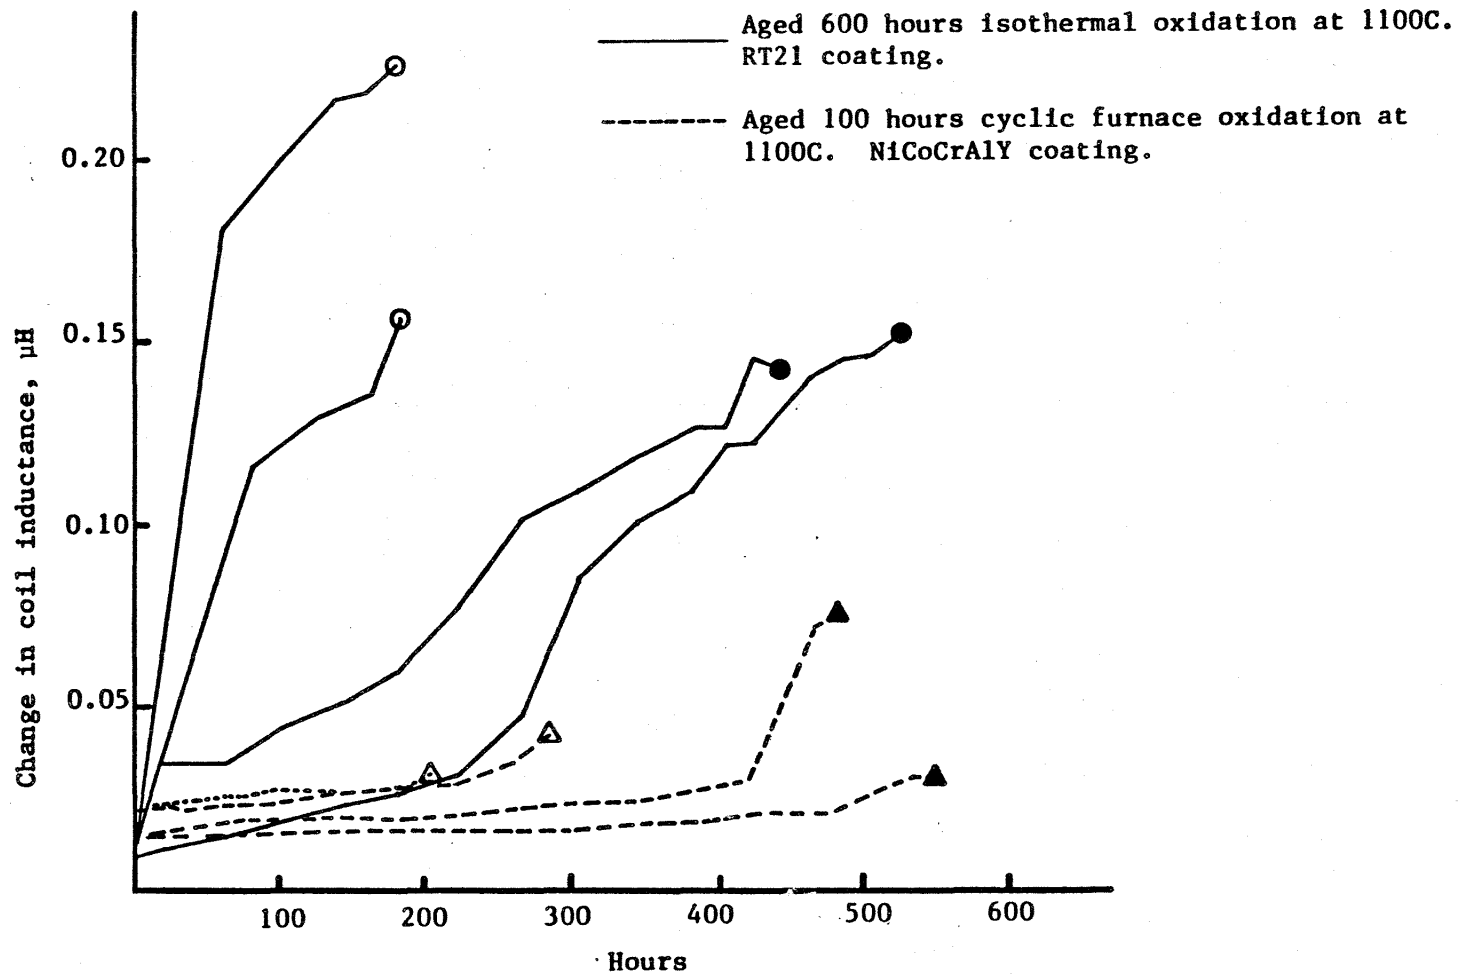
Figure 13. Change in Coil Inductance with Hot Corrosion at 900° C of Aged Coated Specimens.  $\Delta$ OU700,  $\blacktriangle$ René 80.

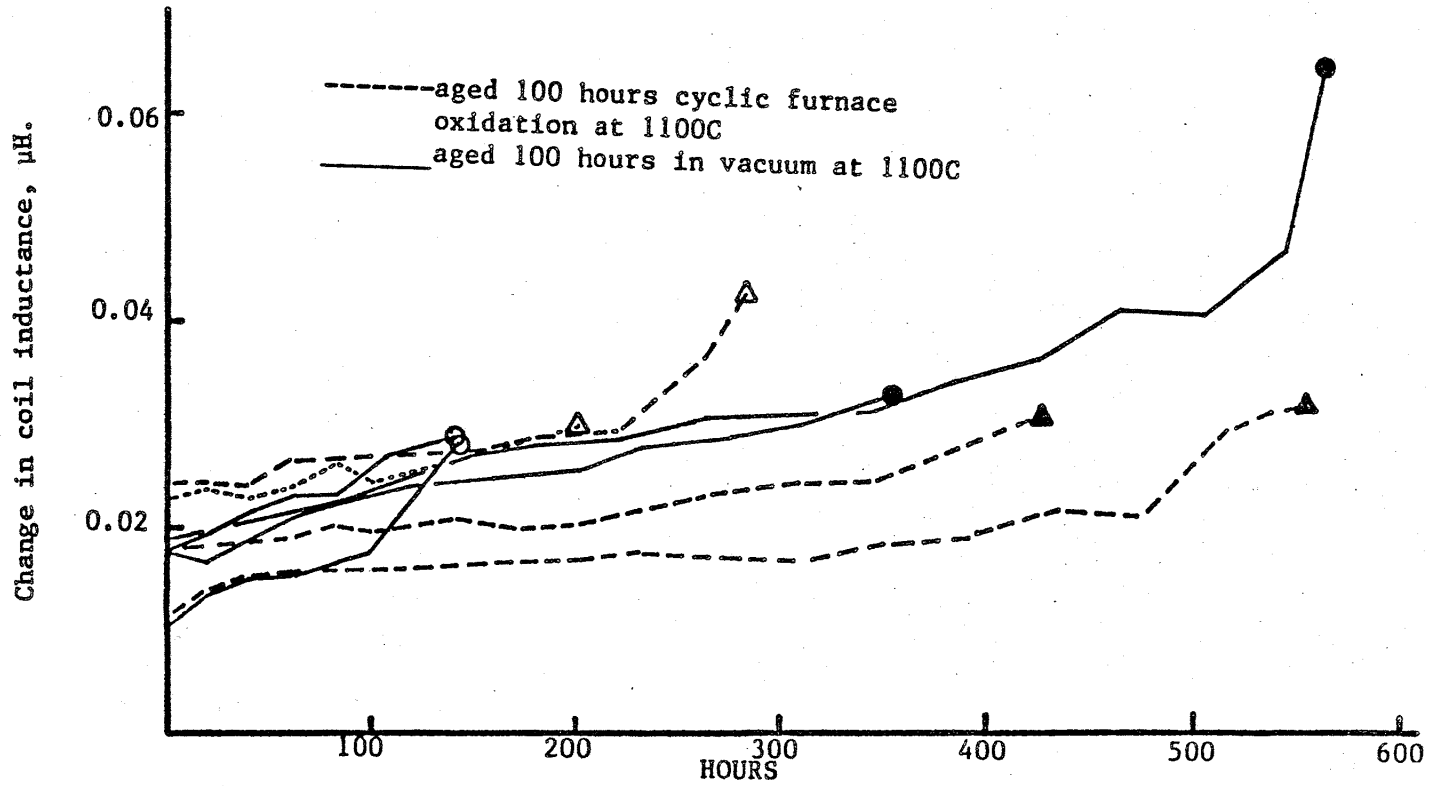
Figure 14. Change in Coil Inductance with Hot Corrosion at 900° C of Aged RT21 Coated Specimens.  $\Delta$ OU700,  $\blacktriangle$ René 80.

The small changes shown in Figure 14 do not suggest a consistent difference between vacuum and oxidizing aging treatments. This reinforces a comment made earlier, concerning coating lives, that compositional changes caused by coating/substrate interdiffusion are more important in decreasing coating life than are compositional changes involved in oxide scale formation.
