# ANALYTICAL AND EXPERIMENTAL INVESTIGATION OF RUBBING INTERACTION IN LABYRINTH SEALS FOR A LIQUID HYDROGEN FUEL PUMP

Francis X. Dolan  
Francis E. Kennedy  
Erland M. Schulson

CREARE R&D INCORPORATED

Contract NAS 3-23276

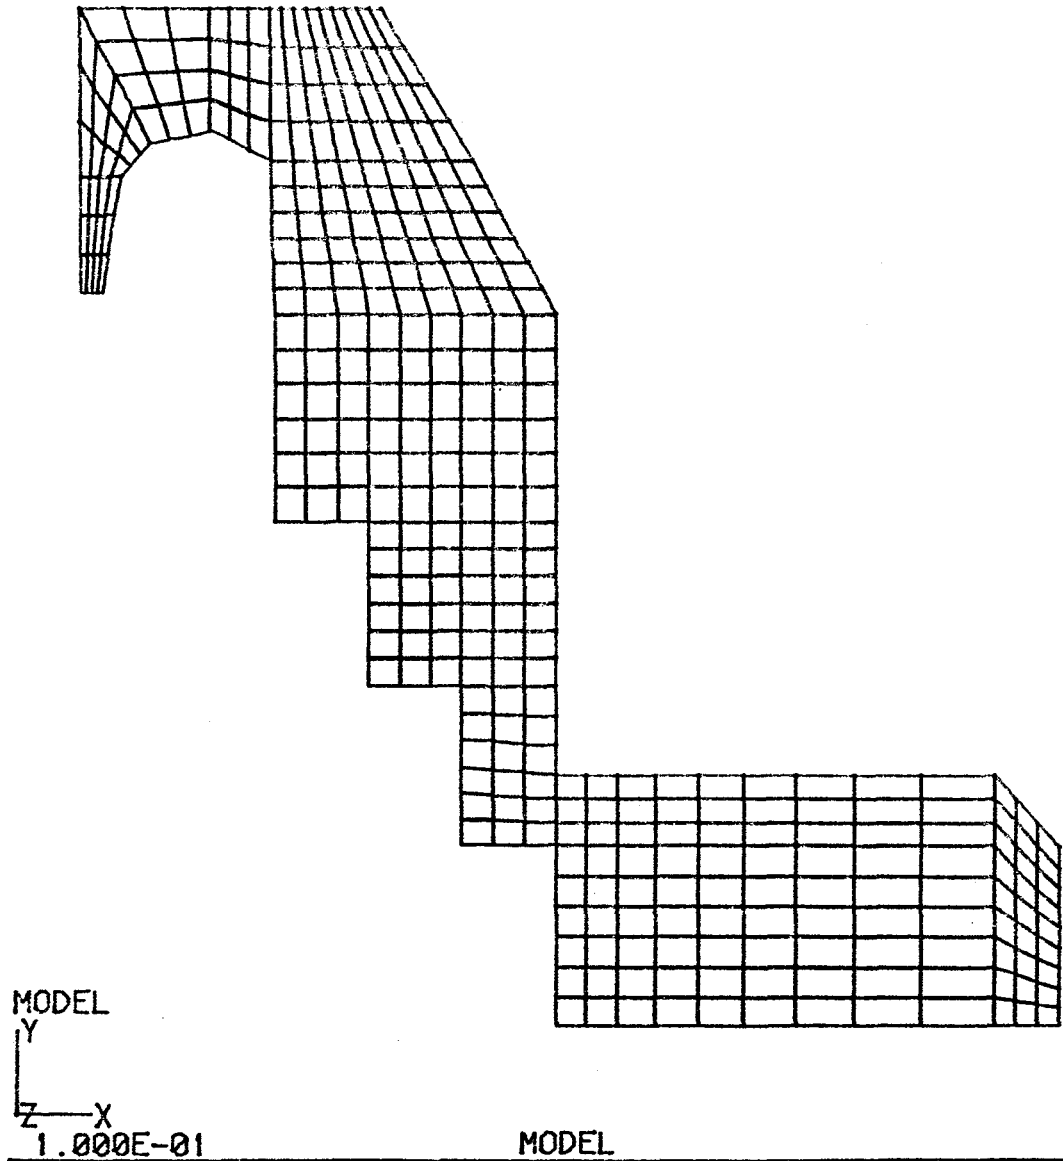
FIGURE 2-1. FINITE ELEMENT MODEL FOR WEAR RING.

The finite element models for the wear ring and impeller are shown in Figures 2-1 and 2-2, respectively, with additional details of the element breakup in the labyrinth fingers shown in Figure 2-3. These models were used to calculate the combined thermal, pressure and centrifugal stresses during a rub.

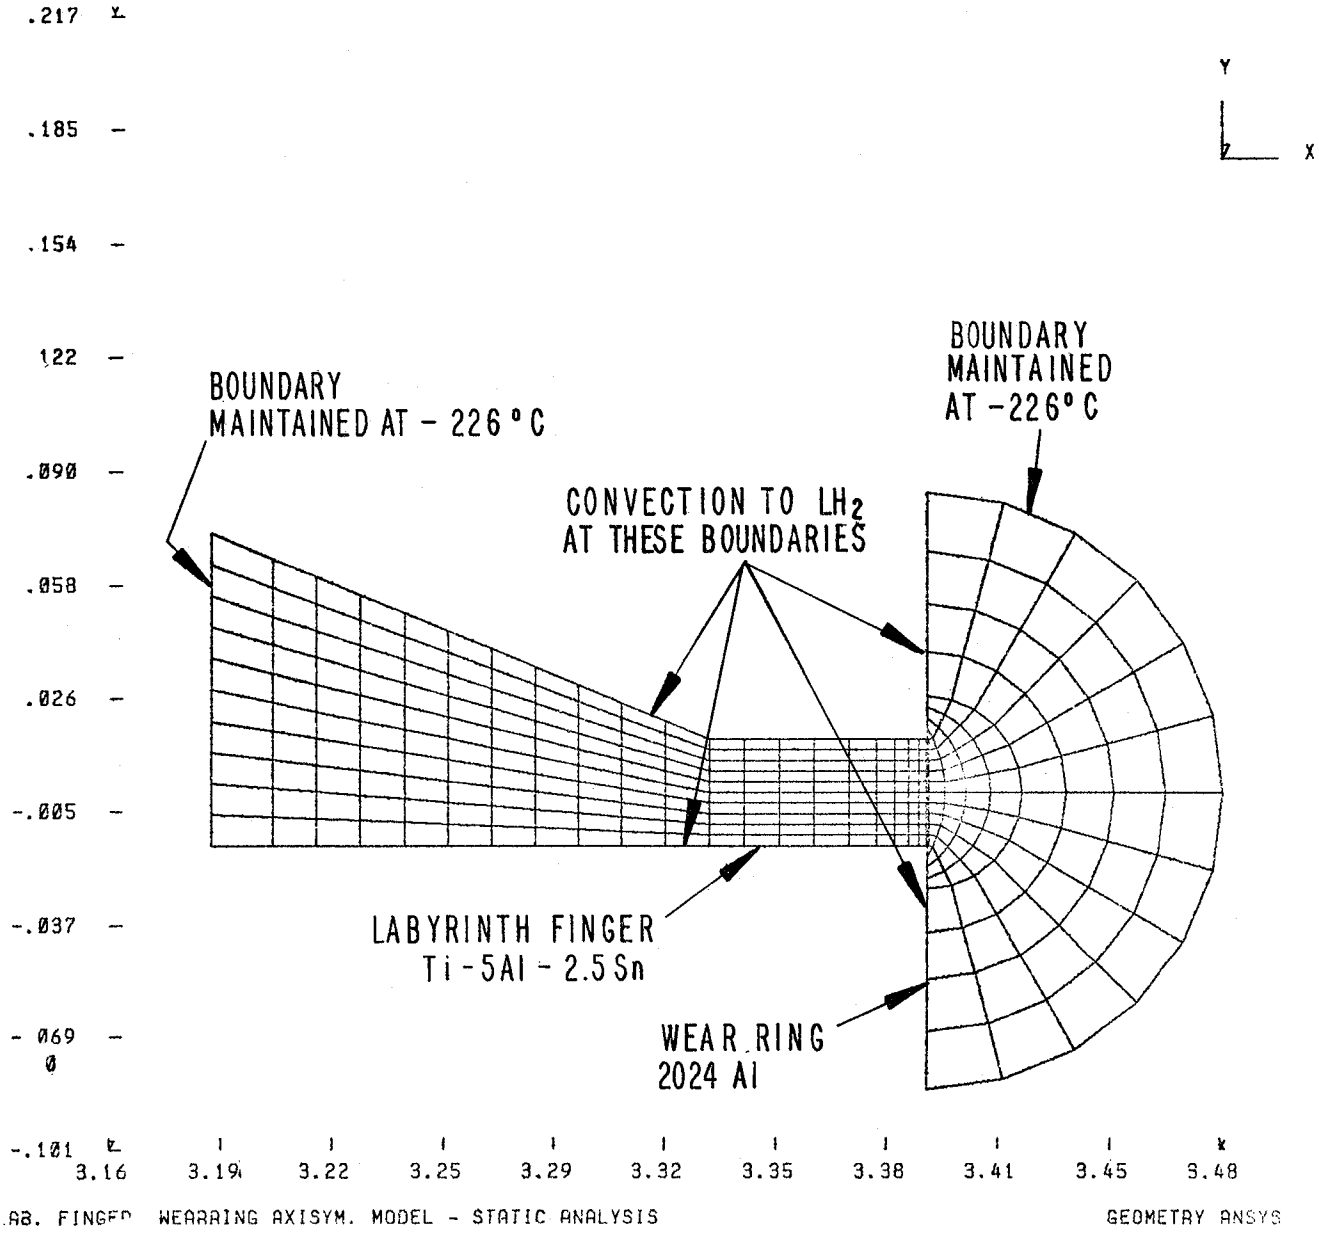
FIGURE 2-6. FINITE ELEMENT MODEL FOR THERMAL ANALYSIS.

A finite element thermal analysis using the ANSYS code was performed to estimate the steady-state temperature distribution at the interface between the labyrinth finger and wear ring during a rubbing contact. The analysis considered different rub contact lengths for the BOM titanium and aluminum materials, and also examined the effects of alternate knife edge and wear ring materials on rub temperatures.

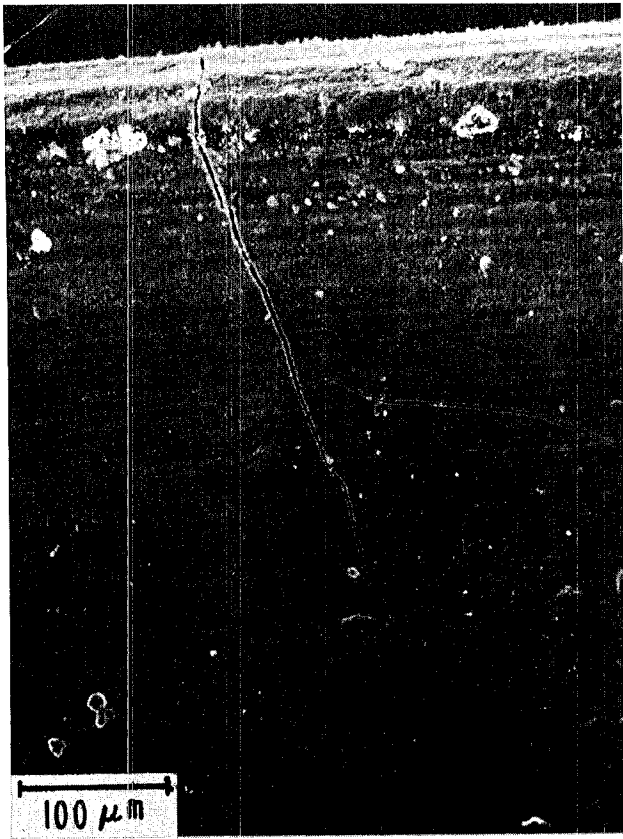
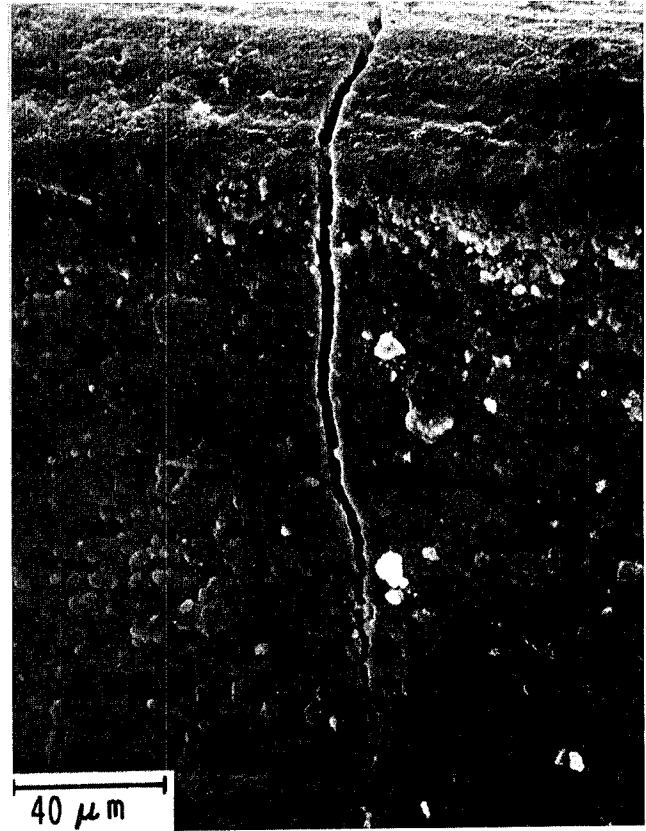
**FIGURE 3.3 SEM MICROGRAPHS OF THERMAL SHOCK SPECIMEN CYCLED 10 TIMES**

The test specimens which were cycled from 593°C to -196°C did not show any evidence of cracking even for the specimen cycled 10 times. After three of the more extreme shocks (1150°C to -196°C) cracks were seen in one area of the test specimen, near to but in from the periphery (approximately 0.4 mm), Figure 3-2. Several cracks emanating from the periphery were observed in the specimen subjected to 10 of the extreme thermal cycles, as

The observation of cracks after only a few thermal cycles implies that simple life prediction methods such as the one cited above may not be applicable in a situation involving complex thermal loading.

These thermal shock tests show that cracking of the titanium alloy knife edge is possible under conditions of repeated cycles over an extreme temperature range. The effect of increased numbers of thermal cycles may also result in cracking even from the lower knife edge temperatures expected in HPFP rub interactions.

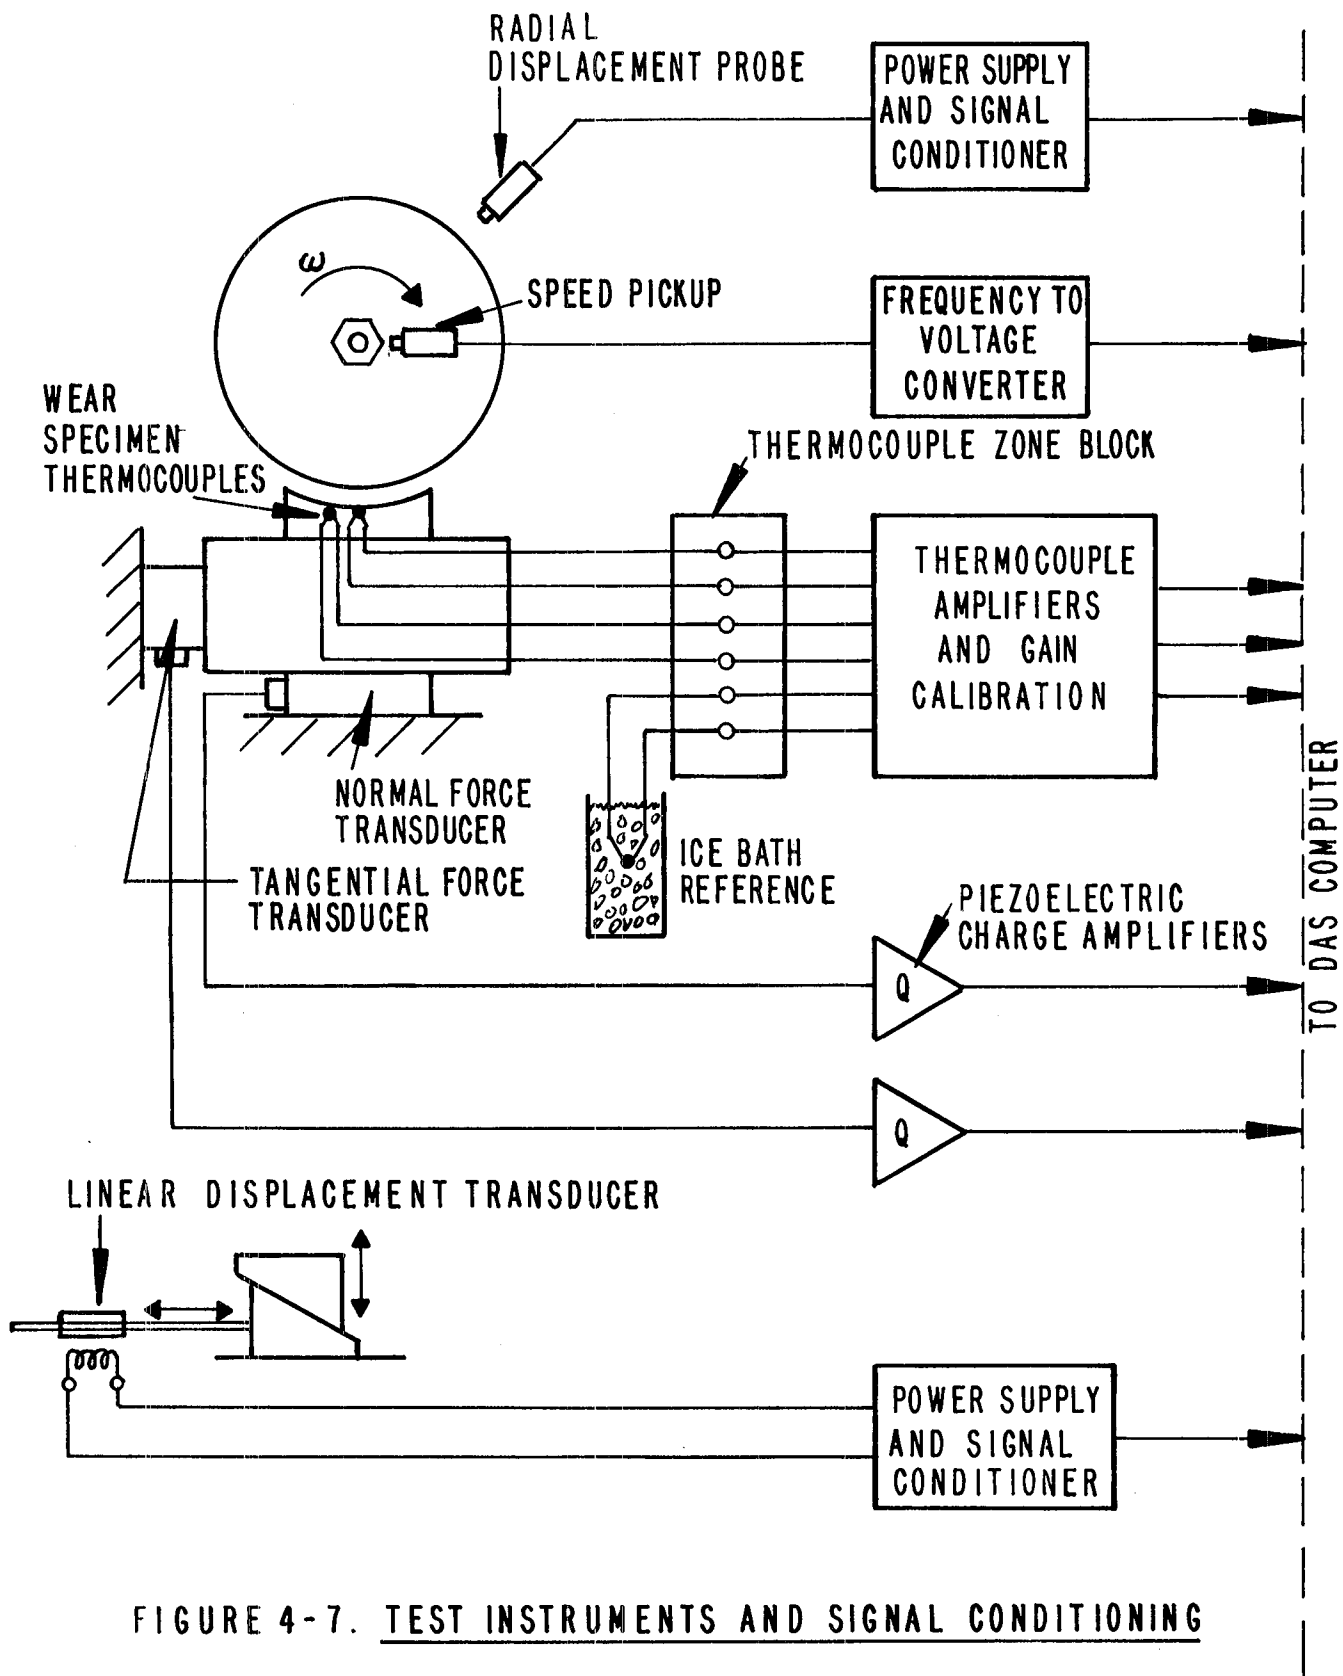
FIGURE 4-7. TEST INSTRUMENTS AND SIGNAL CONDITIONING

For some of the tests the thermocouple amplifier output exceeded 5V full-scale, which was beyond the input range of the analog-to-digital converter in the DAS computer.

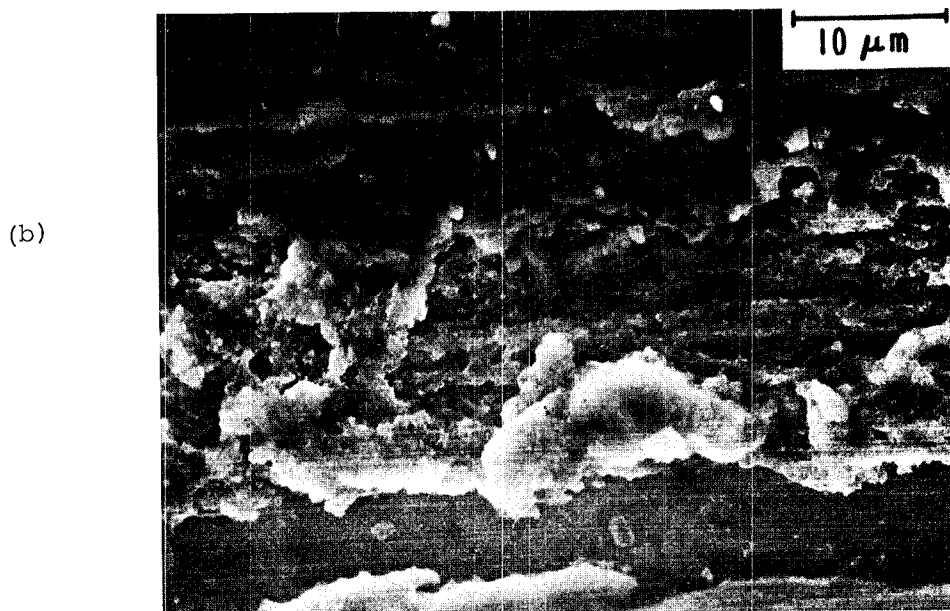
Figure E.2 SEM Micrographs Showing a Transfer Layer on the Turbine Side of the Disk (Periphery of disk at or above top of photo)

(b) higher magnification view of circled region in (a)

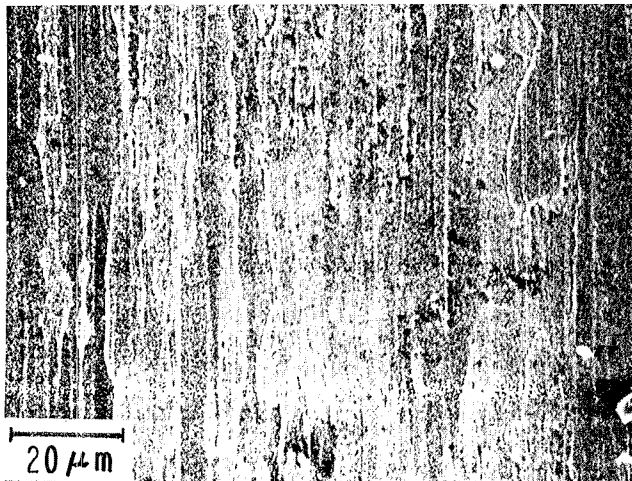
KNIFE EDGE MATERIAL:  
Ti-5Al-2.5Sn ALLOY, ANNEALED

INTERACTION RATE:  
 $2.54 \times 10^{-2}$  mm/sec

FIGURE F-5b. SEM MICROGRAPH OF KNIFE EDGE SURFACE  
TEST NO. TICU03

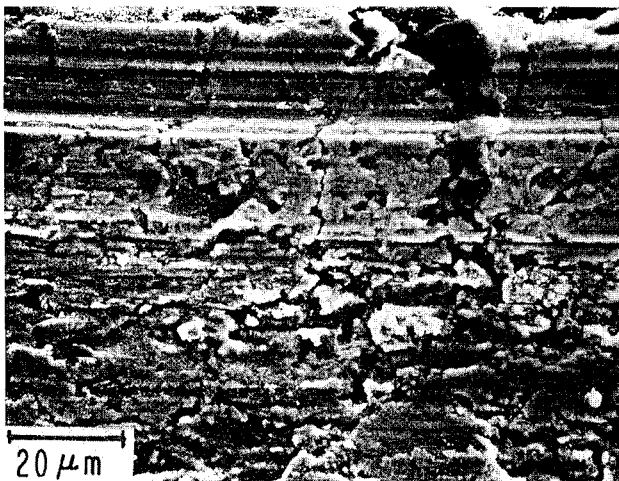
KNIFE EDGE MATERIAL:  
Ti-5Al-2.5Sn ALLOY, ANNEALED

INTERACTION RATE:  
 $1.45 \times 10^{-1}$  mm/sec

FIGURE F-6a. SEM MICROGRAPH OF WEAR RING SURFACE  
TEST NO. TIAG02
