NASA Technical Memorandum 86001

Hygrothermal Effects on Mechanical Behavior of Graphite/Epoxy Laminates Beyond Initial Failure

Ori Ishai, Amar Garg, and Howard G. Nelson

August 1984

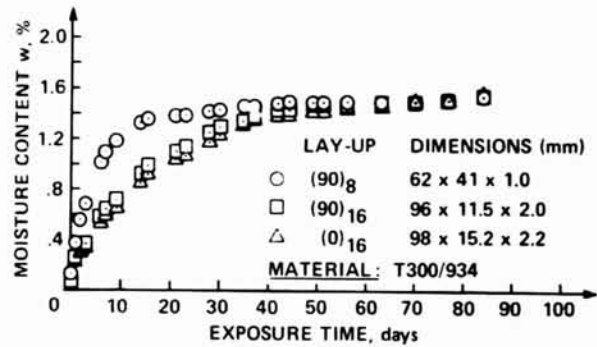
Fig. 7 Moisture absorption behavior of unidirectional graphite/epoxy laminates exposed to 70°C water.

Moisture absorption and swelling were studied in unidirectional laminates of T300/934 and of T300/5209 in order to establish a base for the evaluation of hygrothermal effects in virgin and damaged multidirectional laminates. The typical time dependence of moisture absorption observed in unidirectional laminates is shown in Fig. 7. As would be expected, laminate thickness was found to influence the rate of moisture absorption, but the width of the laminate had no effect. Saturation moisture level was independent of both laminate thickness and width. The moisture saturation levels observed for the unidirectional laminates are listed in Table 3.

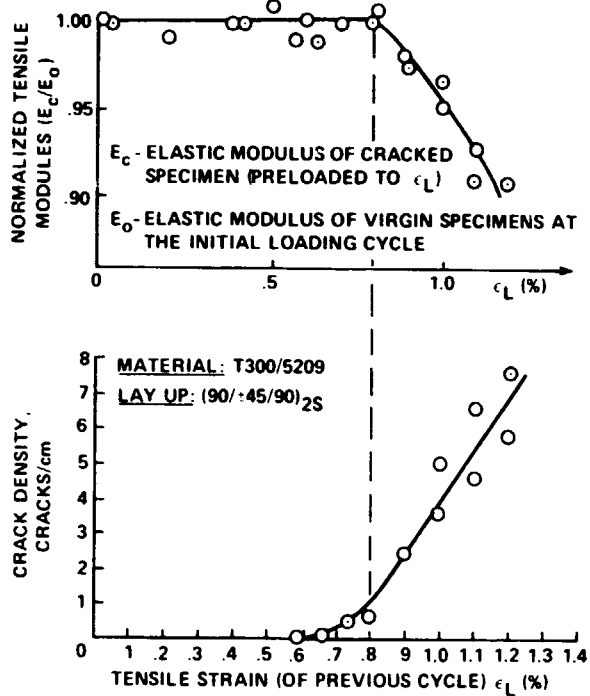
Fig. 11 The effect of preloading tensile strain (ϵ_L) and subsequent cracking on normalized tangent modulus in dry multidirectional graphite/epoxy specimens.

Residual stiffness and strength characteristics of multidirectional laminates that contained various crack densities were determined. Residual stiffness in tension and flexure were established using multicycle loading where the initial tangent modulus was measured and related to the maximum strain of the preceding cycle (ϵ_L). Figure 11 shows the observed strain dependence of the normalized residual tangent modulus [modulus of the cracked laminate divided by the initial modulus of the respective virgin (uncracked) laminate] for the T300/5209, (90/±45/90)_{2S} laminate. From the previously established relationship between transverse crack density and applied strain (Fig. 4), the relationship between the normalized tangent modulus and the transverse crack density can be established and is shown in Fig. 12. As can be seen from this figure, stiffness begins to decay only after a significant amount of transverse

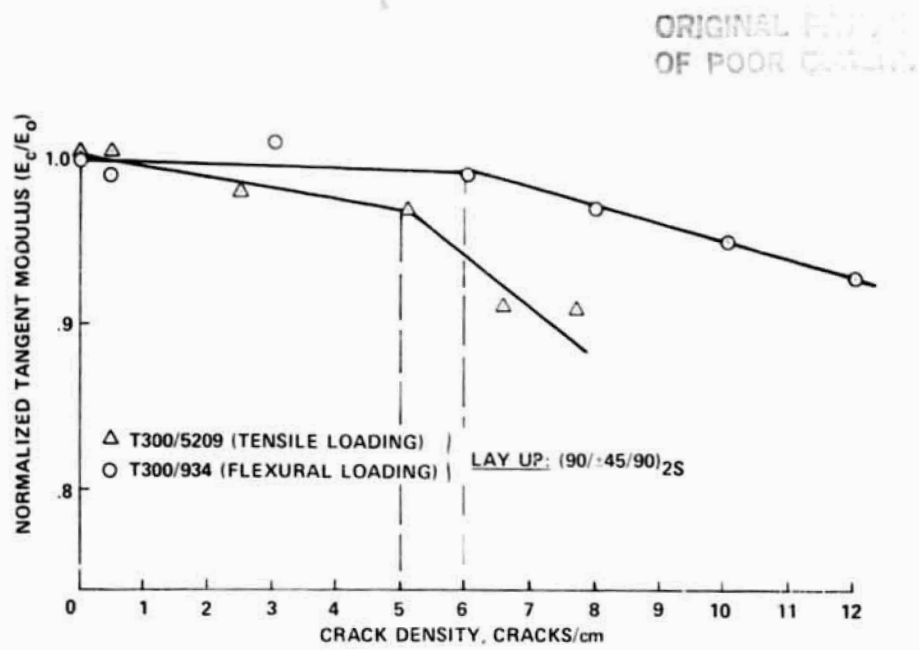
Fig. 12 Residual normalized tangent modulus versus crack density in multidirectional graphite/epoxy specimens.

cracking has occurred. Even at this point, the degradation in stiffness in the cracked laminate is only about 10% of that of the virgin laminate at a crack density of approximately 5 cracks/cm. Similar reductions were observed for the T300/934, (90/±45/90)_{2S} laminate. All data are summarized in Table 4.
