NASA Technical Memorandum 83670

# Deposition Stress Effects on Thermal Barrier Coating Burner Rig Life

Prepared for the  
Eleventh International Conference on Metallurgical Coatings  
sponsored by the American Vacuum Society  
San Diego, California, April 9-13, 1984

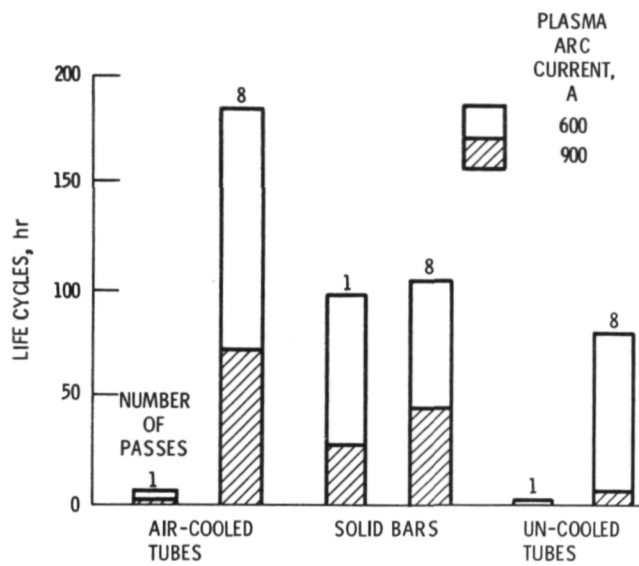
Figure 1. - Effects of process variations on  $ZrO_2-8Y_2O_3/NiCrAlY$  coating life.

The results of the burner rig tests are summarized in Table II and Fig. 1. Lives ranged from 0 cycles to 207 cycles. Zero cycle failures occurred when the stresses developed upon cooling after spraying caused the coating to spall. These failures occurred only with coatings applied at 900 amps in 1 pass to both uncooled and air-cooled tubes. The coatings that lasted longest were those applied at 600 amps in 8 passes to the air-cooled hollow substrates. For any set of parameters, 600 amp coatings outlasted their 900 amp counterparts, by a factor of at least 1.7. In all cases the 8-pass coatings lasted longer than the similar 1-pass coating. The degree of improvement in coating life achieved by going from 1 pass to 8 passes varied widely with the different substrates; on air-cooled substrates coating life improved by a factor of nearly 20 while with the solid substrate coating life improved by a factor of only 1.2. The substrate which produced the most durable coating was not the same for the 1-pass and 8-pass groups of specimens. With the 1-pass coatings the solid bar produced the best coating while among the 8-pass coatings the most durable was that applied to the air-cooled tube.

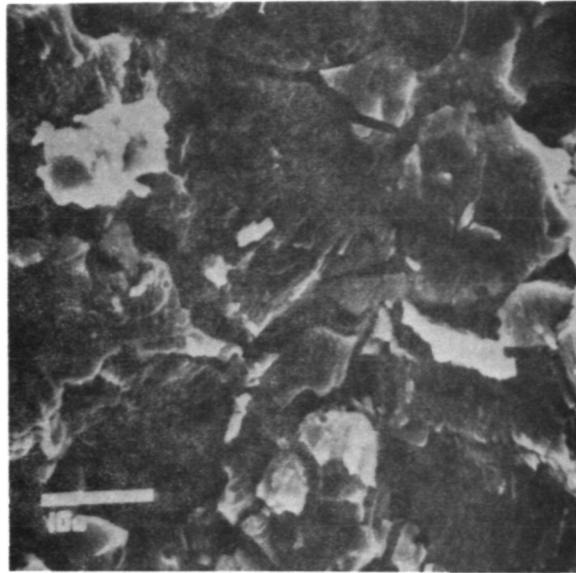
(c) 1-pass, 900 A, un-cooled tube.

The 900 amp coating on the uncooled tube had the most uniform structure and the fewest structural discontinuities (fig. 3(c)). There was, however, extensive randomly oriented microcracking. Figure 3 shows a major crack running parallel to the substrate, but it did not appear to lead to failure. However, it does demonstrate the high residual stress level in this short-lived coating. The failure path did not follow the stepping mechanism. Instead cracks seemed to slice through the entire coating in one plane without revealing the tops of any splats.

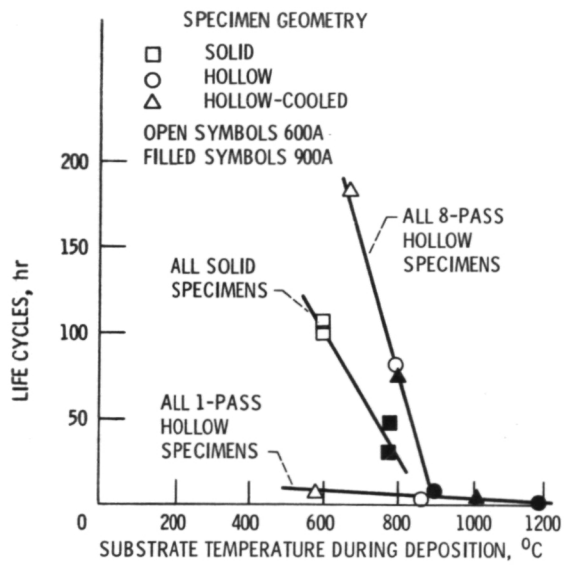
Figure 5. - Effect of substrate temperature on  $ZrO_2-8Y_2O_3/NiCrAlY$  coating life.

A key factor in the coating residual stress picture is substrate temperature. A plot of coating lives versus maximum measured metal temperature during coating deposition is given in Fig. 5. A plot of  $\Delta\alpha(T) \cdot (T_{max} - T_{ambient})$  is very similar. For any substrate/cooling configuration, 600 amp coatings lasted longer than 900 amp coatings. This is inconsistent with other results.<sup>16</sup> With other factors equal, coatings applied in 8-passes always lasted longer than those applied in one-pass. Lower power, more passes, cooling, and high substrate thermal mass tend to reduce residual stress. The fact that a single correlation between temperature and life was not obtained indicates that substrate thermal mass and cooling are important considerations that have a strong effect on ceramic coating build-up stress via solidification and stress relief processes. However, for a given configuration, life followed a linear relation with substrate temperature.
