NASA Contractor Report 168332

DOCUMENTATION OF ICE SHAPES ON THE MAIN ROTOR OF A UH-1H HELICOPTER IN HOVER

January 1984

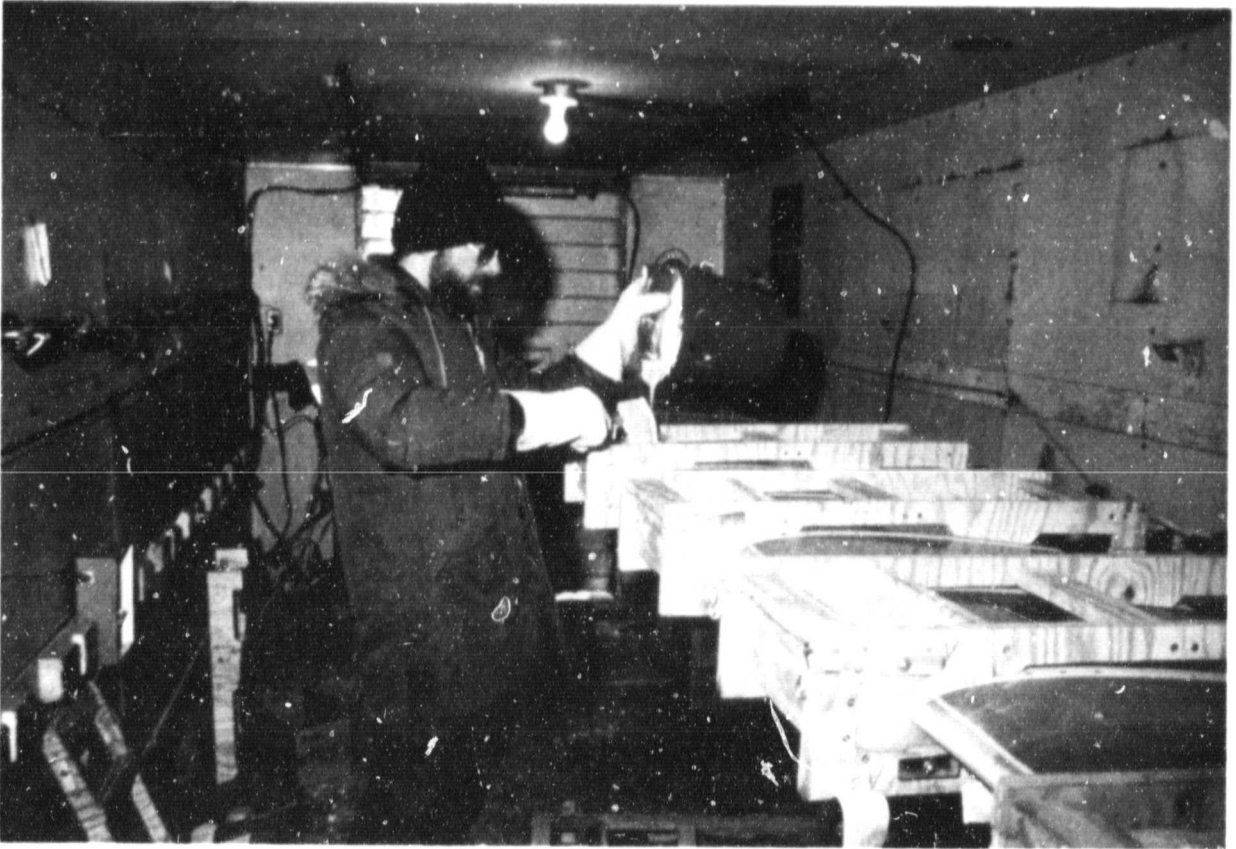
FIGURE 4. Interior of Van Showing Rubber-Mold  
Boxes Attached to the Rotor Blade.

Ten plywood mold-containers were fabricated (see Figure 4) in two parts for attachment around the rotor blade. Each "box" isolated a segment of the blade about ten inches wide (spanwise) and permitted molding of ice form two inches ahead of the leading edge to six inches aft.

Hovey and Associates of Ottawa, Canada, performed the on-site documentation using the equipment described above. An enclosed shelter was assumed necessary in order to control the temperature for the molding process and the lighting for the photography. A "scissors-lift van" was rented from Air Canada and the interior was modified for the test program (see Figures 3, 4, 5).
