NASA Technical Memorandum 85853

# Stress-Corrosion Behavior of Aluminum-Lithium Alloys in Aqueous Salt Environments

P. P. Pizzo, R. P. Galvin and Howard G. Nelson

October 1983

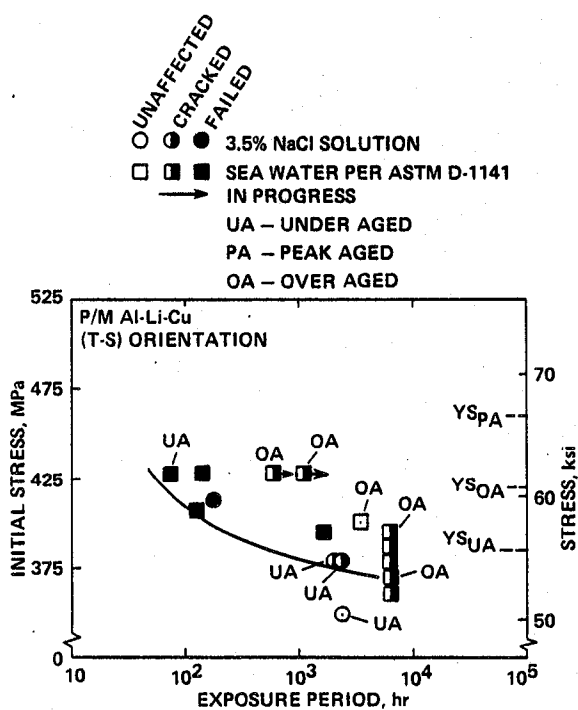
Fig. 4. Alternate-immersion data for the P/M Al-Li-Cu alloy.

The effect of aging on the stress-corrosion behavior of the two P/M Al-Li-Cu alloys was explored in the alternate-immersion tests. Comparison of the underaged, peak-aged, and overaged conditions for the P/M Al-Li-Cu and P/M Al-Li-Cu-Mg is provided in Figures 4 (Al-Li-Cu) and 5 (Al-Li-Cu-Mg). The stress-corrosion resistance is found to increase with aging time for the three conditions investigated, the underaged material having the shortest lifetime. The overaged specimens either took longer to fail or remained unfailed after prolonged exposure. This difference in stress-corrosion resistance as a function of aging time appears to be greater at higher applied stress (Figs. 4 and 5).

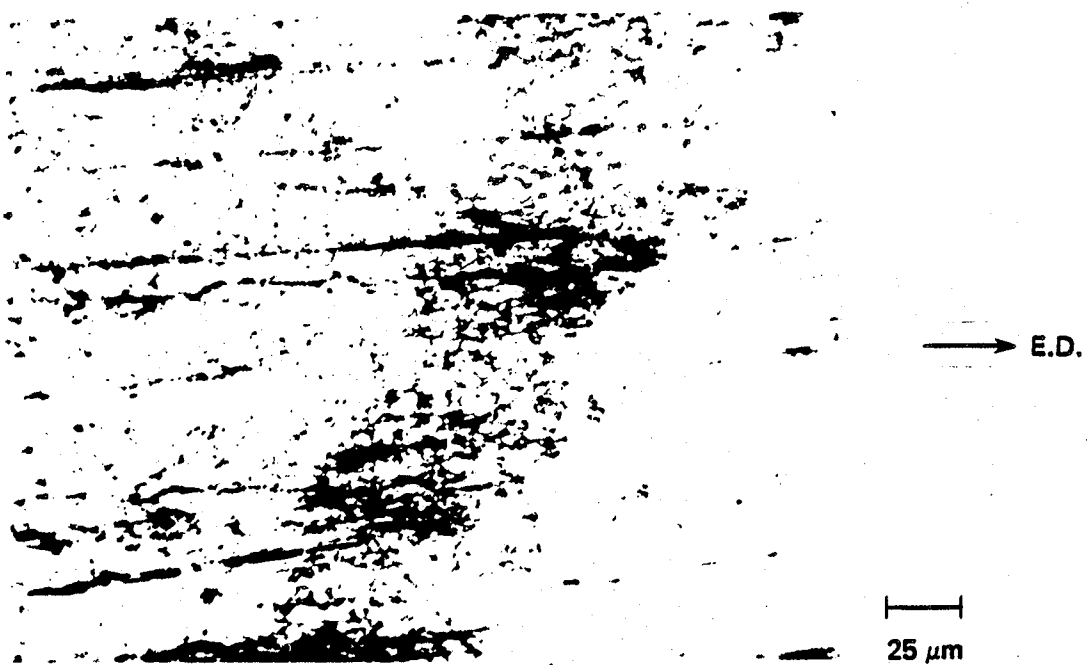
Fig. 14. Intergranular corrosion along shear-deformation bands in Al-Li-Cu base alloy DCB specimen immersed 1.4 years in 3.5% NaCl solution (as polished); (a) corroded slip deformation bands adjacent pre-crack crevice and (b) close-up of intergranular corrosion within band.

occurs at selected regions along the crack plane, as shown in Figure 17. In the P/M Al-Li-Cu alloy, intergranular corrosion is more intense in the slip deformation bands developed during fatigue precracking process, as shown in Figure 14.

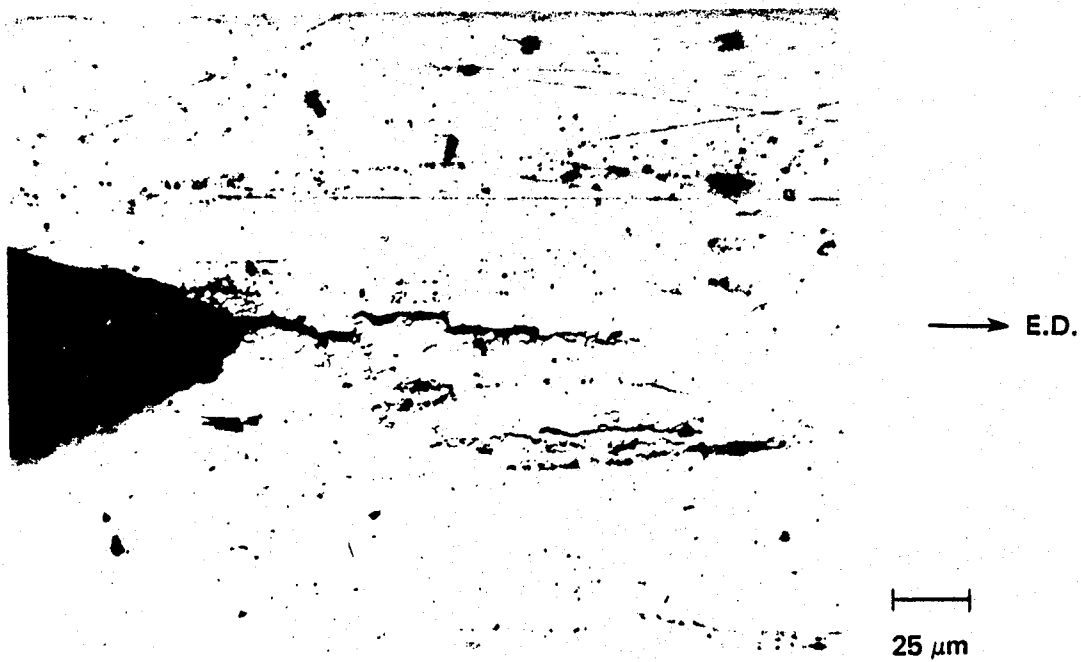
Fig. 15. Intergranular corrosion (a) adjacent machined notch and (b) at crack-tip of P/M Al-Li-Cu alloy DCB specimen (as polished).

The physical appearance of the S-L-oriented DCB specimens that underwent long-term exposure (1.4 yr) to the aqueous NaCl environment is shown in Figures 13-17. The magnesium-bearing alloy was found to be very susceptible to localized pitting, much more so than the base alloy, as shown in Figure 13. Metallographic examination of the rough-polished side-surfaces of the DCB specimens, perpendicular to the pre-crack plane, indicate extensive intergranular cracking and corrosion, both in the P/M Al-Li-Cu alloy, as shown in Figures 14 and 15, and in the magnesium-bearing alloy, as shown in Figures 16 and 17. The intergranular attack is again associated with the stringer particles aligned parallel to the extrusion direction. Intergranular attack is not localized to the region of crack growth but

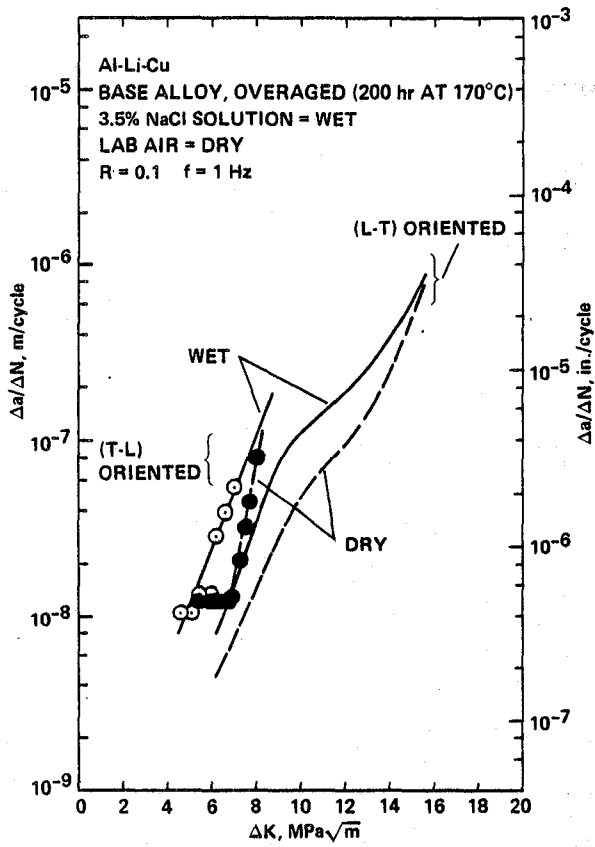
Fig. 20. Fatigue crack growth behavior of the P/M Al-Li-Cu alloy for both wet and dry test conditions.

The curves of Figure 20 demonstrate that the fatigue-crack-growth rate behavior of the P/M Al-Li-Cu alloy is dependent on both specimen orientation and environment. For a given value of stress-intensity range, crack growth occurs more rapidly in the T-L oriented specimens. Similarly, for a given value of stress-intensity range, specimens exposed to aqueous sodium chloride solution grow at a faster rate than those exposed to laboratory air. The degree of environmental influence is not uniform over the range of  $\Delta K$  investigated. This is due to a change in shape of the crack-growth rate versus  $\Delta K$  trend curves for both wet and dry conditions and for both

specimen orientations. The maximum environmental influence occurs at some intermediate  $\Delta K$  value and is equal to an increase in fatigue crack growth rate by a factor of about 2.
