Advanced Gas Turbine

Power-Train System Development

Fifth Semiannual Report

Detroit Diesel Allison
Division of General Motors Corporation
Indianapolis, Indiana 46206

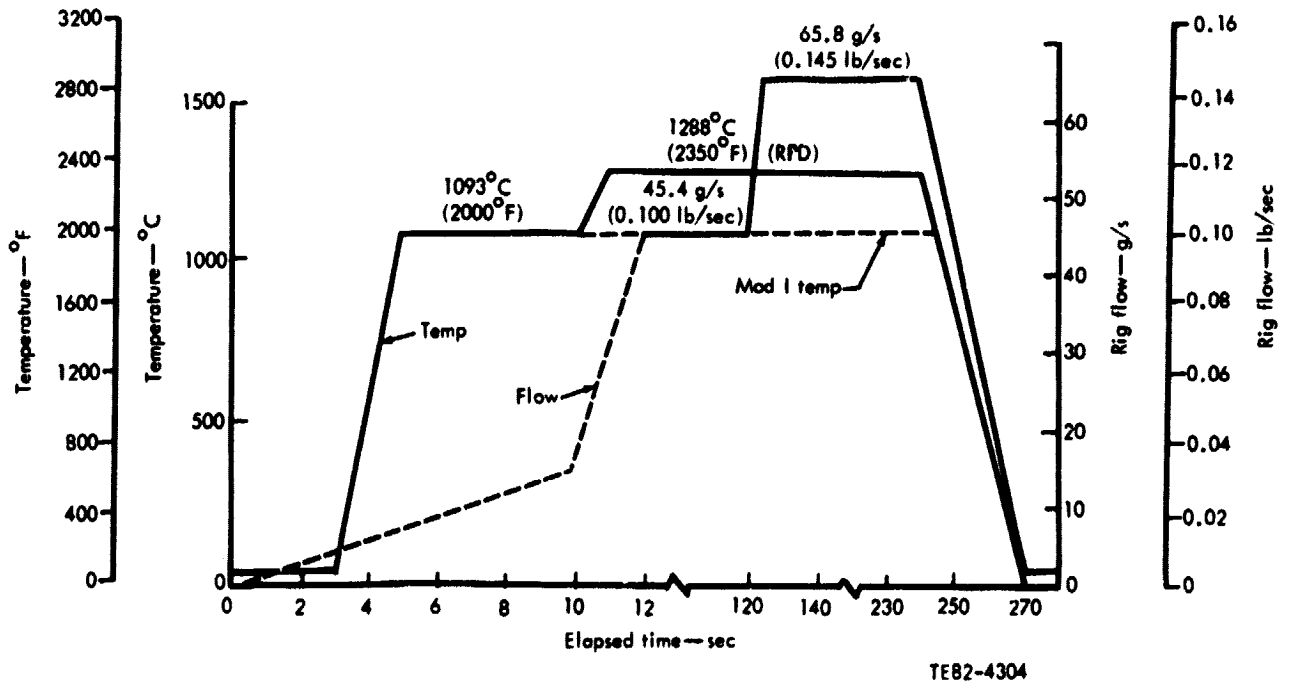
Figure 19. Vane thermal shock rig schedule for gasifier and power turbine.

A transient schedule for both vanes has also been devised and is shown in Figure 19. Eighteen ceramic (sintered alpha silicon carbide) gasifier vanes and 21 power turbine vanes have been qualified in the rig using the Mod I temperature schedule, and no failures have occurred.

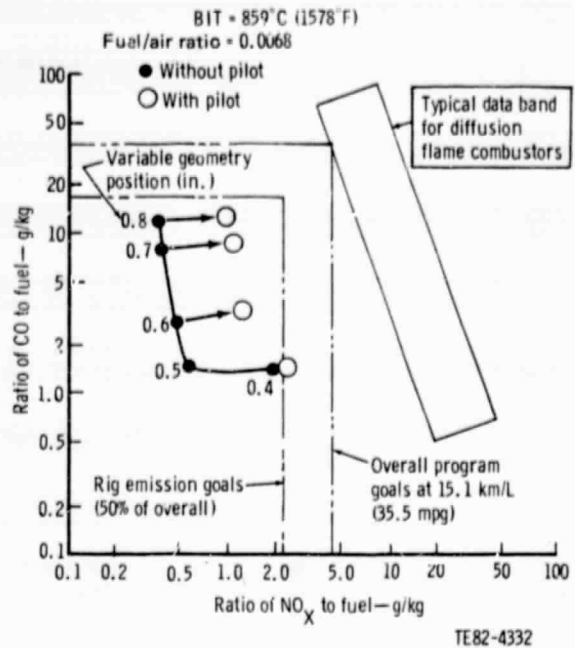
Figure 23. Combustion data for cycle point 8 at 65% speed.

The total fuel flow for the operating condition shown in Figure 23 was approximately 3.1 kg/h (6.8 lb/hr). When 0.27 kg/h (0.6 lb/hr) of this total fuel flow was burned in the diffusion flame pilot nozzle, the NO_x emissions increased nearly 2.5 times over the level measured when all the fuel was burned in the premix/prevaporization mode.

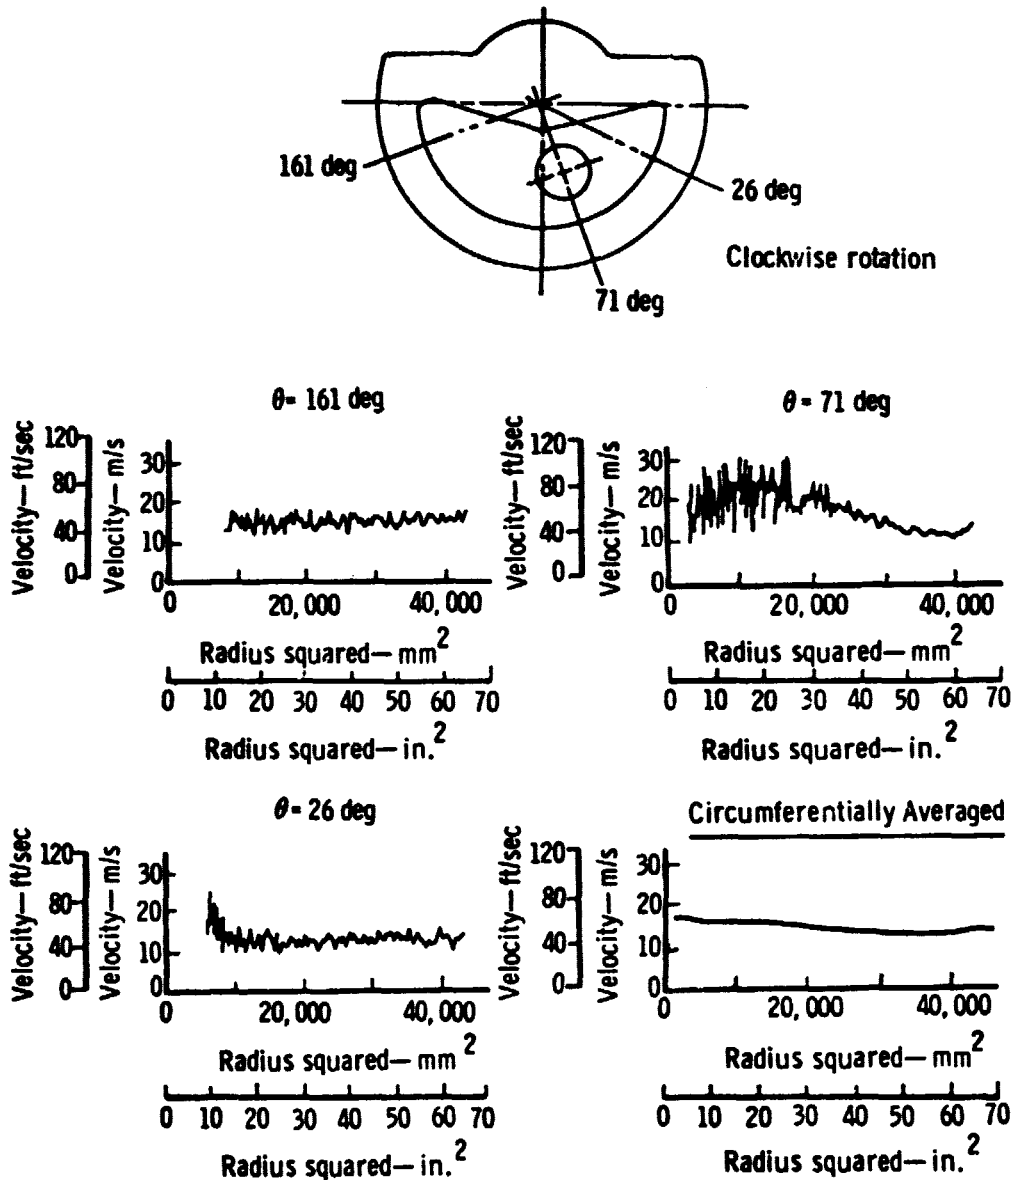
TE82-4308

Figure 27. Regenerator measured gas-side cold flow distributions at maximum power condition.

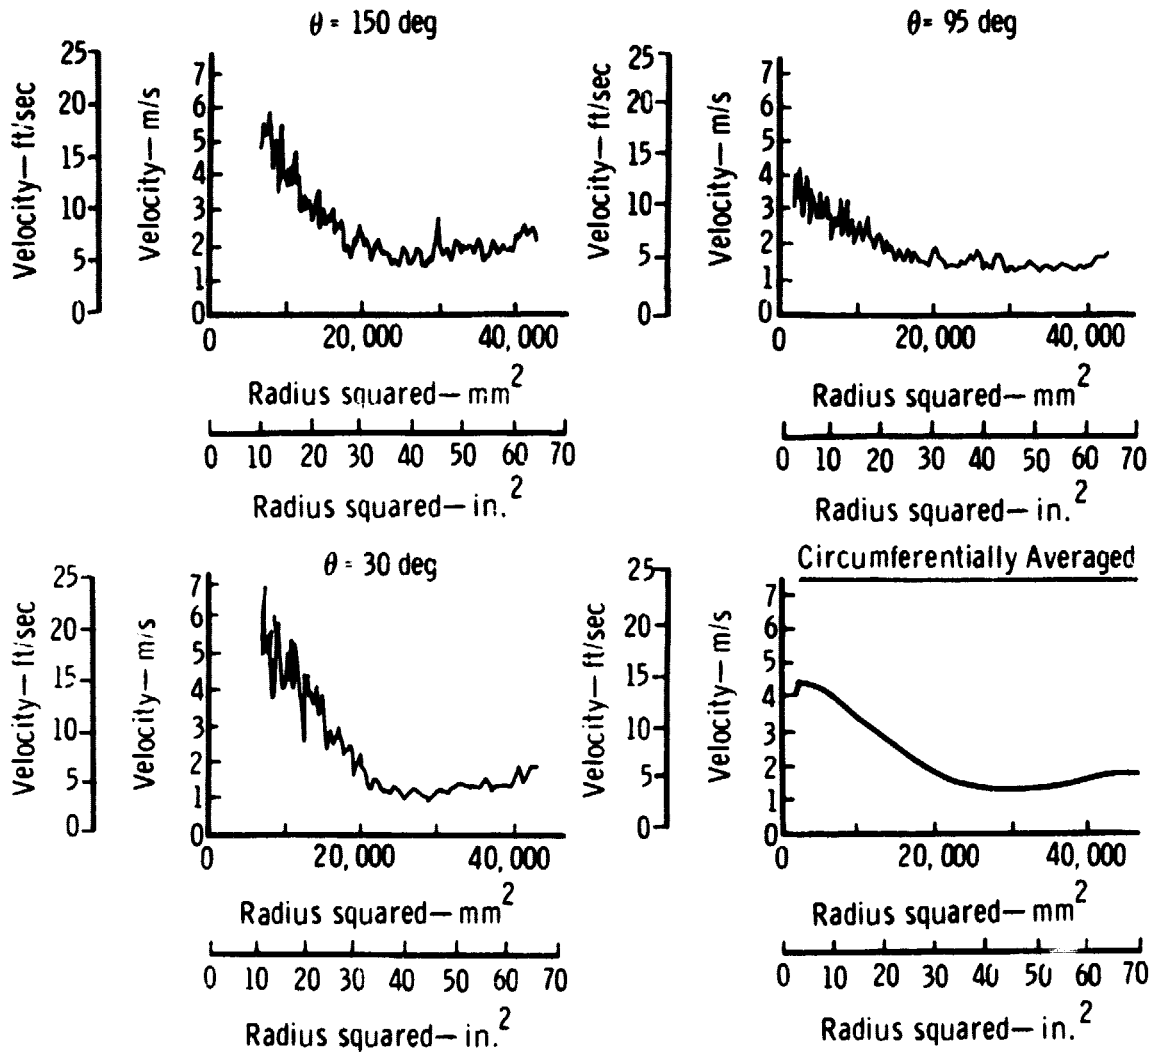
TE82-4309

Figure 28. Regenerator measured air-side cold flow distribution at maximum power condition.

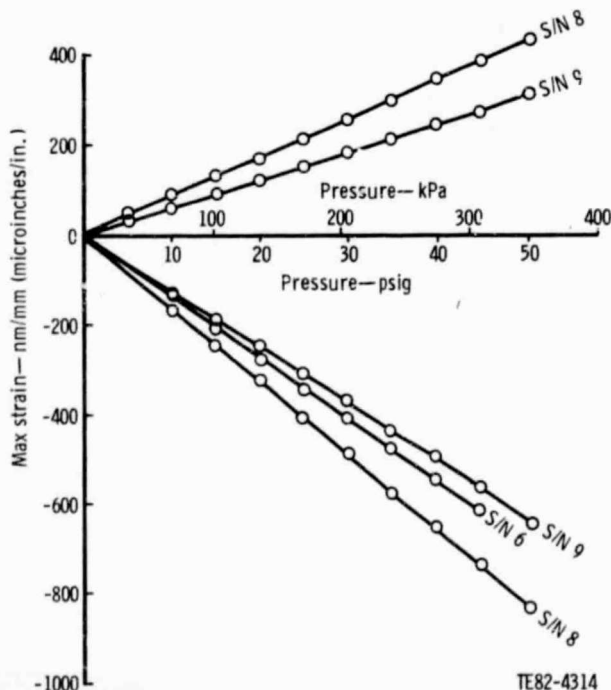
Figure 34. Proof testing of ceramic exhaust duct/seal platform.

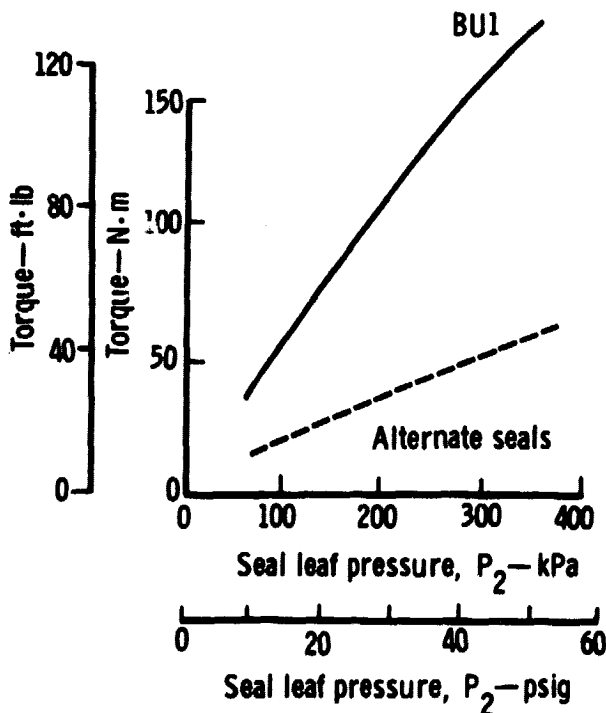
Figure 39. Regenerator drive torque and effectiveness for BU1 and alternate seal set.

Regenerator drive torque and effectiveness for the two sets of seals are shown in Figure 39. The high clamping crossarm of the BU1 seal significantly increases the drive torque requirements. At the low regenerator speeds this represents approximately 0.45 kW (0.6 hp) at maximum power. More than 25 hr of hot rig test time has been accumulated with this high clamping seal without measurable deterioration in the seal wear surface or the disk.

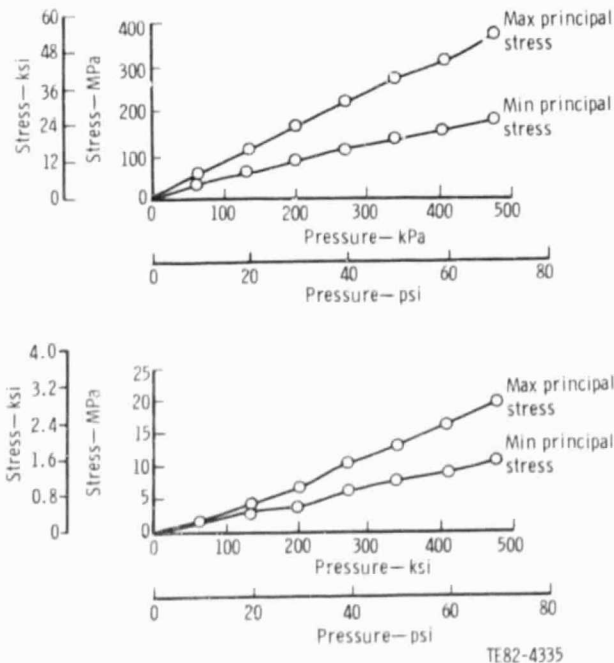
Figure 45. Stress and maximum stress locations for combustor case and inner gear case.

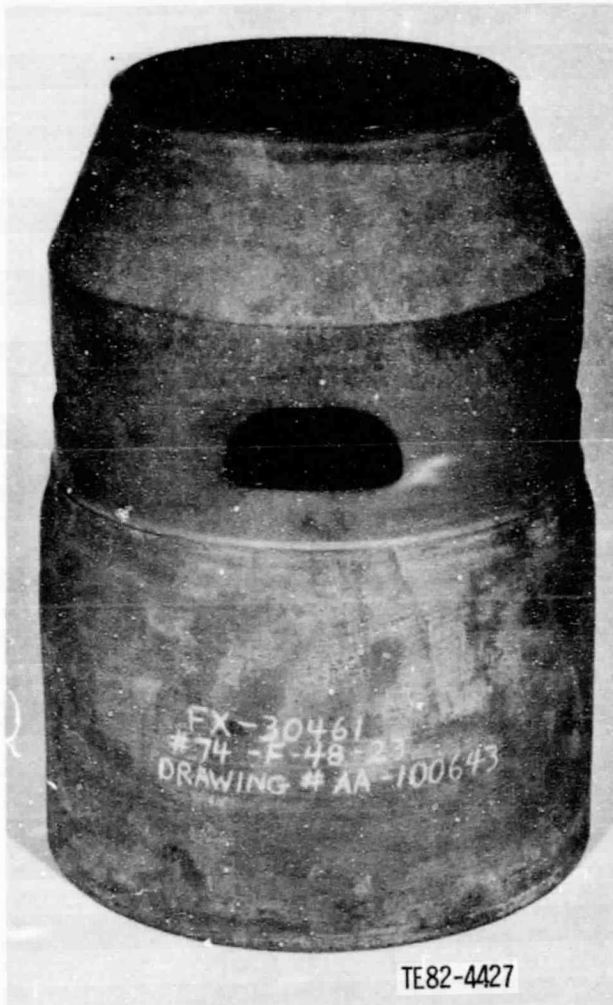
Figure 58. Machined CBO combustor body.

The combustor body is being produced from slip cast alpha silicon carbide. Work previous to this period has centered on prototype component development. During the latter part of 1981 a design was determined for this

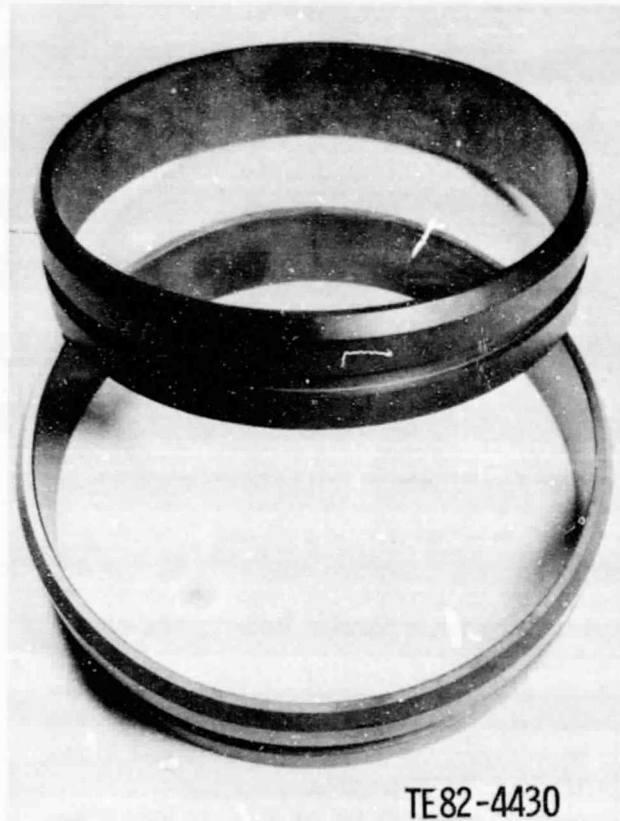
Figure 61. CBO dilution bands.

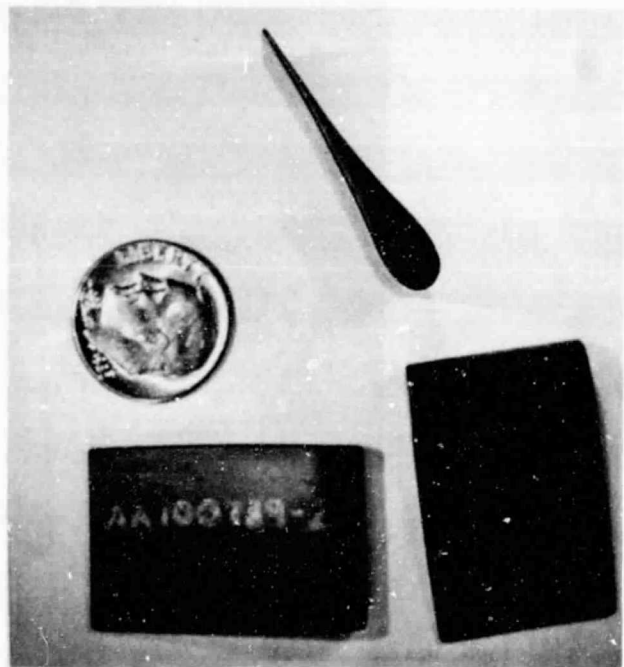
Figure 65. Power turbine vanes.
