**NASA  
Technical  
Paper  
2187**

**Experimental and Analytical  
Investigation of the Fracture  
Processes of Boron/Aluminum  
Laminates Containing Notches**

**W. S. Johnson,  
C. A. Bigelow, and  
Y. A. Bahei-El-Din**

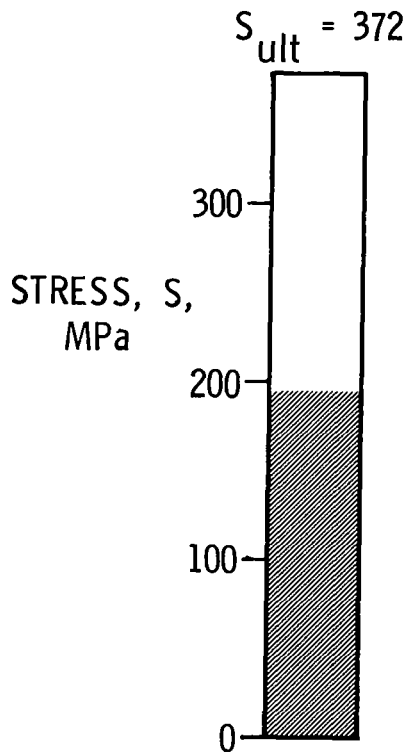
AE EVENTS ABOVE 100 dB = 0

(a) No damage.

Figure 2.- Fracture process of a unidirectional monolayer containing a crack-like slit.  $\nu_f = 0.30$ ;  $w = 78$  mm;  $2a = 19$  mm. (Figure shows one end of the center slit.)

Figure 2(a) shows the specimen at a stress level of 196 MPa with no apparent fiber failure nor any AE events above 100 dB. At a stress level of 216 MPa, a single event above 100 dB was recorded and one broken fiber was observed at the right end of the slit. Figure 2(b) shows two broken fibers at the notch tip at a stress level of 237 MPa. Two AE events above 100 dB were recorded. Figure 2(c) shows six broken fibers with three AE events above 100 dB. Acoustic emission equipment may not record the sound of every fiber break, especially if breaks occur nearly simultaneously. Figure 2(c) clearly shows that the boron fibers break before matrix failure. This is because the fibers have a 0.6 percent strain to failure, whereas the matrix material has more than 7.5 percent strain to failure. Figure 2(d) shows the damage state just before failure; there were 27 broken fibers and 11 AE events above 100 dB.

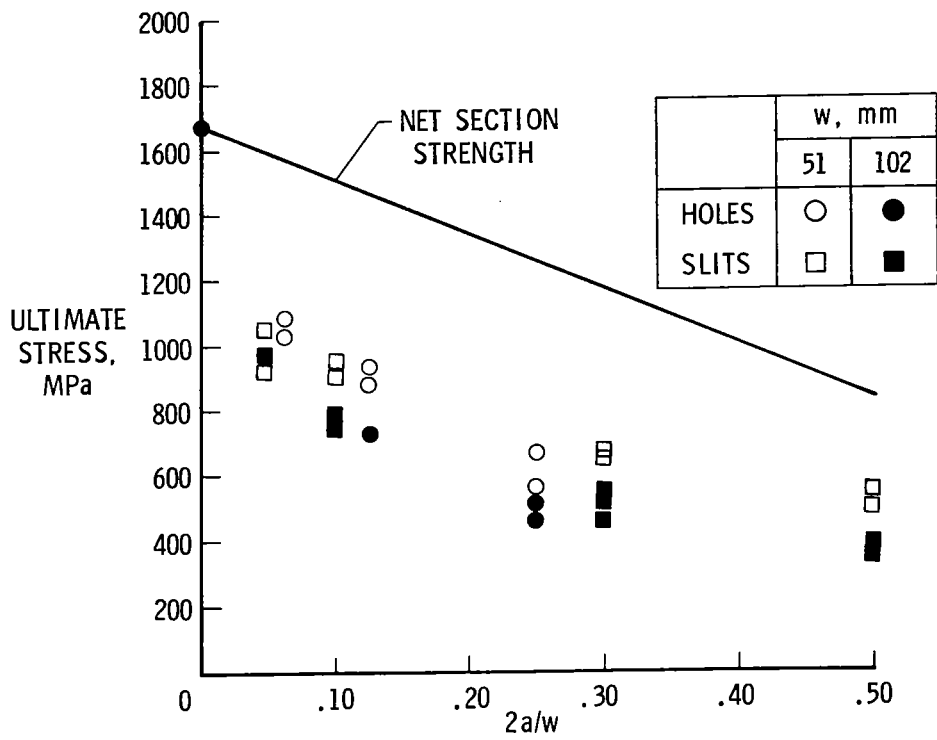
Figure 3.- Strength of  $[0]_6$  laminates with holes or slits.  
 $\nu_f = 0.50$ . (Slit data from ref. 1.)

The [0]<sub>6</sub> tests.- Nine [0]<sub>6</sub> laminate specimens with circular holes were loaded to failure. The gross section ultimate stress for each specimen plotted versus the ratio of hole diameter to specimen width (2a/w) is shown in figure 3. The two specimen widths are distinguished by open and closed symbols. Also plotted in figure 3 are the ultimate strength data obtained from similar specimens containing crack-like slits (ref. 1), for which 2a/w is the ratio of slit length to specimen width. The curve for the net section ultimate strength was found by multiplying the unnotched tensile strength of the laminate by (1 - 2a/w). This curve represents the specimen gross stress that corresponds to a net section stress equal to the unnotched tensile strength of the laminate. The unnotched tensile strengths were determined by Sova and Poe (ref. 5) and are listed in table II for each layup. The strength data and the curve for net section ultimate strength differ because of the notch effect. Note that at a given value of 2a/w, the ultimate stresses are nearly the same for specimens with holes and with slits. As a result, the notch effect appears to be a function of notch length rather than the notch radius or width. This may be attributed to the widespread yielding that occurs near the notch long before the failing load is reached. Examples of the yield patterns are presented in the analytical section. The wider specimens failed at a lower laminate stress for the same value of 2a/w.

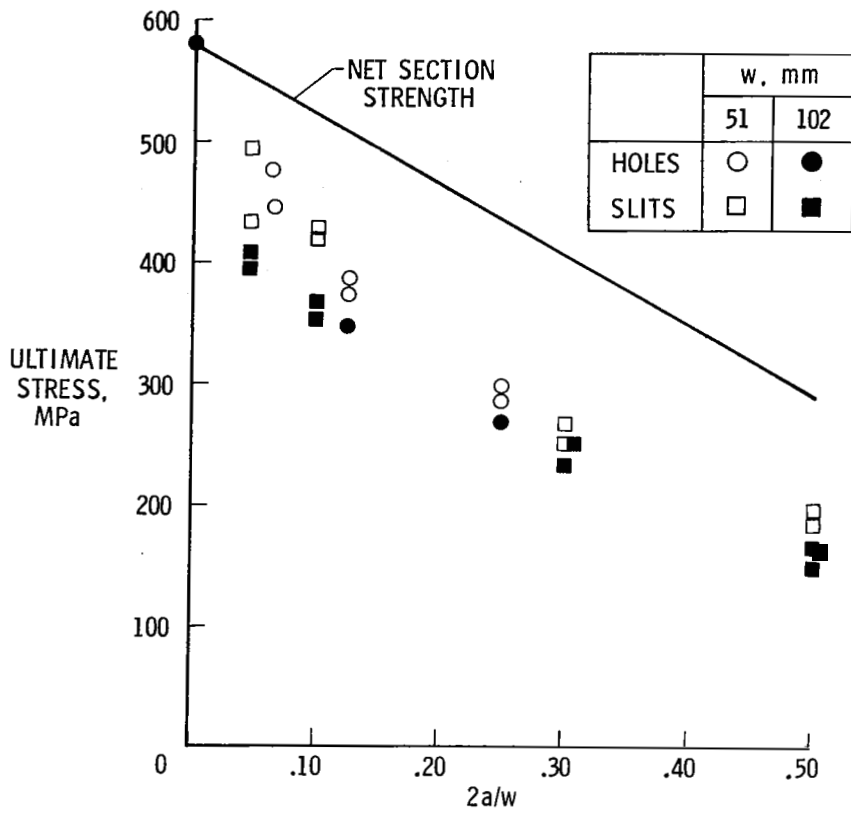
Figure 7.- Strength of  $[0/\pm 45]_s$  laminates with holes or slits.  $v_f = 0.45$ . (Slit data from ref. 1.)

The  $[0/\pm 45]_S$  tests.- Eight  $[0/\pm 45]_S$  laminate specimens with circular holes were loaded to failure. The ultimate laminate stress for each specimen is plotted versus  $2a/w$  in figure 7. The hole data again agree very closely with the slit data of Poe and Sova (ref. 1). Like the  $[0]_6$  laminates, the wider specimens failed at a lower laminate stress for the same value of  $2a/w$ .

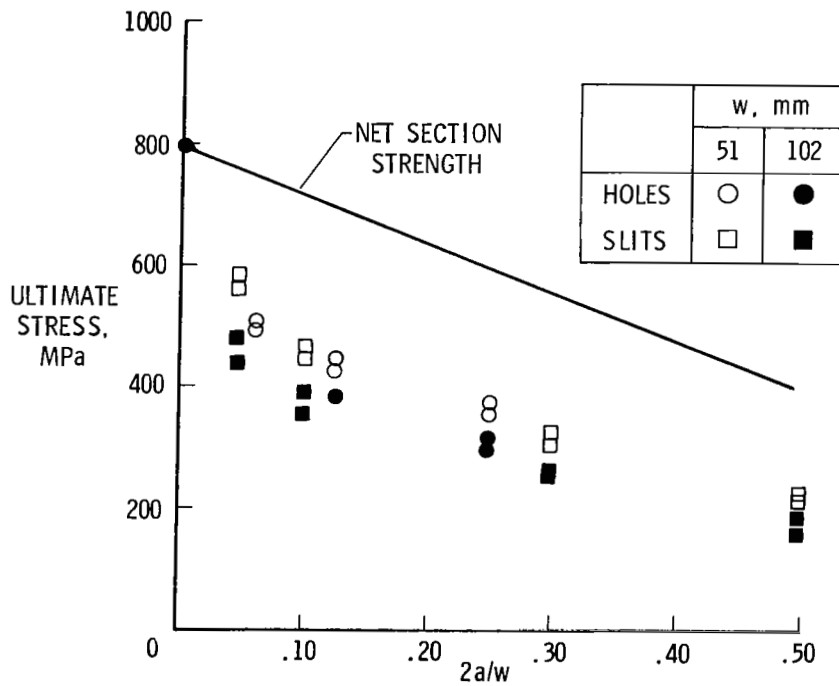
Figure 8.- Strength of  $[0_2/\pm 45]_s$  laminates with holes or slits.  $v_f = 0.45$ . (Slit data from ref. 1.)

The  $[0_2/\pm 45]_S$  tests.- Nine  $[0_2/\pm 45]_S$  laminate specimens with circular holes were loaded to failure. Figure 8 presents the ultimate laminate strength plotted versus  $2a/w$  for each specimen. As previously noted for the  $[0]_6$  and  $[0/\pm 45]_S$  laminates, the  $[0_2/\pm 45]_S$  laminates with holes and with slits exhibited virtually no difference in ultimate strengths, but notch length did have an effect.

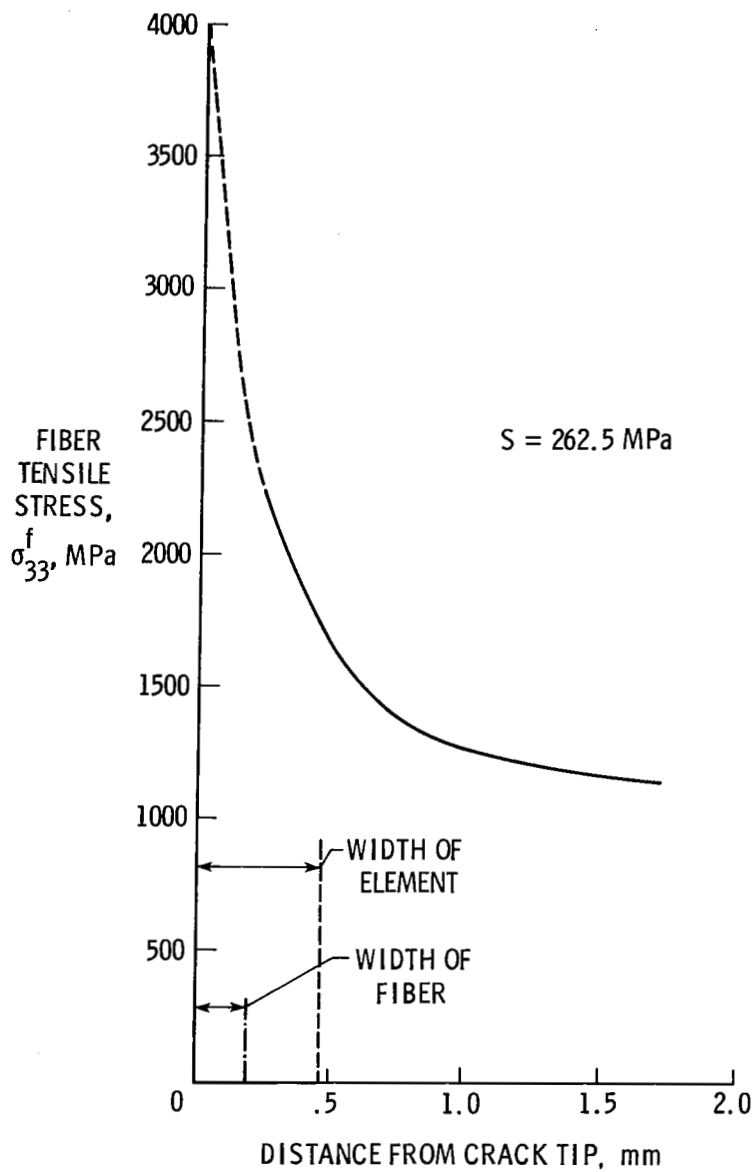
Figure 13.- Predicted fiber stress distribution near crack tip for monolayer specimen.  $2a = 19$  mm;  $w = 76$  mm.

To validate this method of determining element fiber strengths, these values were used in the finite-element model to study the fiber stress in the region of notches. For the unidirectional monolayer with a center slit, figure 13 shows how the fiber stress varies in the region of the crack tip. The solid line represents data results from the finite-element analysis. The program predicts stresses only at element centroids; therefore, to obtain the stress in the first fiber, it was necessary to extrapolate the stress from the element centroid to the edge of the notch. This extrapolation is represented by the dashed line in figure 13. As indicated in the figure, the crack-tip element contained approximately 2.3 fibers. The ultimate strength of a single fiber was assumed to be 3160 MPa, which was obtained from tensile tests of unnotched 0° B/Al specimens (ref. 5). The stress at the center of the fiber next to the crack tip was 3160 MPa when the applied remote stress was 262.5 MPa, a reasonable estimate of the remote stress at first fiber failure. The corresponding stress at the center of the element next to the crack tip was found to be about 2300 MPa. Figure 14 shows a similar plot of the fiber stress concentration for a  $[0]_6$  laminate with a hole. In this example, the element next to the hole contained approximately 3.6 fibers. Here the stress at the center of the fiber next to the hole was found to be about 3160 MPa when the applied remote stress was 465 MPa. Again, the stress at the center of the element next to the hole was about 2300 MPa.

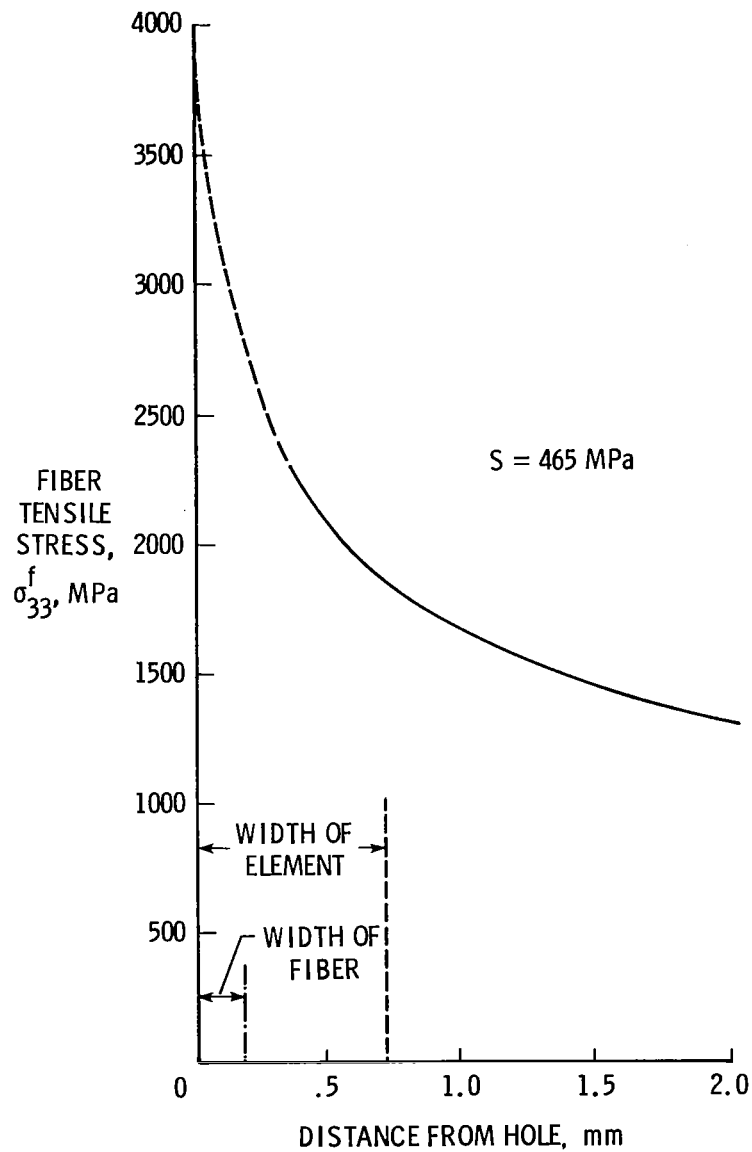
Figure 14.- Predicted fiber stress distribution near circular hole for  $[0]_6$  laminate.  $2a = 12.7 \text{ mm}$ ;  $w = 102 \text{ mm}$ .

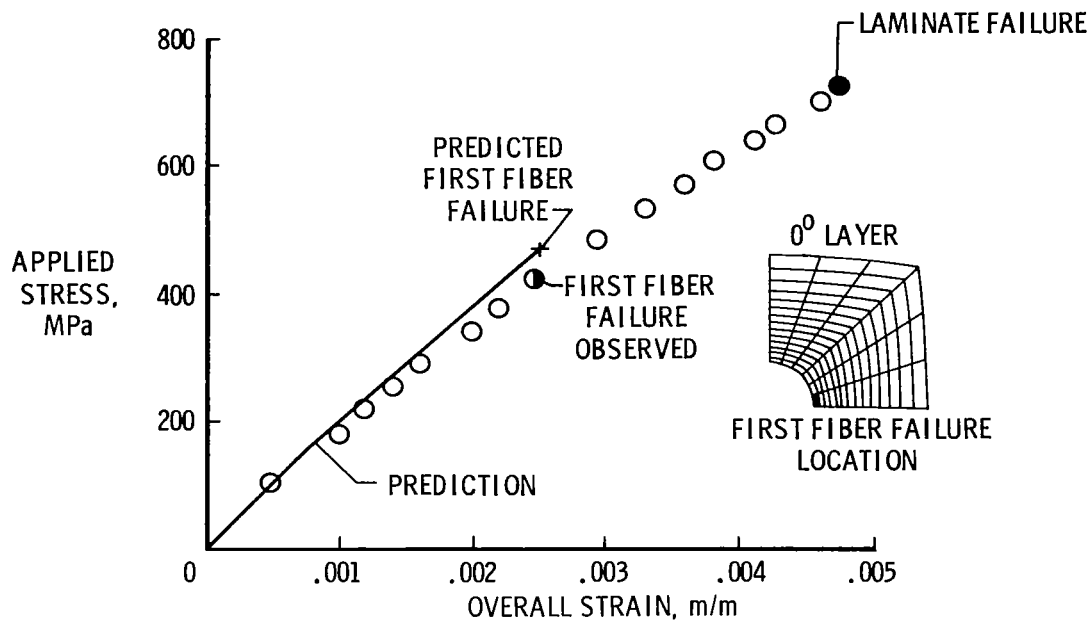
Figure 16.- Stress-strain response to failure of  $[0]_6$  laminate with circular hole.  $2a = 12.7$  mm;  $w = 102$  mm.

represents the predicted response up to first fiber failure. There is excellent correlation between the predicted and observed results up to first fiber failure. As previously noted, the first fiber failed quite early in the loading history for the unidirectional specimens. The sketch shows the predicted location of the first fiber failure.

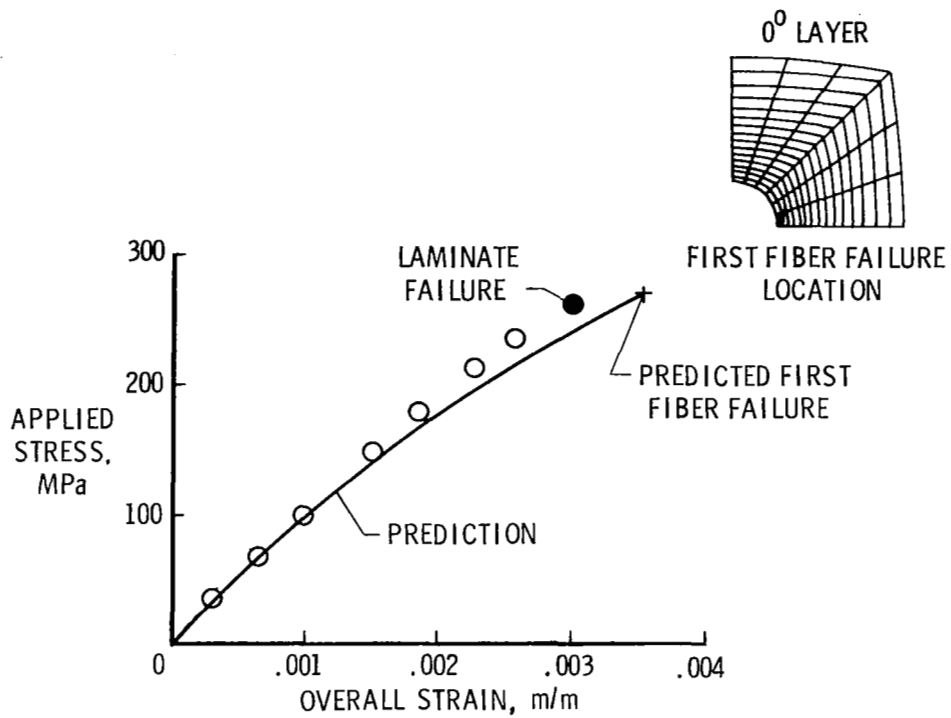
Figure 18.- Stress-strain response to failure of  $[0/\pm 45]_s$  laminate with circular hole.  $2a = 25.4$  mm;  $w = 102$  mm.

The results for a  $[0/\pm 45]_s$  laminate are shown in figure 18. Again, there is a very good correlation between the predicted and the experimental stress-strain behavior. First fiber failure was predicted to occur near laminate failure. Recall that first fiber failure was not observed for this laminate and therefore was assumed to occur at laminate failure. The first fiber failure was predicted next to the hole in the  $0^\circ$  ply element on the transverse axis, as shown by the sketch. Figure 19 shows similar results for a  $[0_2/\pm 45]_s$  laminate. This layup was more dominated by  $0^\circ$  fibers than the  $[0/\pm 45]_s$  laminate, so less plasticity was predicted.

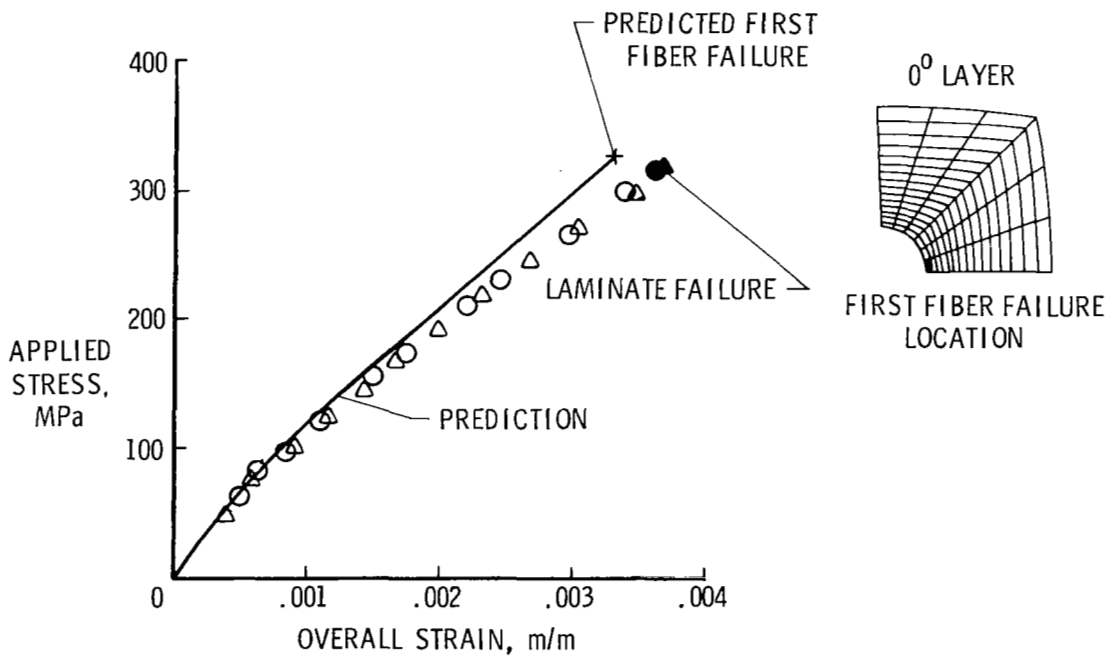
Figure 19.- Stress-strain response to failure of  $[0_2/\pm 45]_s$  laminate with circular hole.  $2a = 25.4$  mm;  $w = 102$  mm.

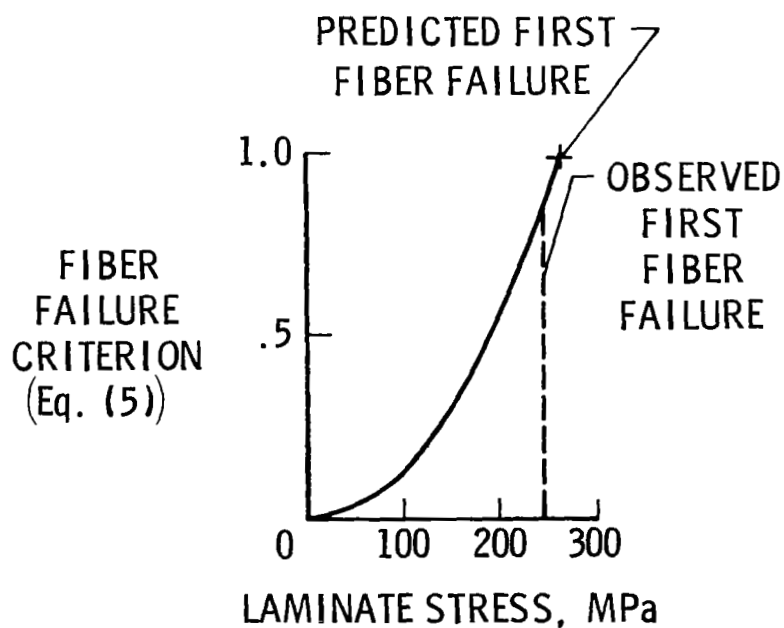
■ INITIAL YIELDING (AT 11 MPa)

▨ YIELDING AT 25 MPa

(a) Yield pattern at notch tip.

(b) First fiber failure.

Figure 20.- First fiber failure of monolayer specimen.  
2a = 19 mm; w = 78 mm.

The PAFAC analysis was also used to predict first fiber failure of a unidirectional monolayer containing a crack-like slit. The results are shown in figure 20. The yield pattern that developed at the notch tip (fig. 20(a)) extends perpendicular to the notch, parallel to the fibers. This behavior has been observed by Jones (ref. 6). Figure 20(b) presents a plot of the normalized fiber stress (fiber failure criterion) versus laminate stress. The solid line represents the predicted fiber stress up to first fiber failure. The dashed line shows the laminate stress for which the first fiber failure was observed. Again, the predicted and observed laminate stresses at first fiber failure agree very well.

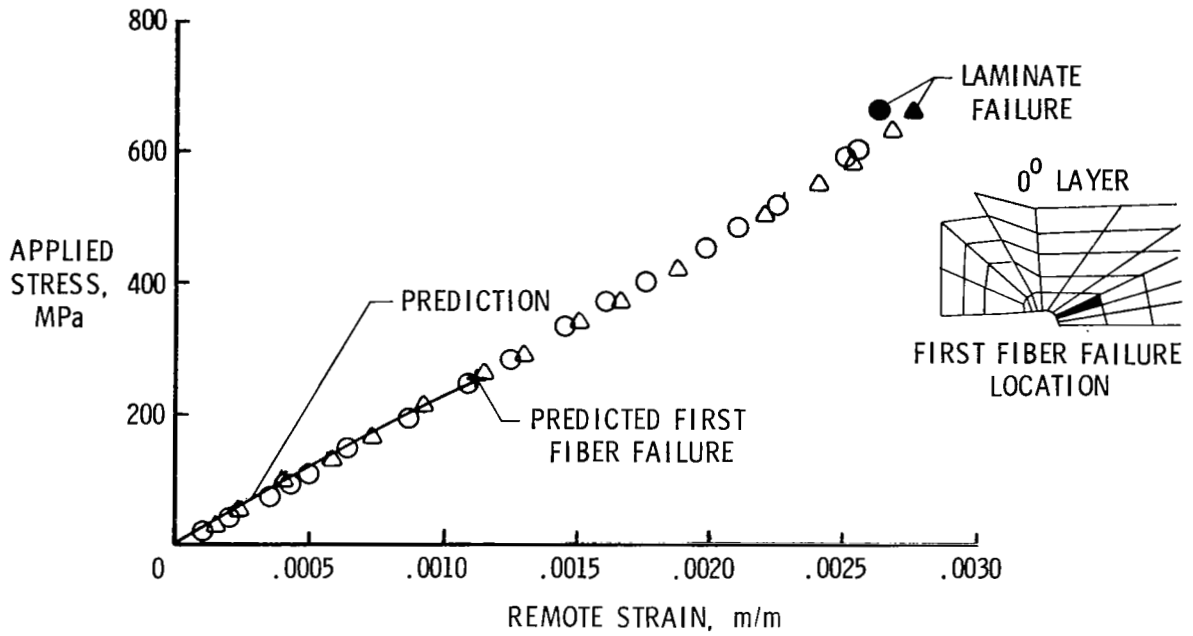
Figure 21.- Stress-strain response to failure of  $[0]_6$  laminate with crack-like slit.  $2a = 15$  mm;  $w = 51$  mm.

Several specimens containing crack-like slits tested by Poe and Sova (ref. 1) were also analyzed with the PAFAC program. Figure 21 shows the predicted and experimental results for a 51-mm-wide  $[0]_6$  specimen containing a 15-mm slit. Poe and Sova measured the remote strain with strain gages. The predicted strains at the same location are compared in figure 21 with the measured remote strains. Again, as with all the other unidirectional specimens tested, the first fiber is predicted to fail early in the loading history. Poe and Sova observed this early failure of fibers but did not record the stress at which the fibers began to fail. The stress-strain prediction is quite good.

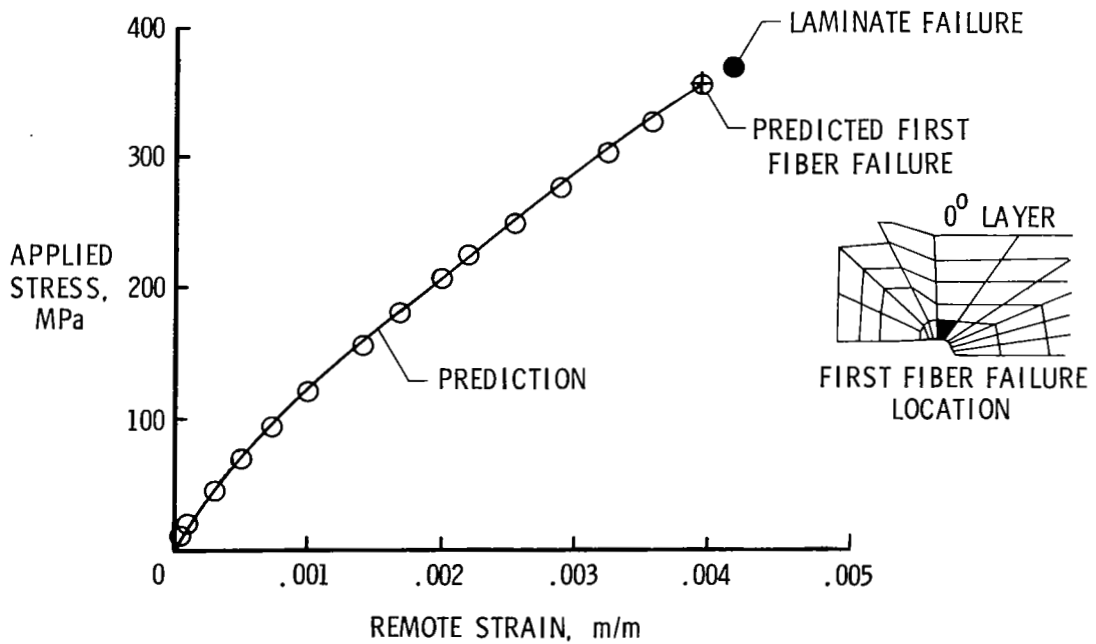
Figure 22.- Stress-strain response to failure of  $[0/\pm 45]_s$  laminate with crack-like slit.  $2a = 10$  mm;  $w = 102$  mm.

Figure 22 shows similar analytical and experimental results (ref. 1) for a 102-mm-wide  $[0/\pm 45]_s$  specimen containing a 10-mm slit. The PAFAC model predicted stress-strain response very well. The predicted first fiber failure was very close to the laminate failure stress.

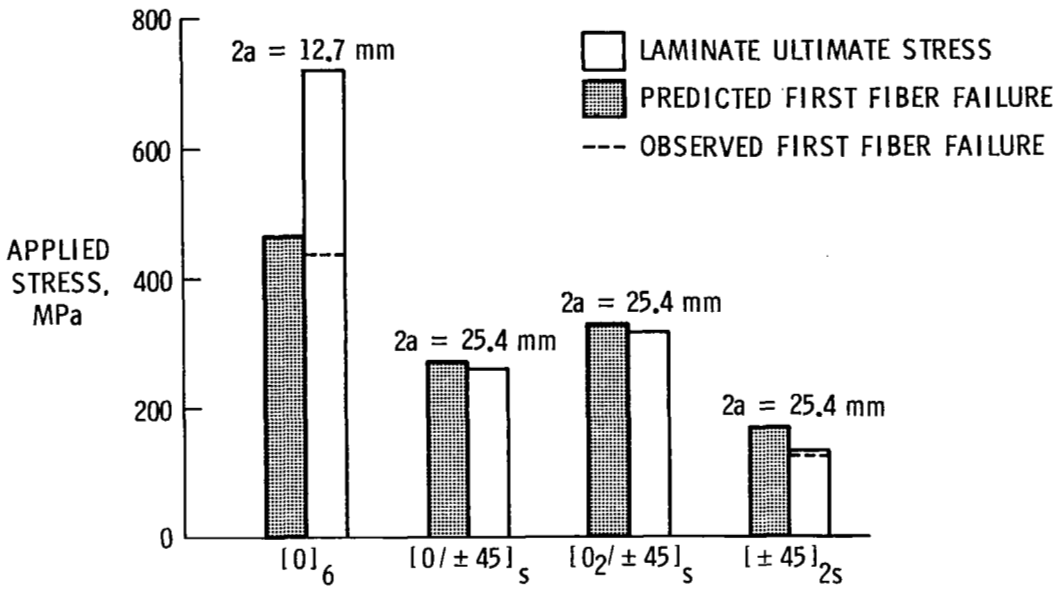
Figure 23.- First fiber failure compared with laminate ultimate stress for specimens with circular holes.  $w = 102$  mm.

fiber failure occurs very close to overall laminate failure in all laminates examined except the unidirectional ones, the first fiber failure criterion is sufficient for predicting ultimate strength of most laminates containing notches. Figures 23 and 24 summarize the elastic-plastic strength predictions made with the first fiber failure criterion. The predictions were made on specimens of various widths and ratios of notch length to specimen width ( $2a/w$ ), as noted in the figures.

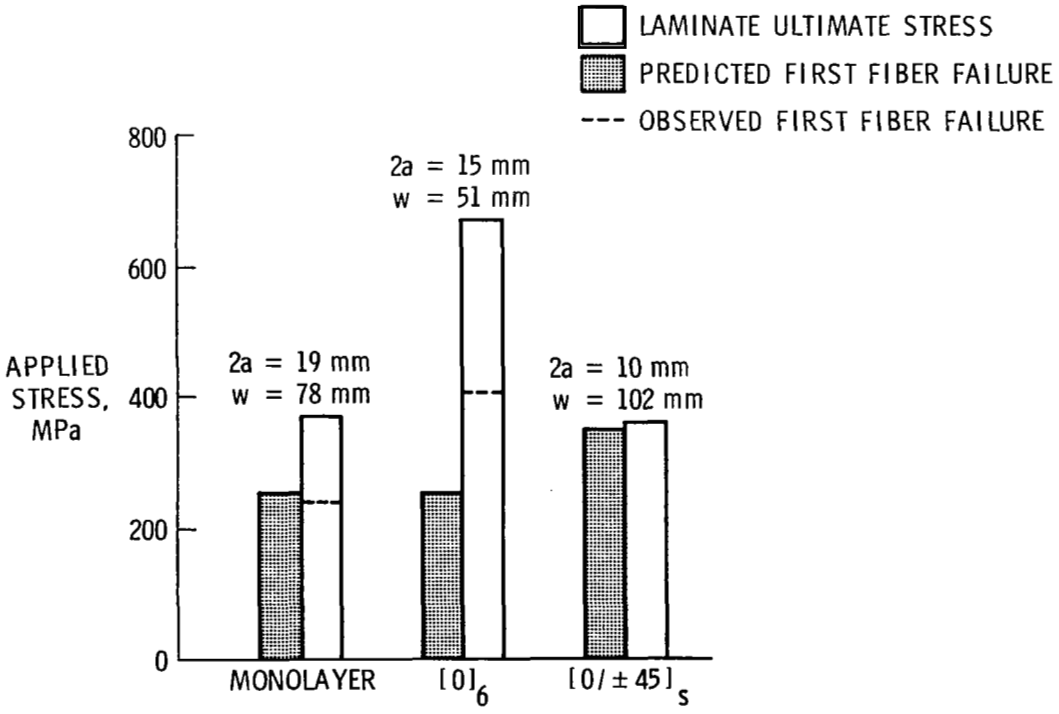
Figure 24.- First fiber failure compared with laminate ultimate stress for specimens with crack-like slits.
