NASA Contractor Report 165635

Advanced Composite Aileron for L-1011 Transport Aircraft Design and Analysis

C.F. Griffin and L.D. Fogg

Lockheed Corporation
Lockheed-California Company
Post Office Box 551
Burbank, California 91520

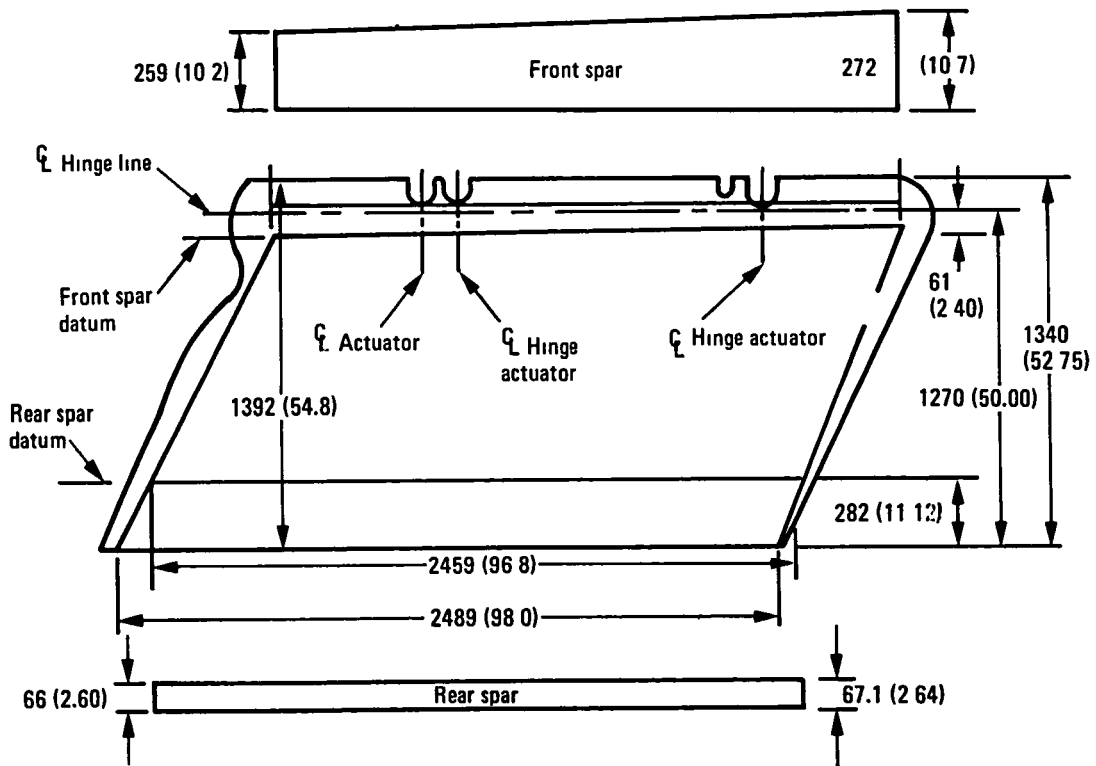
Figure 3. - Inboard aileron dimensions (All dimensions shown in mm (in))

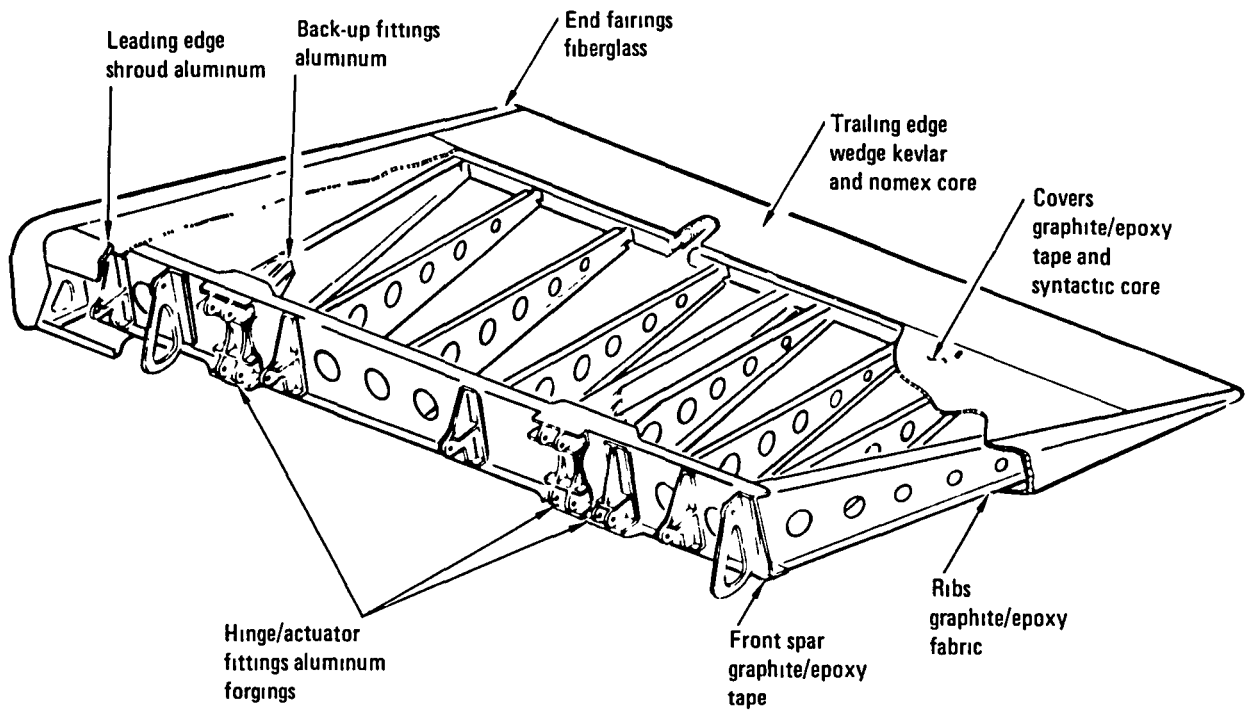
The upper surface, ribs, and spars are permanently fastened with Triwing titanium screws and stainless steel Hi-Lok collars. The removable lower surface, trailing edge wedge, leading edge shroud, and end fairings are attached with the same type of screws but with stainless steel nut plates attached to the substructure with stainless steel cherry rivets.

Figure 5. - Advanced composite aileron.

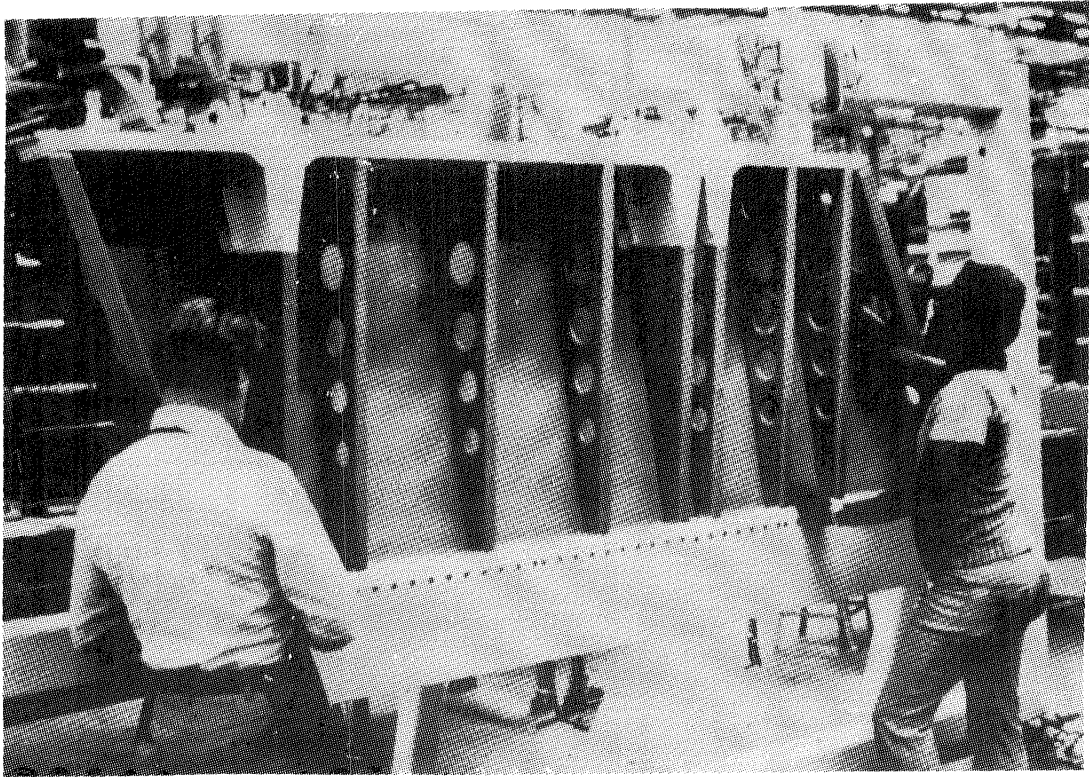
Several of the subassemblies that are currently being used on the metal aileron have been incorporated into the composite aileron design. These include the aluminum hinge/actuator fittings, the aluminum leading edge shroud, the Kevlar 49/epoxy trailing edge wedge and the fiberglass/epoxy end fairings. The aileron assembly is shown in figure 6 without the lower cover, shroud or end fairings installed.

Figure 6. - Aileron assembly.

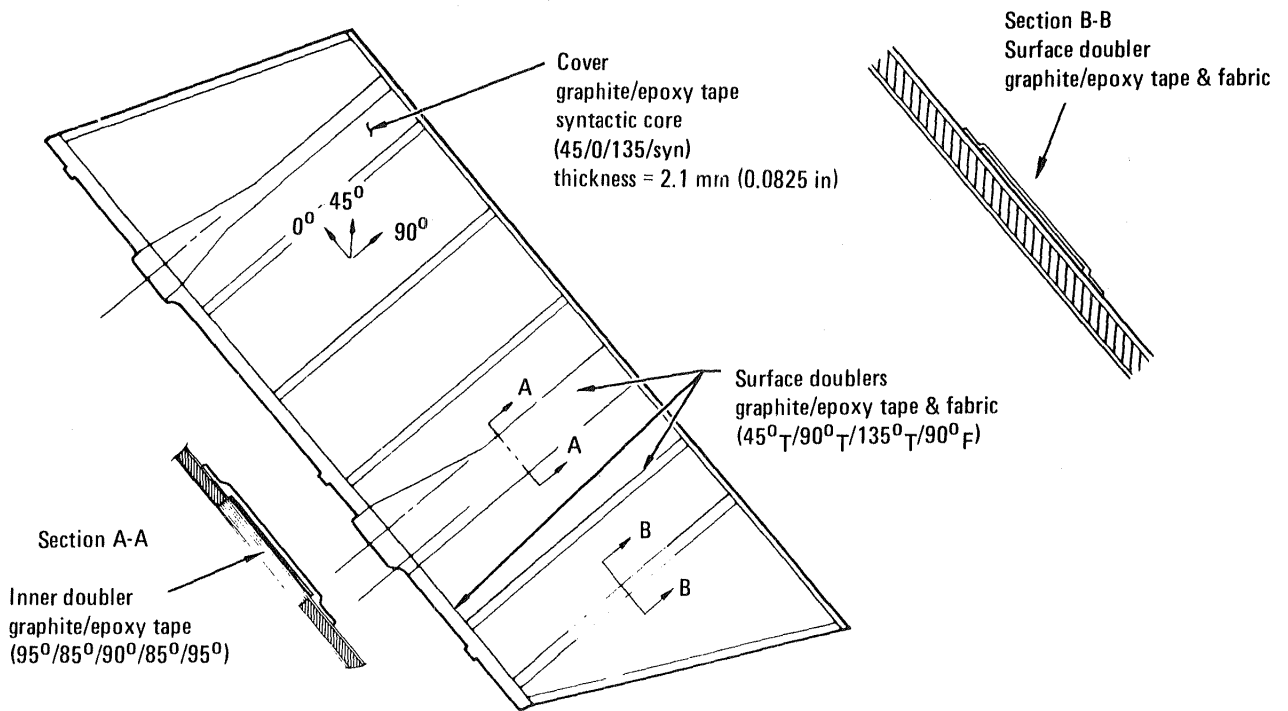
In the vicinity of the main ribs and at the ends of the aileron the syntactic core in the covers is replaced with five plies of graphite/epoxy tape to provide additional chordwise stiffness and act as an additional load path for the rib caps. The $(95^{\circ}/85^{\circ}/90^{\circ}/85^{\circ}/95^{\circ})$ orientation of this five ply internal reinforcement was selected rather than 90°_s to prevent microcracking of the laminate due to curing stresses. Inner surface doublers are cocured with the basic cover over the ribs and spars to assist in load transfer between covers and substructure and to provide the thickness buildup necessary for countersunk fasteners. These doublers consist of three plies of tape, $(45^{\circ}/90^{\circ}/135^{\circ})$, which are then covered with one ply of fabric. At the leading edge of the cover additional inner surface doublers are cocured to the basic cover to function as part of the front spar cap. This arrangement enhances the failsafety of the design by proving an alternate load path for spanwise bending loads.

Figure 7. - Aileron cover configuration.

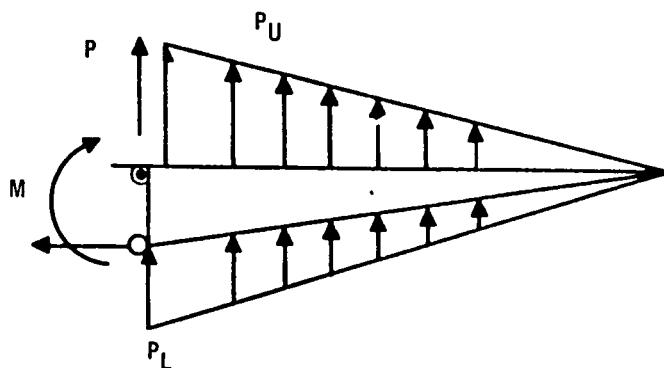
TABLE 4. - AILERON DESIGN ULTIMATE LOADS

Condition number	1	2	3	4	5
Aileron angle, degrees	-20	-12	0*	+12	+20
SI Units					
M, hinge moment kN-m	30.68	32.04	-27.12	-31.73	-30.68
P, hinge shear kN	-73.4	-75.6	48.0	75.2	72.5
P_U kPa	-34.2	-35.4	21.7*	35.1	33.9
P_L kPa	-11.4	-11.8	-8.07*	11.7	11.3
Customary Units					
M, hinge moment 1000 in-lb	271.5	283.5	-240	-280.8	-271.5
P, hinge shear 1000 lb	-16.5	-17.0	10.8	16.9	16.3
P_U psi	-4.96	-5.13	3.14*	5.09	4.92
P_L psi	1.65	1.71	1.17*	1.70	1.64

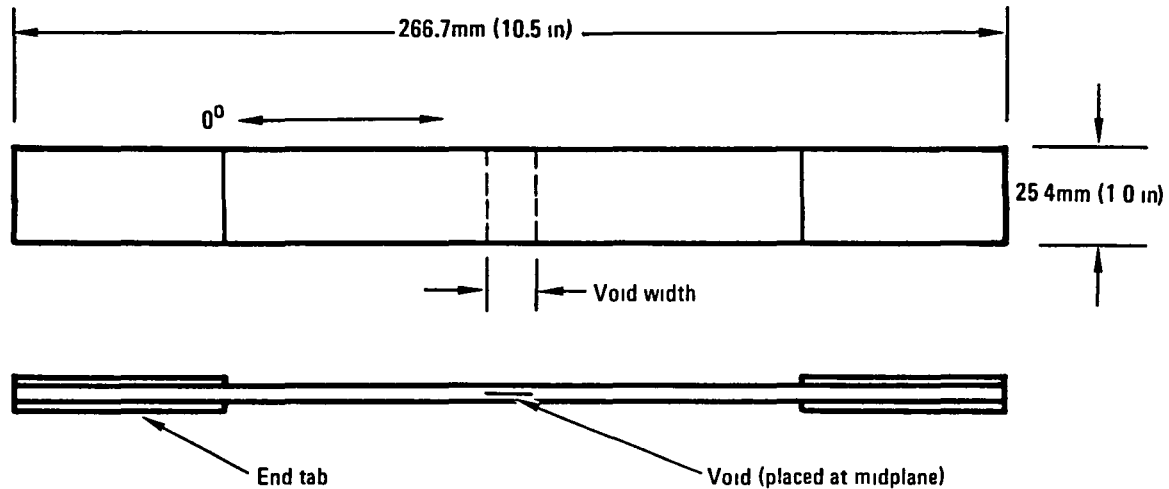
Static and fatigue tests were conducted on typical laminates used within the composite aileron to determine the effect of voids on mechanical strength. The test coupon used for the cover laminate and the intermediate rib laminate is shown in figure 17. A void was created by inserting a teflon coated stainless steel shim 0.038 mm (0.0015 in) thick into the laminate prior to cure.

Figure 17. - Cover and intermediate rib laminates - void tolerance coupon.

Results of cover laminate void tolerance tests are presented in table 8. Also shown for comparison are data for notched and unnotched coupons which did not contain voids. Note that the 12.7 mm (0.5 in) wide void test is twice the size allowed in the ultrasonic inspection criteria. As the data presented indicate, for fully supported compression coupons the effect of the void is approximately equal to the strength reduction due to a 4.76 mm (3/16 in) diameter open hole. All of the specimens containing a defect failed a stress levels in excess of the 126.9 MPa (18.4 ksi) compressive design allowable for the cover laminate. Note that the laminate allowable includes the syntactic epoxy which was assumed to have no inplane load carrying capability.

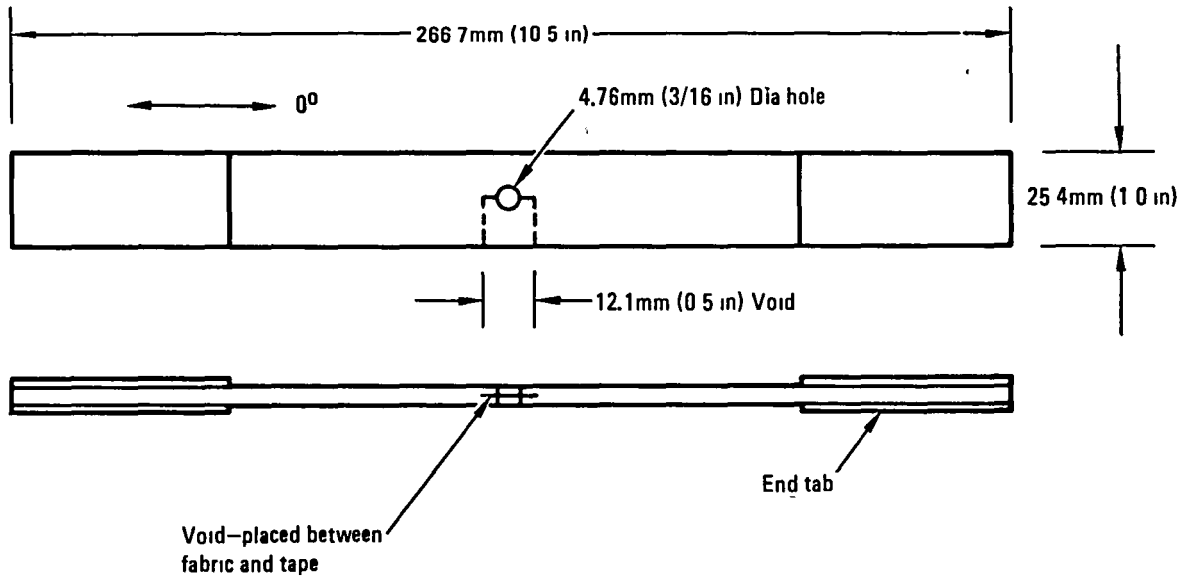
The effects of voids on the main rib cap was determined using a specimen which contained a 4.76 mm (3/16-in) diameter hole and an artificial void. The specimen configuration, shown in figure 18, has a 12.7 mm (0.5 in) wide void across one-half of the width of the coupon in the vicinity of a hole. As with the previously described coupons containing voids the defect was created by inserting a teflon coated shim in the laminate prior to cure and then removing while the coupon was being machined.

Figure 18. - Main rib cap - void tolerance coupon.

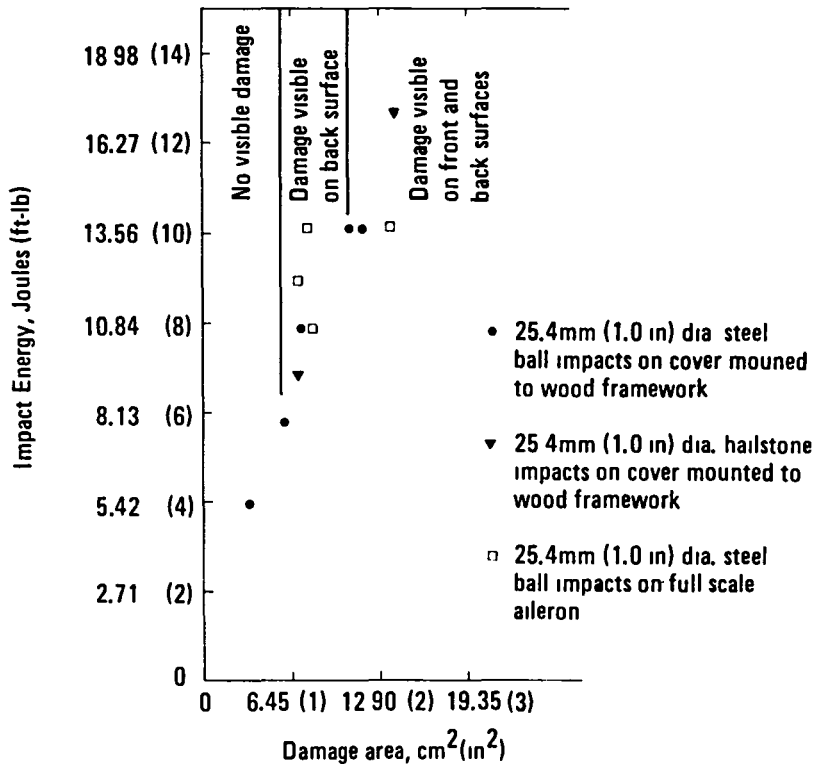
To determine the susceptibility of the aileron to impact damage a variety of impact tests were conducted using blunt object impactors to simulate tool drops and hailstones. Impact test data for the aileron cover are presented in figure 19. For those tests the structure was impacted and then ultrasonically inspected to determine the extent of damage. The data are plotted for impacts on the cover at a distance equidistant between two ribs. Impact energies in excess of 2.7 Joules (2 ft-lb) are required to cause any damage to the cover; this is approximately equivalent to a 25.4 mm (1.0 in) diameter hailstone striking the aileron at terminal velocity. The hailstone impact criteria established for the composite aileron specified no damage at 0.54 Joules (0.4 ft-lb) from a 17.8 mm (0.7 in) diameter hailstone at terminal velocity, thus the structure far exceeds the requirements.

Figure 19. - Aileron cover impact tests.

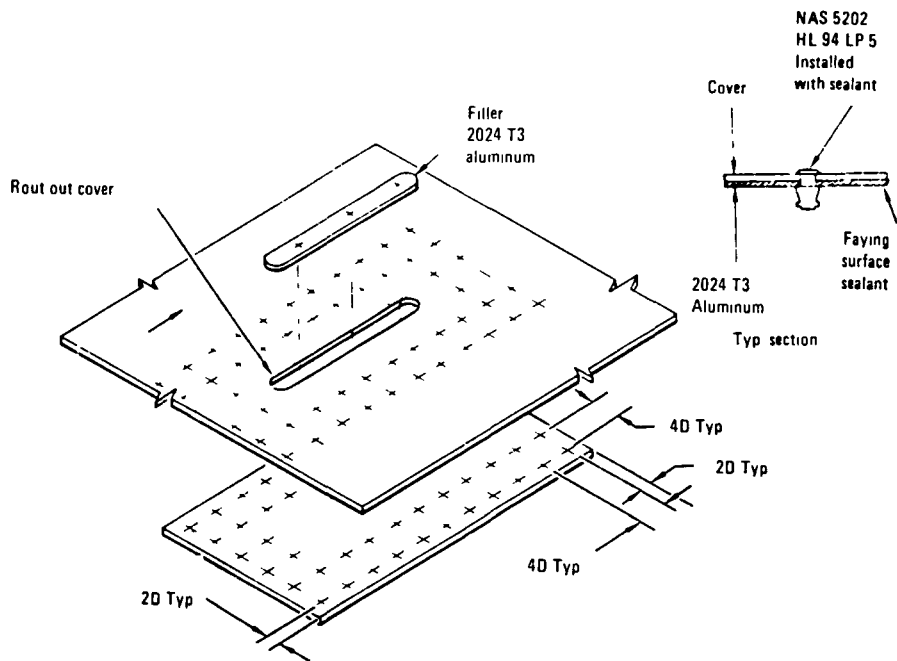
Figure 20. - Typical bolted repair for cover.

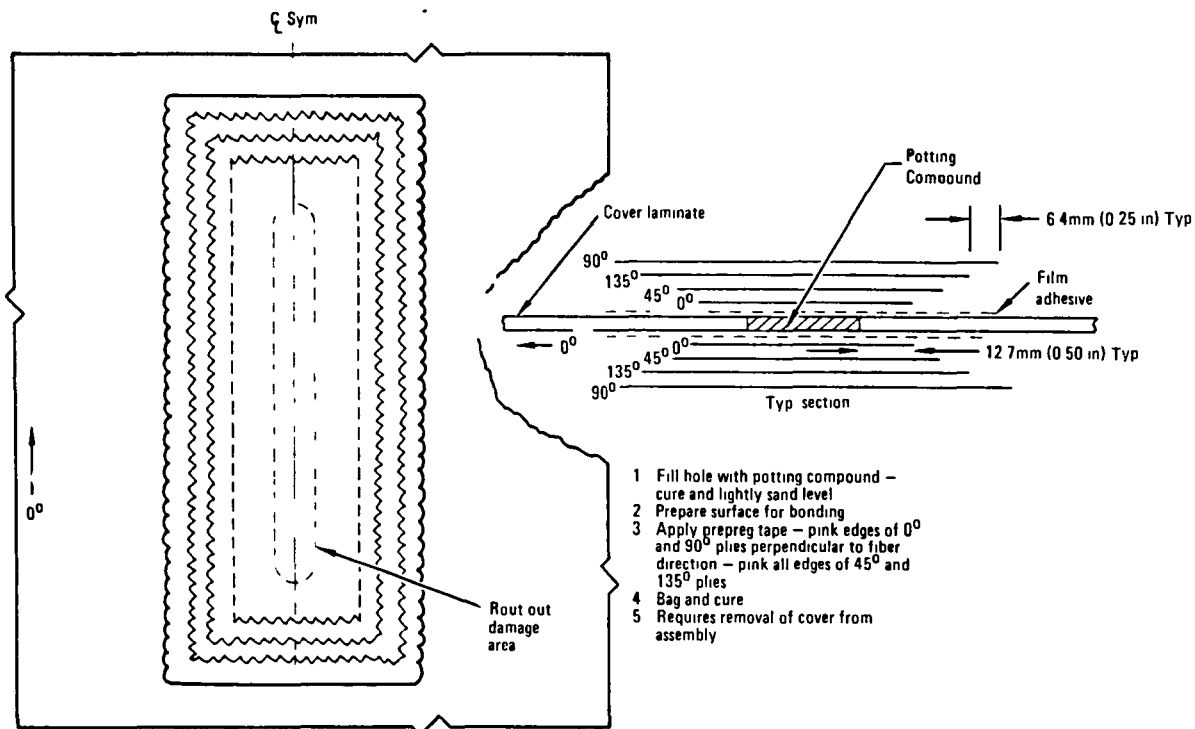
- 1 Fill hole with potting compound - cure and lightly sand level
- 2 Prepare surface for bonding
- 3 Apply prepreg tape - pink edges of 0° and 90° plies perpendicular to fiber direction - pink all edges of 45° and 135° plies
- 4 Bag and cure
- 5 Requires removal of cover from assembly

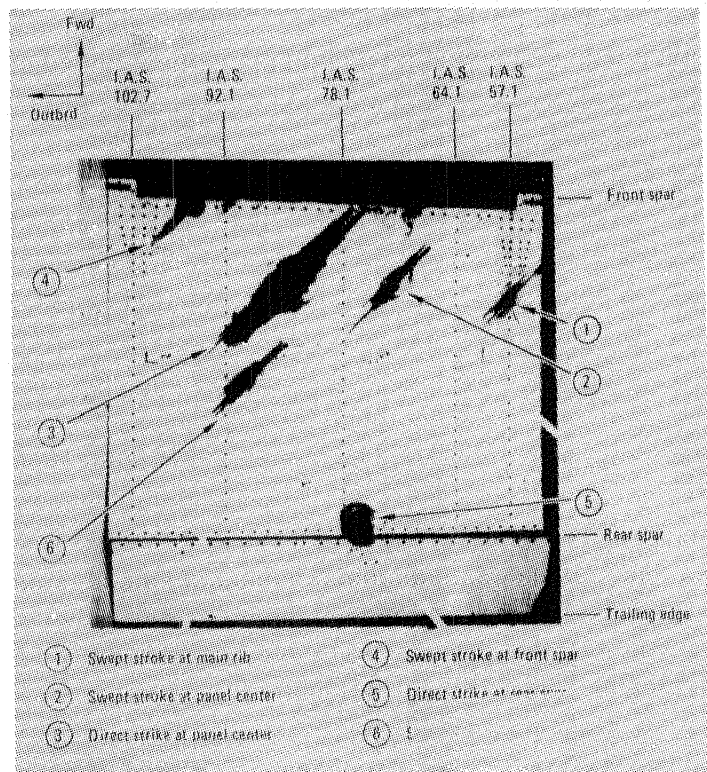
Figure 22. - Exterior of composite aileron after lightning strike tests.

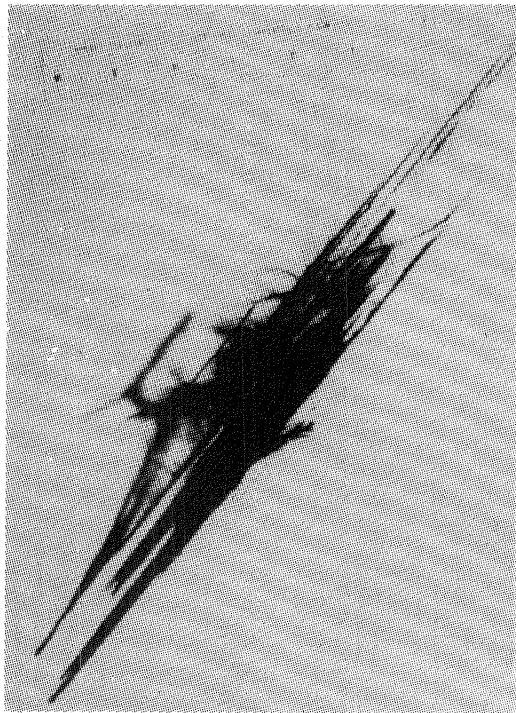
Figure 23. - External damage from swept stroke at center of panel.

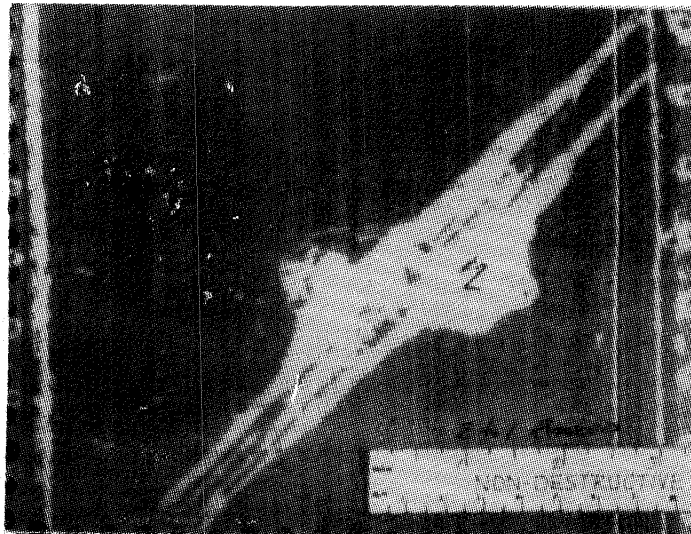
Figure 24. - Cover delamination damage due to swept stroke at center of panel.

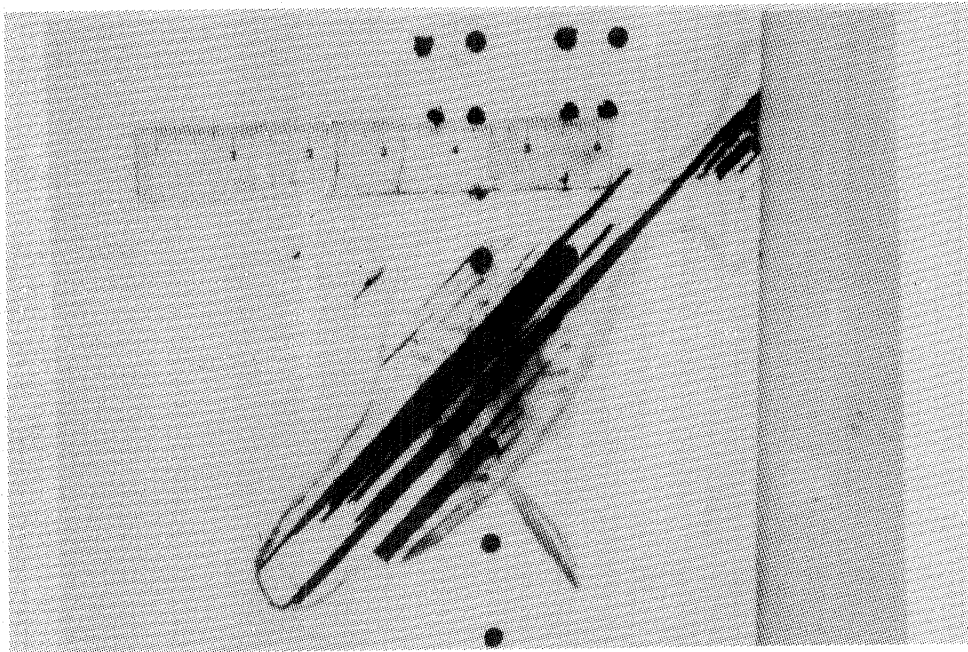
Figure 25. - External damage from swept stroke at main rib location.

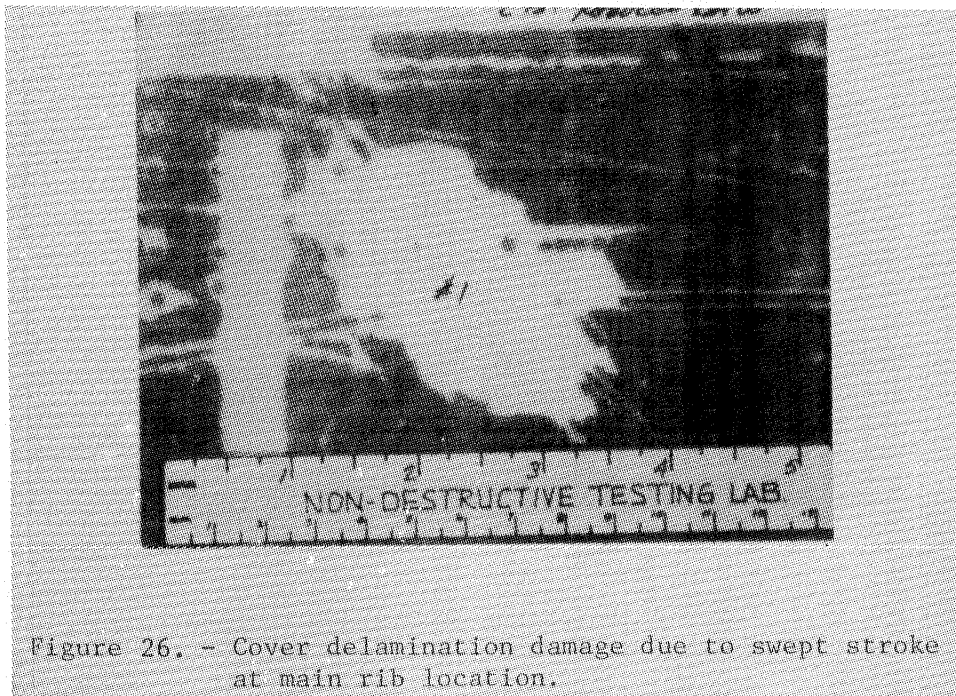
Figure 26. - Cover delamination damage due to swept stroke at main rib location.

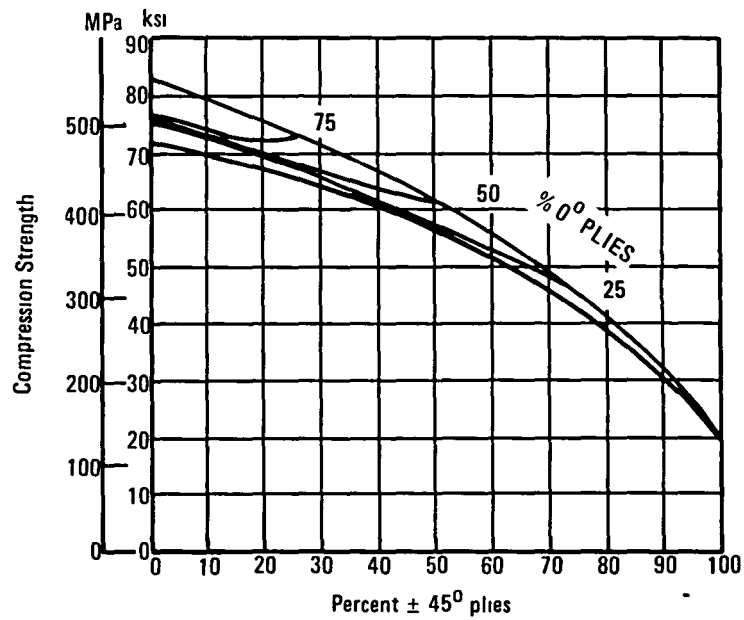
Figure 33. - Fabric compression strength predictions - room temperature dry, unnotched.

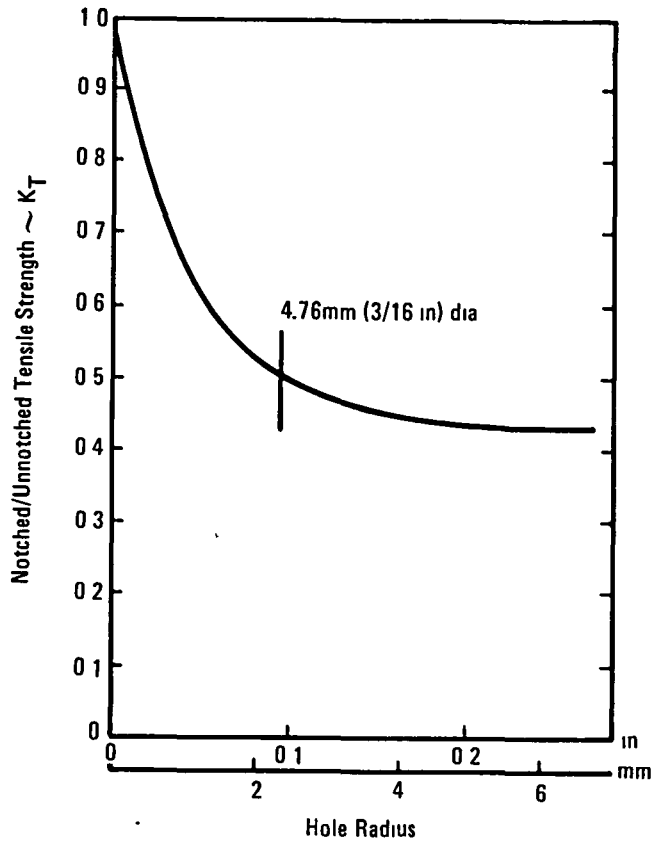
Figure 34. - Hole radius effects on tensile strength.

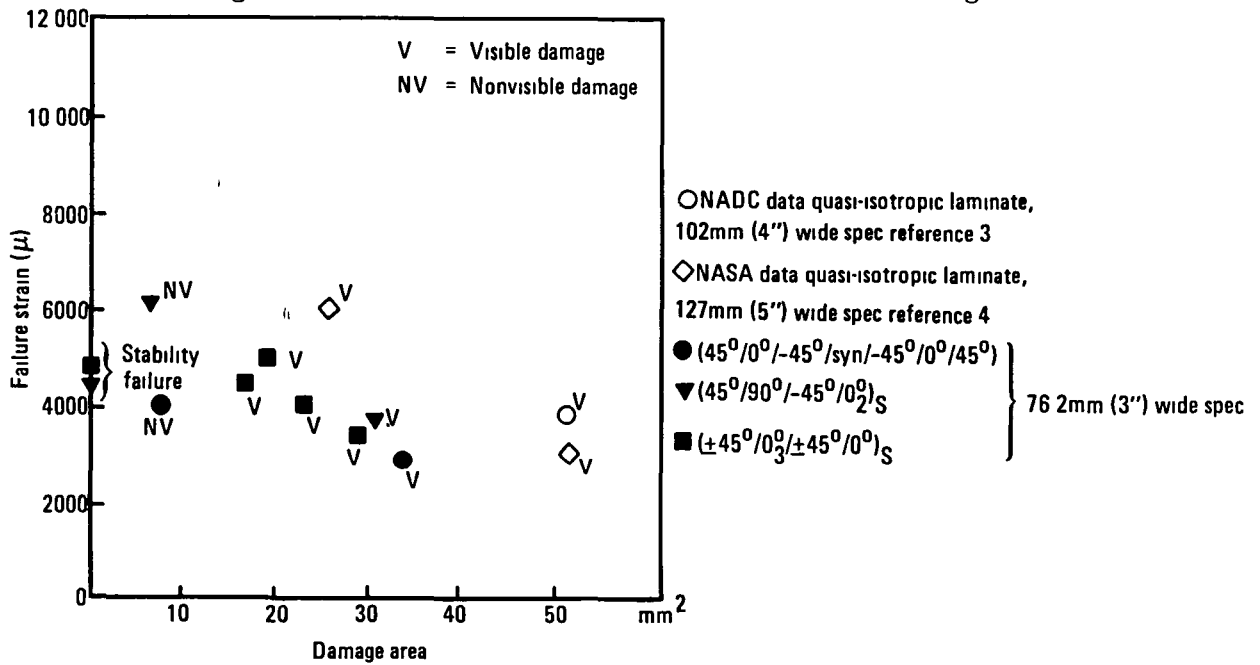
Compression tests have been conducted on coupons containing both non-visible and visible impact damage. Some of these data are summarized in figure 35. Note that the failure strain for nonvisible impact damage is generally lower than previously reported for a laminate containing a 3/16 inch diameter hole. Thus to account for the effect of nonvisible impact damage on the compressive strength of a laminate, a maximum strain of 4000 micro mm/mm (in/in) will be used for all environmental conditions for both tape and fabric laminates.

Figure 35. - Compression impact data.

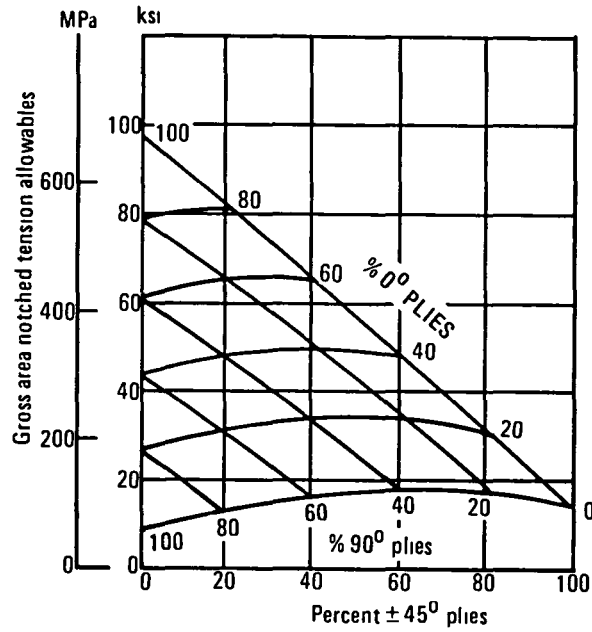
Figure 36. - T300/5208 unidirectional tape tensile strength design allowables, notched.

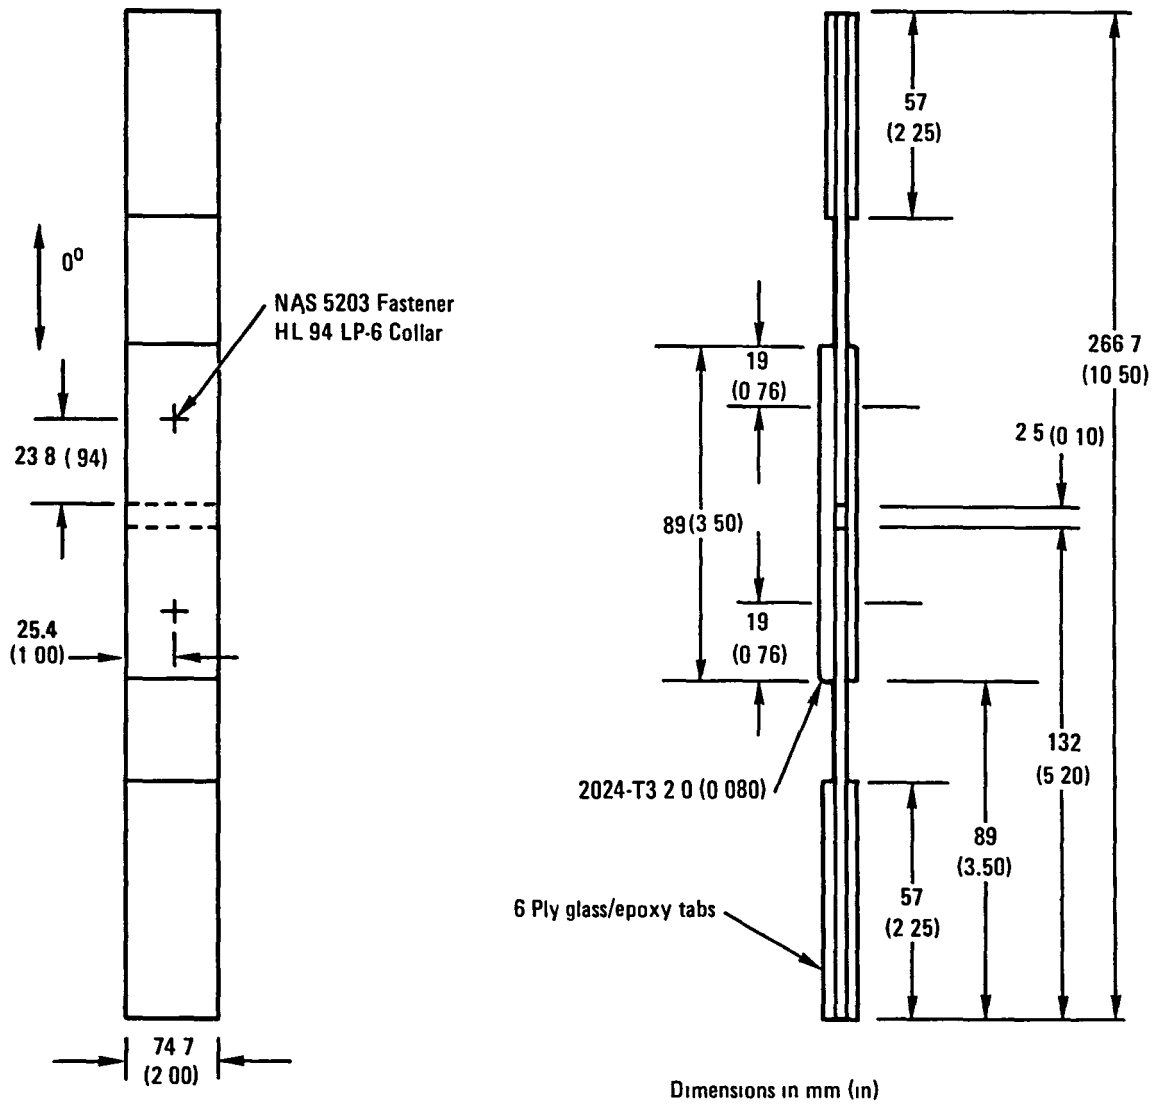
Figure 51. - Double lap cylindrical shear bearing specimen.

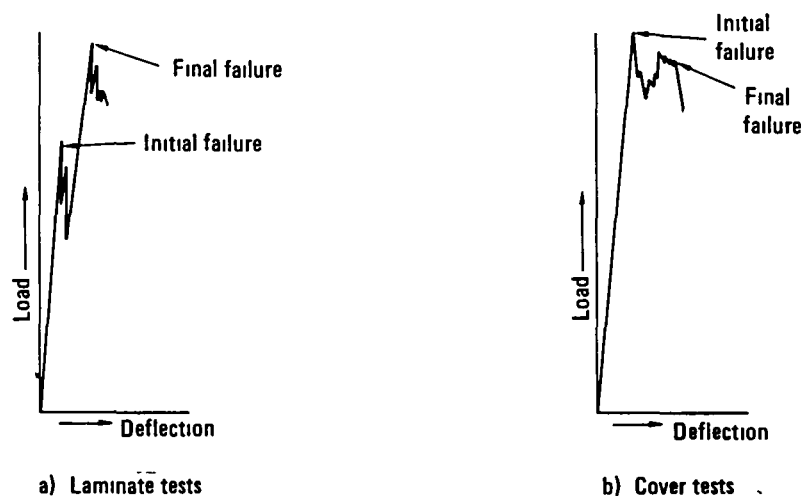
For the aileron cover material, the initial failure load was higher than the final failure load as shown in table 23 and figure 54(b). The initial failure was again due to localized crushing of the material and the final failure, a shear tear-out failure. However, the shear tear-out failure exhibited a lower strength than the initial crushing failure. This is due to the presence of the syntactic core. The countersunk depth extends through the 3 outer plies and into the syntactic core. Therefore, the outer plies plus the syntactic core (~ 1.52 mm (0.060 in.) thickness) cannot be counted on to contribute much to the shear tear-out strength.

Figure 54. - Load deflection behavior for push-through tests.

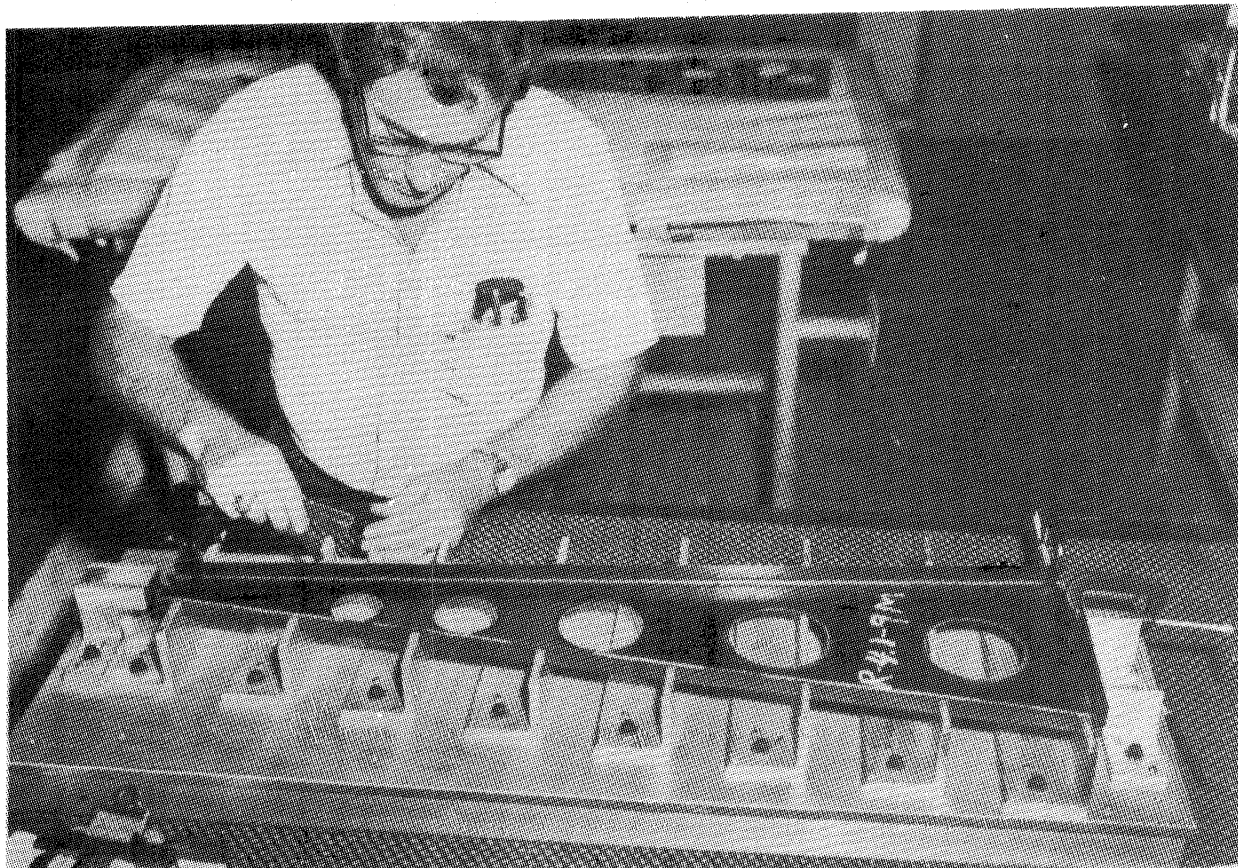
Figure 56. - Rib dimensional check fixture.

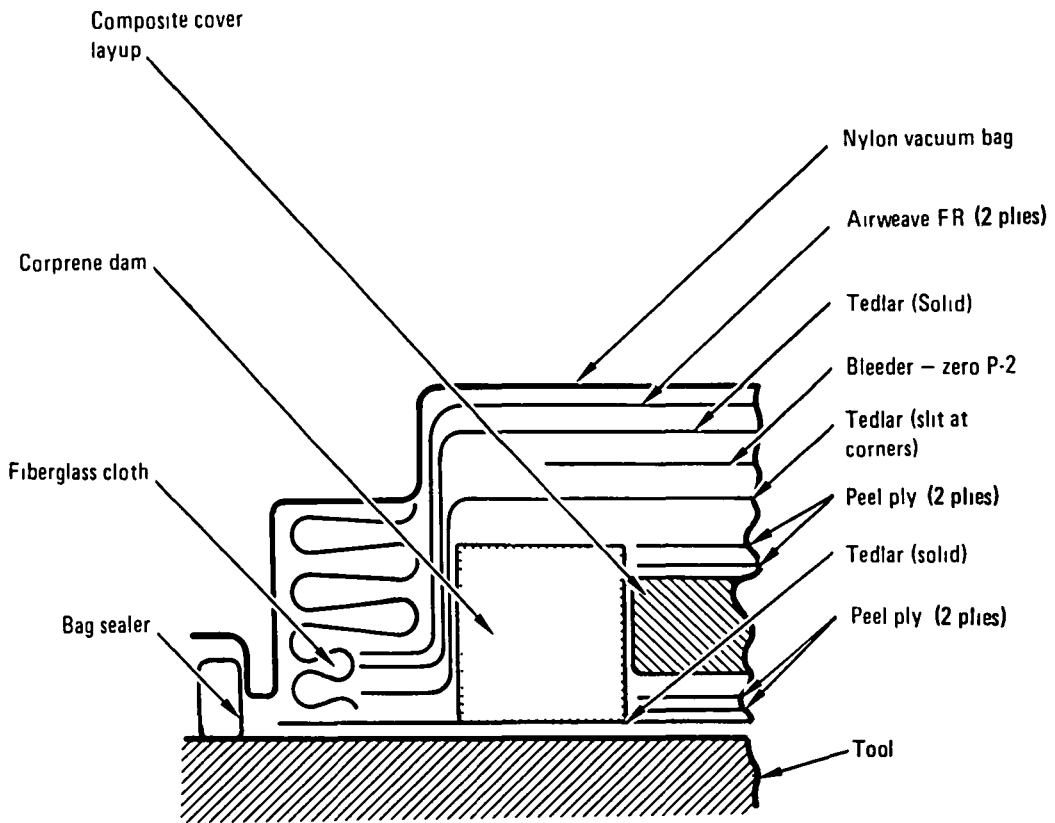
Figure 57. - Process development cover layup.

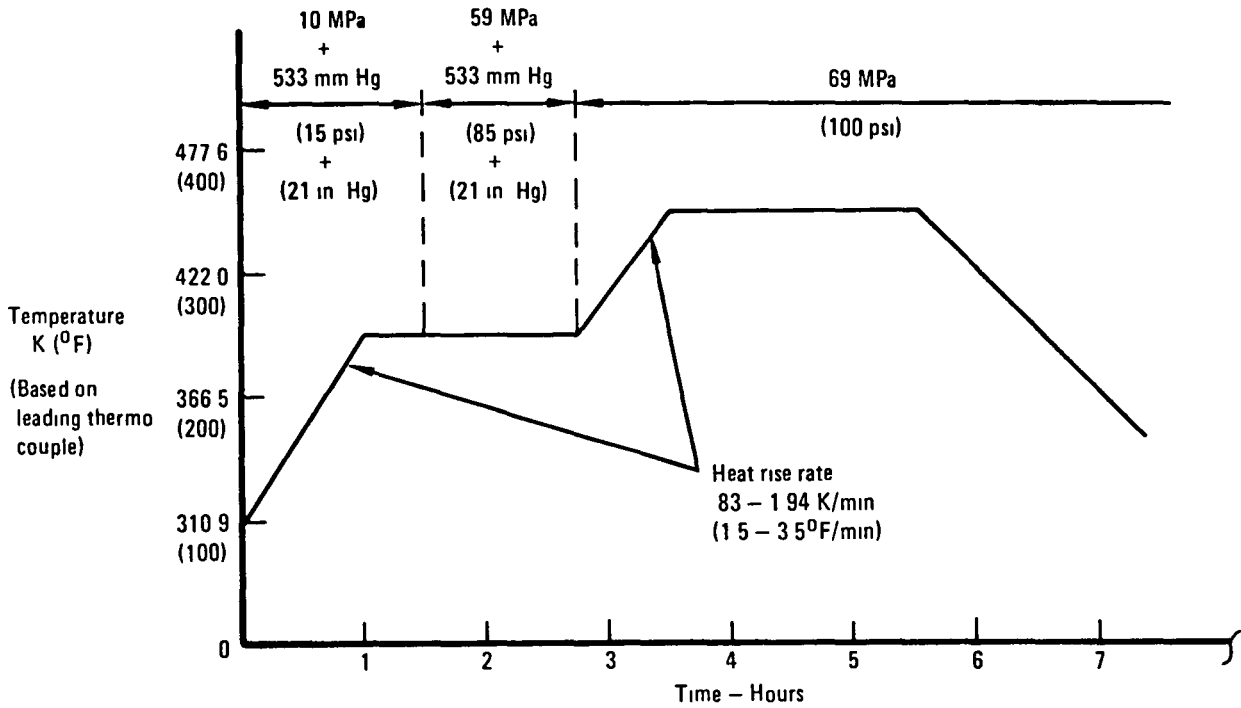
Figure 59. - Revised cure cycle.

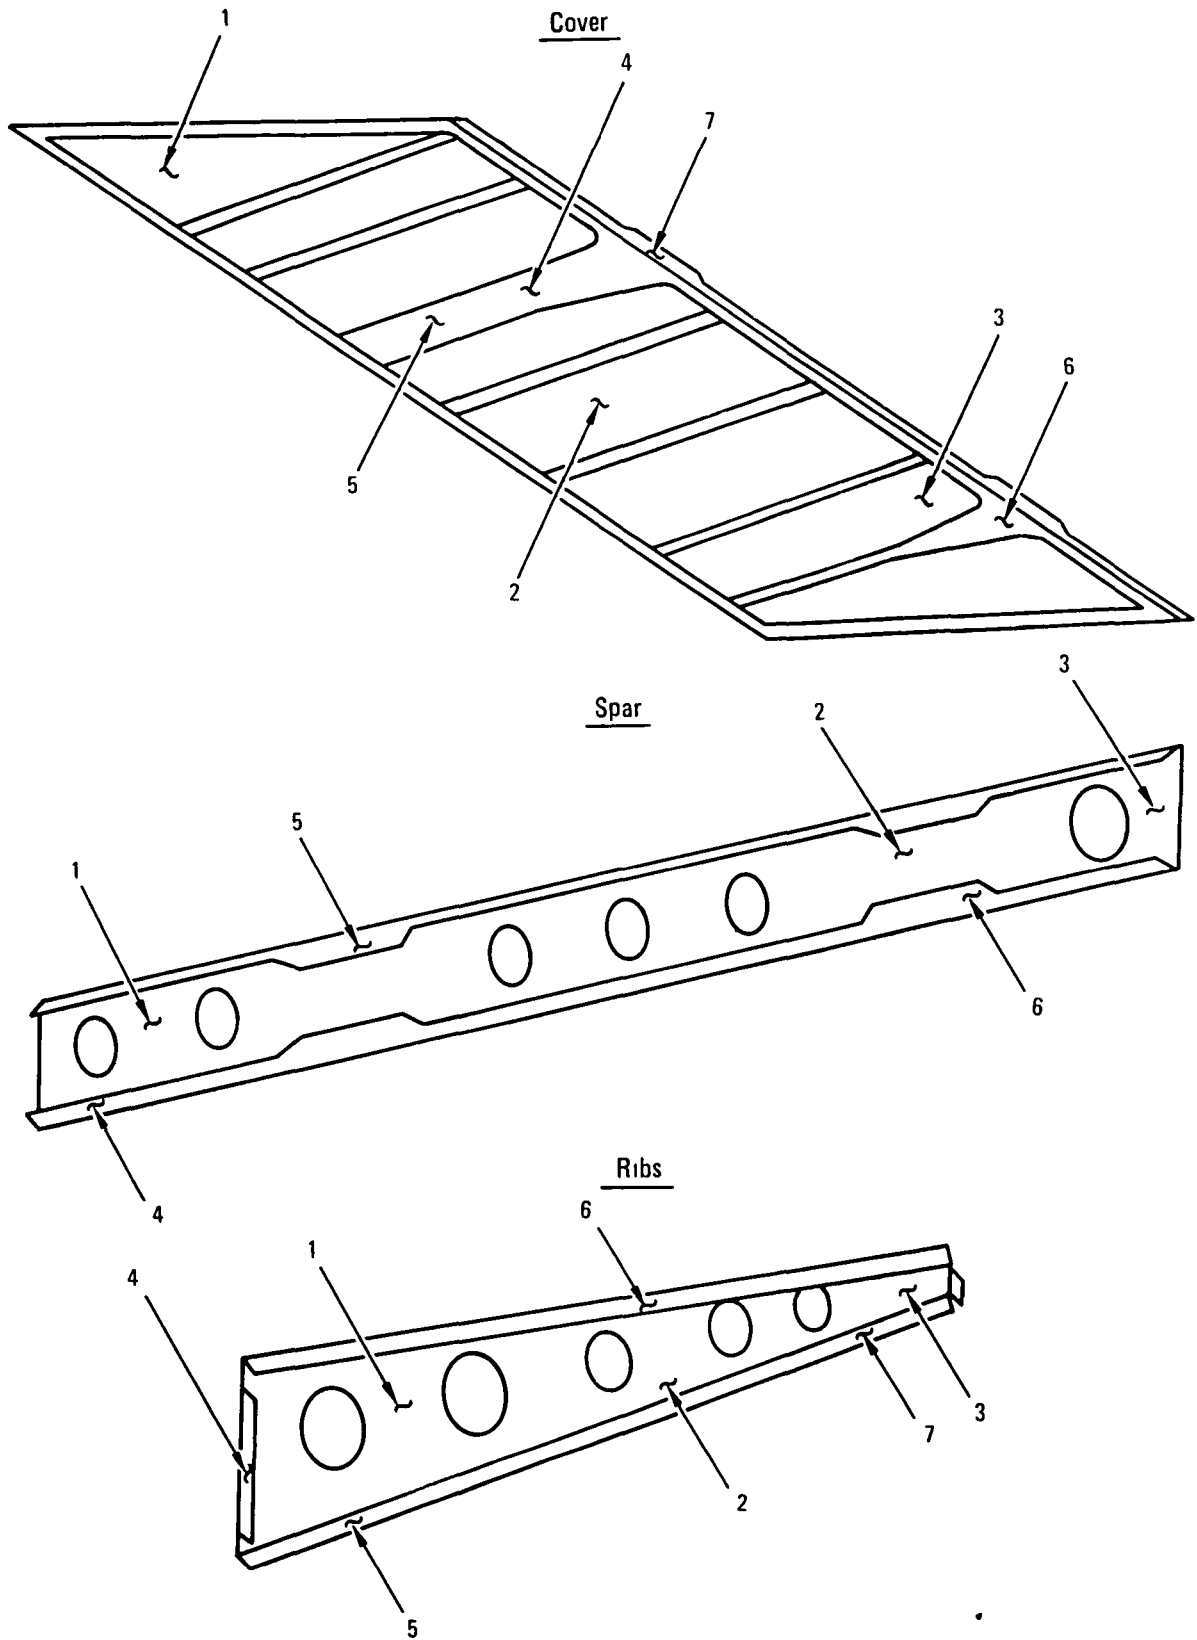
Figure 60. - Specimen location for process verification testing.

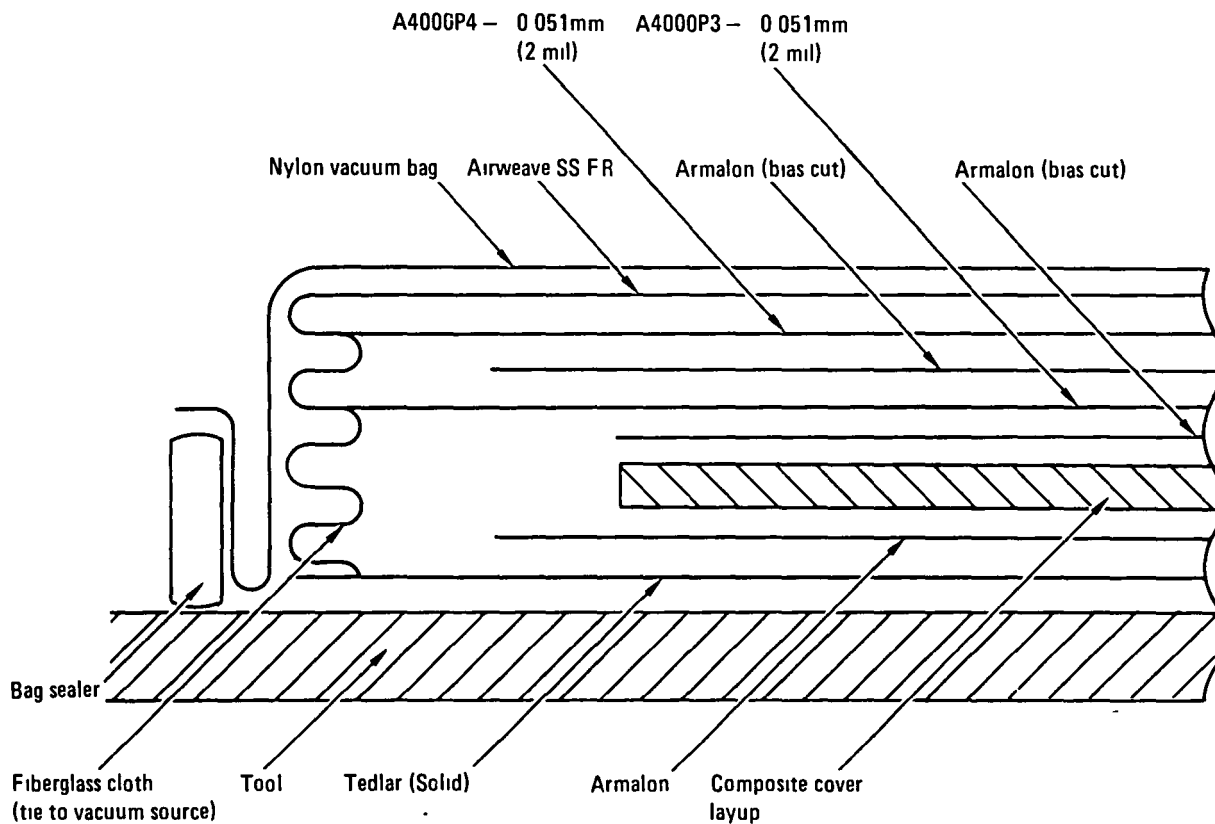
Figure 61. - Vertical bleeder/breather cover layup.

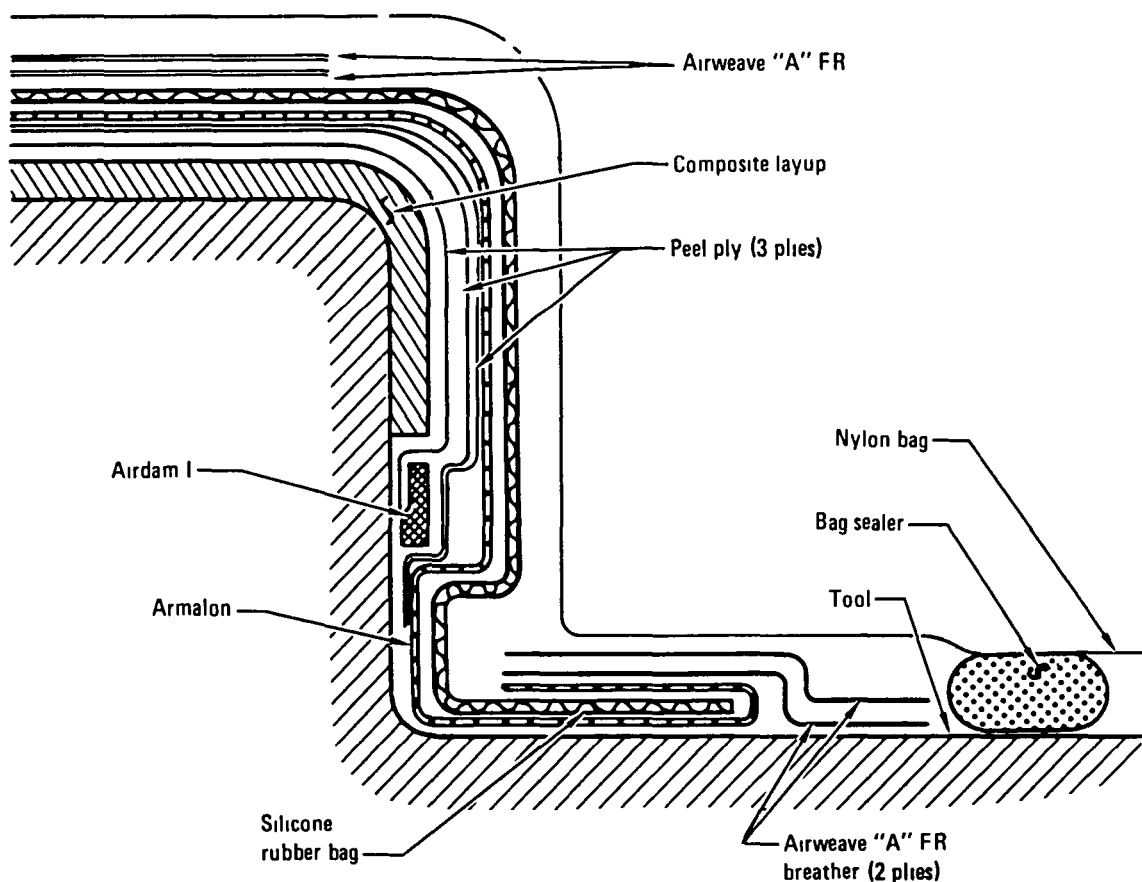
Figure 62. - Process development rib layup.
