NASA Contractor Report 165635

Advanced Composite Aileron for L-1011 Transport Aircraft Design and Analysis

C.F. Griffin and L.D. Fogg

Lockheed Corporation
Lockheed-California Company
Post Office Box 551
Burbank, California 91520

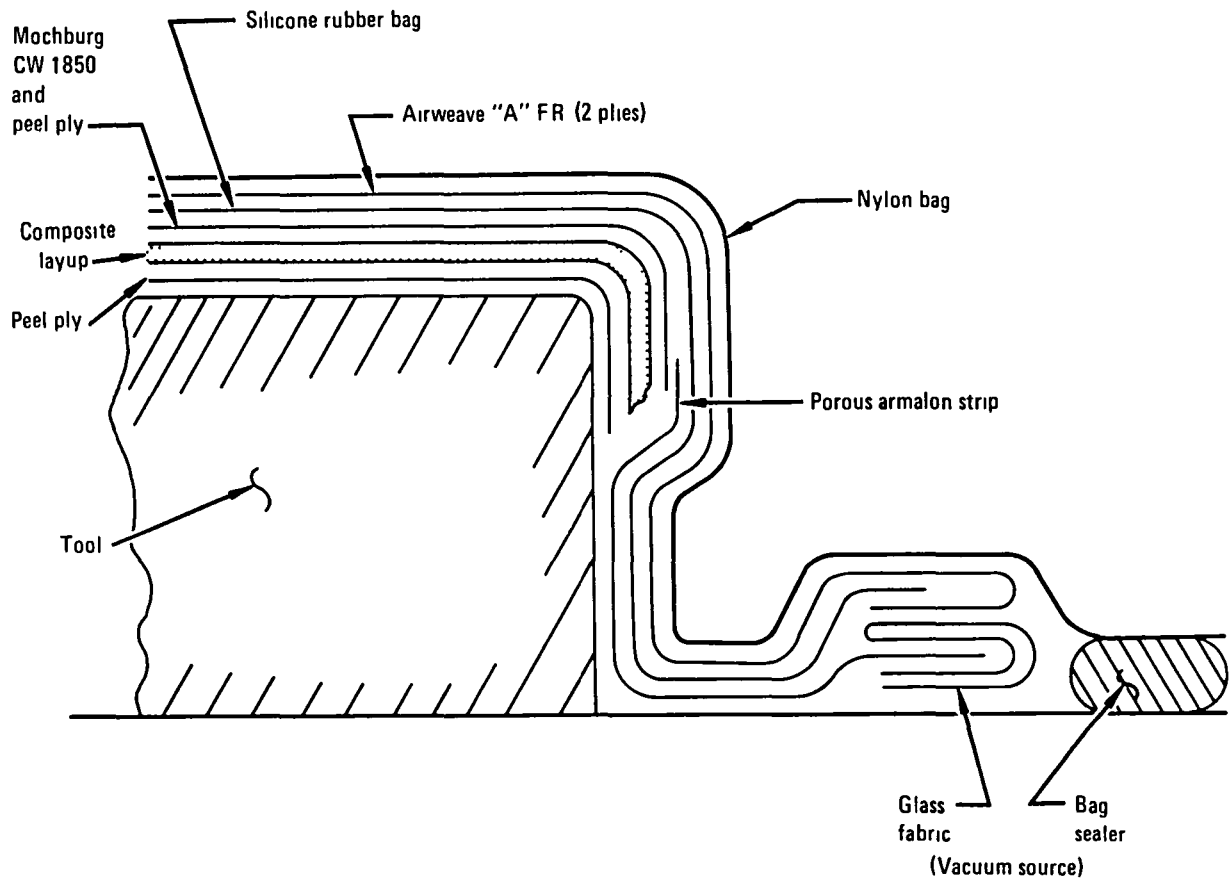
Figure 63. - Damless technique rib layout.

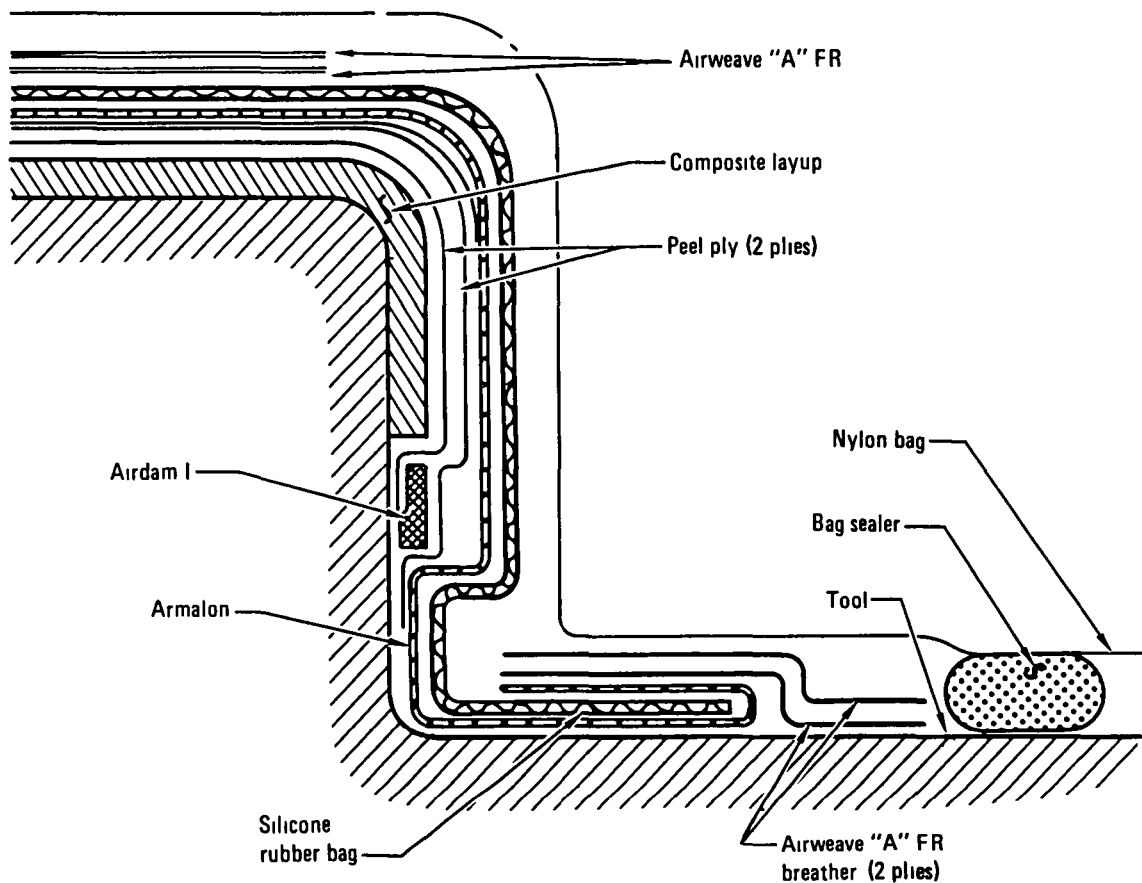
Figure 64. - Process development spar layup.

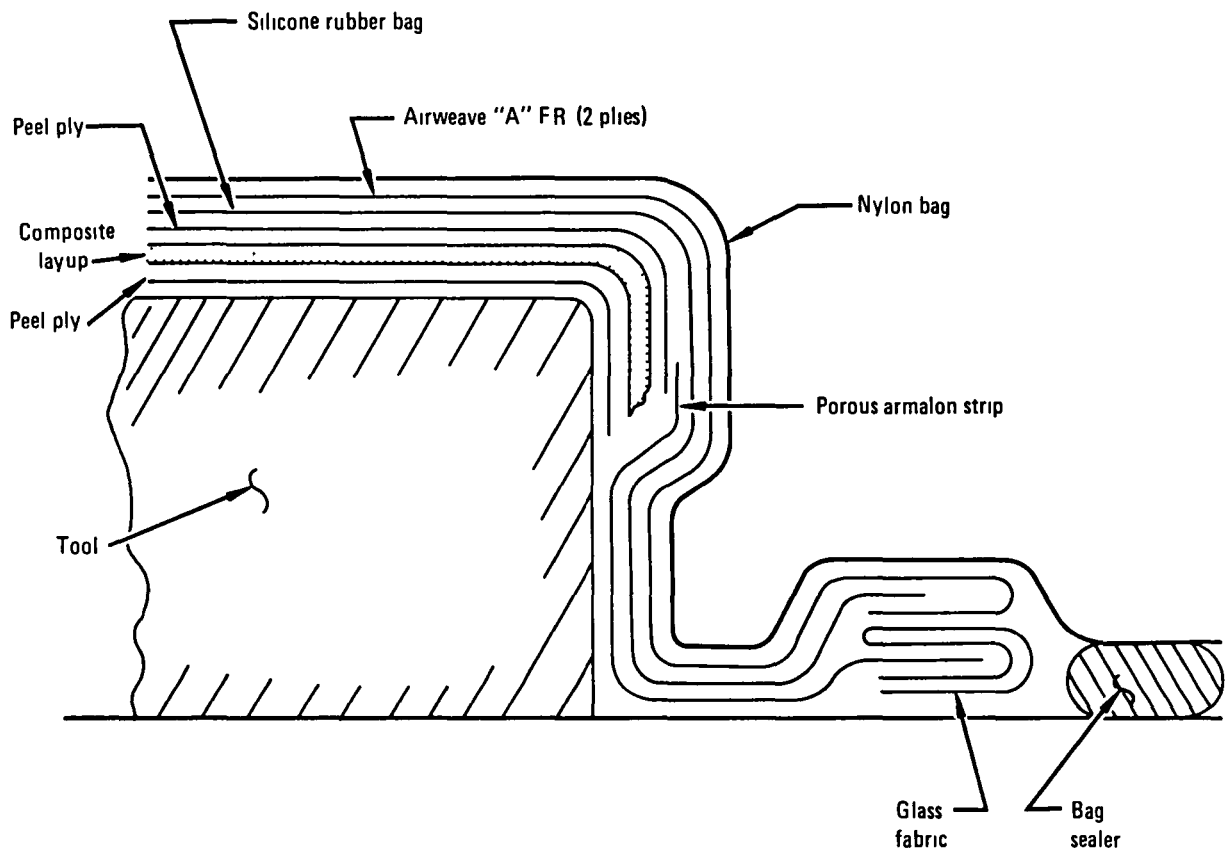
On the spar specimens prepared, each of these methods gave satisfactory results. A derivation of the third method in which the strip overlapped the flange approximately 12.7 mm (0.50 in) was selected, since the porous armalon did not tend to load up as much as the peel ply. A schematic of this bleeding system is shown in figure 65. The process was reverified using this layup

Figure 65. - Damless technique spar layup.

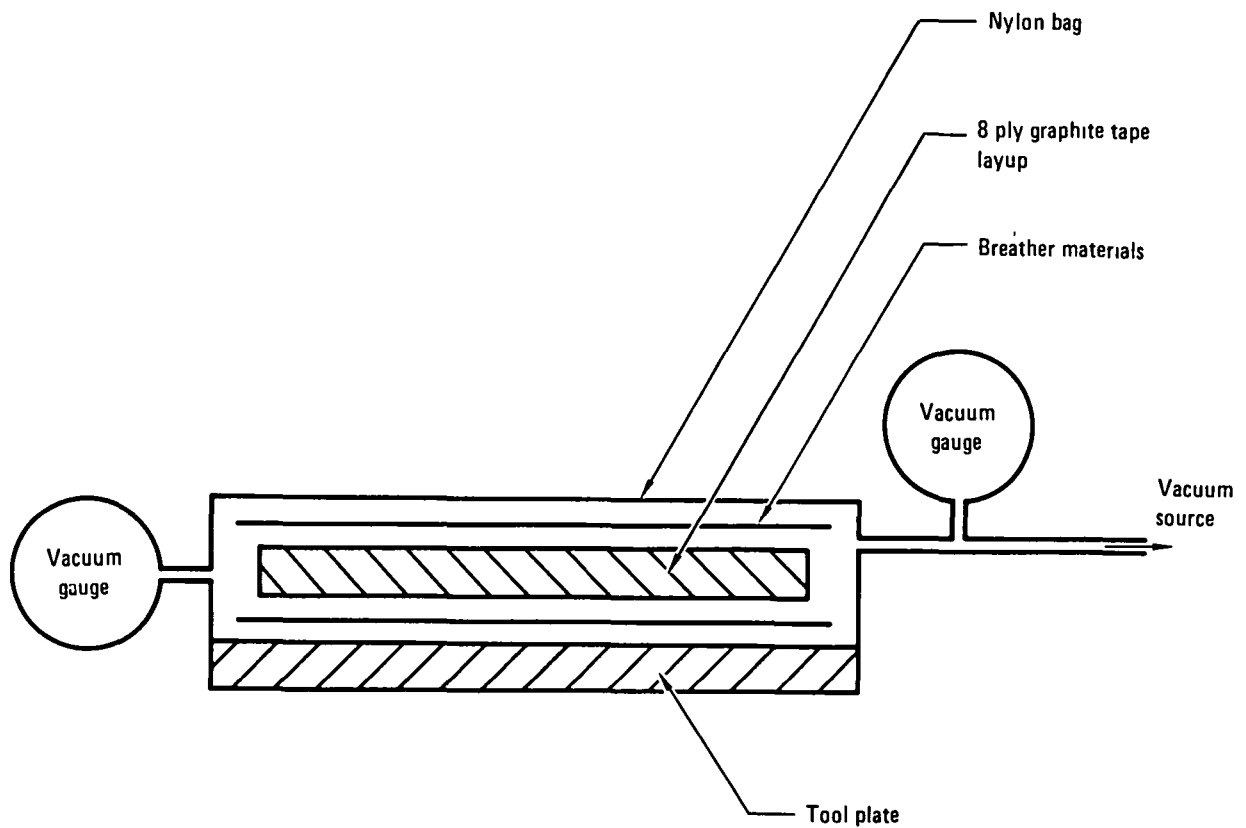
Figure 66. - Schematic lateral breathe test.

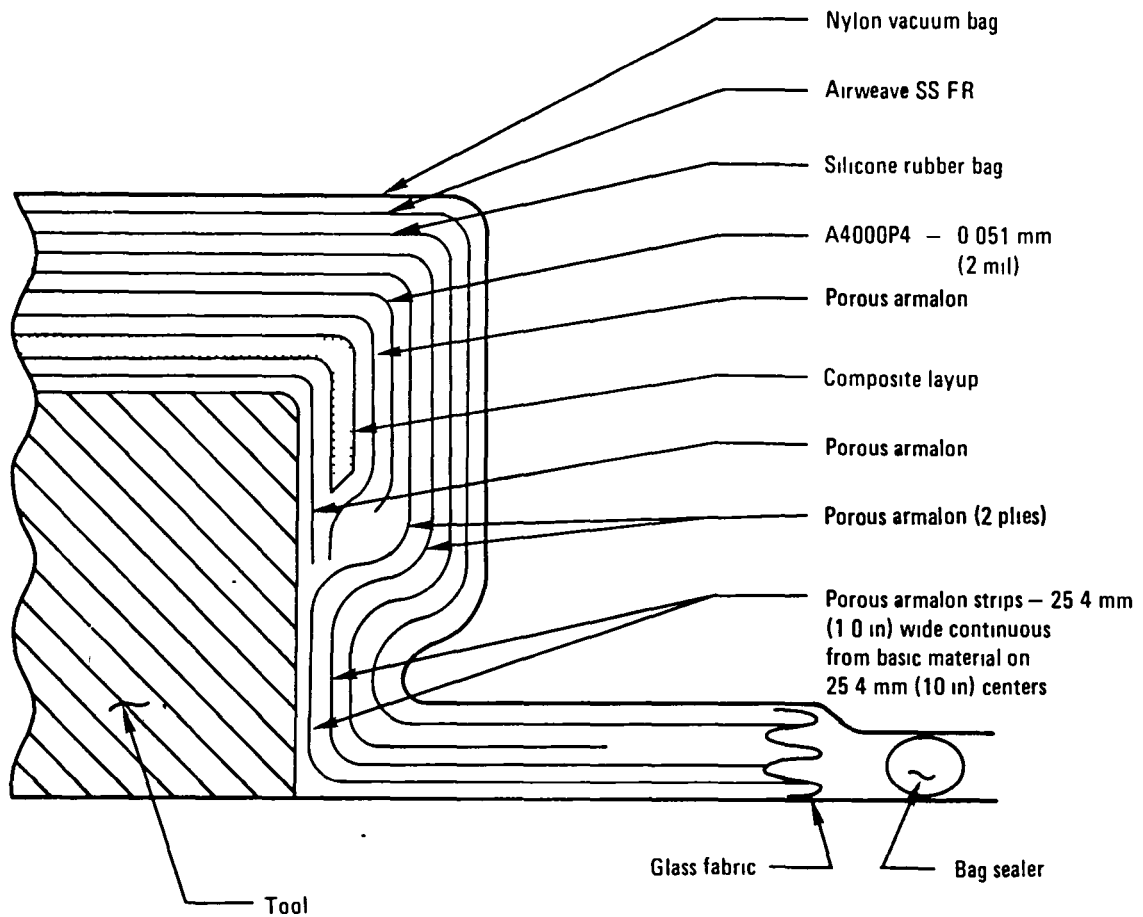
Figure 67. - Vertical breather/bleeder spar layup.

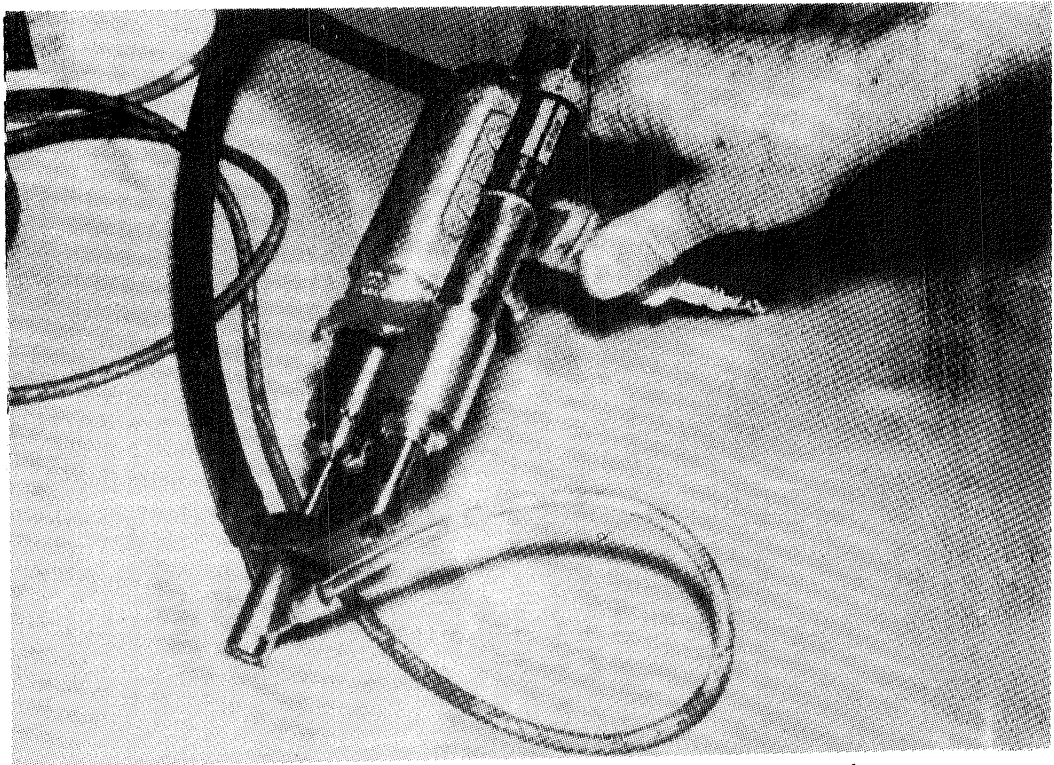
Figure 68. - Closeup of the hydraulic check attachment.

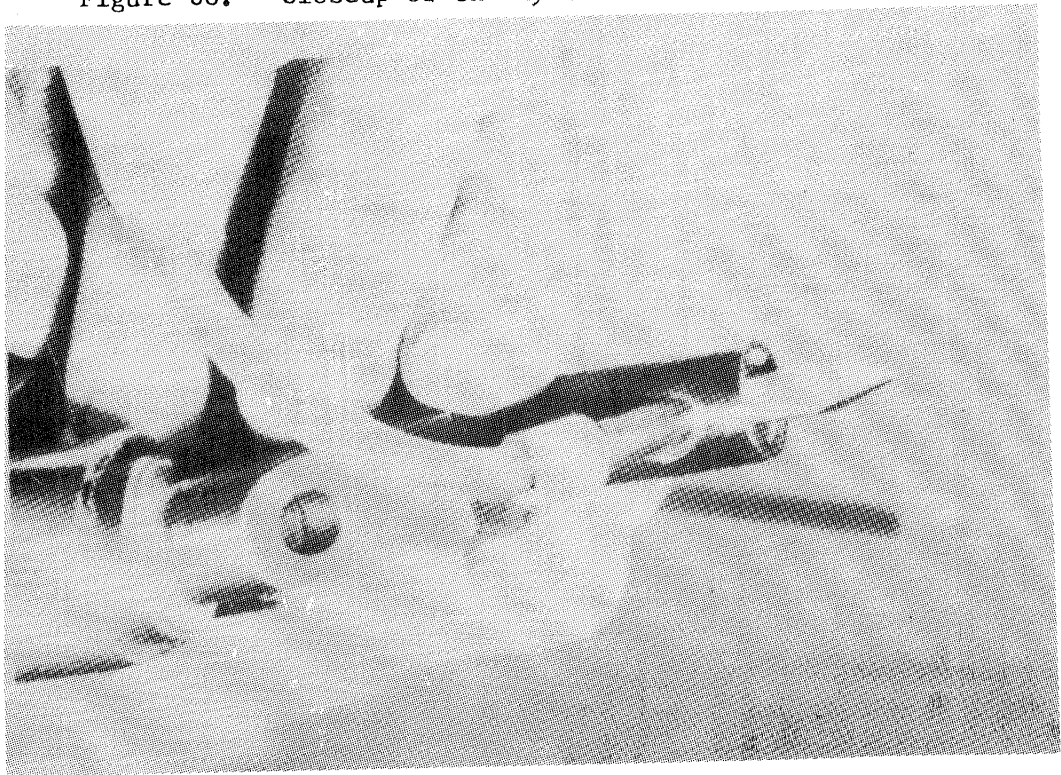
Figure 69. - Dagger drill.

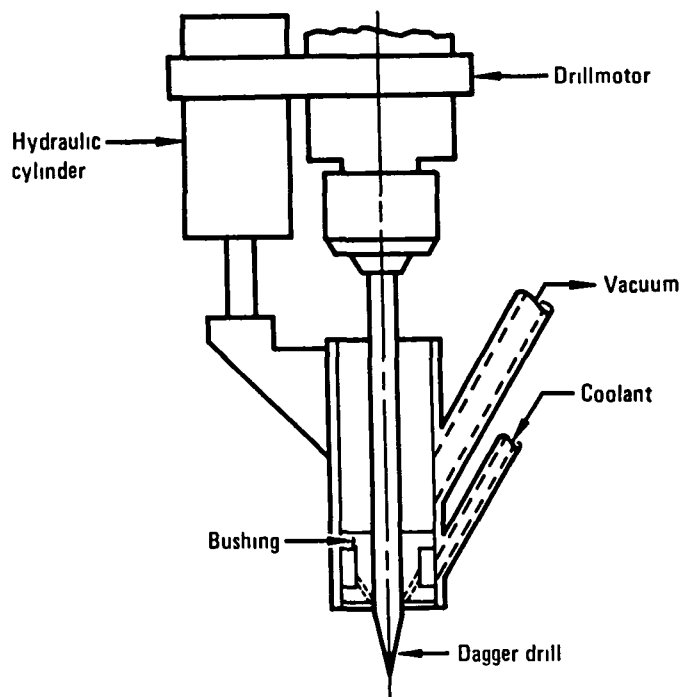
Figure 70. - Drill and countersink system schematic.

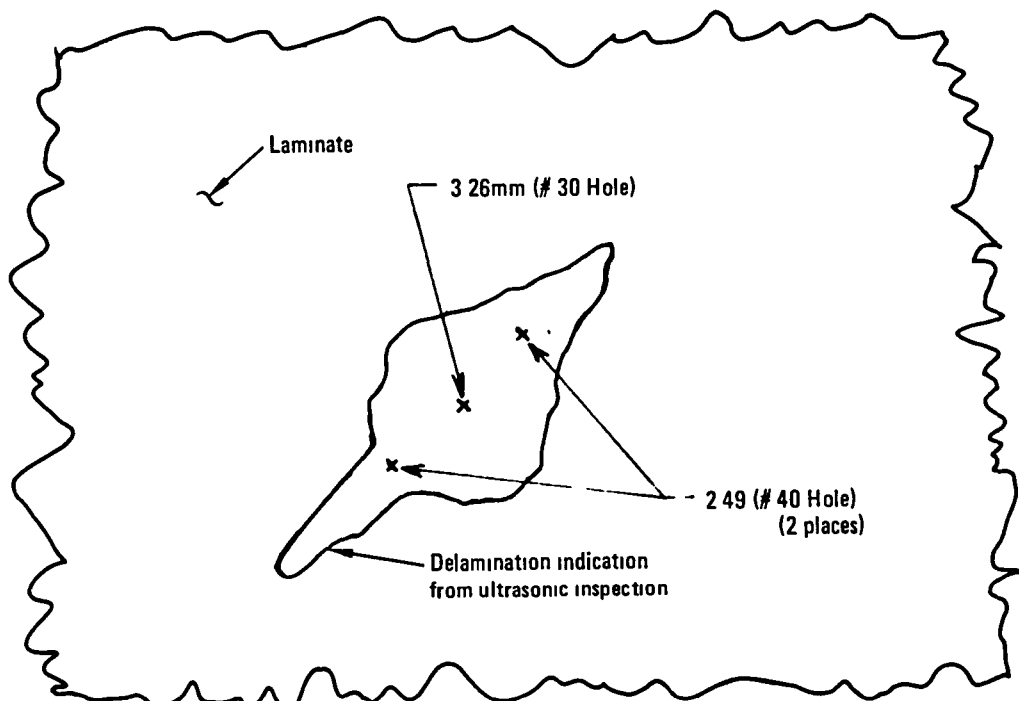
Figure 71. - Typical impact damage area showing holes required for repair.

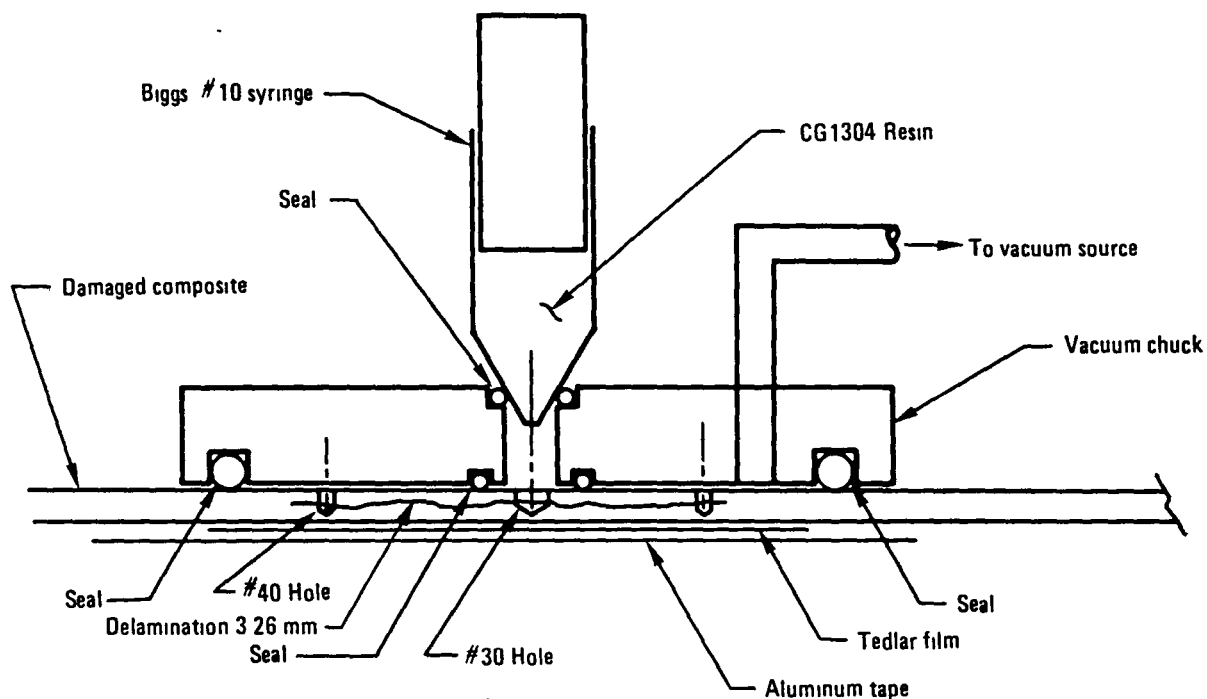
Figure 72. - Resin injection repair setup.

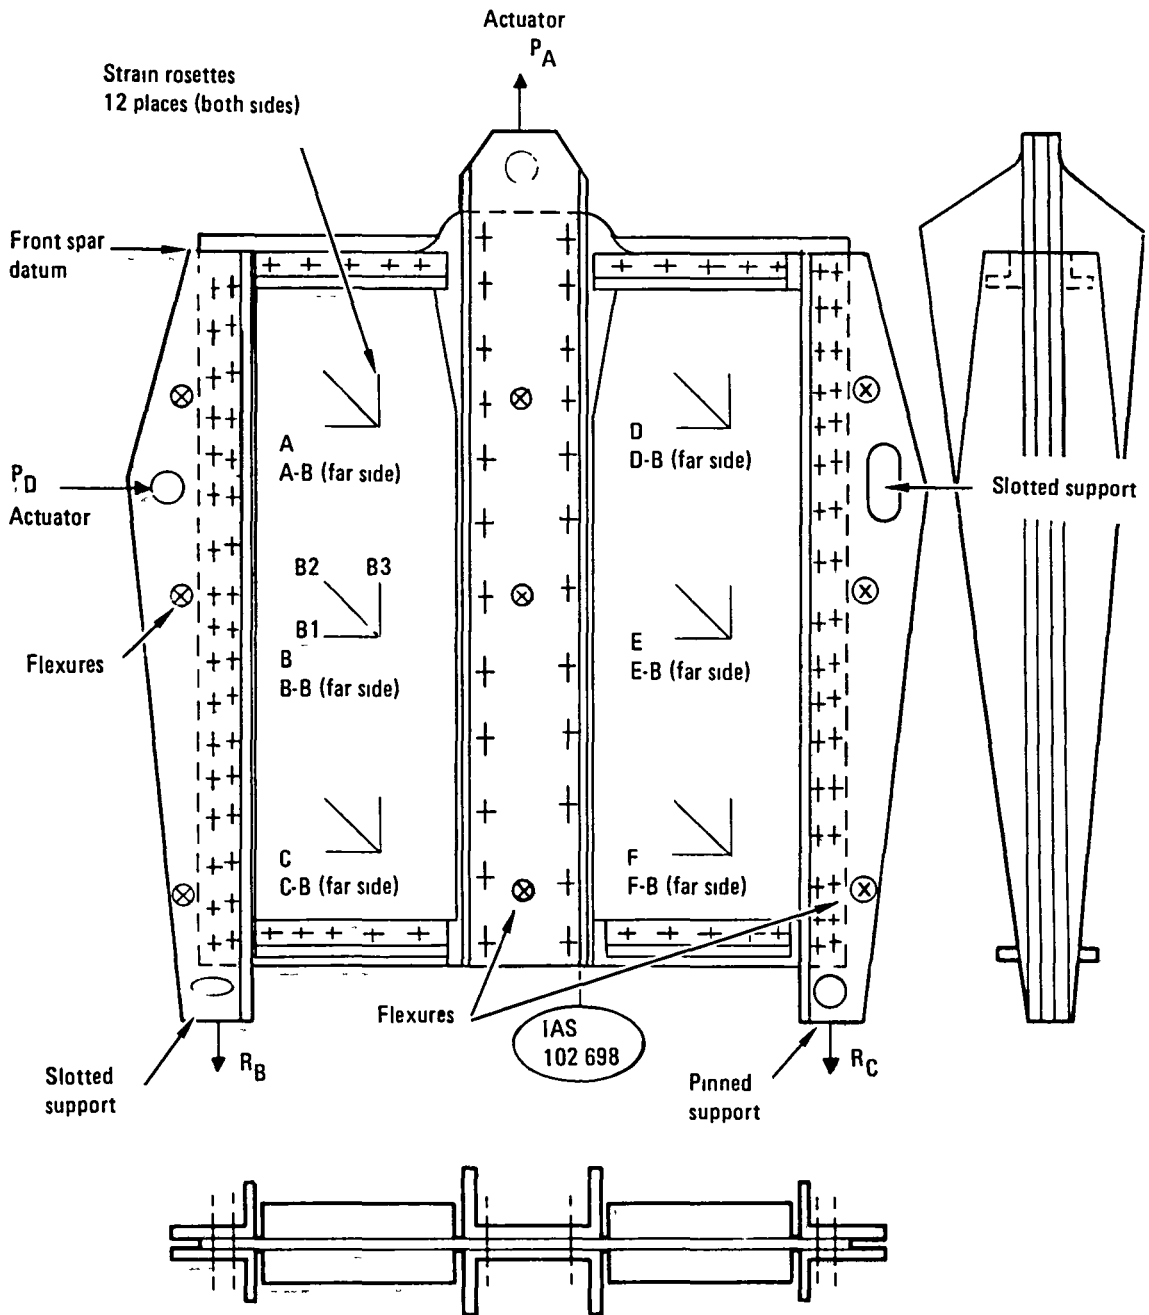
Figure 73. - Cover test configuration and strain gage schematic.

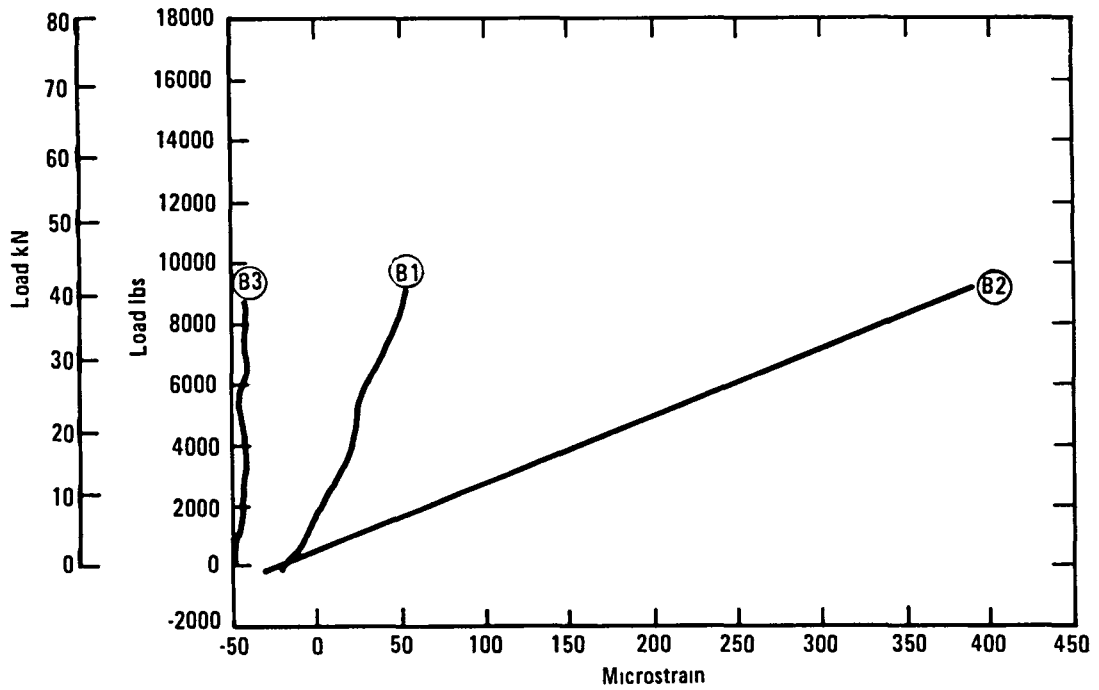
Figure 74. - Rosette gage analysis - Typical strains for rosette B (see figure 73).

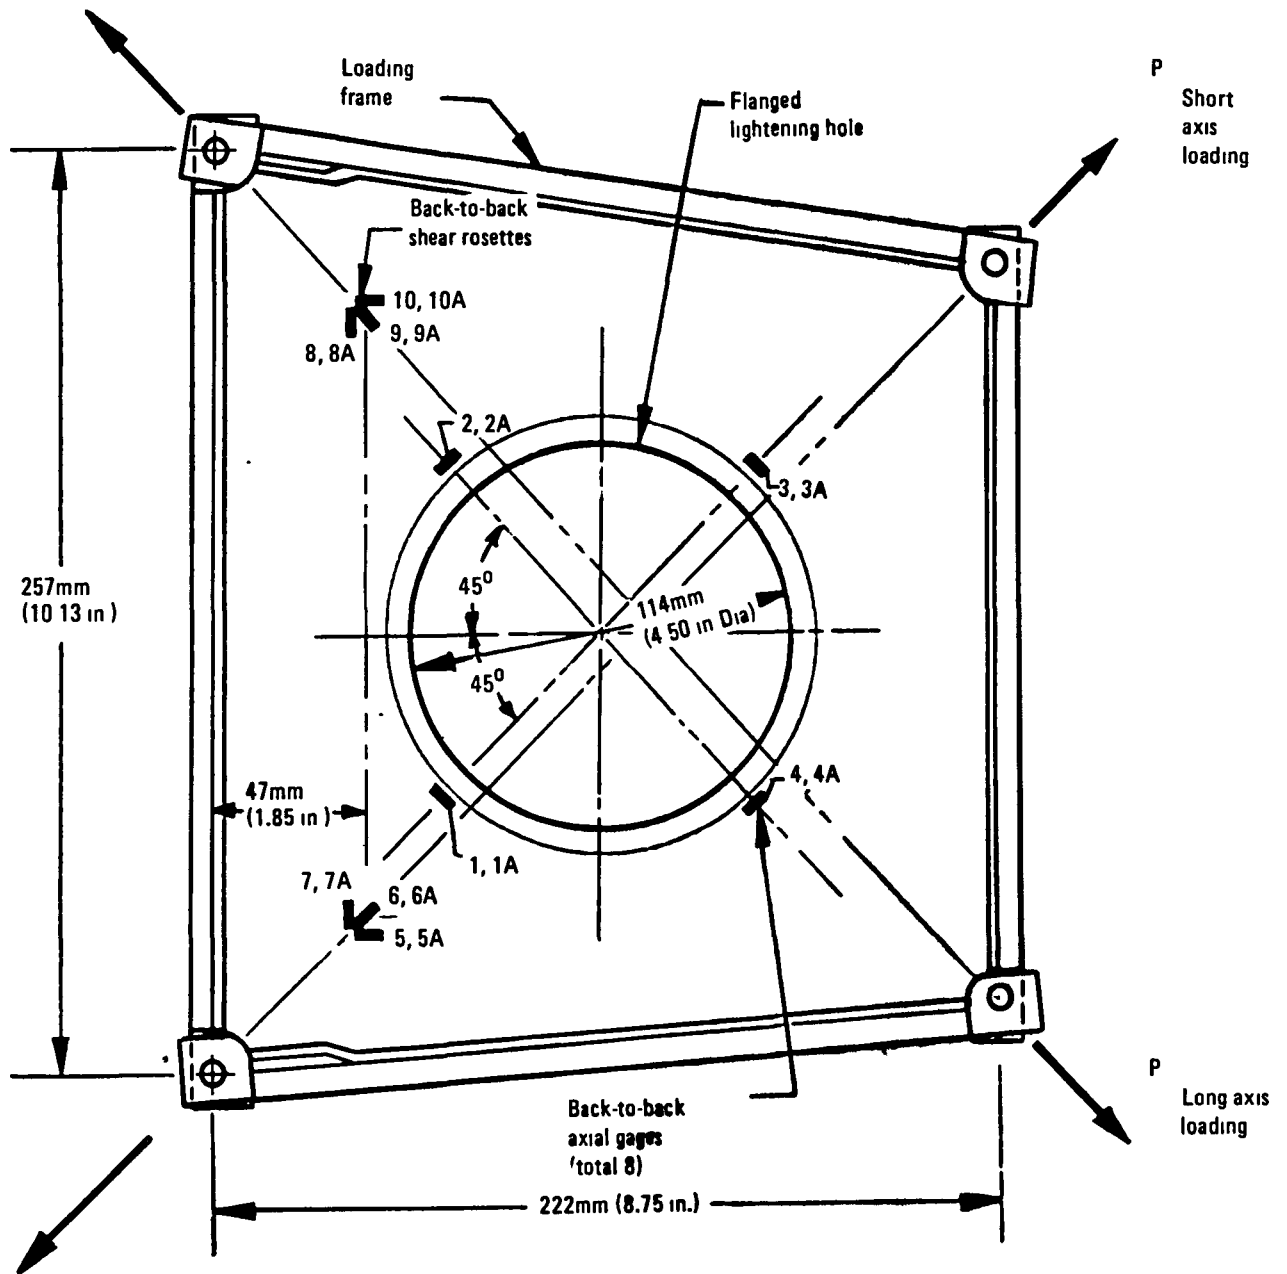
Figure 79. - Rib test configuration and strain gage schematic

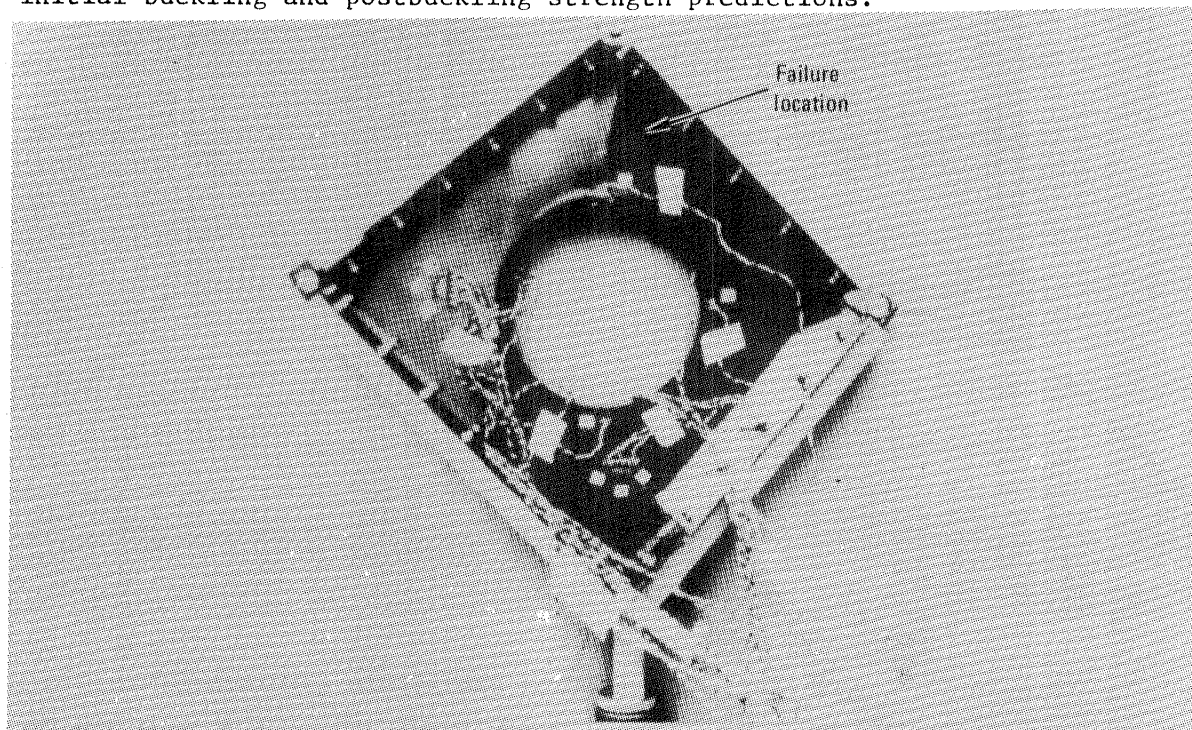
Figure 80. - Compression buckling failure of the rib web.

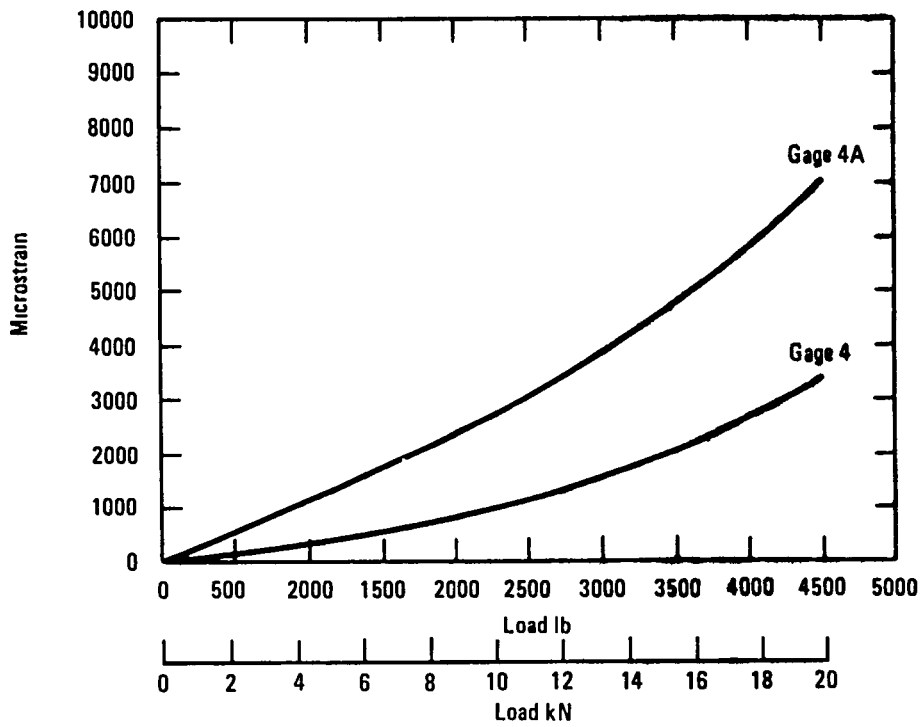
Figure 81. - Test Condition IV (see table 4), strain gages 4 and 4A (see figure 79).

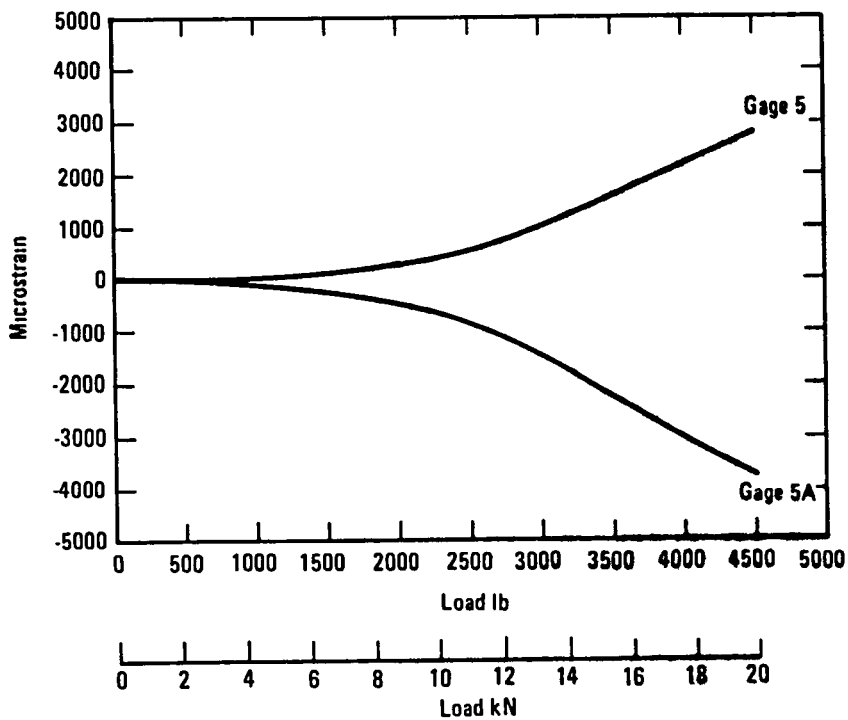
Figure 82. - Test Condition IV (see table 4), strain gages 5 and 5A (see figure 79).

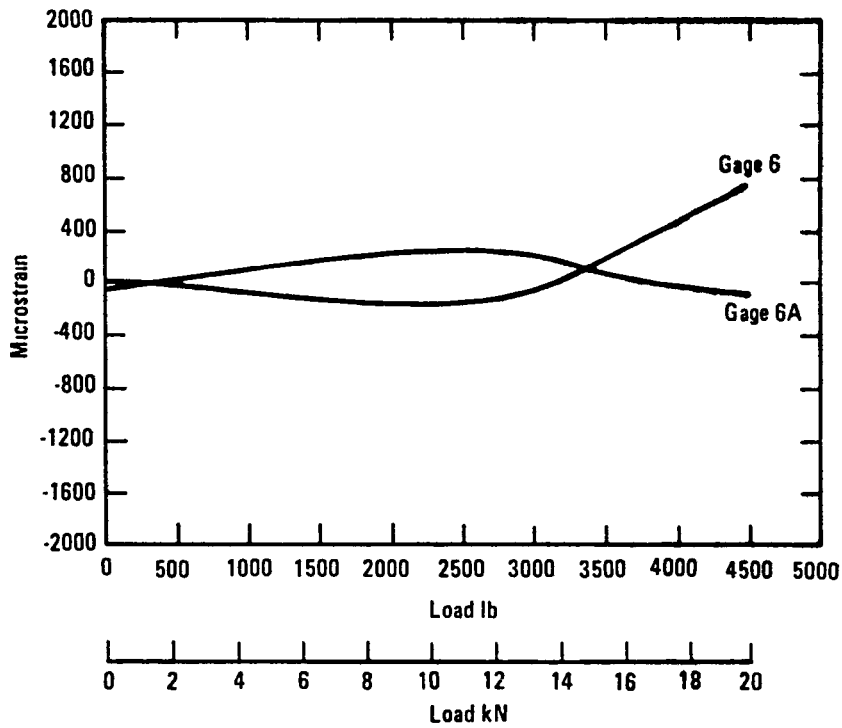
Figure 83. - Test Condition IV (see table 4), strain gages 6 and 6A (see figure 79).

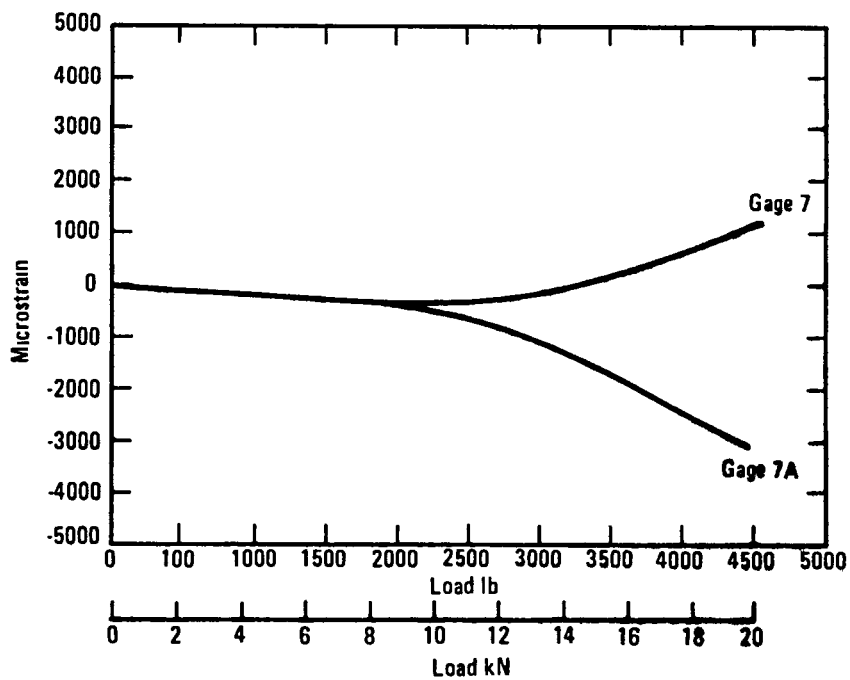
Figure 84. - Test Condition IV (see table 4), strain gages 7 and 7A (see figure 79).

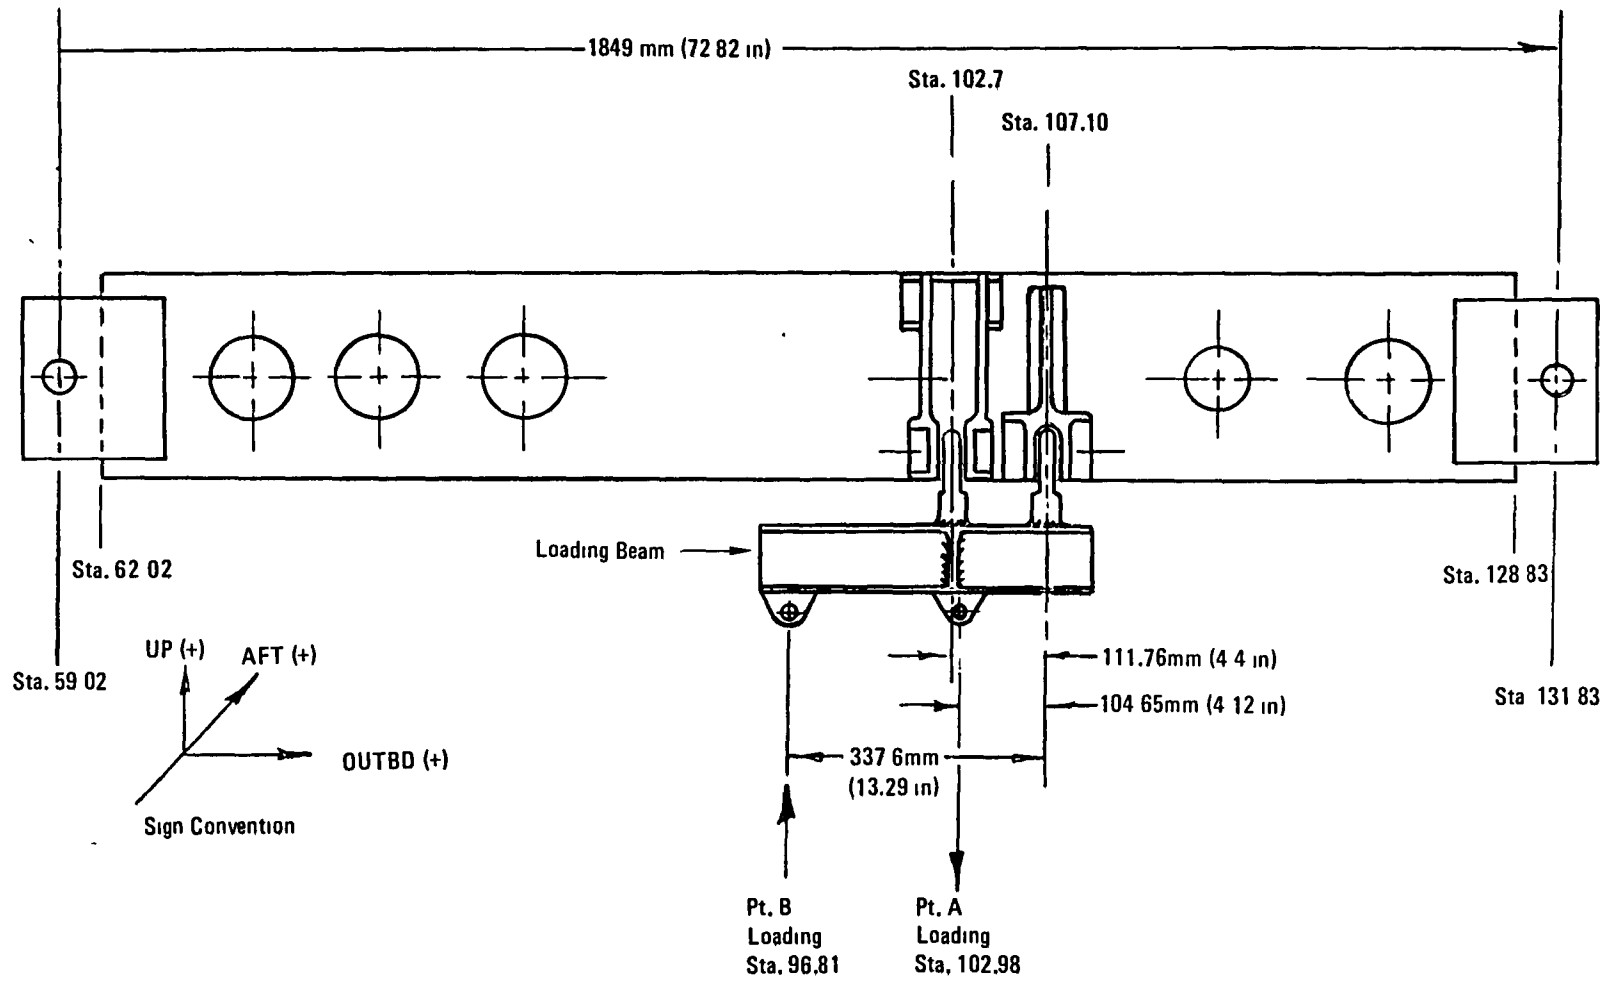
Figure 85. - Front spar loading beam schematic.

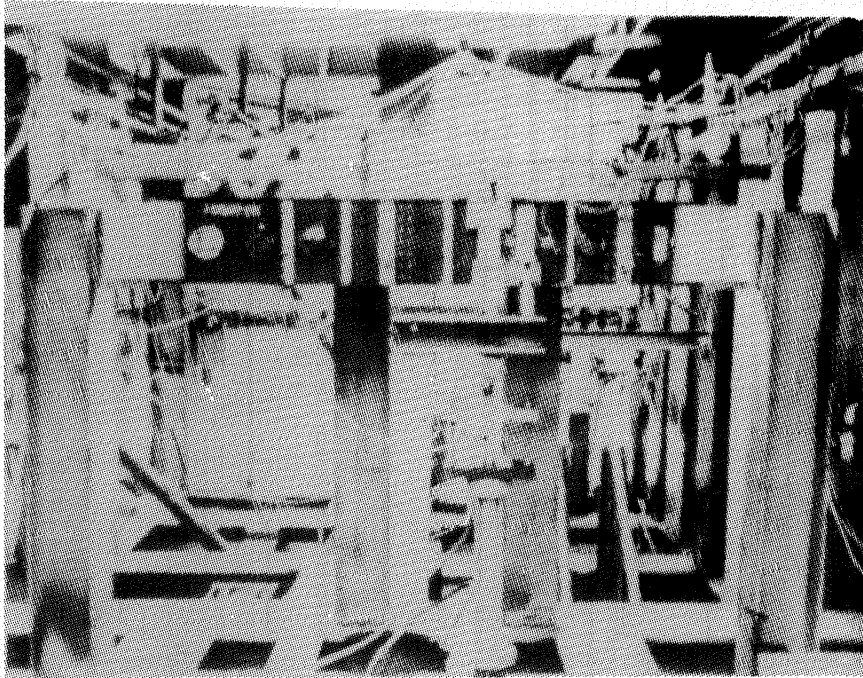
Figure 86. - Aileron front spar test setup.

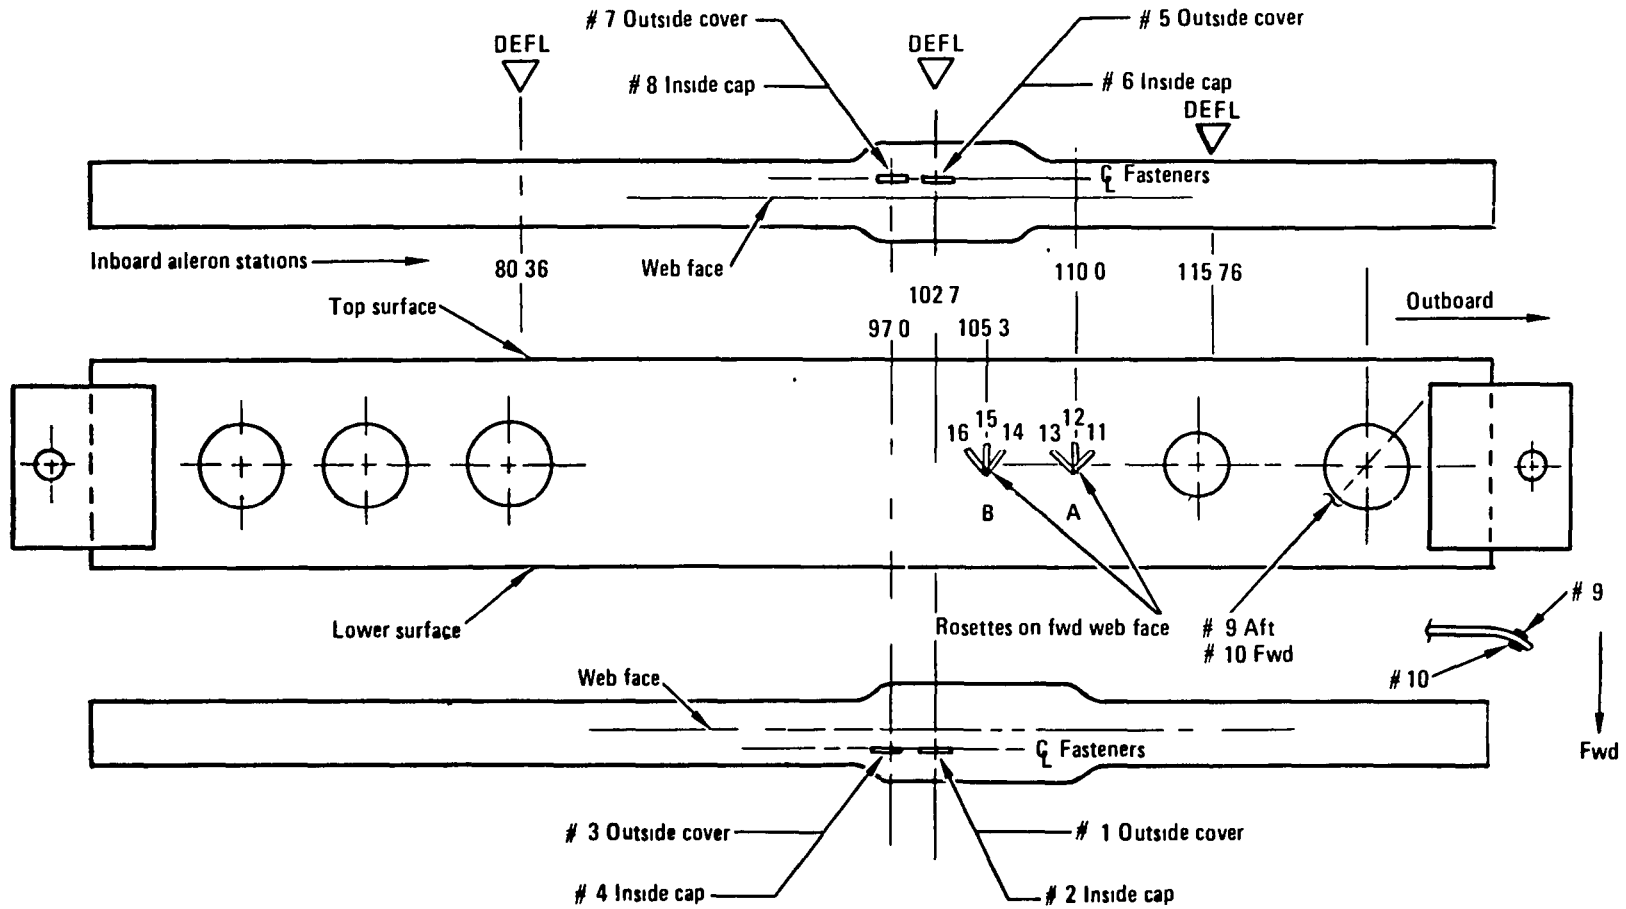
Figure 87. - Spar strain gage locations and identification.

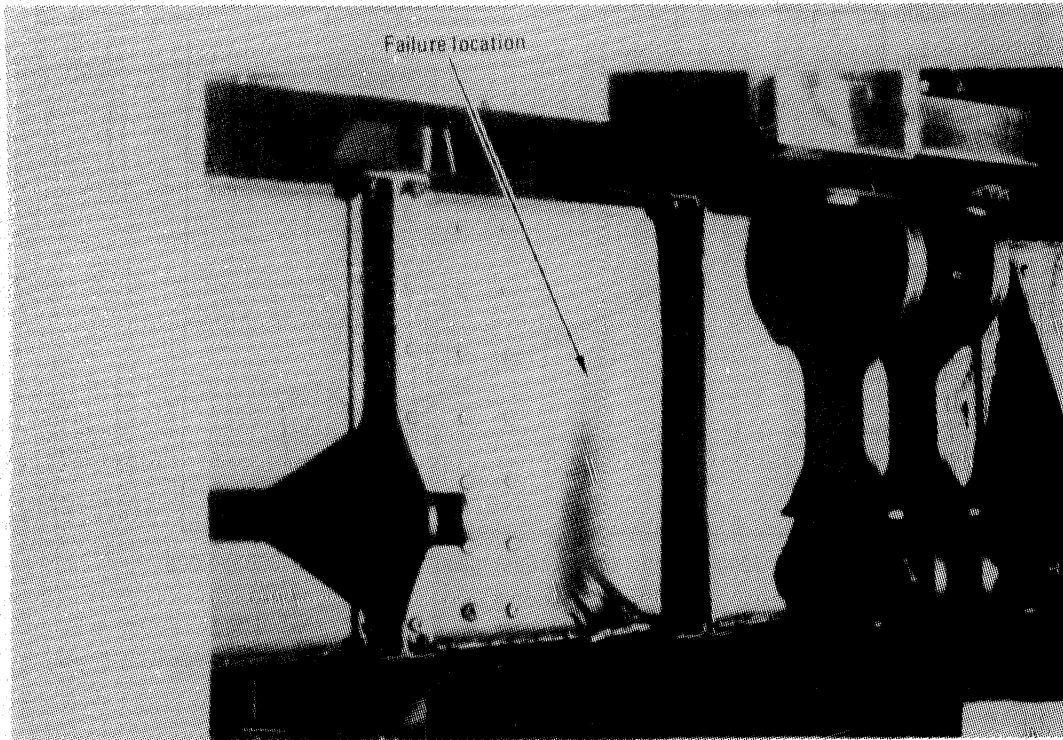
Figure 92. - Forward web face and spar cap/cover failure showing extent of buckling damage.

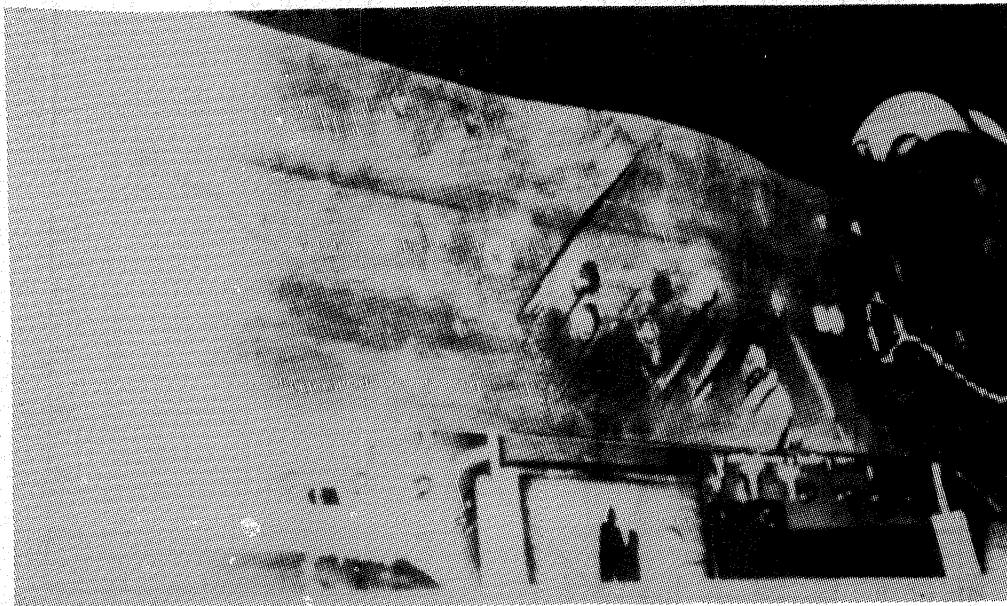
Figure 93. - Cover delamination and ply pulloff from around fastener heads.
