NASA Contractor Report 165635

Advanced Composite Aileron for L-1011 Transport Aircraft Design and Analysis

C.F. Griffin and L.D. Fogg

Lockheed Corporation
Lockheed-California Company
Post Office Box 551
Burbank, California 91520

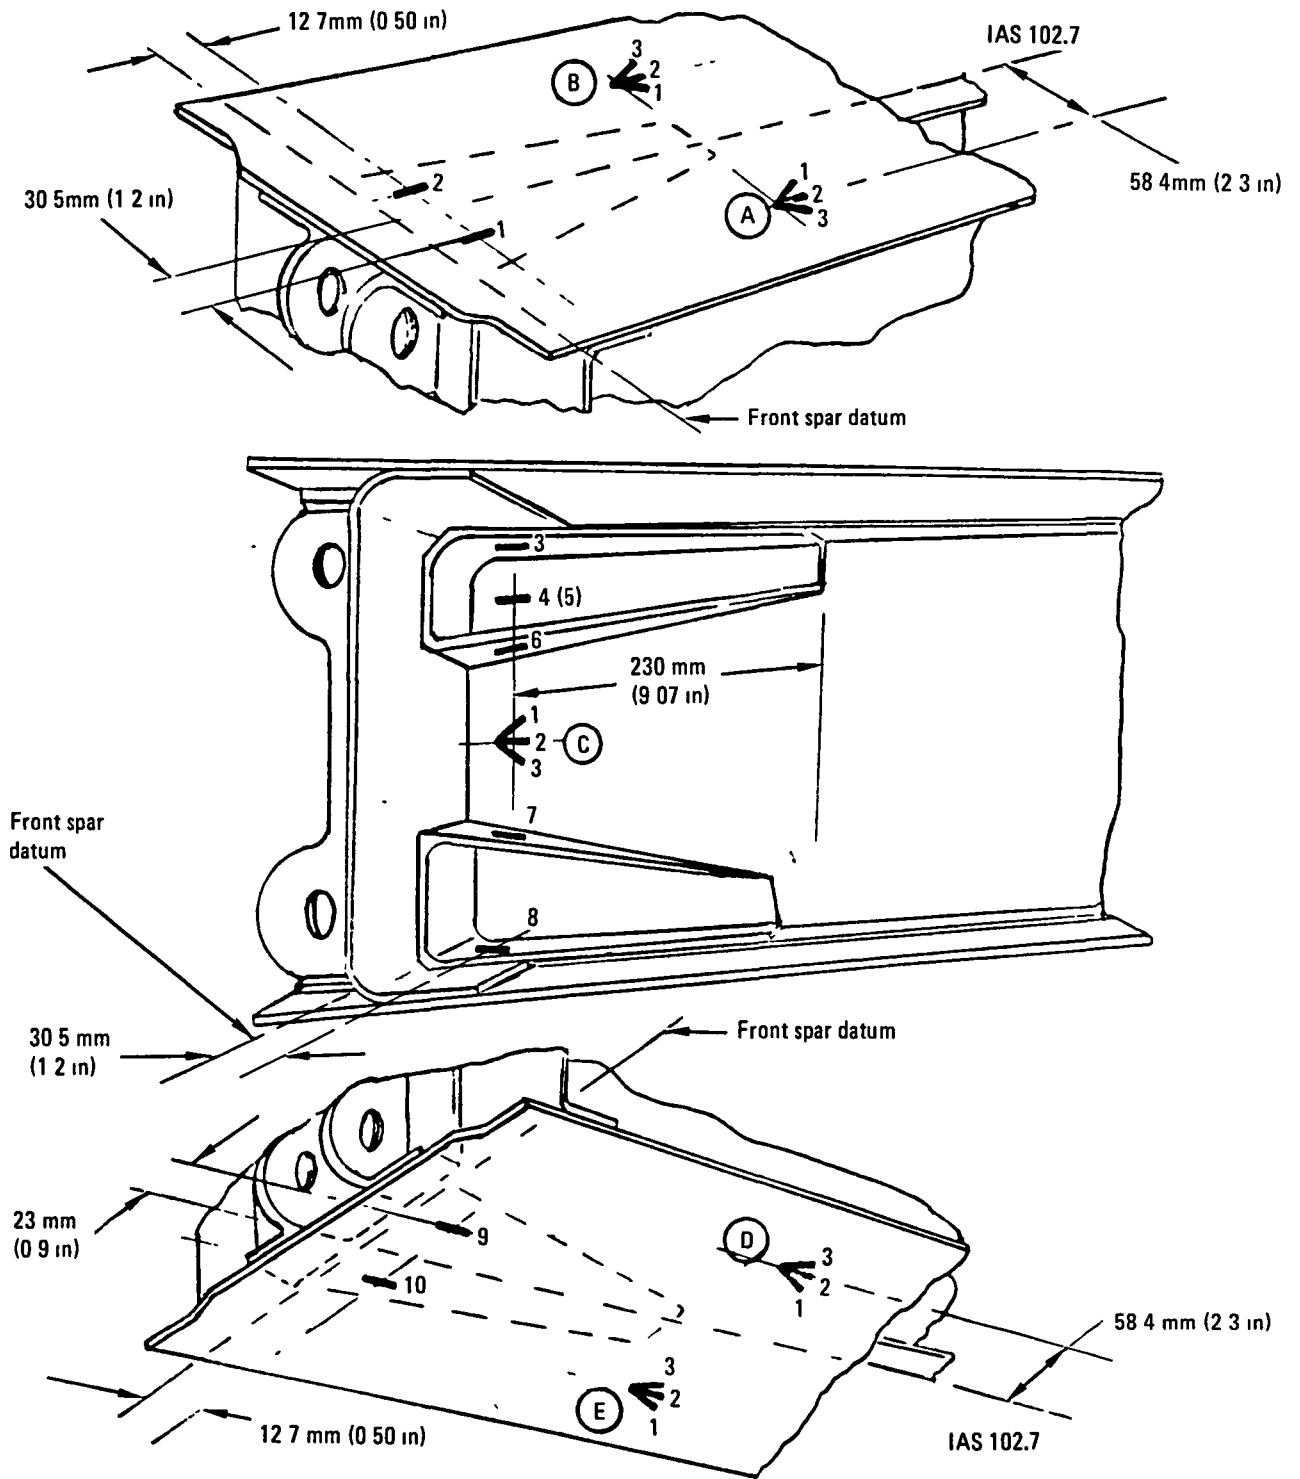
Figure 97. - Strain gage locations and identification for rib/spar specimen.

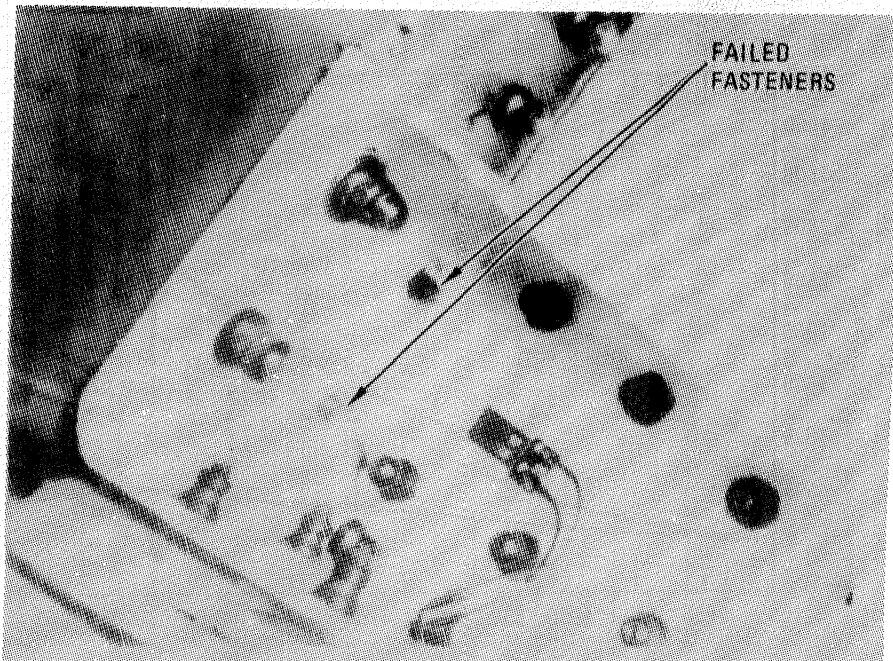
Figure 100. - Failed fasteners in the top inboard cover fitting.

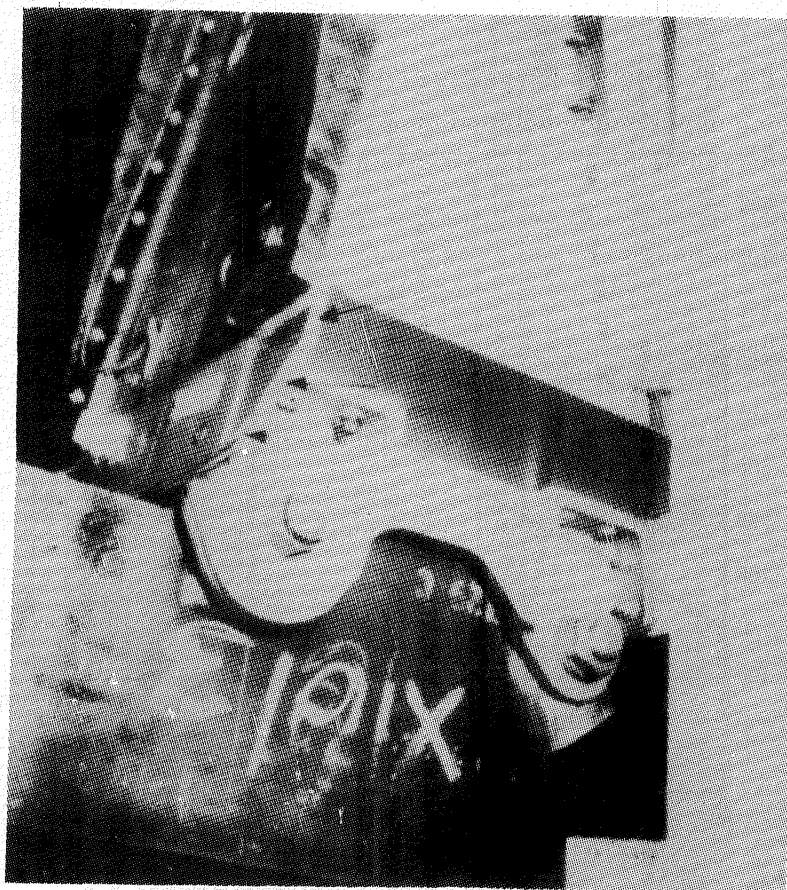
Figure 101. - Upper cover delamination.

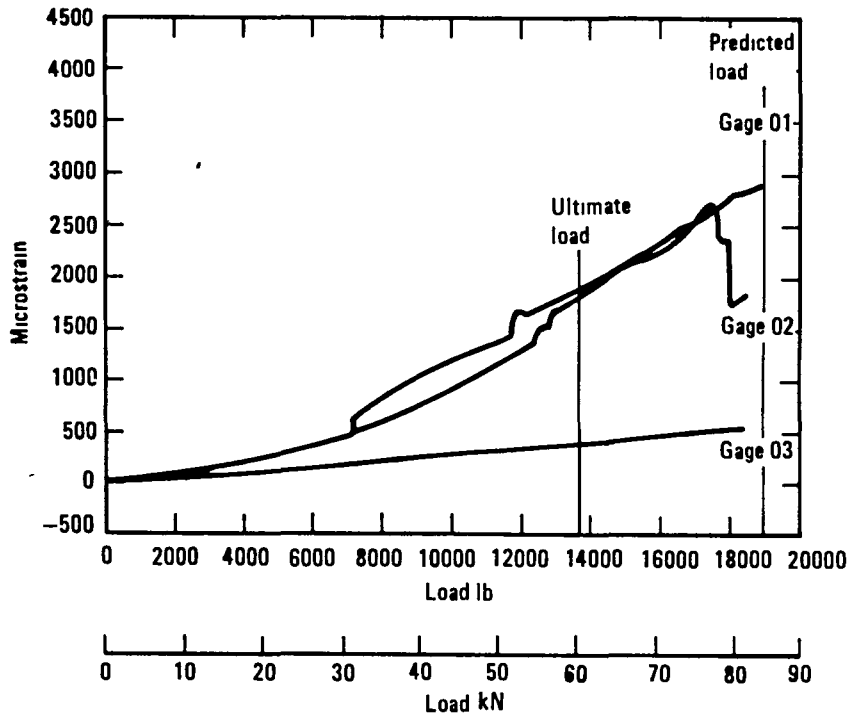
Figure 102. - Rib/spar/fitting strain versus load - gages 1, 2, 3, tensile failure load.

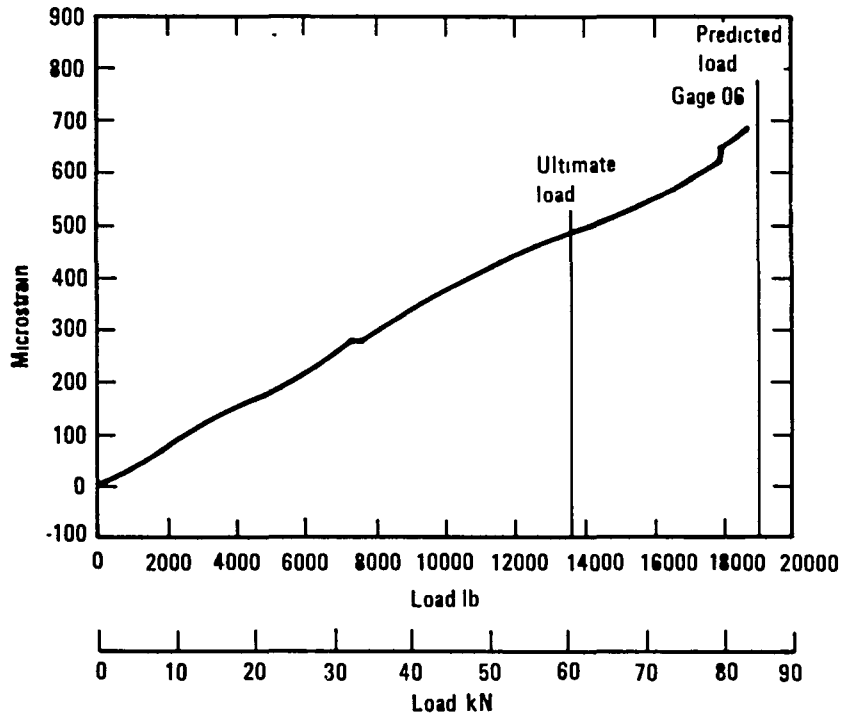
Figure 103. - Rib/spar/fitting strain versus load - gage 6, tensile failure load.

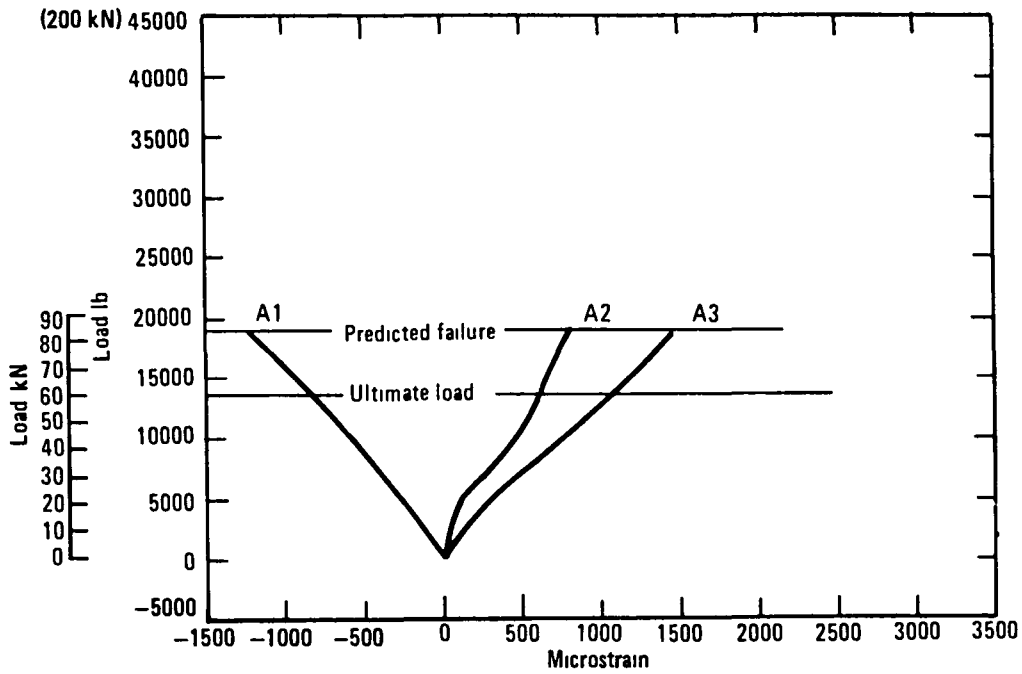
Figure 104. - Rib/spar/fitting strain versus load - rosette A, tensile failure load (see figure 97).

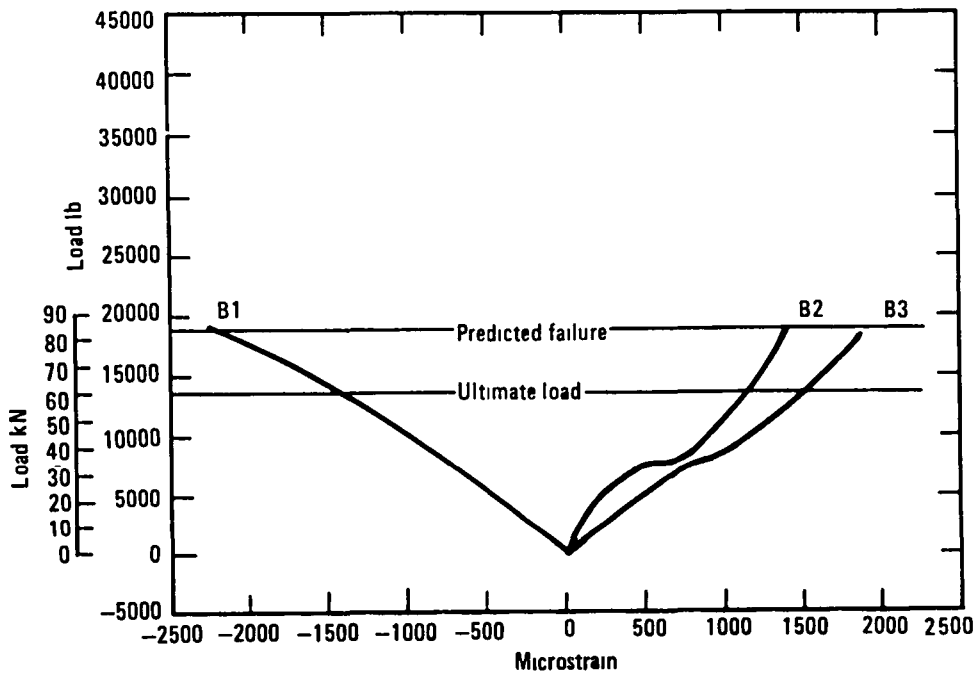
Figure 105. - Rib/spar/fitting strain versus load - rosette B, tensile failure load (see figure 97).

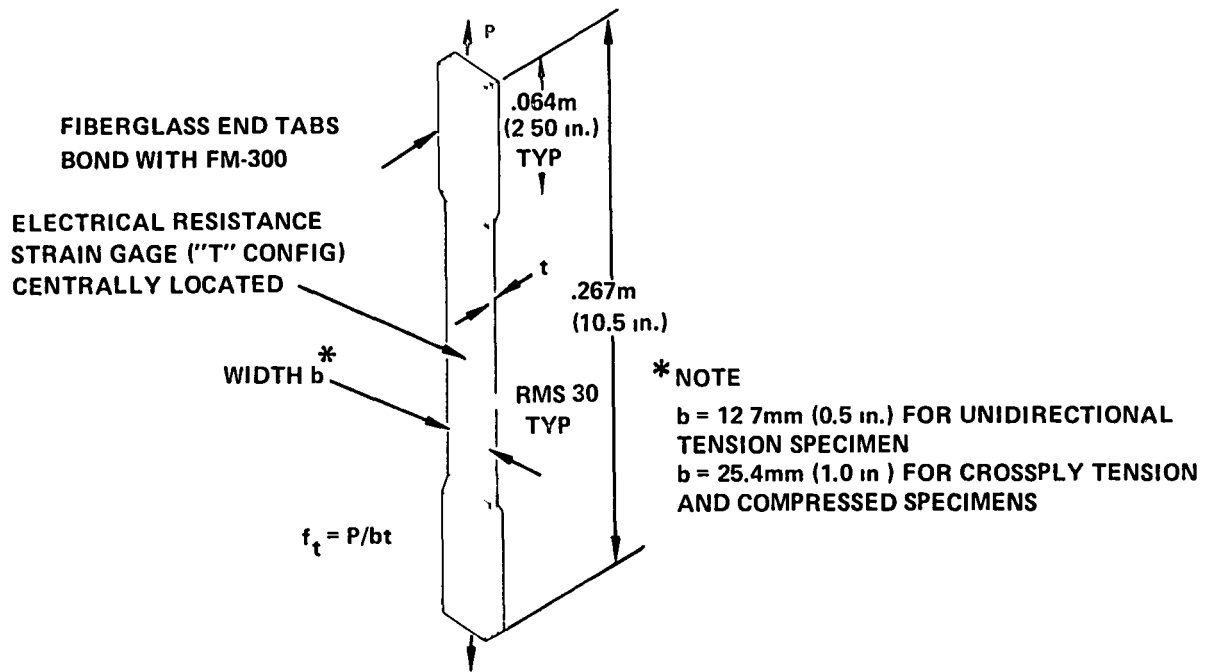
FIGURE B1 CROSSPLY TENSION AND COMPRESSION AND UNIDIRECTIONAL TENSION COUPON

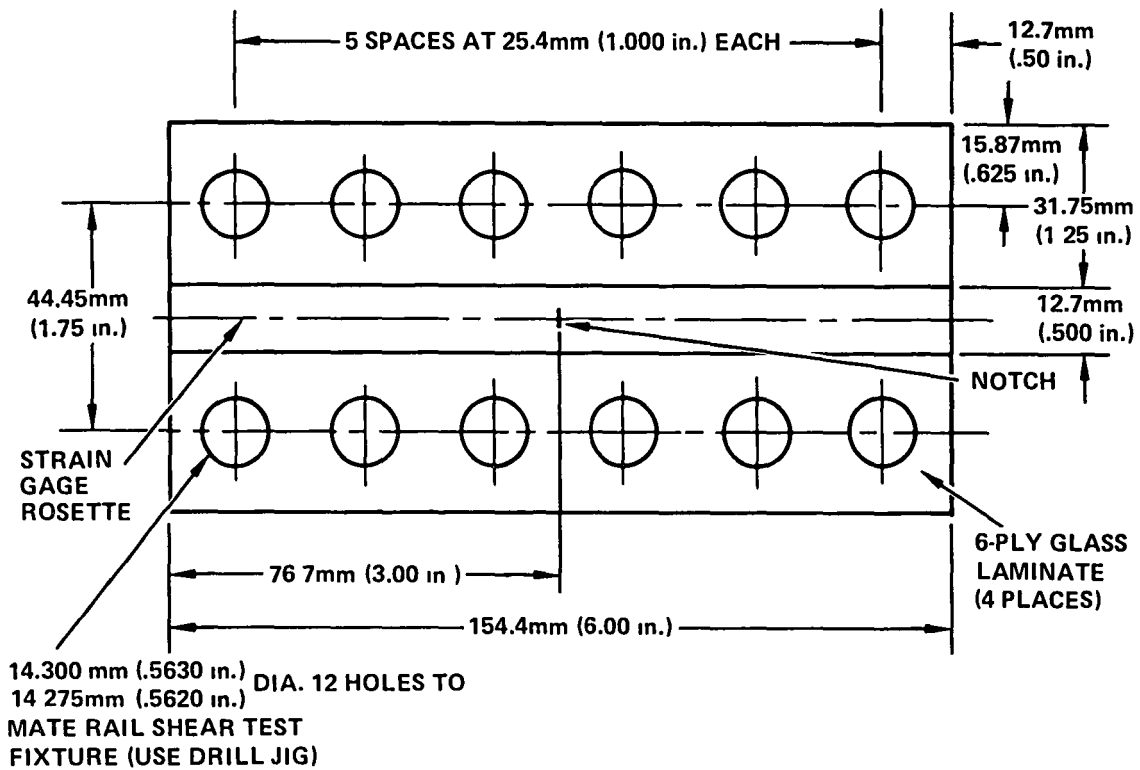
FIGURE B4 IN-PLANE SHEAR SPECIMEN
