5101-215  
Flat-Plate  
Solar Array Project

# FSA Field Test Report 1980-1982

H.G. Maxwell  
C.A. Grimmett  
J. Repar  
P.O. Frickland  
J.A. Amy

JPL Publication 83-29

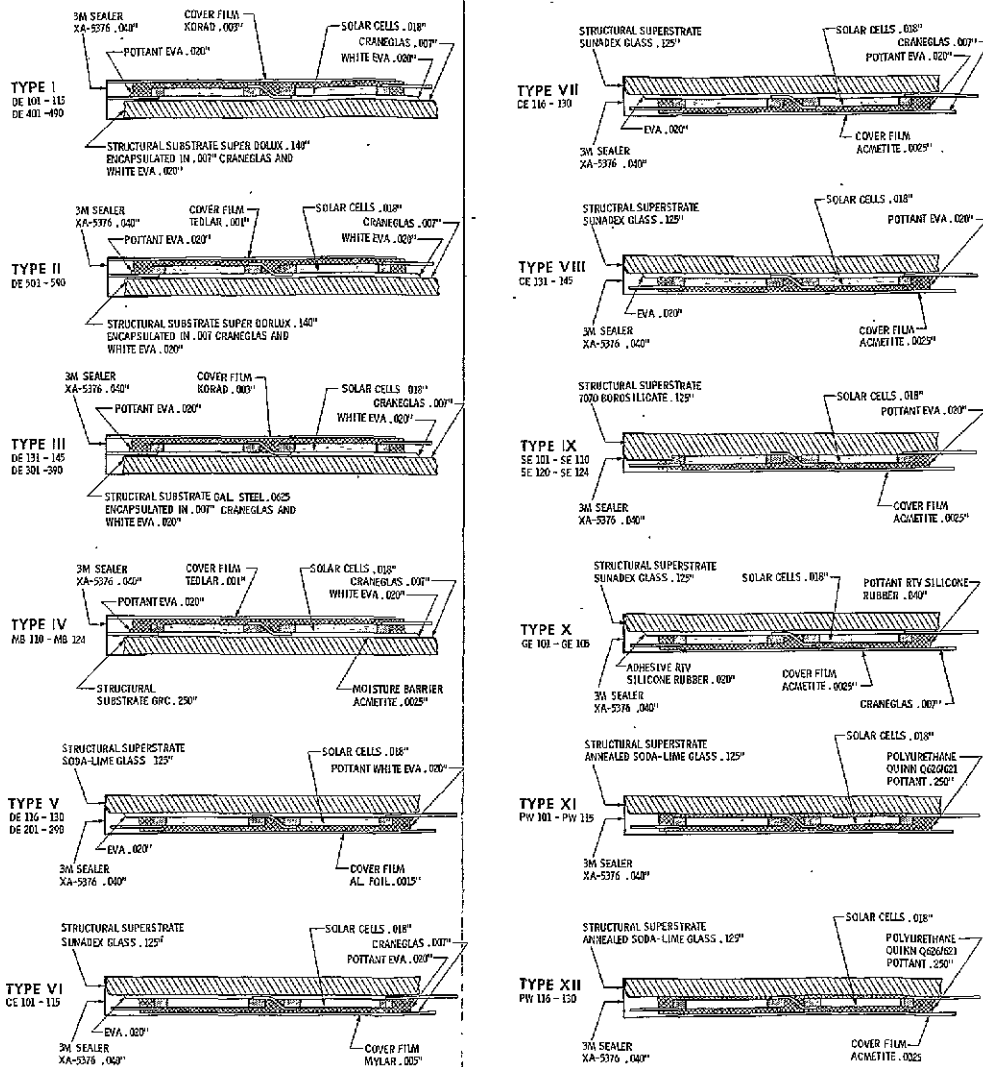
Figure 1-1. Module Types

This field-testing program made use of 150 minimodules of 11 Types--some quite similar in design--and 365 submodules (containing two cells) of four Types. Figure 1-1 provides a convenient guide to the important features of these module Types; more detailed information is presented in Section II and Appendix B. In brief, several modules of each Type were subjected to standard JPL qualification testing: thermal-cycle and humidity-freezing cycle tests, determination of nominal operating cell temperature (NOCT), partial-discharge test, and hail impact test. Some modules underwent accelerated testing at DSET Laboratories, Inc., Phoenix, Arizona. Most, however, were weathered at three locations in Southern California: JPL's main laboratory site in Pasadena, JPL's Goldstone Tracking Station in the Mojave Desert, and at a site just outside the U.S. Coast Guard Station at Pt. Vicente. Table 1-1 shows how these modules were distributed among the various tests.

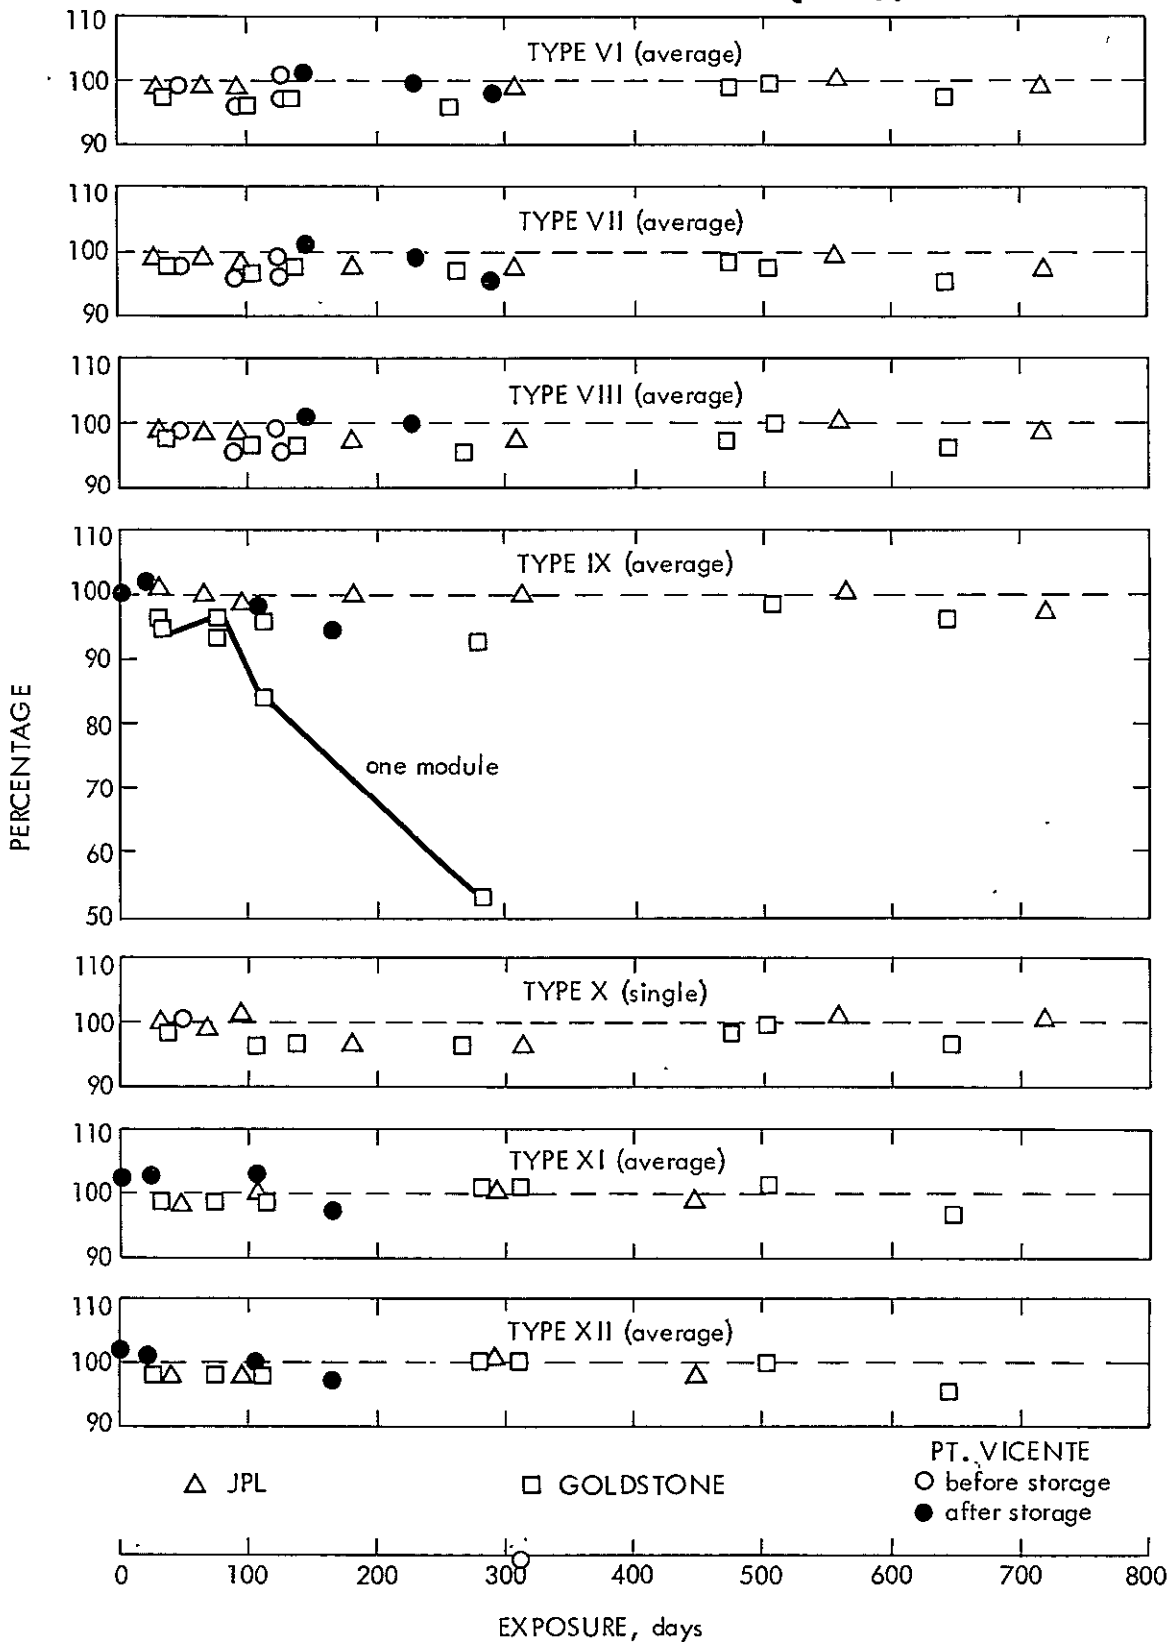
Figure 4-4. Minimodule Field-Test Results: Percentage of Initial Maximum Power Output Retained After Cleaning

Electrical degradation of the modules undergoing field exposure was monitored through changes in maximum power output calculated from LAPSS I-V curves.

Two groups of curves were obtained: the first with the modules in the as-weathered condition; the second after they had been washed (cf. Section III.D). In reviewing the detailed results it can be seen that soiling is site-specific. Modules tested at JPL show maximum power outputs that are consistently 2%-6% higher (occasionally even more) after washing than they were in the as-weathered condition. The other sites show little or no difference. As a result of this observation, comparisons from site to site have been made on the basis of the maximum power developed by washed modules.
