NASA Technical Memorandum 84317

# Comparison of Multispectral Remote-Sensing Techniques for Monitoring Subsurface Drain Conditions

Robert C. Goettelman, Luther B. Grass,  
John P. Millard, and Paul R. Nixon

MAY 1983

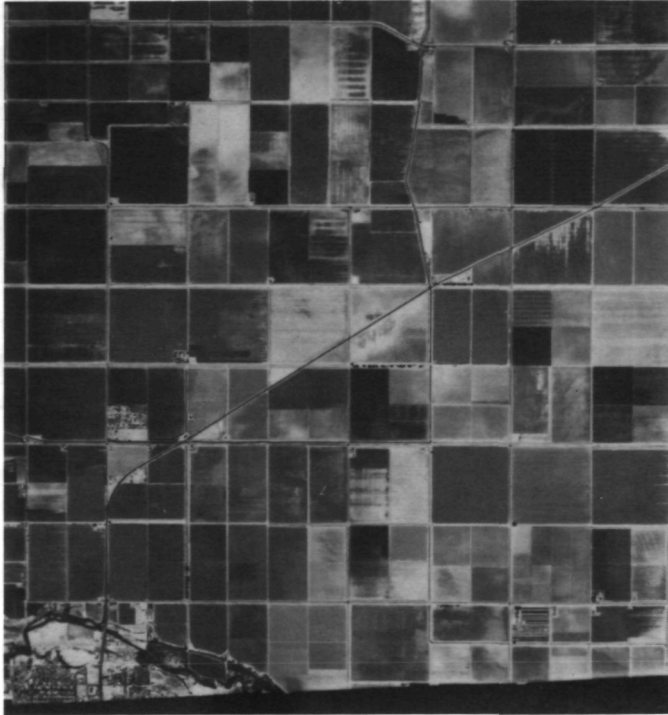
Figure 1.- U-2 photograph of area of Imperial Valley showing visible sub-surface drainage patterns.

If a drain malfunction could be detected at an early stage, corrective action could be initiated at a relatively low cost. An added benefit would be knowing where and when action was required. This would be a considerable saving over any routine preventive maintenance program for which the cost of high-pressure water cleaning can be about \$42,000 for one section of land with drain lines at 30.5-m (100-ft) intervals. Contracted routine "ground truthing" would be costly. Normally, the farmer does not have the facility or the time to monitor the out-flow from each individual drain line. Thus, the need for a cost-effective remote monitoring approach exists. Airborne observations appear to offer the best solution. Previous work has shown that drains in highly saturated soils are easily observed using aerial photography, as can be seen in figure 1. This photograph was taken over agricultural land located near Brawley, Calif. by a U-2 aircraft on October 31, 1979. Drying patterns are visible in many of the fields.

Regional monitoring of drainage conditions is possible with careful choice of time and weather conditions. The optimum would be completely bare fields saturated with moisture. Such conditions often exist in the east, midwest, and western states prior to planting and just after heavy spring rains. Large regions can be easily documented by high-altitude photography such as that provided by the U-2 in figure 1.

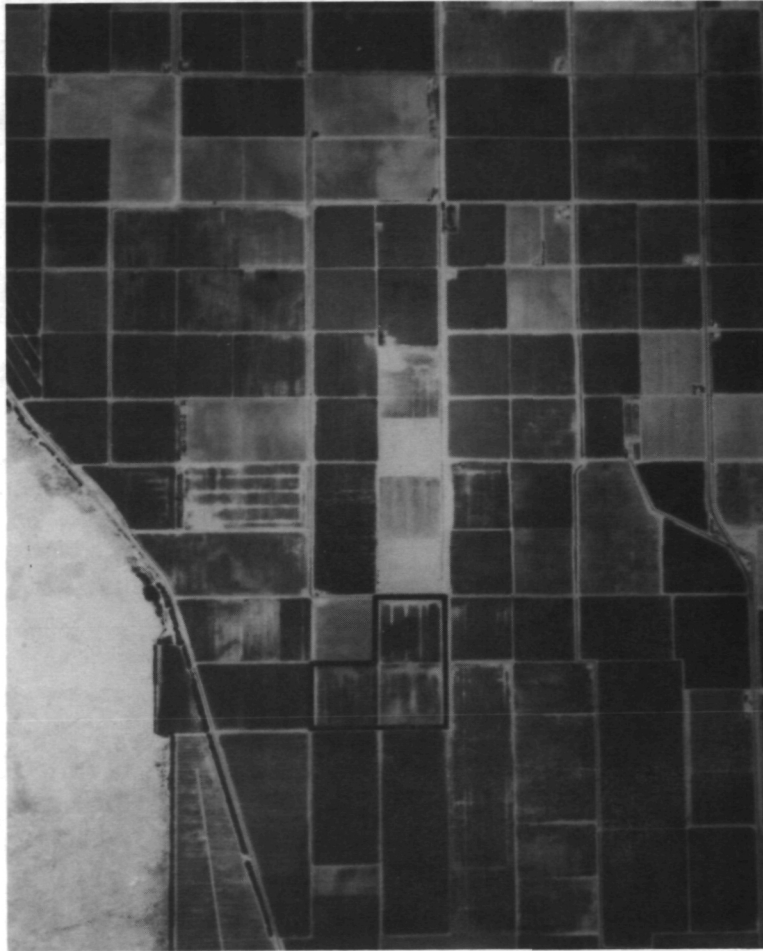
(a) Wet fields, showing uneven drying patterns and areas of wetness.

Figure 5.- Three adjoining bare fields.

Photographic evidence. Data on drying patterns observed on coarse, sandy fields were similar to the November 1980 flight series. Figure 5a shows three small adjoining fields (bordered in black), in an early stage of their drying cycle. If this single observation, made on June 21, had been the only one available for analysis, a drainage failure would have been concluded from the uneven appearance of the drying pattern. Examination of the three fields during dry-soil conditions (Figure 5b, June 16) shows the field soils to be very inhomogeneous. A close comparison between figures 5a and 5b shows that most of the uneven patterns of wet soil (fig. 5a) directly match the areas of soil with reduced reflectivity, and thus a drainage failure cannot be concluded. This result has two important implications: interactive data sets showing fields under drying conditions, and also in a dry-soil stage, are required for accurate drainage analysis; and within-field inhomogeneity complicates analysis, and may greatly reduce analysis accuracy.

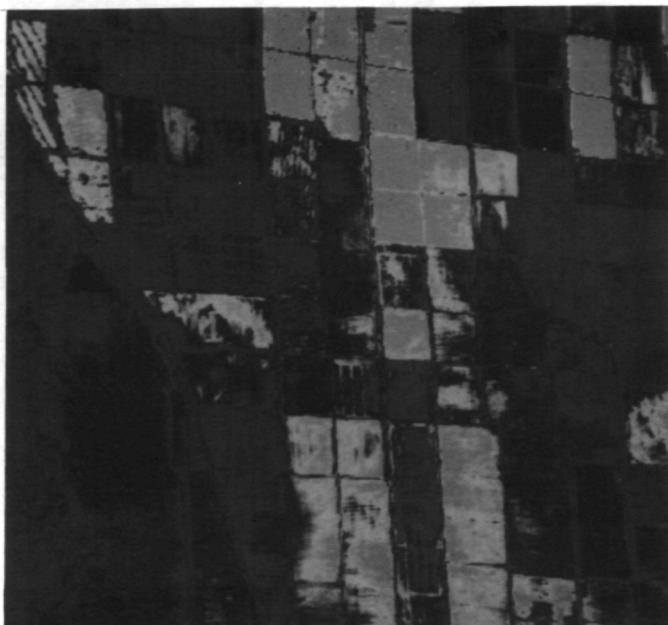
Figure 6.- Computer-generated image of near-IR (800- to 890-nm) data.

Figure 6 is a black and white reproduction of a pseudo-colored, computer-generated image (ref. 7) of near-IR (Ch. 9) data gathered on June 21 in a region on the west side of the Valley at the start of the south-to-north flight line (solid

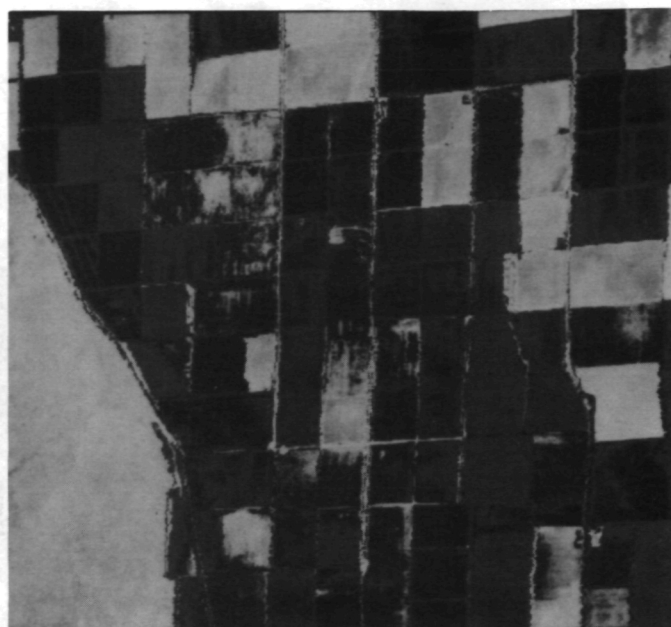
Figure 7.- Computer-generated image of thermal-IR (10.5- to 12.5- $\mu\text{m}$ ) data.

black line in fig. 2). Figure 7 is a computer-generated image of thermal-IR data from the same region, gathered on June 16. No comparable thermal image for June 21 was available because of a malfunction in the thermal detector on that date. The computer-generated images for the red channel (Ch. 6), and the near-IR/red (Ch. 9/Ch. 6) ratio look essentially identical to figures 6 and 7 except for different color patterns and different color-level values. Extensive examination of all fields observed along the flight lines showed the following.
