NASA Technical Memorandum 82955

Corrosion of Simulated Bearing Components of Three Bearing Steels in the Presence of Chloride-Contaminated Lubricant

**CORROSION OF SIMULATED BEARING COMPONENTS OF THREE BEARING STEELS
IN THE PRESENCE OF CHLORIDE-CONTAMINATED LUBRICANT**

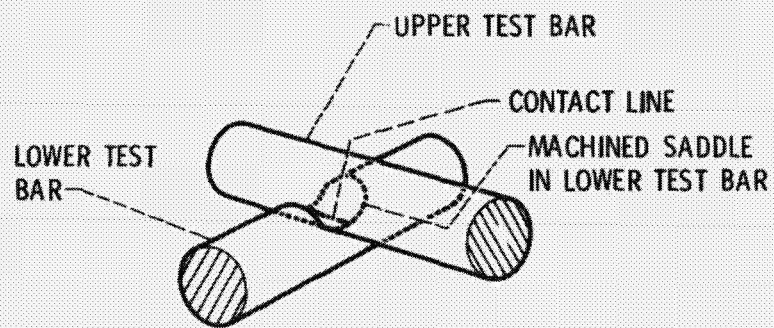
Figure 1. - Corrosion test bar contact.

The chemical composition of the materials used in these tests is given in Table 1. The test specimens were made from rolling-contact (RC) rig test bars (11). Rod materials of approximately 13 mm (0.5 in) in diameter were heat treated to obtain a nominal Rockwell C hardness of 62. The heat treating cycles are described in Table 2. Cylindrical bars 76.2 mm (3.0 in) long and 9.5 mm (0.375 in) in diameter were ground from the heat treated rods. Half of the test bars were ground with saddles as shown in Fig. 1 with a radius slightly greater than the bar radius. This saddle provides a contact and crevice situation to simulate the contact of a ball or roller and a bearing raceway as shown in Fig. 1. Both the cylindrical and the saddle surfaces were ground to a finish of 0.15 to 0.20 μm (6 to 8 μin).

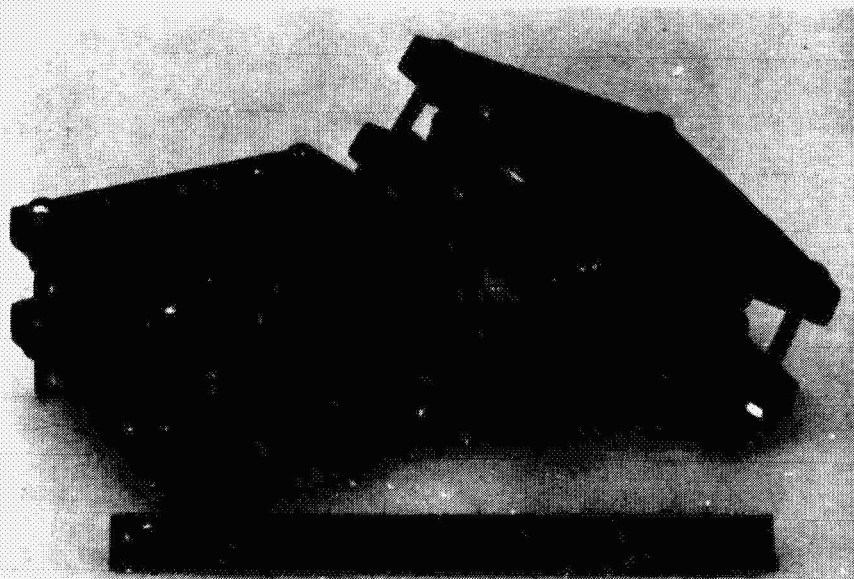
Figure 2. - Specimens and test fixtures after corrosion test.

The bars were then placed in a special fixture, shown in Fig. 2, with the lower two bars having the saddle, and the mating two bars placed across the saddles. This arrangement produces a contact and crevice situation similar to that in a ball or roller bearing and provides the opportunity for the crevice corrosion mechanism. The fixture was made of polyethylene material. The fixture was clamped together and suspended in a large beaker which was then loosely covered with aluminum foil. This assembly, called the corrosion cell, was then cycled alternately between a 339 K (150° F) oven and a 276 K (37° F) refrigerator. Total exposure was 14 cycles, each cycle consisting of 8 hours in the oven and 16 hours in the refrigerator. Corrosion cells were assembled with each of the three materials.

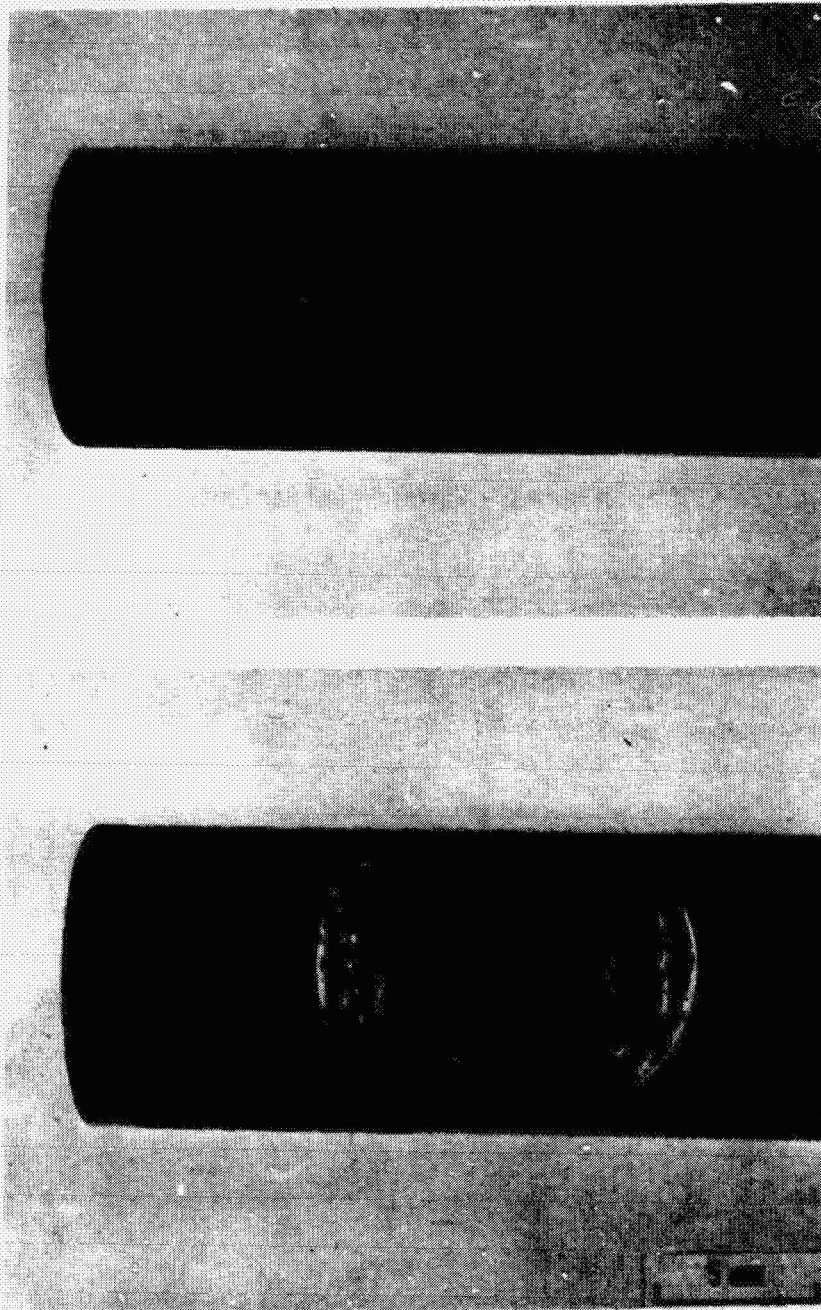
Figure 3. - Macrophotos of AISI 52100 specimens after corrosion test.

Corrosion tests were performed with test bars of AMS 5749, AISI 52100, and AISI M-50 assembled to simulate crevice corrosion in the presence of a lubricant-chloride solution. After the 14 thermal cycles were completed, the test bars were cleaned and examined. Visual inspection revealed that AISI M-50 and AISI 52100 had extensive corrosion damage. A slight amount of corrosion was present on the AMS 5749 bars. As shown in Figs. 3 and 4, the corrosion was not limited to crevice corrosion, but pitting corrosion also occurred on exposed surfaces of both materials. The slight amount of corrosion on the AMS 5749 bars appeared to be limited to the saddle area where crevice corrosion occurred, as shown in Fig. 5.

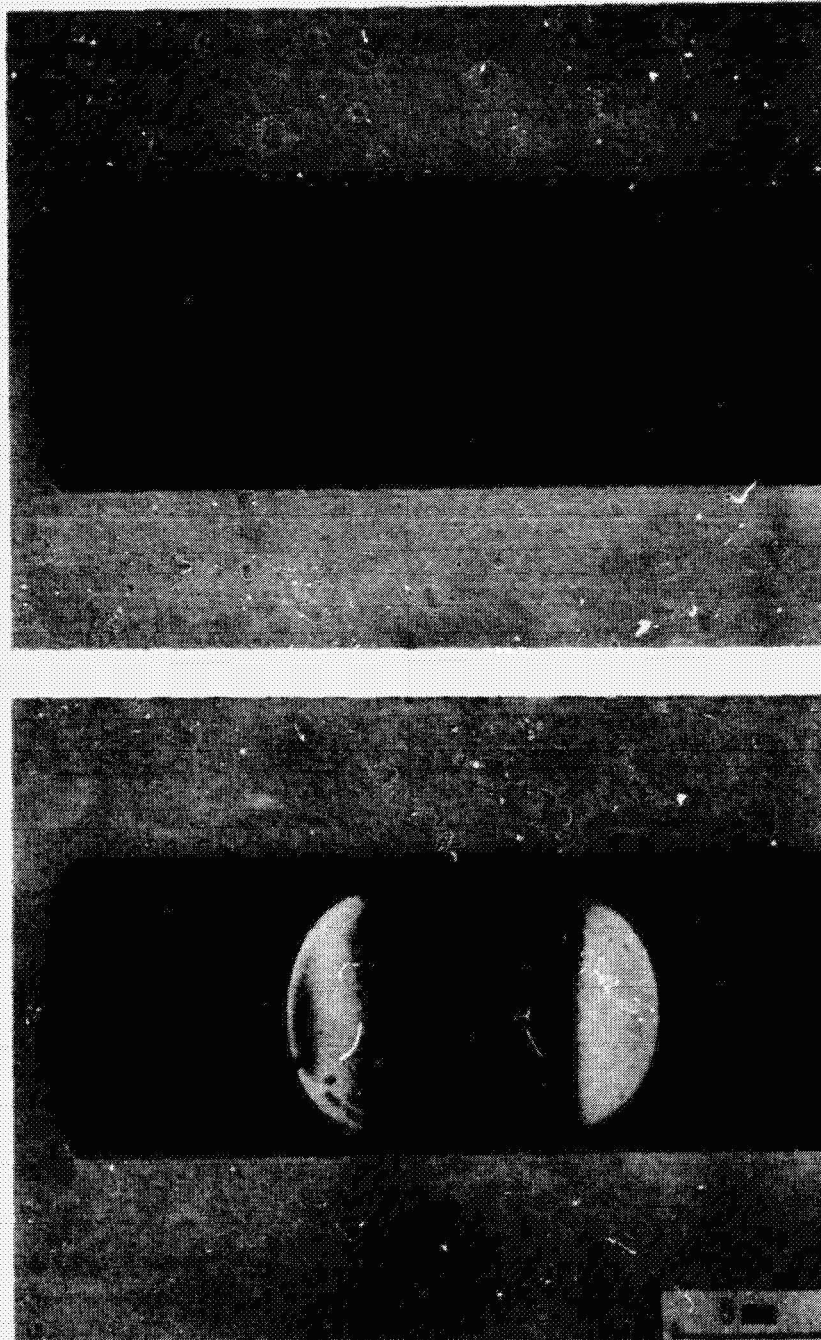
Figure 4. - Macrophotos of M-50 specimens after corrosion test.

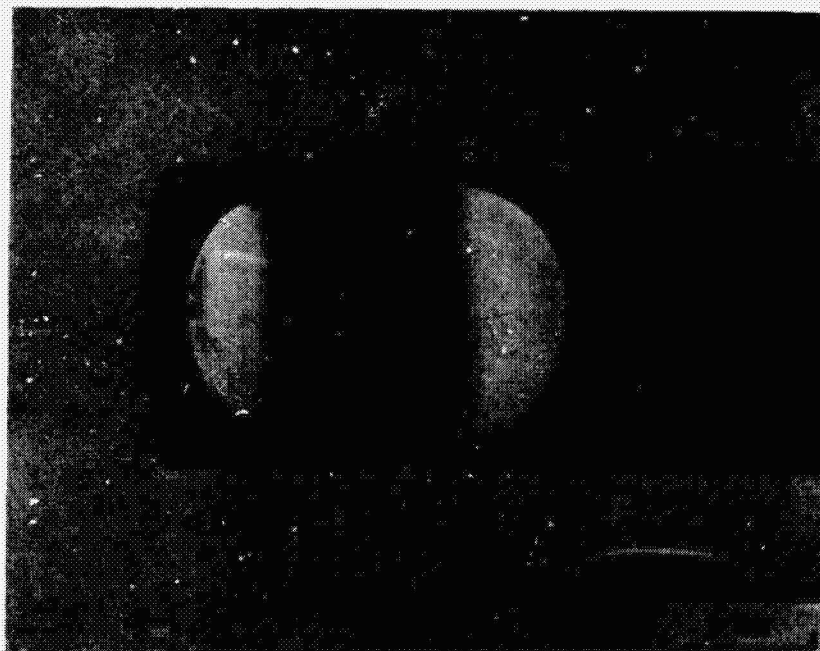
Figure 5. - Macrophotos of AMS 5749 specimens after corrosion test.

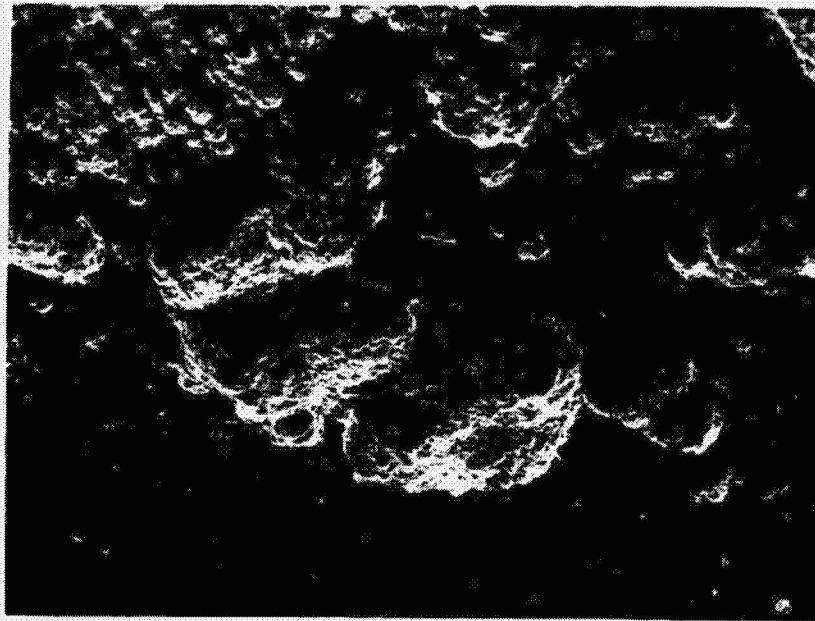
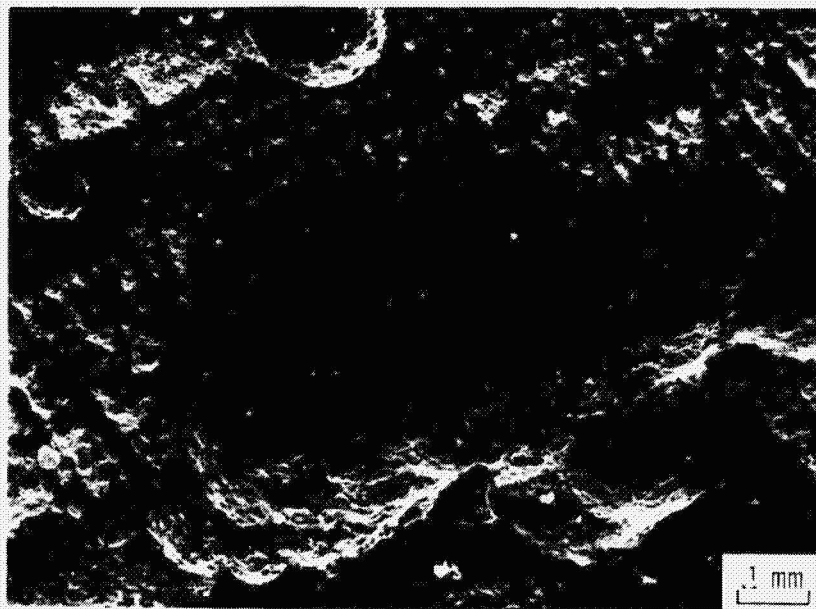
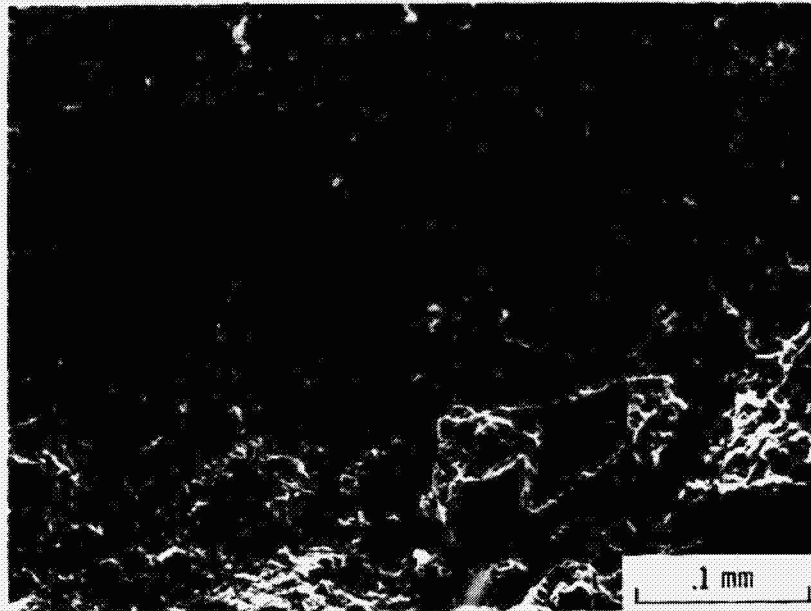
Figure 7. - Scanning electron micrographs of AISI M-50 specimen after corrosion test.

For a detailed examination of the corrosion damage, scanning electron microscopy was employed. Typical corrosion areas are shown in Figs. 6 to 8. In general, there was no significant difference between the corrosion in the crevice areas and that on the exposed surfaces. Differences were noted between the appearance of the AISI M-50 and the AISI 52100. The corrosion on AISI 52100 appeared to cover more surface area, but the corrosion pits on the AISI M-50 bars appeared to be deeper. This observation is not readily apparent in Figs. 6 and 7, but test bars of both materials were sectioned through typical corrosion pits for further observations.

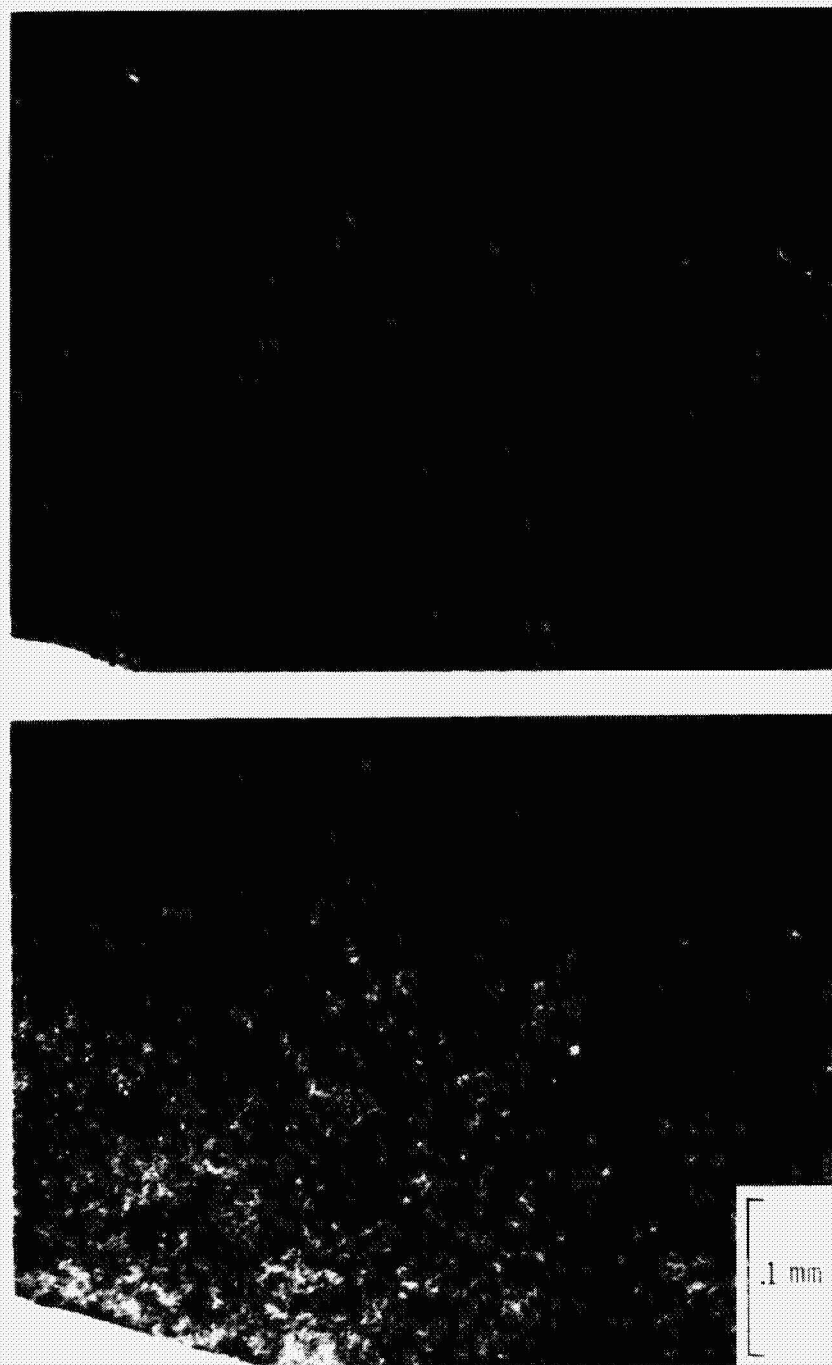
Figure 9. - Optical micrograph of AISI 52100 specimen after corrosion test.

Optical photomicrographs of the sections through the pits are shown in Figs. 9 and 10. The greater depths of the AISI M-50 corrosion pits are apparent by comparing these photos. This observation agrees with those of (12) which illustrate that effect in bearings removed from service.

The pits shown in Figs. 9 to 11 were selected as typical of the deepest pits observed in each material. These deepest pits had depths of approximately 120, 70, and 20 μm (0.005, 0.003, and 0.0008 in) in the AISI M-50, AISI 52100, and AMS 5749, respectively. The deepest pits in a bearing surface are the most detrimental, since they are most likely to be initiation sites for rolling-element fatigue cracks and subsequent spalling. Thus, the corrosion observed would tend to reduce rolling-element fatigue life in AISI M-50 more than in either AISI 52100 or AMS 5749.

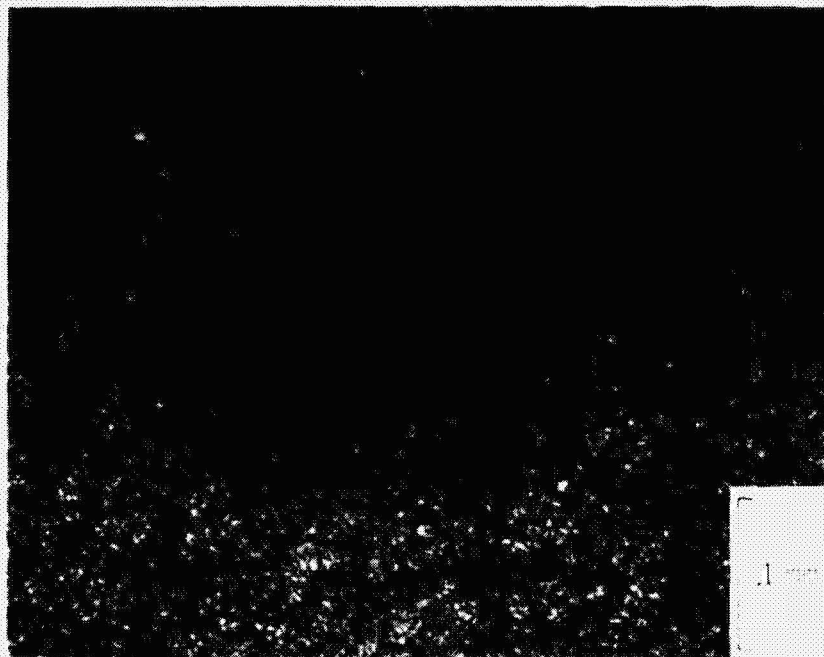
Figure 10. - Optical micrograph of AISI 440 specimen after corrosion test.
