(NASA-CR-169798) AN INVESTIGATION OF
ADHESIVE/ADHEREND AND FIBER/MATRIX
INTERACTIONS. PART B: SEM/ESCA ANALYSIS OF
FRACTURE SURFACES Final Technical Report
(Virginia Polytechnic Inst. and State Univ.) G3/24

FINAL TECHNICAL REPORT
AN INVESTIGATION OF ADHESIVE/ADHEREND
AND FIBER/MATRIX INTERACTIONS
PART B - SEM/ESCA ANALYSIS OF
FRACTURE SURFACES

B. Beck, E. Widayani and J. P. Wightman

Prepared for
National Aeronautics and Space Administration
January, 1983
Grant NAG 1-127

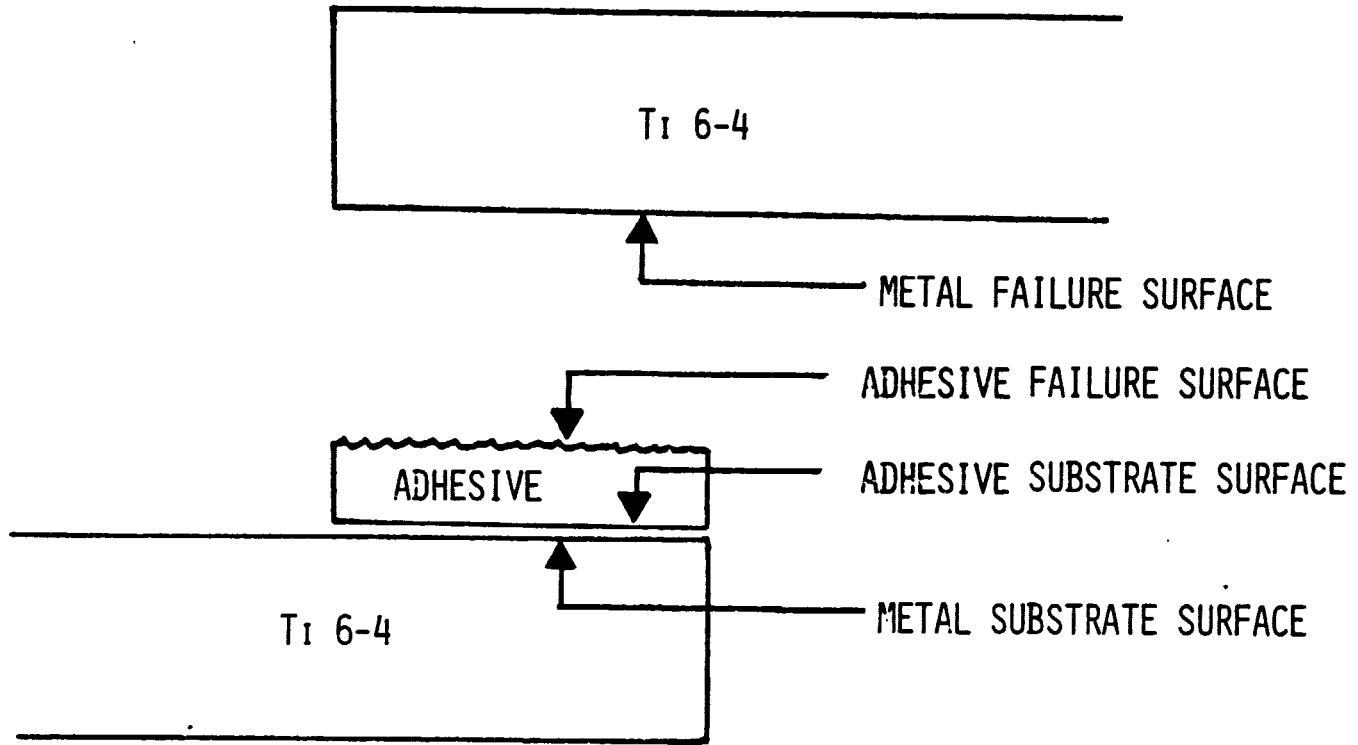
Figure 1. Schematic of fractured lap shear specimen.

failure classified as (i) interfacial (mostly adhesive showing on one member, mostly metal showing on the other member) (ii) cohesive (adhesive showing on both members) and (iii) mixed mode (significant amounts of metal and adhesive showing on both members). Generally, lower lap shear strengths were associated with interfacial failure. For some of the interfacial failure samples, the adhesive on one member "popped off" when the sample was punched for ESCA/SEM analysis. Thus four surfaces were generated as depicted in Figure 1.

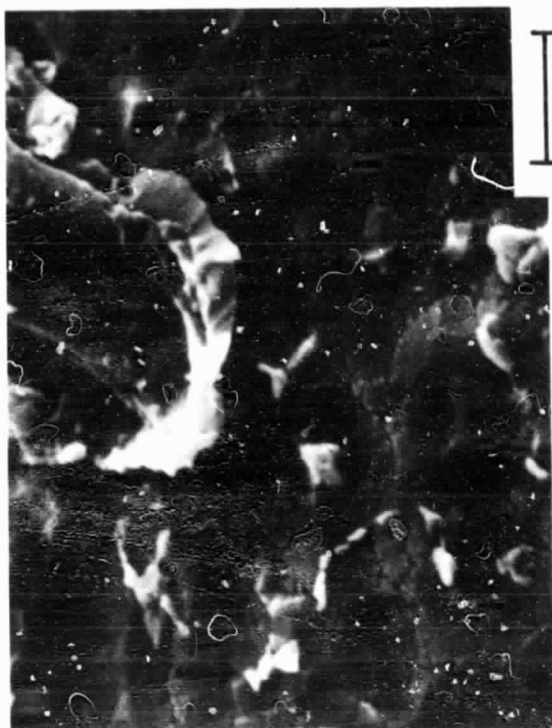
B

(B) METAL FAILURE SURFACE AT 5000X

The imprint of the adherend on the adhesive failure surface (AFS) is clearly seen in the SEM photomicrograph in Figure 2C on comparison with Fig. 2B. In addition, cracks and/or voids are noted on the adhesive failure surface. The nodule in the center of Fig. 2C is an alumina particle based on EDAX analysis. Alumina is a component of the L13 adhesive.

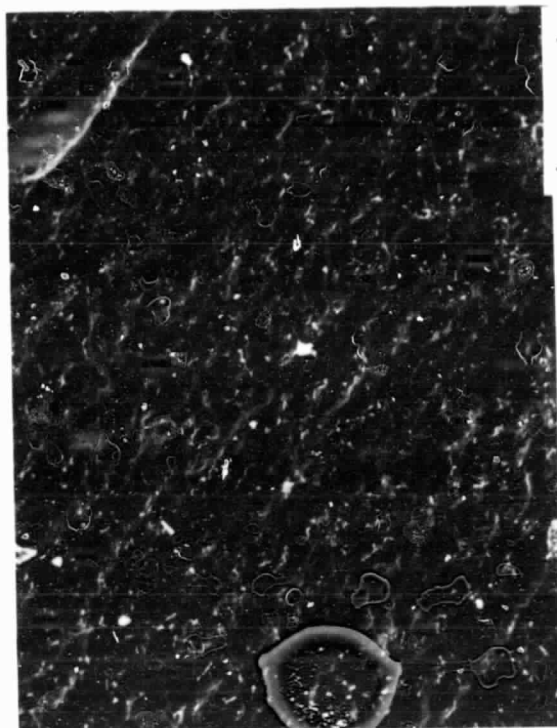
D

(D) METAL SUBSTRATE SURFACE AT 550X

The SEM photomicrograph of the metal substrate surface (MSS) is shown in Figure 2D. Similar features are seen on comparing Fig. 2D with Fig. 2A. Thus, minimal adhesive remains on the metal substrate surface (MSS).

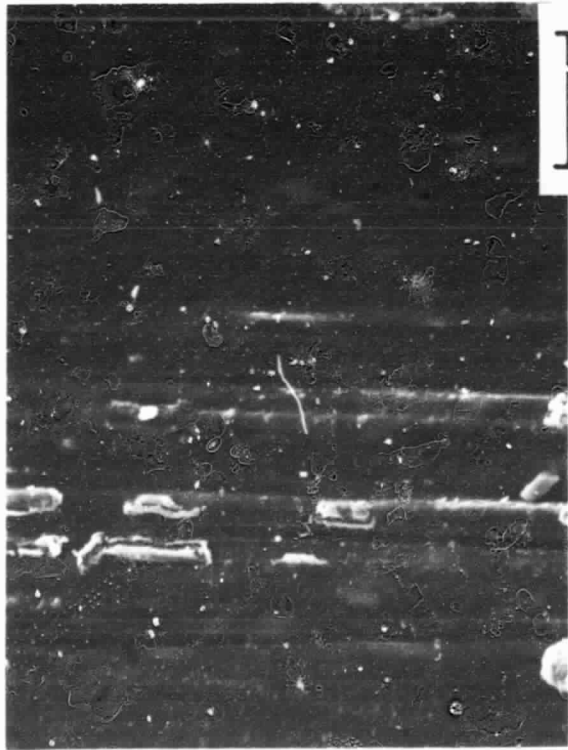
A

(A) SAMPLE NO. P-1-6 #1 at 500X

Scanning electron microscopy/electron spectroscopy for chemical analysis (SEM/ESCA) techniques have been applied to the analysis of two LARC-160/ Celion 6000 composite panels. SEM analysis of the untreated panel (P-1-G #1) showed a regular array of well-coated fibers as noted in Figure 4A. Carbon, fluorine, nitrogen and oxygen were the elements present in the composite surface as detected by ESCA. The fluorine to nitrogen ratio of 6.3 for this surface was quite high. Evidently, fluorine contamination occurred during fabrication. The grit blasted panel (P-1-G #2) showed extensive changes in surface morphology as noted in Figure 4B. The F/N ratio calculated from the ESCA results also decreased by more than a factor of 10 for the grit blasted panel.

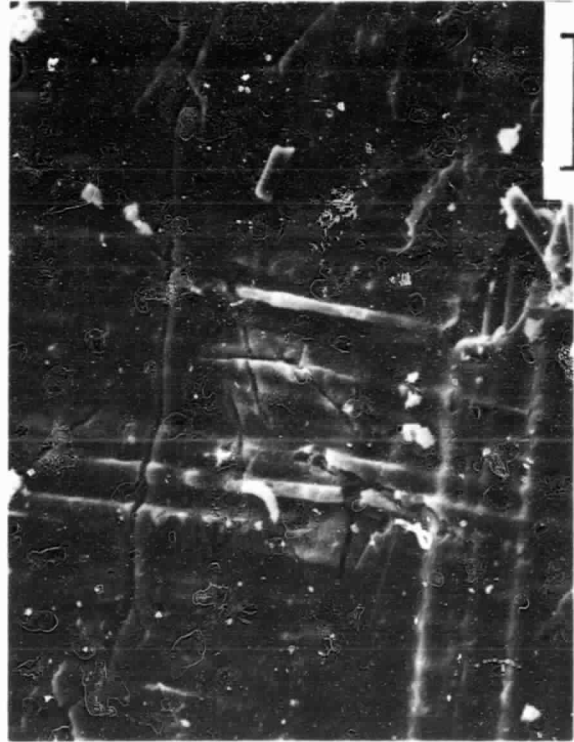
C

(C) FWT SAMPLE NO. 2-20: SIDE ADJACENT TO HONEYCOMB STRUCTURE.

1. Sample No. 2-20 - The side of the LARC 160/Celion 6000 panel adjacent to the honeycomb structure showed similar SEM features to P-1-6 #1 but a number of cracks were noted in the matrix as seen in Figure 4C. The ESCA F/N ratio of 0.55 was similar to the ratio for the grit blasted panel (P-1-G #2).

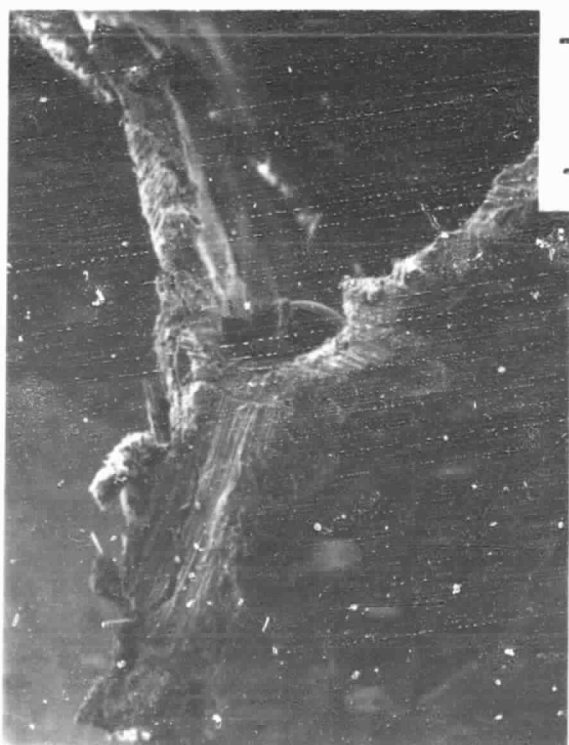
- (A) HONEYCOMB STRUCTURE AT 50X
- (B) HONEYCOMB STRUCTURE AT 500X
- (C) ADHESIVE ADJACENT TO HONEYCOMB STRUCTURE AT 500X
- (D) ADHESIVE ADJACENT TO COMPOSITE PANEL AT 500X

2. Sample No. 3-26 - This sample yielded 3 surfaces for analysis. The honeycomb structure was examined by SEM and showed fibers well wet by the matrix as can be noted in Figures 5A and 5B. No ESCA analysis was made on this surface because of sample configuration. The surface of the adhesive next to the honeycomb structure and next to the composite panel were analyzed. The SEM photomicrographs were quite different. For example, the honeycomb side (see Fig. 5C) showed no fibers whereas fibers were seen on the composite sides (see Fig. 5D). Again carbon, fluorine, nitrogen and oxygen ESCA
