MATERIALS FOR ADVANCED TURBINE ENGINES

Project Completion Report Project 3

ADVANCED BLADE TIP SEAL SYSTEM Volume I

J.W. Zelahy
N.P. Fairbanks

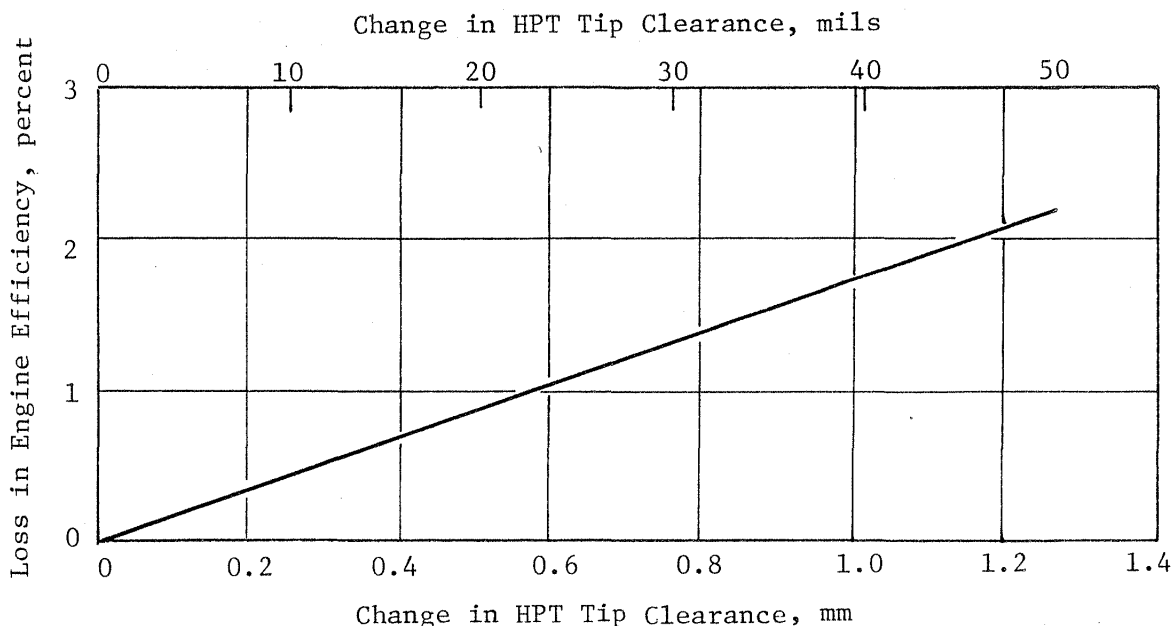
Figure 6. Effect of HPT Tip Clearance on Large-Turbofan Efficiency.

1. The predicted 2X increase in blade life from the monocrystal Normalloy oxidation/corrosion/thermal-fatigue-resistant tip in 1979 dollars would result in an \$0.88/engine-hour savings.
2. A predicted 0.33 mm (0.013 inch) tip-clearance improvement resulting from the abrasive treatment to the tip would provide an 0.43% sfc improvement, as shown in Figure 6.

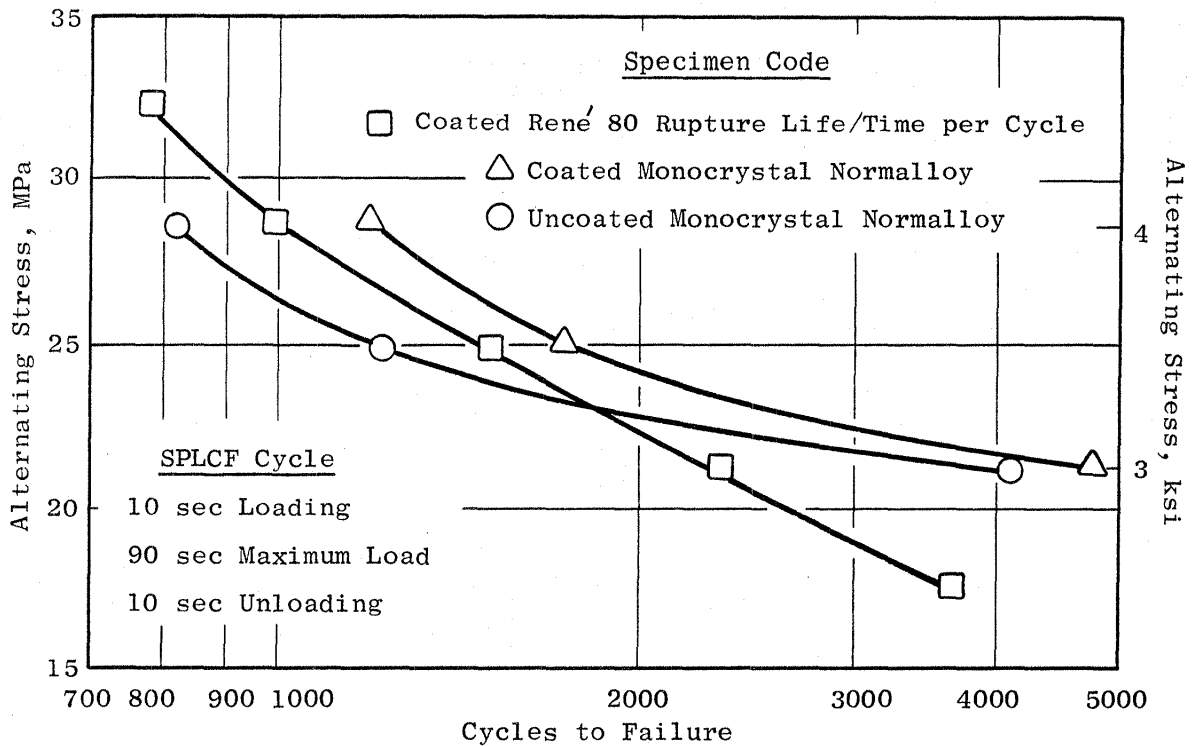
Figure 8. SPLCF Results for Bare and Codep-Coated Monocrystal Normalloy Compared to René 80.

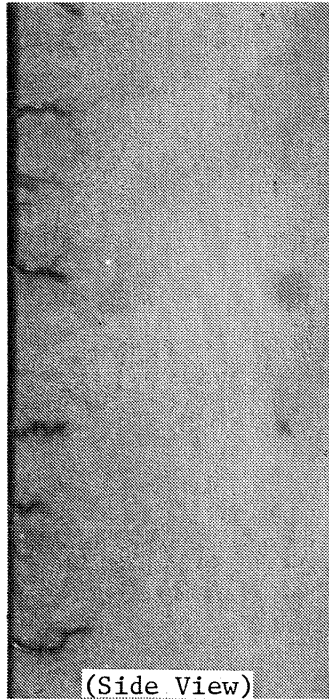
Conventionally Cast Rene' 80

Bare Monocrystal Normalloy

Figure 11. SETS Specimens at 740 Cycles.

cracked. All of the uncoated Normalloy specimens exhibited several small cracks. The René 80 specimens had several large cracks extending well into the specimen. Photographs showing the condition of the SETS specimens at 740 cycles are shown in Figure 11.

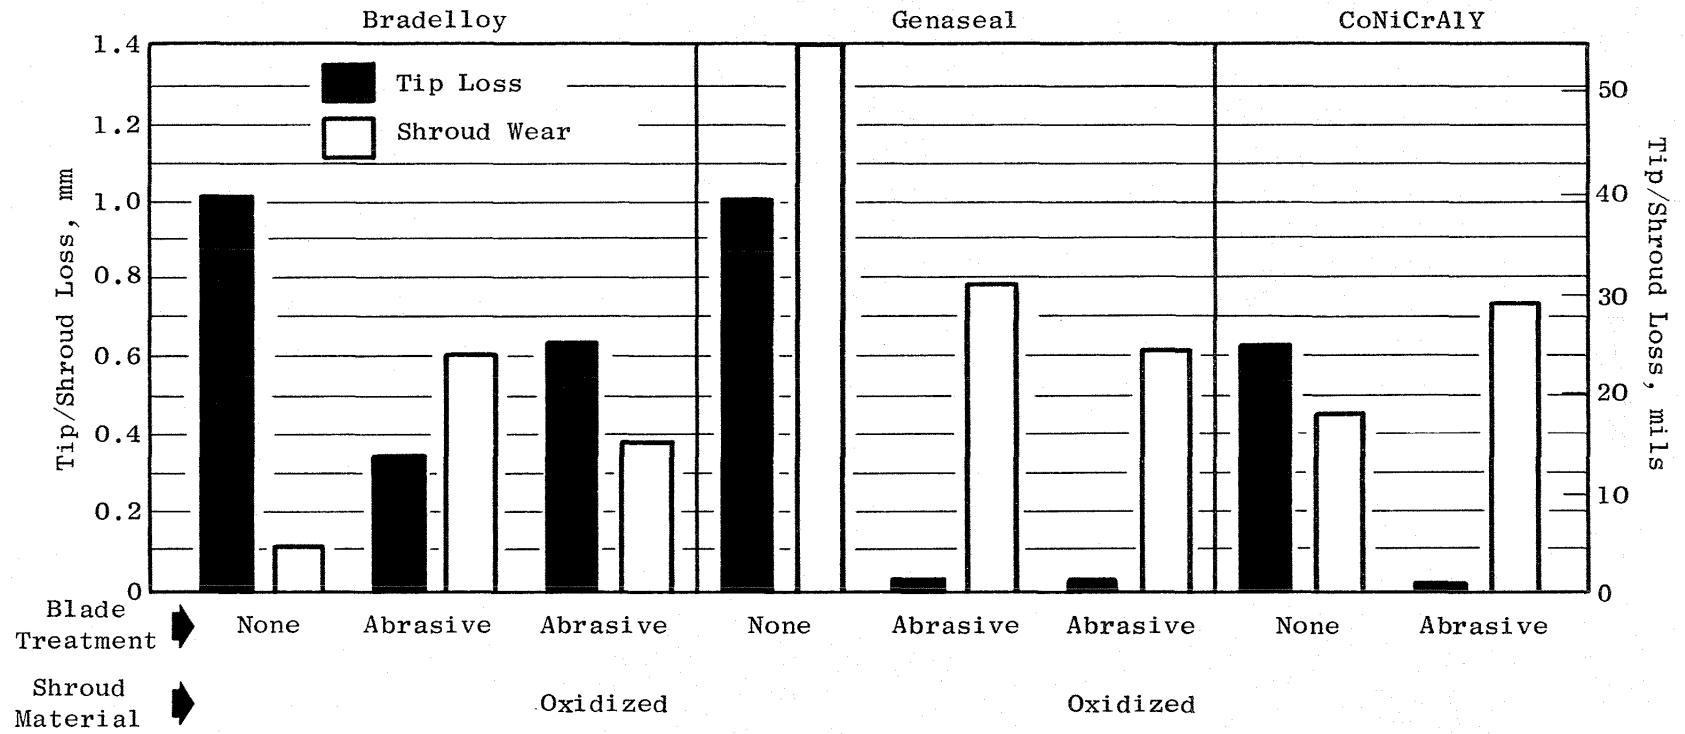
Figure 25. Summary of Wear-Test Results (About 60 Tests).

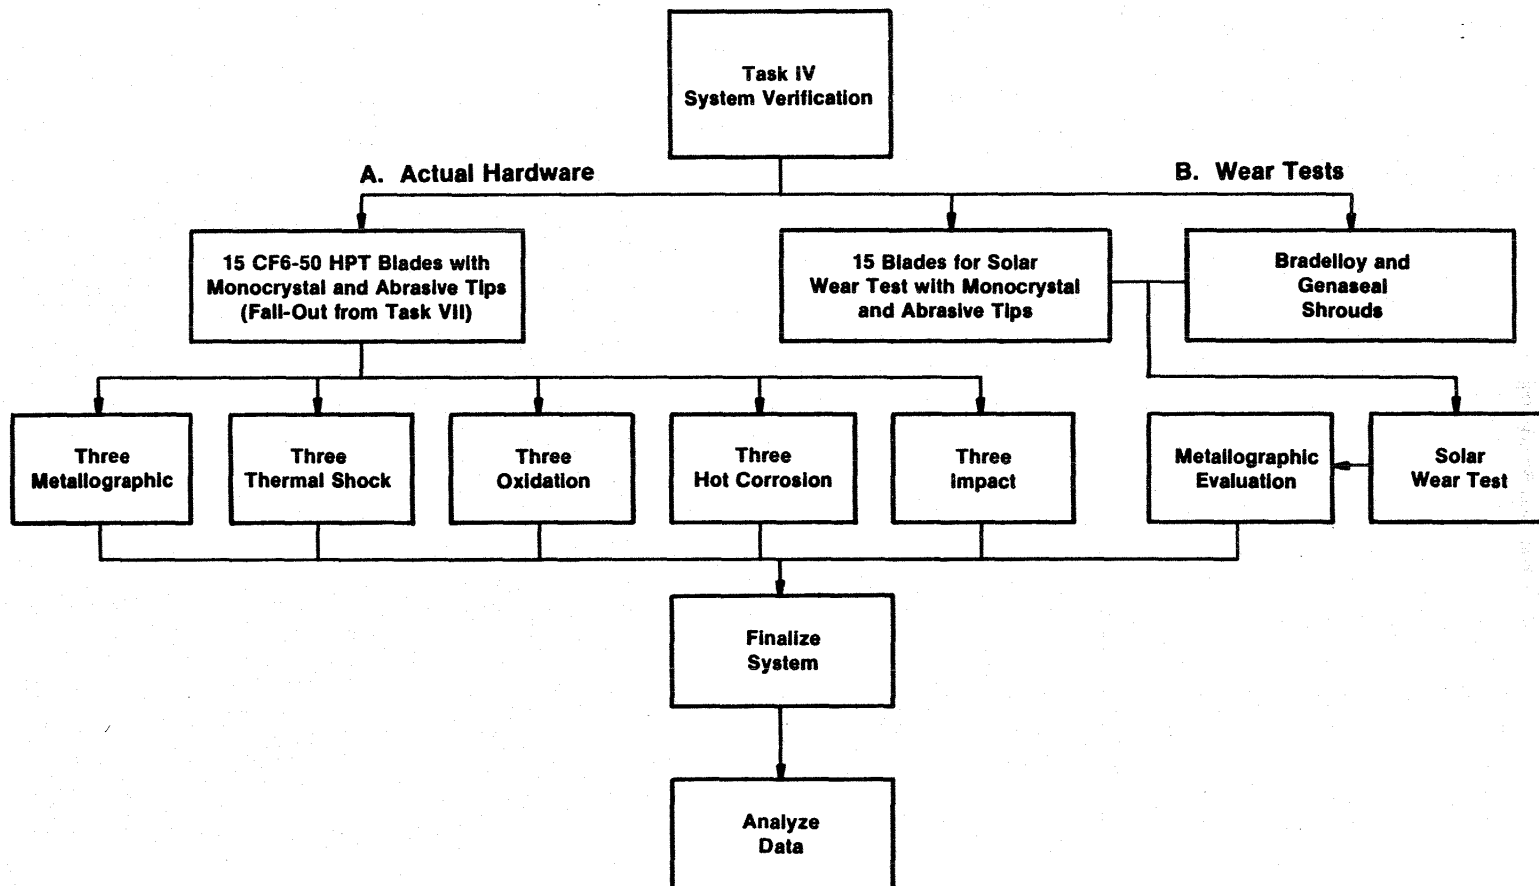
Figure 30. Test Plan for Seal System Verification.

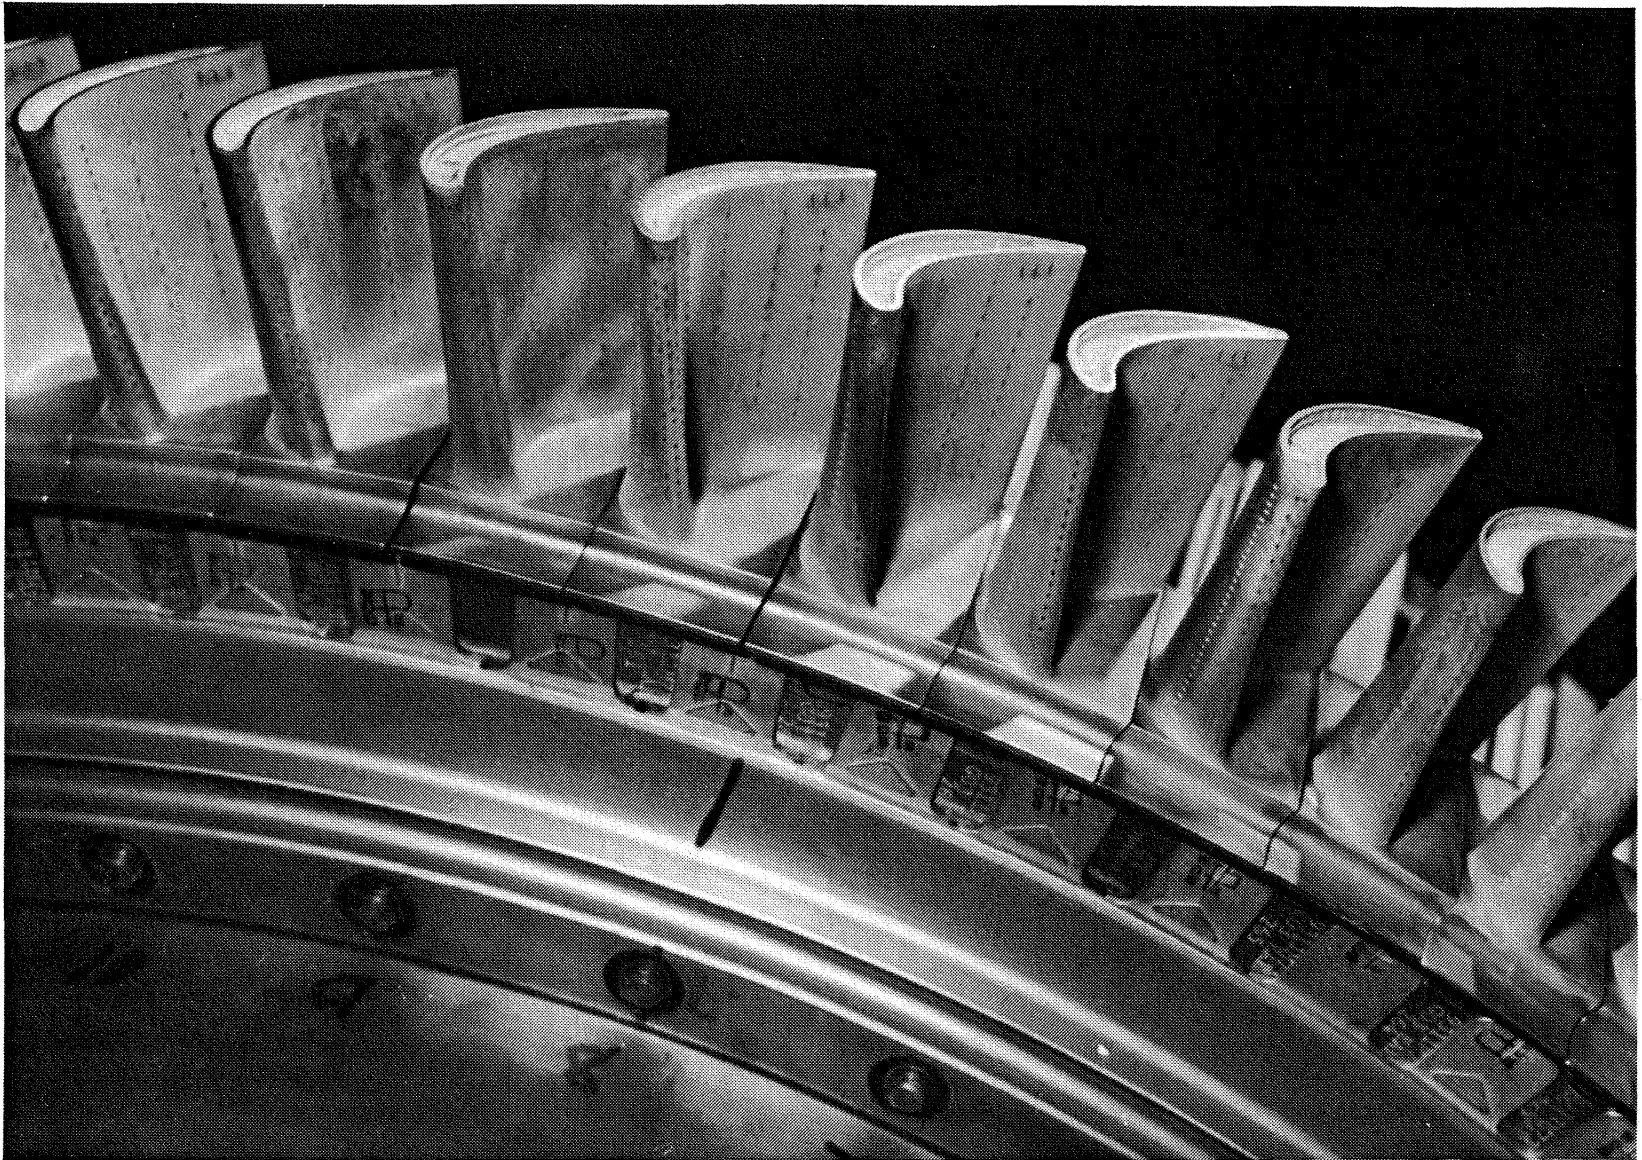
Figure 43. Turbine Blades, with the Advanced Tip System, Assembled into the Rotor.
45.
