ADVANCED GAS TURBINE (AGT) POWERTRAIN SYSTEM DEVELOPMENT PROGRAM

ELEVENTH MONTHLY
TECHNICAL PROGRESS REPORT
FOR THE PERIOD
AUGUST 1, 1980 THROUGH AUGUST 31, 1980

REPORT NO. 31-3480(11)
SEPTEMBER 26, 1980

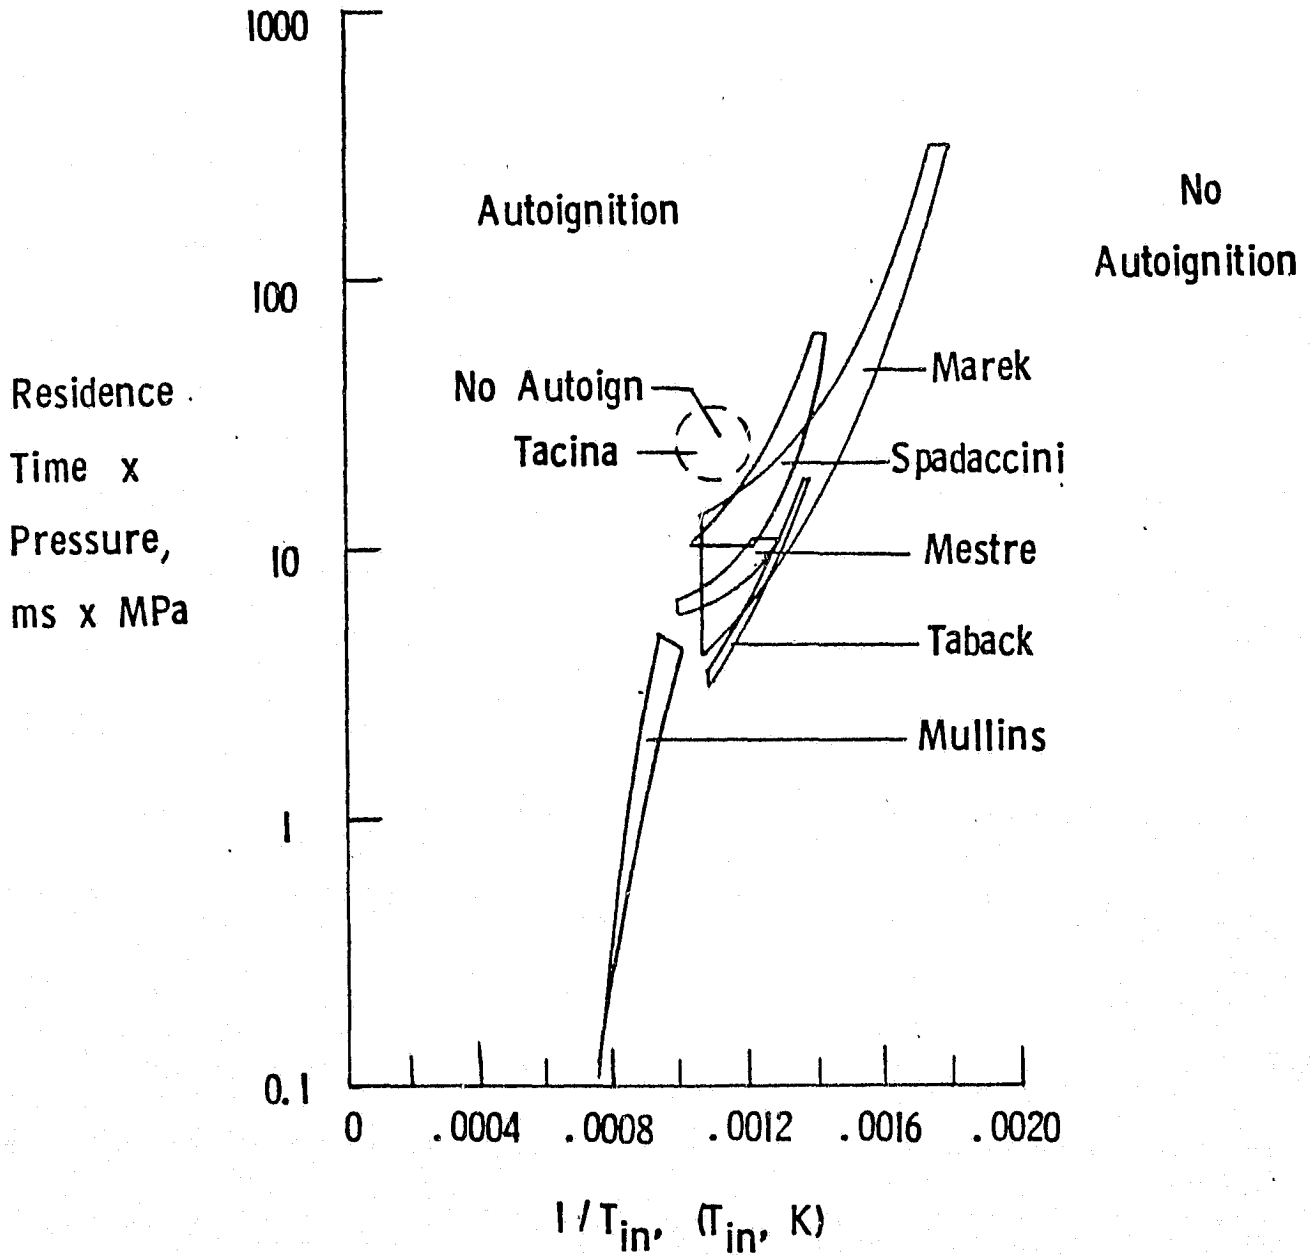
Test points for the autoignition rig were calculated based upon data presented at the "Premixed Pre vaporized Combustor Technology Forum" at NASA Lewis on January 9-10, 1979. (See Figure 2-2). A set of test points is shown in Table 2-1 where the calculated autoignition was based on Figure 2-2 data and test autoignition time is based on the inlet conditions to the test section, a 5.08 cm diameter test section, and a 30.48 cm long test section.

Figure 2-2. NASA Lewis Presented Autoignition Data.

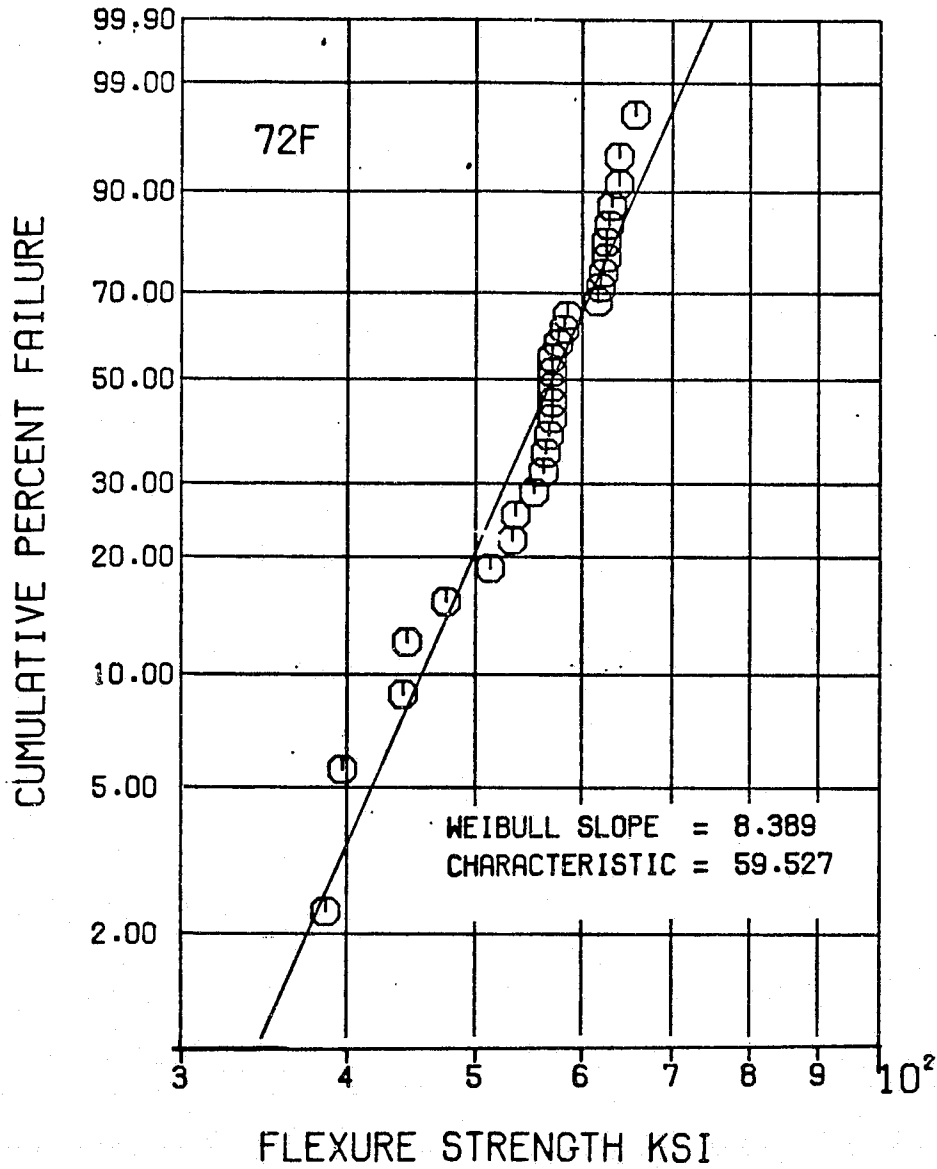
Figure 2-22. Weibull Plot for Cold-Pressed SASC After 4-Hour Oxidation in Air at 2500°F.

Included in Table 2-4 are data on a group of cold-pressed test bars which had been oxidized for 4 hours at 2500°F prior to testing at room temperature. Previous data have demonstrated the effectiveness of oxidation treatments in healing machining damage. Since components will be given an oxidation treatment prior to use, it seemed appropriate to determine the effect of oxidation on the properties of as-received test bars. As indicated in Table 2-4 and Figure 2-22, the oxidation treatment resulted in a minimal improvement in strength. Therefore, measurements on un-oxidized test bars are representative of the component materials.

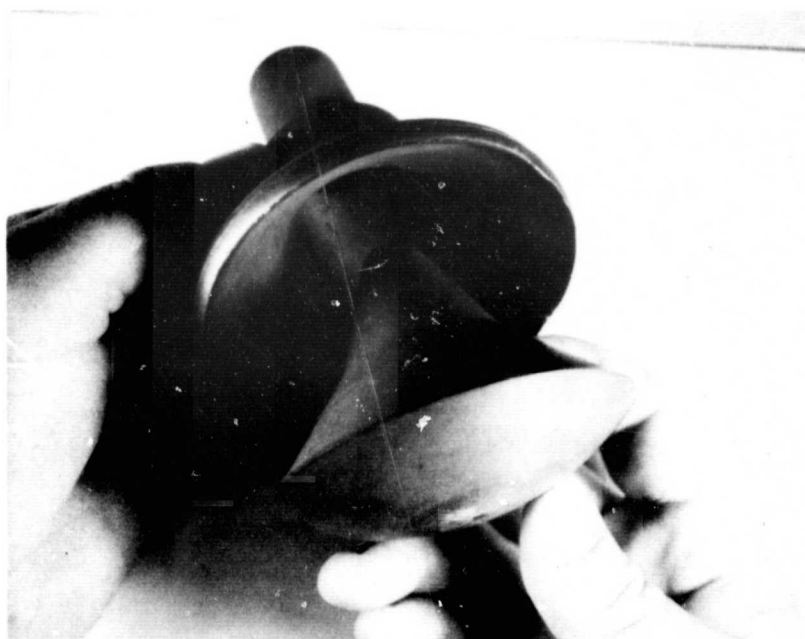
FIGURE 2: COMPONENT ASSEMBLY SCHEME FOR SIMULATED ROTOR

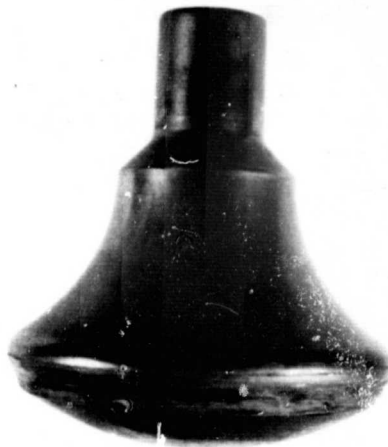
FIGURE 3: HOT PRESSED ROTOR ASSEMBLY D655-35

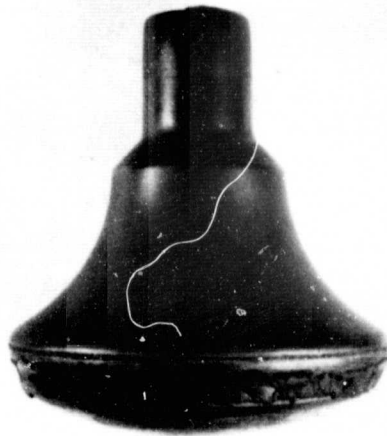
FIGURE 4: HOT PRESSED SIMULATED ROTOR WITH 3 SEGMENT CORE

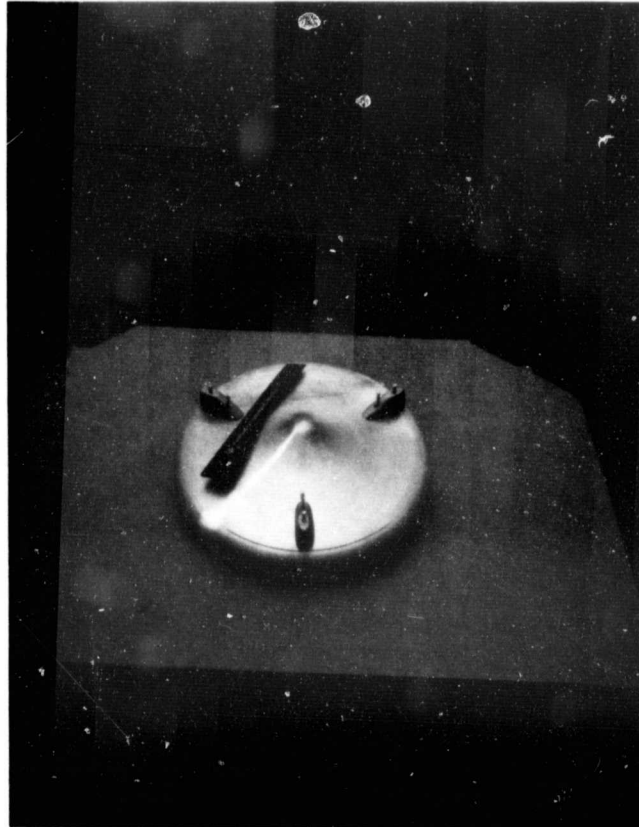
FIGURE 5: COMBUSTOR BAFFLE MODEL
