NASA CR-165556

CF6 JET ENGINE PERFORMANCE IMPROVEMENT: HIGH PRESSURE TURBINE ACTIVE CLEARANCE CONTROL

GENERAL ELECTRIC COMPANY

June 1982

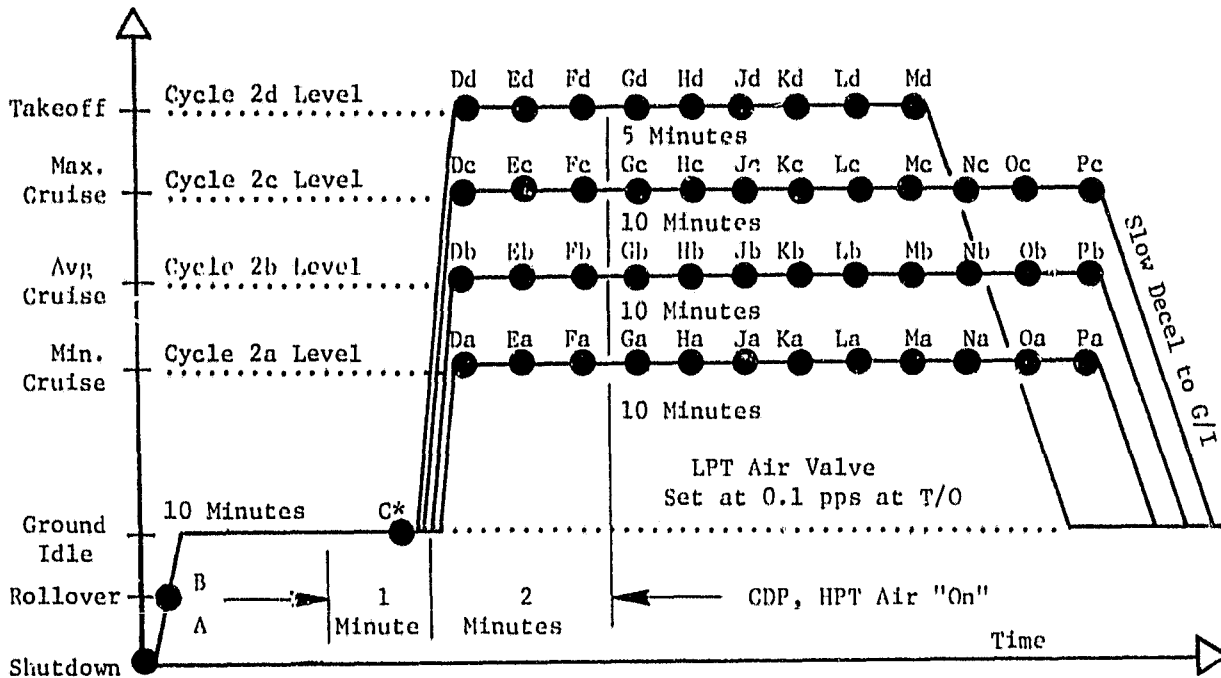
Figure 34. Ground Idle to Intermediate Power Thermal Test Cycle.

Cycle Point	Engine Time/Condition
A	- Engine Shutdown
B	- Engine Starting Rollover
C	- Steady-State Ground Idle for 10 Minutes
Dx	- Throttle Burst to 2x Power Level + 10 Seconds
Ex	- Throttle Burst to 2x Power Level + 25 Seconds
Fx	- Throttle Burst to 2x Power Level + 40 Seconds
Gx	- Throttle Burst to 2x Power Level + 60 Seconds
Hx	- Throttle Burst to 2x Power Level + 90 Seconds
Jx	- Throttle Burst to 2x Power Level + 130 Seconds
Kx	- Throttle Burst to 2x Power Level + 180 Seconds
Lx	- Throttle Burst to 2x Power Level + 240 Seconds
Mx	- Throttle Burst to 2x Power Level + 300 Seconds
Nx	- Throttle Burst to 2x Power Level + 400 Seconds
Ox	- Throttle Burst to 2x Power Level + 500 Seconds
Px	- Throttle Burst to 2x Power Level + 600 Seconds

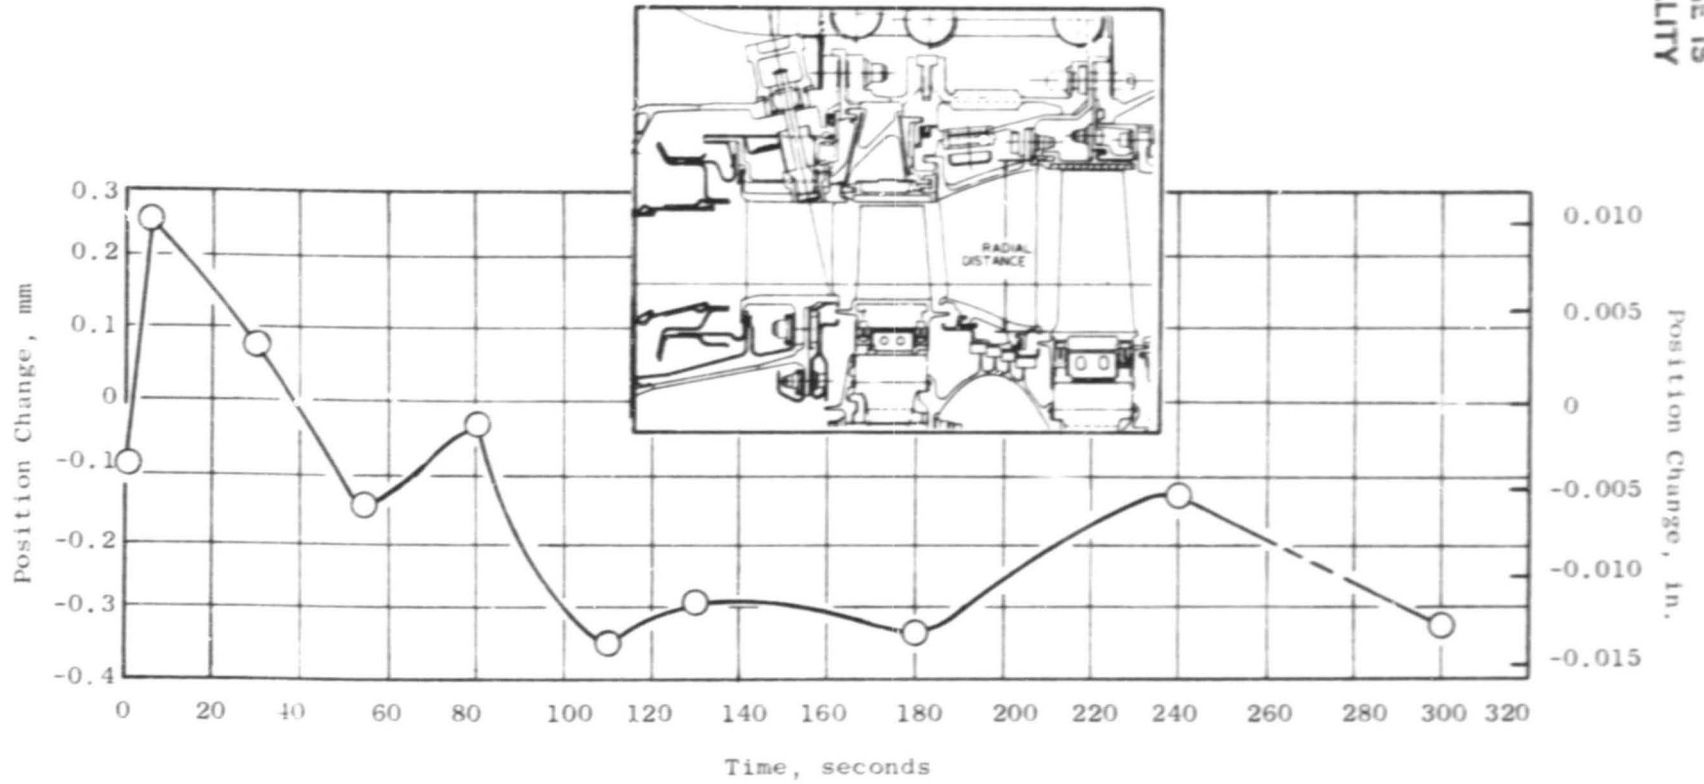
Figures 65 through 69 illustrate the results of the HEX testing. These figures represent the change in the distance between the measurement points relative to a cold rollover point. To obtain actual rotor/stator clearance requires that the blade growth be factored into the measured data.

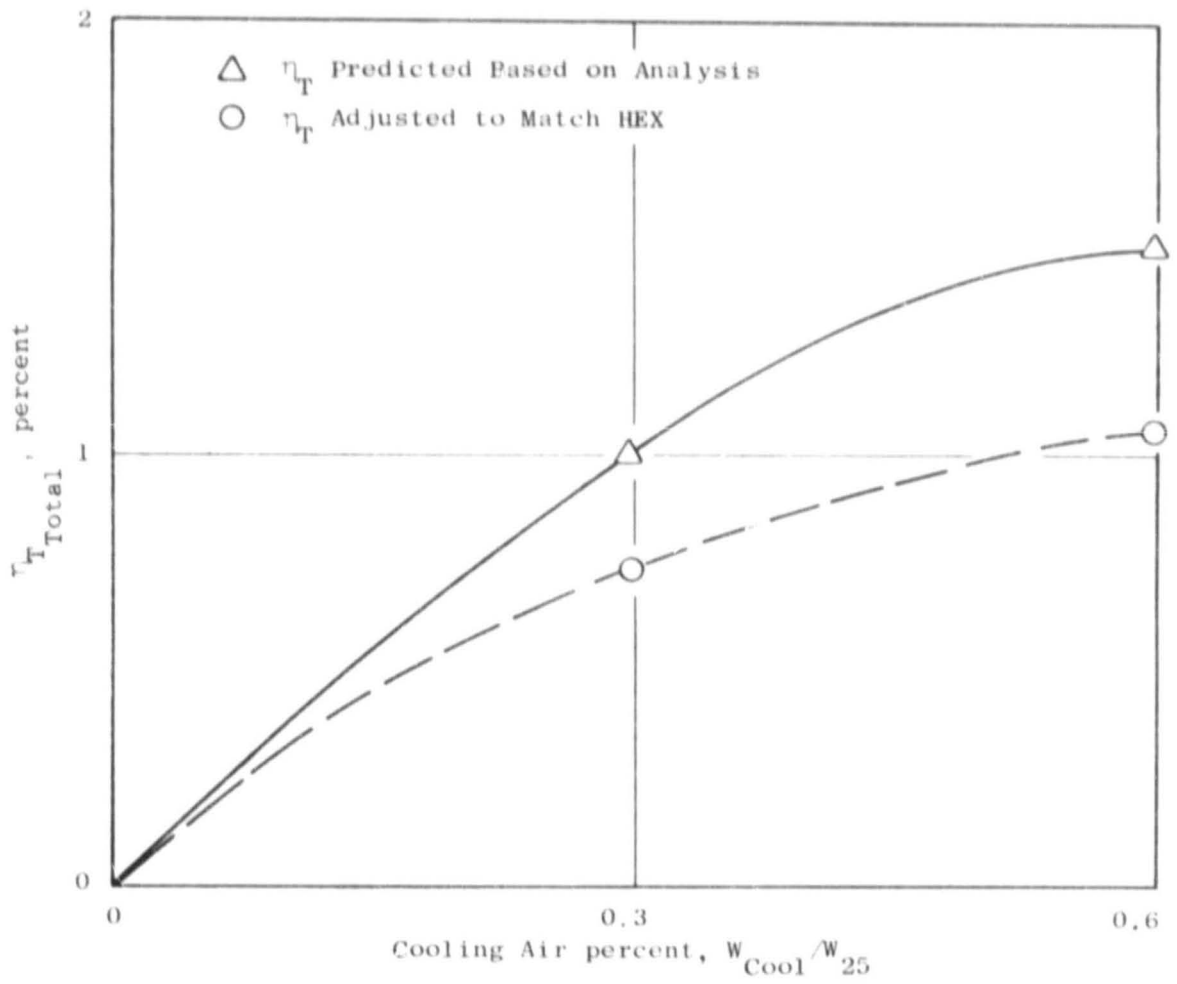
It should be noted that Figures 78 and 79 are closures based on match temperature data, and Figures 80 and 81 are predictions based on these analyses. Included on Figures 80 and 81 are turbine efficiency and sfc improvements based

The following method was used to estimate the sfc improvement at altitude cruise. A series of thermal analyses were completed using the engine altitude cycle conditions and the modified heat transfer coefficients determined from the temperature matching process. In completing these analyses, the assumptions were made that the heat transfer coefficient was a constant throughout the flight-regime. These temperatures were then imposed on the structural model, and a graph of Stage 1 and Stage 2 clearance reduction and turbine efficiency vs. cooling air was generated.
