# CHOPPER-CONTROLLED DISCHARGE LIFE CYCLING STUDIES ON LEAD-ACID BATTERIES

## FINAL REPORT

by Joseph J. Krami and Ernest P. Ames  
TRW SPACE AND TECHNOLOGY GROUP

APPENDIX A  
EV-106 LEAD-ACID BATTERY FAILURE NO. 16 (S/N 097)  
SAMPLE REPORT

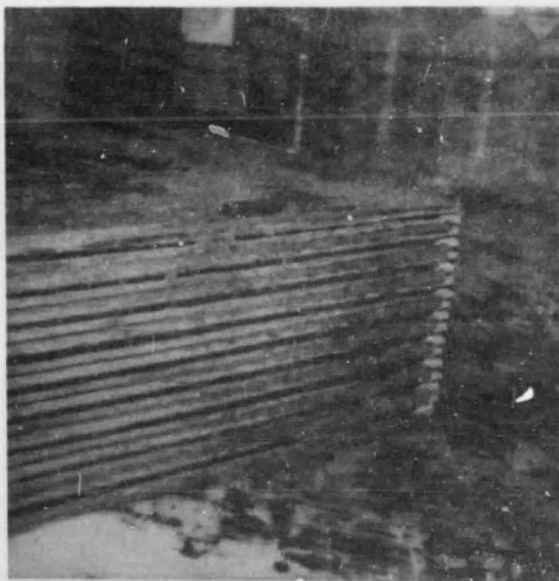
Figure 3. "Mossing" and "bridging" on one of the side surfaces of the element from cell No. 2.

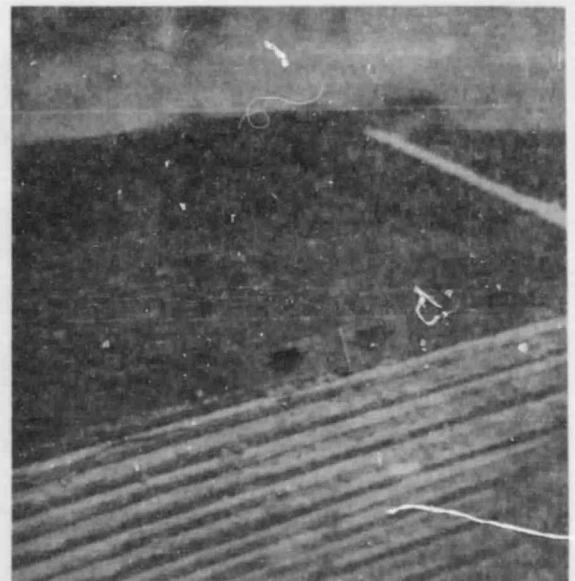
Figure 4. Negative active material beachheads on the positive plate (P-1) from cell No. 2.

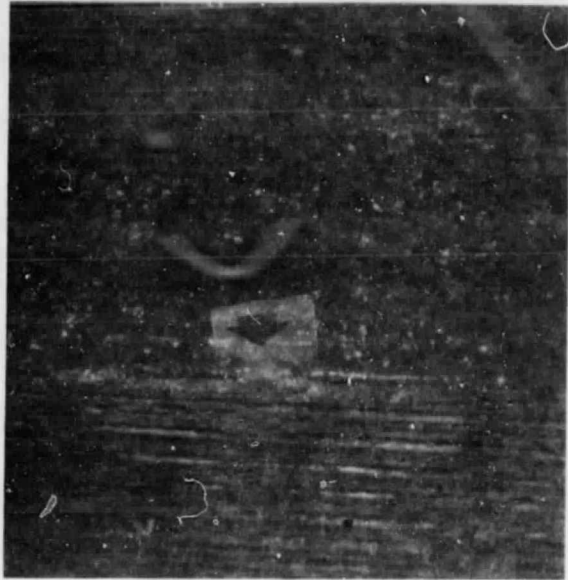
Figure 6. "Bridging" between positive and negative plates in cell No. 3.

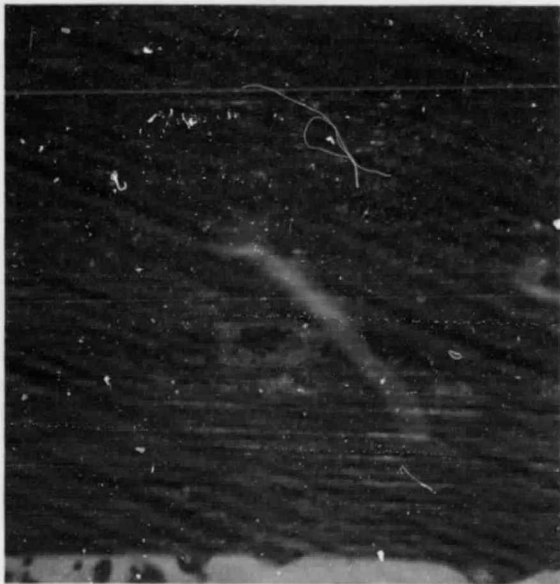
Figure 7. Top plates and separators removed to reveal more "bridging" in cell No. 3.

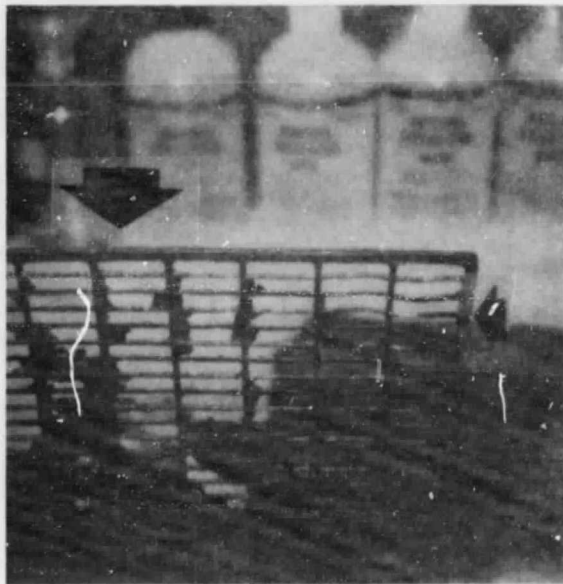
Figure 8. Spalling in plate (P-5) from cell No. 1.

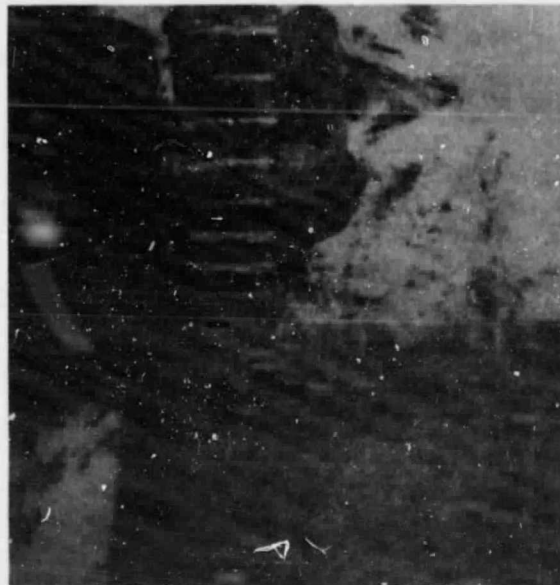
Visual inspection of the negative plates revealed the usual amount of material loss and plate shrinkage. This has also been observed in the plates from failed Battery S/N 070. One negative plate (N-7) from Cell No. 3 had a small portion of it missing, as shown in Figure 11. Part of the grid also disappeared, as shown in the same figure.

Figure 11. Moderate-size hole near tab in negative plate (N-7) from cell No. 3.

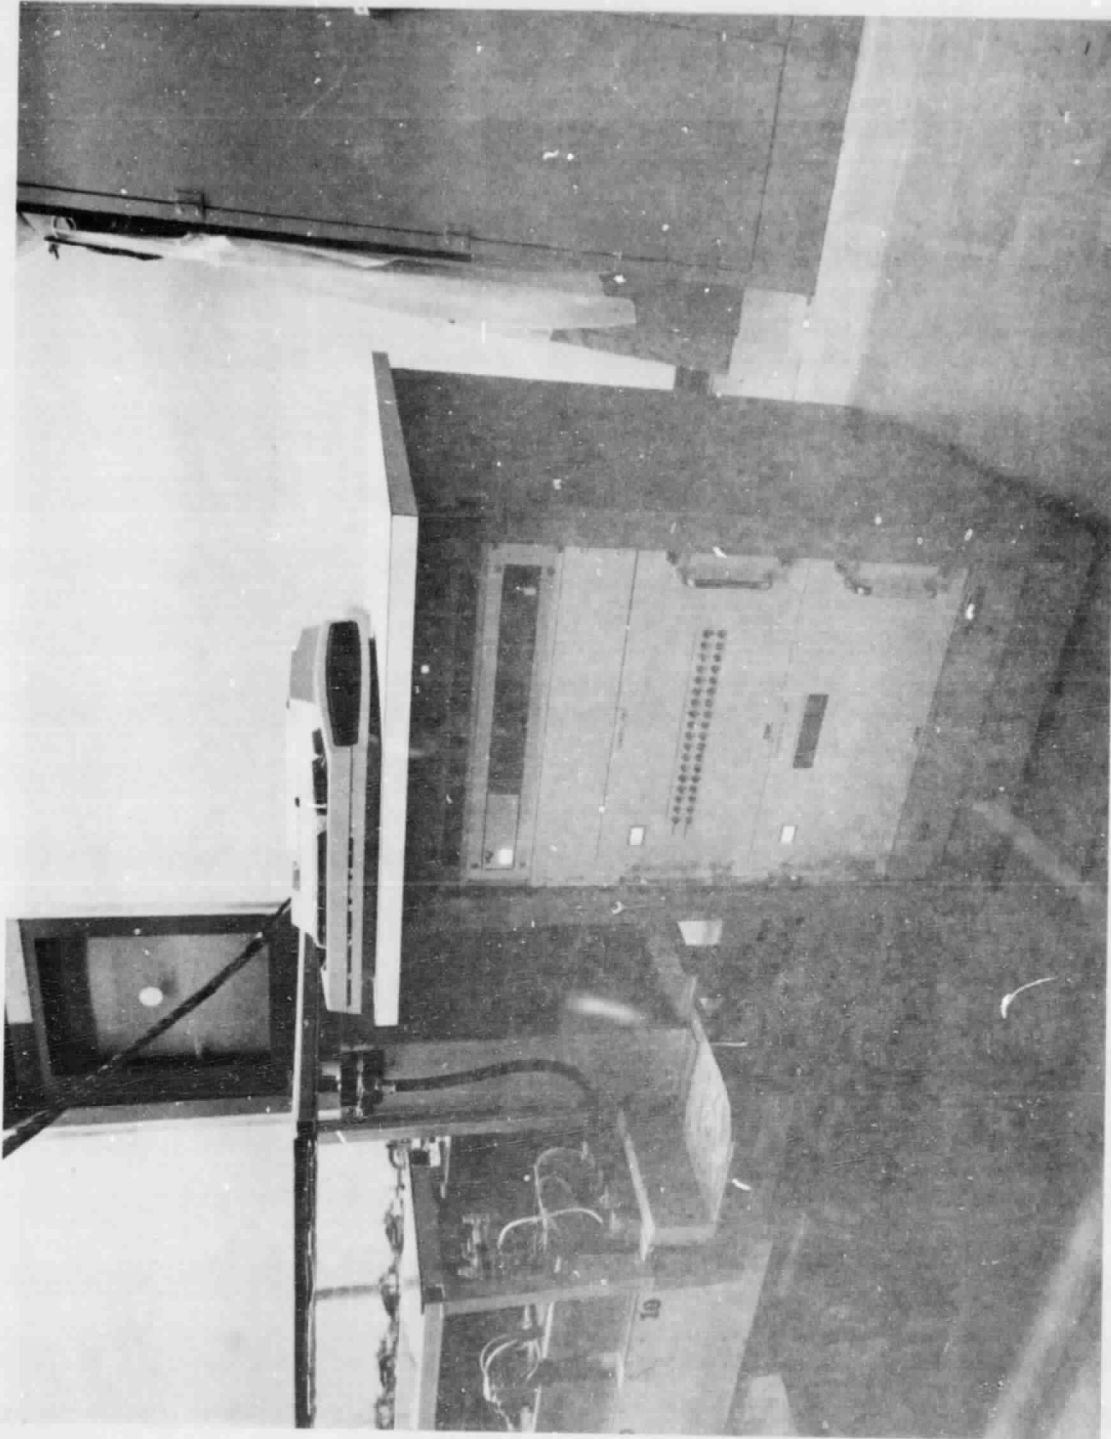
Figure 4. Test Data System, Microcomputer and Printer for System II

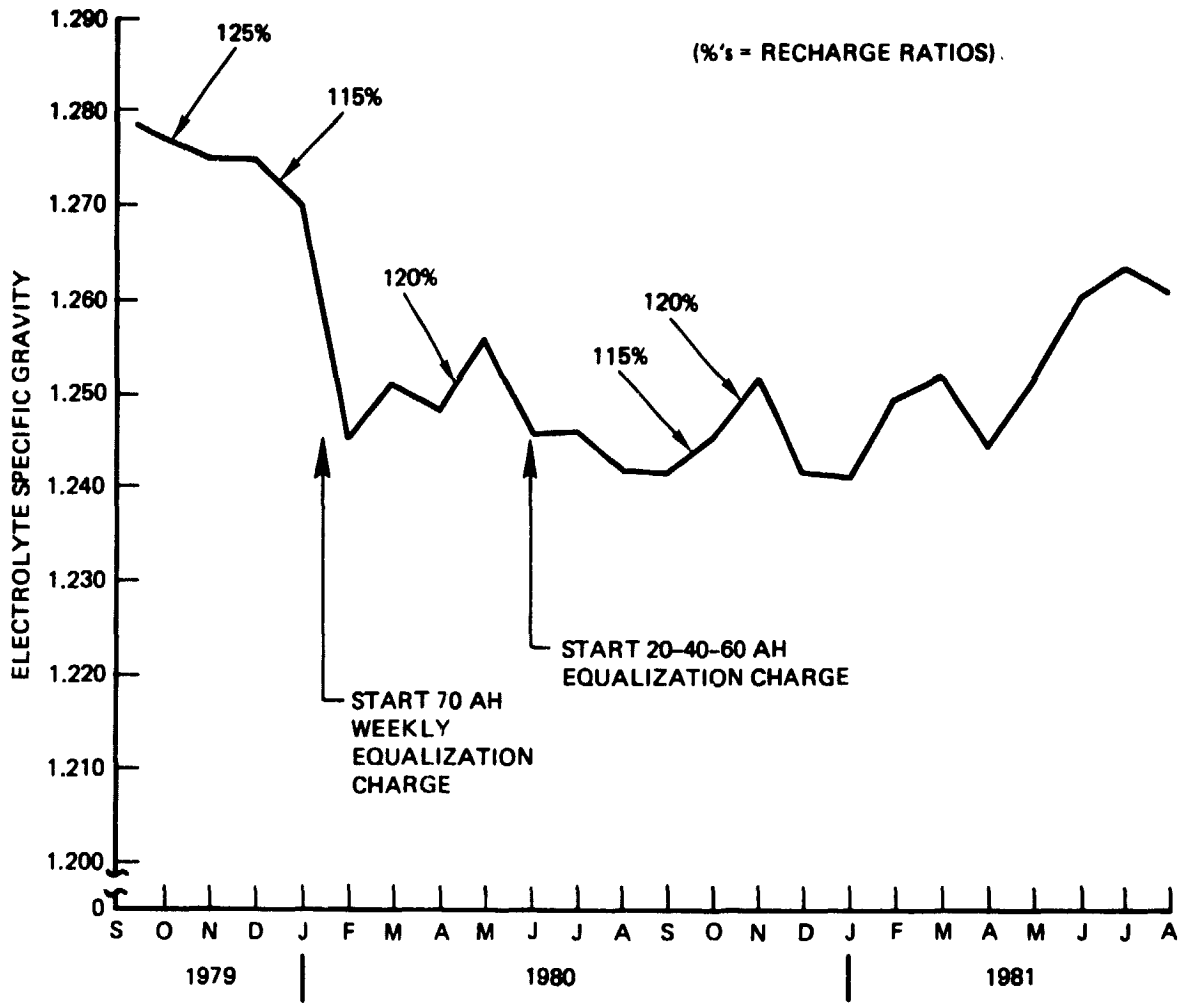
Figure 8. Specific Gravity Monthly Averages of all Test Batteries
