EBIC/TEM INVESTIGATIONS OF DEFECTS IN SOLAR SILICON RIBBON MATERIALS

Final Report

JPL Contract No. 954852

D.G.Ast

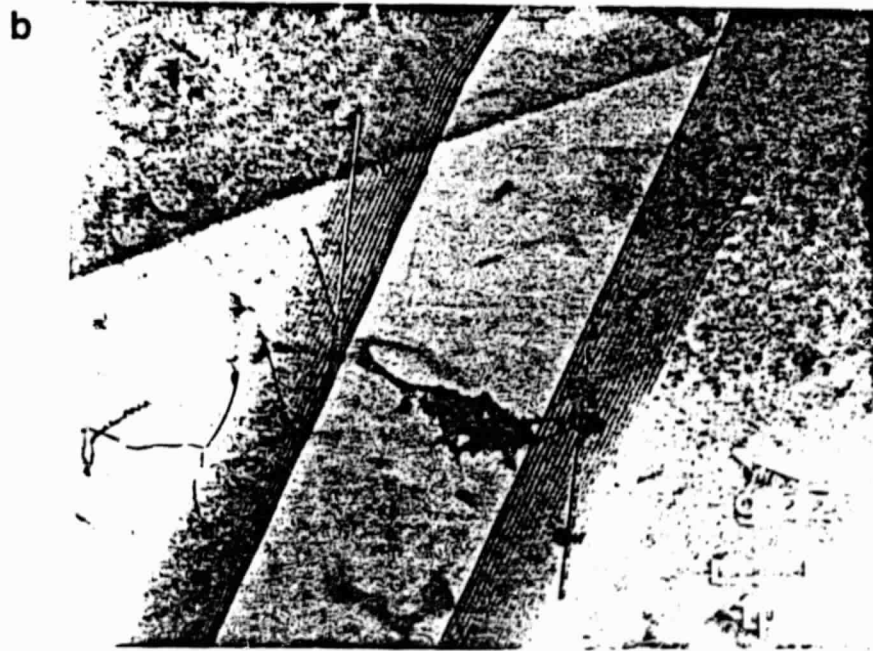
Figure 6 shows HVTEM micrographs of stacking faults connecting the two twin boundaries. The stacking faults are out of contrast in Figure 6(b) and the bounding dislocations can be seen. Although the overlapping fringes from the two faults makes it difficult to determine their nature it seems likely that one is intrinsic and one extrinsic. This arrangement preserves the stacking sequence on either side of the faults. Figure 7 is an EBIC micrograph of "pairs" of active defects along the twin boundary imaged in Figure 6. In view of the HVTEM results we propose that the "pairing" is caused by stacking faults between the twin planes and that the contrast is due to the active partials which bound these stacking faults.

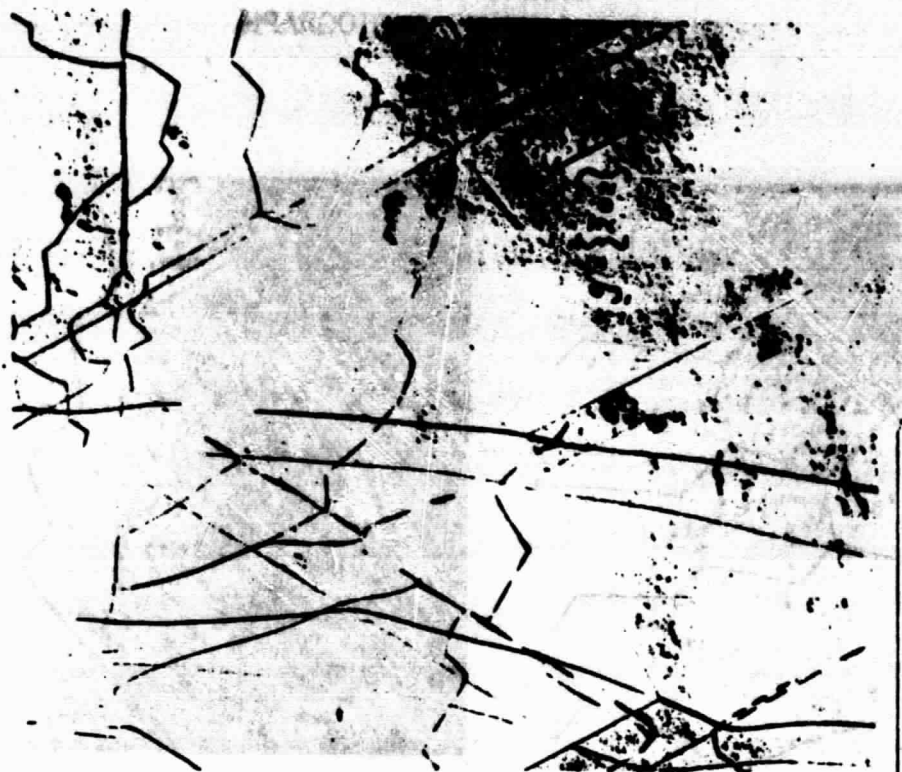
Fig. 10

and $\frac{1}{2}[1\bar{1}0]$, 30° . The diffraction vector in Figure 10(6) was chosen such that the partials were out of contrast. O'Hara and Schwuttke, using a large area scanning oscillator technique (SOT) identified the edge and 30° perfect dislocations but did not resolve the 60° partials. They also reported dislocations with Burgers vectors $[101]$ and $[110]$ type lying in the $[2\bar{1}\bar{1}]$ direction, although they also noted that such dislocations should not slip readily, as opposed to the ones reported above.
