NASA Technical Memorandum 82767

# Operational Performance of the Photovoltaic-Powered Grain Mill and Water Pump at Tangaye, Upper Volta

James E. Martz, Anthony F. Ratajczak,  
and Richard DeLombard  
*Lewis Research Center  
Cleveland, Ohio*

February 1982

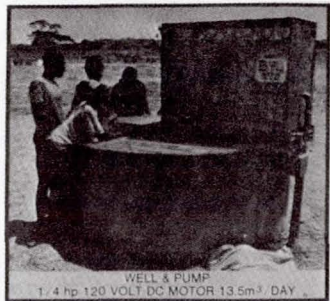
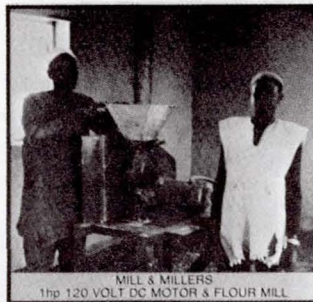
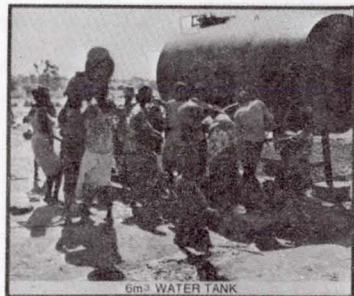
FIGURE 2.

A block diagram of the system is shown in Figure 1 and pictures showing various aspects of the system are shown in Figure 2. Additional general information relative to the system as well as the overall project is given in references 1 through 3.

TANGAYE VILLAGE SOLAR ELECTRIC SYSTEM

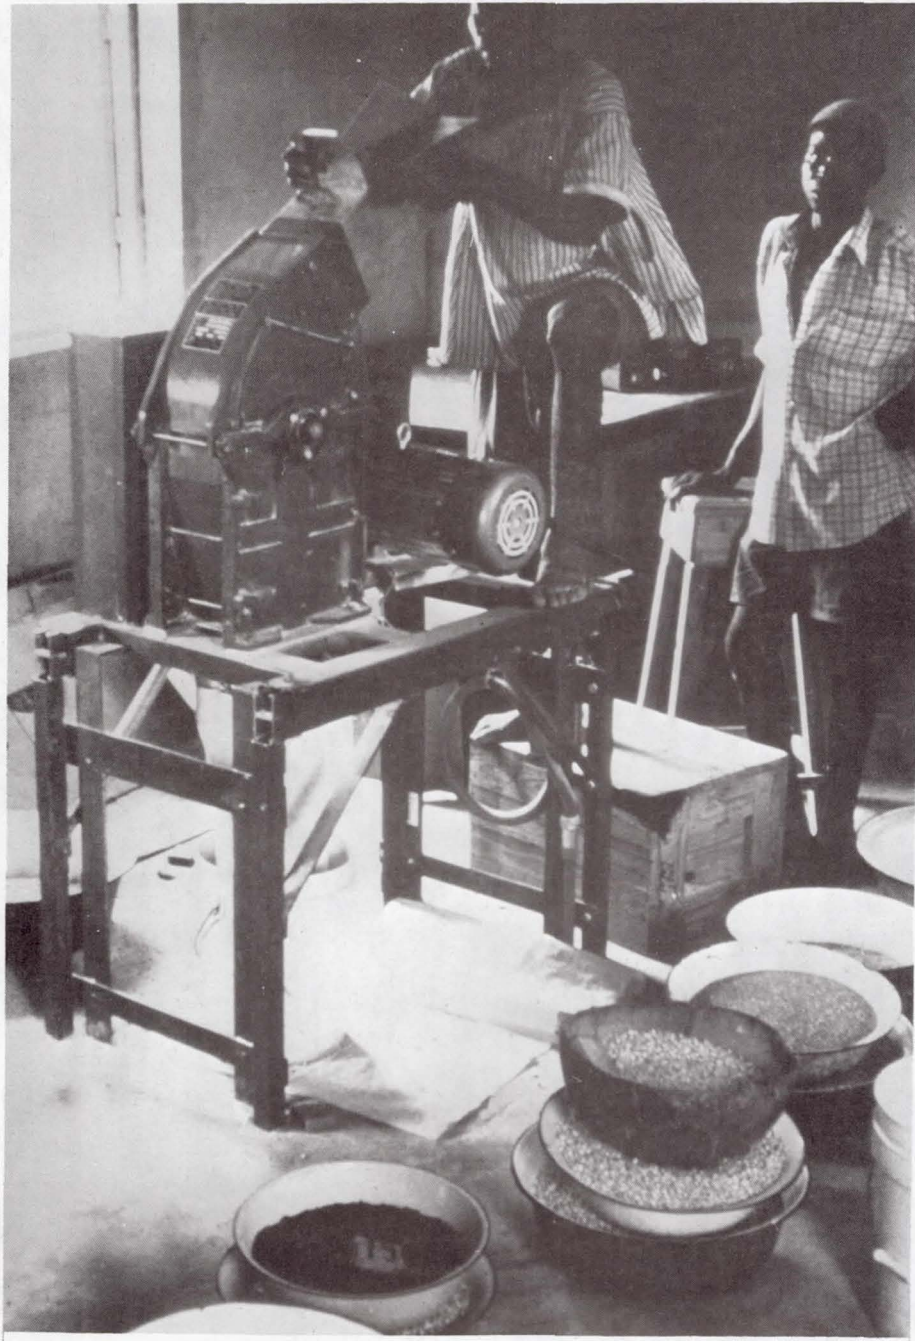
BELL MODEL #10 HAMMERMILL  
FIGURE 3

The hammermill and motor were shipped to Upper Volta in July 1979 and installed by LeRC personnel in September 1979 (Figure 3). Except for an initial minor seal erosion problem which allowed some unground grain to enter the flour and which has since been remedied, the mill has performed satisfactorily since its installation. An unexpected benefit of this mill to the women is the fact that it will grind the grain without first removing the hulls. This capability relieves the women of the chore of dehulling the grain which they would otherwise need to do before hand grinding or before milling in the diesel-driven stone (burr type) mills commonly used in Upper Volta.

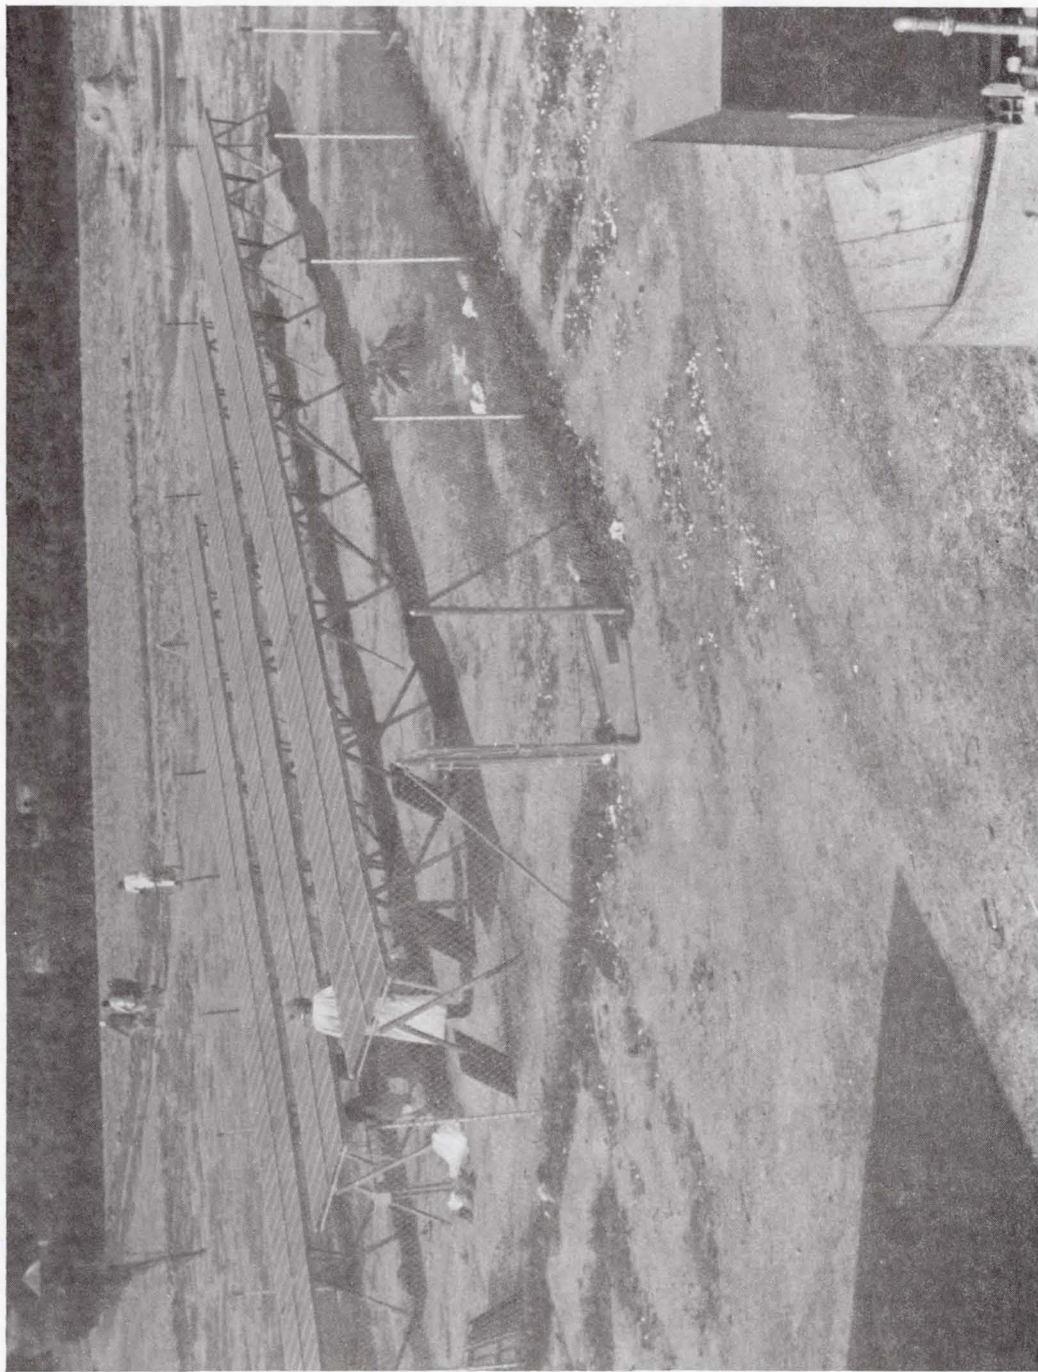
FIGURE 5. - TANGAYE PV ARRAY  
EXPANDED TO 3.6 Kw Pk.  
MAY 1981

Upon identification of the failure mode, modules obtained under the JPL-LSA project from a different manufacturer and of a different design were evaluated and tested as possible replacements for the original Tangaye modules. These replacement modules were selected on the basis of design, operational history in another LeRC system, and their ability to replace the original modules without major system modifications. A sufficient number of suitable modules were found in the LeRC/DOE inventory to replace the original modules and to double the array size to 3.6 kW peak to increase allowable milling time to the range of 48 to 56 hours per week. These modules were made available to this project by the DOE and were installed in May of 1981 (Figure 5).

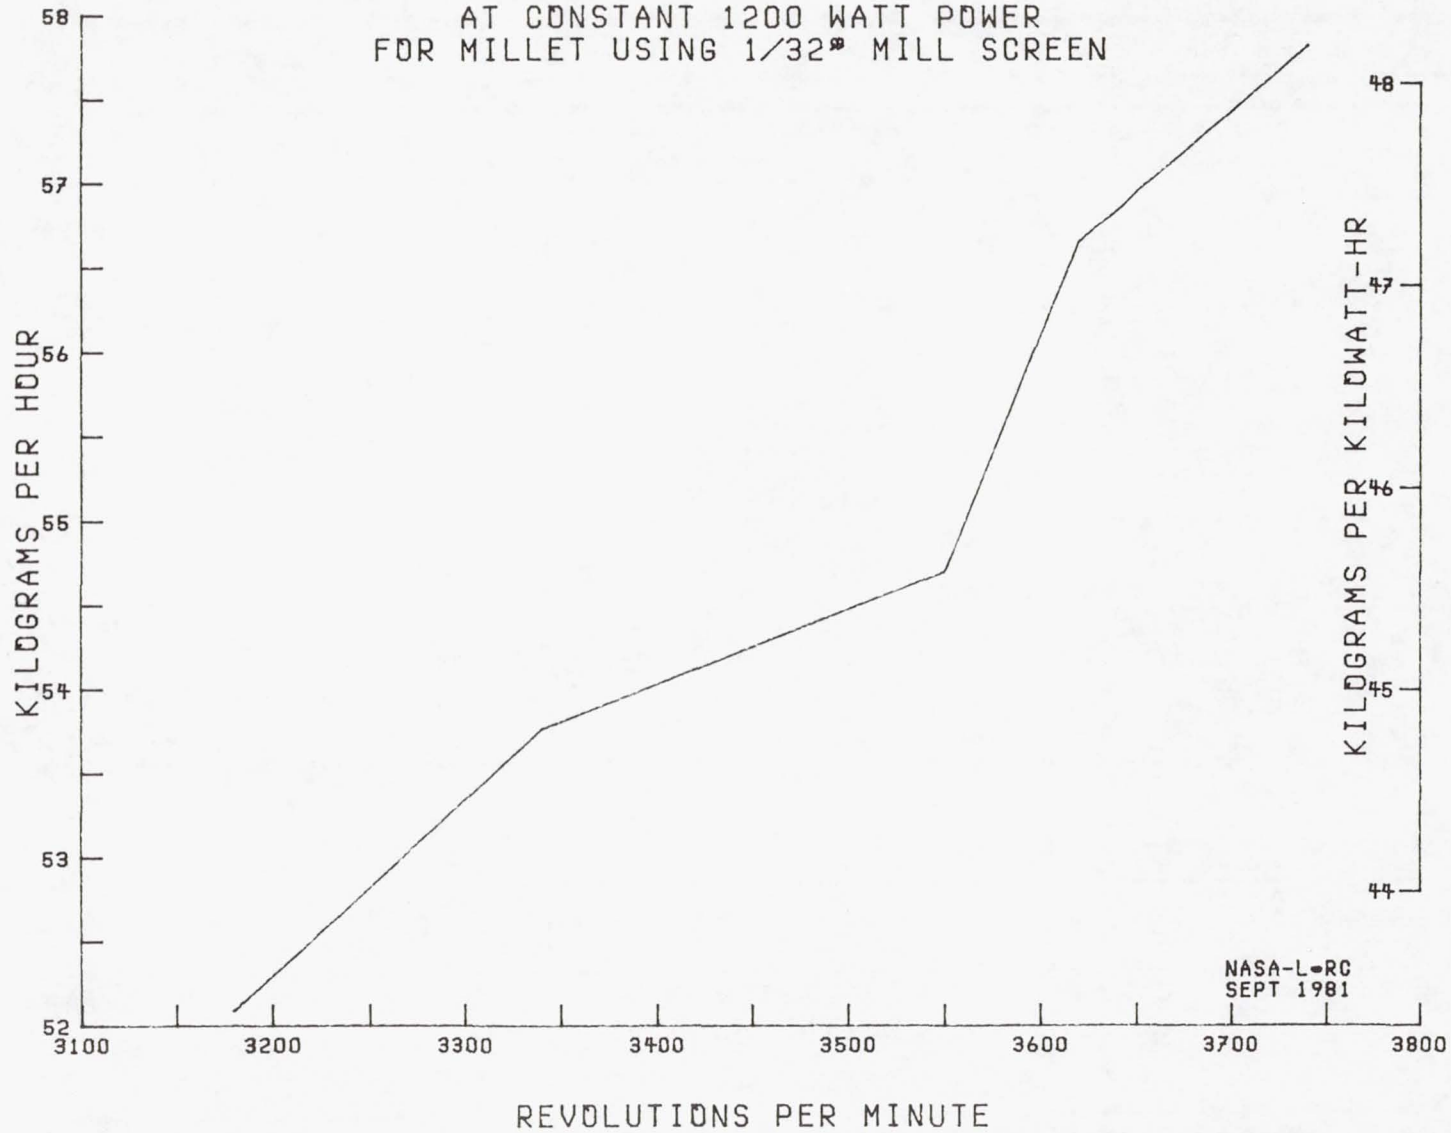
Figure 4.

EFFECT OF RPM ON THROUGHPUT  
AT CONSTANT 1200 WATT POWER  
FOR MILLET USING 1/32" MILL SCREEN
