NASA CR-165234  
PWA 5642-21

# TAILORED PLASMA SPRAYED MCrAlY COATINGS FOR AIRCRAFT GAS TURBINE APPLICATIONS

UNITED TECHNOLOGIES CORPORATION  
PRATT & WHITNEY AIRCRAFT  
COMMERCIAL PRODUCTS DIVISION

January 1981

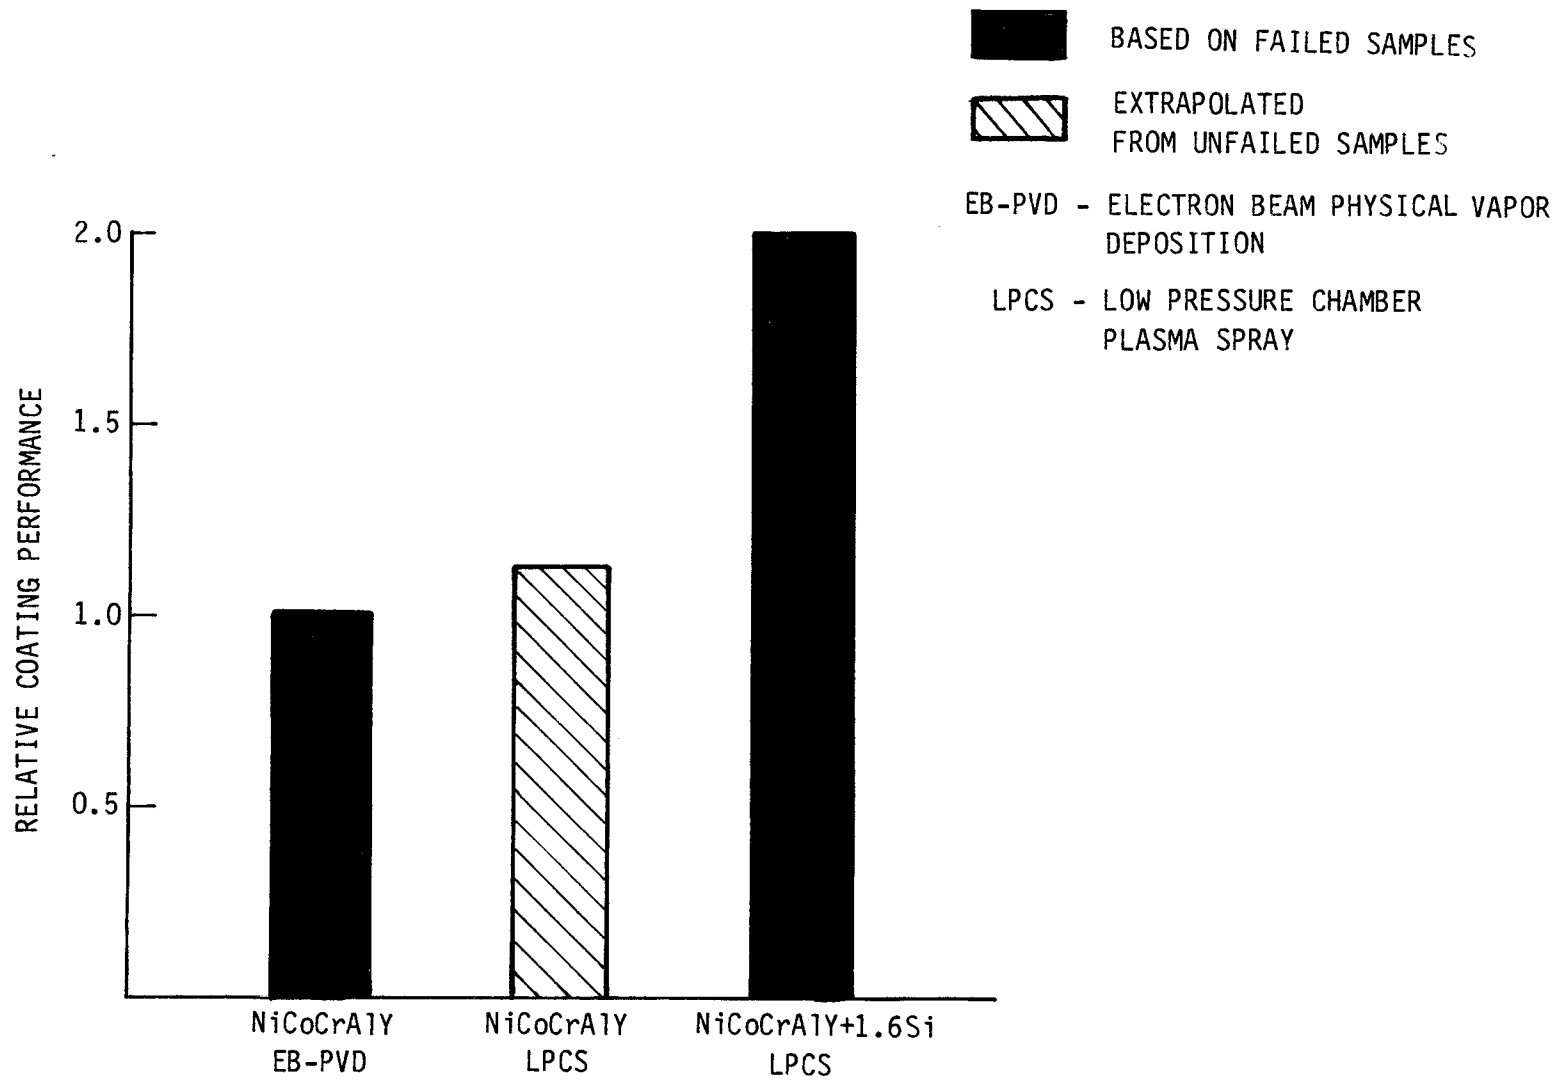
Figure 1 1394<sup>o</sup>K (2050<sup>o</sup>F) Burner Rig Life Results of Various NiCoCrAlY Based Coatings on the Single Crystal Alloy.

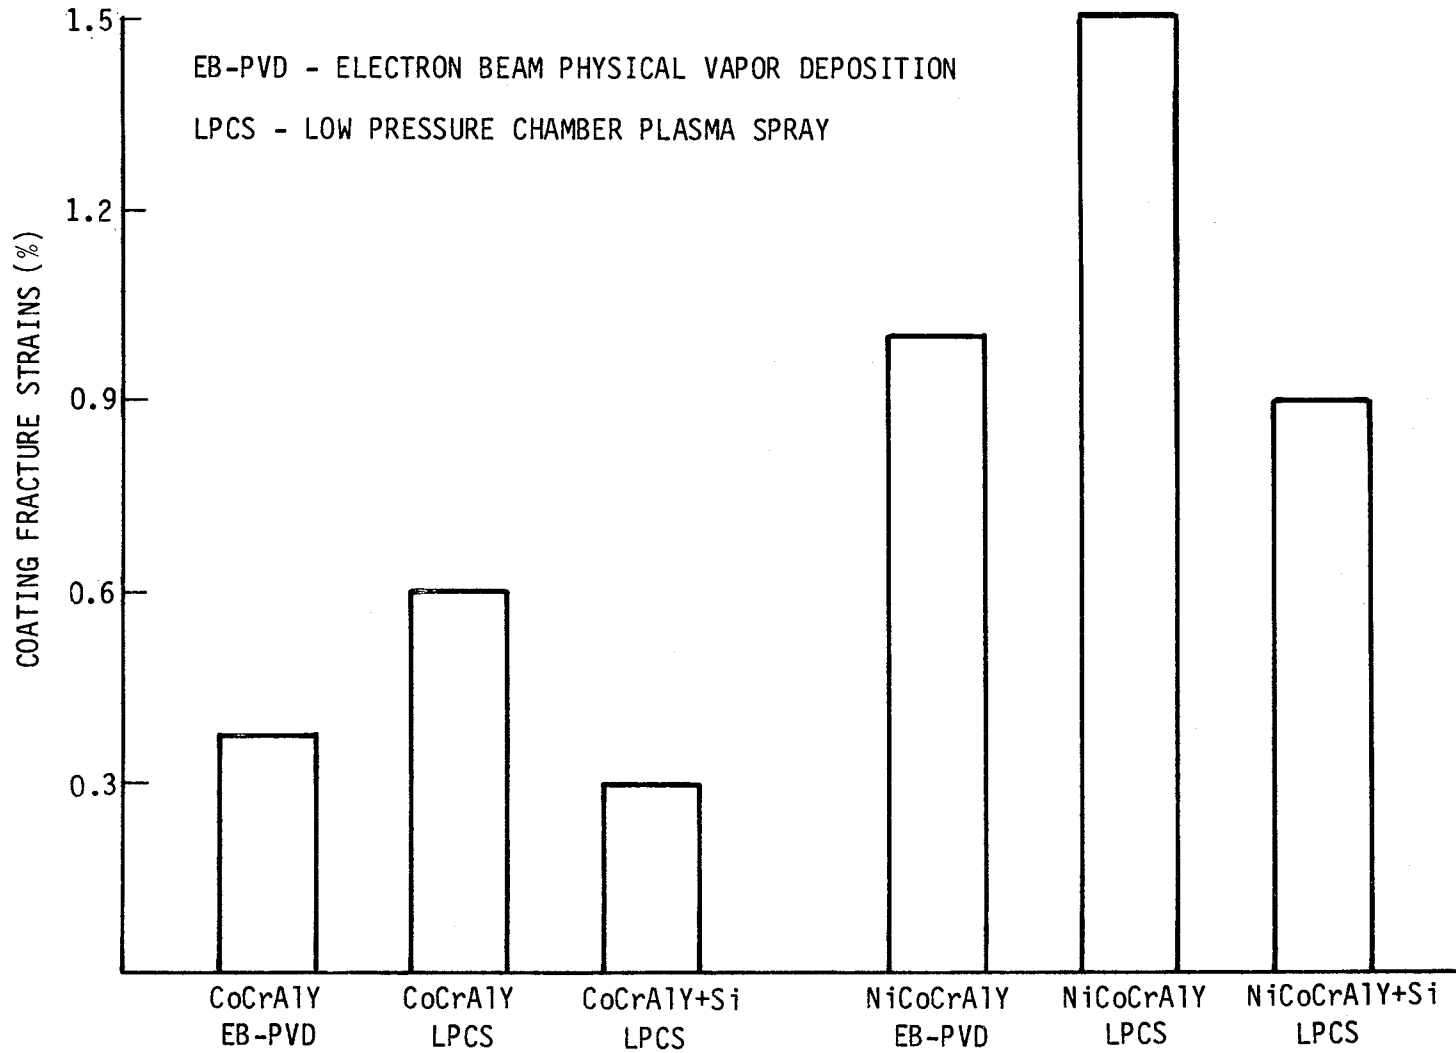
Figure 3 588°K (600°F) Coating Ductility Test Results on Coated B1900+Hf Alloy Samples.

Tensile ductility tests conducted at 588<sup>0</sup>K (600<sup>0</sup>F) indicated that low pressure chamber sprayed NiCoCrAlY and CoCrAlY coatings provide fracture strains superior to those of similar composition vapor deposited coatings. This behavior, which is illustrated in Figure 3, may be related to the difference in structural features such as grain orientation and defect characteristics present in coatings produced by these two processes. Figure 3 also shows the ductility of NiCoCrAlY+Si and CoCrAlY+Si coatings. Test data and coating beta (NiAl,CoAl) phase analysis showed that an increase in the amount of beta present in a coating results in a reduction of ductility. Silicon and tantalum additions to the MCrAlY coatings increase the stability of the beta phase. This increase in beta concentration (for the same value of aluminum present in the coating) reduces coating ductility. However, low pressure chamber plasma sprayed NiCoCrAlY+1.6Si and CoCrAlY+2.0Si coatings exhibited fracture strains which appear equivalent to those of the baseline vapor deposited NiCoCrAlY and CoCrAlY coatings respectively.

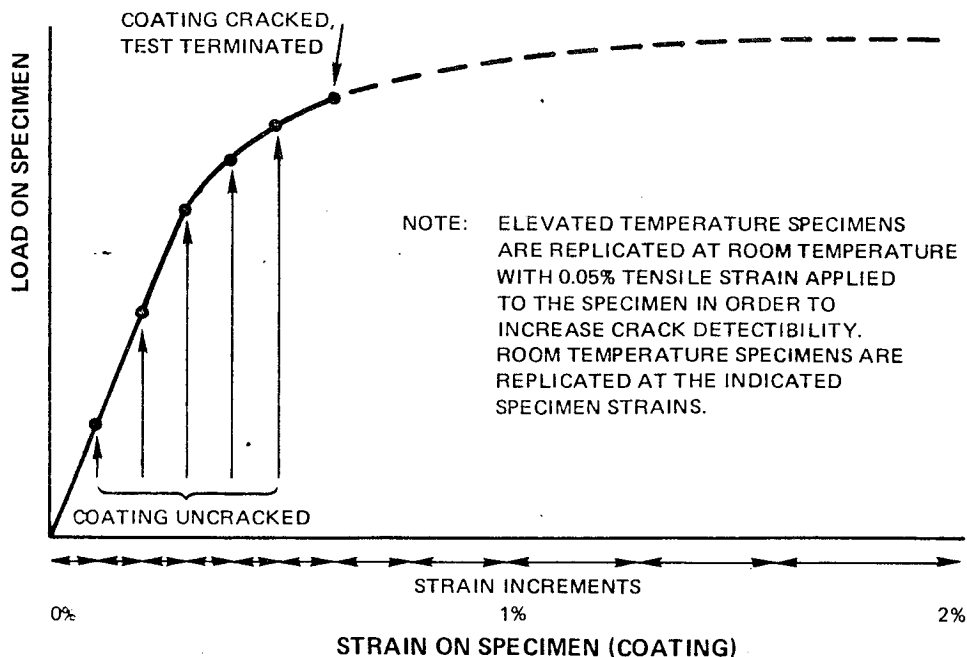
Figure 12 Procedure for Interrupted Tensile Coating Ductility Test. Large coated areas can be evaluated in this test

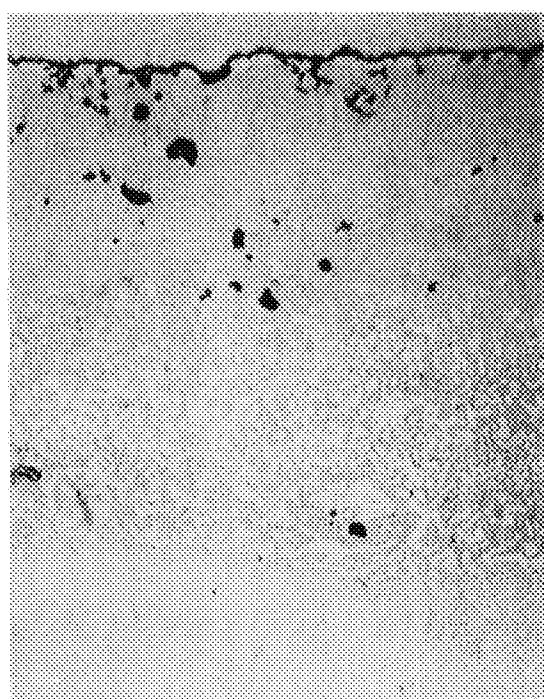
Figure 21

CoCrAlY + Si 400X

CoCrAlY (High Cr, Low Al) 400X

CoCrAlY + HIP 400X

Pre-Test Microstructures of Low Pressure Chamber Sprayed  
CoCrAlY-Type Coatings With Modified Composition/Processes.  
HIP = Hot Isostatic Pressing

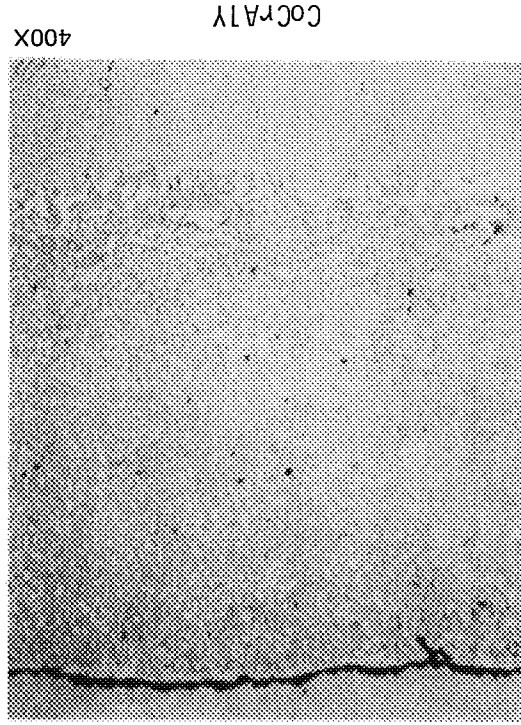
Pre-Test Microstructures of Low Pressure Chamber Sprayed  
CoCrAlY-Type Coatings on B-1900+Hf Alloy After Post-Coating  
Processing

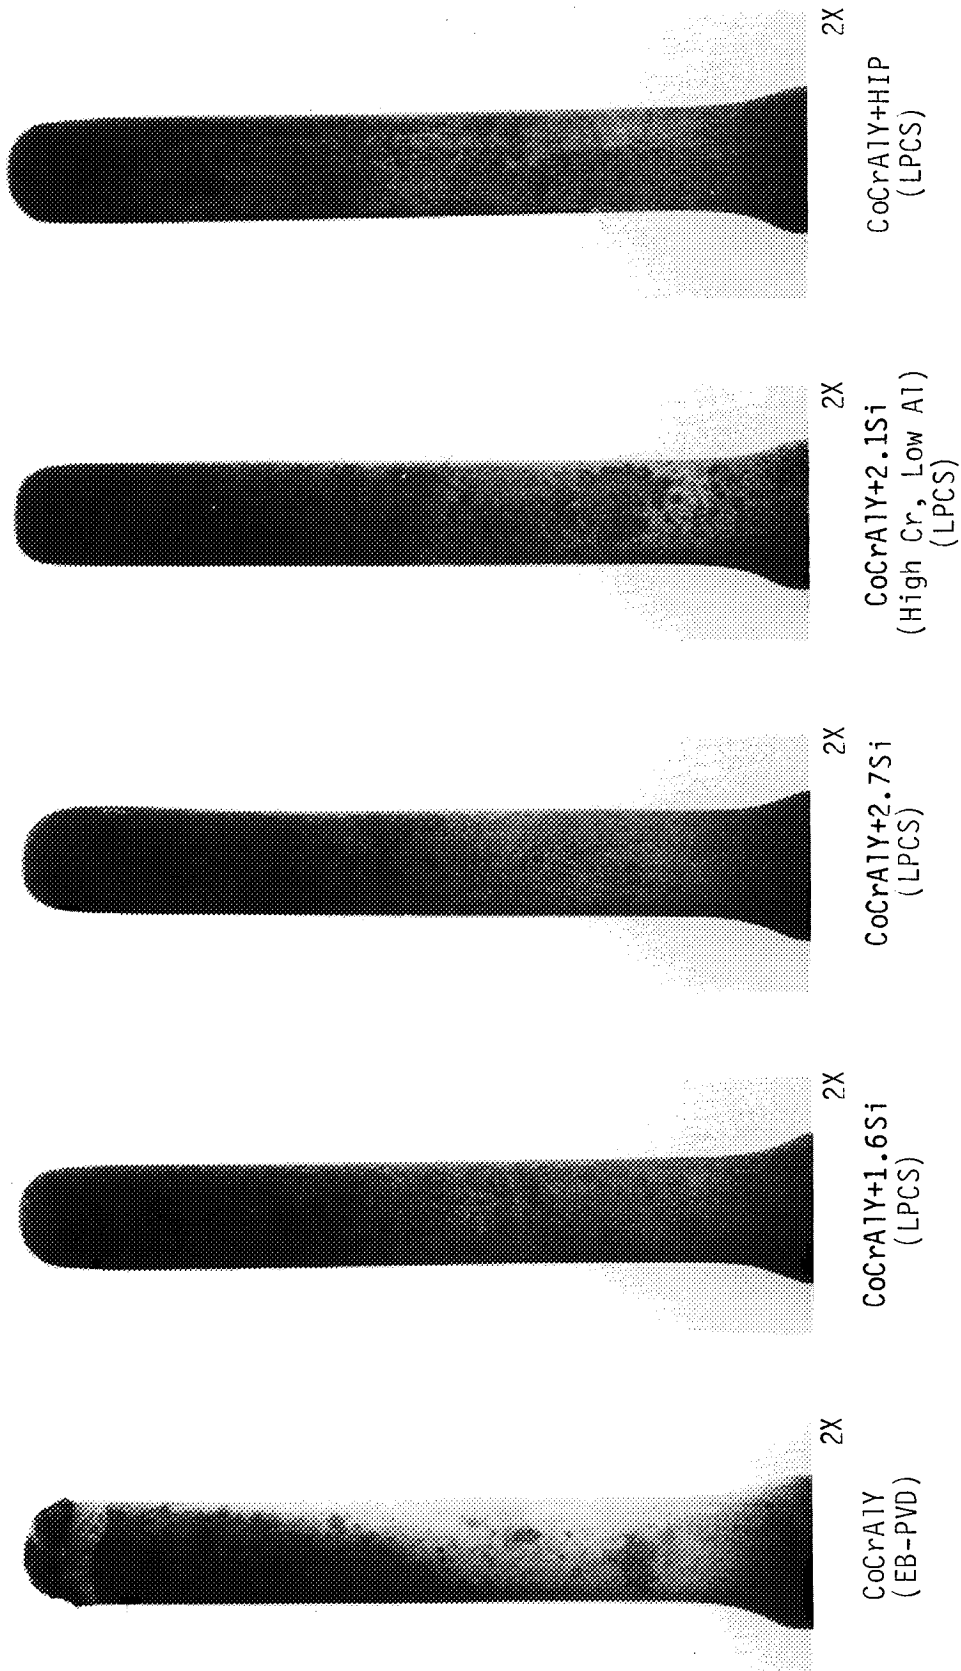
Figure 50 Surface Photographs of Test Samples With CoCrAlY-Type Coatings on B-1900+Hf Alloy Exposed 500 Hours to a Hot Corrosive Environment at 11720K (1650°F). EB-PVD = Electron-Beam Physical Vapor Deposited; LPCS = Low Pressure Chamber Sprayed
