EVALUATION OF PRESENT THERMAL BARRIER COATINGS FOR  
POTENTIAL SERVICE IN ELECTRIC UTILITY GAS TURBINES

by R. J. Bratton, S. K. Lau and S. Y. Lee

WESTINGHOUSE ELECTRIC CORPORATION  
Research and Development Center  
Pittsburgh, Pennsylvania 15235

Contract NAS3-21377

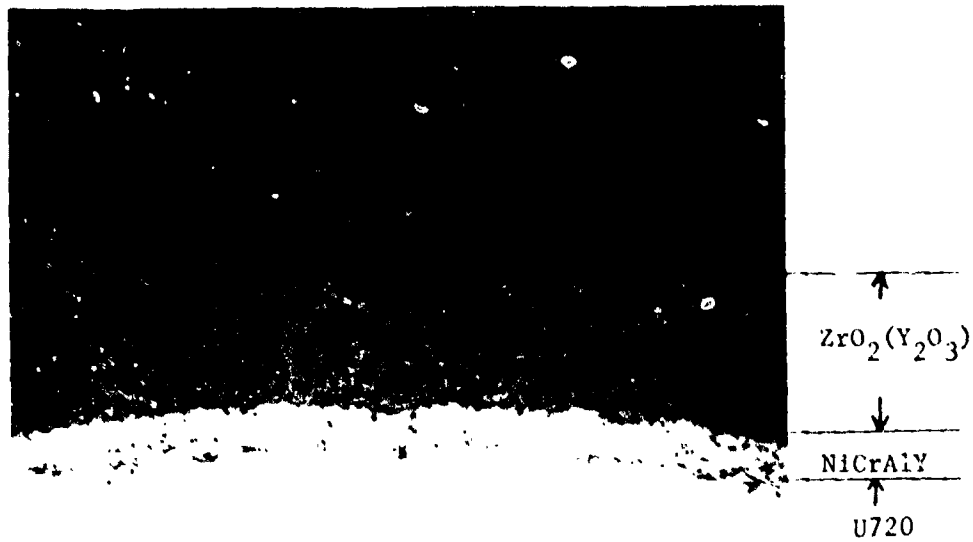
(50X)

Fig. 5 - Typical metallographic cross-section of a duplex  $ZrO_2 \cdot Y_2O_3$  coating

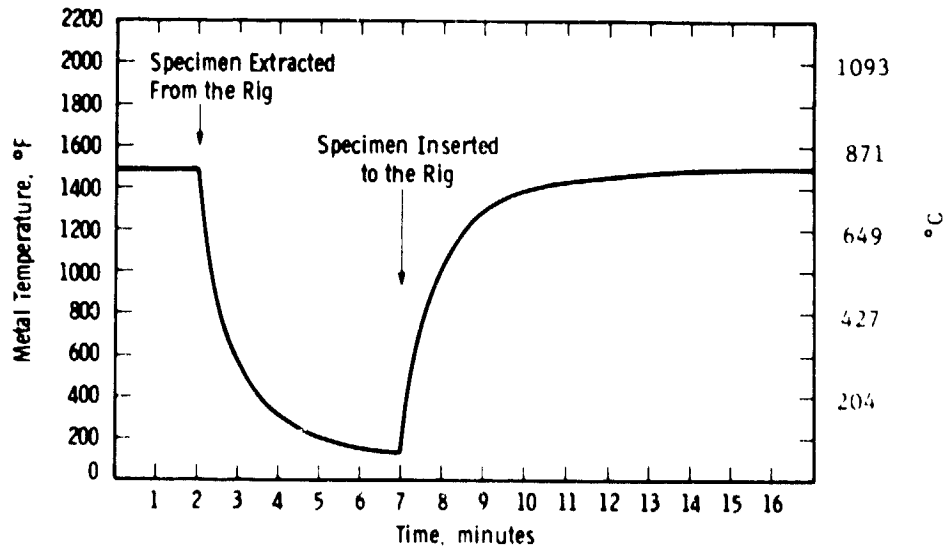
Fig. 10 - (a) air-cooled specimen assembly  
(b) specimen cooling and heating cycle

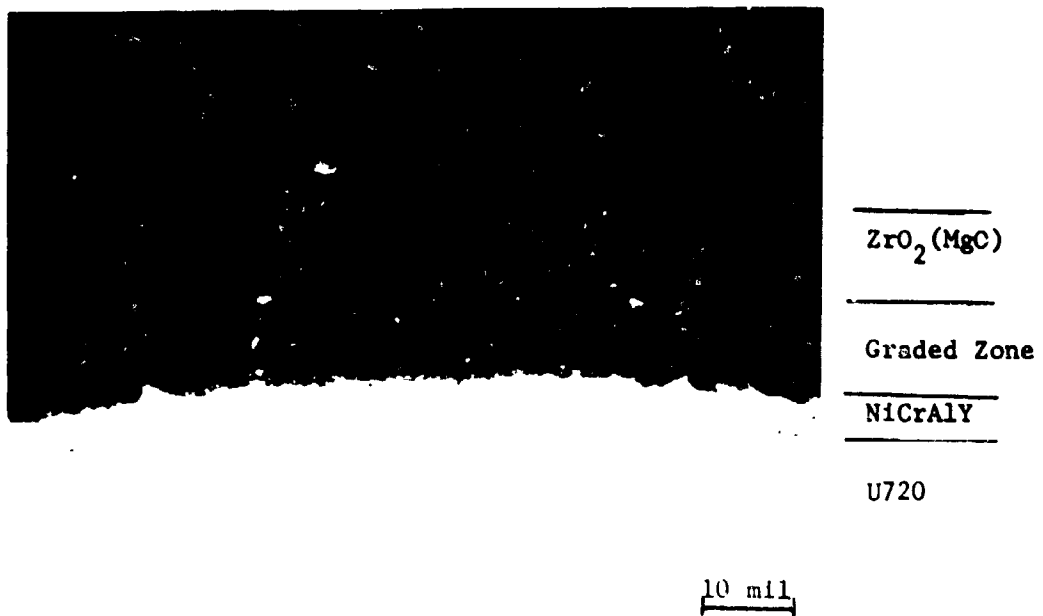
Fig. 17 - Specimen CB2 (G- $ZrO_2$ •24.65 MgO) 350 cycles,  
Test IA1

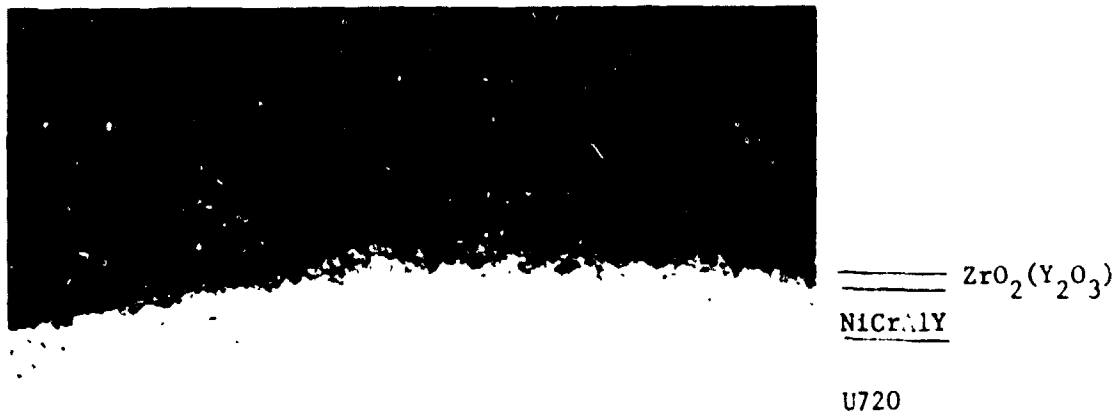
Fig. 25 - Specimen AB4 ( $D-ZrO_2 \cdot 8Y_2O_3$ ) 150 cycles, Test IB5

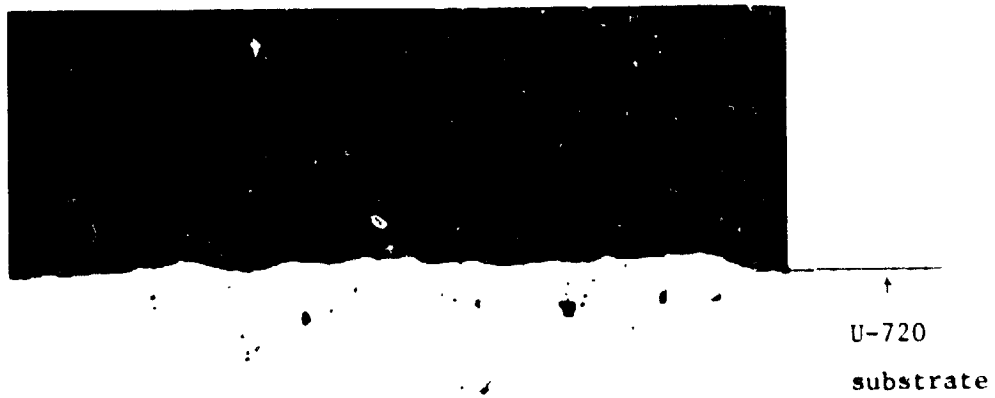
Fig. 33 - Specimen N-2 (NiCrAlY) 151 cycles, Test 1B6  
1150°C gas/857°C metal  
(100X)

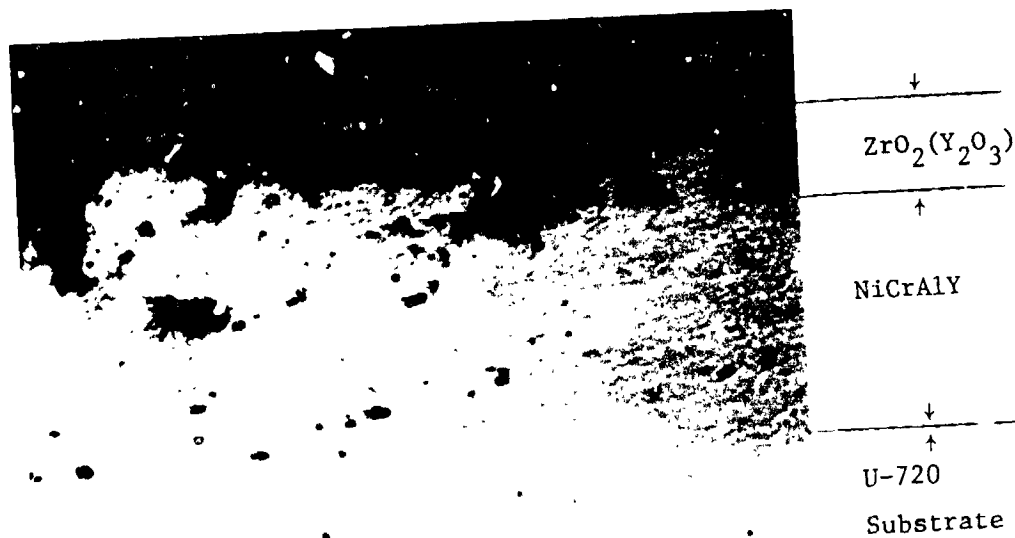
Fig. 36 - Specimen A-2 ( $D-ZrO_2 \cdot 8Y_2O_3$ ) 151 cycles, Test 1B6  
1150°C gas/900°C metal  
(400X)

treatments employed by Linde have resulted in a highly dense structure (Fig. 36). Thus although the porous nature of the NASA NiCrAlY bond coat may offer good thermomechanical performance, it also provides easy paths for corrodants to penetrate into the coating and thereby enhance hot corrosion attack. These results suggest that in order to have both chemical and thermomechanical stability, the microstructure of the NiCrAlY coats still need to be optimized.

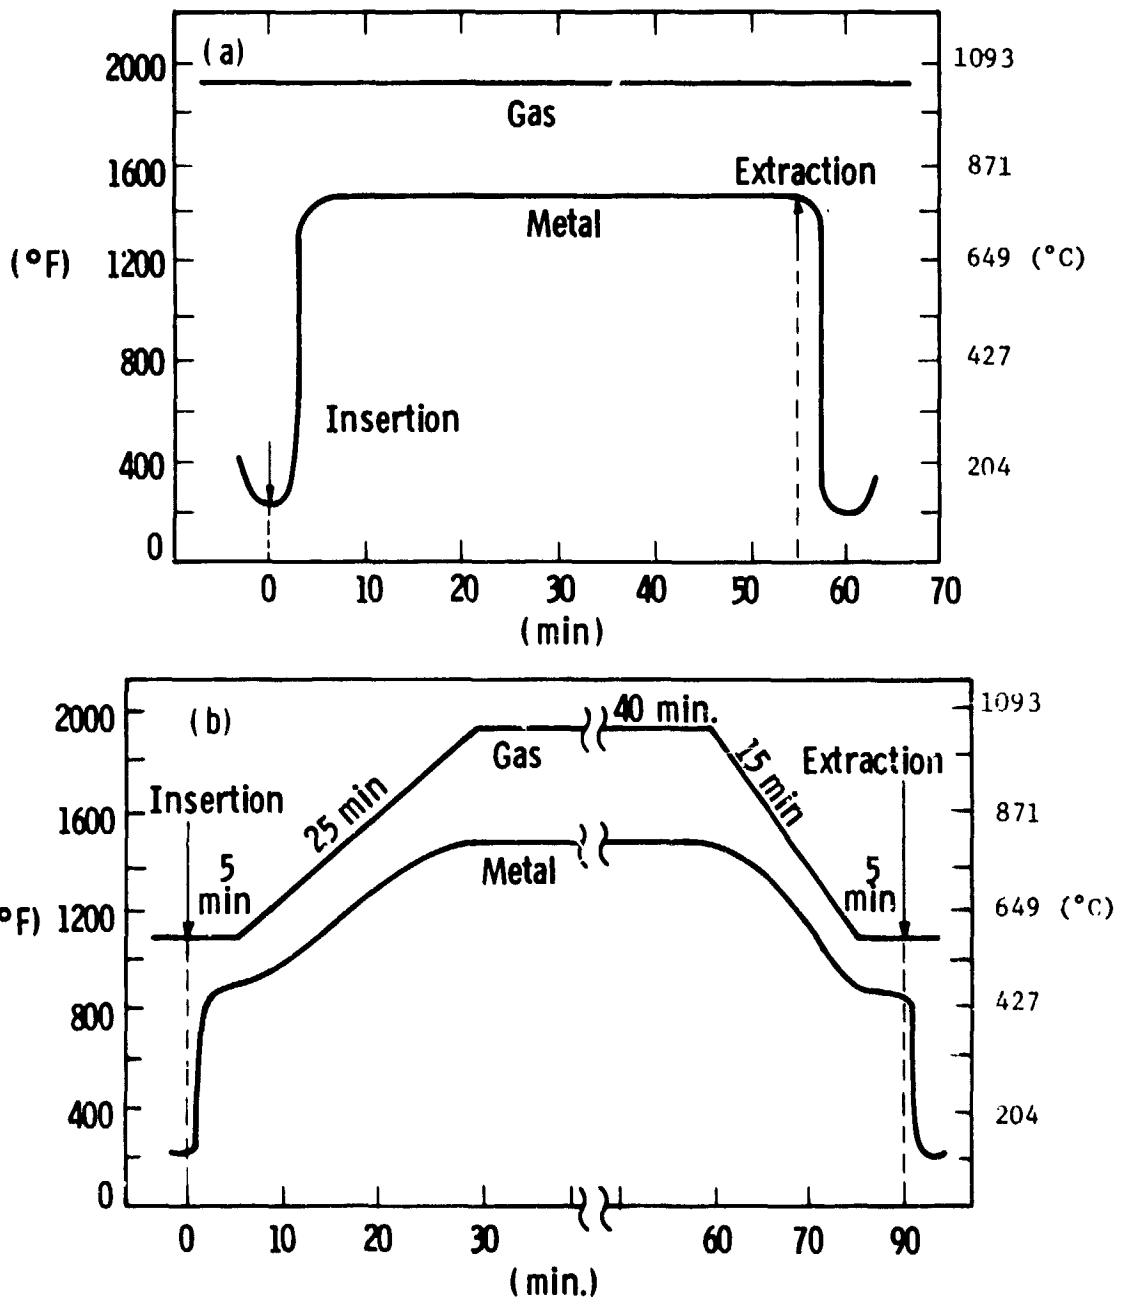
Figure 47 - Thermal cycles for test pins in pressurized passage

Due to the physical constraints of the testing passage, direct measurement of specimen coating surface temperatures was impossible. Therefore, they were calculated from heat transfer data instead. An iterative procedure using Newton's method showed that under the testing conditions of 1066°C gas temperature (actual temperature varied between 980-1090°C) and 800°C metal temperature, the coating surface temperature was about 870-925°C.
