**NASA
Technical
Paper
1961**

Thermal and Aerothermal Performance of a Titanium Multiwall Thermal Protection System

Don E. Avery,
John L. Shideler,
and Robert N. Stuckey

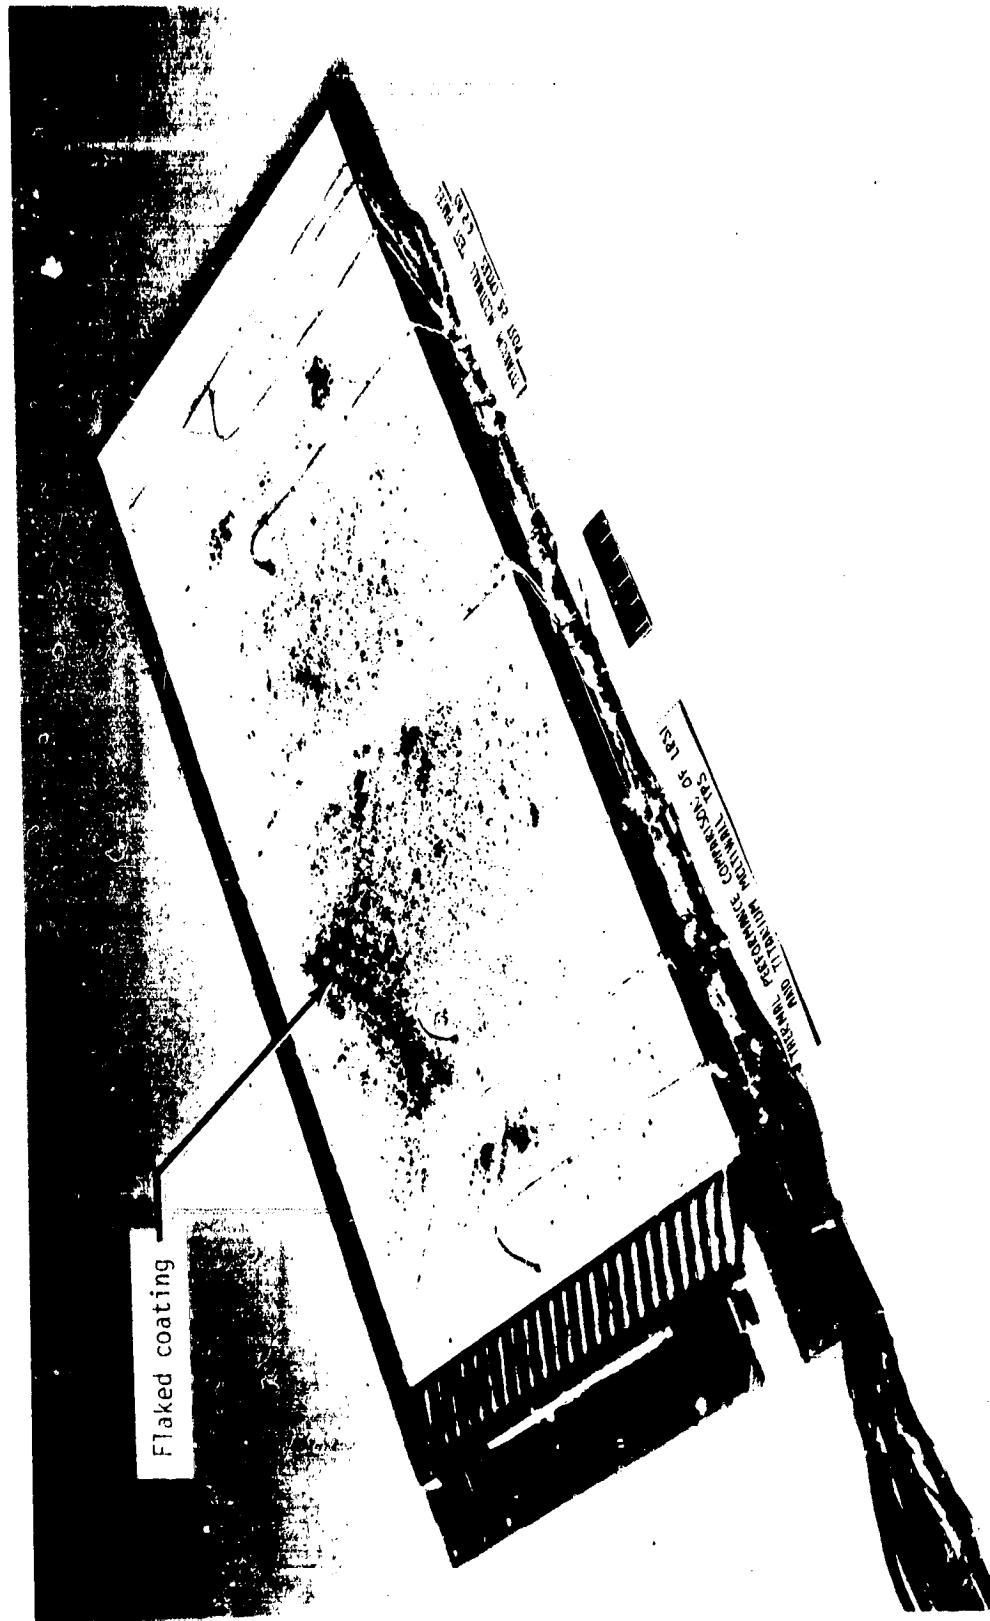
L-81-248

Figure 22.- Multiwall two-tile model after 25 thermal tests.

Structural performance.- The structural integrity of the two-tile multiwall model was maintained throughout the test series, although the coating began to flake at the beginning of the test series. It was learned after the test series began that the coating was uncured. The curing process removes the volatiles by slowly heating the coating to 756 K. Heating the model at the entry temperature rate shown in figure 2 was rapid enough to cause the coating to flake. The model condition before and after testing is shown in figures 7 and 22, respectively. Although the multiwall structure appeared to be undamaged after the 25 radiant heating tests, two areas were found where the face sheet debonded from the dimpled layer. The first area contained one debonded node and the other area contained approximately three debonded nodes. The model was not disassembled for close examination of the tile backface because further tests may be desired. The top surface lip of the front tile was properly in contact with the adjacent tile before testing started. However, after 25 thermal cycles, the lip was permanently deflected 0.10 cm above the adjacent tile surface. This deflection may result from a rotation of the tile edges caused by thermal bowing of the multiwall tiles. The bowing is spherical in nature because the temperature distribution through the thickness is approximately linear, and rotation occurs about the corner attachment points where the tile is essentially simply supported. The deflection is accentuated by the scarfed edge which locates the lip approximately 5.1 cm from the attachment. (See fig. 4.) The maximum edge deflection was hand calculated to be 0.35 cm. This calculated deflection would be lowered to 0.12 cm if the scarf angle were increased from 25° to 90°. Approximately 0.10 cm deflection can be accommodated before the yield stress is exceeded. Consequently, the permanent deformation could nearly be eliminated by use of a 90° edge closure and completely eliminated if a 0.02-cm vertical gap existed between the tile upper lip and the adjacent downstream tile.

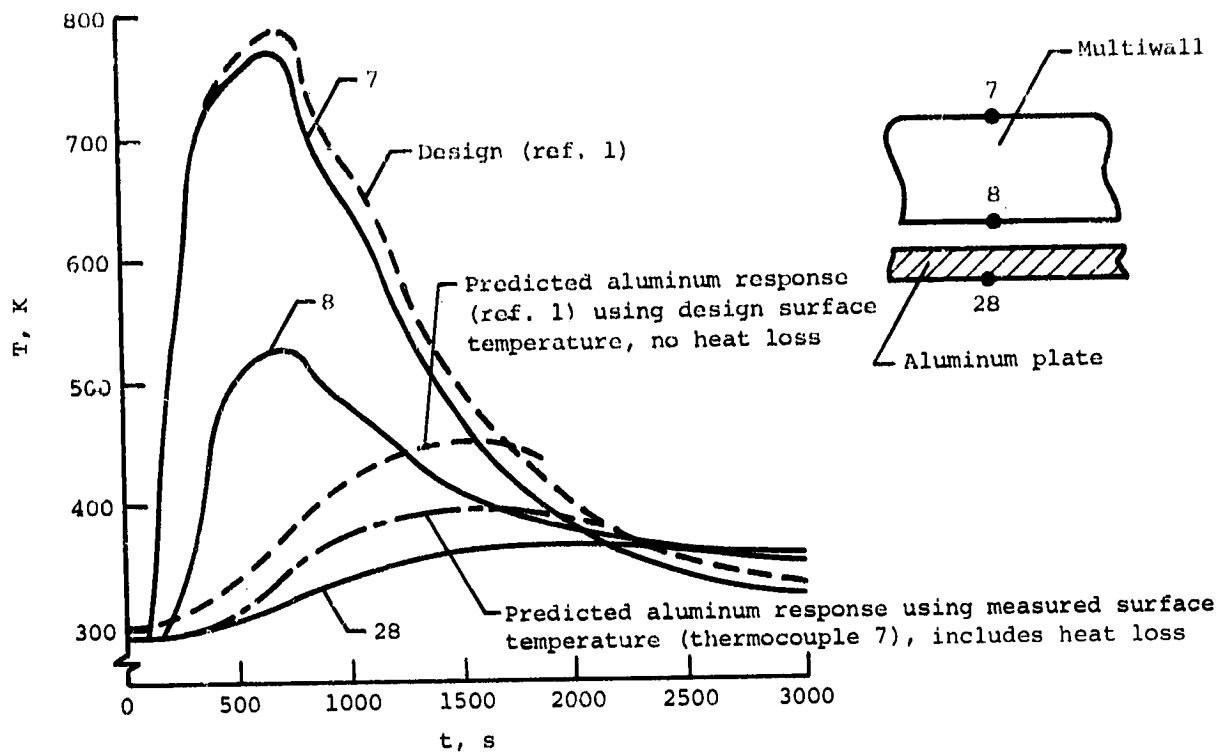
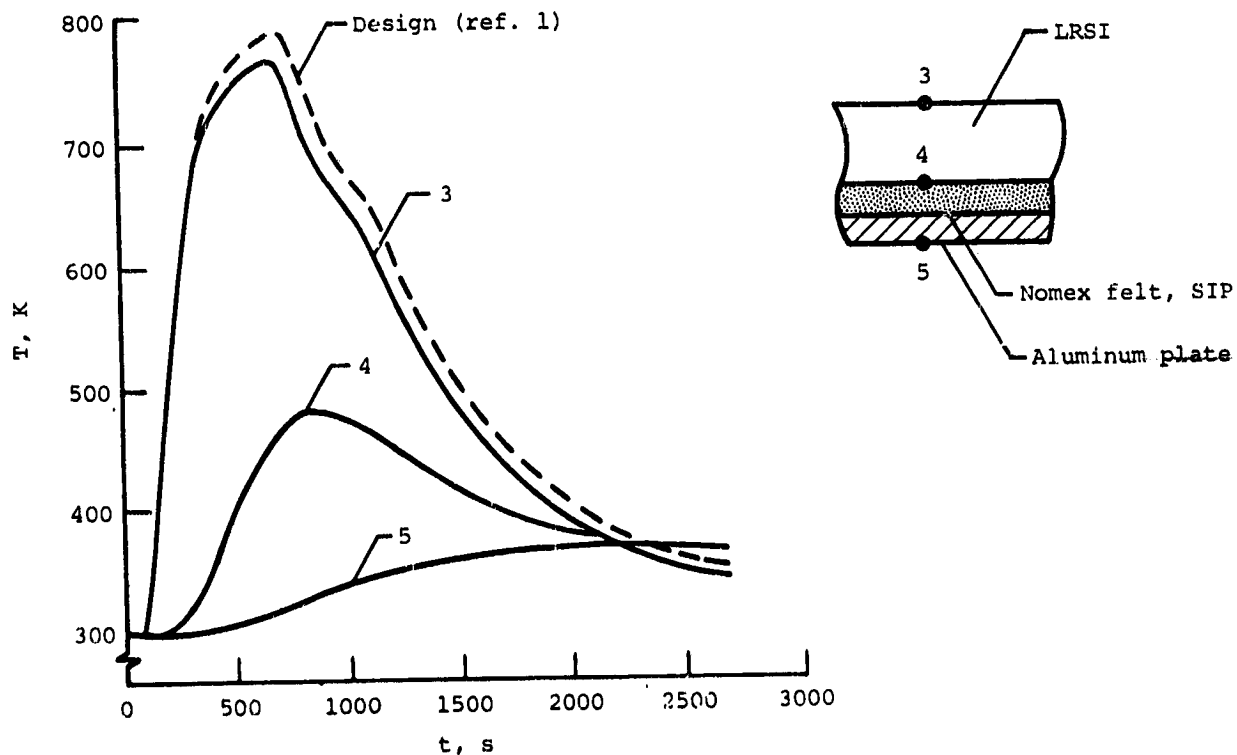
(a) Multiwall TPS.

(b) LRSI.

Figure 24.- Temperature histories for cyclic radiant heating through models (test 1).

As previously mentioned, the multiwall tile thickness was determined for the temperature and pressure histories shown in figure 2, but the LRSI tile thickness was determined by an aerodynamic fairing requirement at body point 3140. Consequently, the LRSI tiles are thicker than would be required for thermal considerations only. Test data for the first test of the two models are shown in figure 24 along with the design and predicted temperature histories. Thermal performance was unchanged during the test series. Thus, these data are typical of each of the 25 cycles. The surface temperature histories (thermocouples 7 and 3) and the temperature histories of the aluminum plates (thermocouples 28 and 5) indicate that the thermal performance of the two systems was the same. Because the LRSI tile model is designed conservatively (thicker than that required for thermal design), it appears that the multiwall tile model is also designed conservatively.

The predicted aluminum plate response taken from reference 1 and shown in figure 24(a) is based on the design surface temperature history and assumes no heat loss from the aluminum plate. The measured thermal response (thermocouple 28) differs by as much as 86 K. The long-dash--short-dash curve shows the predicted temperature response using the measured surface temperature history (thermocouple 7) as the heat load and accounting for heat loss through 2.54 cm of LI-900 which was beneath the aluminum plate (fig. 11). This response is much closer to the measured response (thermocouple 28) but it is still as much as 29 K higher, which further substantiates that the analysis used for the thermal design of the multiwall is conservative.
