COAL/ROCK INTERFACE DETECTION BY SENSITIZED PICK

Contract NAS8-33064

Final Report

August 1981

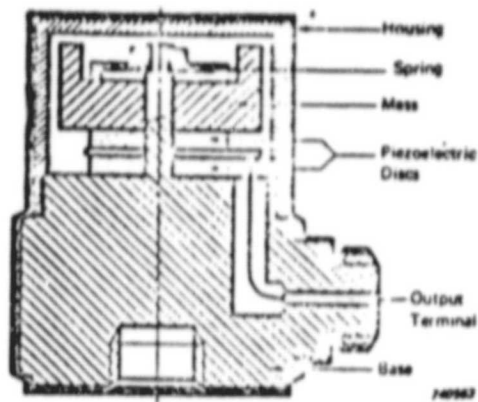
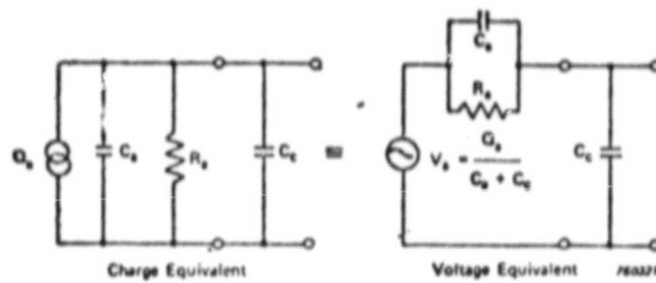
FIGURE 1. Schematic of B&K 4344 accelerometer and its equivalent electrical circuit.

Schematic of piezoelectric accelerometer

Equivalent circuits of piezoelectric accelerometer with connection cable

C_c = Cable capacitance = 103 PF

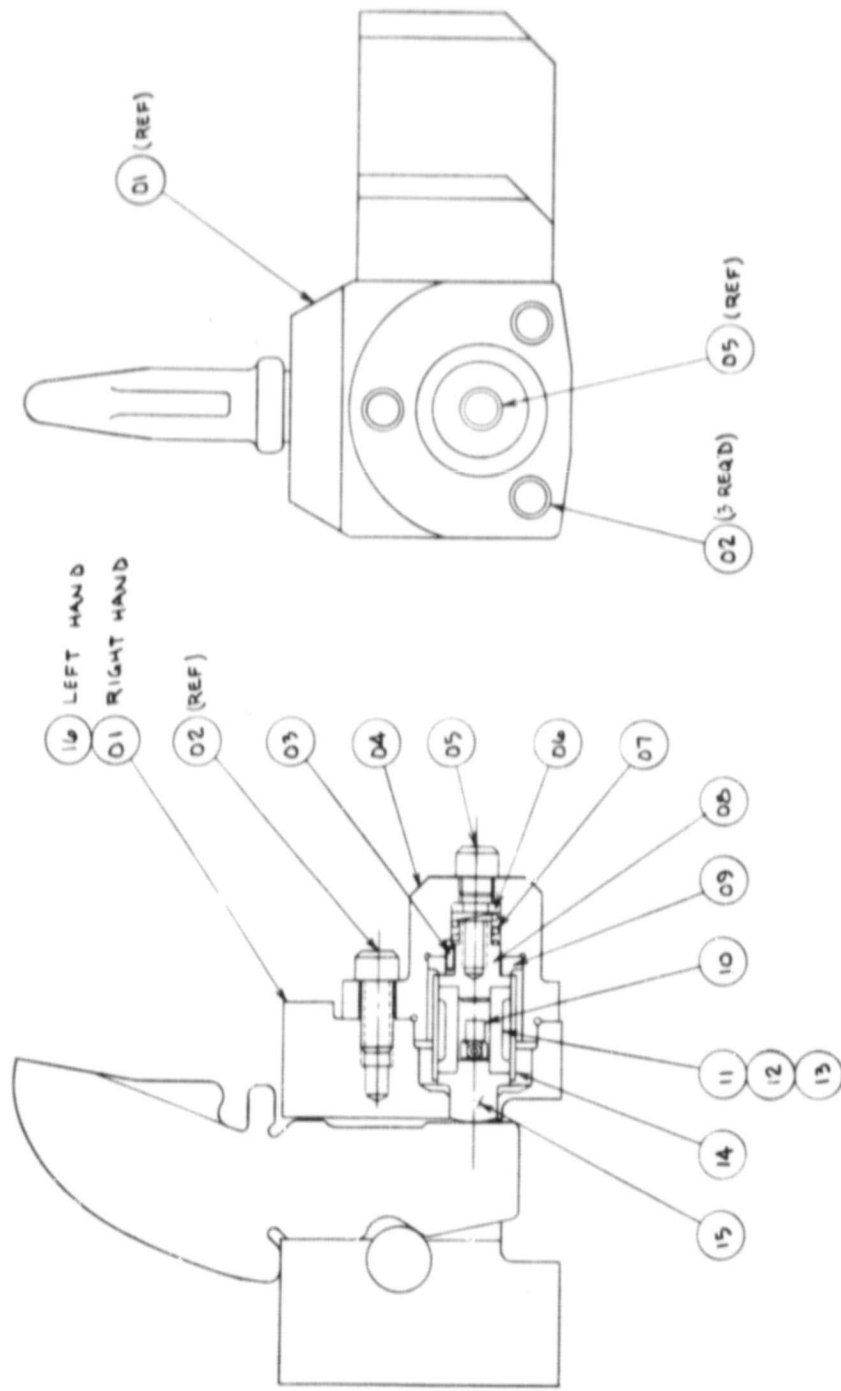
Figure 1. Original Shaker Research Labs design

SENSITIZED PICK/BLOCK DESIGN

1. The loading on the sensitized pick was transmitted to the load cell through a pivot joint which was not controlled. Due to normal wear, slight differences in dimensions of replacement picks and the exact manner in which the pick was seated in the pick block, the pivot point could shift and the shifting would produce errors in pick load measurement.

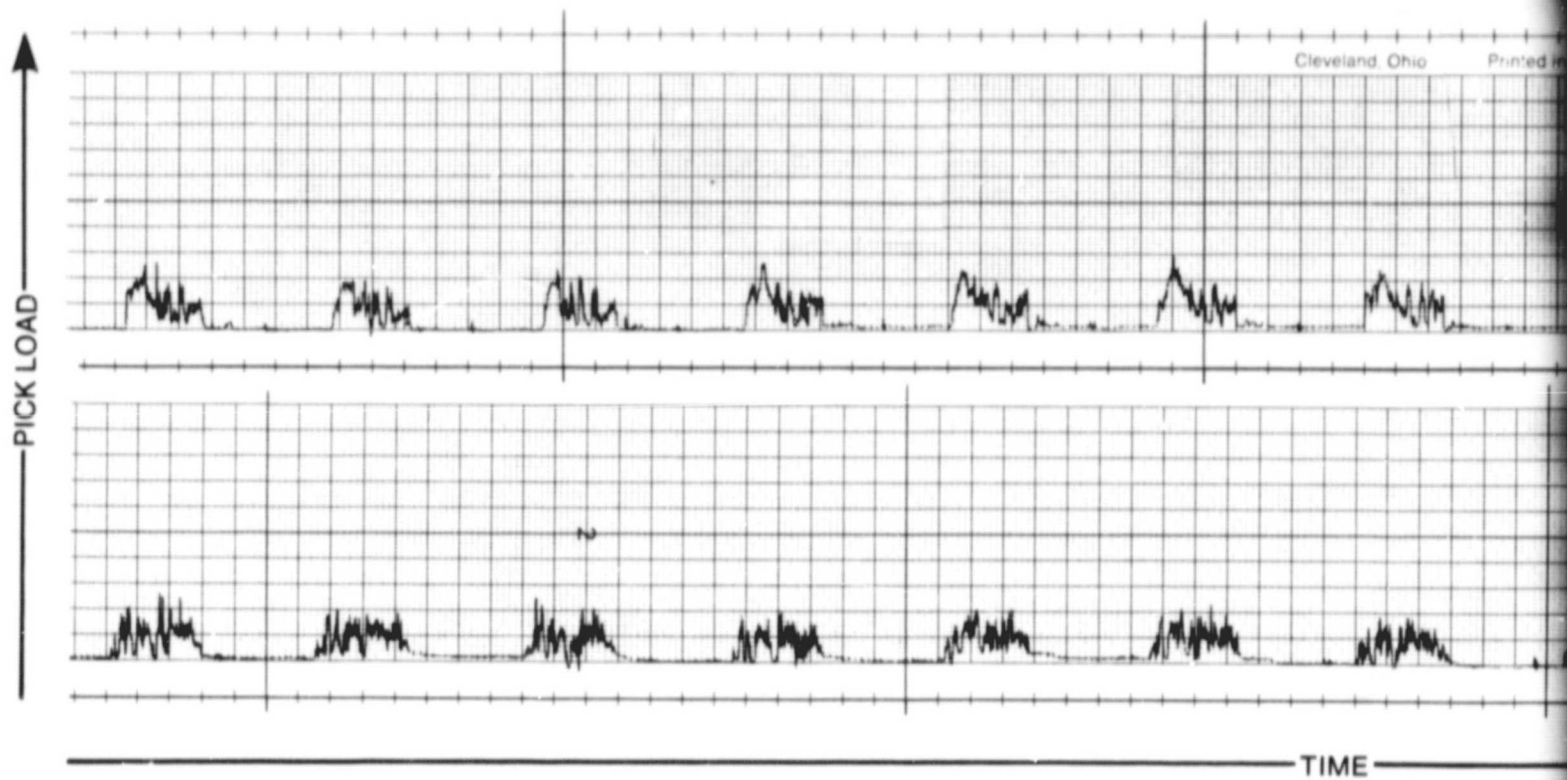
Figure 16. Samples of pick load signals for rock (upper

oad signals for rock (upper curve) and coal (lower curve)

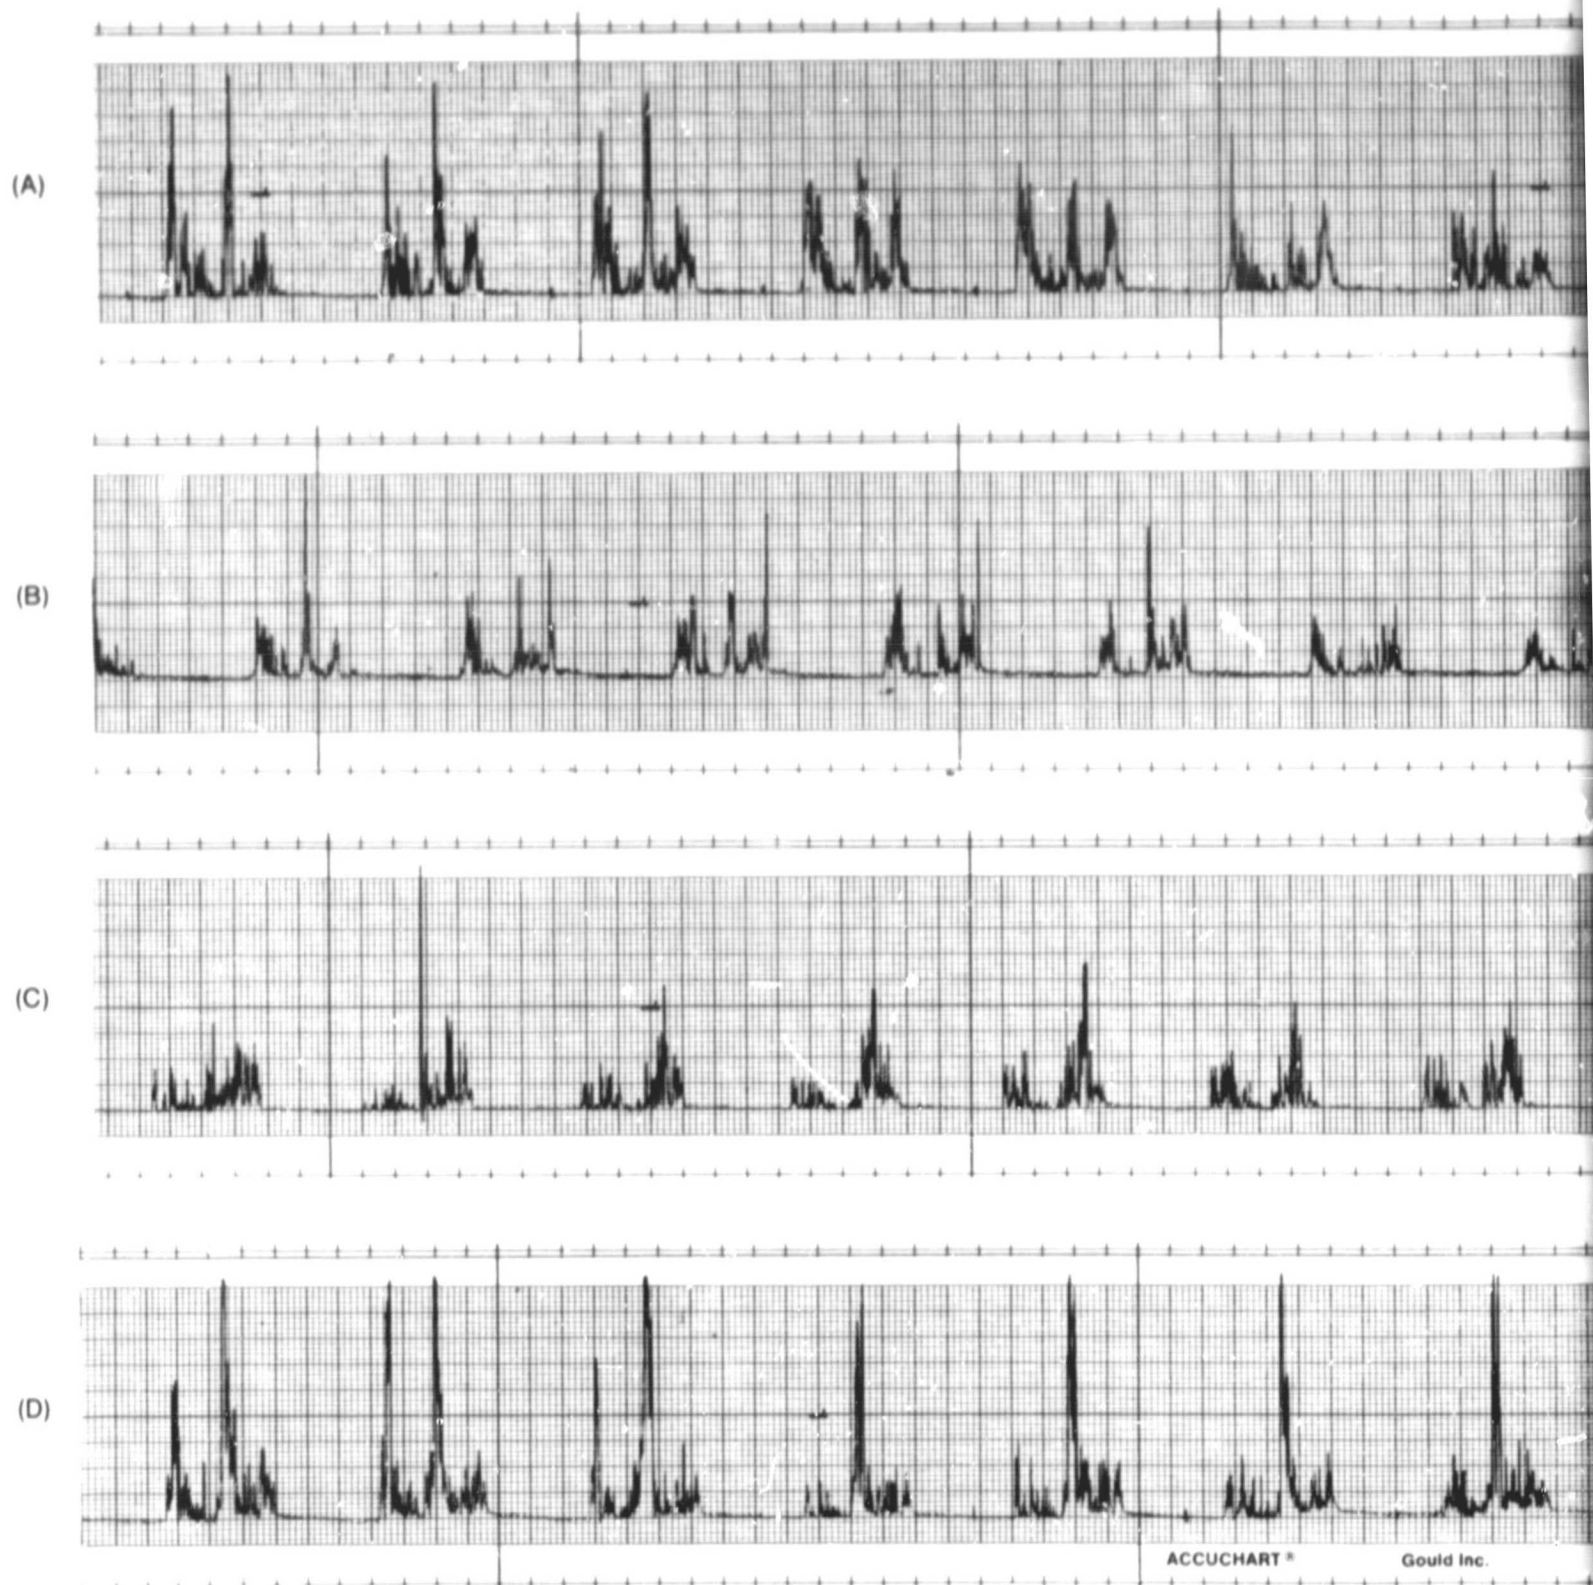
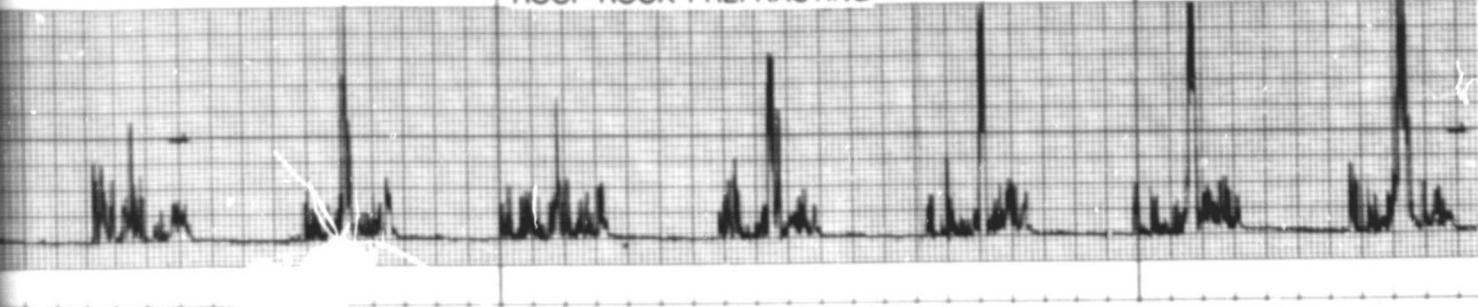
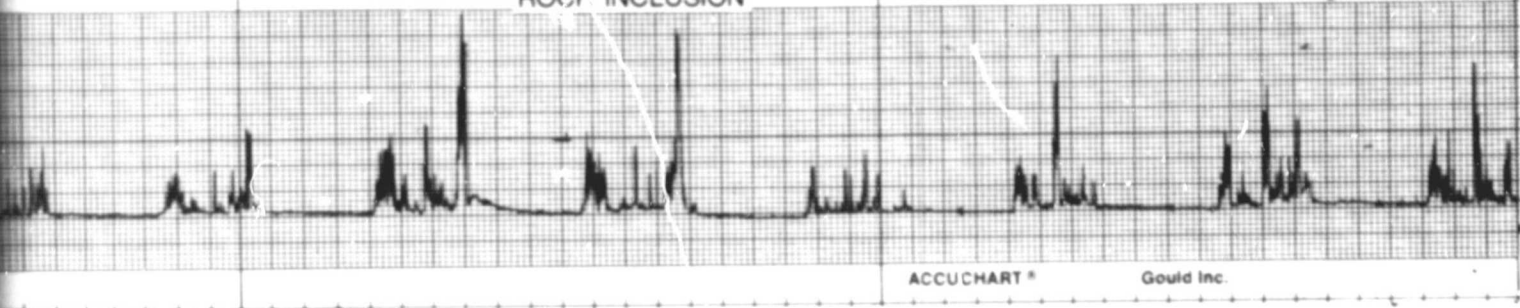
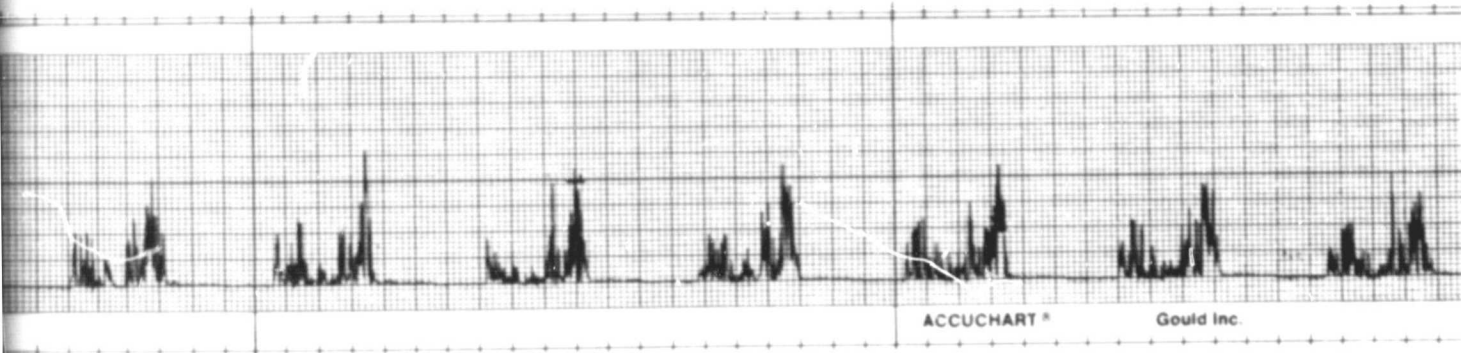
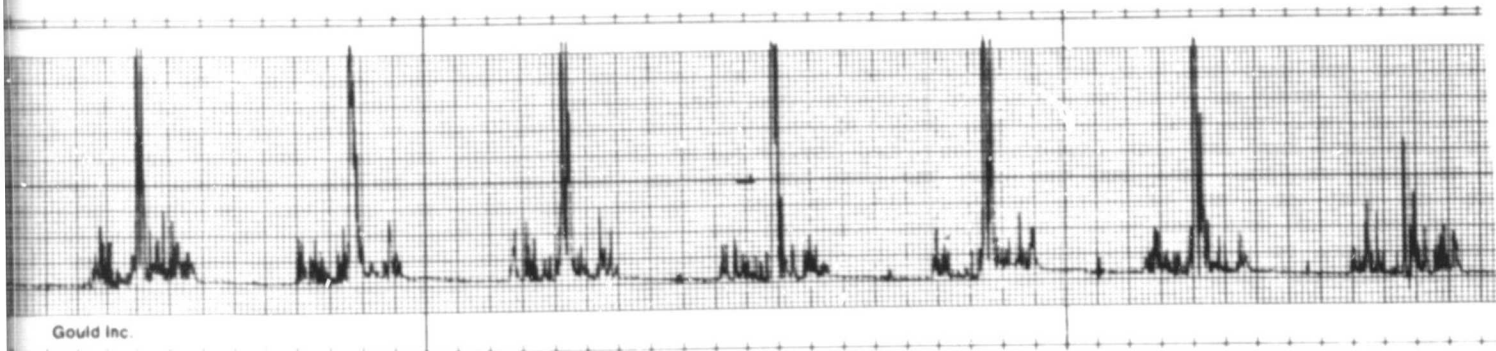
Figure 34. Cutting force signals measured
 (a) Typical "rock-cutting" signal
 (b) Typical "coal-cutting" signal
 (c) Typical signals where the "rock" is
 (d) Typical signals where the "coal" is

signals measured at York Canyon mine
"rock-cutting" signals
"ice-cutting" signals
signals where the "middleman" was small
signals where the "middleman" was thick

3. The major differences noted between the signatures of coal/rock cutting obtained from Bruceton and from York Canyon were the following:
 - a. The roof rock in the real mine has a much greater variation in properties such as hardness and degree of prefracture, than that of the roof cap at Bruceton. Therefore, in rock area, the rock signals at the leading edge of the signal cycle were much less uniform than had been seen at Bruceton. Under cutting force, roof rock often broke up into chunks and fell off the roof. For one or more cycles after the roof rock fell off, the sensitized pick might not make contact with rock, and therefore would produce "coal" signals, although the drum was ostensibly cutting into a rock layer. This is illustrated by a sample of "rock-cutting" signals, shown in Figure 34(a).

- b. The characteristic signatures of coal cutting in a real mine also have much greater variation than those of the simulated coal at Bruceton. In the same general location of the coal seam, some coal was very loose and would crumble readily, whereas other sections of coal were tightly packed and hard. Sometimes there were hard materials other than coal embedded in the coal seam in a random manner. Therefore, isolated "rock" signals may appear while cutting in coal. These features can be seen in the sample of "coal-cutting" signals shown in Figure 34(b).

5. The vibration signals measured at the end of the ranging arm were fed to the vibration CID processor. Since the data contain the effect of a huge "middle man" rock layer, the vibration CID processor detected rock almost all the time. York Canyon mine in its current condition is therefore not a suitable test site for the vibration CID. As can be seen in Figures 34(c) and (d), the "middleman," although almost

always present, varied considerably in thickness, (and in the forces required to cut it); it should also be noted that the middleman layer, like the roof rock material, would occasionally prefracture, producing weak signals for a drum rotation or two.
