SEMI-ANNUAL REPORT
AN INVESTIGATION OF ADHESIVE/ADHEREND
AND FIBER MATRIX INTERACTIONS

September, 1981

The Application of Surface Analysis to Polymer/Metal Adhesion

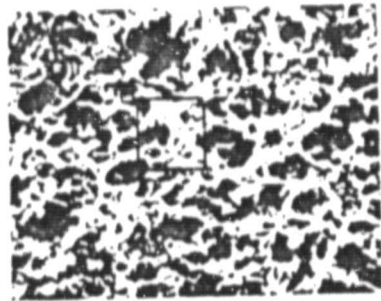
2

The effect of thermal aging on the morphology of a freshly pretreated Ti 6-4 surface is illustrated dramatically in the SEM photomicrographs in Fig. 2. Here, a TU pretreated Ti 6-4 coupon was placed in a forced air oven at 498 K (450°F) for 10 hours. The SEM photomicrographs of the unheated sample are shown in Fig. 2A. A comparison of Fig. 2B with Fig. 2A demonstrates the marked change in surface morphology accompanying thermal aging. The implication of this gross change of physical structure in bond durability studies at elevated temperatures is clear.

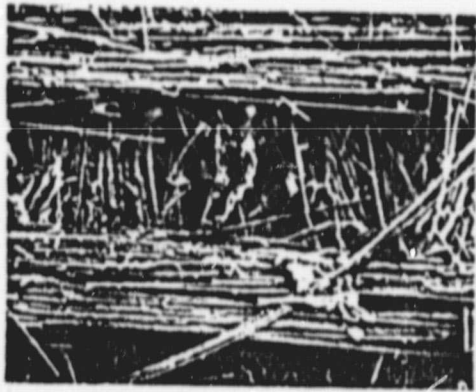
5

SEM photomicrographs of a fractured lap shear sample bonded with polyphenylquinoxaline (PPQ) are shown in Fig. 5. The synthesis of PPQ has been described elsewhere (9,10). The PPQ bonded CAA T1 6-4 adherends gave a measured lap shear strength at room temperature of 4650 psi. It is clear that no features characteristic of the T1 6-4 adherend are seen in the photomicrographs; thus, the sample failed cohesively. The XPS results for the fracture surface are shown in Table V. No Ti photopeak was observed, confirming cohesive failure. The O 1s, N 1s and C 1s photopeaks are characteristic of PPQ. Note the shift in the binding energy of the O 1s photopeak compared to the adherend (see Table II). The Si 2p photopeak is due to the glass scrim cloth which is seen in the SEM photomicrographs.

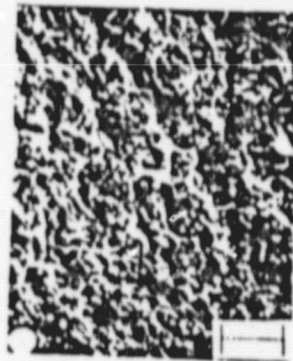
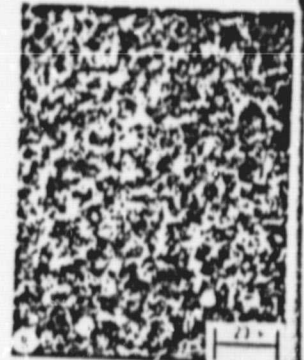
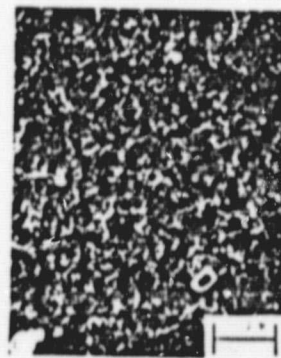
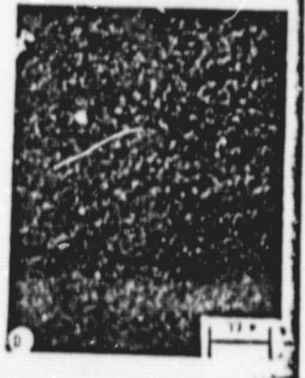
6

By contrast, a lap shear strength of 1950 psi was determined in the case of phosphate-fluoride (P-F) treated T1 6-4 adherends bonded with PPQ. Apparent interfacial feature is noted from the SEM photomicrographs of the fracture surfaces in Fig. 6A and 6B. The metal failure surface (MFS) in Fig. 6A shows a surface morphology characteristic of P-F etched T1 6-4 surfaces. The adhesive failure surface (AFS) in Fig. 6B shows the "imprint" of the adherend. Closer inspection shows micro-voids in the adhesive left after pull-out of the β phase.

The P-F surface pretreatment invariably led to debonding of the adhesive slab when punched for XPS sample preparation. The various fracture surfaces are depicted schematically in Fig. 7. The SEM photomicrograph of the metal substrate surface (MSS) and the adhesive substrate surface (ASS) are shown in Figs. 6C and 6D. Similar features are noted in these photomicrographs as were seen in Figs. 6A and 6B.

The XPS results for the four surfaces are shown in Table VI. The AFS (Fig. 6A) shows a significant Ti signal which fact is further confirmation of the assignment of interfacial failure for this sample. The photopeak at a binding energy of 529.5 eV is assigned to oxygen in the surface oxide layer. We have reported (11) a value of 529.5 eV for the O 1s photopeak following P-F treatment of Ti 6-4. Thus, the ESCA results support the existence of a titanium oxide layer on the metal failure surface. Ca is present as a residual on the Ti 6-4 adherend surface after the P-F treatment. The N 1s photopeak at 398.3 eV is consistent with the N 1s photopeak observed for the Ti 6-4 adherend surface after any chemical pretreatment (see Table II). However, the origin of the nitrogen is not clear since a N 1s photopeak at about the same binding energy is observed for both pretreated Ti 6-4 and for PPQ (see Table V). The observation of a significant Si 2s photopeak is quite interesting. Again, the origin of this Si signal is not clear. However, the fact that failure occurred at this interface may be associated with the presence of silicon. The SEM photomicrographs (see Fig. 6A) shows no evidence of glass fragment from the scrim cloth. It is known that the scrim cloth is coated with an organo-silicon compound. Does in fact degradation and subsequent migration of silicon-containing compounds to the interface occur? The answer to this question will involve additional experiments.

The AFS gives an O 1s photopeak at 531.7 eV (see Table VI) characteristic of PPQ (see Table V). Again, a significant Si signal is observed on this surface where no glass fibers are seen (see Fig. 6C). The absence of a Ti photopeak is additional confirmation of interfacial failure. A further conclusion can be drawn. Failure occurred at the primer/oxide interface rather than in the oxide layer in which case a Ti signal should have been observed.

The MSS (Fig. 6C) shows an O 1s photpeak at 529.2 eV characteristic of the pretreated Ti 6-4. In this case a small V peak and a significant Ti peak were detected. The presence of Ca is consistent with the composition of a P-F treated Ti 6-4 surface. The presence of a trace quantity of lead on this surface and on the adhesive substrate is not explained. The ASS (Fig. 6D) shows an O 1s photpeak at 532.2 eV characteristic of PPQ. A small Ti peak was detected here indicative of fracture of the oxide layer. No silicon was noted on either of these substrate surfaces.
