Failure of Morphology of (0°)₈ Graphite/Epoxy as Influenced by Environments and Processing

Linda L. Clements and Michael J. Adamson

August 1981

ABSTRACT: Optical and scanning electron microscopy were used to investigate the failure morphology of $(0^\circ)_8$ T300/5208 graphite/epoxy specimens which had been tested until tensile failure. Failure morphology was studied as a function of the quality control variables of specimen preparation technique, prepreg batch, and cure condition, and also as a function of the environmental parameters of temperature and moisture content. Defective specimens were found to exhibit a low-energy failure morphology. Poor specimen edge preparation and one batch of prepreg — when tested at elevated temperature or moisture content — also exhibited this low-energy failure morphology. Postcuring had no effect on strength but did slightly alter failure morphology. Temperature or moisture appeared to decrease flaw sensitivity and thus increase strength; however, moisture also appeared to increase interfacial debonding between filament and matrix. When combined moisture and temperature increased interfacial debonding and made the epoxy matrix more prone to

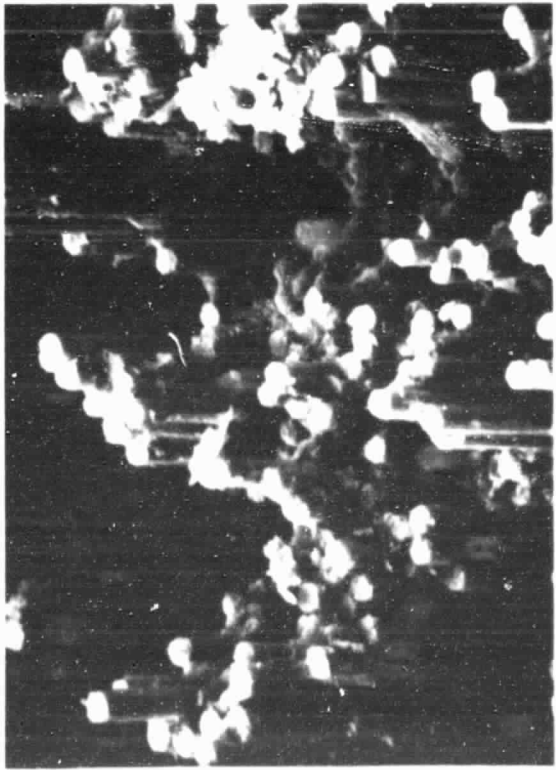
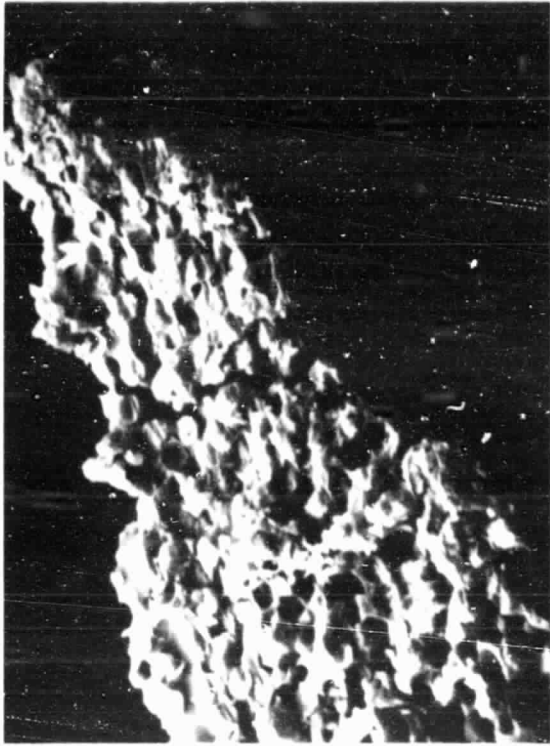
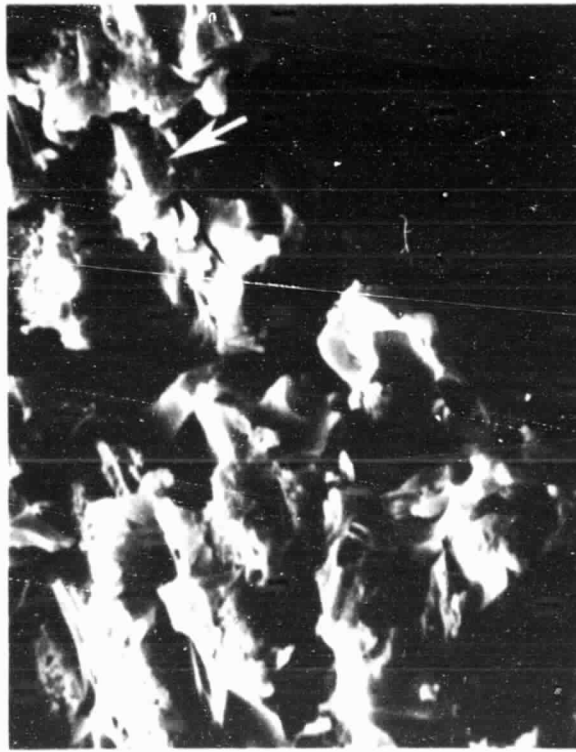
Figure 1.- Scanning electron micrographs comparing failure morphologies resulting from (a) high, and (b) low-energy failure propagation. (c) shows low-energy failure region and "river pattern" (arrow) at higher magnification.

SEM failure-surface examination revealed some general types of failure morphologies resulting from different types of failure propagation modes. Figure 1 illustrates the two most distinctive morphologies. The failure surface in Fig. 1a shows a varied topography with filaments and filament bundles at many different heights. The fracture path in this specimen was quite circuitous, and in fact was probably due not to a single crack but rather to a coalescence of cumulative damage. By analogy with metals, we assume that this morphology resulted from relatively "high energy" failure propagation. On the other hand, the failure surface in Fig. 1b is relatively smooth. As the higher magnification view in Fig. 1c shows, this smoother surface even displays the "river patterns" (striations perpendicular to the moving crack front - see arrow) - due to stopping and starting of a propagating crack - which are typical of more homogenous materials. This topography indicates that the failure crack

went through the material easily, with little secondary damage (such as intersecting secondary cracks) or other hindrance to its direct progress. We assume that this morphology results from relatively "low-energy" failure propagation.

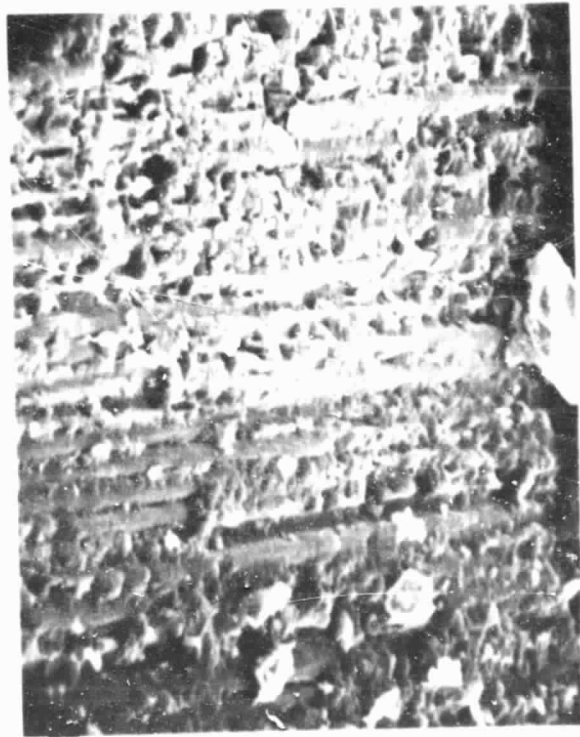
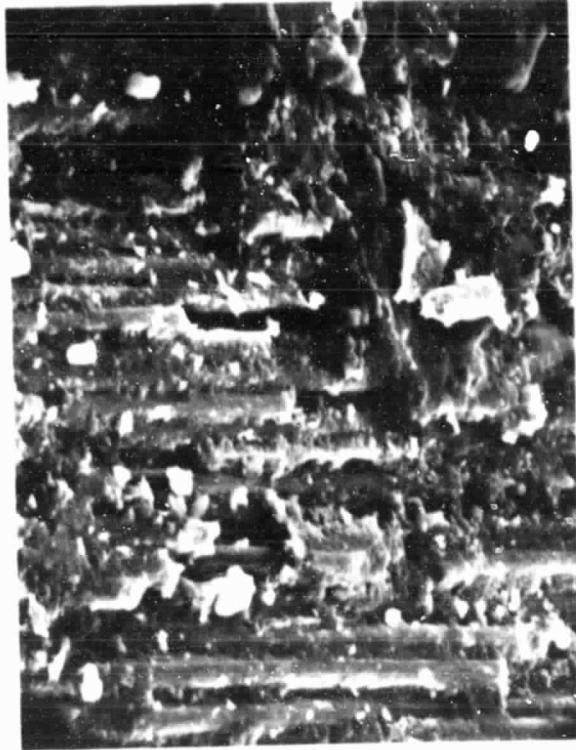
Figure 2.- Scanning electron micrographs comparing appearance of (a) unpolished to (b) polished specimen edges.

edges. Figure 2 compares a typical scanning electron micrograph of a polished edge (Fig. 2a) to one of an unpolished edge (Fig. 2b). While the polished edge has individual damaged filaments, the unpolished edge shows numerous areas where groups of filaments are damaged. An examination of specimen failure mode revealed the apparent effect of these groups of damaged filaments on the failure of unpolished-edge specimens. More than 60% of the specimens with unpolished edges failed by low-energy failure propagation, and the balance failed at the tabs or by splitting and delamination. On the other hand, more than 70% of the specimens with polished edges failed by high energy or mixed modes; few failed by low-energy failure propagation. We conclude that the damaged edges of the unpolished-edge specimens constituted defects which produced the low strengths observed.

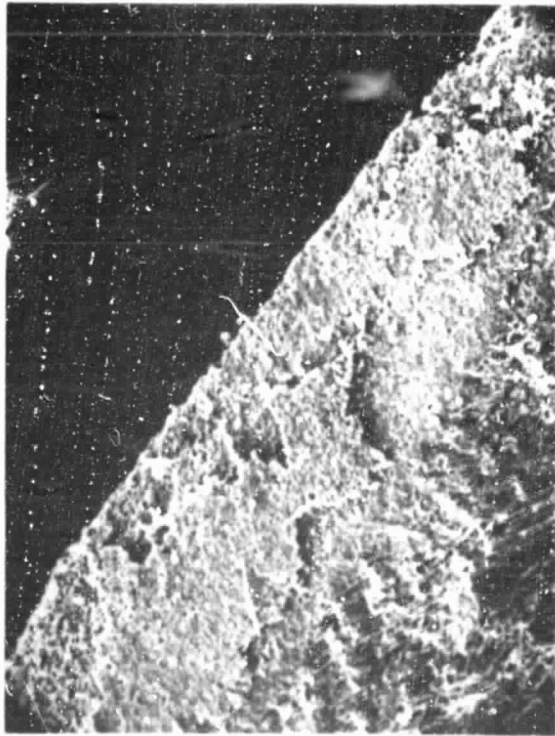
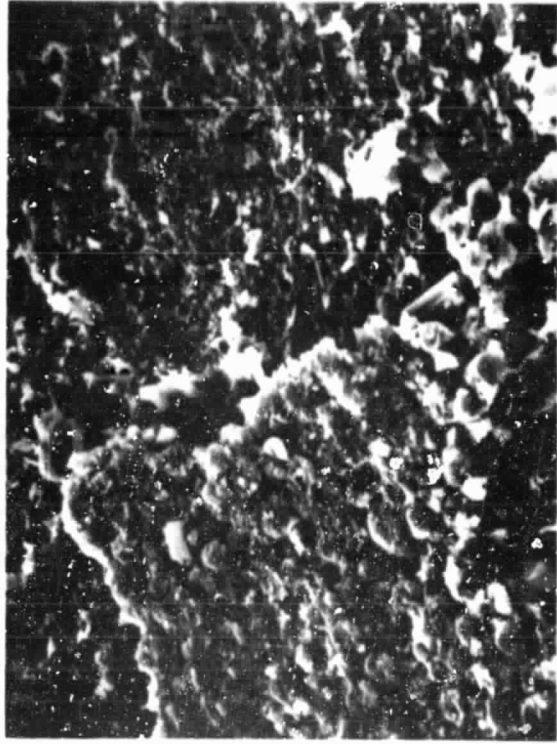
Figure 3.- Scanning electron micrographs showing at two magnifications a low-energy failure region with obvious differences between different fiber bundles in a batch B specimen (tested at 25°C wet).

SEM examination of the failure surfaces of batch B specimens detected differences in the fiber bundles in the specimens. Figure 3 illustrates this difference in a low-energy failure region. Even in such a relatively smooth area individual fiber bundles stand out. In other specimens, the borders between fiber bundles were traced as the location of a 0° split in the composite, and in others a delamination seemed to originate at the border between such bundles. We conclude from these observations that the regions of altered epoxy associated with some of the batch B fiber bundles led to a different failure mode for batch B specimens and to lower strengths at elevated temperature or moisture content. At 25°C dry the differences in failure modes in batches A and B are only slight, thus the strength effect is minimal. (The batch B mean strength is lower than batch A, but the difference is not statistically significant.) The altered epoxy has a more important influence at elevated temperature or moisture content, however, and apparently produces severe degradation when temperature and moisture are combined.

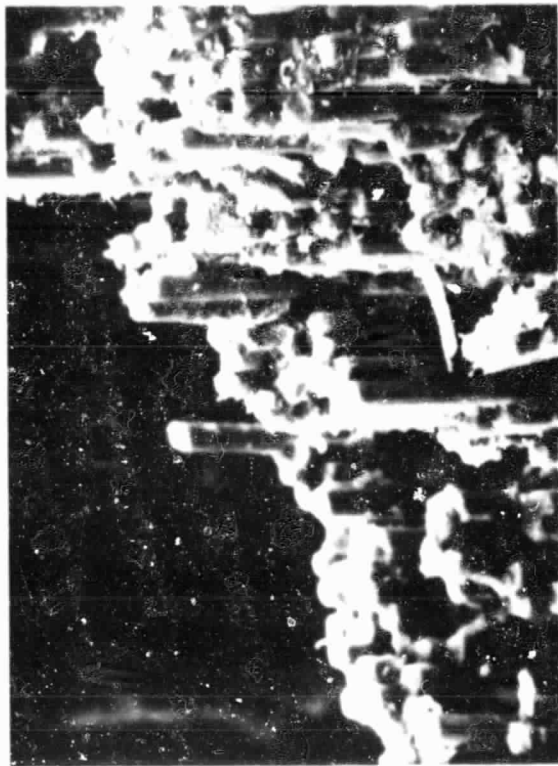
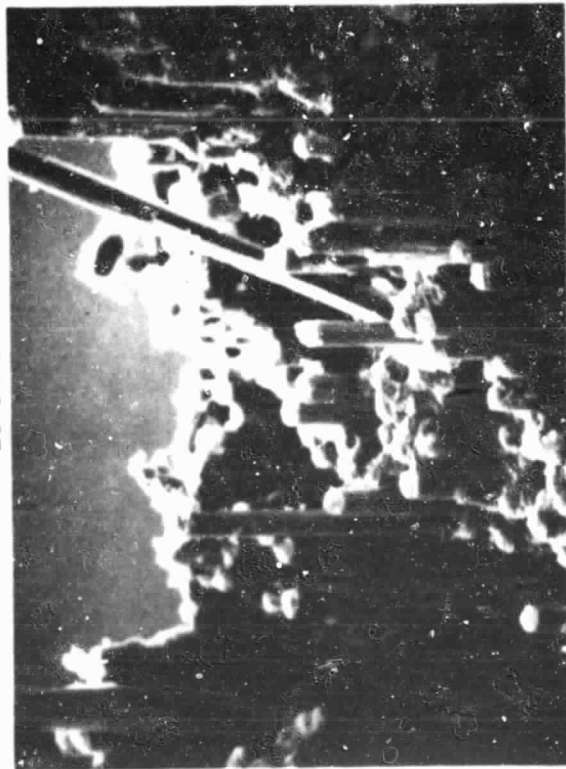
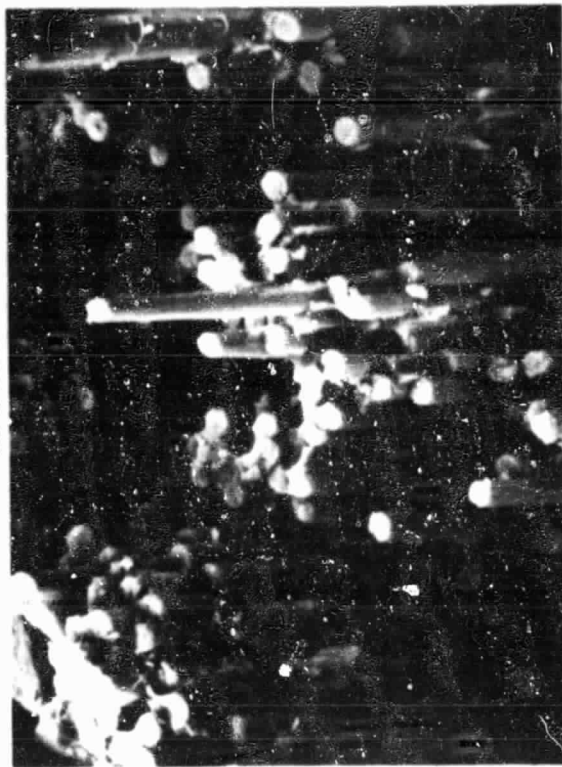
Figure 4.- Representative failure morphologies of unpostcured batch A specimens with polished edges tested at four environmental conditions: (a) 25°C dry, (b) 96°C dry, (c) 25°C wet, and (d) 96°C wet.

Figure 4 shows representative failure morphologies for unpostcured batch A specimens with polished edges at the four environmental conditions considered. It should be noted that while a representative micrograph is given for 96°C wet, early end-tab failures on many of the specimens cast doubt upon all of the strength data at this condition. Thus, Clements and Lee did not report 96°C wet strength in Ref. 1. (The data we show in Tables 1 and 2 are taken from their raw data.)

In examining Fig. 4, it is also important to remember that there was considerable specimen-to-specimen and area-to-area variation in morphology for all conditions. Thus, these micrographs in no way represent the diversity of morphologies encountered at any environmental condition, but rather are typical of the most common or average morphology at that condition.

There is another difference, on the average, between the morphologies at the two conditions, however. At 25°C wet the filaments protruding from the failure surface tend to be cleaner and longer than at 25°C dry. The micrographs of Figs. 4a and 4c illustrate this difference. This observation is consistent with increased interfacial debonding between filament and matrix. Since the longitudinal tensile strength nonetheless increases, either the increased interfacial debonding does not weaken the overall composite, or any weakening is offset by decreased flaw sensitivity.

The influences of temperature and moisture are combined at 96°C wet. As is shown in Fig. 4d, at this condition the failure morphology contains many bare filaments - filaments that are longer and considerably cleaner than those at 25°C wet. Such long clean filaments are often considered to be filament "pull-outs," but, as is seen in Fig. 5a, there are few corresponding pull-out holes. Figure 5b demonstrates the reason for this discrepancy. The epoxy between filaments has not only debonded but has also broken up and fallen away. We thus conclude that the combined influence of temperature and moisture

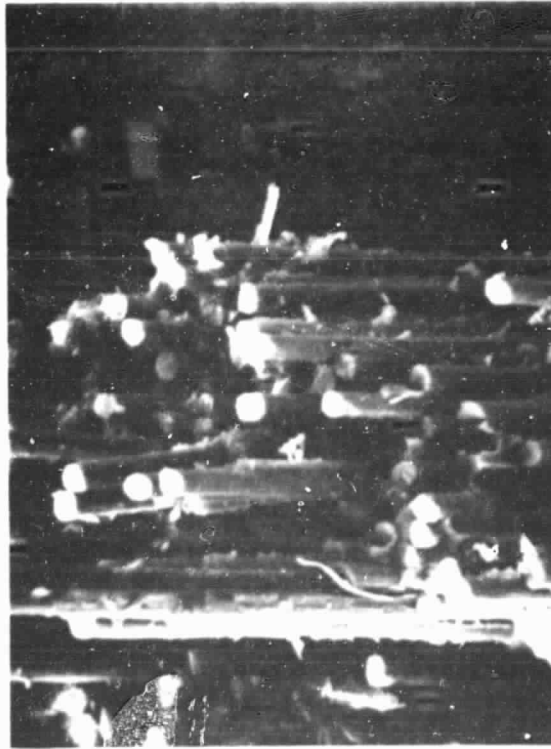
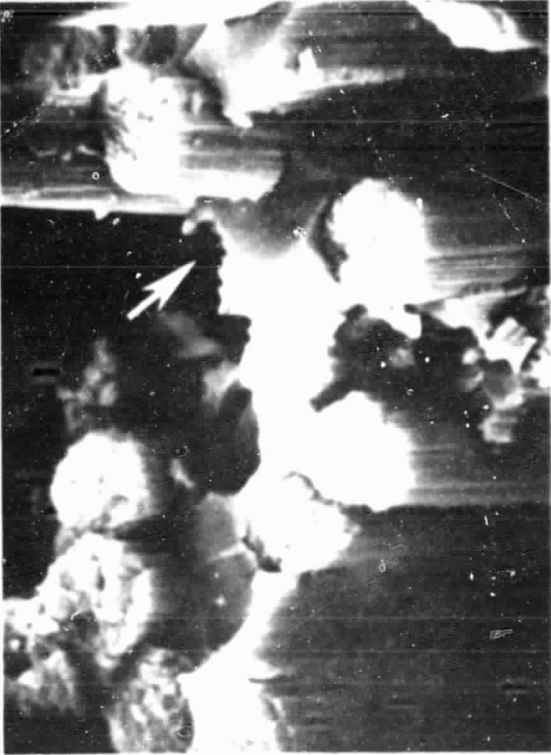
Figure 5.- Scanning electron micrographs of failure surfaces of unpostcured batch A specimens with polished edges tested at 96°C wet. (a) shows long clean filaments but few "pull-out" holes, and (b) shows epoxy that has broken up and is ready to fall away (arrow).

The 96°C wet specimens tested by Clements and Lee actually differed from the 25°C wet specimens in a respect other than temperature. All of their specimens were held at 25°C until shortly before mechanical testing. Adamson [3] has shown that, for temperatures below the conditioning temperature at which moisture was introduced (60°C in this case), the saturation moisture content of graphite/epoxy specimens is inversely proportional to temperature. Thus, as was confirmed by weight-gain studies of Clements and Lee's specimens, their specimens saturated at 60°C picked up yet more water at 25°C. Furthermore, the resulting saturation (or near saturation) moisture content achieved at 25°C is greater than the saturation moisture content at 96°C. Thus, when the temperature of wet specimens held at 25°C was increased, a condition of supersaturation was introduced. Thus, in spite of the essentially 100% humidity of the mechanical test at 96°C wet, desorption would have occurred (and would have continued for several days). During this period of supersaturation, particularly with the aid of the applied tensile stress, covalent bonds may have been broken. Thus, first microcracking and then the type of epoxy cracking shown in Fig. 5b may have resulted.
