Endurance Test with Large-Bore Tapered-Roller Bearings to 2.2 Million DN

ENDURANCE TESTS WITH LARGE-BORE TAPERED-ROLLER
BEARINGS TO 2.2 MILLION DN

by Richard J. Parker

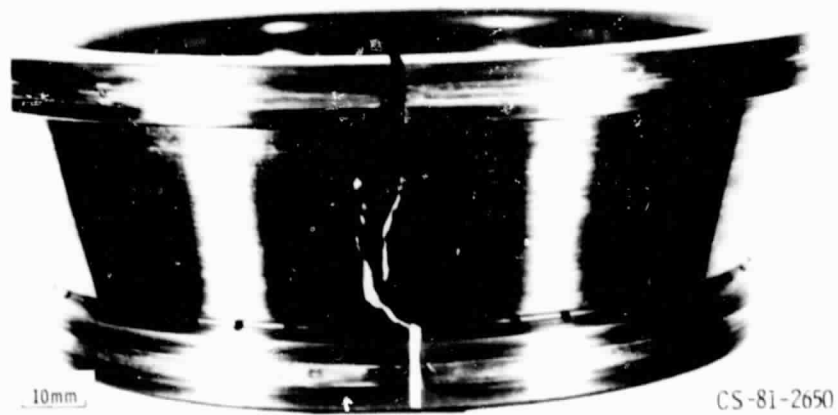
Figure 7. - Fractured cone of AISI M-50 bearing S/N 78-10 after 188 hours of operation at 18 500 rpm.

The cone of bearing S/N 78-10, with the complete fracture, is shown in figure 7. A portion of the initial crack and advanced stages of fracture are shown in figure 8. Initial crack dimensions are approximately 22 mm (0.87 in.) long and 6 mm (0.24 in.) deep.

Fatigue spalling is noted in figures 5 and 7 adjacent to the cracks. It is believed that the fatigue cracks, related initially to the spalling pro-

cess, propagated at an accelerated rate due to the presence of the superimposed high hoop tensile stress field in the cones. In the case of bearing serial number 78-10, the crack propagated to its critical value and destructive fracture occurred. Fortunately, the test rig was shut down before complete fragmentation of the cone occurred. The crack in bearing S/N 78-9, although at an advanced stage, had not yet reached the critical fracture stage.

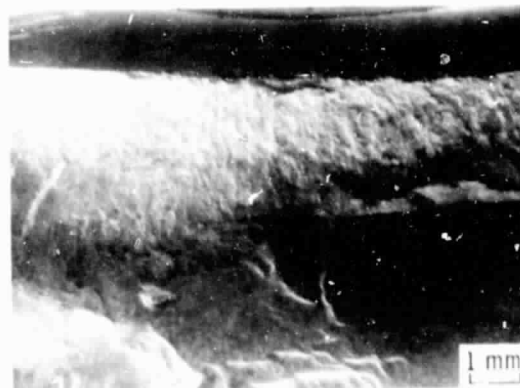
RACEWAY
SURFACE

INITIAL
CRACK

ADVANCED
STAGE OF
FRACTURE

Figure 8. - Photomicrograph of cone raceway crack on AISI M-50 bearing S/N 78-10 after 188 hours of operation at 18 500 rpm.

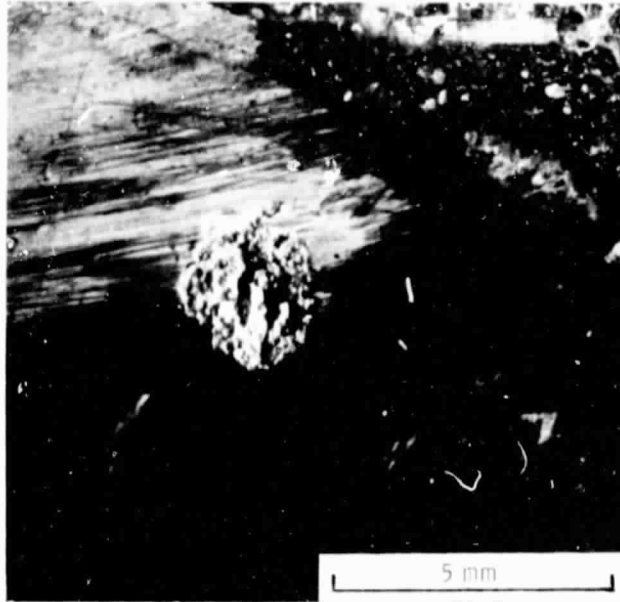
Figure 9. - Fatigue spall on cone raceway of CBS-1000M bearing S/N 76-17 after 135 hours of operation at 18 500 rpm.

CBS 1000M bearing tests. - Five computer optimized, high-speed design tapered roller bearings made of case-carburized CBS 1000M material were also life tested at conditions identical to those of the AISI M-50 bearings. Four of these bearings ran to the 1100 hour cutoff time without failure. One test resulted in a severe failure of one test bearing after 135 hours as a result of failure detection and shutdown system malfunction. The extent of damage was too great to determine the origin or cause of the failure. However, close observation revealed at least two spalls in the cone raceway. The largest spall is shown in figure 9. No cracks or fracture of the cone were observed although considerable damage to the raceway, cone rib and cage occurred. This result offers some, although admittedly meager, evidence that a high-temperature, case-carburized material such as CBS 1000M can resist fracture or cracking at conditions of high tensile hoop stress after spalling and significant cone raceway damage had occurred.
