NASA Contractor Report 159060

Manufacturing Development of DC-10 Advanced Rudder

MCDONNELL DOUGLAS CORPORATION
DOUGLAS AIRCRAFT COMPANY
LONG BEACH, CALIFORNIA 90846

15. Supplementary Notes	
16. Abstract This is the final technical report covering design, manufacture and ground test activities during development of production methods for an advanced composite rudder for the DC-10 transport aircraft.

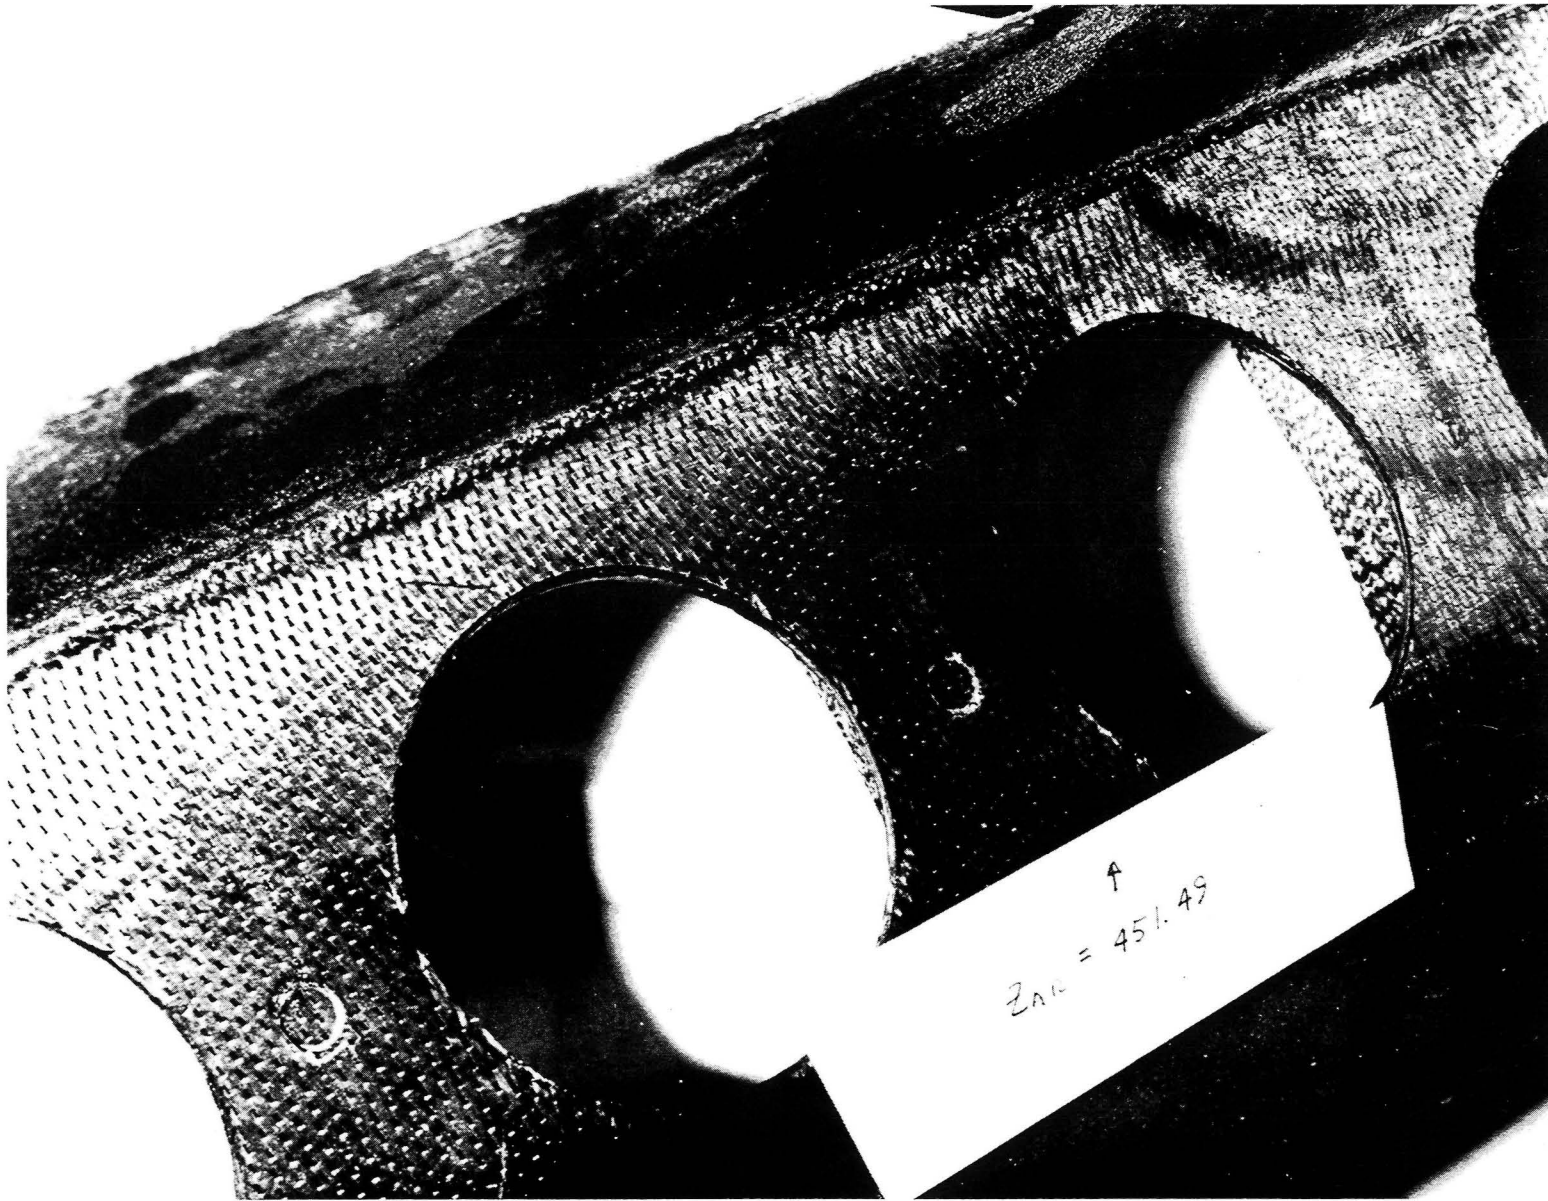
FIGURE 24. FRONT SPAR WEB THERMOCOUPLE INDENTATIONS

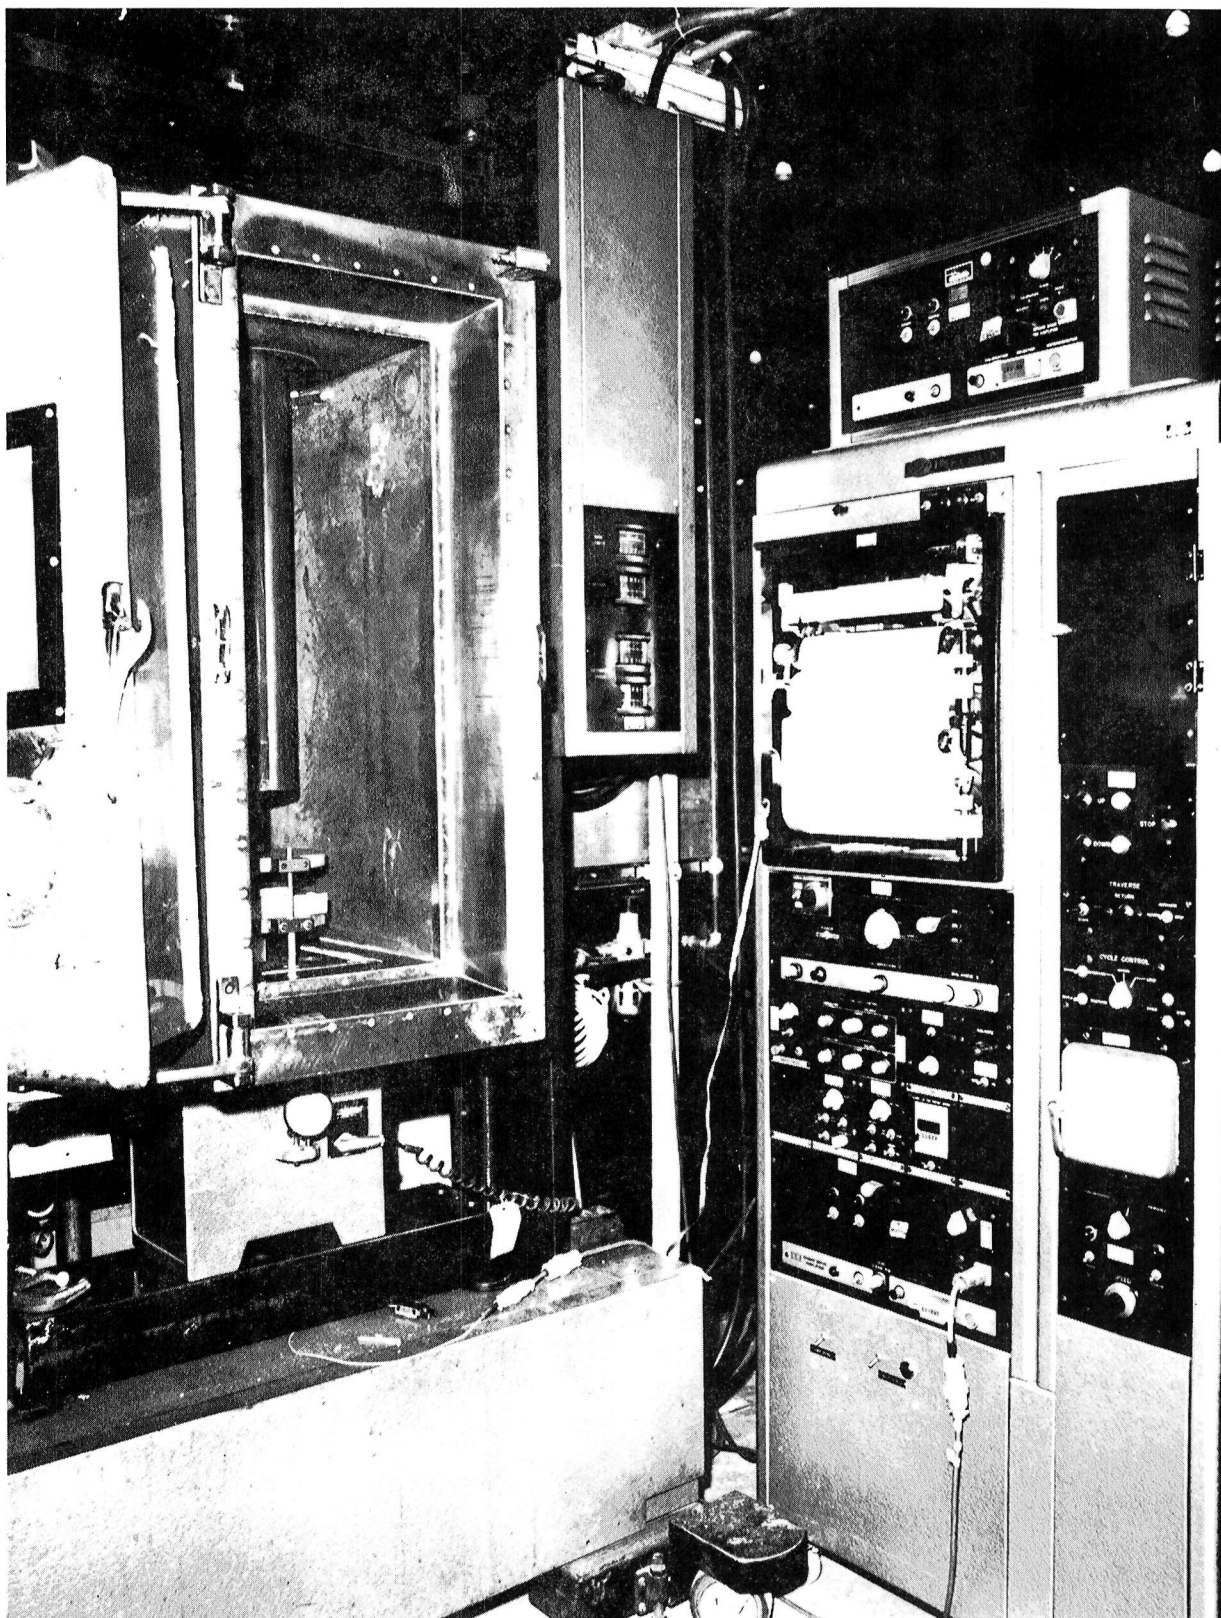
FIGURE J-6. OVEN AND INSTRON RECORDING AND CONTROL BOARD
