NASA Technical Memorandum 81974

THUNDERSTORM HAZARDS FLIGHT RESEARCH -
STORM HAZARDS '80 OVERVIEW

JUNE 1981

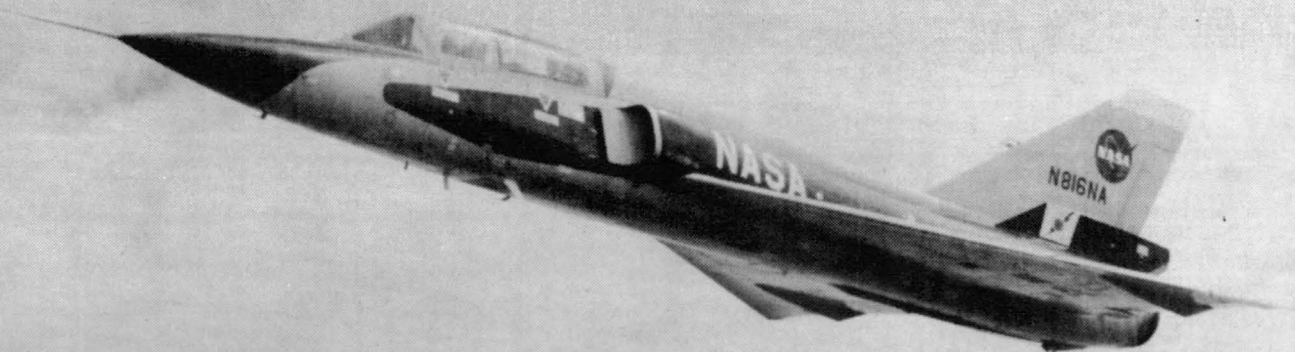
NASA
L-79-7207

Figure 1.- NASA F-106B research aircraft.

The F-106B (Fig. 1) is well suited for thunderstorm research. In addition to its typical all-weather fighter aircraft characteristics, it has a cockpit for two crewmembers and a large internal weapons bay to house the research instrumentation systems. Also, the canopy design provides metal structure above the crew to minimize the possibility of canopy puncture or electric shocks to the crew from lightning. The J-75 engine has proven to be reasonably resistant to flameouts due to ingestion of large amounts of precipitation, and the F-106 has shown itself to be relatively free from lightning strike damage, as compared with other aircraft in the United States Air Force (USAF) inventory. Additional reasons for choosing the F-106B are provided in References 2 and 3.

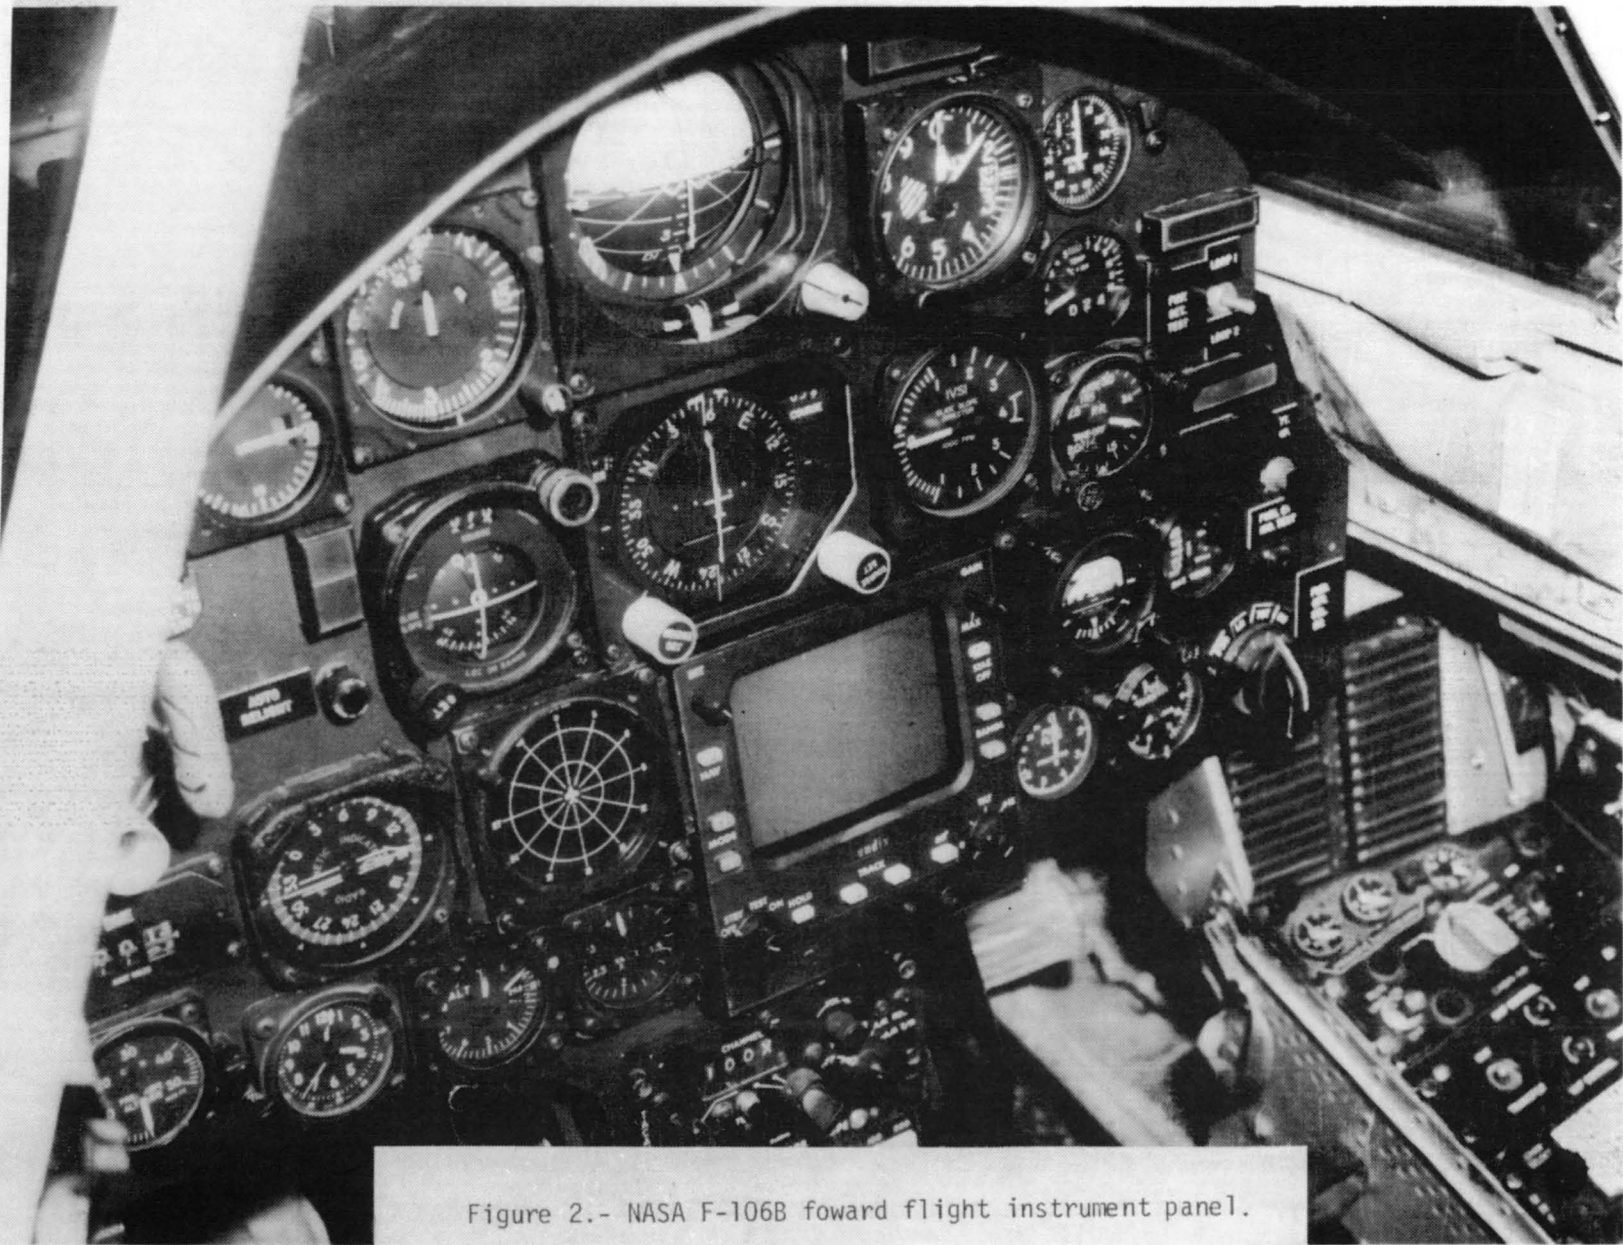
NASA
L-80-3582

Figure 2.- NASA F-106B forward flight instrument panel.

The front and rear instrument panels are shown in Figures 2 and 3.

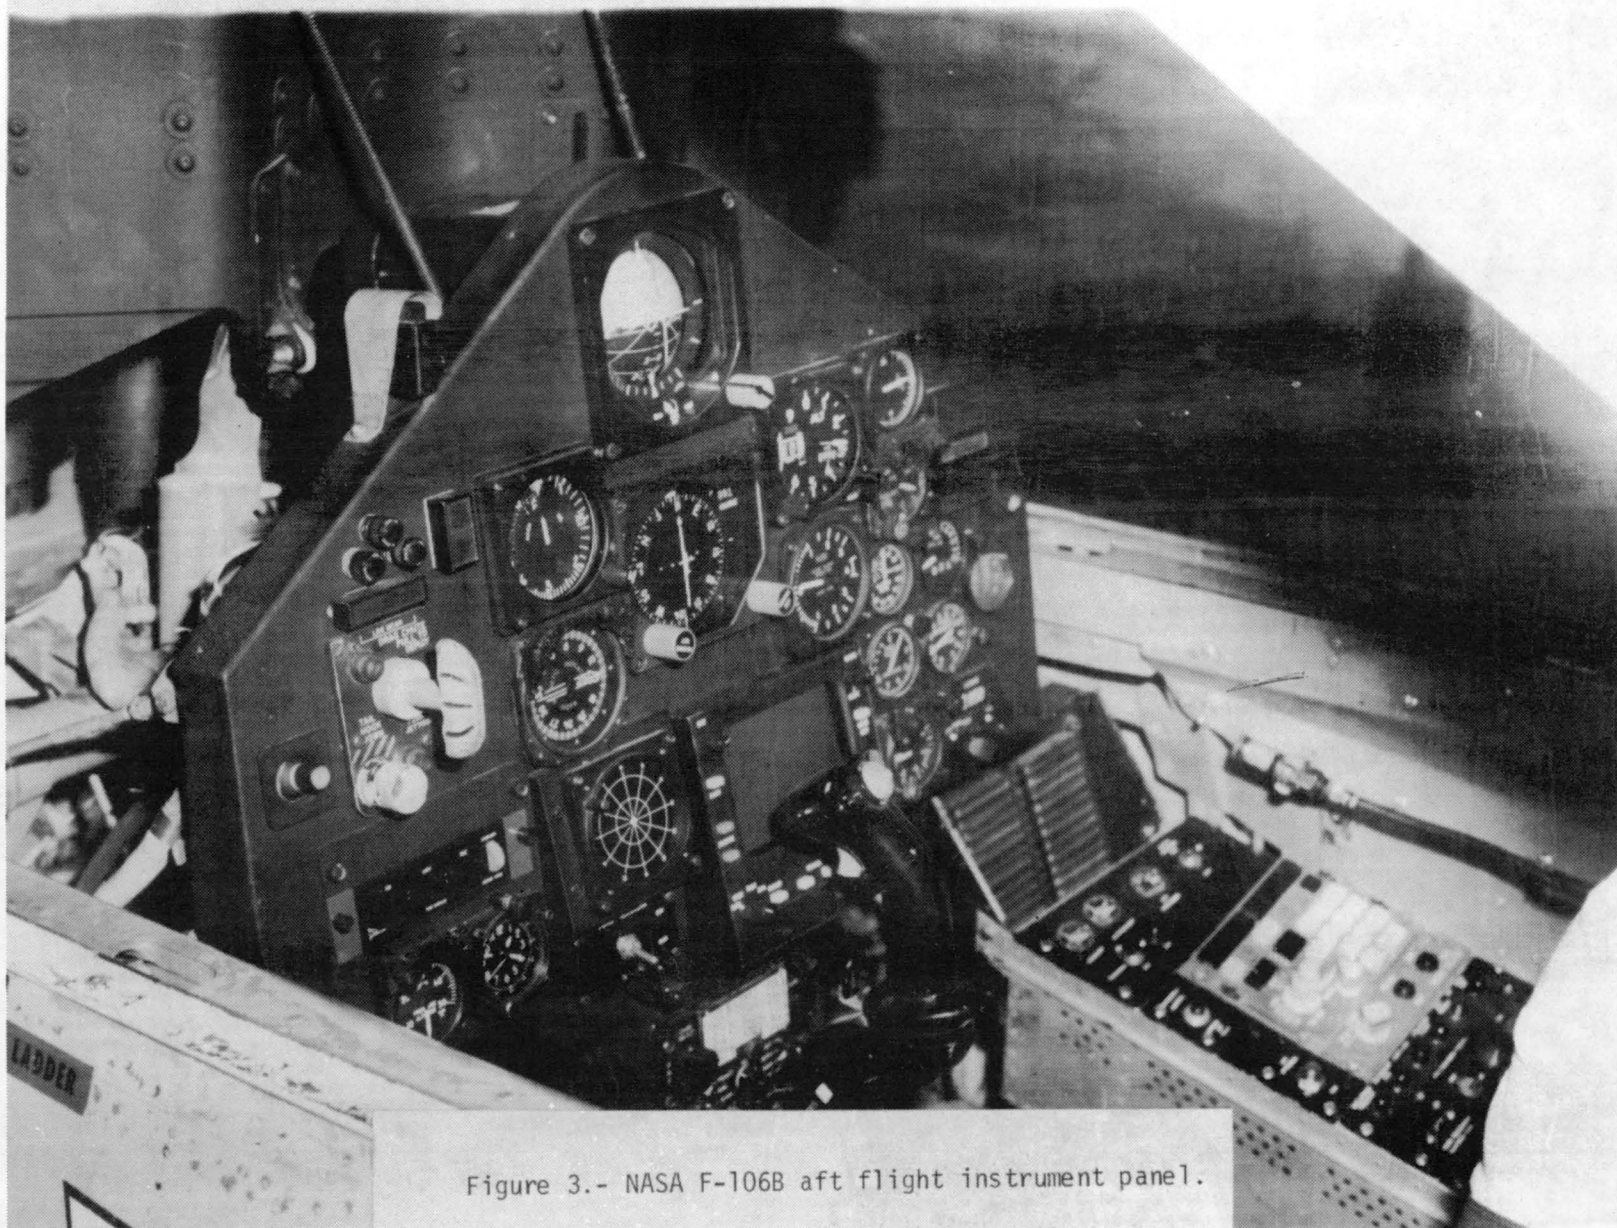
NASA
L-80-3583

Figure 3.- NASA F-106B aft flight instrument panel.

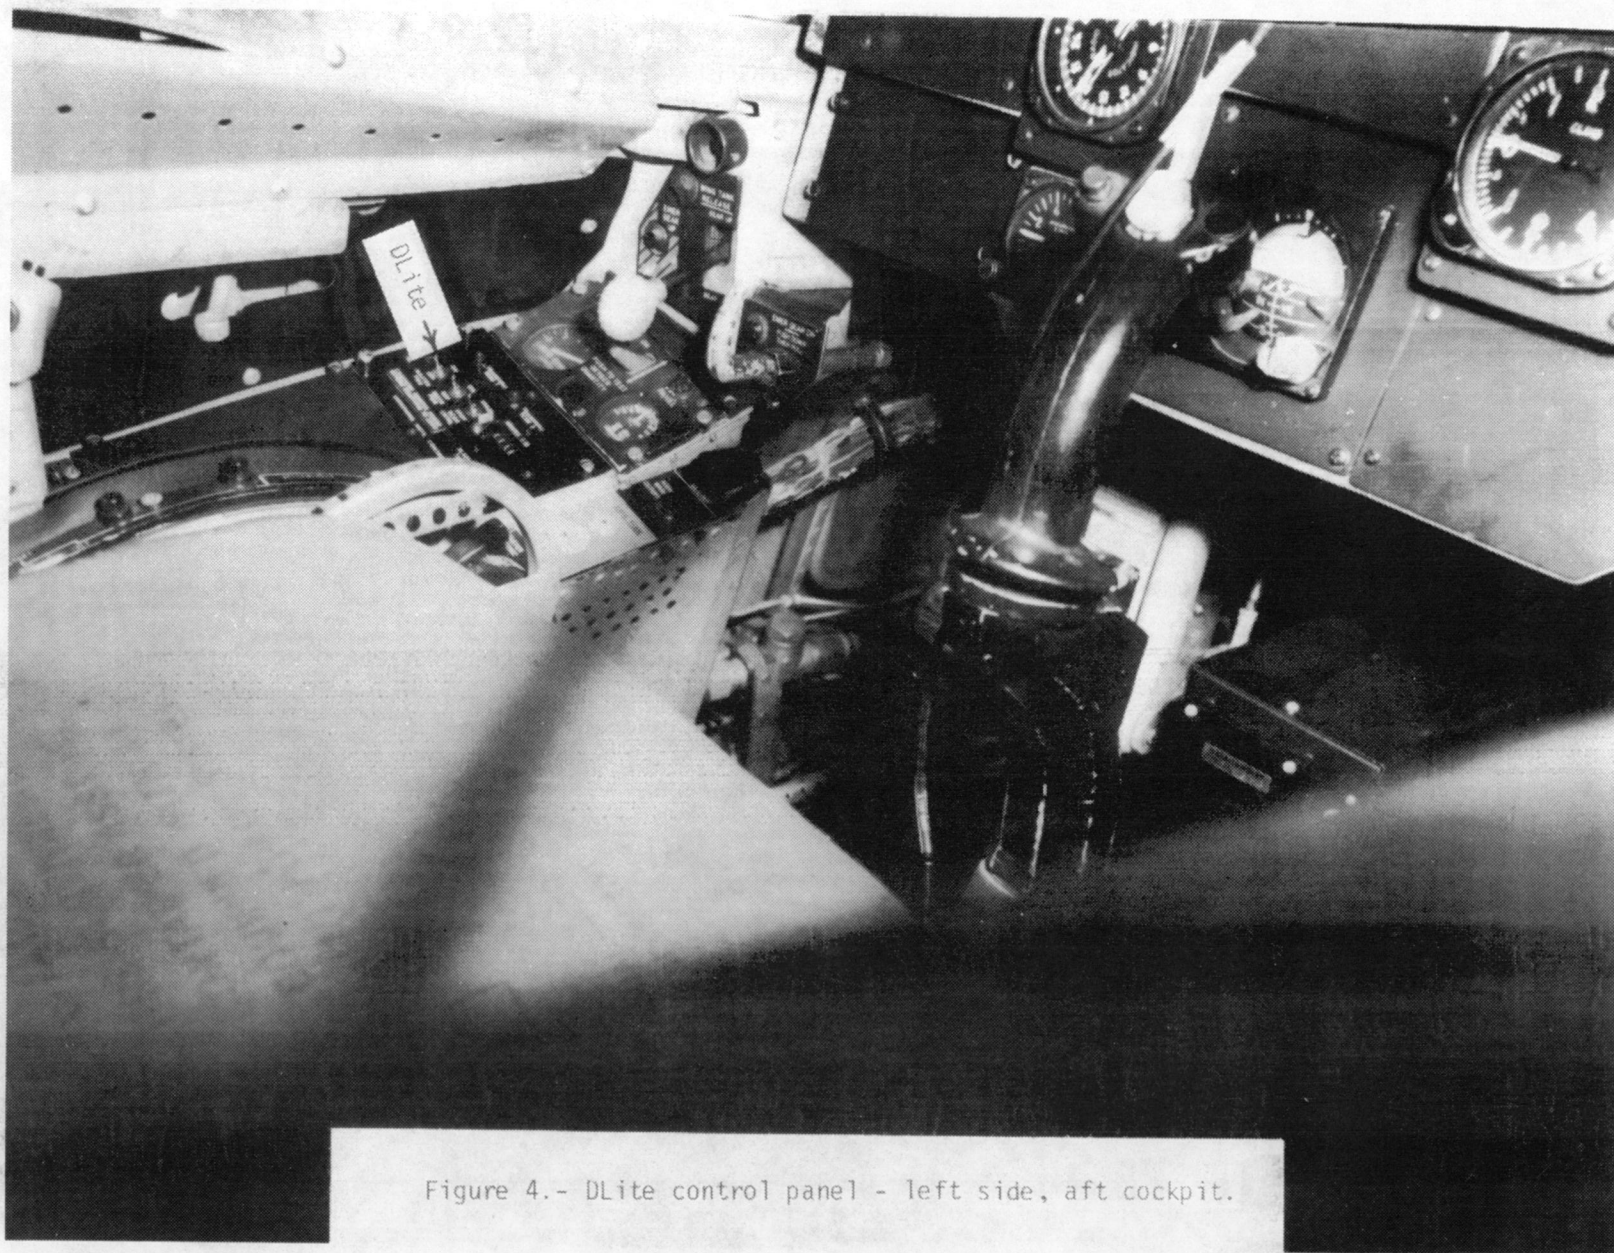
NASA
I-79-6308

Figure 4.- DLite control panel - left side, aft cockpit.

The control panels for all of the research instrumentation and data systems are located in the aft cockpit (Figs. 4 and 5), however, a single master switch is installed in the front cockpit to provide the pilot the capability of eliminating electrical power to all of the research data systems in case of an emergency. Rather than relocate circuit breakers for remotely located flight critical electrical circuits, paralleled circuit breakers are installed in the aft cockpit. These circuit breakers are flown in the open position and could be closed in the event a lightning strike causes one of the remote circuit breakers to open. This safety feature has not been used to date. Another safety precaution is the use of JP-5 or Jet A fuel because the vapor from this fuel is too lean to be ignited at the altitudes where lightning strikes are prevalent, as compared with the more volatile JP-4. External drop fuel tanks are not used because they might provide additional unwanted lightning strike attachment points. Other lightning protection features and modifications are described in Reference 2.

Direct-strike lightning measurement experiment (DLite).- The instrumentation concept consists of seven sensors mounted at strategic points on the aircraft's surface that detect the electromagnetic properties during lightning strikes and a recording system especially shielded and isolated in a lightning instrumentation enclosure located in the weapons bay of the aircraft. All components are tied together by shielded cables and fiber optic links. The DLite control panel is shown in Figure 4, and the recording system is shown in Figure 8.

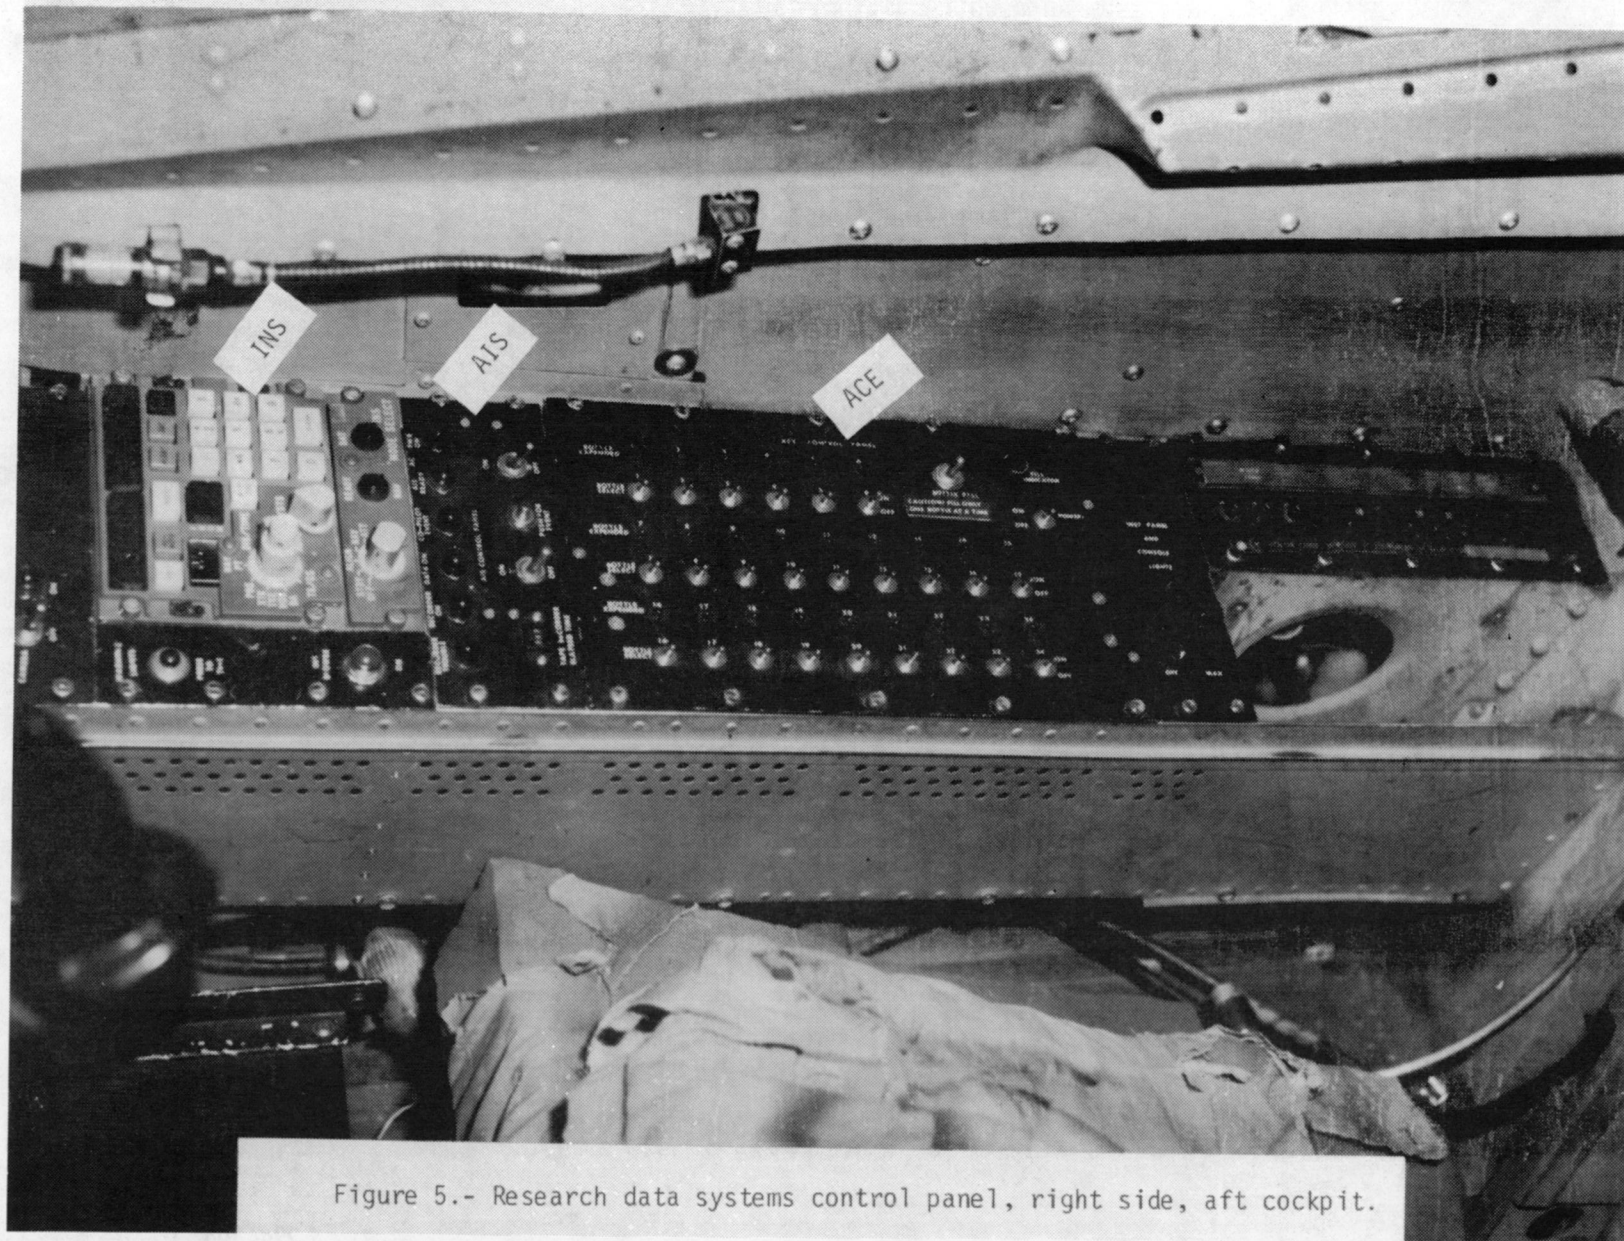
NASA
L-80-3584

Figure 5.- Research data systems control panel, right side, aft cockpit.

The ACE sampling system consists of 24 stainless steel collecting bottles, an air pump and associated plumbing located in the missile bay compartment and a control panel in the aft cockpit. The control panel is shown in Figure 5. As lightning is observed during a thunderstorm penetration, individual bottles are opened and closed remotely from the control panel to collect the air samples.

Turbulence measurements.- The objective is to determine the intensity, frequency content, and spatial location of atmospheric turbulence associated with severe storms by means of in-flight measurements during aircraft penetrations of severe storms. These measurements are correlated with other turbulence intensity measurements obtained from ground-based Doppler weather radars, and with measurements of the other storm hazards such as wind, lightning, and precipitation. The aircraft instrumentation system (AIS) measures and records the aircraft motion, flight parameters and location (through the INS) for the turbulence and wind measurement experiments. Figure 5 shows the AIS and INS control panels in the right side panel of the aft cockpit.

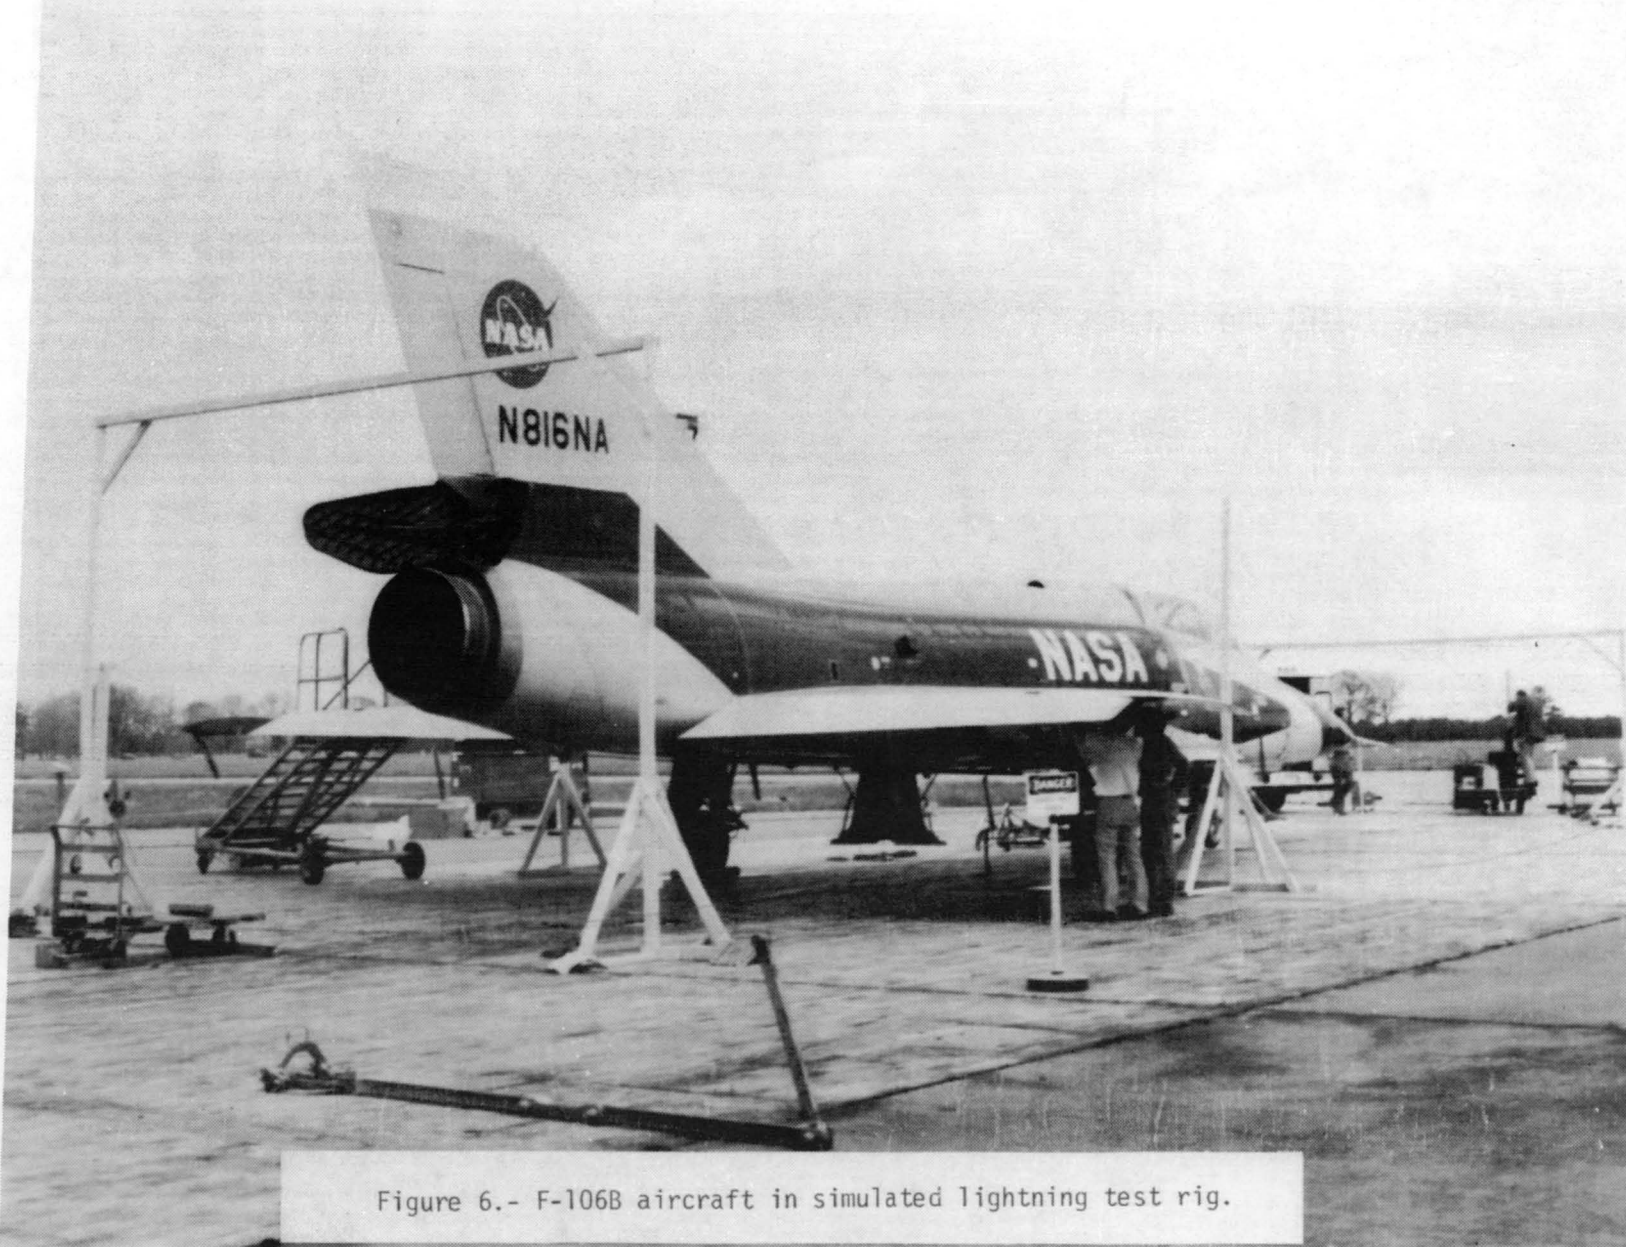
NASA
L-80-2966

Figure 6.- F-106B aircraft in simulated lightning test rig.

A contract was awarded to Lightning Technologies, Inc., to study the storm hazards aircraft and mission from all aspects (hardware, software, procedures, and techniques) and make recommendations to insure maximum flight safety relative to lightning hazards (Ref. 3). The U.S. Air force Rough Rider personnel, who had been making thunderstorm penetration flights for 20 years, were also consulted to take advantage of their experience in operating procedures and in hardening aircraft for thunderstorm penetration flights. After all aircraft and data systems were prepared, Lightning Technologies, Inc., conducted a series of simulated lightning strike tests to obtain additional assurance that the aircraft was adequately protected. Figure 6 shows the F-106B in the simulated lightning test rig. Electrical currents up to 29,500 amps were applied to the aircraft's noseboom and wingtips with the aircraft manned, engine running, and all normal avionics and research instrumentation systems operating. The simulated lightning tests showed that the on-board systems were protected and afforded an opportunity to verify the operation of the on-board lightning sensors and recording systems.

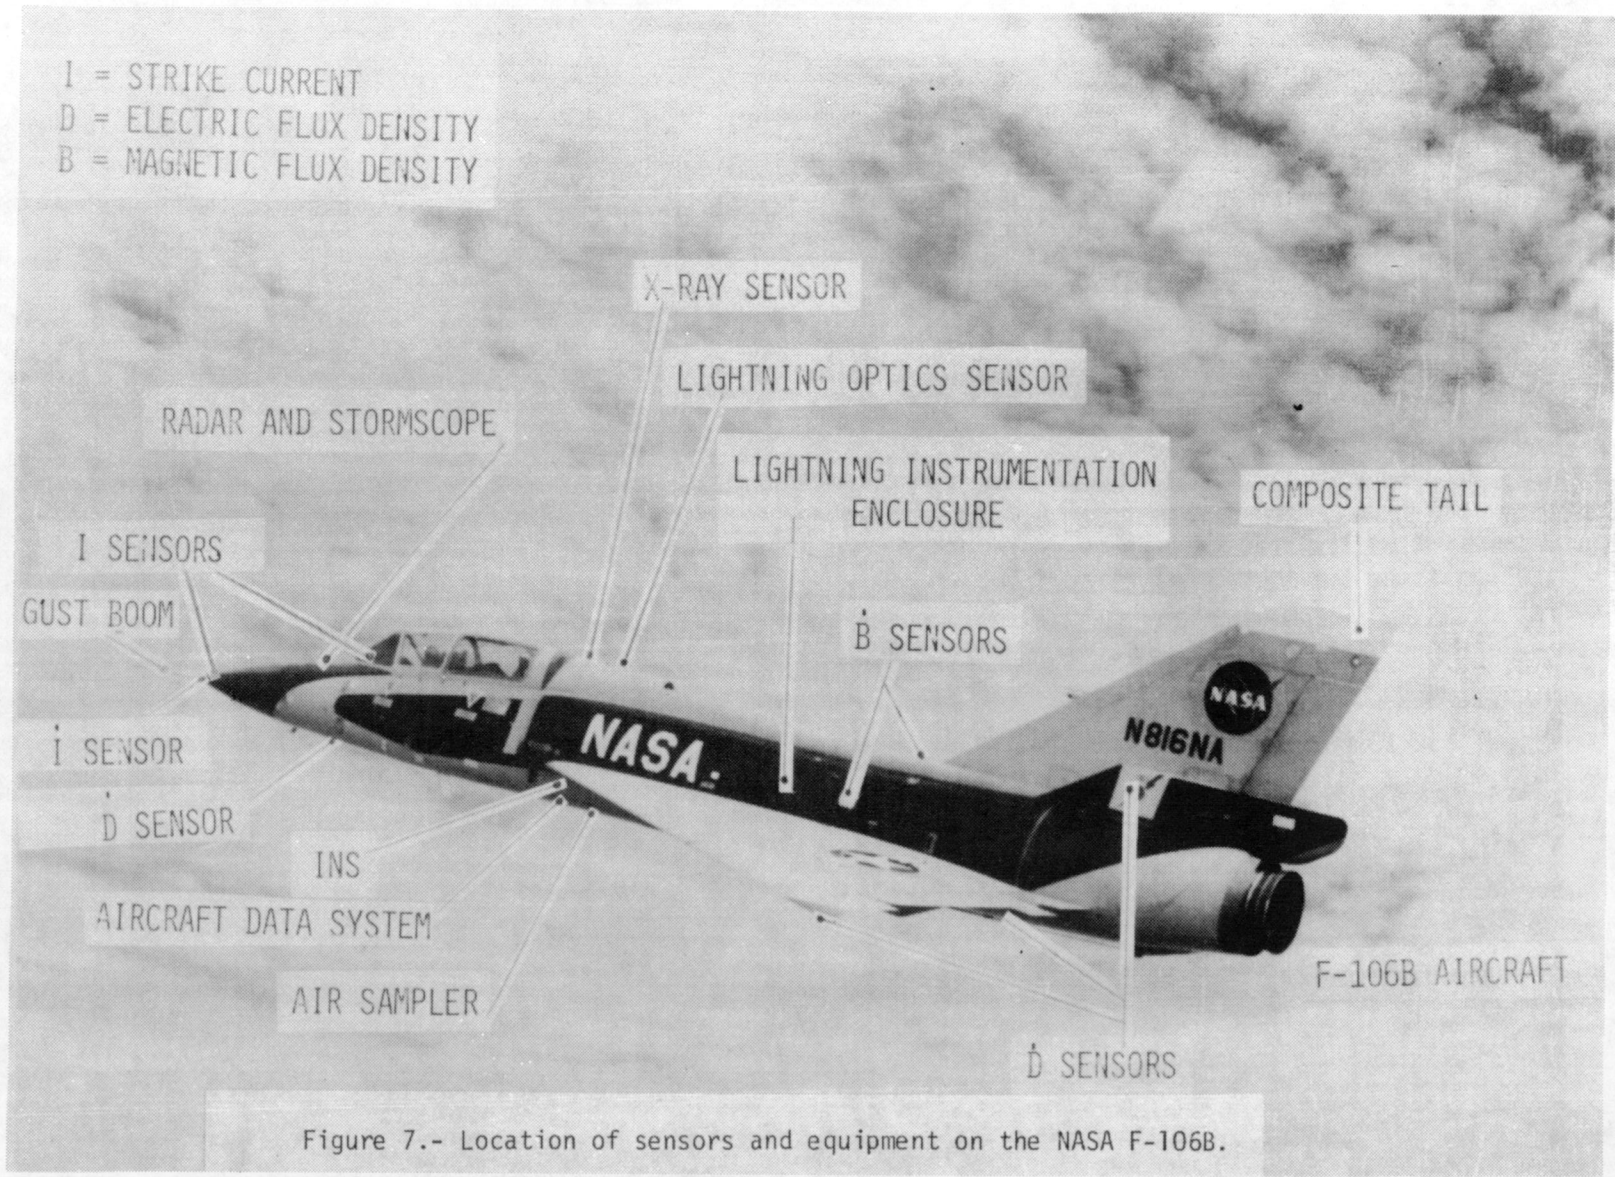
Figure 7.- Location of sensors and equipment on the NASA F-106B.

Figure 7 shows the location of the sensors and other equipment associated with the various experiments.

Lightning X-ray detecting experiment.- This experiment is furnished by the University of Washington and is designed to determine whether lightning produces X-rays, which, in turn, could have an effect on aircraft equipment and passengers. The X-ray detector experiment measures the X-ray flux and energy spectrum within certain ranges from nearby strikes as well as direct strikes to the aircraft. This experiment is activated just prior to engine start before each flight by a manual switch located at the X-ray sensor (Fig. 7).

Lightning optical signature experiment. This experiment is furnished by the NSSL and is designed to record amplitude and frequency of the visible light waveforms generated by lightning inside storms to compare with measurements from the ground. These waveforms will be used to provide fundamental information on optical transients from lightning and to aid in the design of a satellite package for observation of lightning from space. The sensor is located on top of the fuselage aft of the cockpit (Fig. 7).

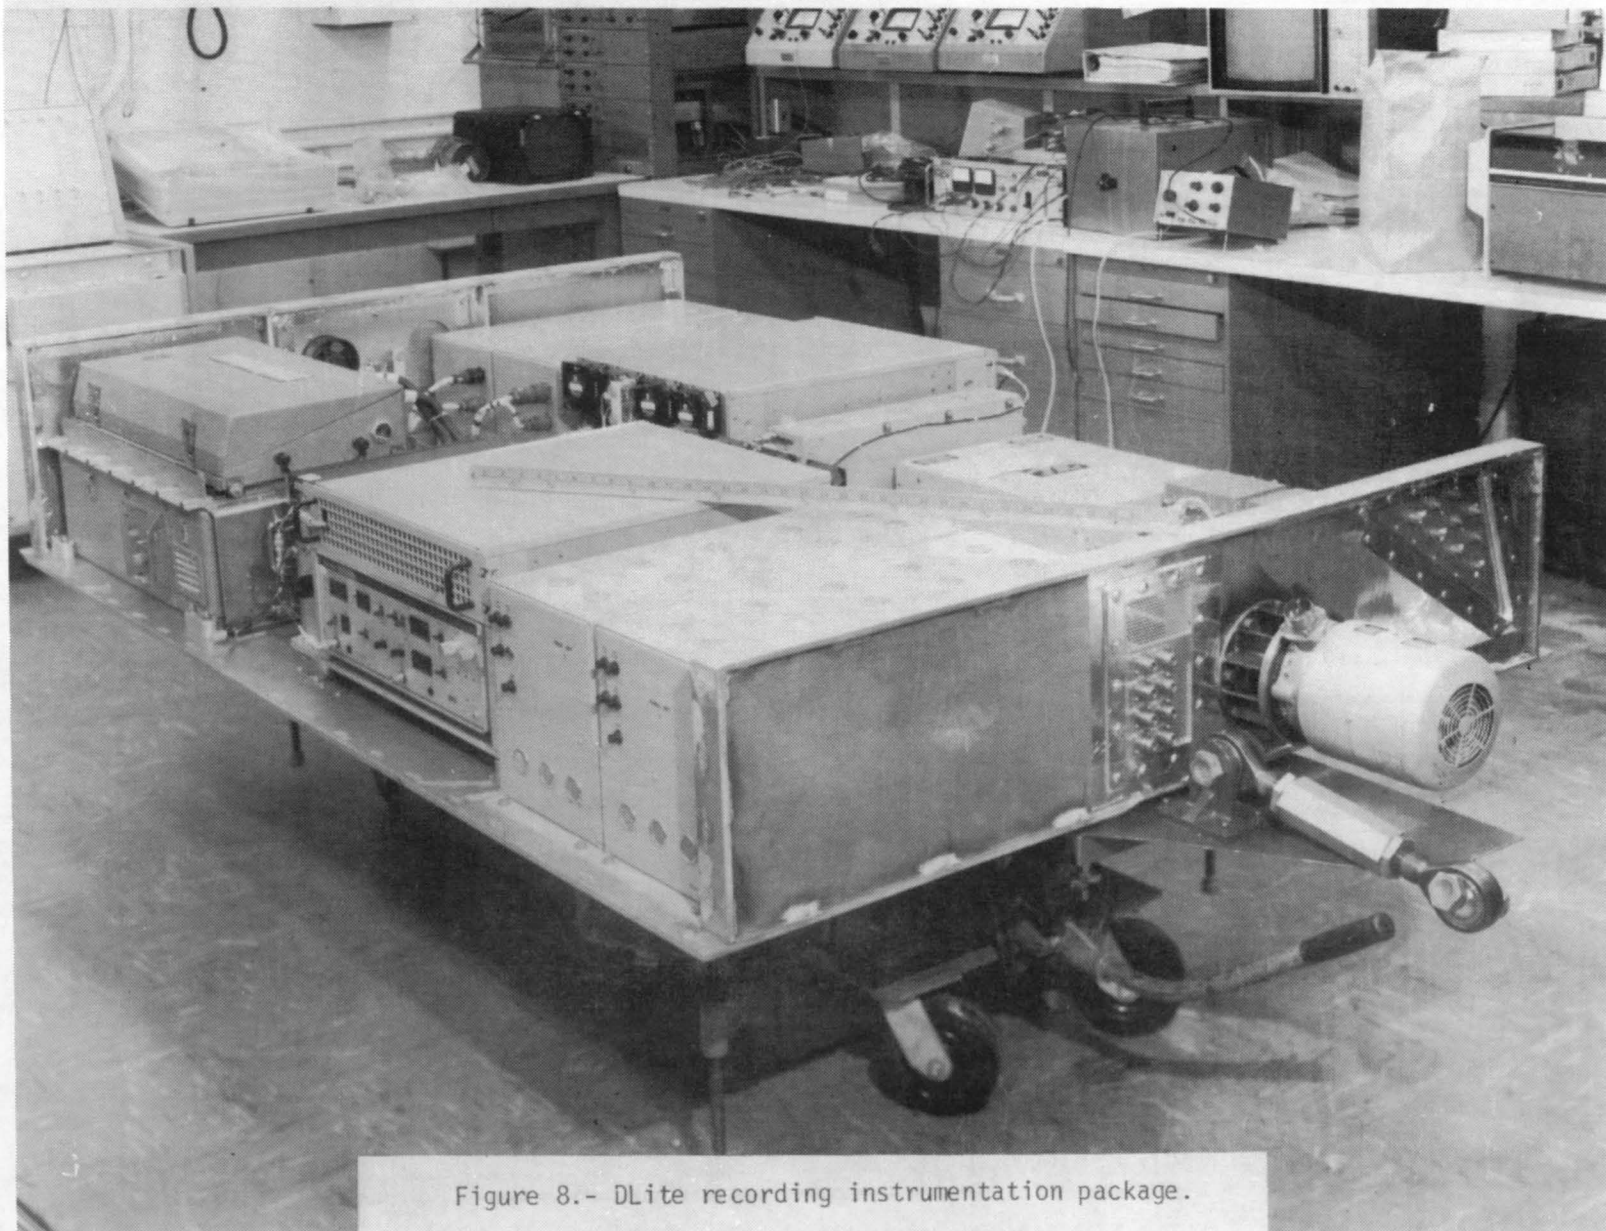
NASA
1-79-5627

Figure 8.- DLite recording instrumentation package.

The recording instrumentation (Fig. 8) in the shielded enclosure includes a wideband (6 MHz) video recorder for overall lightning strike phenomena and two transient waveform recorders modified to capture 1.3 milliseconds of data at a 10-nanosecond resolution. The outputs of both transient recorders are recorded on a single 14-track analog recorder.

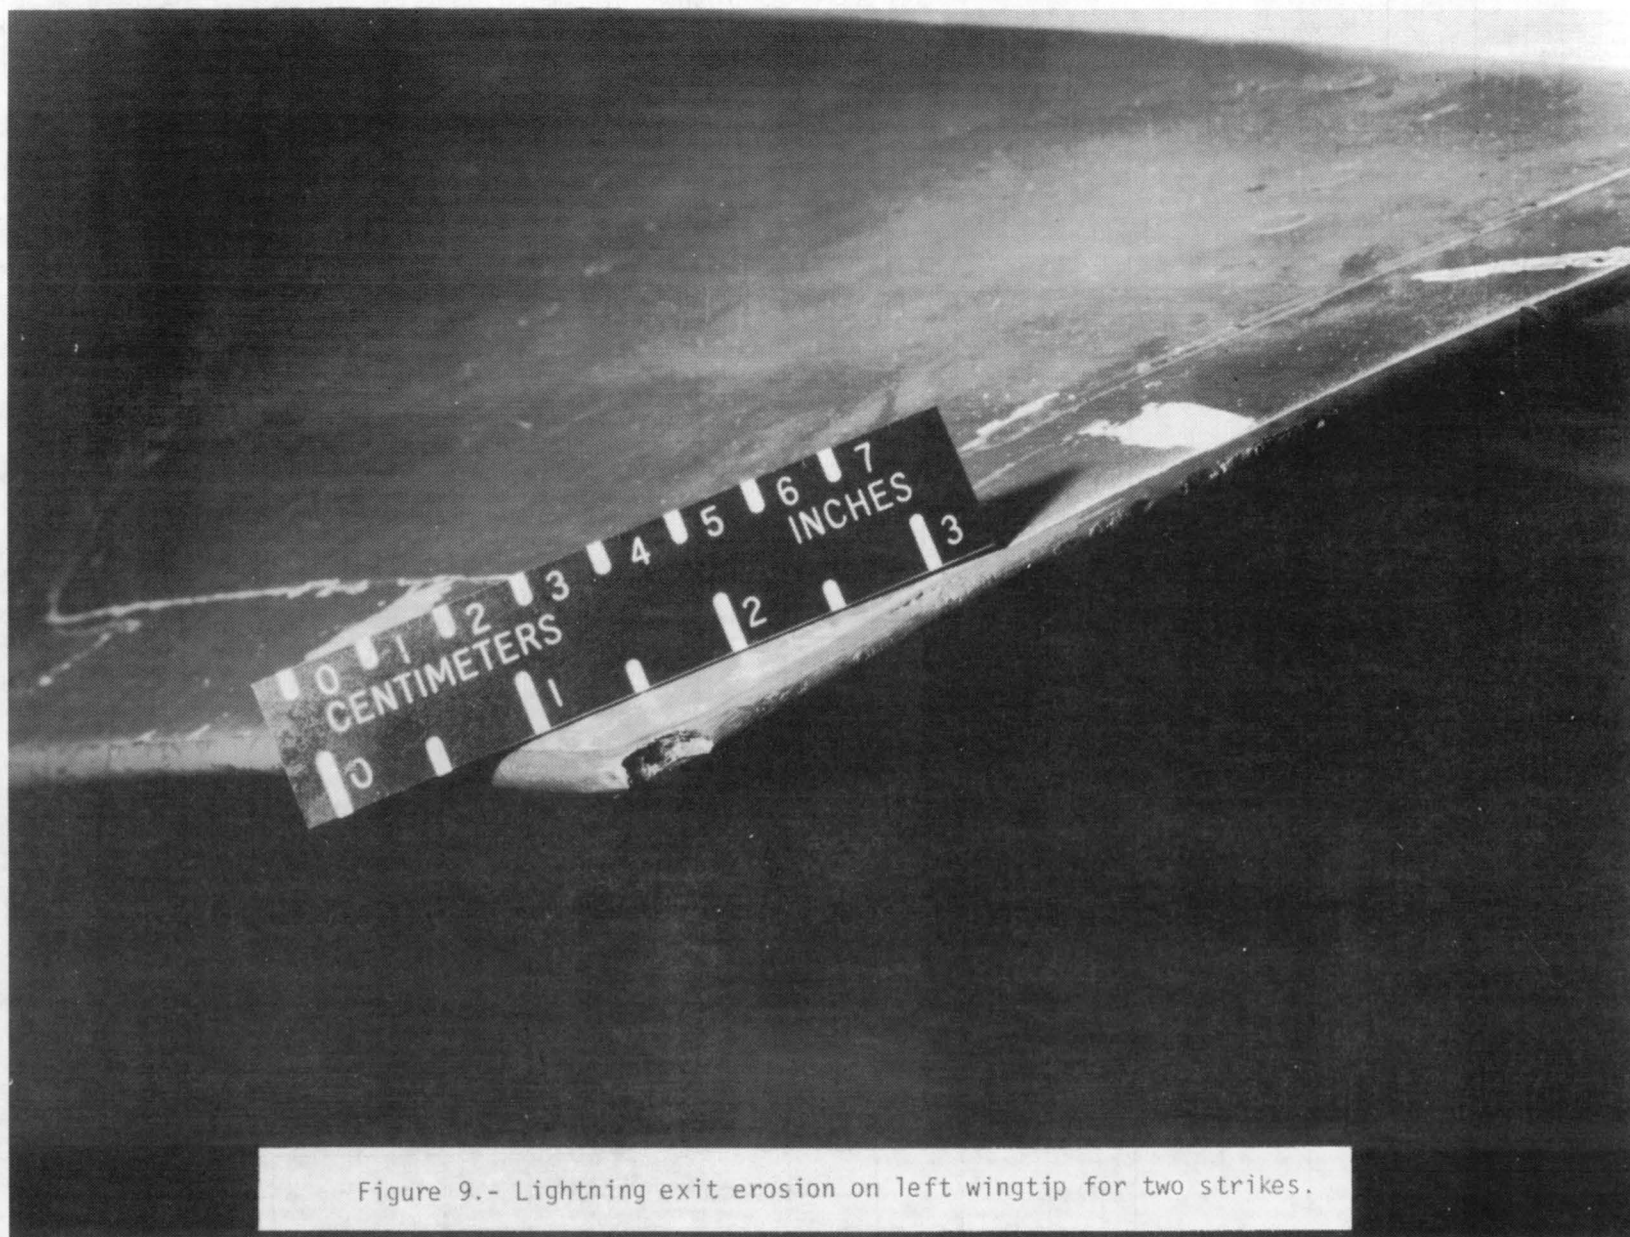
NASA
L-80-5354

Figure 9.- Lightning exit erosion on left wingtip for two strikes.

General.- There were 69 thunderstorm penetrations made during the 1980 program, resulting in 10 direct lightning strikes to the aircraft. The initial attachment point for all 10 strikes was the nose of the aircraft, and eight strikes exited the wingtips, and two exited the vertical tail, aft and below the fin cap. All 10 lightning strikes were considered to be of mild intensity, resulting in only superficial damage to the external surface. Strike attachment points looked like small burn marks; however, the exit points on the tips of the wings and vertical tail showed more erosion, since all of the current must leave the aircraft at one or two exit points. The exit damage to the left wingtip is shown in Figure 9. There were no problems encountered with the aircraft electrical or avionics systems, and the research instrumentation systems performed as designed. After one flight in very heavy rain and turbulence in Oklahoma (no lightning strikes), the inspection revealed that both rotating beacons had been broken, some rivet heads and metal skin edges exposed directly to the wind stream had been peeled back, a crack had developed in the canopy frame, and several small leaks developed in the hydraulic systems' plumbing. Also, the fiberglass radome, which was original equipment on the airplane (23 years old), showed signs of considerable stress and erosion and had to be replaced. The normal acceleration extremes recorded during this flight were approximately 2 g positive and .5 g negative, resulting from the heavy turbulence. On another flight in Virginia,

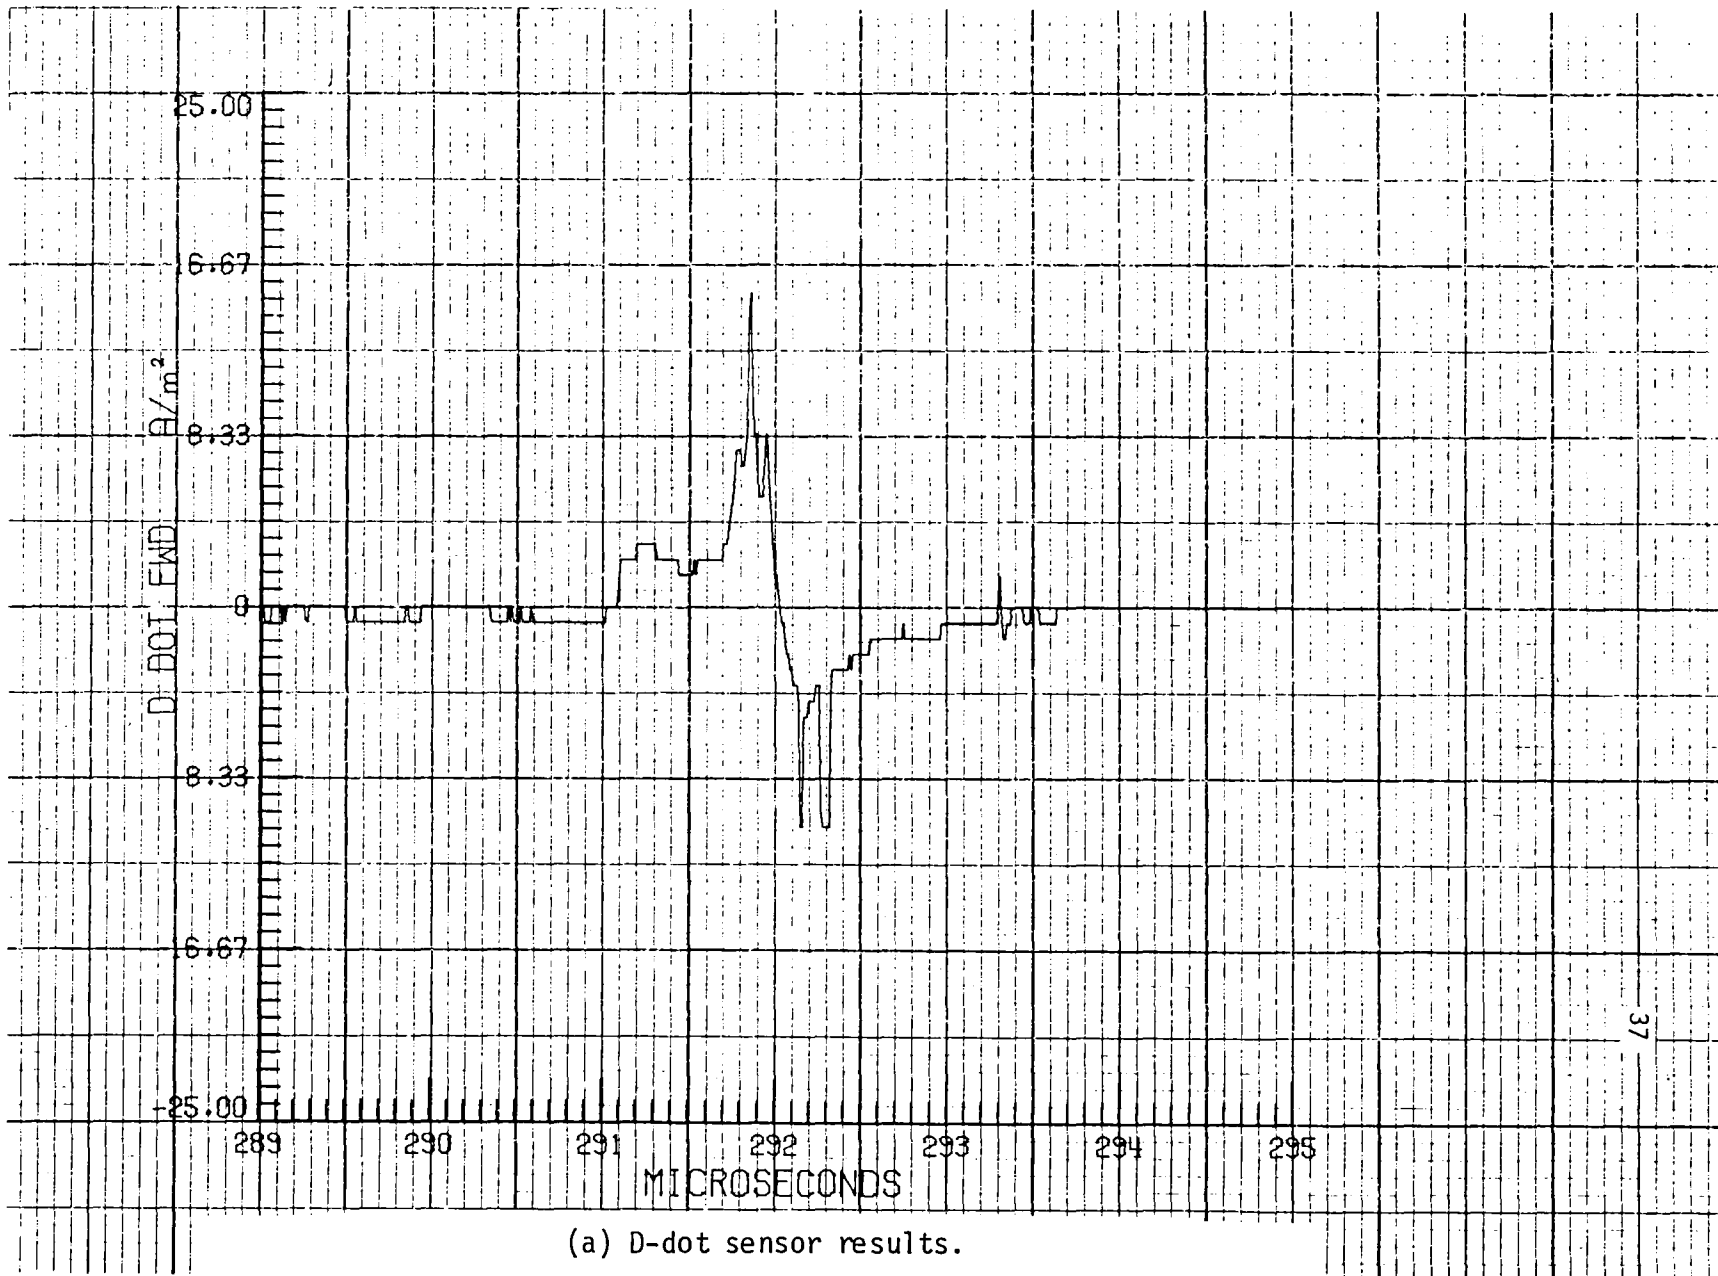
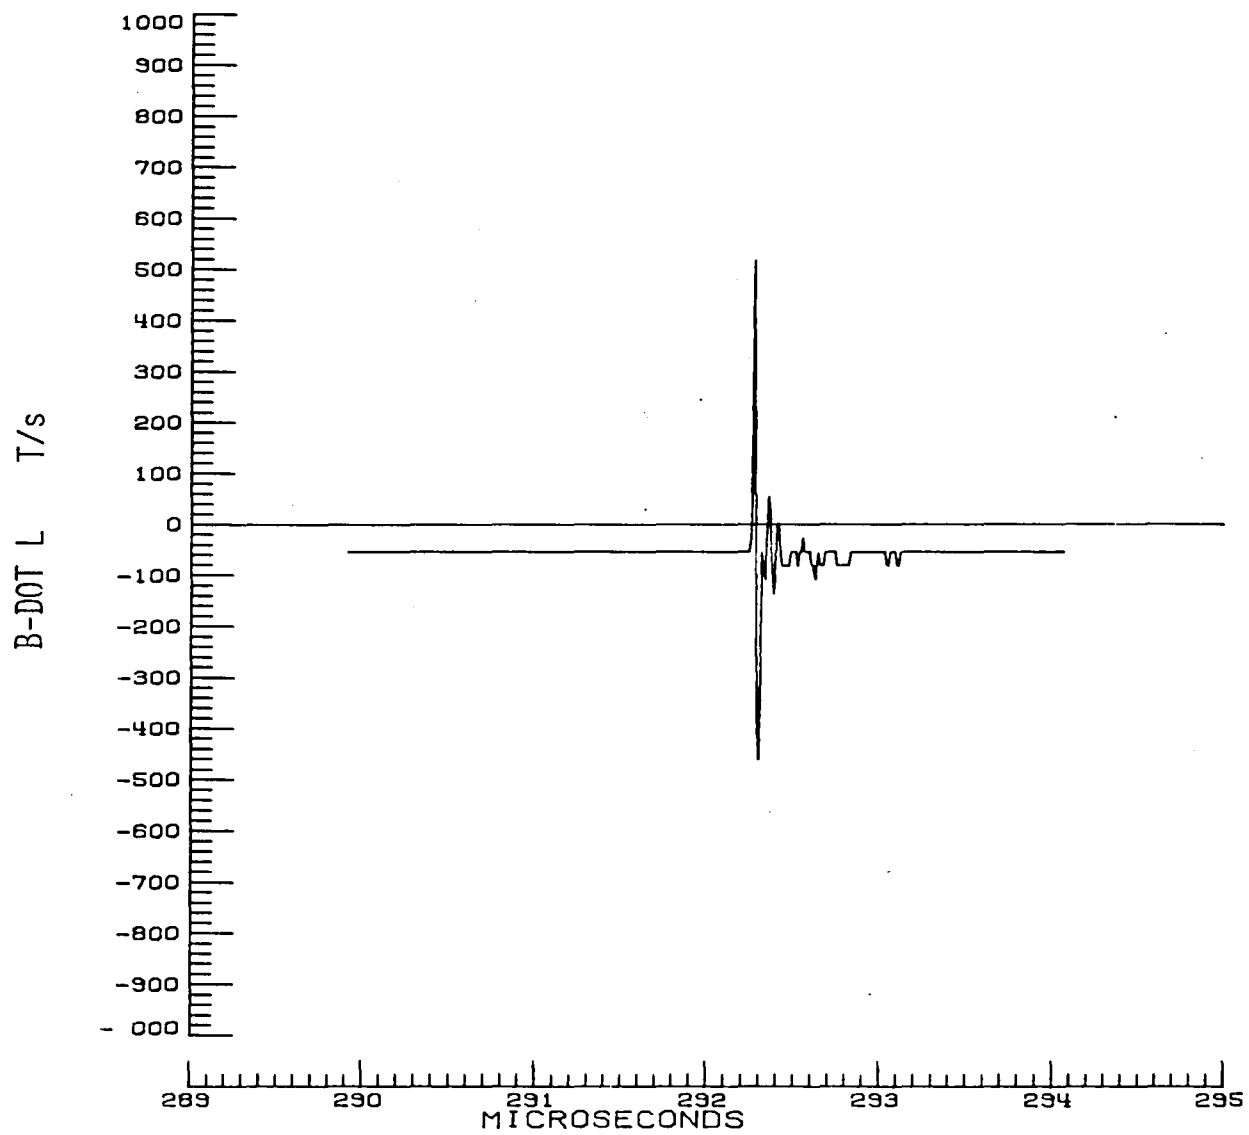
Figure 10.- Representative results from a single lightning strike.

(b) B-dot sensor results.

Direct-strike lightning experiment (DLite).- Interpretation and analysis of the lightning strike data is still in progress; however, Figure 10 shows representative data recorded concurrently from the D-Dot and B-Dot sensors during a single lightning strike to the aircraft. The symbols used on the lightning data figures are as follows:

D-Dot - Amperes per square meter (A/m^2)
B-Dot - Tesla per second (T/s)

Preliminary interpretation of the data in general indicates that significant electric flux density changes (D-Dot) accompany relatively mild intensity lightning strikes; whereas, the magnetic measurement (B-Dot) was low. The magnetic measurement had been expected to be higher to reflect the electromagnetic wave relationship found in free space. The characteristics of the D-Dot waveforms varied with the different lightning encounters; some with fast rising, mostly unipolar waveforms of either polarity and others with slower rising, bipolar waveforms.
